Department of Energy  
Office of Legacy Management

Subject: 2005 Annual Site Inspection and Monitoring Report for UMTRCA Title I Disposal Sites

# **2005 Annual Site Inspection and Monitoring Report for Uranium Mill Tailings Radiation Control Act Title I Disposal Sites**

**December 2005**

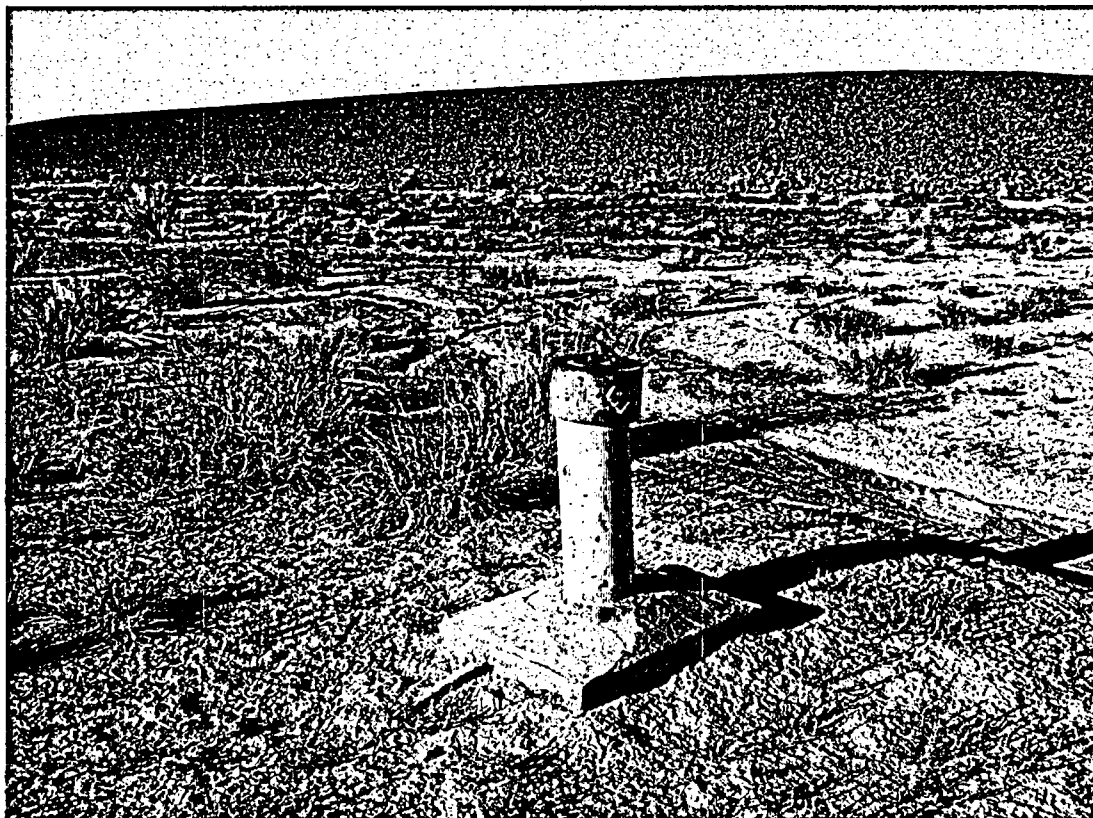
*AMB 8/2005. PL-3. Monitor well MW-0678.*

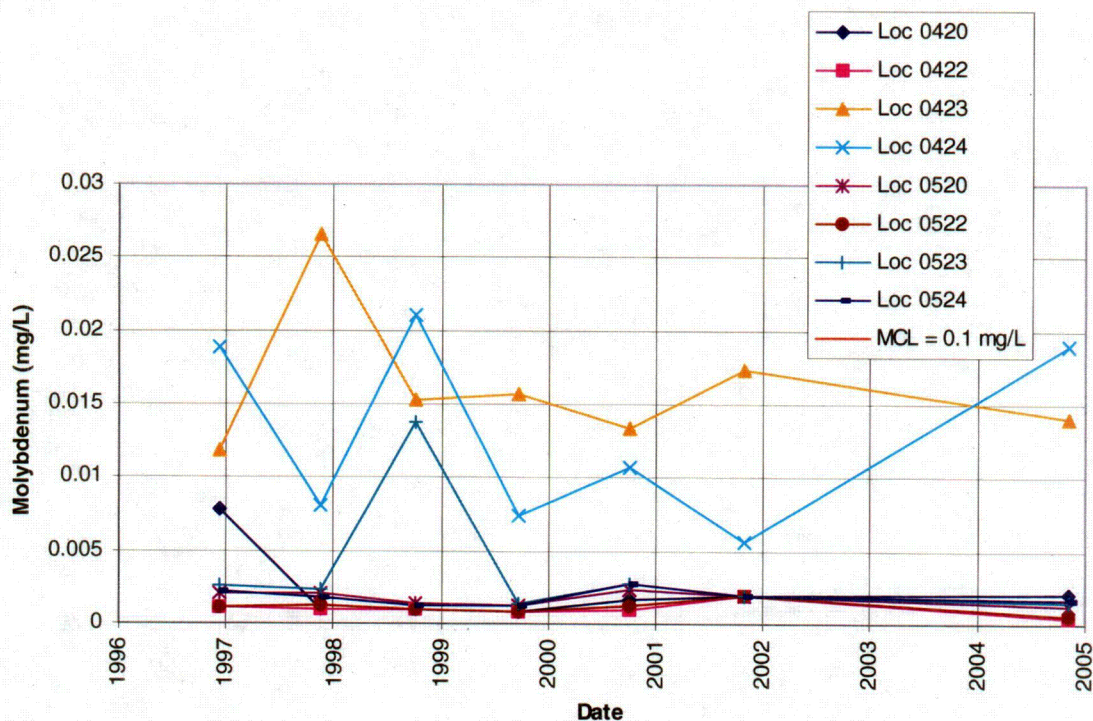
Figure 2-3. Time-Concentration Plots of Molybdenum in Ground Water at the Burrell, Pennsylvania, Disposal Site

Concentrations of molybdenum in ground water in both the shallow alluvial wells (400-series wells) and the deeper bedrock wells (500-series wells) remain well below the MCL; 2004 results from all locations, except downgradient wells MW-0423 and MW-0424, were more than an order of magnitude below and at or near the laboratory detection limit. Concentrations in wells MW-0423 and MW-0424, although still well below the MCL, have fluctuated more than other wells. Since 1996, molybdenum concentrations in all wells have remained within the historical range or have decreased (Figure 2-3).

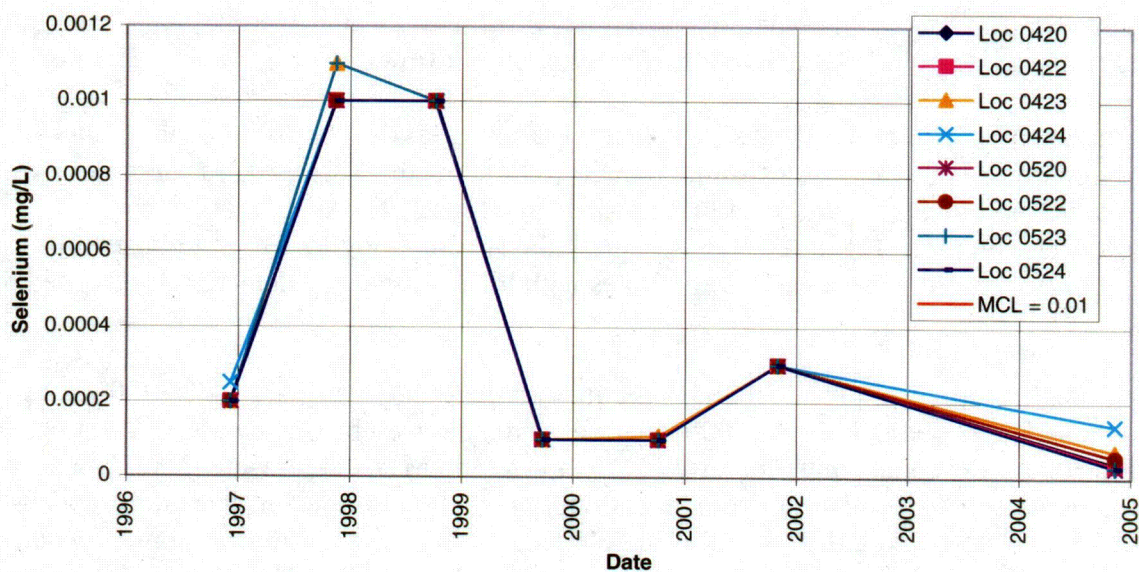
Figure 2-4. Time-Concentration Plots of Selenium in Ground Water at the Burrell, Pennsylvania, Disposal Site

laboratory detection limit (Figure 2-4). Since 1996, an apparent downward trend in selenium concentrations at all wells correlates with the lower laboratory detection limits used over the same time period.

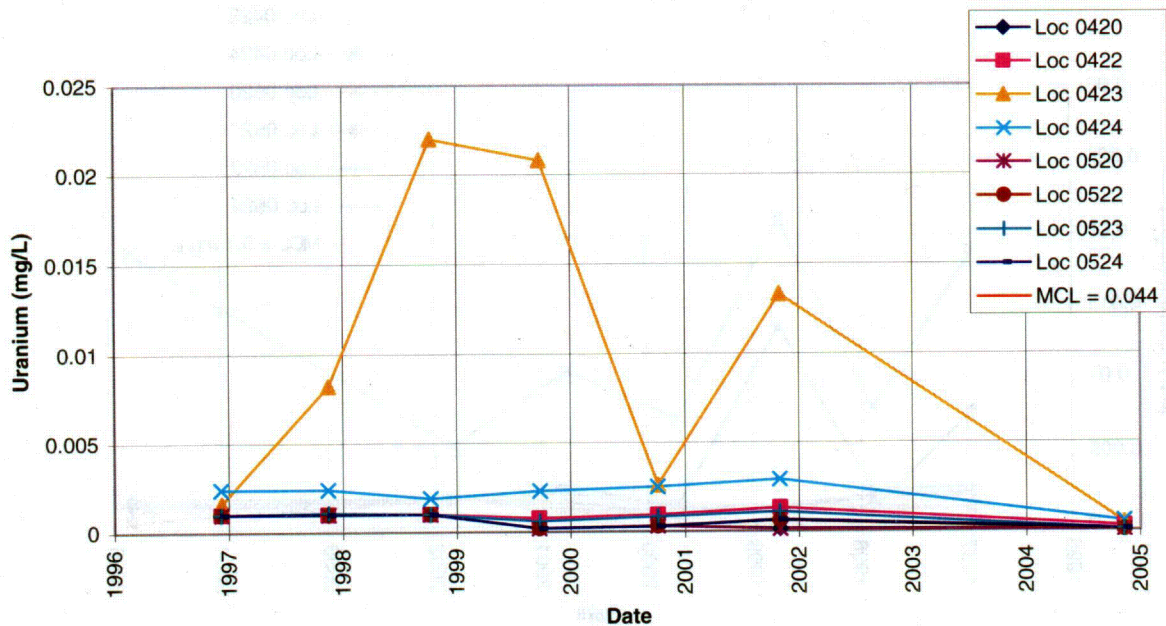
Figure 2-5. Time-Concentration Plots of Uranium in Ground Water at the Burrell, Pennsylvania, Disposal Site

Concentrations of uranium in ground water in both the shallow alluvial wells (400-series wells) and the deeper bedrock wells (500-series wells) remain well below the MCL; 2004 results from all locations were two orders of magnitude or more below the MCL and approach the laboratory detection limit. Since 1996, uranium concentrations in all wells have remained relatively constant, except in downgradient well MW-0423, which has shown considerable fluctuation below the MCL (Figure 2-5).

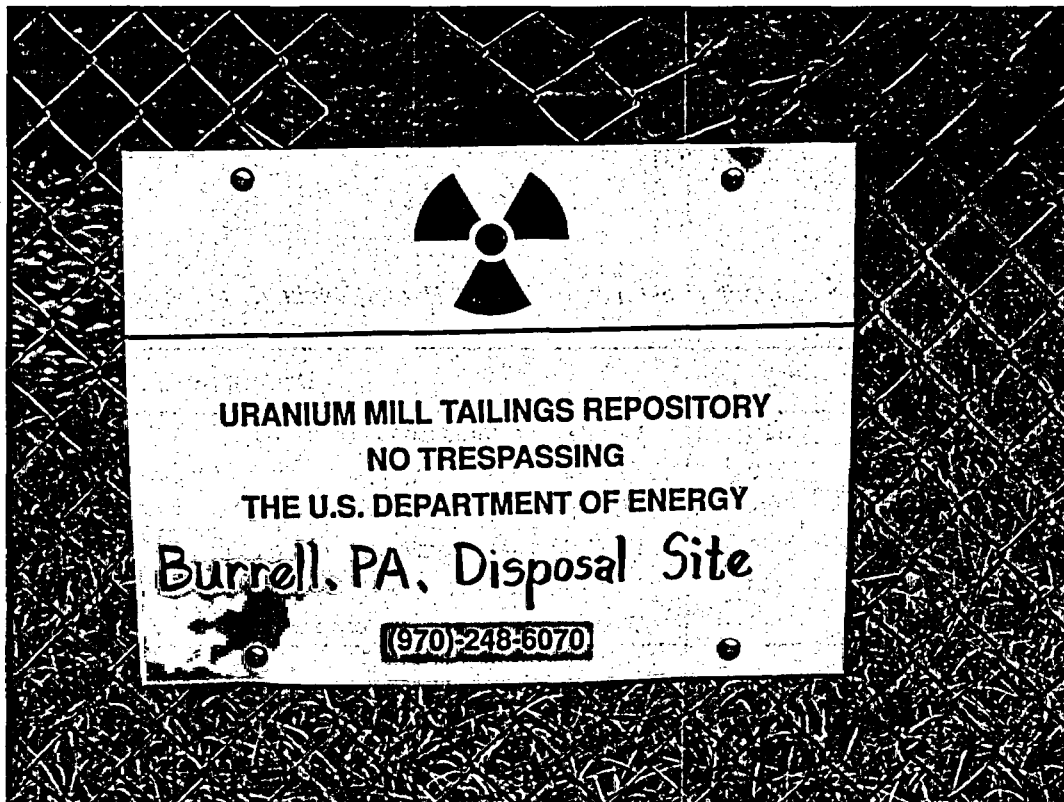
2D Perimeter signs attached to the northern perimeter fence (P1 through P8) were replaced in 2002 because they became illegible from gunshot damage. Perimeter signs P5 and P12 were replaced in fall 2004, and bullets have already damaged sign P5. Public access to this portion of the disposal cell is essentially unimpeded and there continues to be a significant amount of activity in this area. In 2005, most of the signs were in serviceable to excellent condition. The entrance sign was missing and a perimeter sign, with contact information added, was mounted temporarily on the gate (PL-2). A replacement entrance sign will be installed in 2006. Perimeter sign P1 is bent but remains legible.

*BUR 9/2005. PL-2. Temporary entrance sign.*

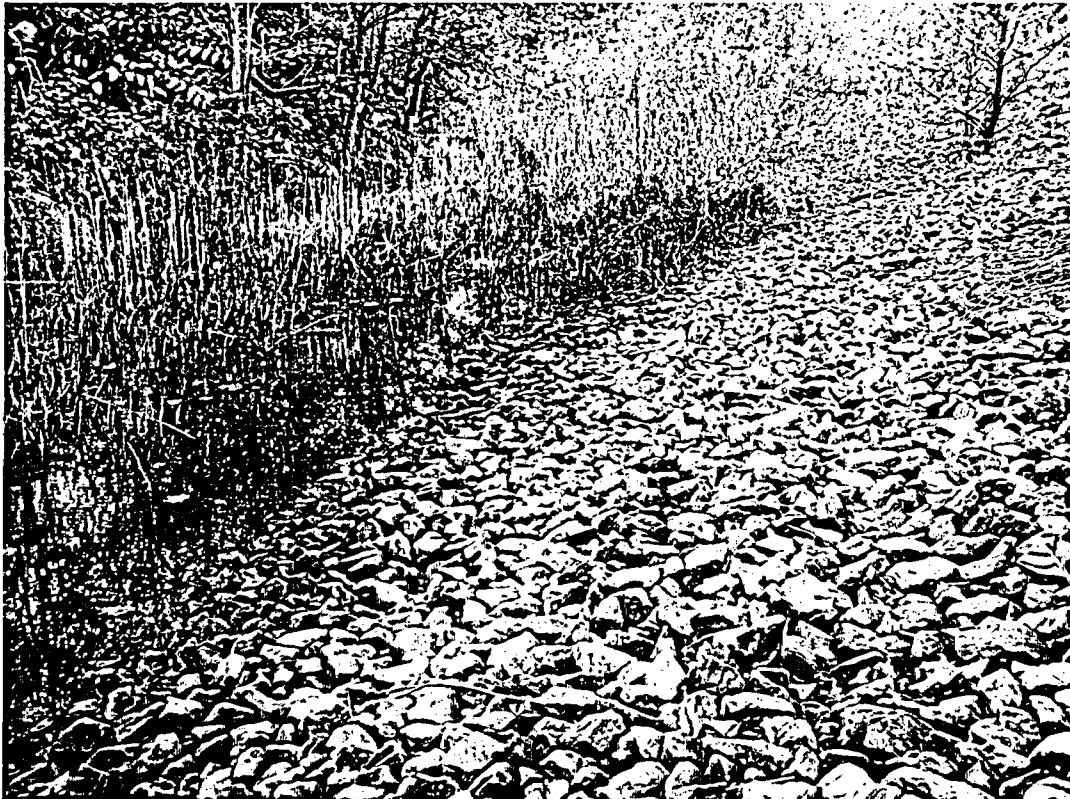
*BUR 9/2005. PL-5. Toe of the cell's south side slope showing water level in slough.*

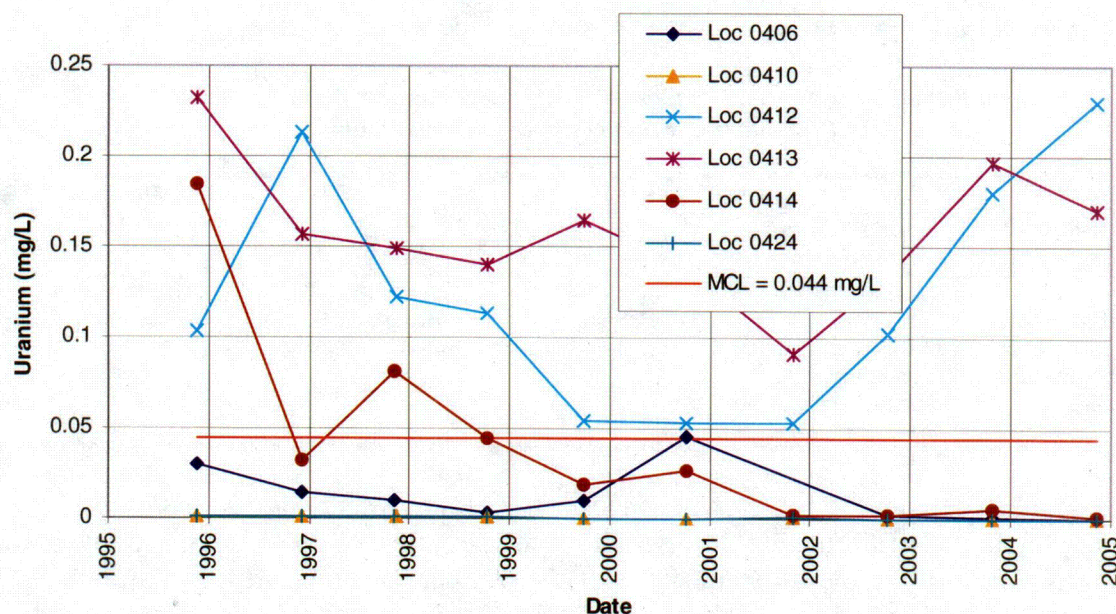
Figure 3-2. Time-Concentration Plots of Uranium in Ground Water at the Canonsburg, Pennsylvania, Disposal Site

Uranium is the analyte of primary concern at this site because of the frequency with which it has exceeded its MCL of 0.044 mg/L, particularly in two of the downgradient wells (MW-0412 and MW-0413). In 2004, uranium concentrations in ground water continued above the MCL, but considerably below the ACL, in these two wells (Figure 3-2). Concentrations at well MW-0412

have increased during the last 3 years, following a continued downward trend, to the highest concentration (0.23 mg/L) since the LTSP-required monitoring began in 1995. Concentrations at well MW-0413 had increased for two years, following several years of a downward trend, with the latest result again having decreased from the previous result. Uranium levels were substantially below the MCL, and well below the ACL, at the rest of the locations in 2004. Uranium concentrations were near the laboratory detection limit at all sampling locations in Chartiers Creek (Figure 3-5).

DOE continues to consider the risk associated with uranium in ground water within the unconsolidated materials and shallow bedrock beneath the site to be negligible because neither unit is considered a viable aquifer from a water resource perspective, but only in the sense that the zone is capable of discharging to surface water (Appendix A to 10 CFR Part 40). Because the materials are not ideal for aquifer formation and the source of recharge to the shallow units is minimal, sustained yield to a well from these units would be limited. The shallow ground water is not normally used as a drinking water supply in the area, although some domestic water is derived from a few private wells deeper than 100 feet. Institutional controls, in the form of government ownership of the site, prevent access to the ground water directly beneath the site. NRC concurred in deleting ground water use restrictions for Area C in 2003. Most of the residents in the area are connected to a municipal water system, which is supplied by surface water reservoirs upgradient from the site. Chartiers Creek, adjacent to and the discharge point for the shallow ground water beneath the site, is not a source of potable water. Additionally, uranium concentrations reported from samples collected from the creek are near the detection limit and have declined in recent years. Therefore, human health and the environment are adequately protected.

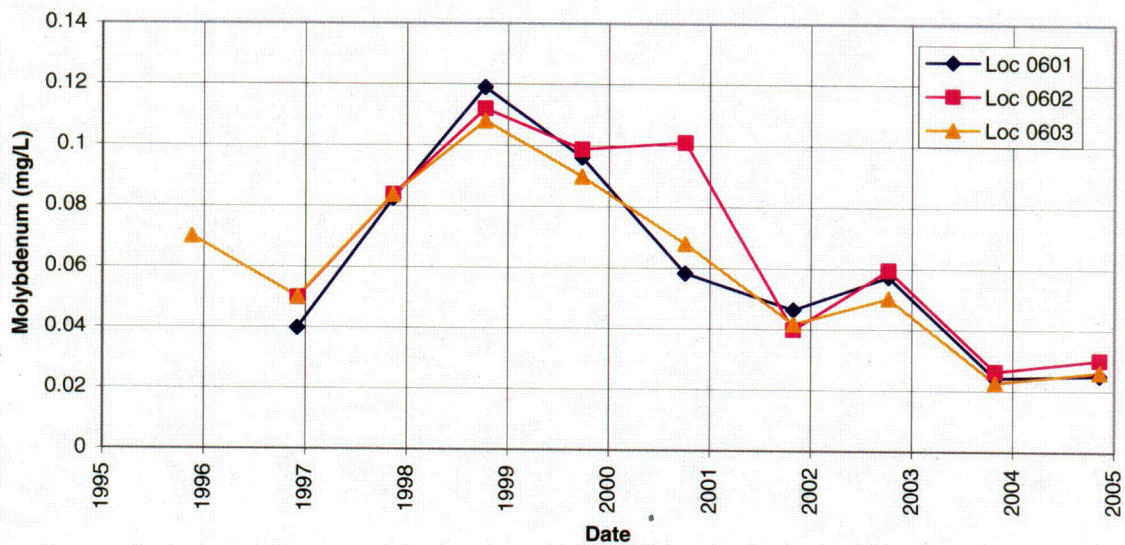
Figure 3-6. Time-Concentration Plots of Molybdenum in Surface Water at the Canonsburg, Pennsylvania, Disposal Site

The concentrations of molybdenum in the Chartiers Creek samples, as in the past, were higher than in ground water samples, though still well below the MCL in recent years. Concentrations at all locations exceeded the MCL in 1998 and again, although only slightly, at location SW-0602 in 2000 (Figure 3-6). Surface water concentrations both upstream and downstream of the site, in excess of those in ground water, although decreasing, indicate an ambient or upstream source of molybdenum rather than from site related activities. The surface water quality is indistinguishable between upgradient and downgradient locations.

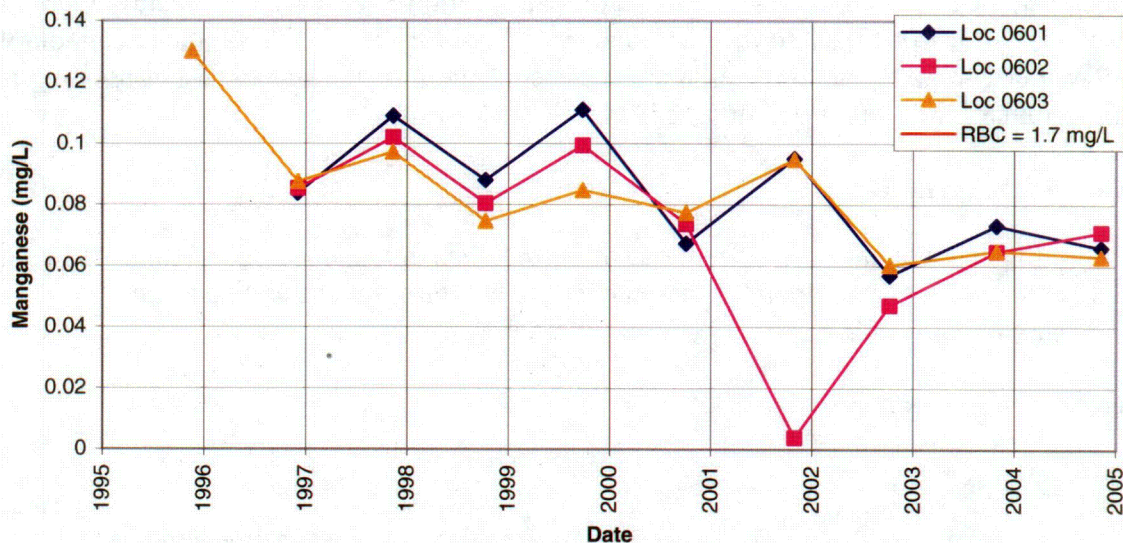
Figure 3-7. Time-Concentration Plots of Manganese in Surface Water at the Canonsburg, Pennsylvania, Disposal Site

Manganese concentrations in surface water at the point of exposure in Chartiers Creek display an overall decreasing trend at all three locations, although location SW-0602 has recently increased from a low reached in 2001 back to the historical trend line (Figure 3-7). With the exception of location SW-0602 in 2001 and 2002, all manganese concentrations in surface water remain just above the secondary drinking water standard.

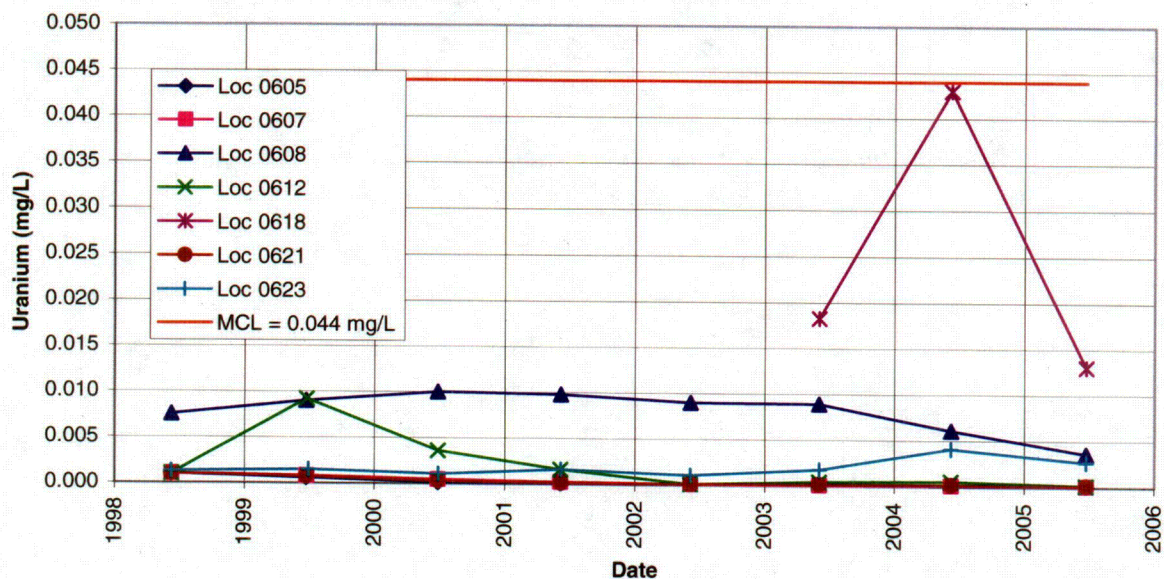
Figure 4-2. Time-Concentration Plots of Uranium in Ground Water at the Durango, Colorado, Disposal Site

As shown on Figure 4-2, the uranium concentration of 0.043 mg/L in monitor well MW-0618 had increased substantially in 2004, the second annual sampling event for that well, from the initial 0.018 mg/L concentration reported in 2003. In 2005, however, the concentration of 0.013 mg/L was consistent with the 2003 result. The 2004 concentration of 0.043 mg/L, although still below the MCL, is considered anomalous. DOE suspects the cause of this anomaly can be correlated with closure of the collection drain system.

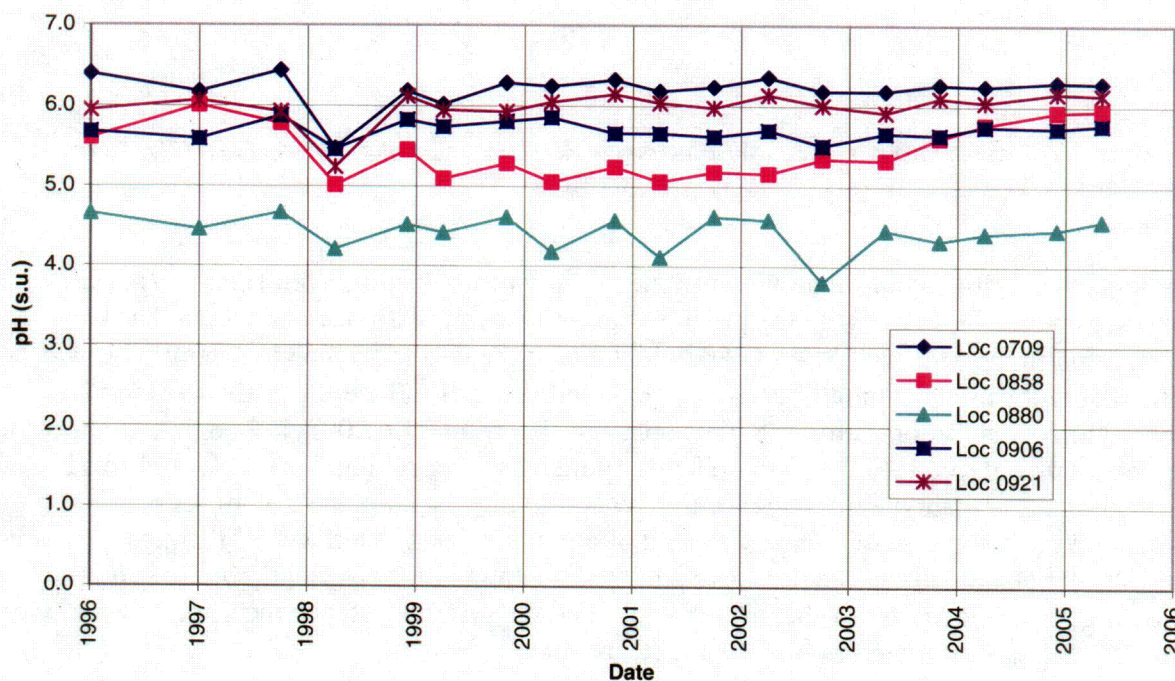
Figure 5-3. pH in Ground Water at Cell Performance Monitoring Locations at the Falls City, Texas, Disposal Site

Levels of pH did not vary significantly from previous results, and have historically shown consistency since late 1998 with two exceptions: MW-0880 and MW-0886 fluctuated one and two units of measurement, respectively (Figures 5-3 and 5-4).

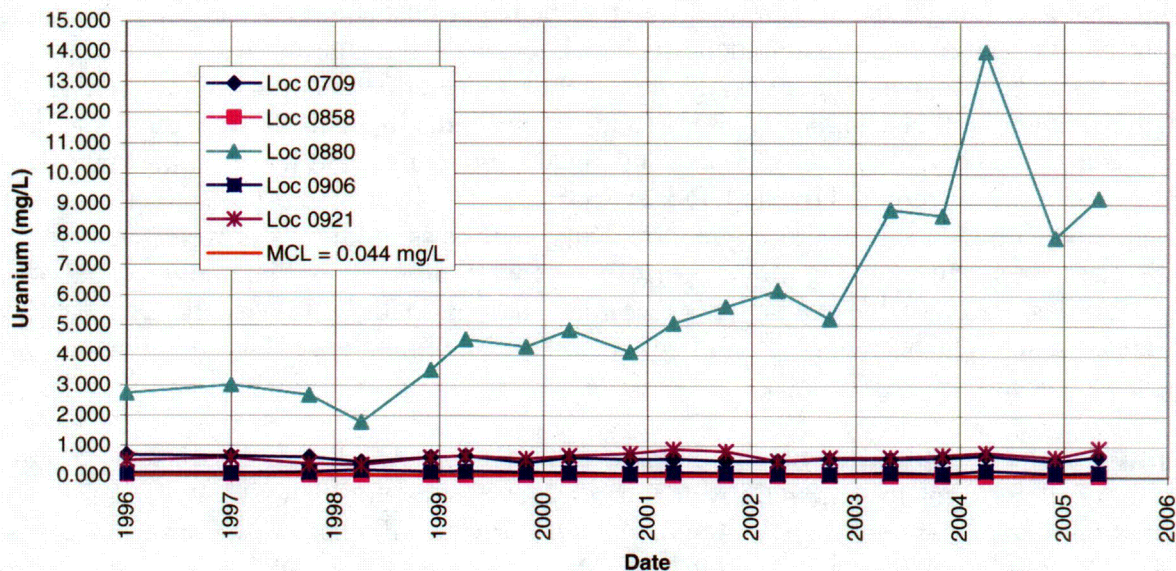
Figure 5-5. Uranium in Ground Water at Cell Performance Monitoring Locations at the Falls City, Texas, Disposal Site

Uranium concentrations in ground water in the vicinity of the disposal cell (i.e.; performance monitoring) were consistent with the previous sampling event with one exception. The concentration in monitor well MW-0880, which had increased from 8.63 to 14 milligrams per liter (mg/L) and was substantially greater than the other wells (all were less than 1.0 mg/L), decreased to concentrations similar to those previously reported in 2003; although still appearing to be on an upward trend (Figure 5-5). The sharp increase reported in April 2004 (14 mg/L) appears anomalous. The overall increase in MW-0880 may be an indication of seepage from the disposal cell or dissipation of a legacy mound of contaminated ground water. Tailings pore water is very similar chemically to the processing related contamination. Currently, there is no risk because there is no local use of the ground water and the ground water in the uppermost aquifer beneath the site is designated as limited use (Class III).

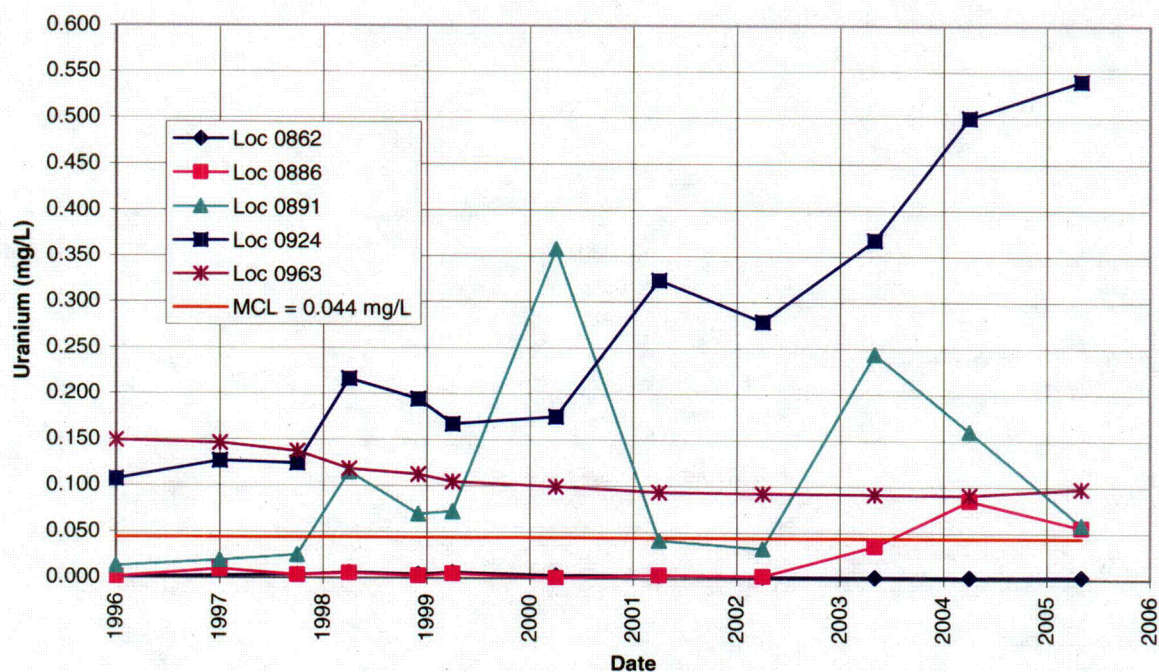
Figure 5-6. Uranium in Ground Water at Compliance Monitoring Locations at the Falls City, Texas, Disposal Site

As shown on Figure 5-6, uranium concentrations in ground water in the compliance monitoring network has varied substantially in two wells (MW-0891 and MW-0924) since 1997 and has exceeded the maximum concentration limit of 0.044 mg/L in four wells (MW-0886, MW-0891, MW-0924, and MW-0963). The increasing trend in uranium concentration in well MW-0924 is likely the result of naturally occurring uranium because the pH hasn't decreased which would indicate movement of the processing related plume, particularly in this environment where uranium is highly mobile. Additionally, the uranium distribution varies spatially and the wells between well MW-0924 and the cell continue to have low concentrations.

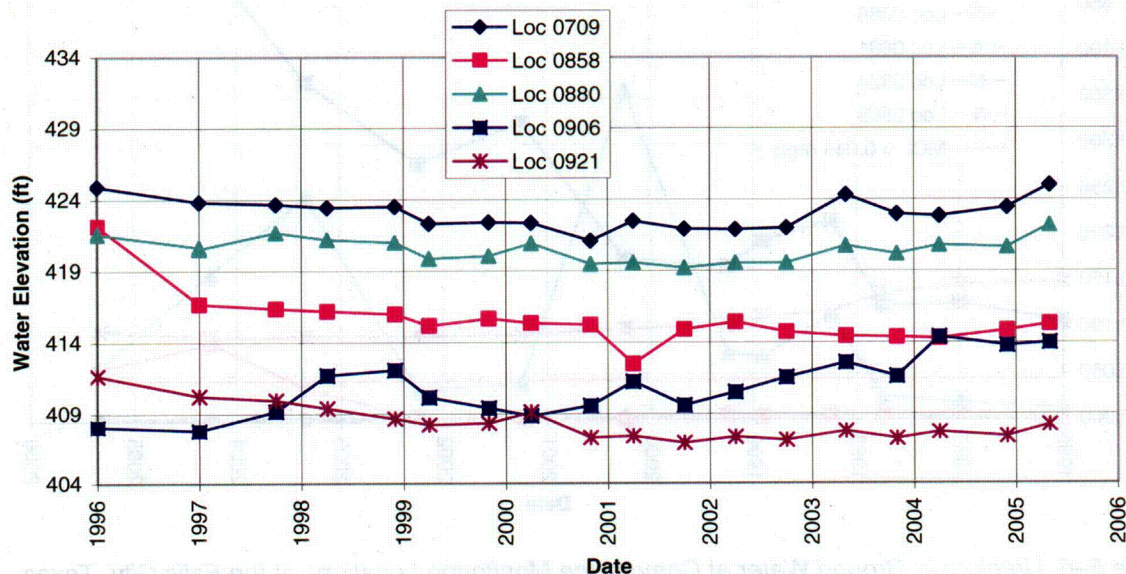
Figure 5-7. Water Level Measurements at Cell Performance Monitoring Locations at the Falls City, Texas, Disposal Site

**Ground Water Level Monitoring**—Ground water levels in the wells near the disposal cell used to monitor cell performance had initially declined by several feet for the first few years following construction with one exception: MW-0906 which had fluctuated up and down several feet (Figure 5-7). Beginning in late 2002 all the wells began to rise except MW-0858, which began in 2004. Since that time two of the wells (MW-0709 and MW-0880) have returned to initial levels and two others (MW-0858 and MW-0921) have risen only slightly. Monitor well MW-0906, which had initially fluctuated, began to rise in early 2002 increasing approximately two feet and currently is more than five feet higher than initial post-construction levels. Monitor wells MW-0908 and MW-0916, completed in the unsaturated zone of the Conquista Sandstone, have been dry at the time of sampling since 1996.

The cell performance water level data through the first several years following construction indicate that the falling water table in the vicinity of the cell was likely related to dissipation of the processing site-related ground water mound beneath the disposal cell. The more recent rise in water levels may be a result of increased precipitation or localized mounding from water being shed from the disposal cell.

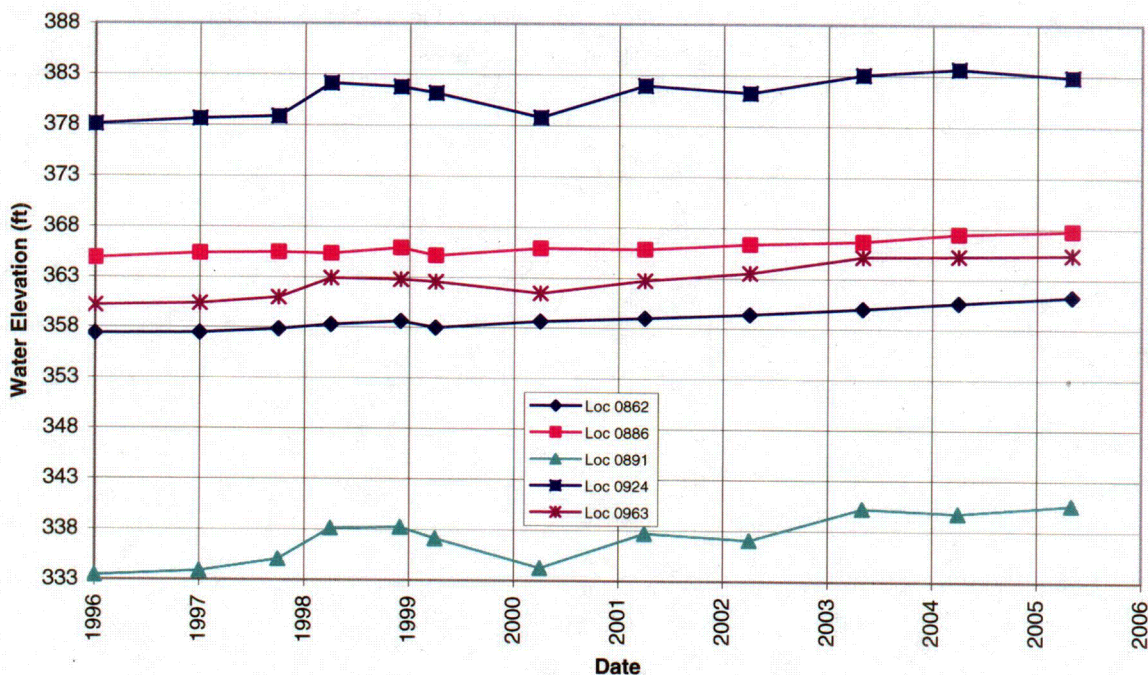
Figure 5-8. Water Level Measurements at Ground Water Compliance Monitoring Locations at the Falls City, Texas, Disposal Site

Water levels at the ground water compliance monitoring locations have all steadily increased several feet since monitoring began in 1996, indicating a regional effect (Figure 5-8).

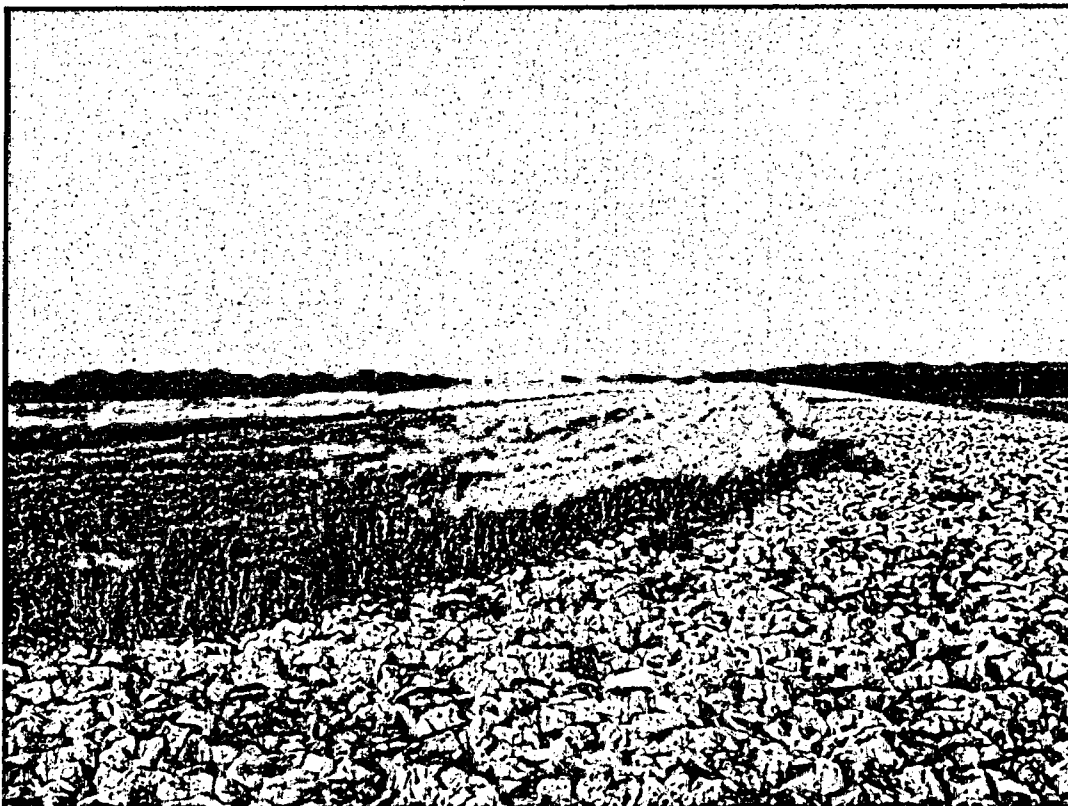
*FCT 1/2005. PL-1. East top slope of the disposal cell showing healthy vegetative cover.*

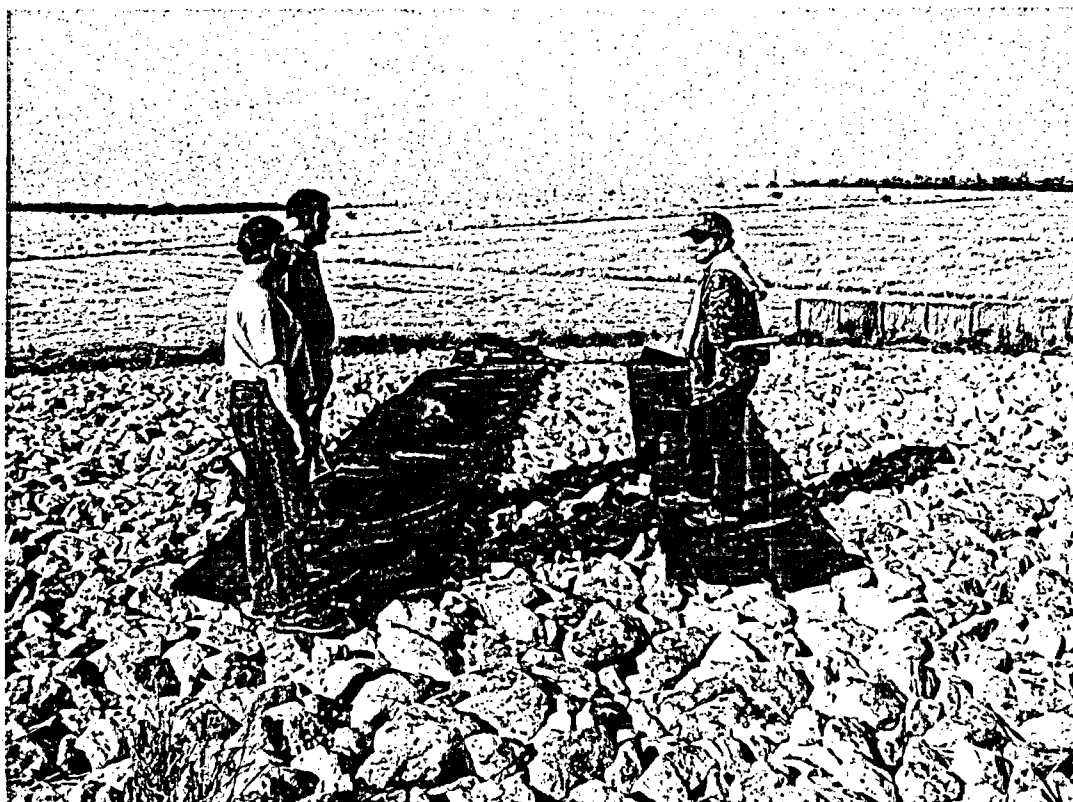
*FCT 1/2005. PL-2. Ramp on side slope in the west corner used for farming equipment to access the cell top.*

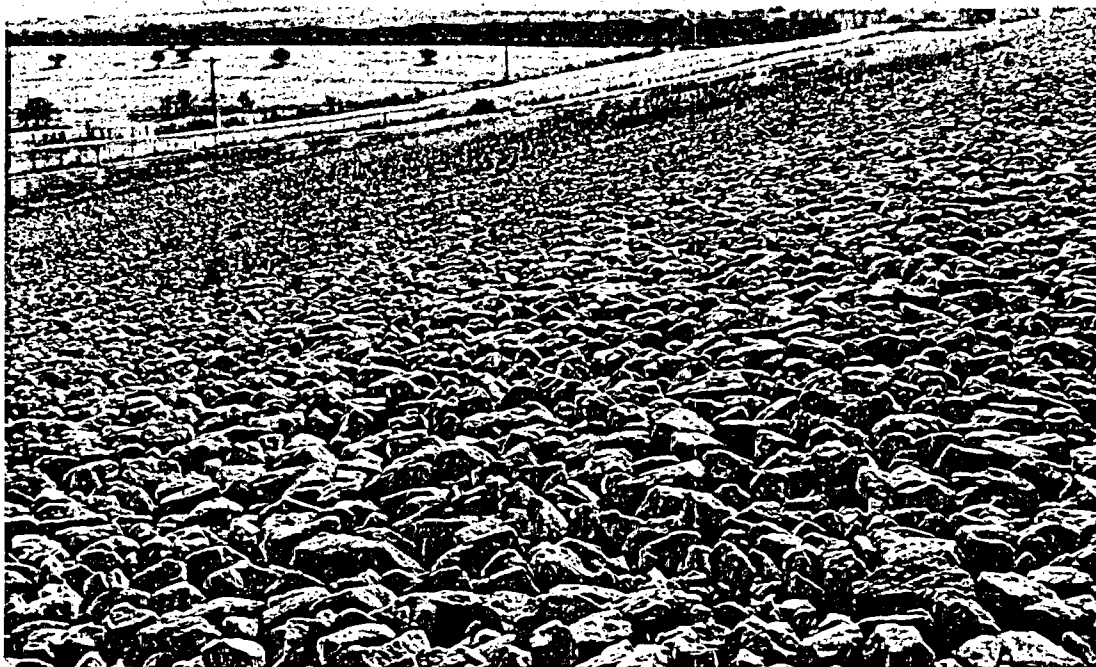
*FCT 1/2005. PL-3. Undesirable vegetation on the northeast side slope.*

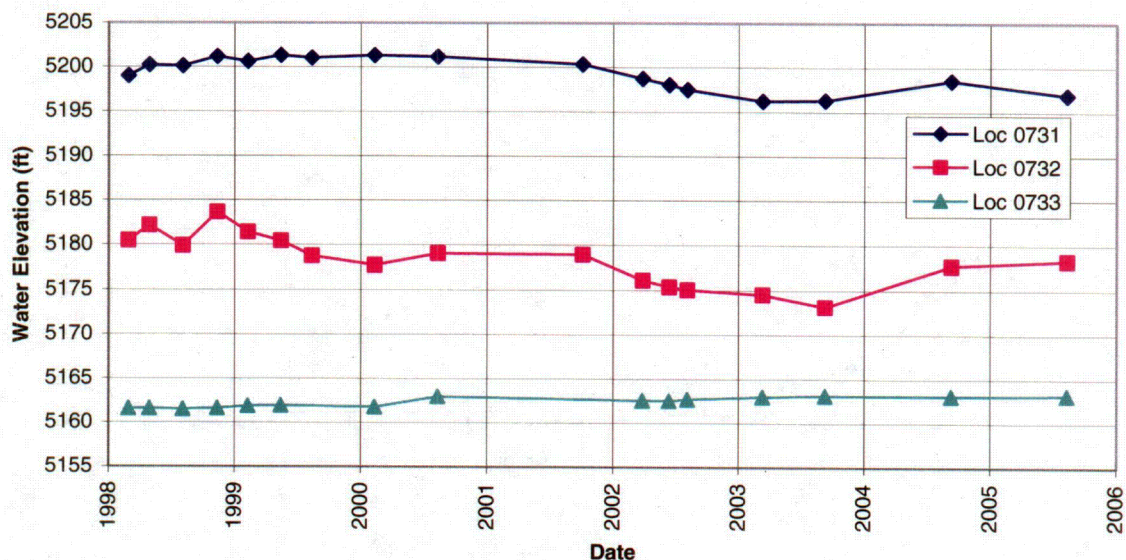
Figure 6-2. Water Level Measurements at the Grand Junction, Colorado, Disposal Site

**Ground Water Level Monitoring**—The water level in the disposal cell well MW-0733 has remained relatively steady, with less than 2 feet of variation since 1998. In comparison, water levels within the two paleochannels at wells MW-0731 and MW-0732 have varied up to approximately 5 and 10 feet, respectively, since 1998. Still the water level in the disposal cell well MW-0733 has remained at least 30 and 10 feet lower (deeper) than water levels in the paleochannels at wells MW-0731 and MW-0732, respectively, since 1998 (Figure 6-2).

On the basis of this information, there is no hydraulic potential for ground water at the base of the disposal cell at well MW-0733 to migrate to the paleochannels at wells MW-0731 and MW-0732.

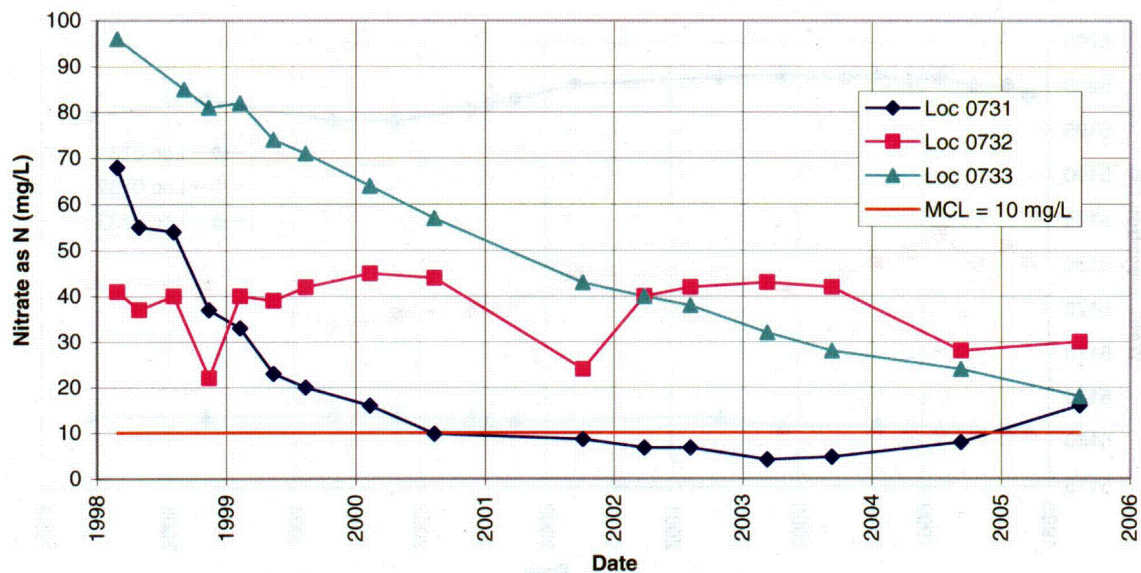
Figure 6-3. Time-Concentration Plots of Nitrate (as N) in Ground Water at the Grand Junction, Colorado, Disposal Site

Nitrate (as nitrogen) concentrations in ground water exceeded the MCL of 10 mg/L in all three monitor wells. Concentrations in well MW-0731 have been below the MCL since 2000 following a steep downward trend, but increased to just above the MCL in 2005. Concentrations in well MW-0732 remain relatively consistent above the MCL, and concentrations in well MW-0733 continue to trend downward to slightly above the MCL in 2005 (Figure 6-3). In 2005, the highest concentration of nitrate, 30 mg/L, occurred in paleochannel well MW-0732. Historically, the highest concentration of nitrate (96 mg/L) occurred in 1998 from the disposal cell well MW-0733.

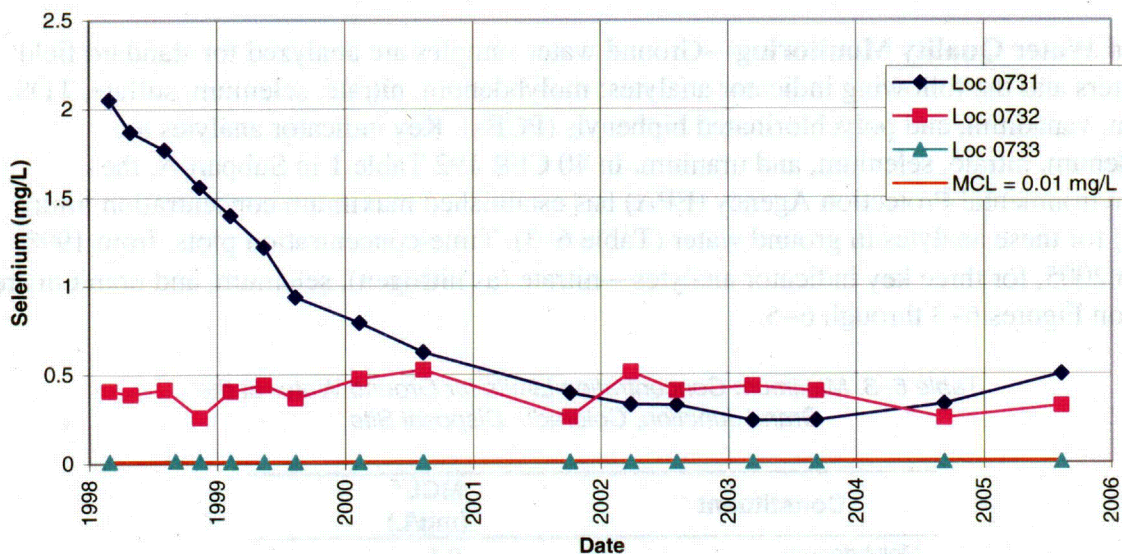
Figure 6-4. Time-Concentration Plots of Selenium in Ground Water at the Grand Junction, Colorado, Disposal Site

Selenium levels continued to exceed the MCL of 0.01 mg/L in both paleochannel wells MW-0731 and MW-0732, and remained well below the standard in MW-0733 in the disposal cell (Figure 6-4). In 2005, the highest concentration of selenium, 0.5 mg/L, occurred in paleochannel well MW-0731 and compares to an historical high of 2.05 mg/L in 1998 from the same well. These concentrations can be expected as selenium levels are typically elevated in sediments of the Mancos Shale in the area.

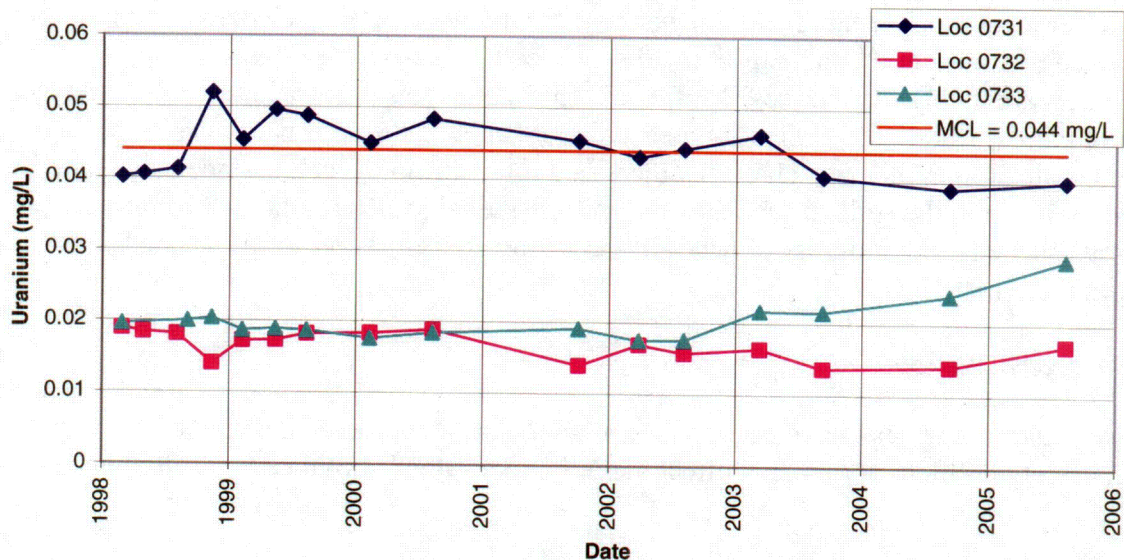
Figure 6-5. Time-Concentration Plots of Uranium in Ground Water at the Grand Junction, Colorado, Disposal Site

Uranium concentrations in ground water were below the MCL of 0.044 mg/L in all three monitor wells and have remained relatively consistent since 1998 (Figure 6-5). In 2005, the highest concentration of uranium, 0.04 mg/L, occurred in paleochannel well MW-0731 and compares to an historical high of 0.052 mg/L in 1998 from the same well.

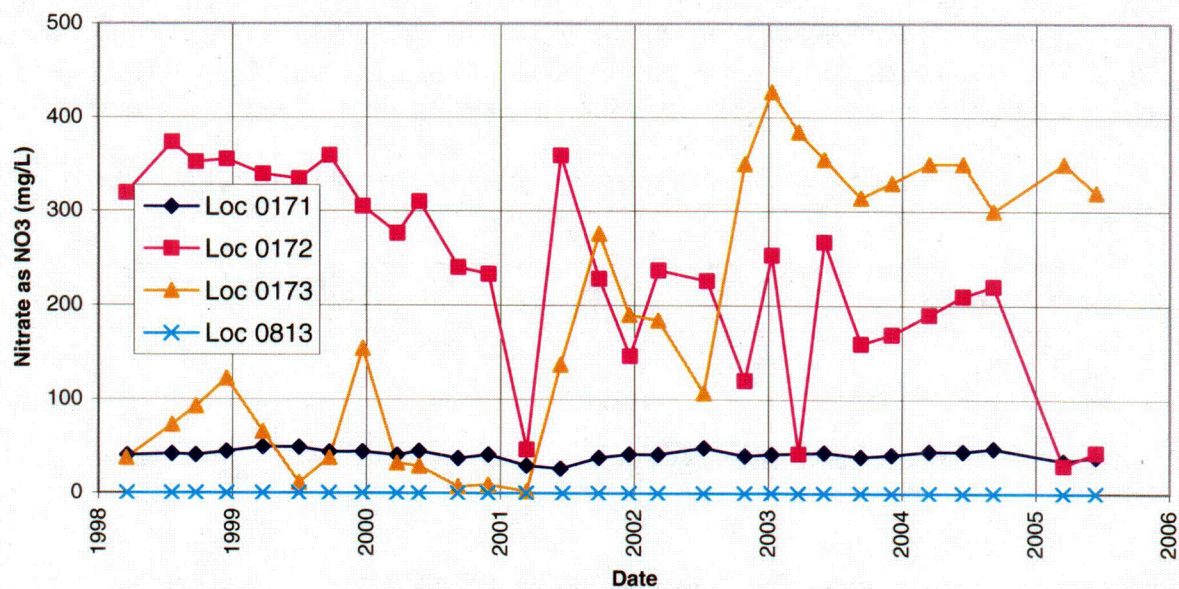
Figure 7-2. Time-Concentration Plots of Nitrate (as N) in Ground Water at the Green River, Utah, Disposal Site

Concentrations of nitrate in ground water continued above the MCL but are considerably below the proposed ACL (Table 7-2) except in well MW-0813, where values continue near the laboratory detection limit (Figure 7-2). Since 1998, concentrations in wells MW-0171 and MW-0813 have remained essentially constant, while there has been an overall upward trend for well MW-0173 and a downward trend for well MW-0172.

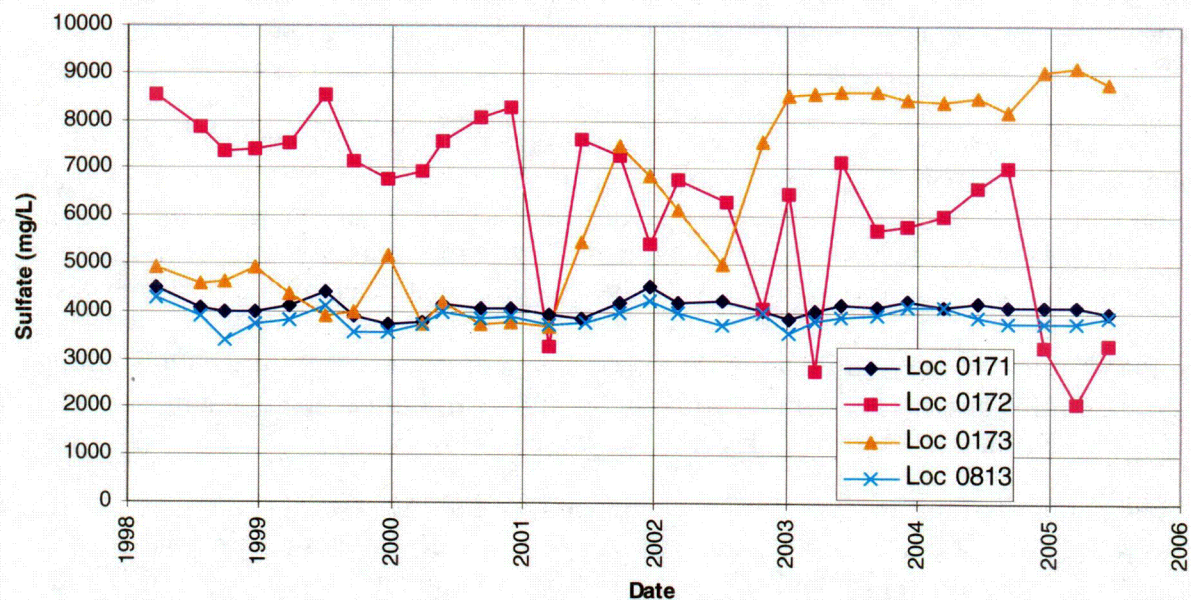
Figure 7-3. Time-Concentration Plots of Sulfate in Ground Water at the Green River, Utah, Disposal Site

Sulfate concentrations in ground water have remained relatively constant in wells MW-0171 and MW-0813 since the disposal cell was constructed (Figure 7-3). Concentrations in wells MW-0172 and MW-0173 have fluctuated substantially since 1998; as with nitrate, a decreasing trend in MW-0172 and an increasing trend in MW-0173 can also be observed with sulfate concentrations.

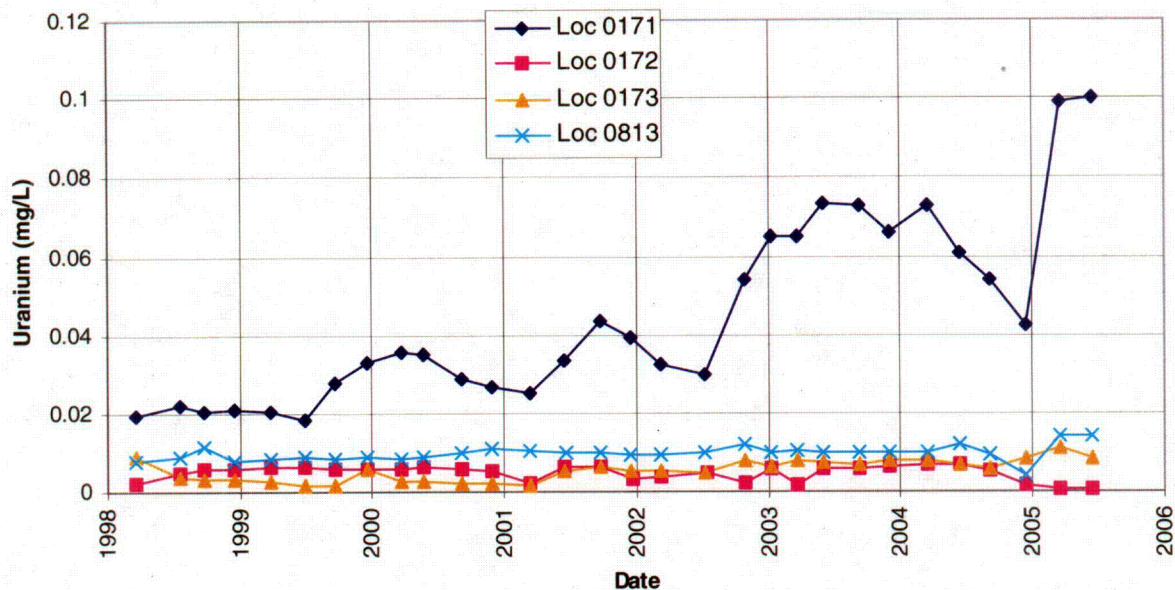
Figure 7-4. Time-Concentration Plots of Uranium in Ground Water at the Green River, Utah, Disposal Site

Uranium concentrations in ground water remain below the MCL and considerably below the proposed ACL (Table 7-2) in three of the four point-of-compliance wells. At well MW-0171, with only one exception since fall 2002, levels have exceeded the MCL (Figure 7-4). Uranium concentrations continue to remain essentially constant in wells MW-0172, MW-0173, and MW-0813. However, an overall upward trend continues in well MW-0171. Uranium is the only constituent of concern in well MW-0171 that has indicated an upward trend; no conclusions regarding the cause of the trend can be reached with the current data.
