Department of Energy  
Office of Legacy Management

Subject: 2005 Annual Site Inspection and Monitoring Report for UMTRCA Title I Disposal Sites

# **2005 Annual Site Inspection and Monitoring Report for Uranium Mill Tailings Radiation Control Act Title I Disposal Sites**

**December 2005**

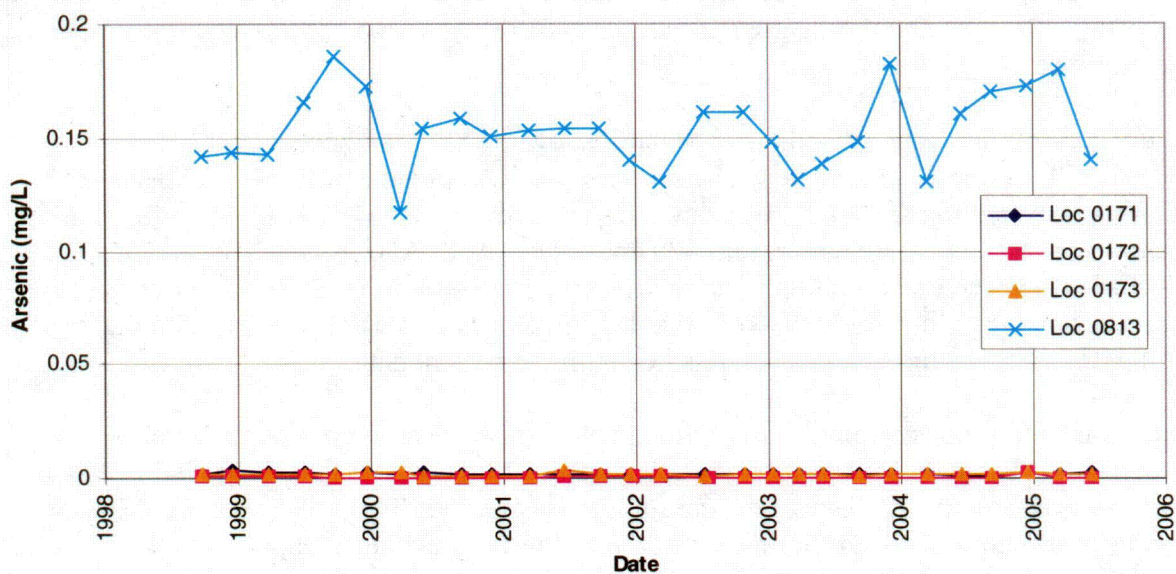
Figure 7-5. Time-Concentration Plots of Arsenic in Ground Water at the Green River, Utah, Disposal Site

Arsenic concentrations in ground water remain below the MCL and considerably below the proposed ACL (Table 7-2) in wells MW-0171, MW-0172, and MW-0173. In well MW-0813, levels have exceeded the MCL over the entire sampling period (Figure 7-5) but are substantially below the proposed ACL. Concentrations in MW-0813 have averaged approximately 0.15 mg/L since 1998 with no apparent trend.

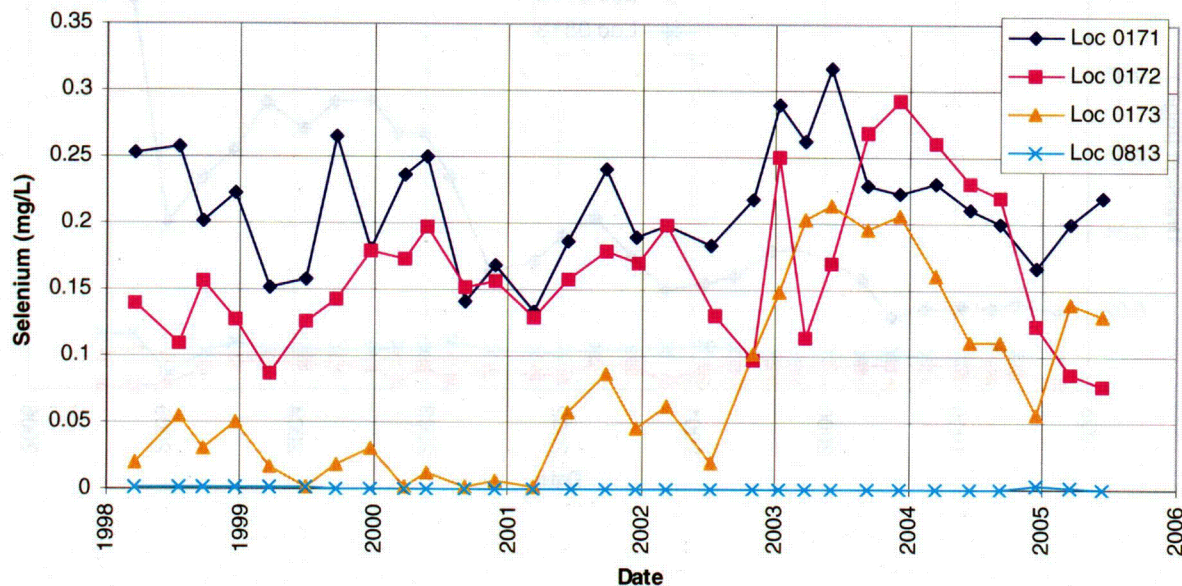
Figure 7-6. Time-Concentration Plots of Selenium in Ground Water at the Green River, Utah, Disposal Site

MW-0813 remain near the laboratory detection limit (Figure 7-6). Except for MW-0813, there has been considerable variation in selenium concentrations; however, no trends are apparent.

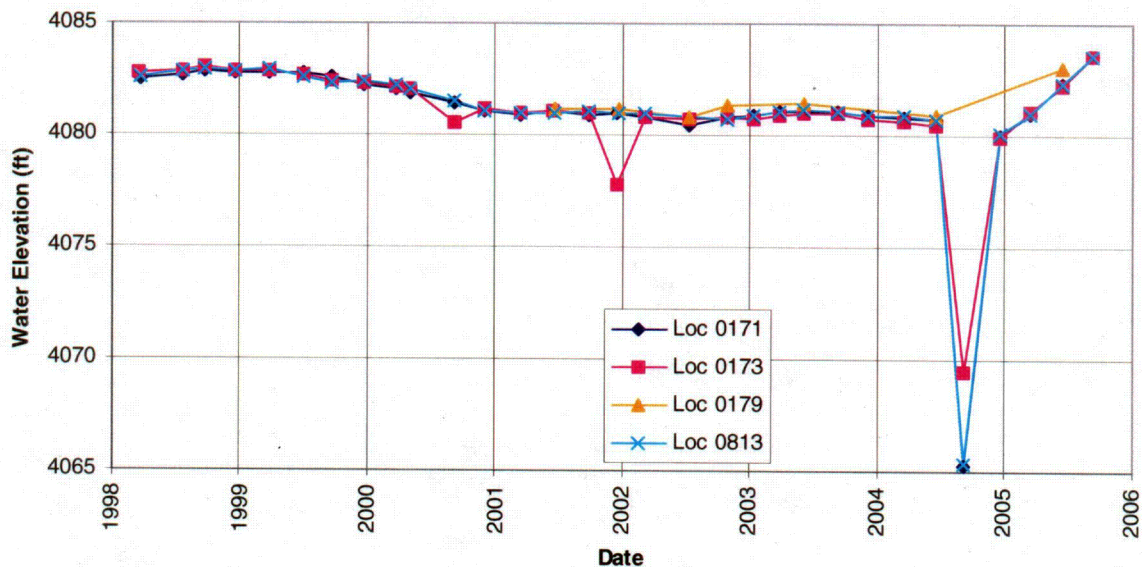
Figure 7-7. Ground Water Elevations at the Green River, Utah, Disposal Site

**Ground Water Level Monitoring**—Ground water levels in several monitor wells adjacent to the disposal cell have been measured manually since 1991, and continually with down-hole dataloggers since 1999. Continuous measurements indicate four erroneous manual measurements occurred in 2000, 2001, and 2003—the continuous measurements indicated essentially no change at those times (Figure 7-7). Well hydrographs indicate that an overall decrease in the ground water elevation of approximately 2 feet occurred from 1998 through 2004, followed by a sharp increase of approximately 3 feet in 2005. This increase in ground water elevations is likely a result of recharge caused from the increased regional precipitation that occurred in late 2004 and throughout 2005.

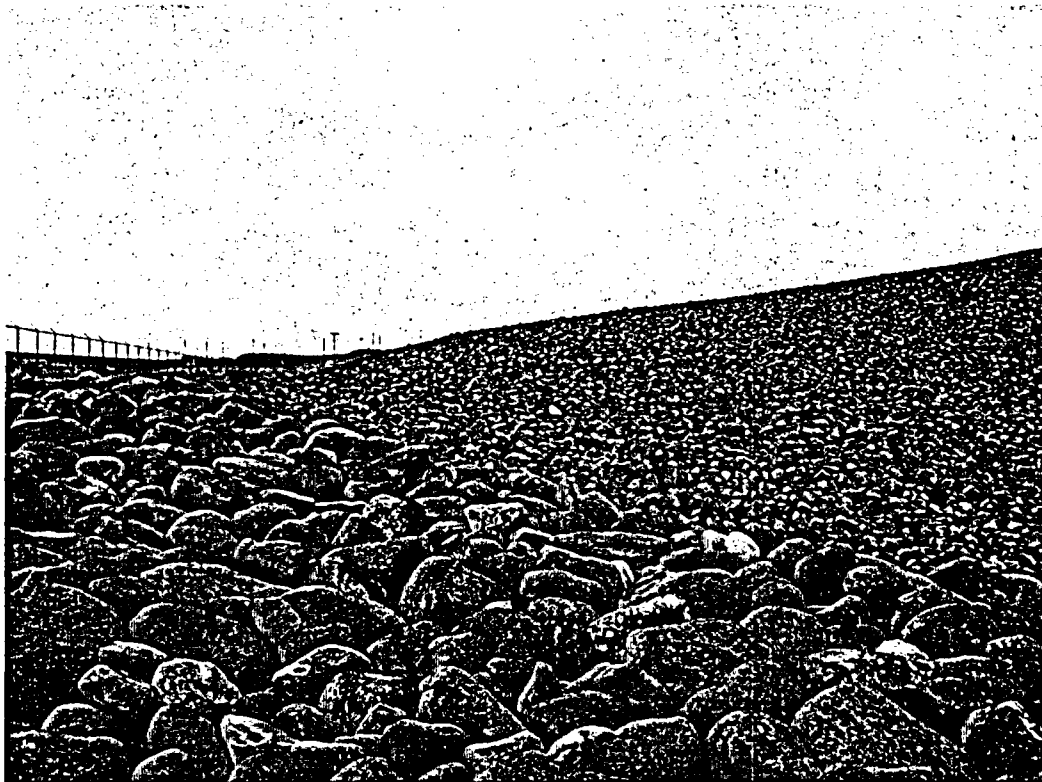
side slopes of the cell were again carefully inspected during the 2005 inspection and it was apparent that a minor grade break exists about 15 to 20 feet above the toe of the slope on all sides of the cell, with the steeper segment at the bottom of the slope (PL-1). All side slope surfaces are slightly irregular due to construction methods or minor settling that has occurred within the cell. There was no evidence of displacement of cover rock or bedding material on the side slope surfaces or along their contacts with the perimeter apron. Therefore, the disposal cell is stable and in excellent condition (PL-2).

*GRN 3/2005. PL-1. The southeast side slope of the disposal cell viewed from the east corner.*

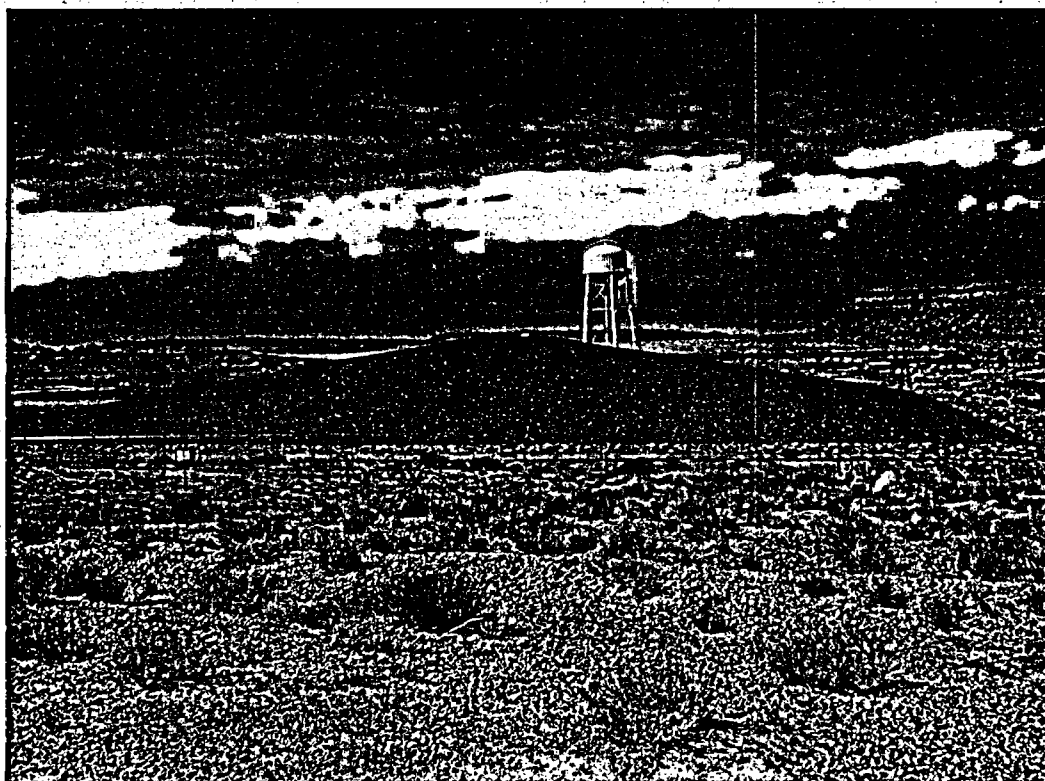
*GRN 3/2005. PL-2. View northwest towards the disposal cell.*

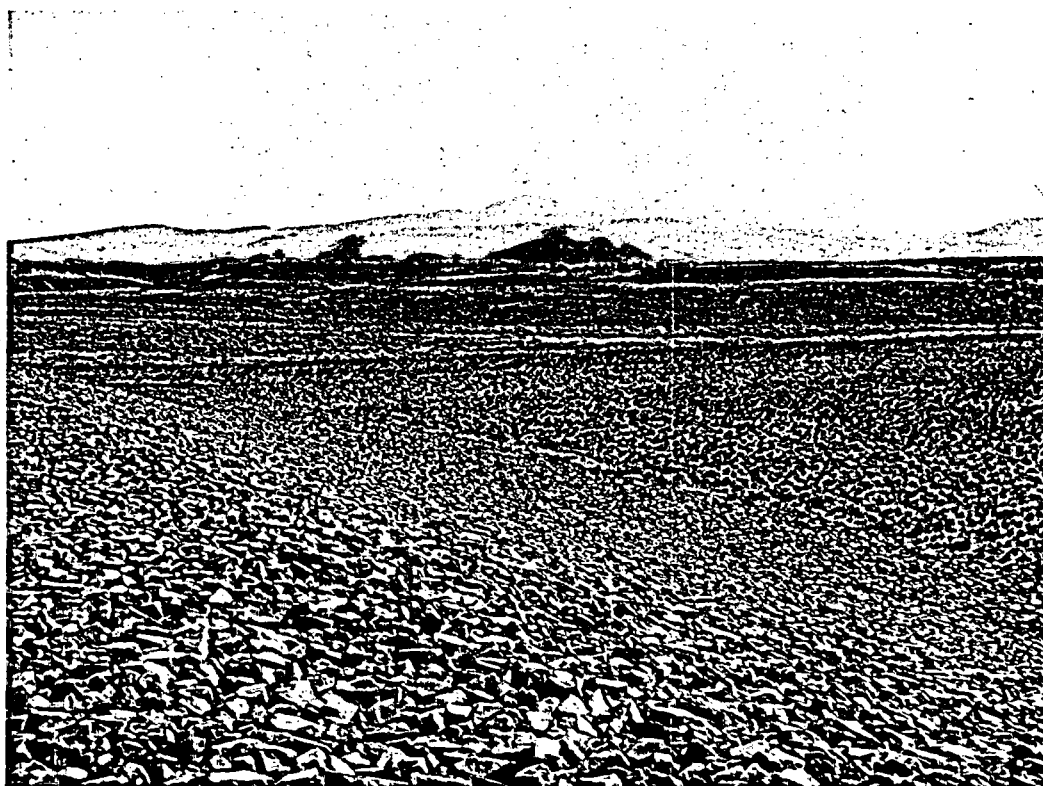
**Side Slopes, Apron, and Diversion Ditches**—The riprap-covered side slopes, apron, and diversion ditches were in excellent condition (PL-3). No evidence of slumping, settling, or significant encroachment of vegetation was observed.

*GUN 6/2005. PL-3. East side slope and diversion channel, county landfill in background.*

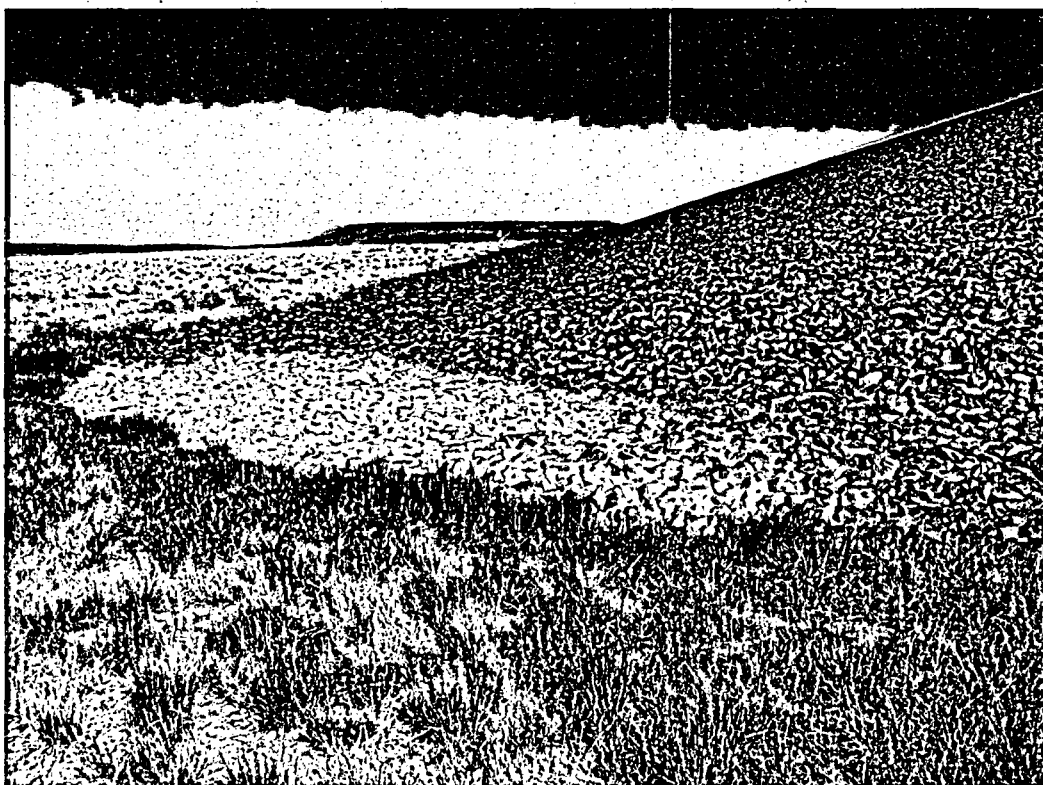
*GUN 6/2005. PL-4. Southeast toe of the cell showing high water mark from ponded water.*

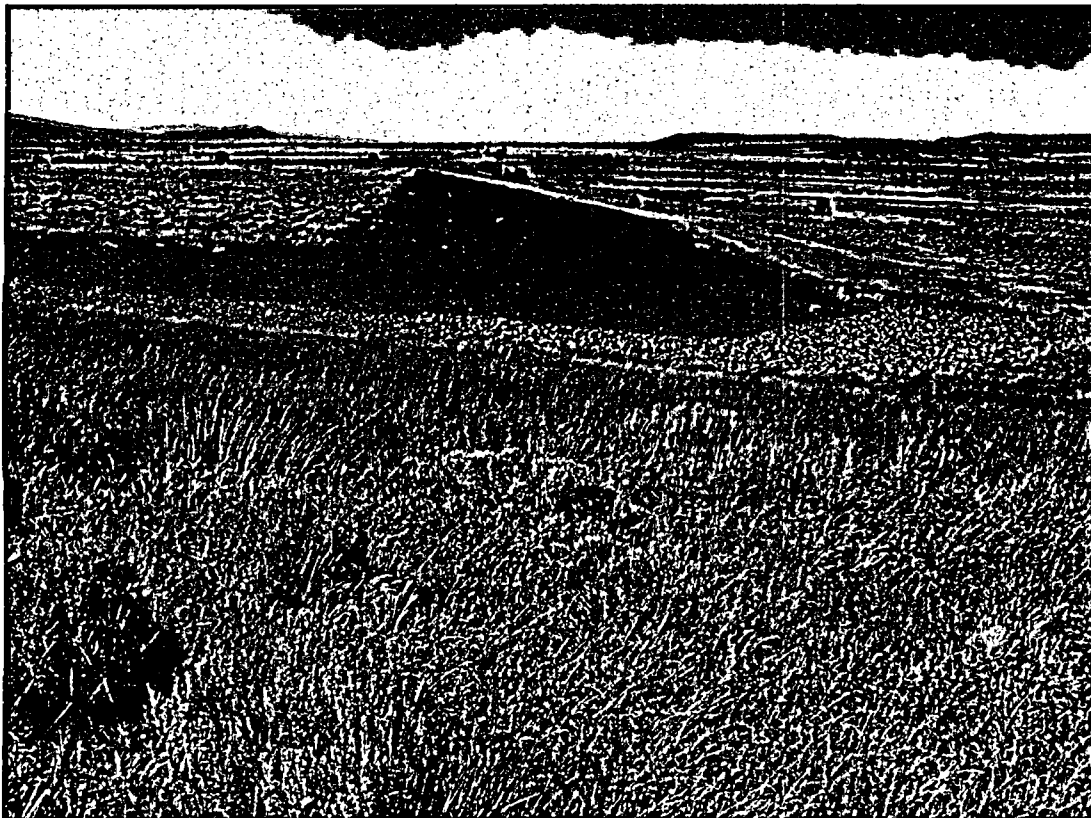
*LKV 7/2005. PL-2. West side of the disposal cell showing the riprap-covered west side slope and drainage channel energy dissipation area.*

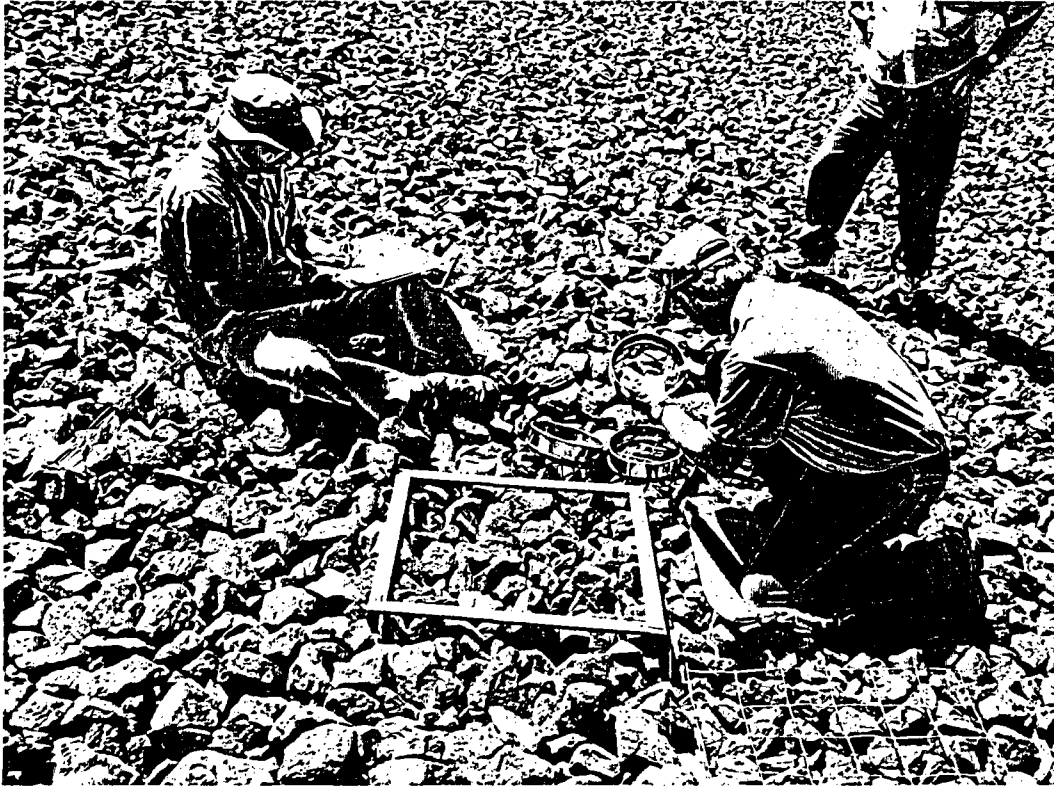
LKV 7/2005. PL-3. Collecting annual side slope riprap gradation test measurements.

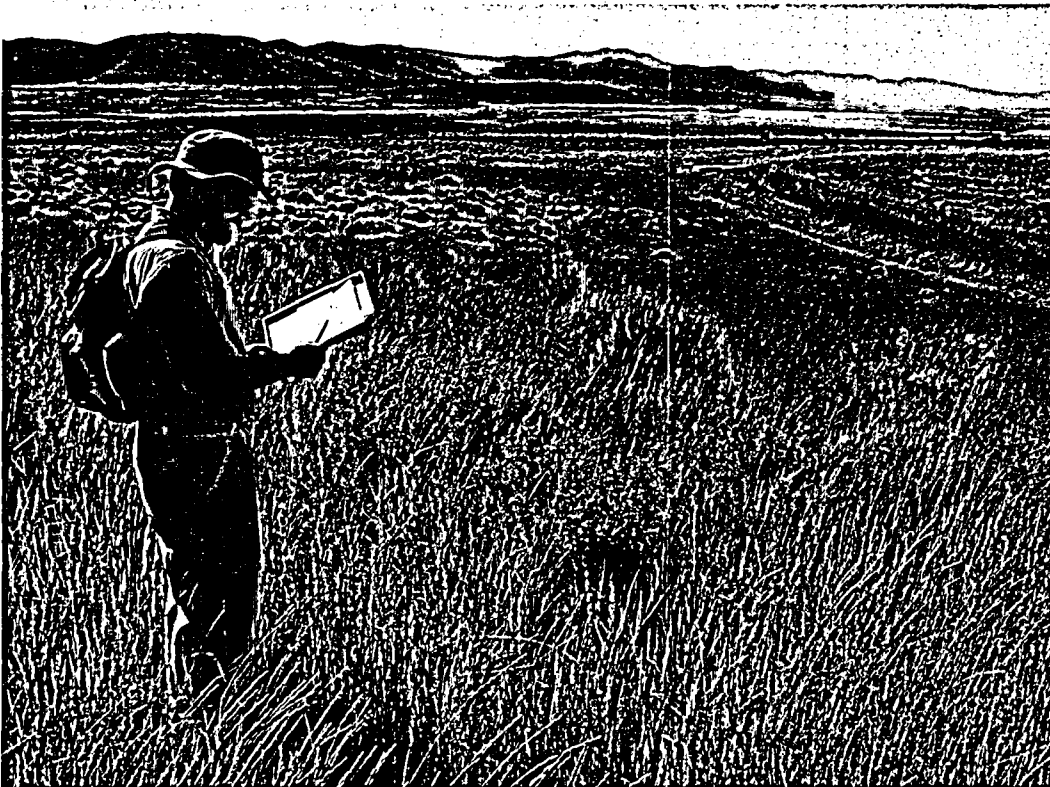
LKV 7/2005. PL-4. Northeast site showing increased vegetation on the disposal cell, north side slope, and upper drainage channel.

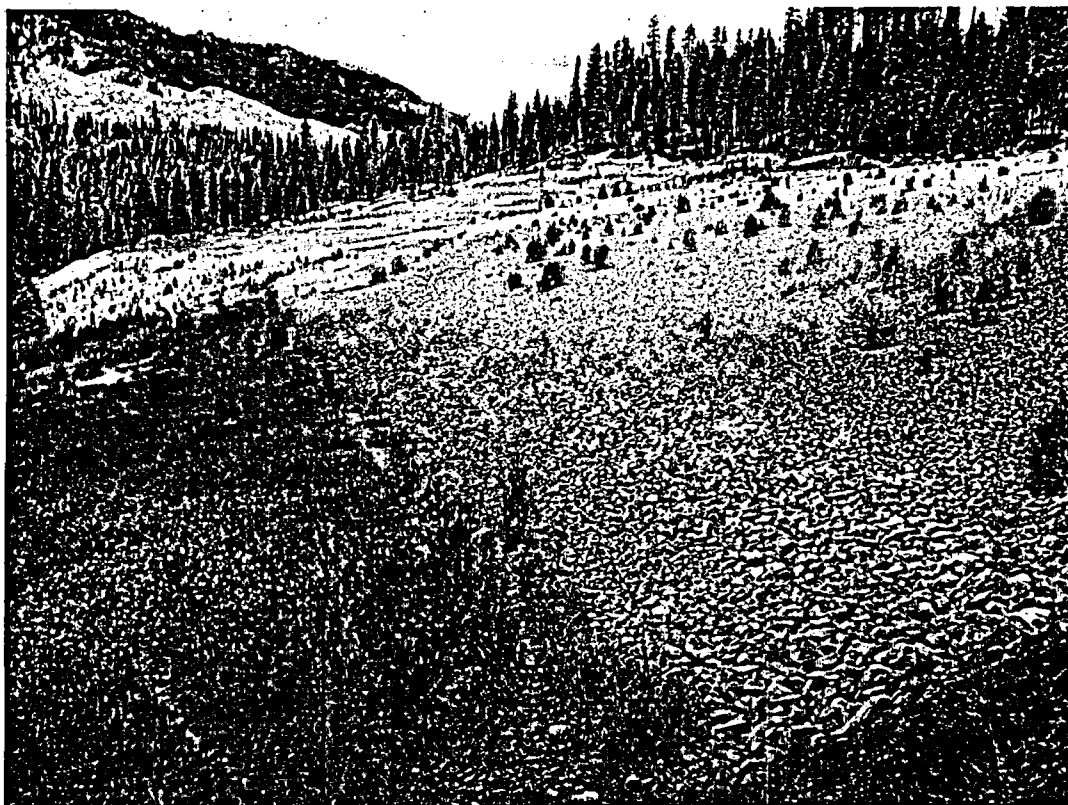
**Top and Side Slope of the Disposal Cell**—Basalt riprap armors the top and west-facing side slope of the disposal cell. An apron of larger riprap surrounds the disposal cell on all sides. The riprap was in excellent condition (PL-3).

Vegetation encroachment continues on the top and side slope of the disposal cell (PL-2 and PL-3). Encroachment is expected as part of the natural processes operating at this location. The State of Idaho also recommended that the surrounding ponderosa pine forest be allowed to encroach and establish on the disposal cell with no requirement or plan for future logging because logging activities would damage the cell cover. As subsequently confirmed by a plant specialist, ponderosa pine trees have deep root systems and do not tend to be blown down, so there is minimal risk of exposing the encapsulated materials due to uprooting of the trees. The largest ponderosa pine trees on the cover are now approximately 7 feet in height.

*LOW 6/2005. PL-3. View north across the toe of the disposal cell.*

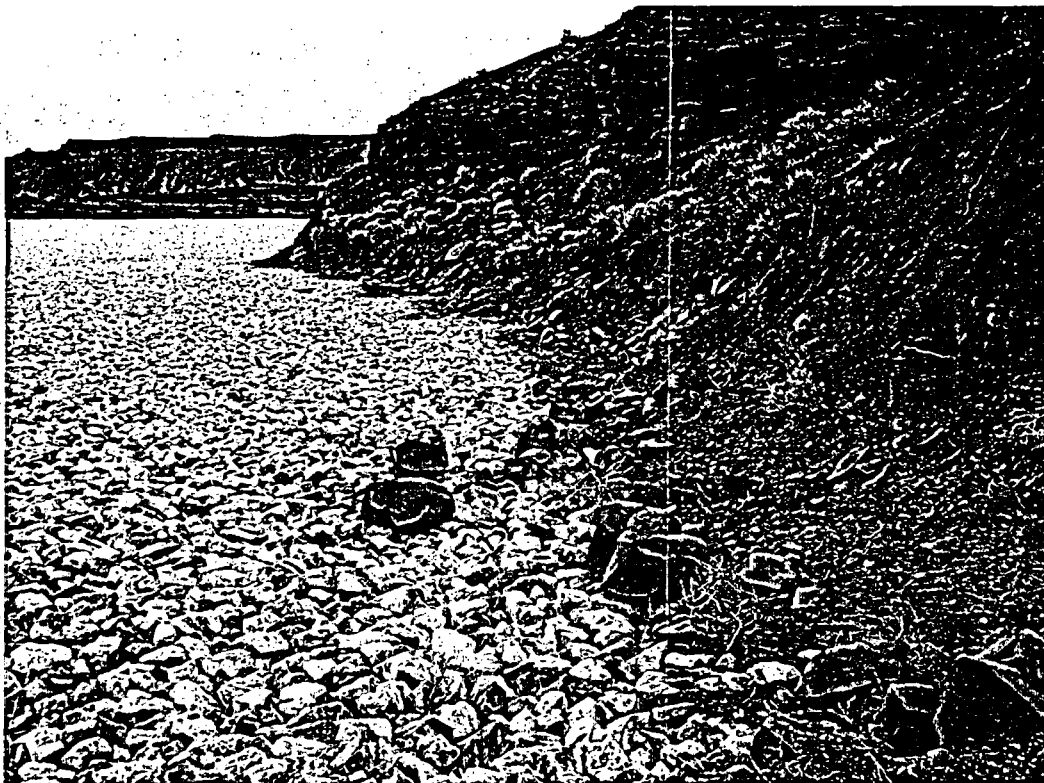
*HAT 4/2005. PL-4. Fallen rock along apron edge at the south end of the disposal cell.*

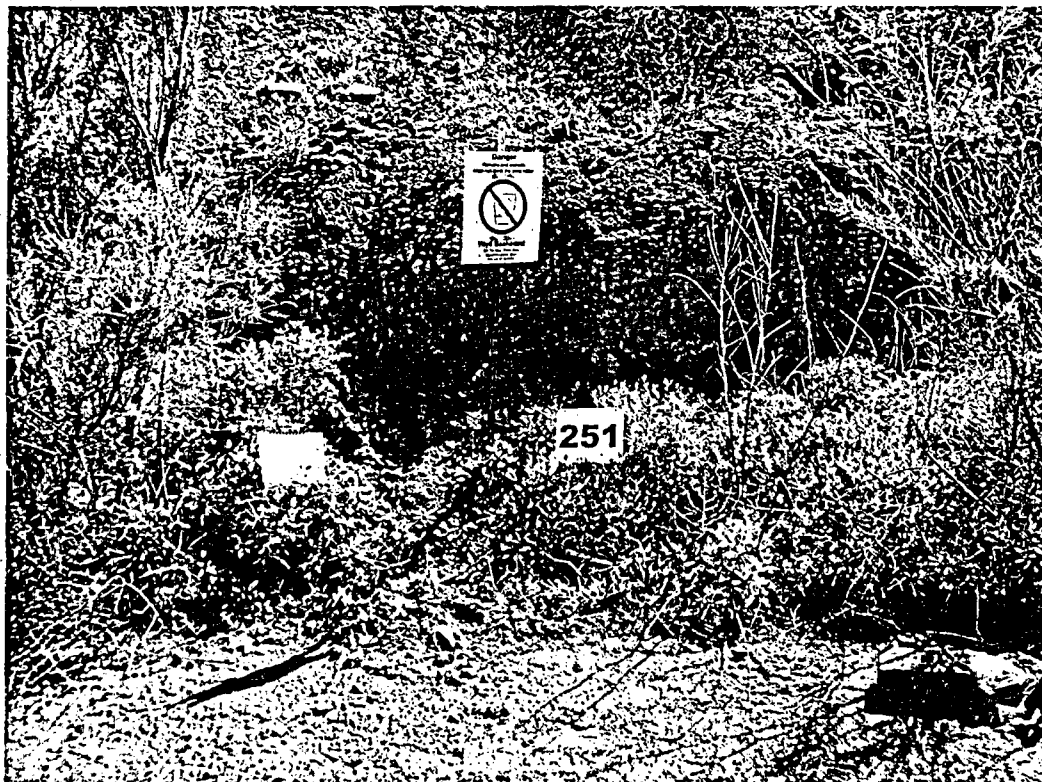
Due to ice or insufficient water, DOE was able to sample only three of the six seeps in February 2004. In 2005, sampling was moved to April to avoid freezing conditions and to maintain sampling during a wetter time of the year when disposal cell performance would be most evident. Samples were collected from five of the six seeps in 2005; only seep 0251 was not sampled due to insufficient water (PL-6).

*HAT 4/2005. PL-6. Seep location 0251 in North Arroyo.*

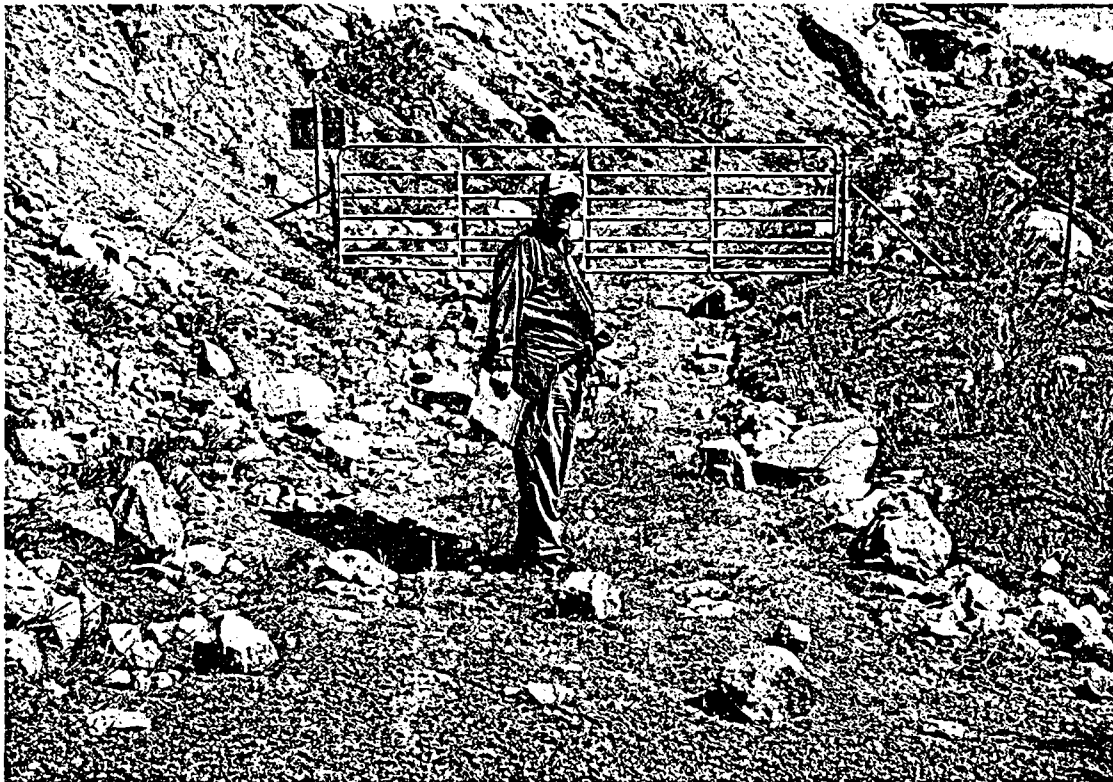
*NAT 4/2005. PL-1. Onsite access road showing fallen rock and placement within a roadside gully for erosion prevention.*

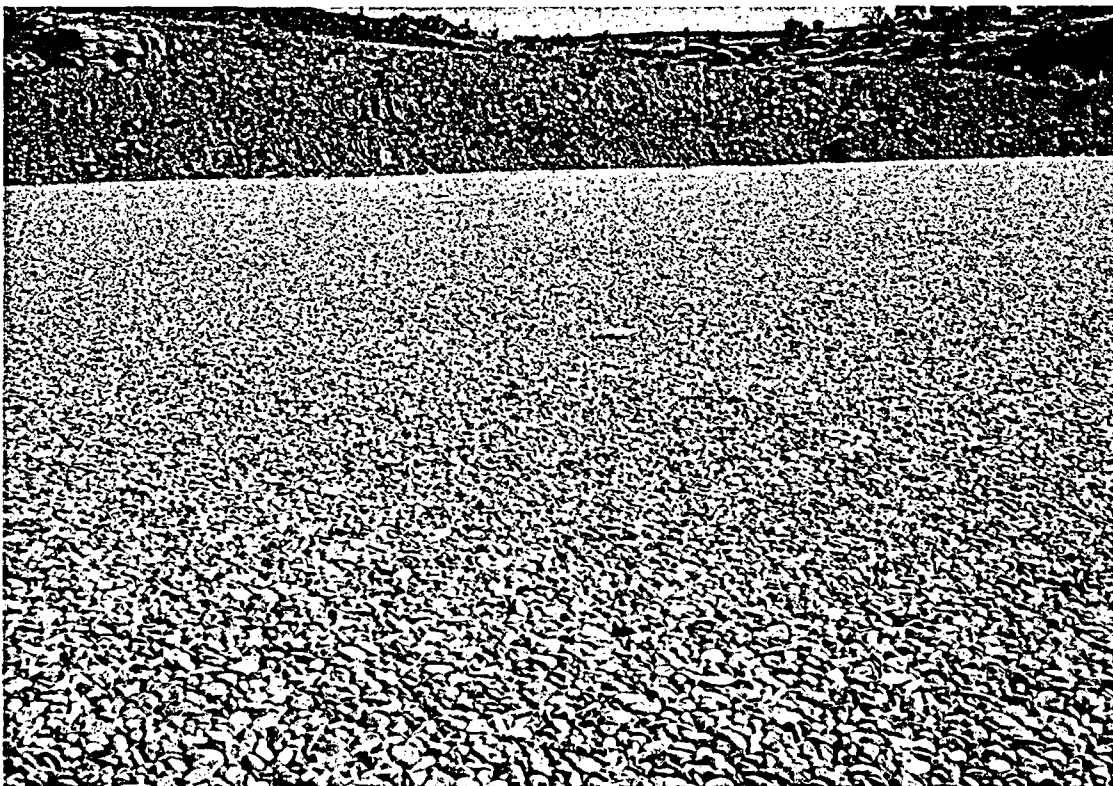
*NAT 4/2005. PL-2. Slightly irregular surface on the southwestern portion of the disposal cell top.*

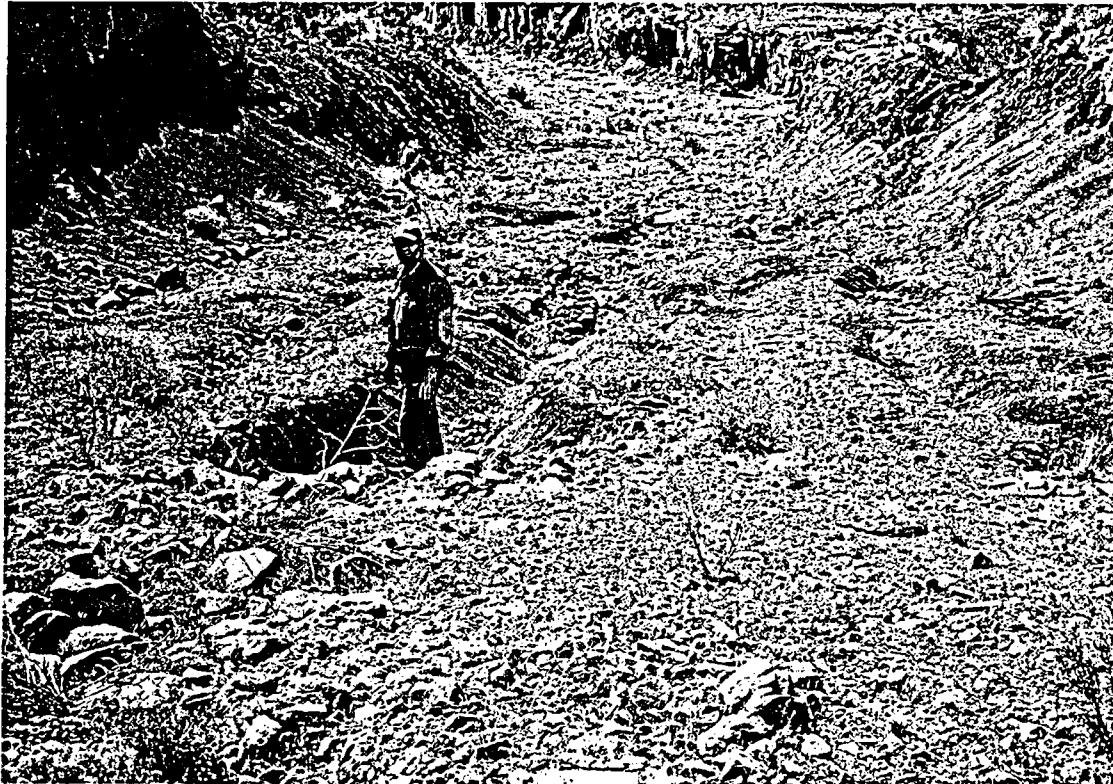
*NAT 4/2005. PL-3. Lower part of southwest toe drain just beyond rock armor where erosion has produced a knickpoint between softer shale and harder sandstone.*

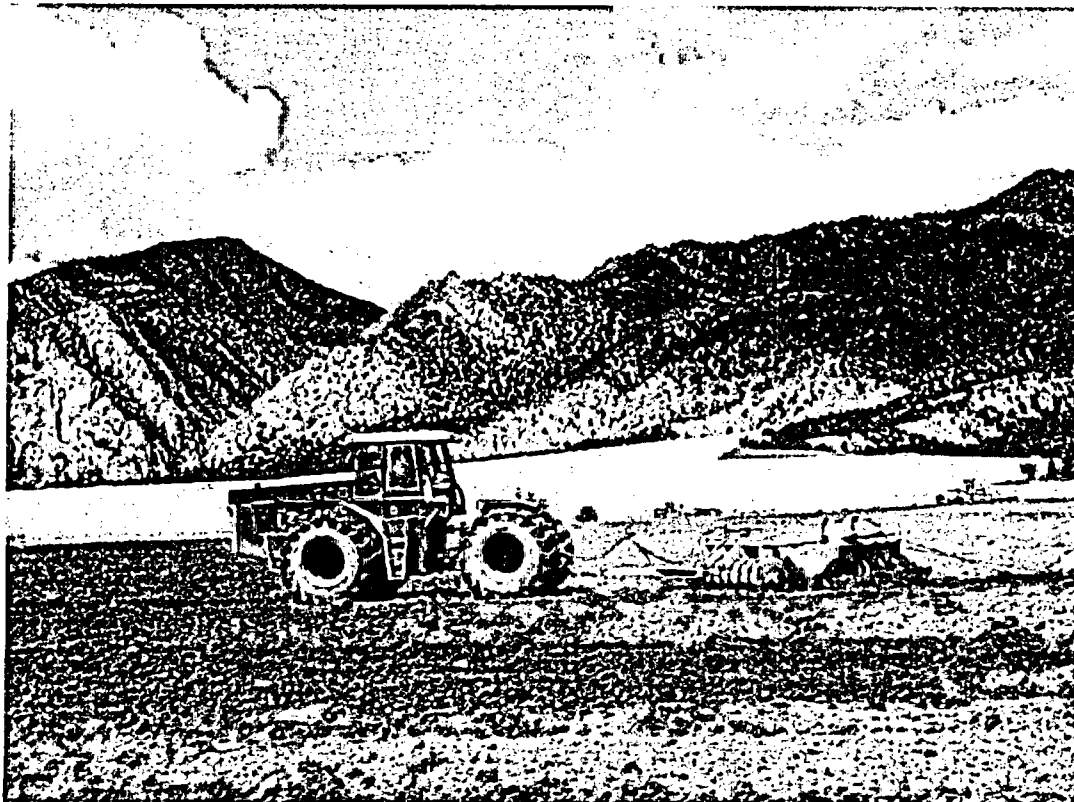
RFL 8/2005. PL-6. Heavy tractor double-discing the BLM Right-of-Way Reservation area south of site.

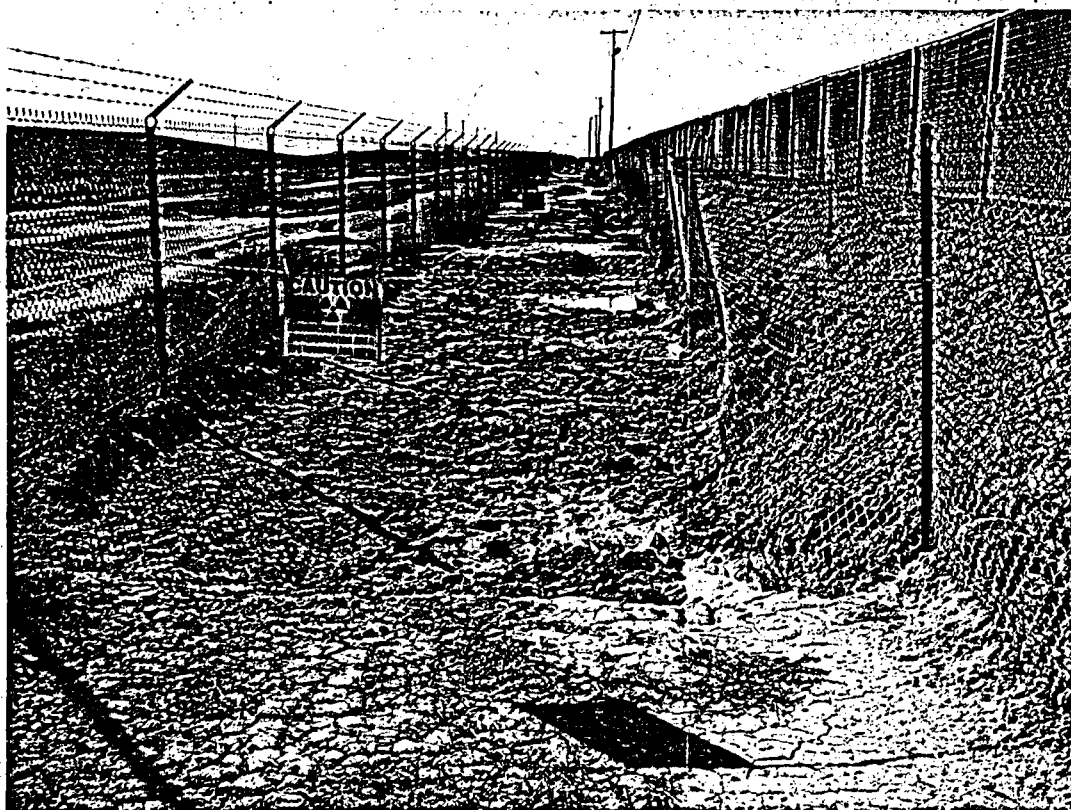
*SLC 3/2005. PL-4. Posted radiological surface contamination area directly north of the site boundary excavated to approximately 1 foot in depth.*

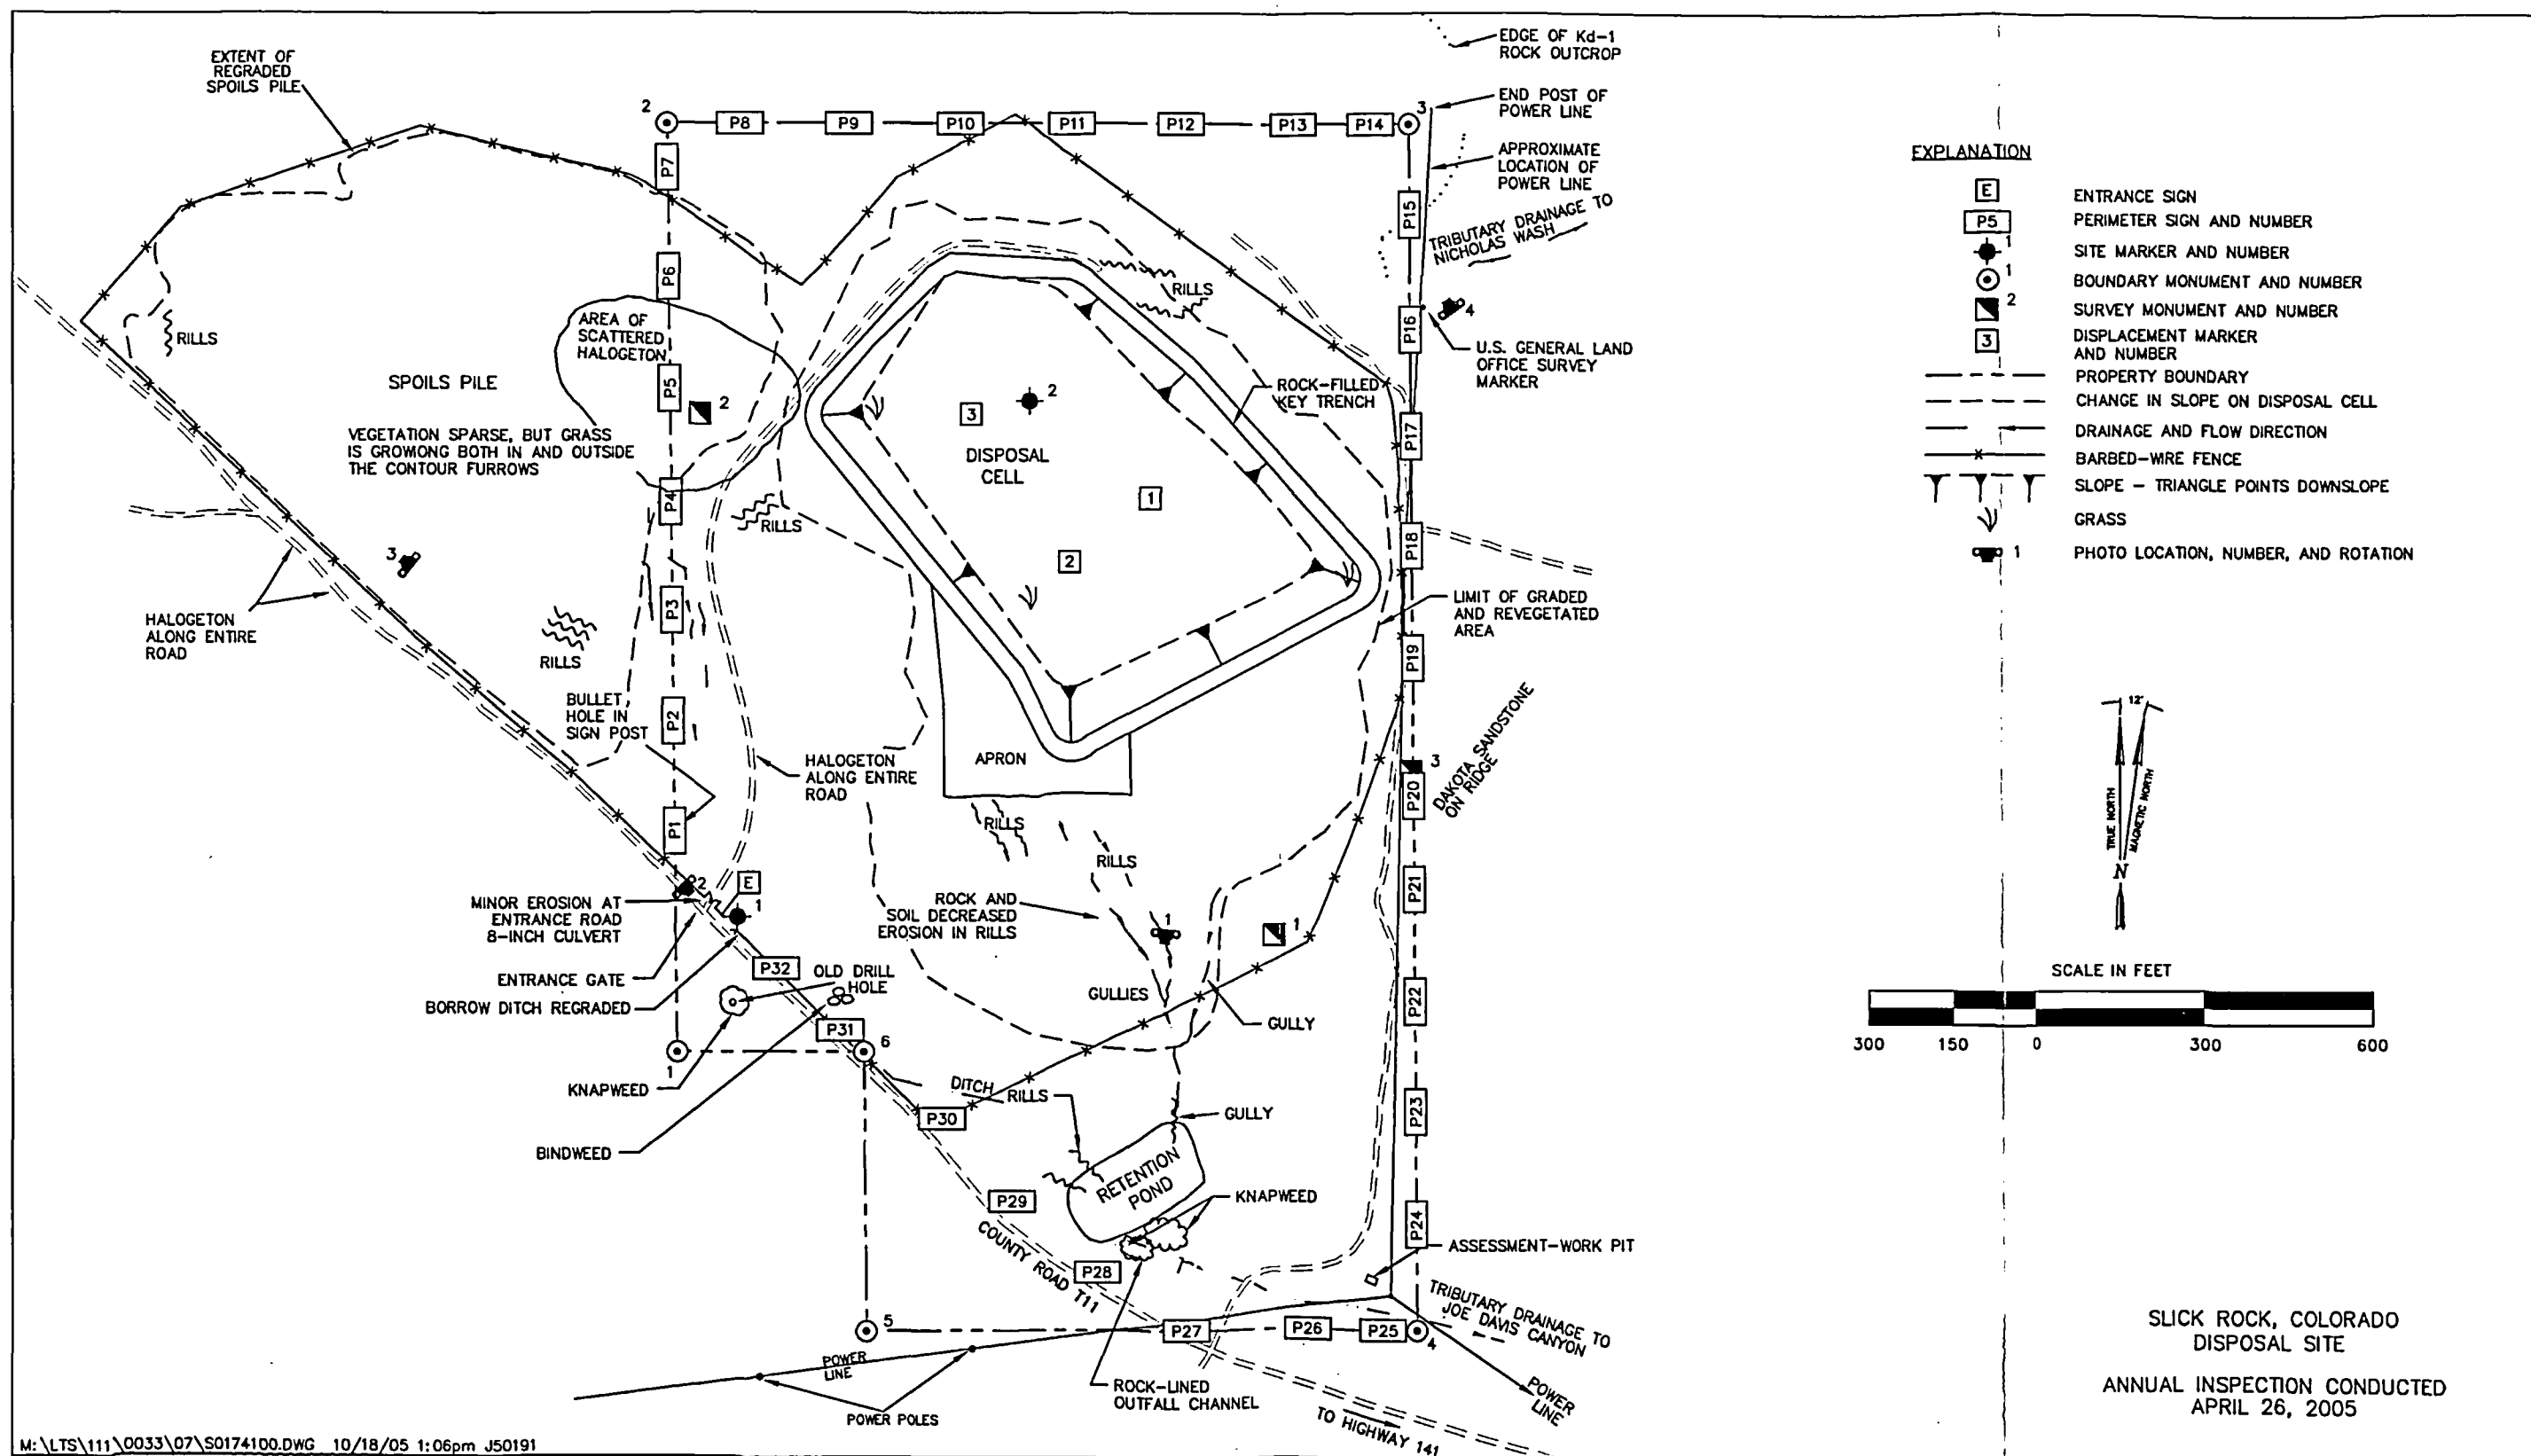
Figure 17-1. 2005 Annual Compliance Drawing for the Slick Rock, Colorado, Disposal Site

The Slick Rock Disposal Site, inspected on April 26, 2005, remains in excellent condition. Gravel fill placed in rills in 2004 south of the disposal cell is retarding erosion, but the area continues to show minor erosion. No disturbances have been observed following an earthquake that occurred in November 2004 near the site. Vegetation on the reclaimed right-of-way permit areas show good progress in 2005 due to the above-average rainfall. Noxious weeds were sprayed with herbicide in 2005. No other maintenance needs or cause for a follow-up inspection was identified.

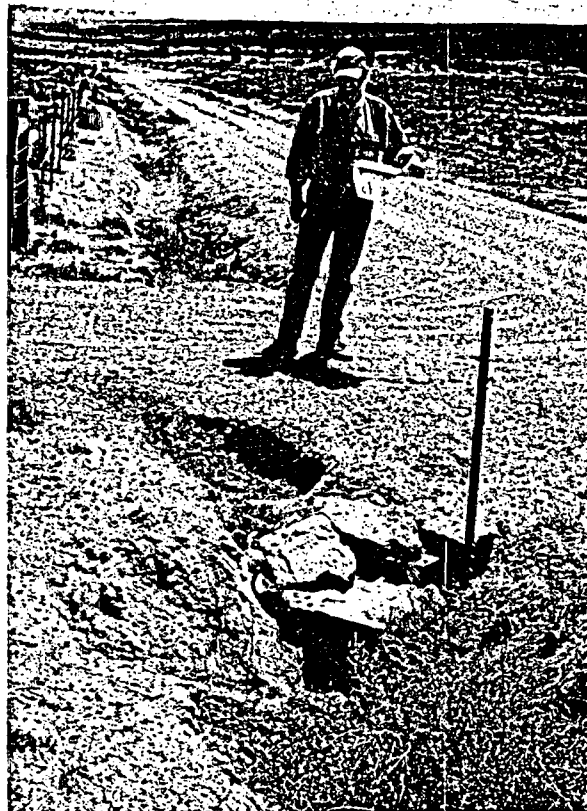
*SRK 4/2005. PL-2. Erosion of culvert installed at site entrance in 2004.*

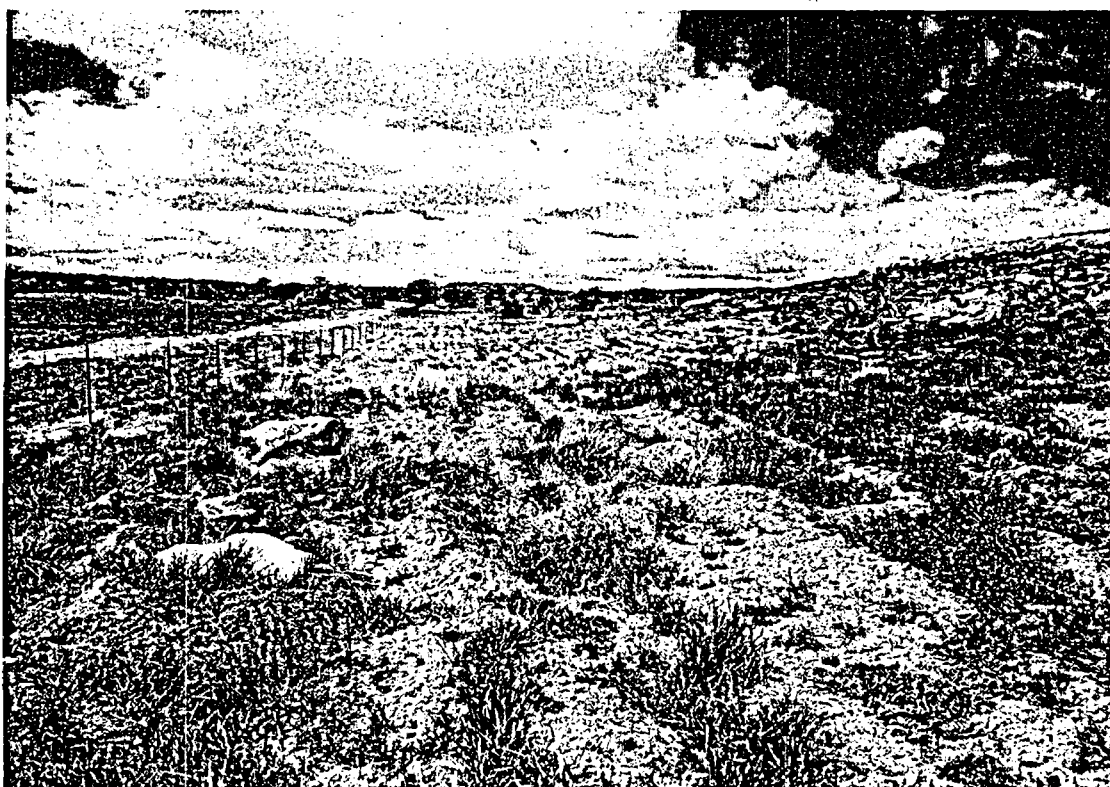
*SRK 4/2005. PL-3. Vegetative cover on the northwest corner of the reclaimed spoils pile.*
