Department of Energy  
Office of Legacy Management

Subject: 2005 Annual Site Inspection and Monitoring Report for UMTRCA Title I Disposal Sites

# **2005 Annual Site Inspection and Monitoring Report for Uranium Mill Tailings Radiation Control Act Title I Disposal Sites**

**December 2005**

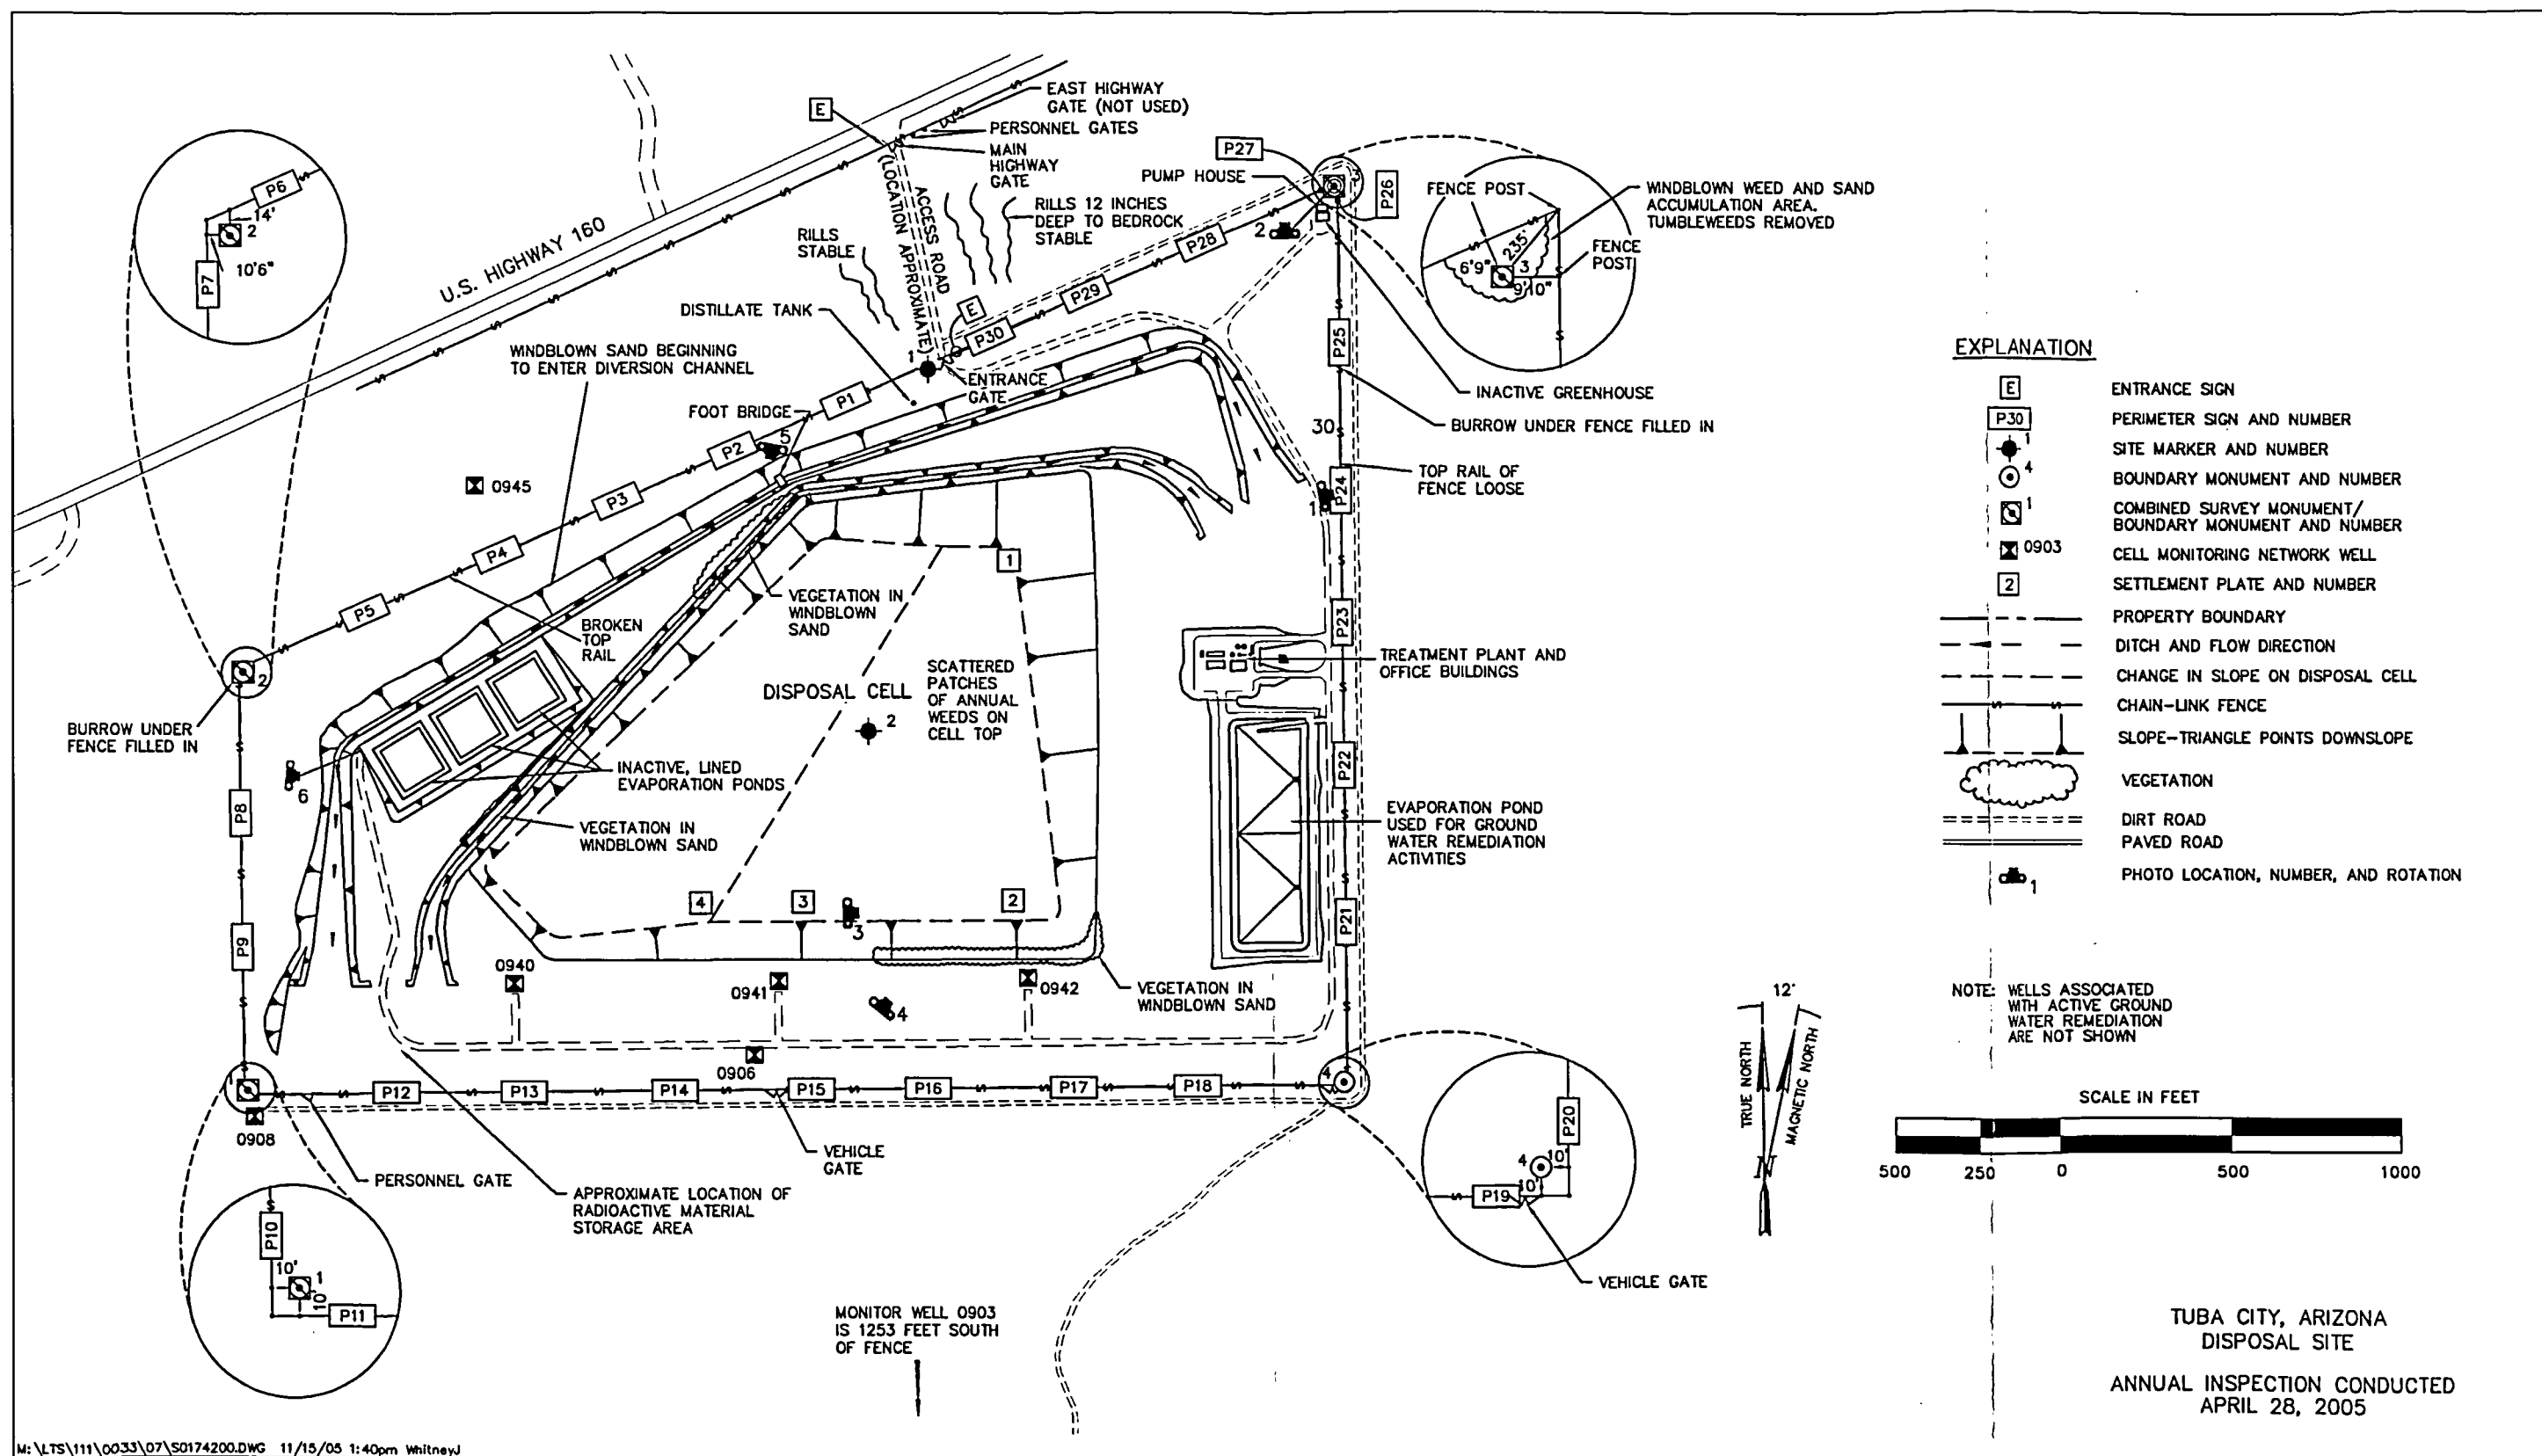
Figure 19-1. 2005 Annual Compliance Drawing for the Tuba City, Arizona, Disposal Site

19A The security fence around the site is chain link with three strands of barbed wire at the top. The fence is in good condition. During the 2004 inspection, segments of the fence had gaps up to 24 inches in height caused by wind erosion. These gaps subsequently were filled with granular material and the segments were in excellent condition at the time of this inspection. Two burrows, probably dug by dogs, were noted and subsequently were filled with granular material. Other gaps up to approximately 3 inches in height, caused by wind erosion, were present at several locations. Such gaps are not considered to be a security concern because they are too small to allow unauthorized access into the site; however, most were filled with granular material also. The top rail of the perimeter fence is broken near perimeter signs P4 and P5 and is loose near perimeter sign P24. The broken top rail will be repaired. However, the breaks are minor and do not compromise site security.

Two entrance signs and 30 perimeter signs are situated around the site. Perimeter signs are posted in pairs. Each sign pair, secured to a metal post and set back about 5 feet from the site boundary, consists of a "No Trespassing" sign with a radioactive materials tri-foil symbol and a schematic sign with a diagram of the disposal cell and the site boundary (that also includes the radioactive materials tri-foil symbol and lightening bolts which signify danger to the Navajo). All of the "No Trespassing" signs were noted to be in poor condition during the 2004 inspection due to vandalism (i.e., bullet holes) or deterioration from exposure to the weather and windblown sand; all of these metal signs were replaced by plastic signs in the fall of 2004. Many of the new signs were misaligned due to wind and will be straightened and better secured to the posts (PL-1). The metal schematic signs remain in good condition.

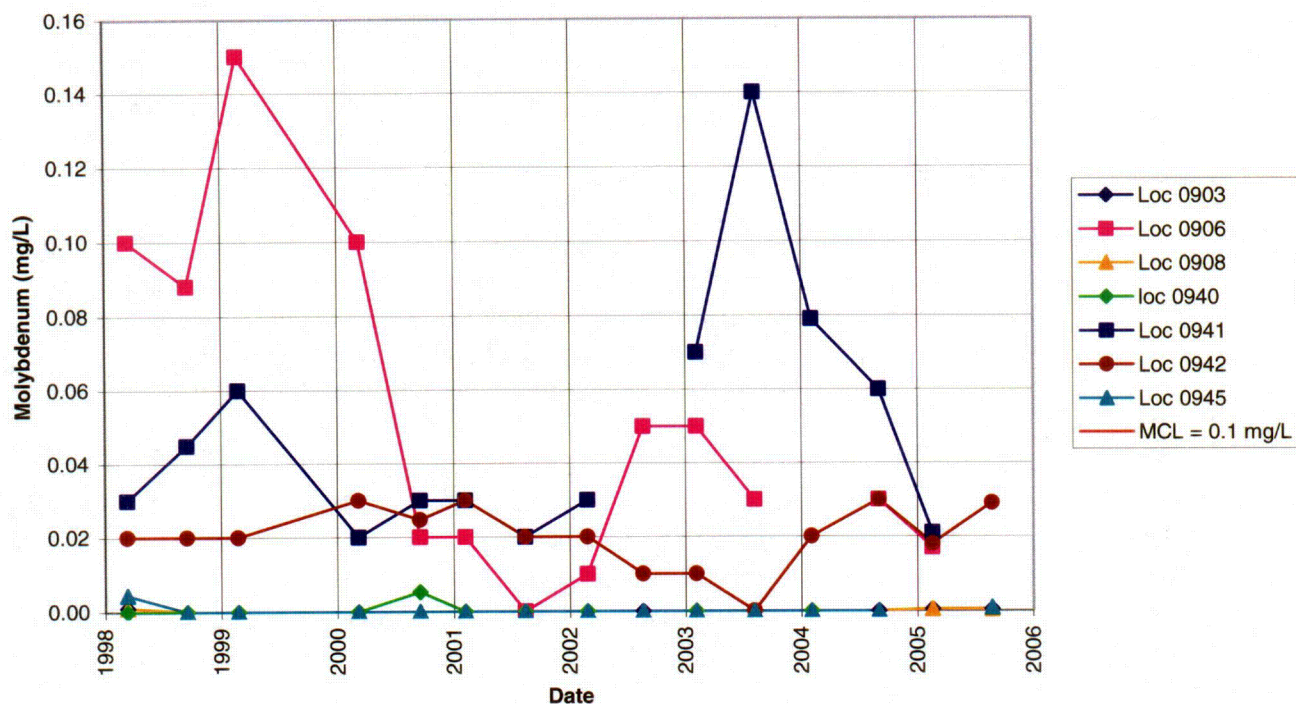
Figure 19-2. Time-Concentration Plots of Molybdenum in Ground Water at the Tuba City, Arizona, Disposal Site

Molybdenum concentrations in ground water were below the MCL (0.01 mg/L) in 2005 in all wells (Figure 19-2). Concentrations in onsite downgradient wells MW-0906 and MW-0941 have fluctuate substantially since 1998. Reported concentrations in these two wells have ranged from 0.01 mg/L to 0.15 mg/L in well MW-0906 and from 0.02 mg/L to 0.14 mg/L in well MW-0941. The remaining locations have historically shown concentrations below 0.04 mg/L, and the upgradient background well MW-0945 and the off-site downgradient well MW-0903 were at or near the detection limit.

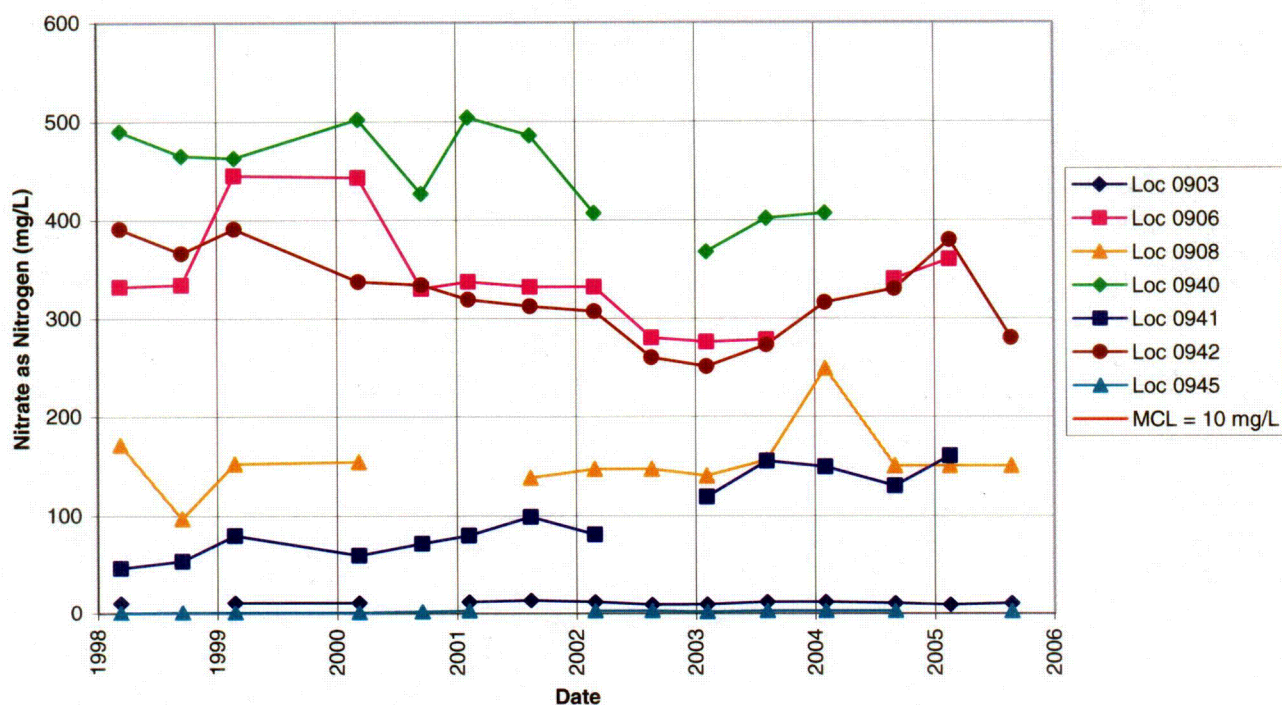
Figure 19-3. Time-Concentration Plots of Nitrate (as N) in Ground Water at the Tuba City, Arizona, Disposal Site

Nitrate concentrations in ground water exceeded the MCL (10 mg/L), by an order of magnitude or more, in all onsite monitor wells except the upgradient background well MW-0945 (Figure 19-3). Concentrations in the off-site downgradient well MW-0903 were at the MCL in 2004 and only slightly above in 2005. Concentrations in all wells have remained relatively consistent, except in MW-0941 where an upward trend seems apparent. Nitrate concentrations have varied considerably from well to well since 1998.

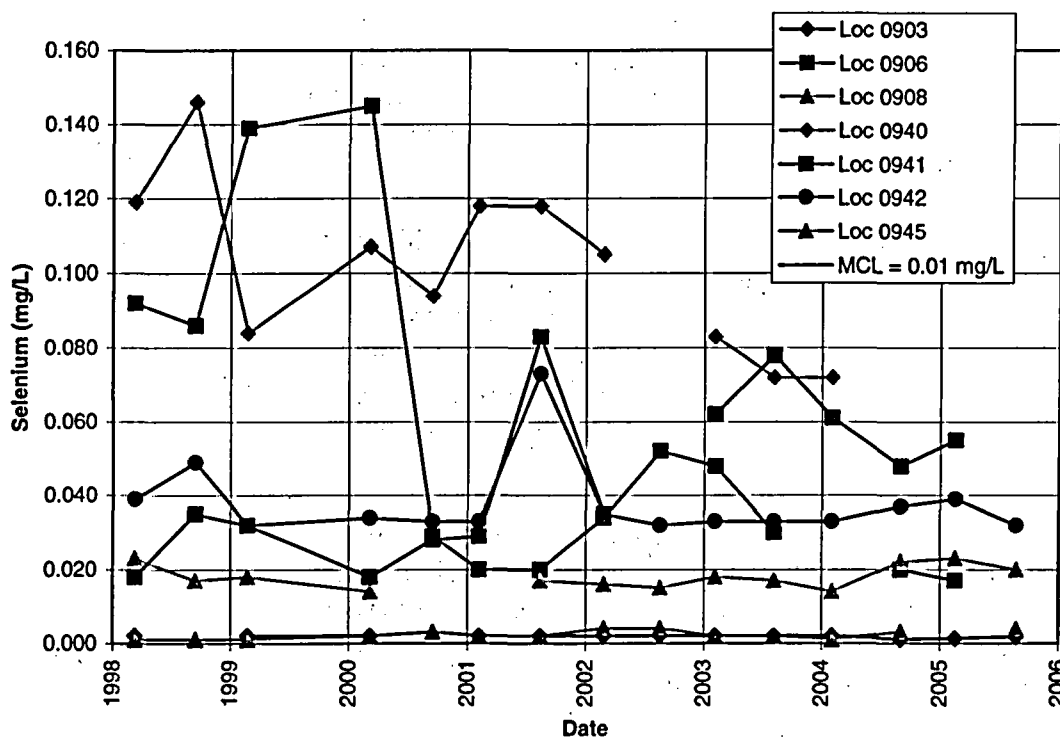
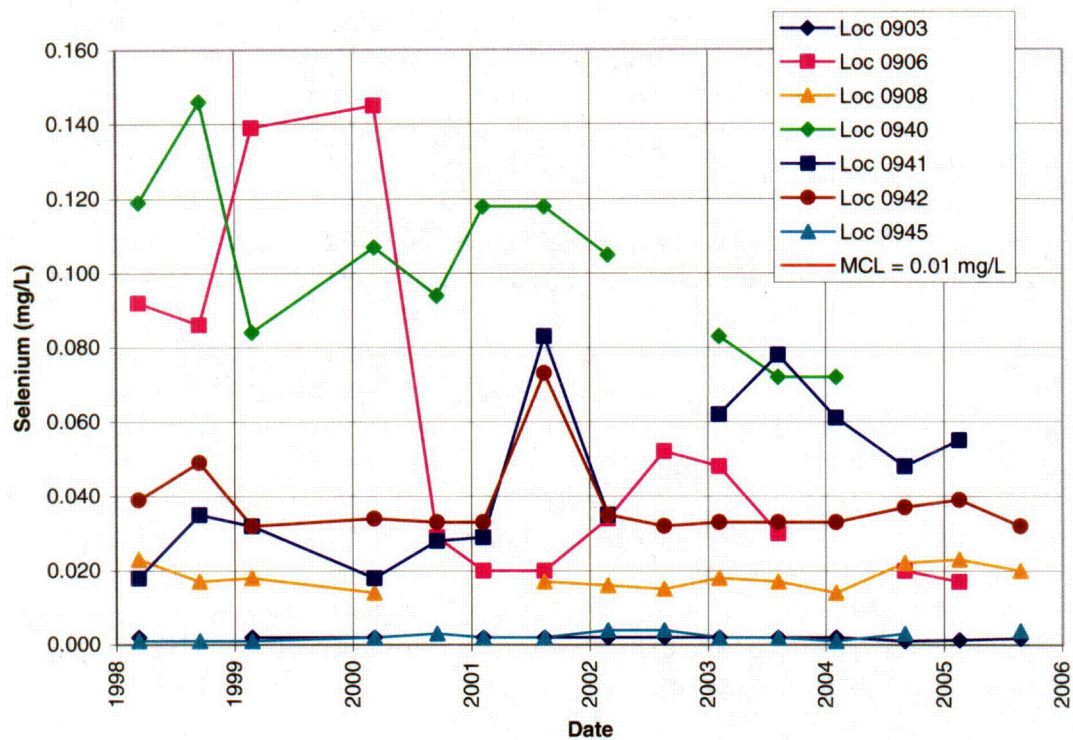
Figure 19-4. Time-Concentration Plots of Selenium in Ground Water at the Tuba City, Arizona, Disposal Site

Selenium concentrations in ground water exceeded the MCL (0.01 mg/L) in 2005 in all wells except the upgradient background well MW-0945 and the off-site downgradient well MW-0903 (Figure 19-4). Concentrations have remained fairly constant over time in two wells MW-0908 and MW-0942 (with one exception); the remaining on-site wells have fluctuated substantially since 1998.

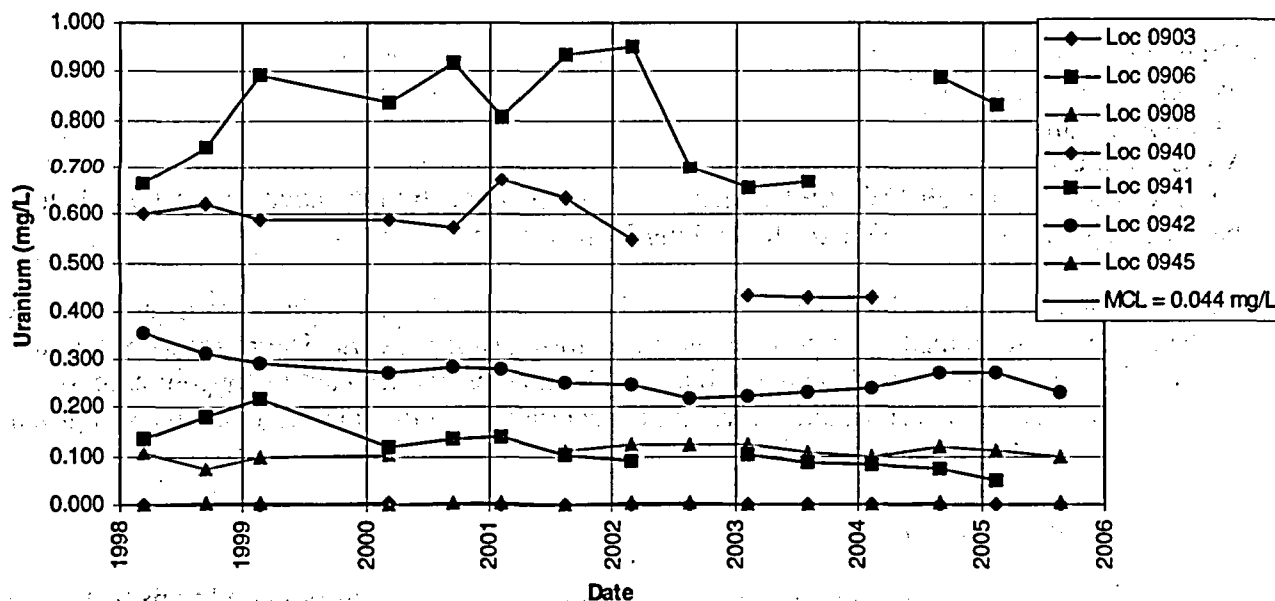
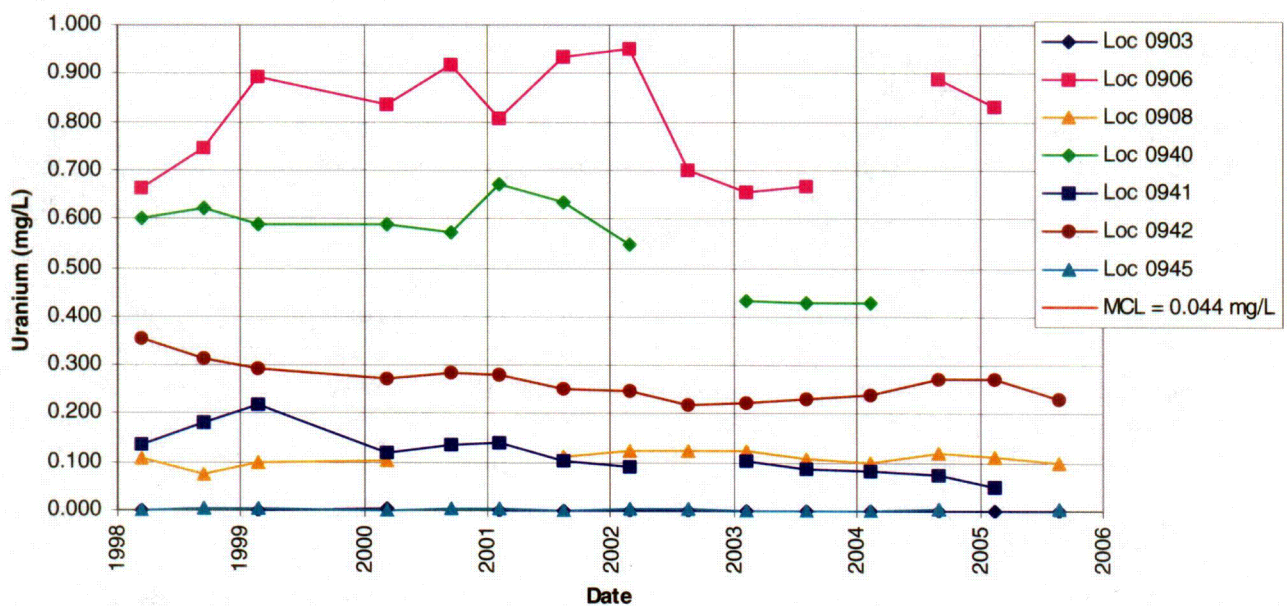
Figure 19-5. Time-Concentration Plots of Uranium in Ground Water at the Tuba City, Arizona, Disposal Site

Uranium concentrations in ground water exceeded the MCL (0.044 mg/L) in 2005 from all wells except the upgradient background well MW-0945 and the off-site downgradient well MW-0903; although, concentrations in well MW-0941 were reported only slightly above the MCL (Figure 19-5). Concentrations have remained fairly constant over time in all wells except onsite downgradient well MW-0906, where the highest concentrations have been reported and have fluctuated between 0.65 mg/L to 0.95 mg/L since 1998.
