**U.S. DEPARTMENT OF ENERGY
NEVADA OPERATIONS OFFICE**

**REPORT OF THE INVESTIGATION
OF THE ACCIDENT AT THE
MIDAS MYTH/MILAGRO TRAILER PARK
ON RAINIER MESA AT NEVADA TEST SITE
ON FEB. 15, 1984**

**DATE OF INVESTIGATION REPORT
APRIL 9, 1984**

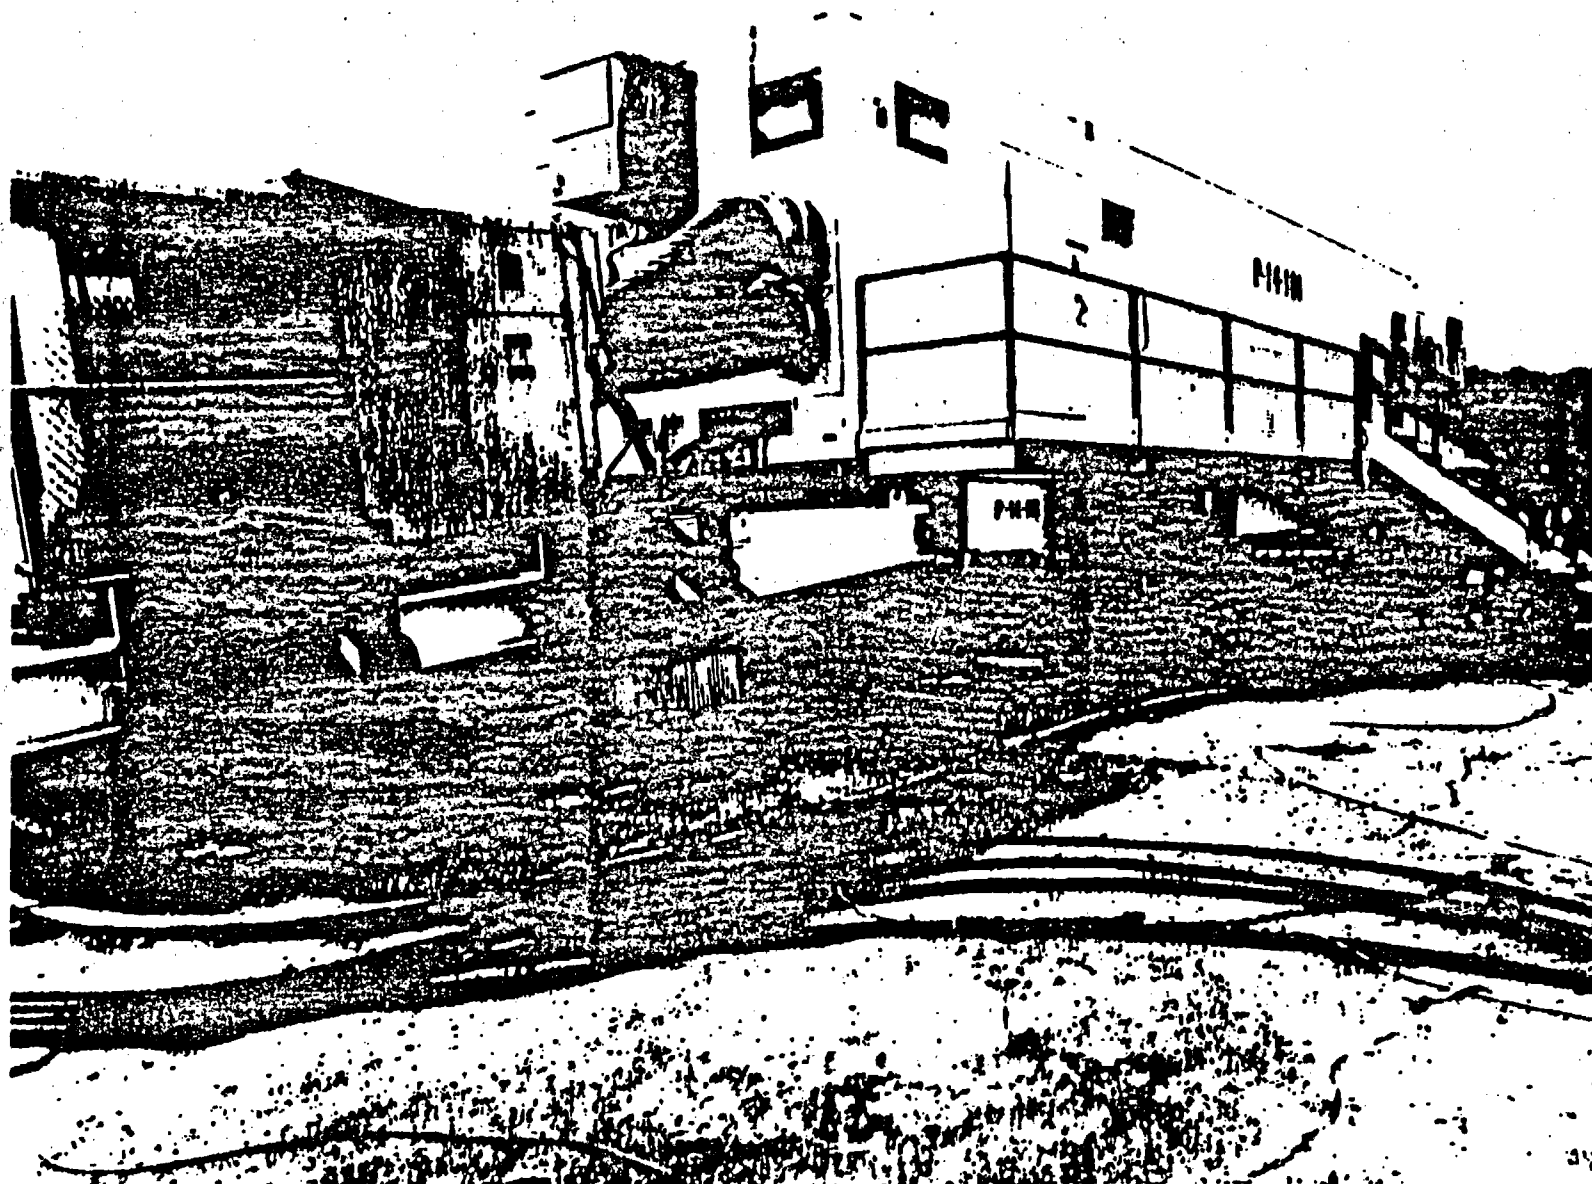
Figure 11 — MILAGRO Traller Park, Traller P-14-101 NW Corner,
Postshot, Prior to Collapse

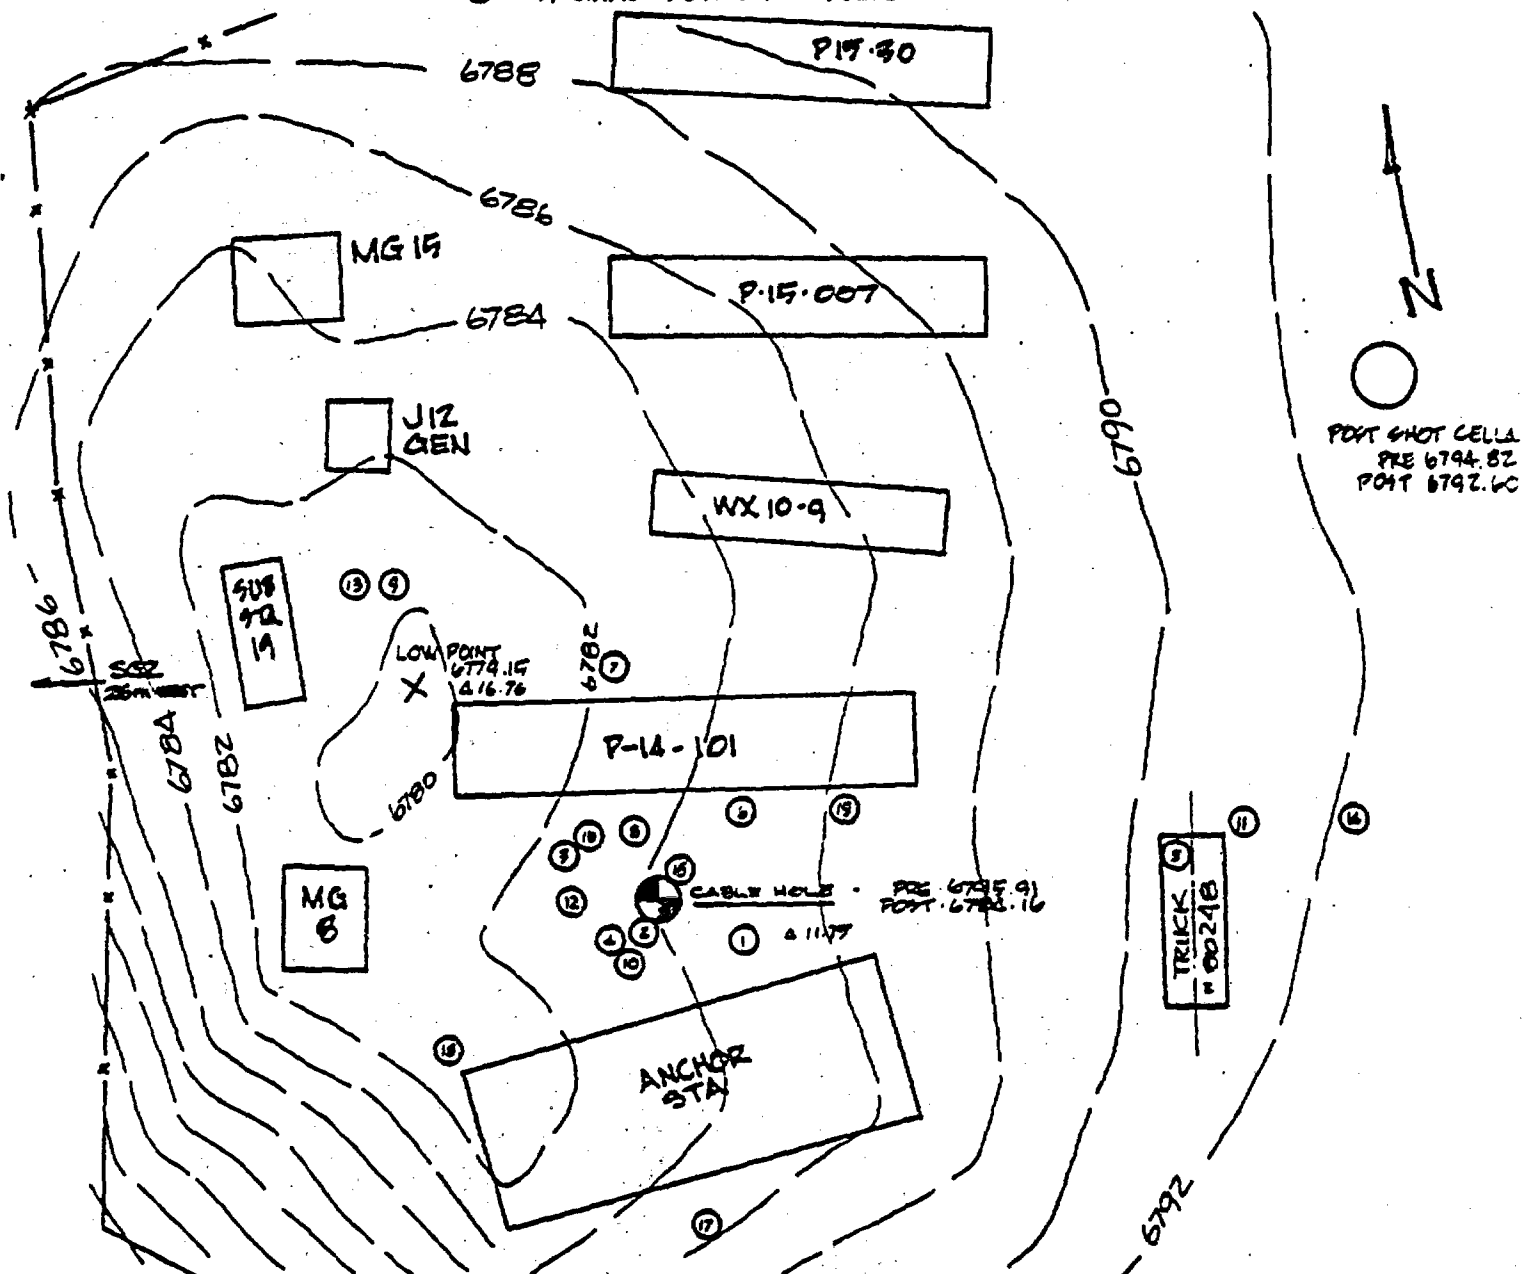
Figure 16 — MILAGRO Trailer Park,
 Collapse Contours and Personnel Location

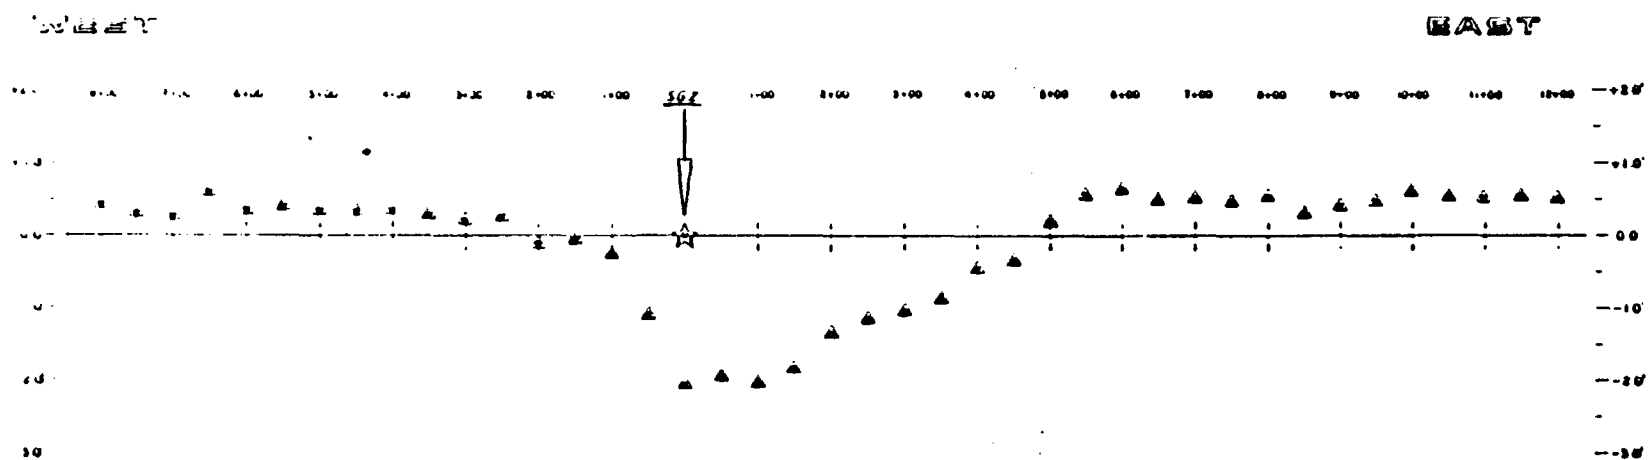
FIGURE 7-- Cross section showing differences in elevation (pre- vs. post-event) measured along a N75°E line through HURON LANDING SGZ.

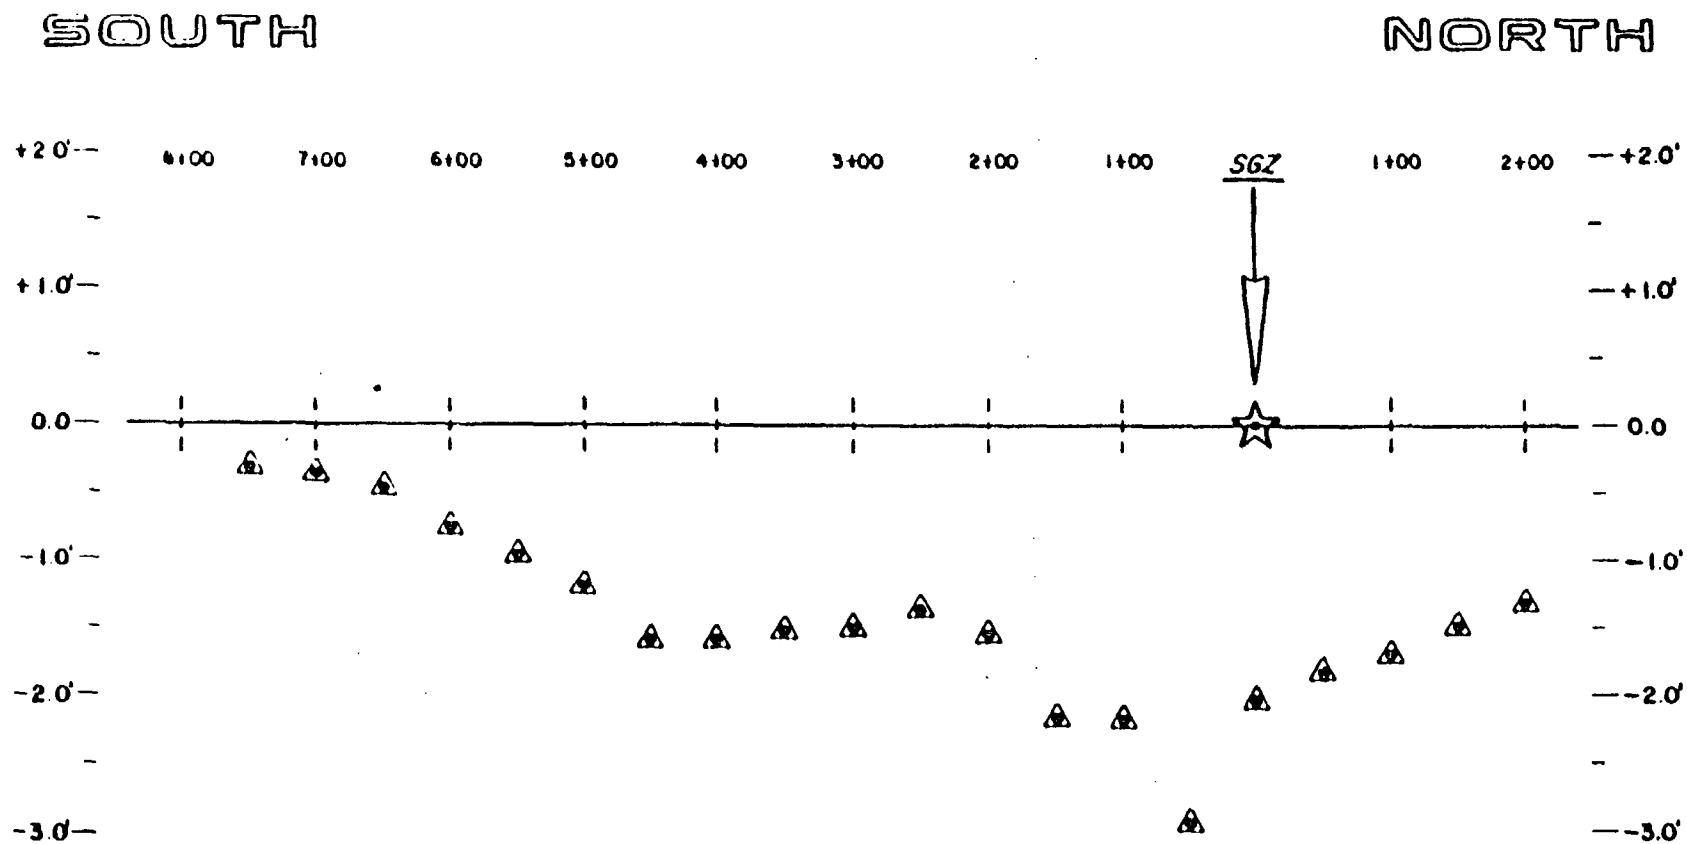
FIGURE 8.--Cross section showing differences in elevation (pre-vs.post-event) measured along a N15°W line through HURON LANDING SGZ.

note the apparent reversal of the true surface displacement versus the measured relative displacement along Fault #1.

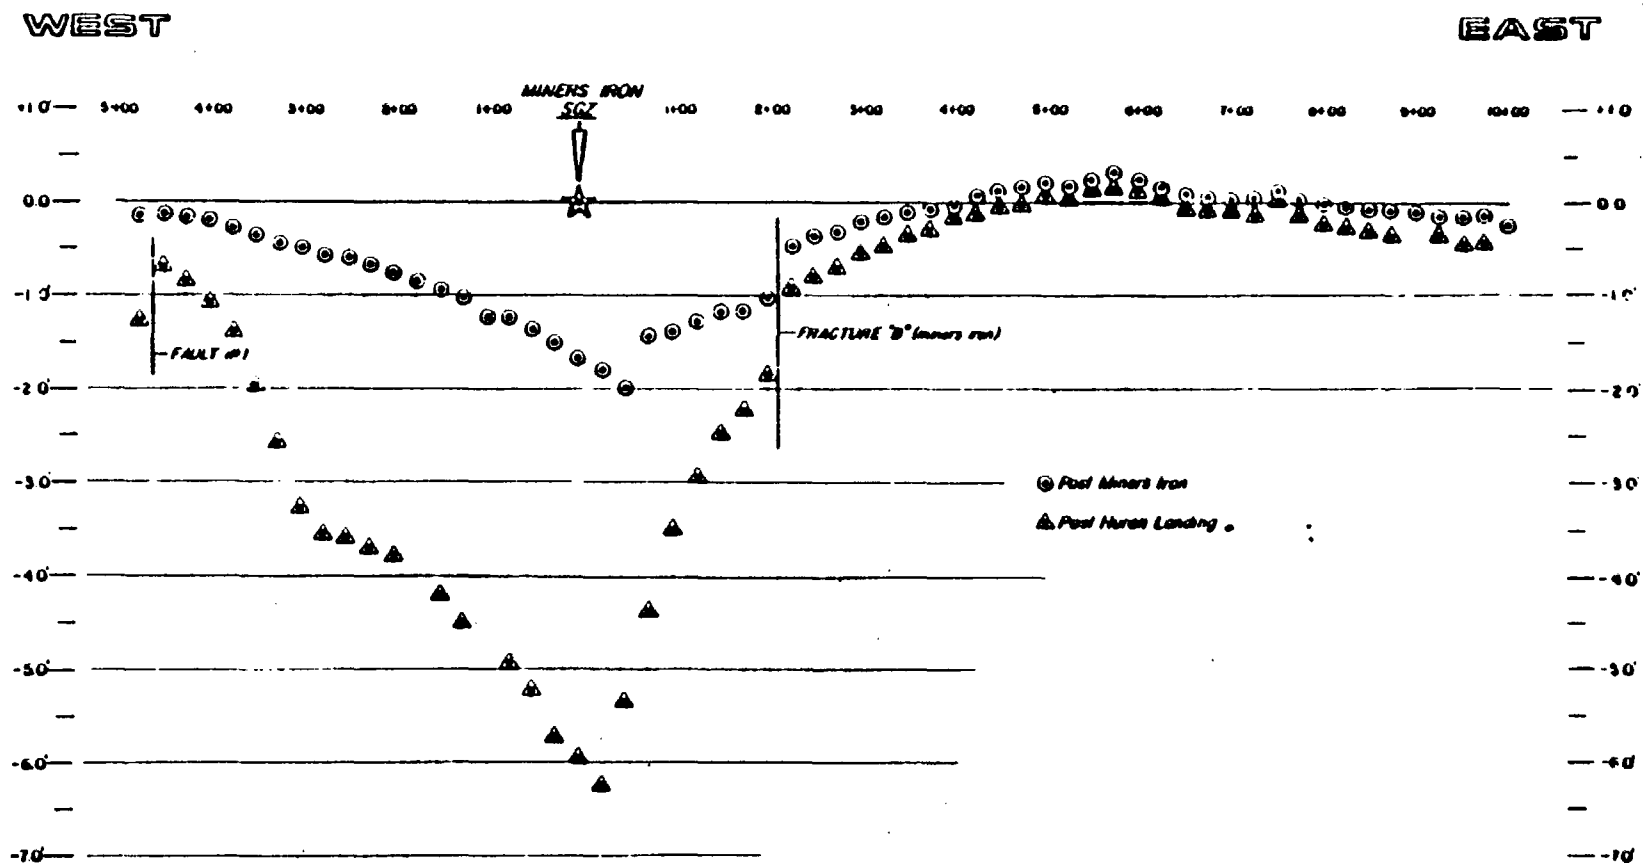
FIGURE 9.--Cross section showing differences in elevation (post MINERS IRON vs. post HURON LANDING) measured along a N75°E line through MINERS IRON SGZ.

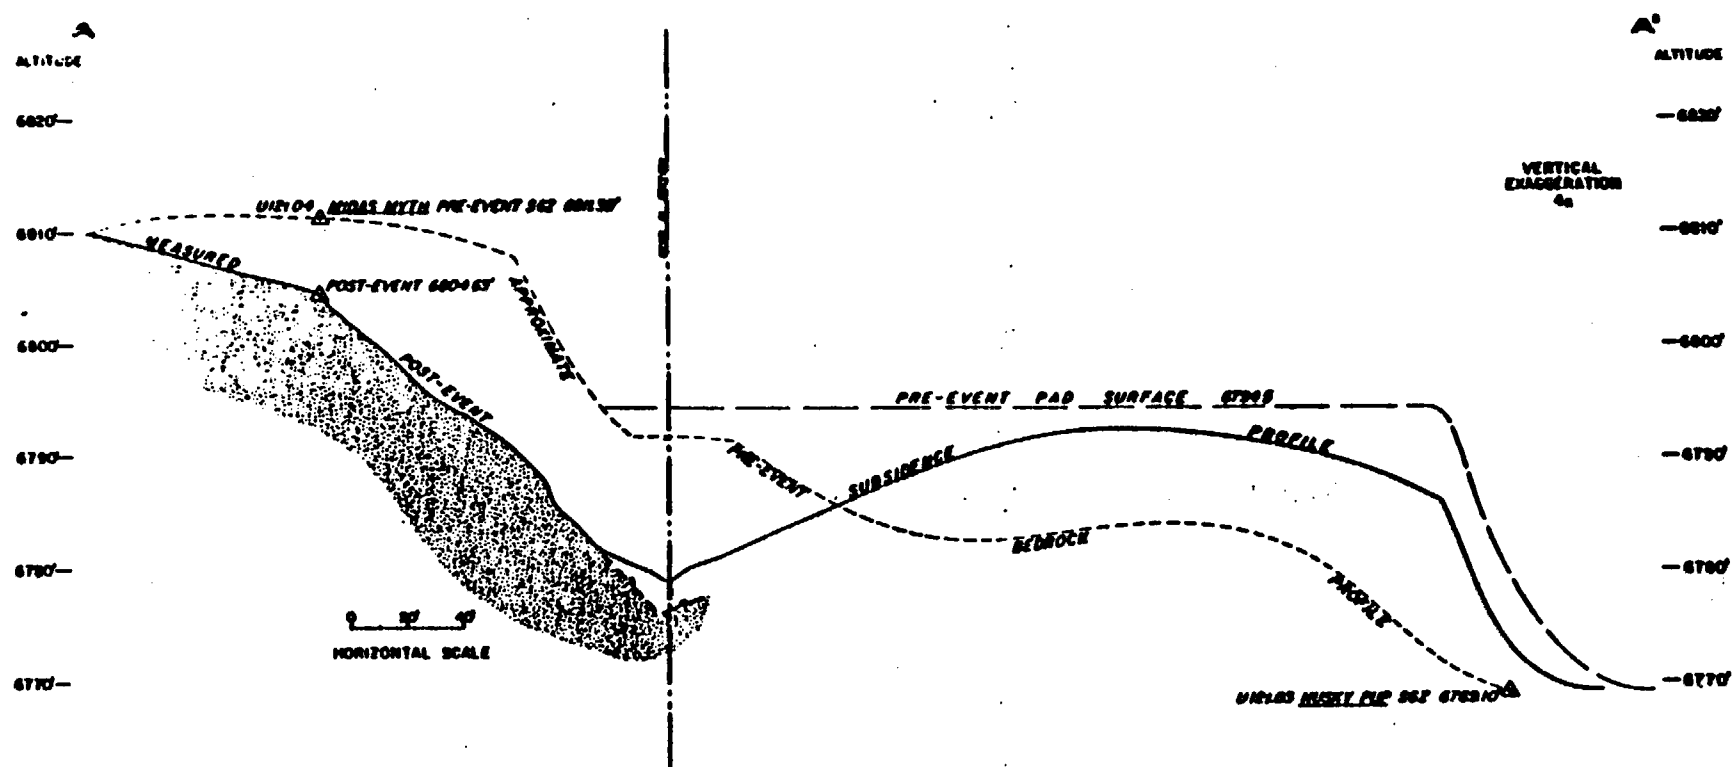
FIGURE 8.--Cross section through MIDAS MYTH SGZ--subsidence crater--HUSKY PUP SGZ, showing pre-vs post-event topography.

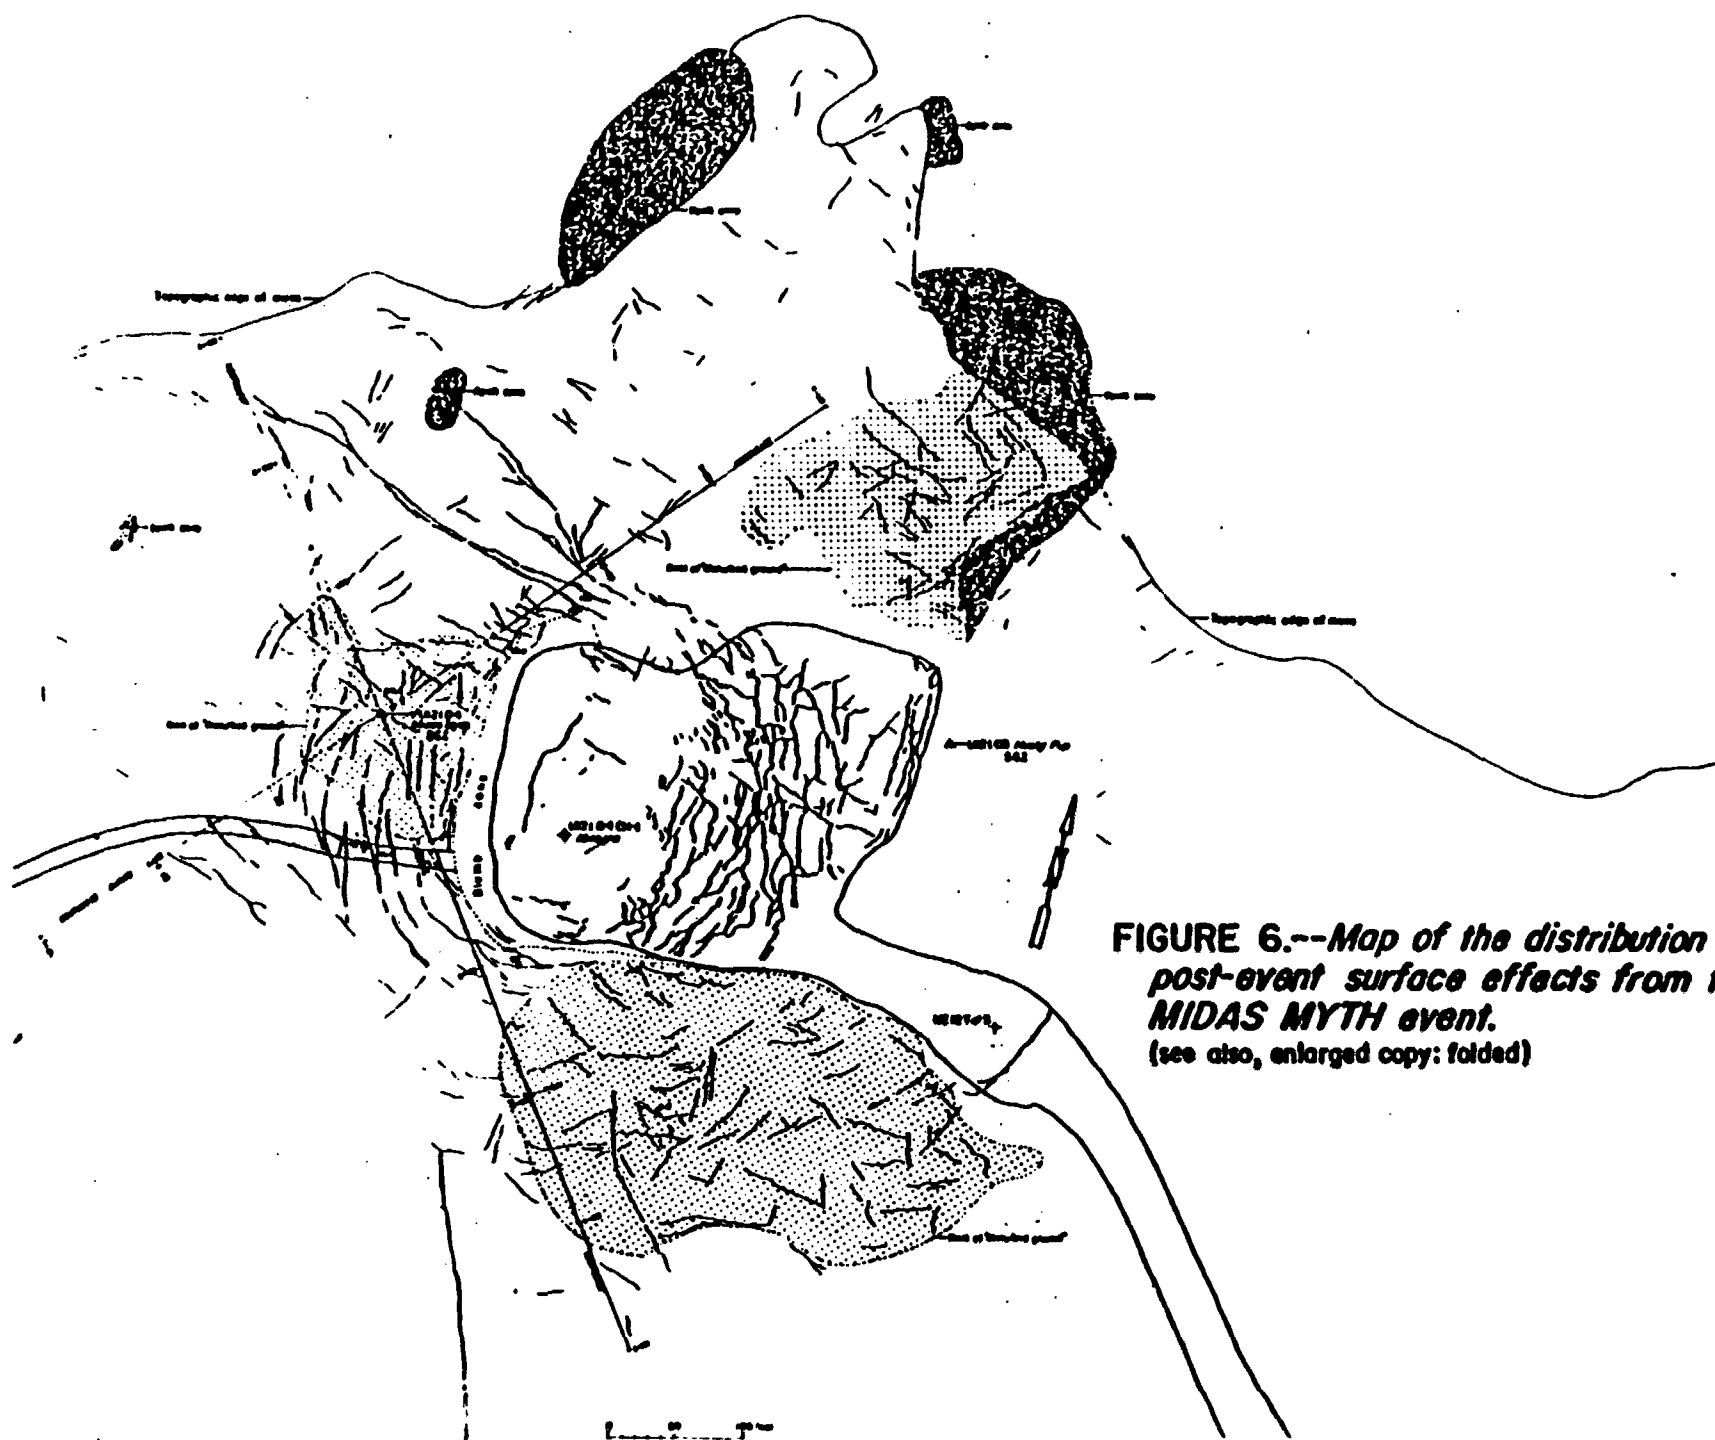
Cracking on the MILAGRO pad can be subdivided into two types: First, the apparently randomly-oriented cracks produced by the event; and second, the concentric fractures produced or enhanced by the subsidence. Figure 6 (page size and folded) illustrates the relationships of the major cracks on the prepared surface. It should be noted that the area under and between the trailers was never directly examined following the collapse. The few fractures shown in the trailer area were mapped from aerial photographs.

FIGURE 6.--Map of the distribution of post-event surface effects from the MIDAS MYTH event.
(see also, enlarged copy: folded)

cracks developed on the pad. These cracks are open from 1 to 50 mm, are nearly vertical, and generally are less than 0.3 m deep. The subsidence-related cracks trend north-south on the pad, and begin to curve slightly at the extremities (fig. 6). These cracks are irregular in form, probably because they were north-south oriented, pre-collapse fractures (fig. 2, Photo A) that have been enhanced by the subsidence. Photo G on Figure 7 shows a typical subsidence-related fracture. These fractures are open up to 0.6 m, have depths of over 3 m, and tend to dip away from SGZ.

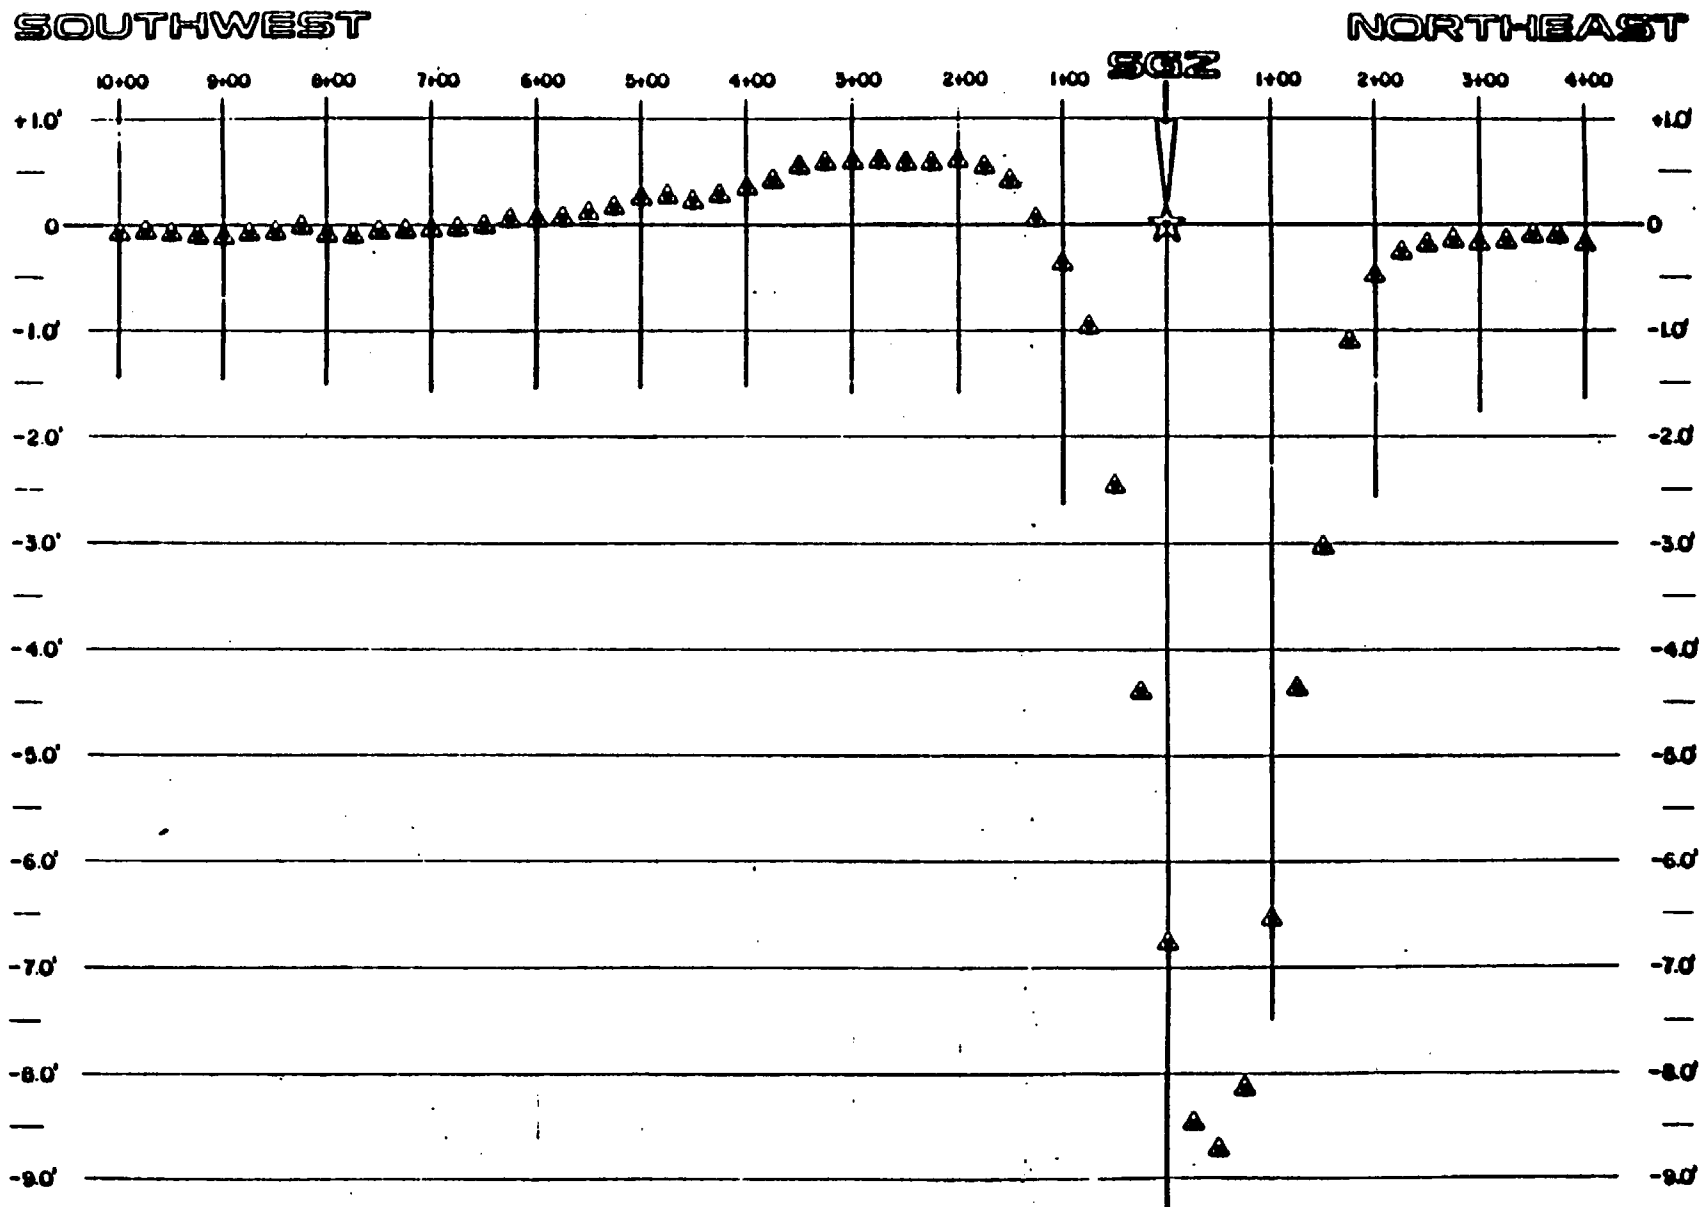
FIGURE 13.--Cross section showing differences in elevation (pre-vs. post-event) measured along a N40°E line through MIDAS MYTH SGZ.

The southwest-northeast line (fig. 13) shows a slight increase in elevation south of SGZ, and the subsidence crater starts approximately 200 ft southwest of SGZ. Toward the northeast, the subsidence extends to slightly more than 200 ft, and the remainder of the line is slightly lower than it was pre-event. The maximum decrease in elevation on this line is 8.72 ft, 50 ft northeast of SGZ.

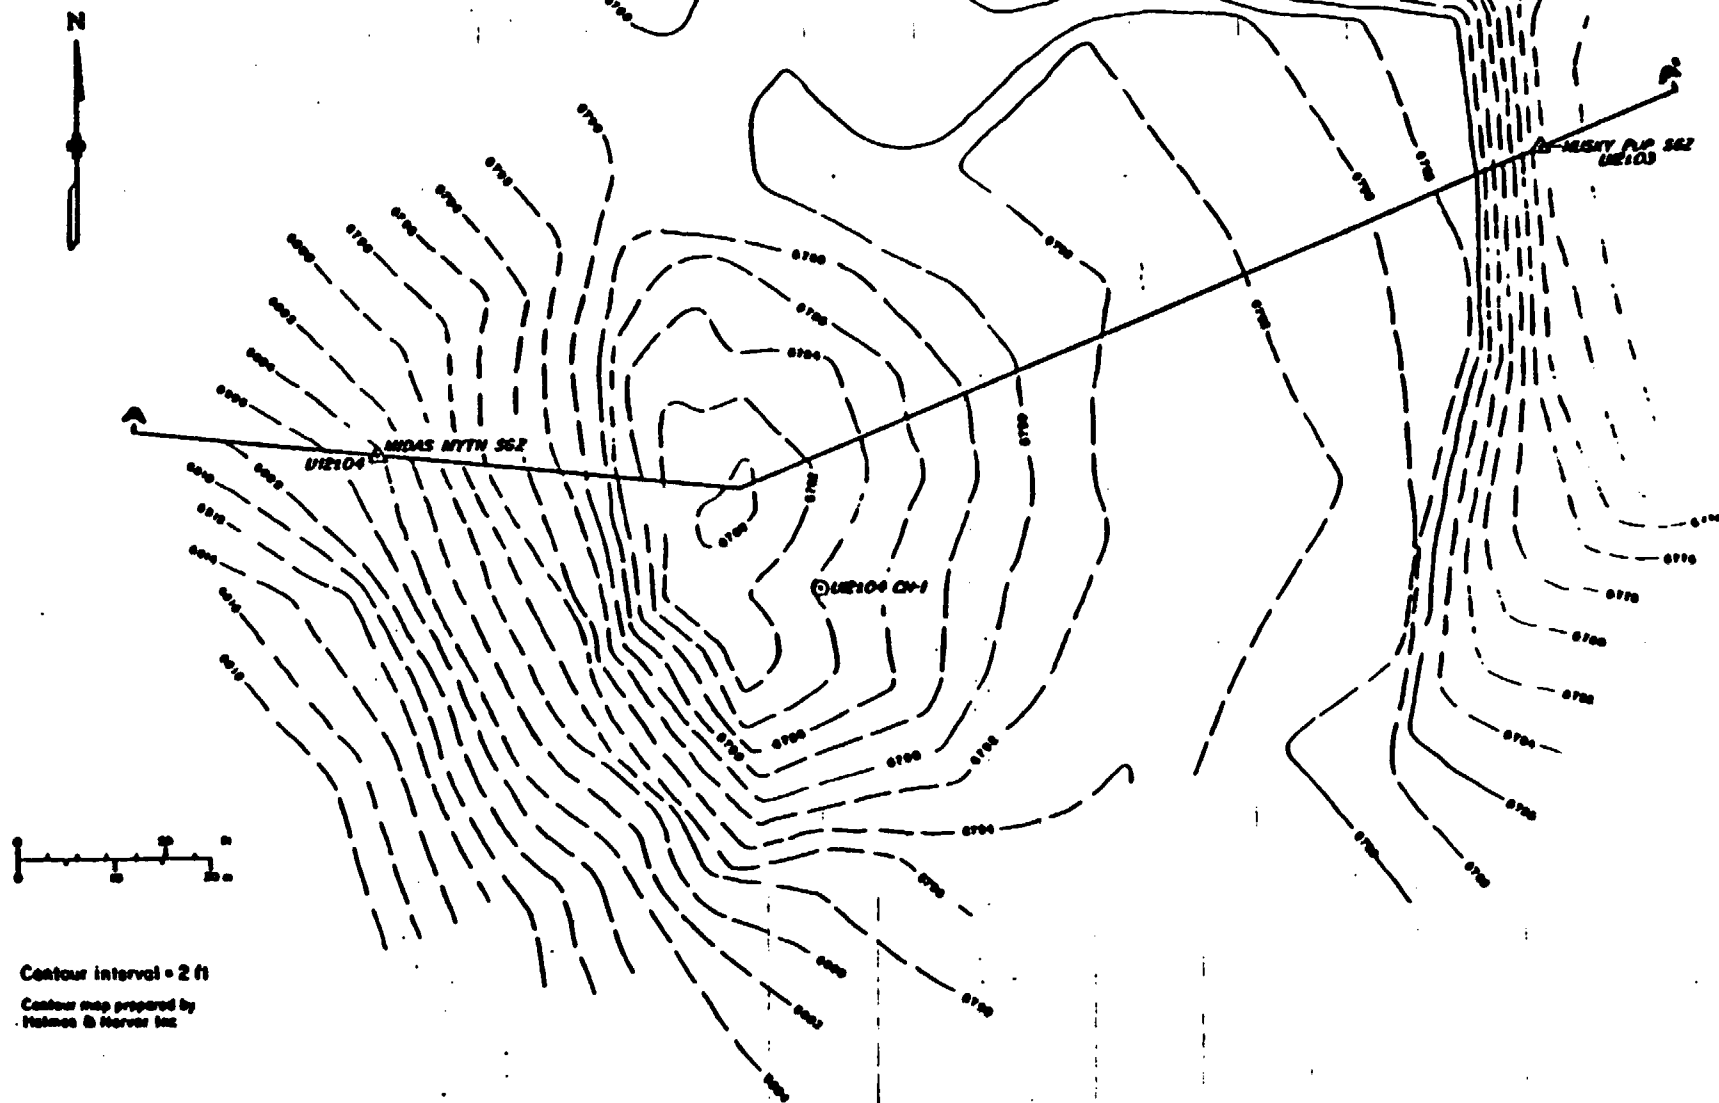
FIGURE 15.--Post-event topographic map of the MIDAS MYTH area, showing location of cross section A-A' (via-B).

Unfortunately, the majority of the surface subsidence occurred between the survey lines. Holmes & Narver Inc. has prepared a preliminary topographic map of the subsidence area (fig. 15). Cross section A-A', shown on Figure 8, gives the topographic relationships through the apparent deepest part of the subsidence.
