Quad Cities Unit 2 (QC2) Dryer Update

April 10, 2006

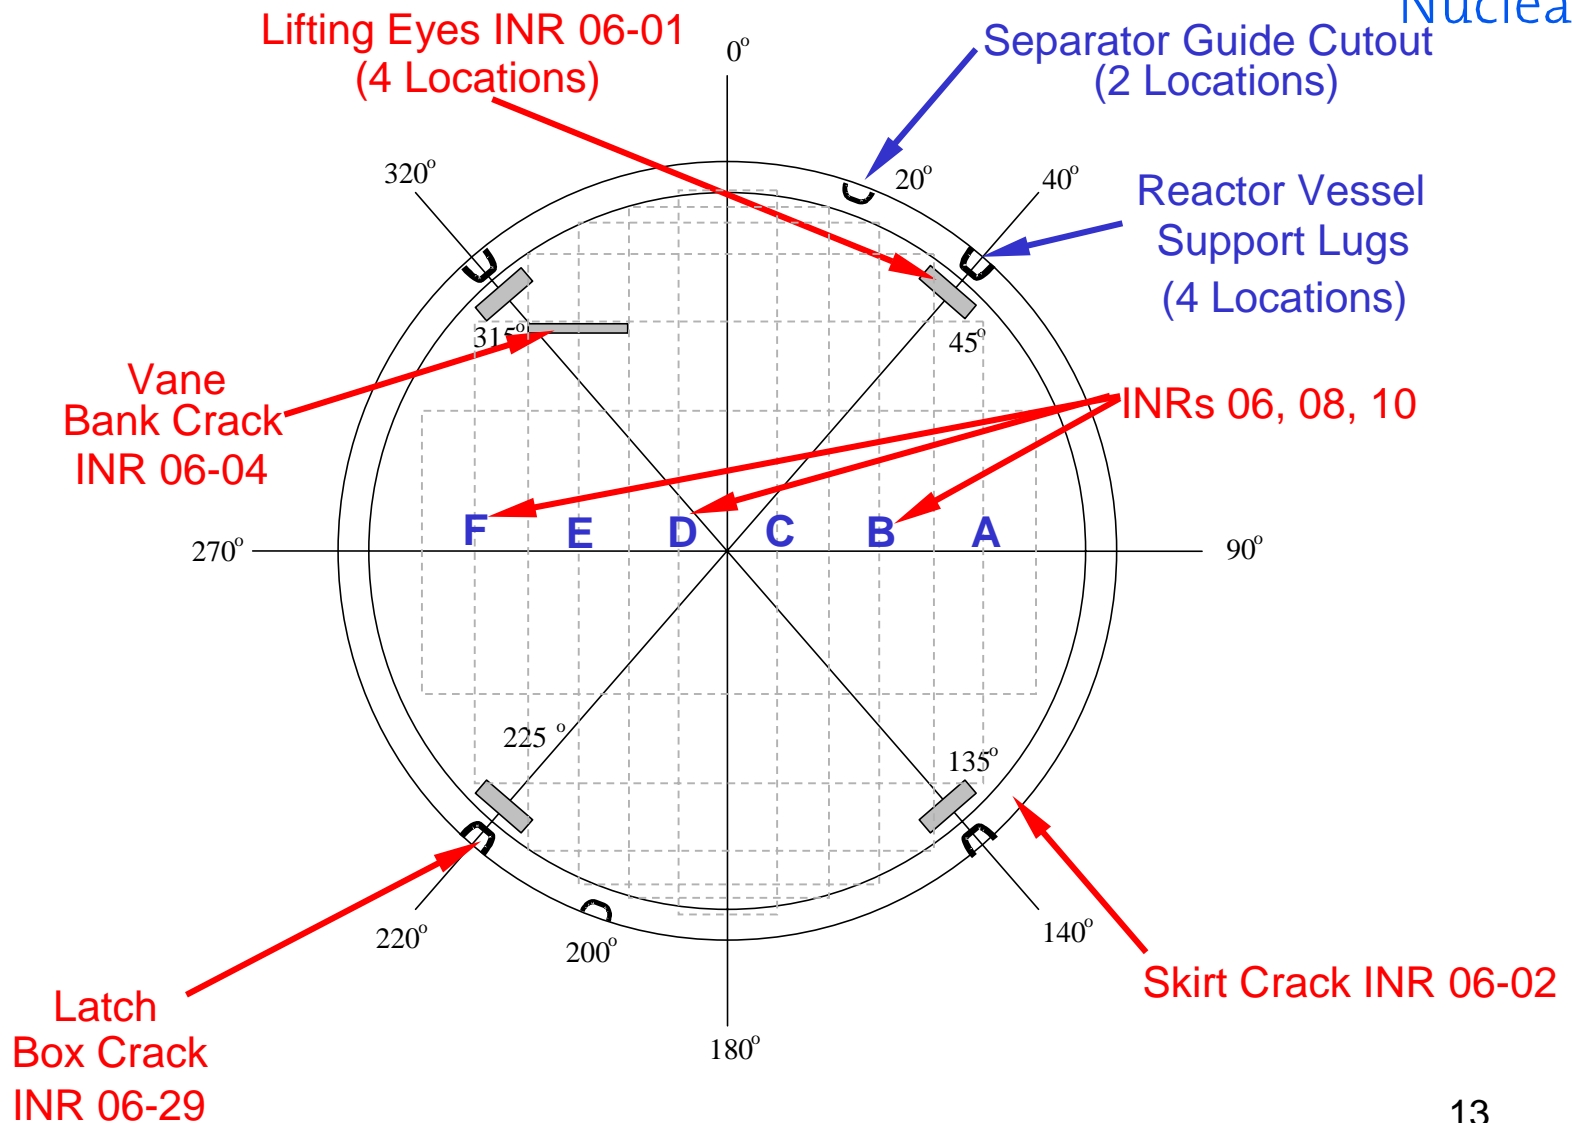
- The following 7 indications will be discussed:
 - 3 documented small cracks in the end vane in three vane assemblies (INRs 06-06, 06-08, and 06-10)
 - 1 documented the rotation of the lifting eyes and damage to the lifting rod threads (INR 06-01)
 - 1 documented a crack in the latch box located at the 220° location (INR 06-29)
 - 1 documented a crack in the vane assembly end plate near the 320° location (INR 06-04)
 - 1 documented a large crack in the dryer skirt and base plate at the 140° location (INR 06-02)

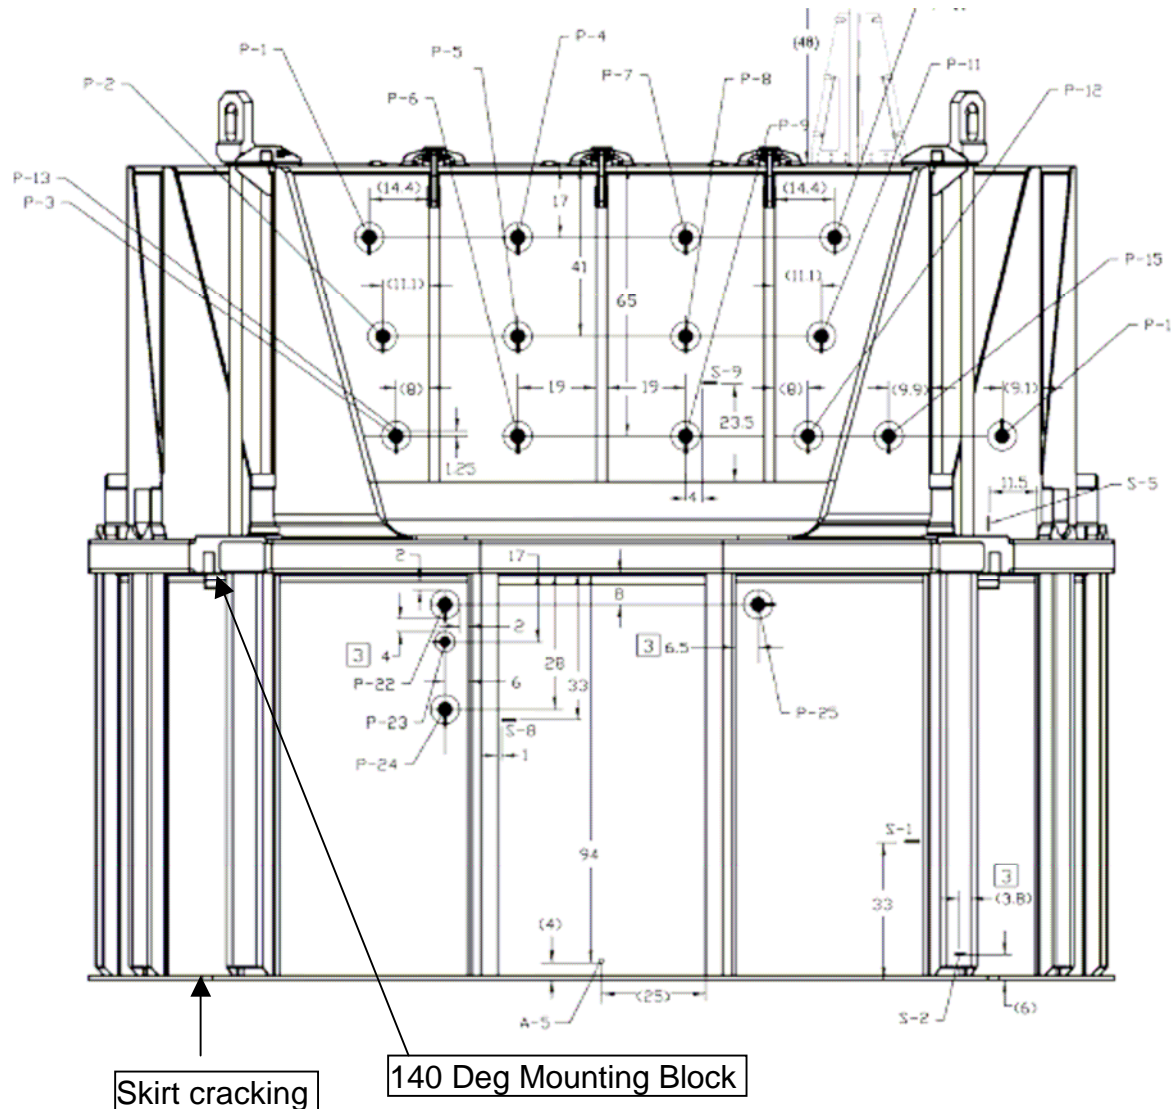
Dryer Pressure and Strain Measurements

Skirt pressure transducers

- P22, P24, and P25
