Title: Q2R18 Concerns Related to Steam Dryer

Unit(s): Quad Cities Unit 2

Report Date: 05/16/2006

Table of Contents

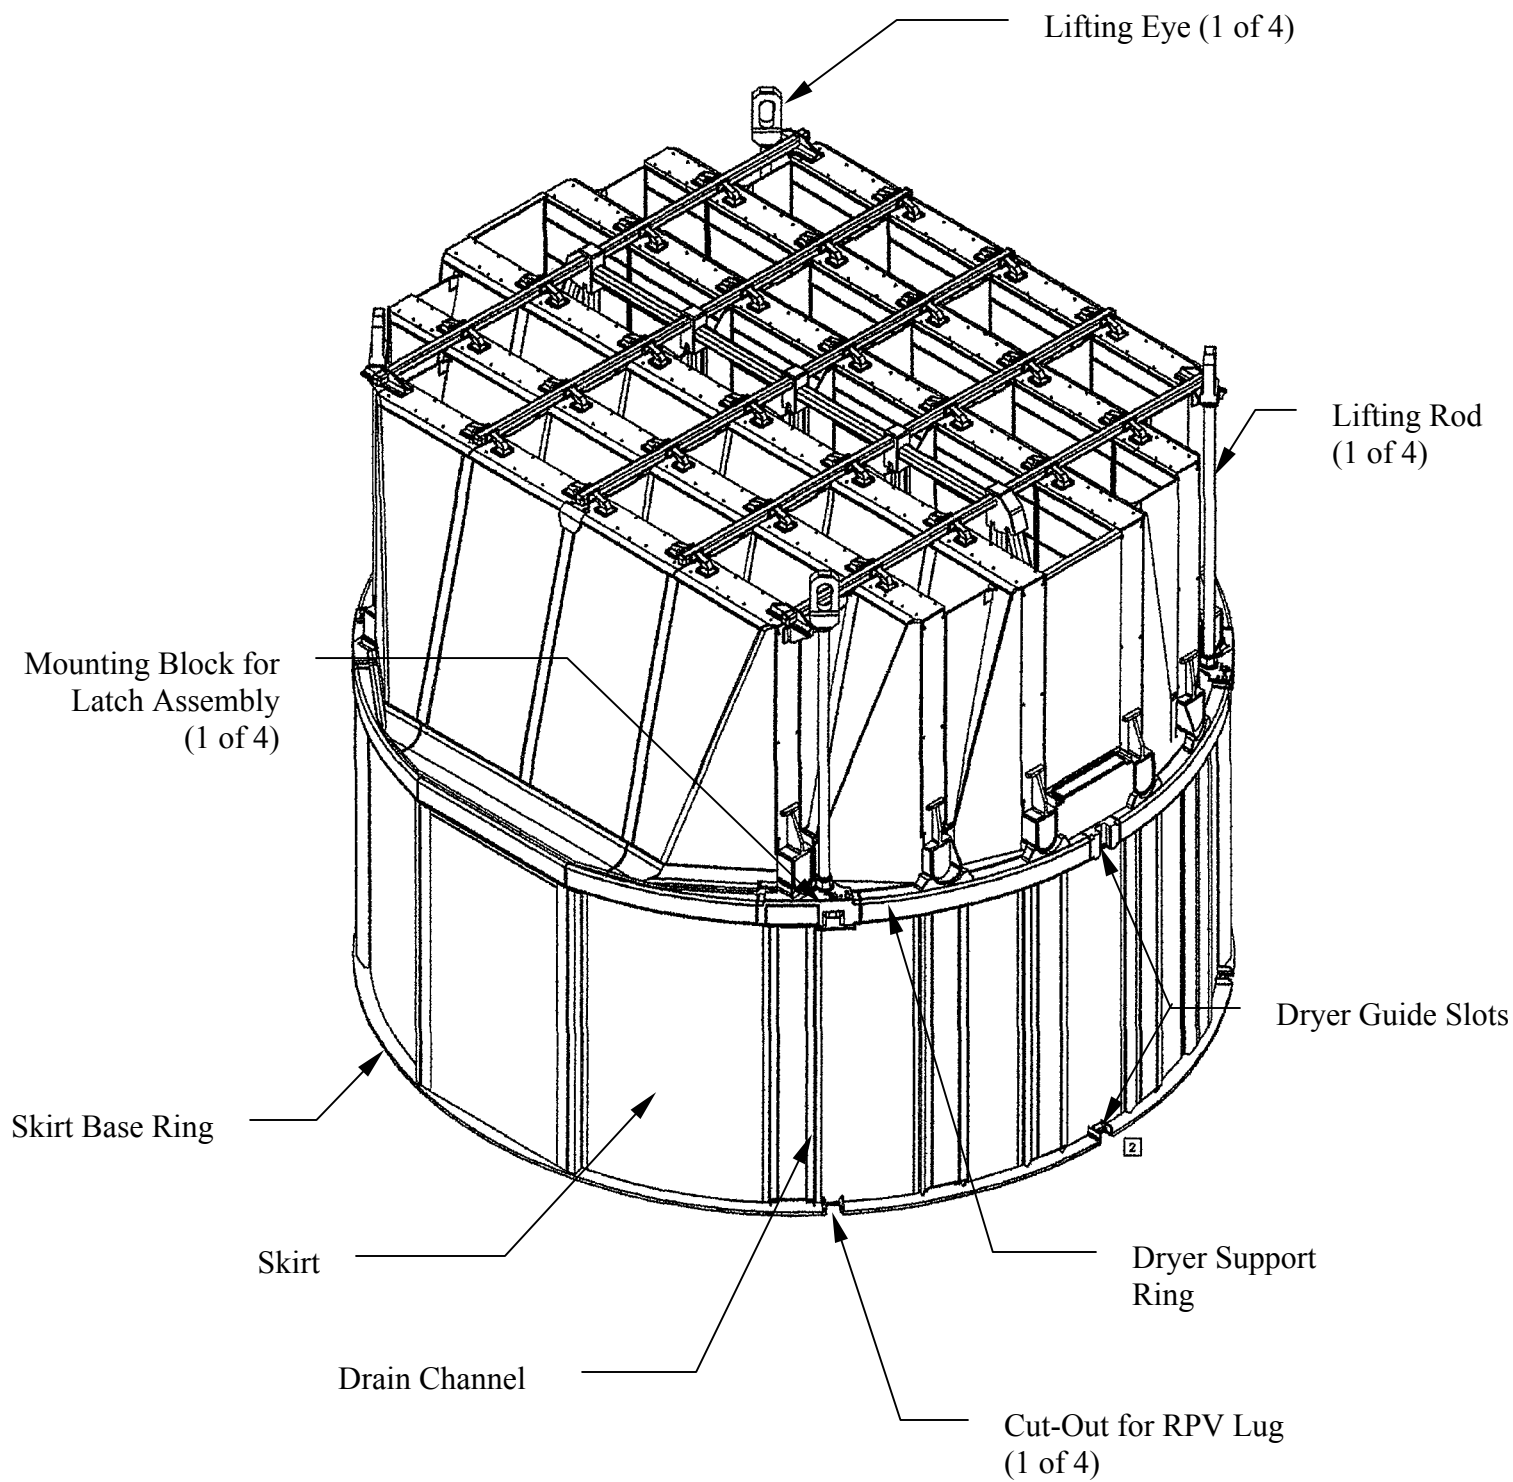
Figure 1: Steam Dryer

The basis for the determination of minimal weld thickness, proximity to a weld-stop (stress riser) is photographic observation by the Quad Cities root cause team. Reference 17, Figure 1, last image, shows that the weld buildup is smaller than adjacent portions of the weld and also shows the weld-stop. Additionally, hood assembly and weld residual stresses may have been produced due to the alignment of 6 vane panels in the “E” hood and the weld shrinkage when welding the hood panels and gussets to the vane panel end plates and trough. (This results from differential thermal expansion and contraction that occur from the temperature difference between the weld bead and the cooler base metal.) These factors are postulated to, in the presence of operating vibration loads, have initiated the crack.
