NUREG/CR-5580  
SAND90-1507  
Vol. 2

# Evaluation of Generic Issue 57: Effects of Fire Protection System Actuation on Safety-Related Equipment

Appendices A, B, and C

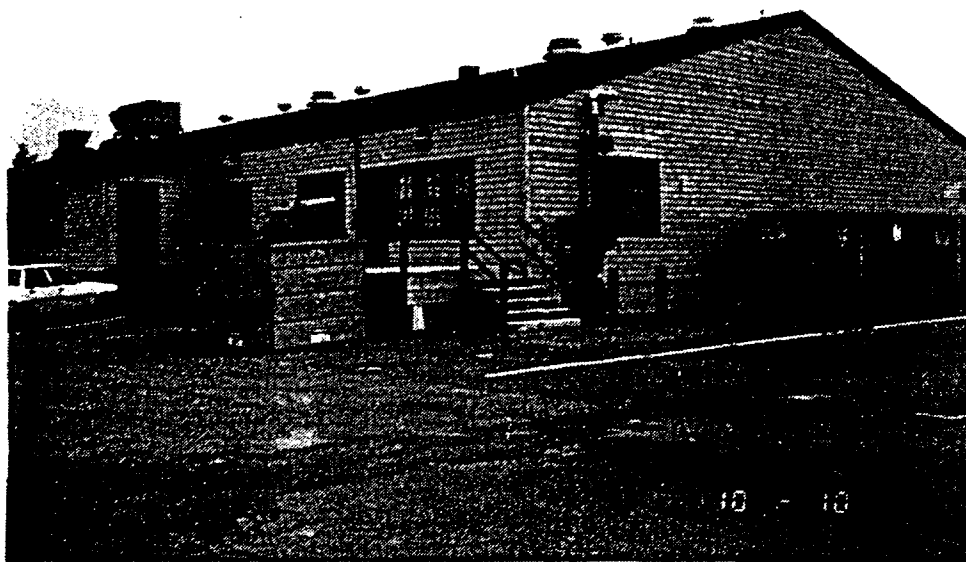
The Oakland Army base was constructed in 1941 and is built on landfill construction primarily wood frame (Figure 3.7). Most of the fire protection systems were installed during original construction. All of the systems on the Oakland Army base are wet systems.

Figure 3.7. Typical Wood-Frame Structure at Oakland Army Base

While there were signs of minor building settlement, the settlement was not as widespread or severe as observed at other landfill sites.

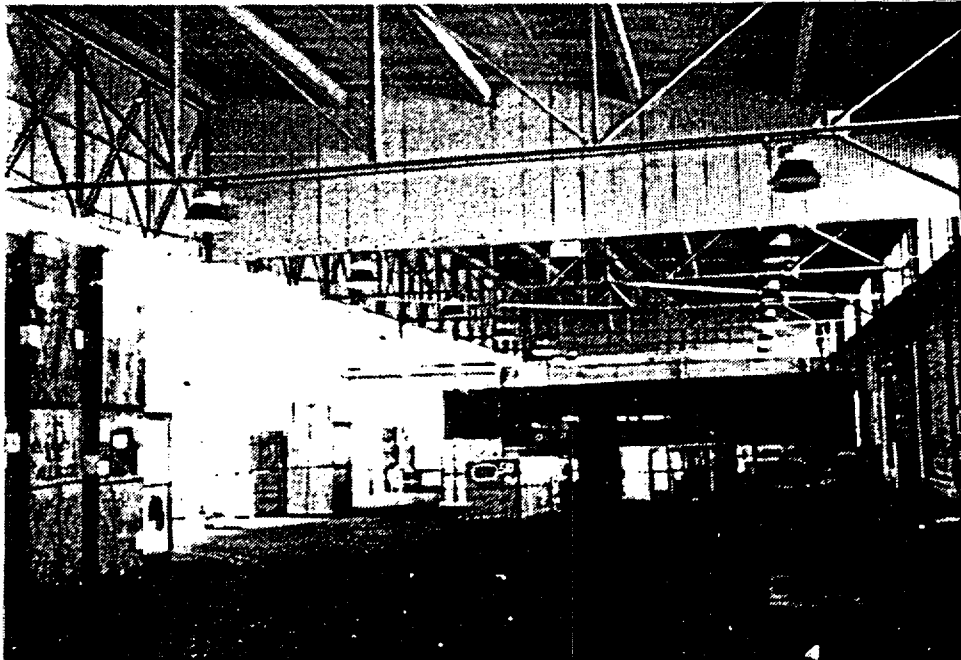
There are approximately 300 buildings of which about 50 are fire-protected. Most of the fire protection systems were installed during original construction. A typical warehouse is shown in Figure 3.10. The port also leases airplane hangars to airlines using the Oakland Airport.

Figure 3.10. Typical Port of Oakland Warehouse

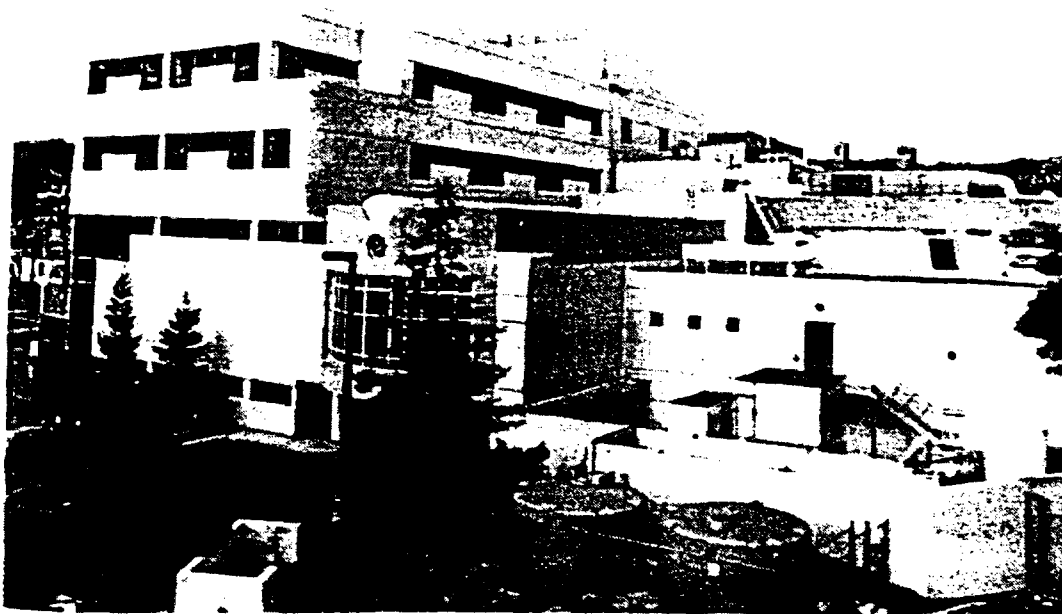
structures range from post-1906 in San Francisco to modern structures (Figure 3.16). Several older (pre-1973) non-conforming structures sustained various degrees of damage to reinforced concrete and unreinforced masonry. One hospital was "redtagged" as a possible collapse hazard and others were posted "Limited Entry." Much of the damage consisted of cracking of concrete and nonstructural damage to elevators, lights, tanks, equipment and water lines. About two-thirds of the structures were located in San Francisco and Oakland and associated with ground motions of about 0.1 g. The balance of the facilities were located in areas with ground motion between 0.2 to 0.4 g.

Figure 3.16. Main Hospital Building, Children's Hospital, Oakland, California
