Subject: 2006 Annual Site Inspection and Monitoring Report for UMTRCA Title I Disposal Sites

# 2006 Annual Site Inspection and Monitoring Report for Uranium Mill Tailings Radiation Control Act Title I Disposal Sites

Work Performed by S.M. Stoller Corporation under DOE Contract No. DE-AC01-02GJ79491  
for the U.S. Department of Energy Office of Legacy Management, Grand Junction, Colorado

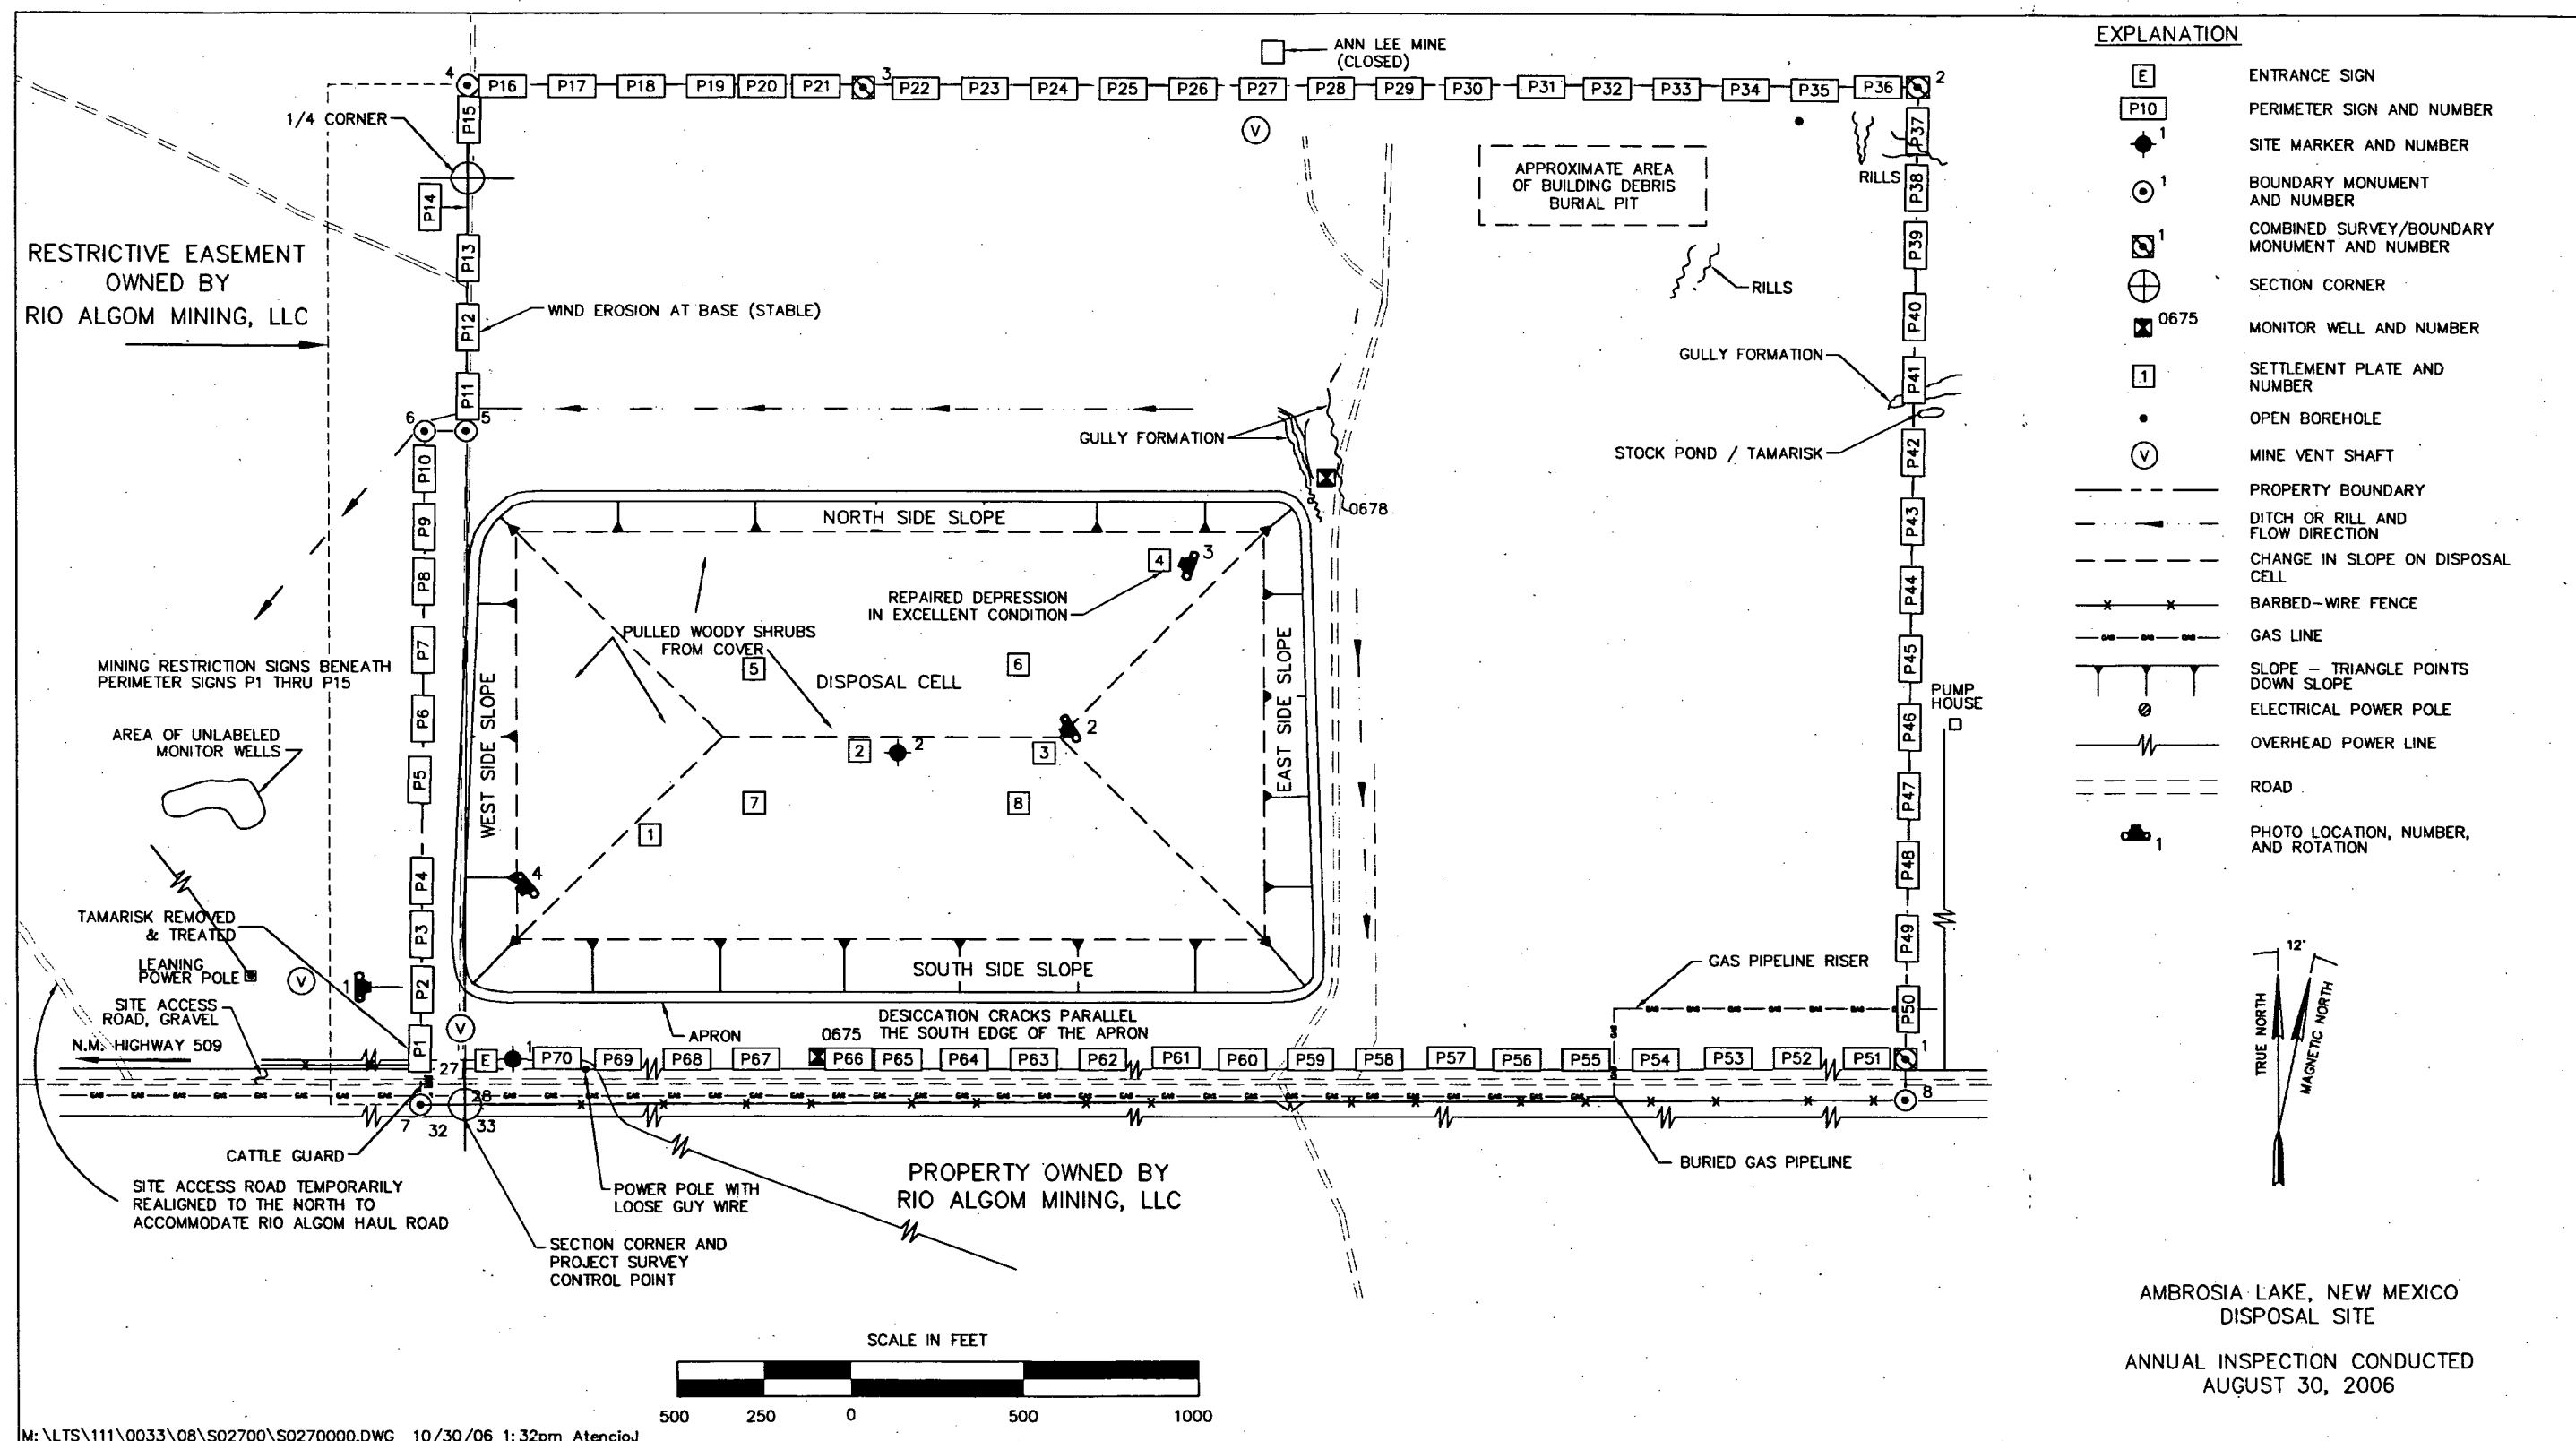
Figure 1-1. 2006 Annual Compliance Drawing for the Ambrosia Lake, New Mexico, Disposal Site

**Top of Disposal Cell**—The disposal cell was completed in 1994. The basalt riprap-covered top of the disposal cell is in excellent condition (PL-2). There was no evidence of cracking, settling, slumping, or erosion. Repairs were made in August 2005 to a shallow depression in the cell cover around settlement plate SP-4; the repaired area was in good condition (PL-3).

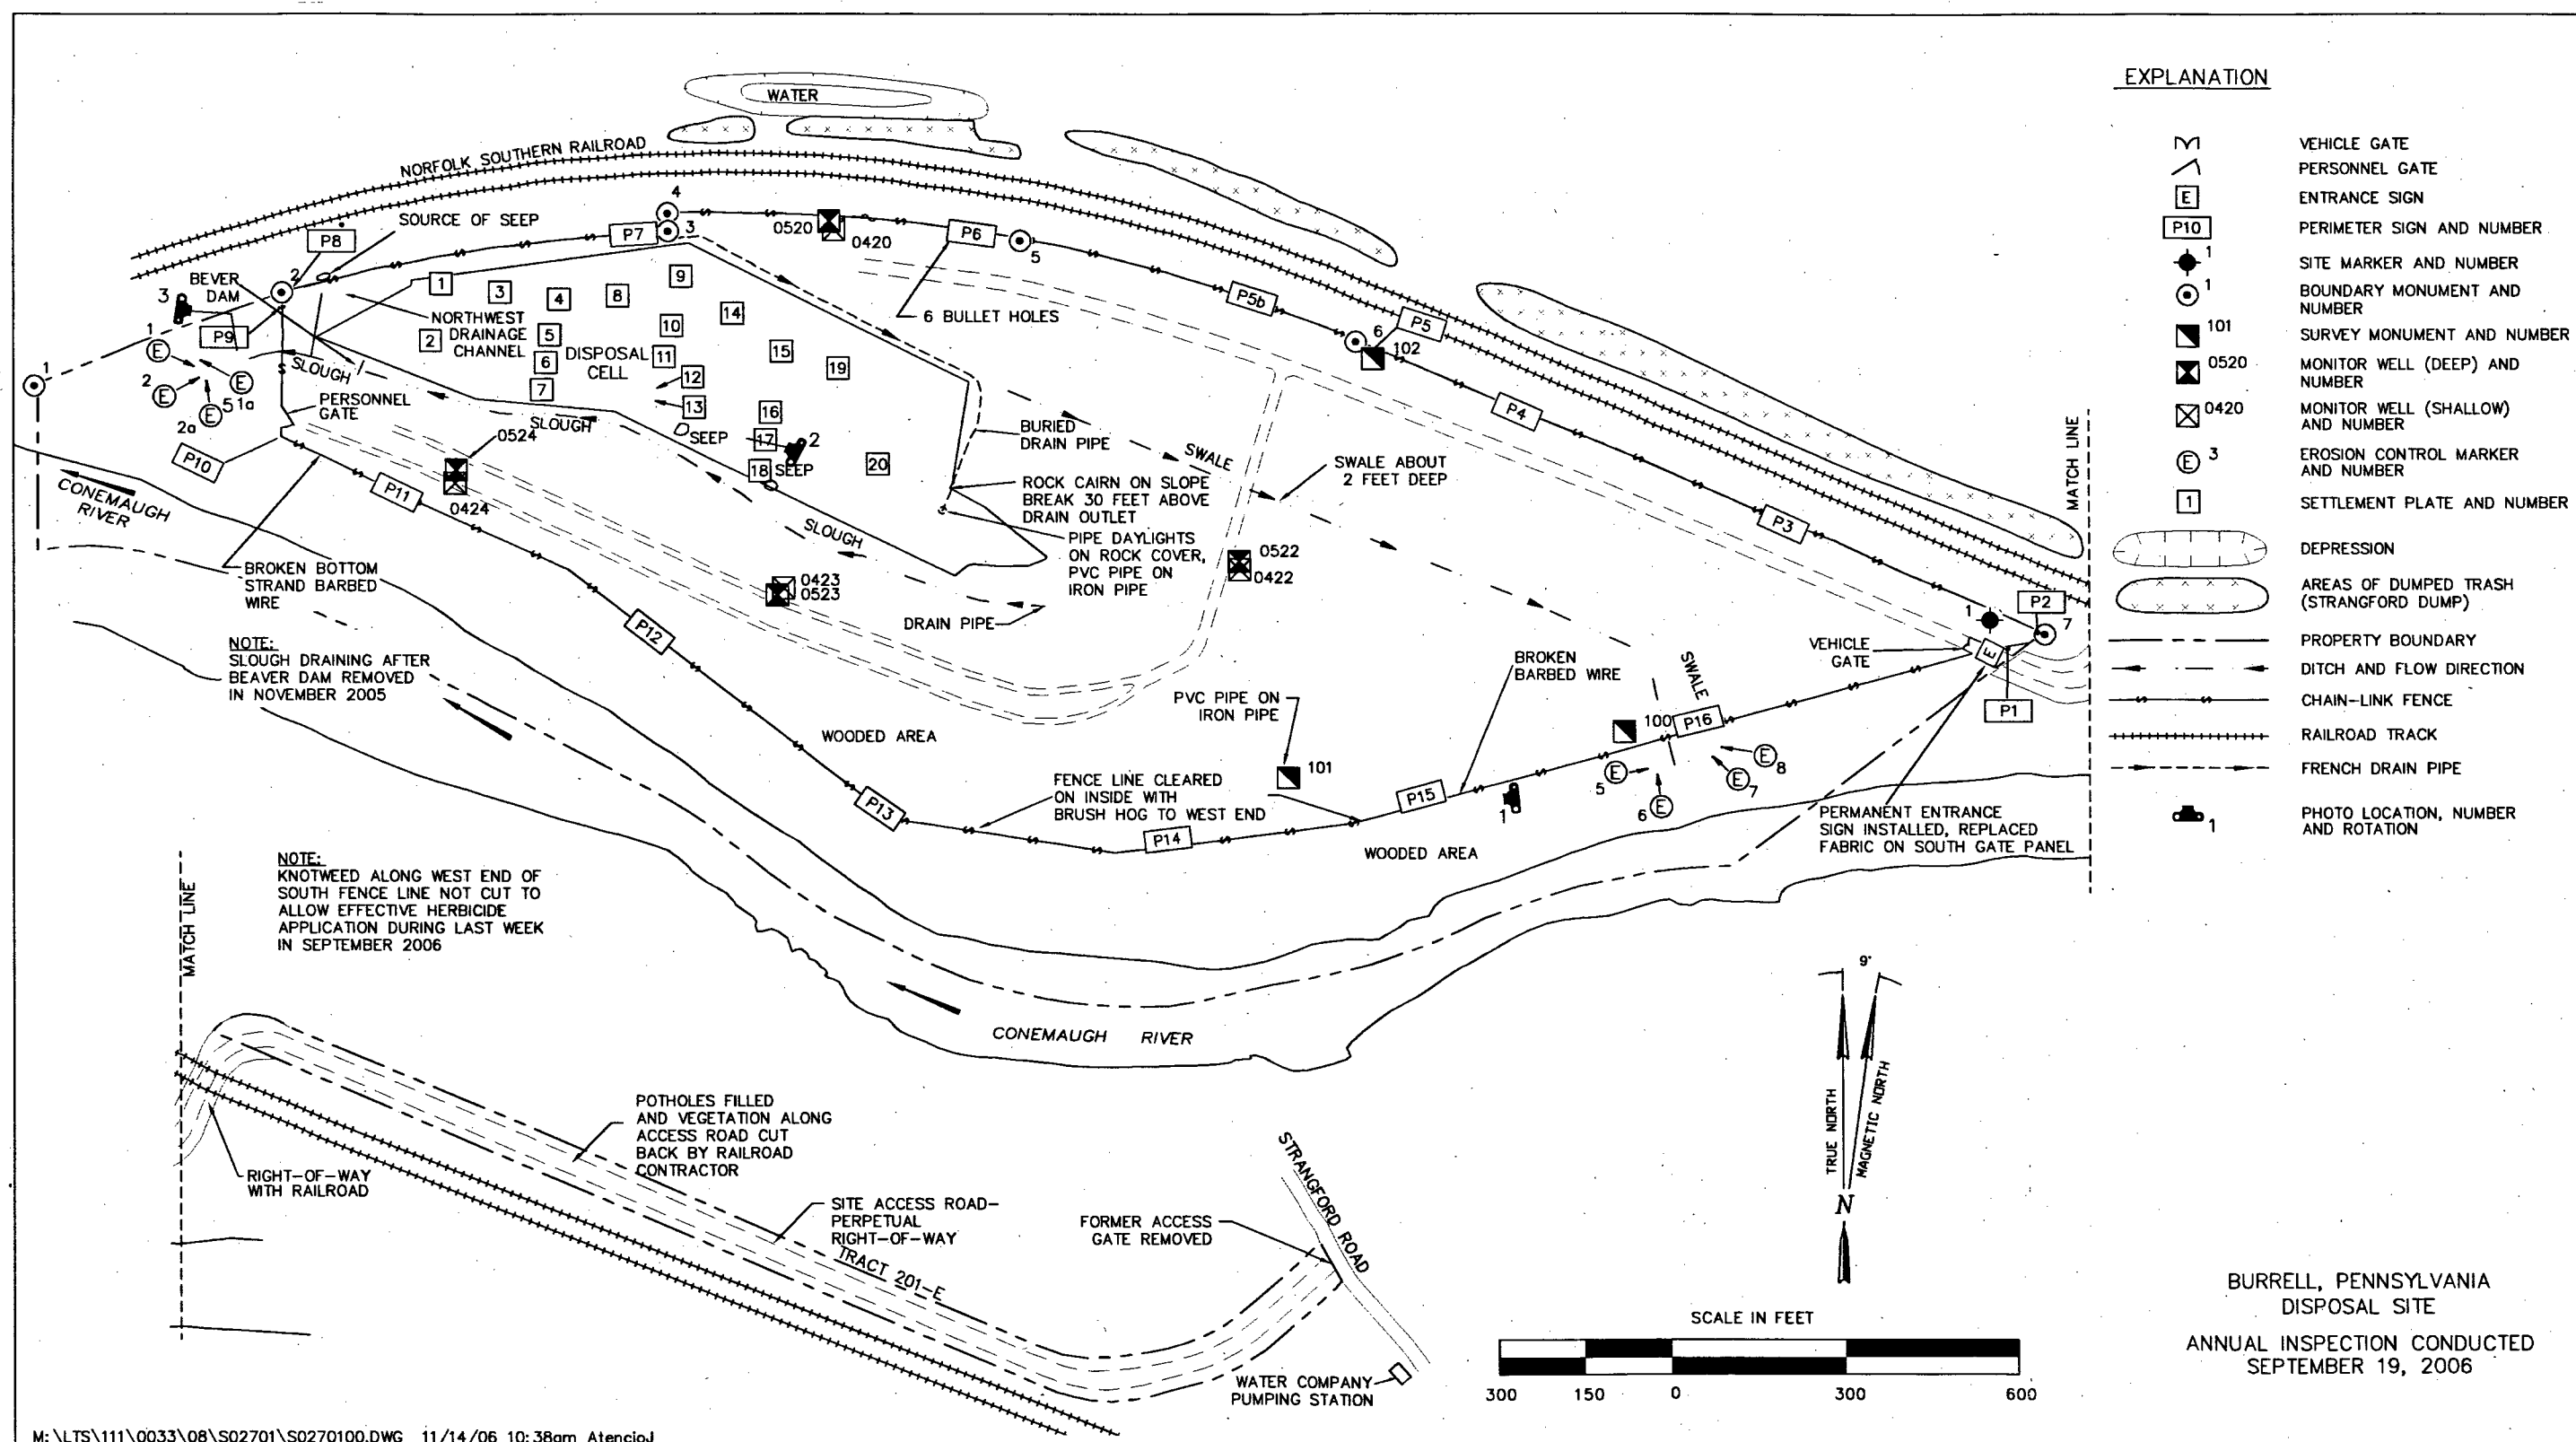
Figure 2-1. 2006 Annual Compliance Drawing for the Burrell, Pennsylvania, Disposal Site

Four pairs of erosion control markers are located in dense stands of vegetation, where they often are difficult to find. In 2006, all erosion control markers were located, inspected, and found to be in good condition. There was no sign of erosion at the site.

**Monitor Wells**—The site has four pairs of monitor wells, with a shallow (alluvial) completion and deeper (bedrock) completion well in each pair. New submersible bladder pumps were installed in all eight wells in fall 2004. Corridors to the wells are mowed annually to maintain access to and provide working space around the wells. All monitor wells were secure and in good condition.

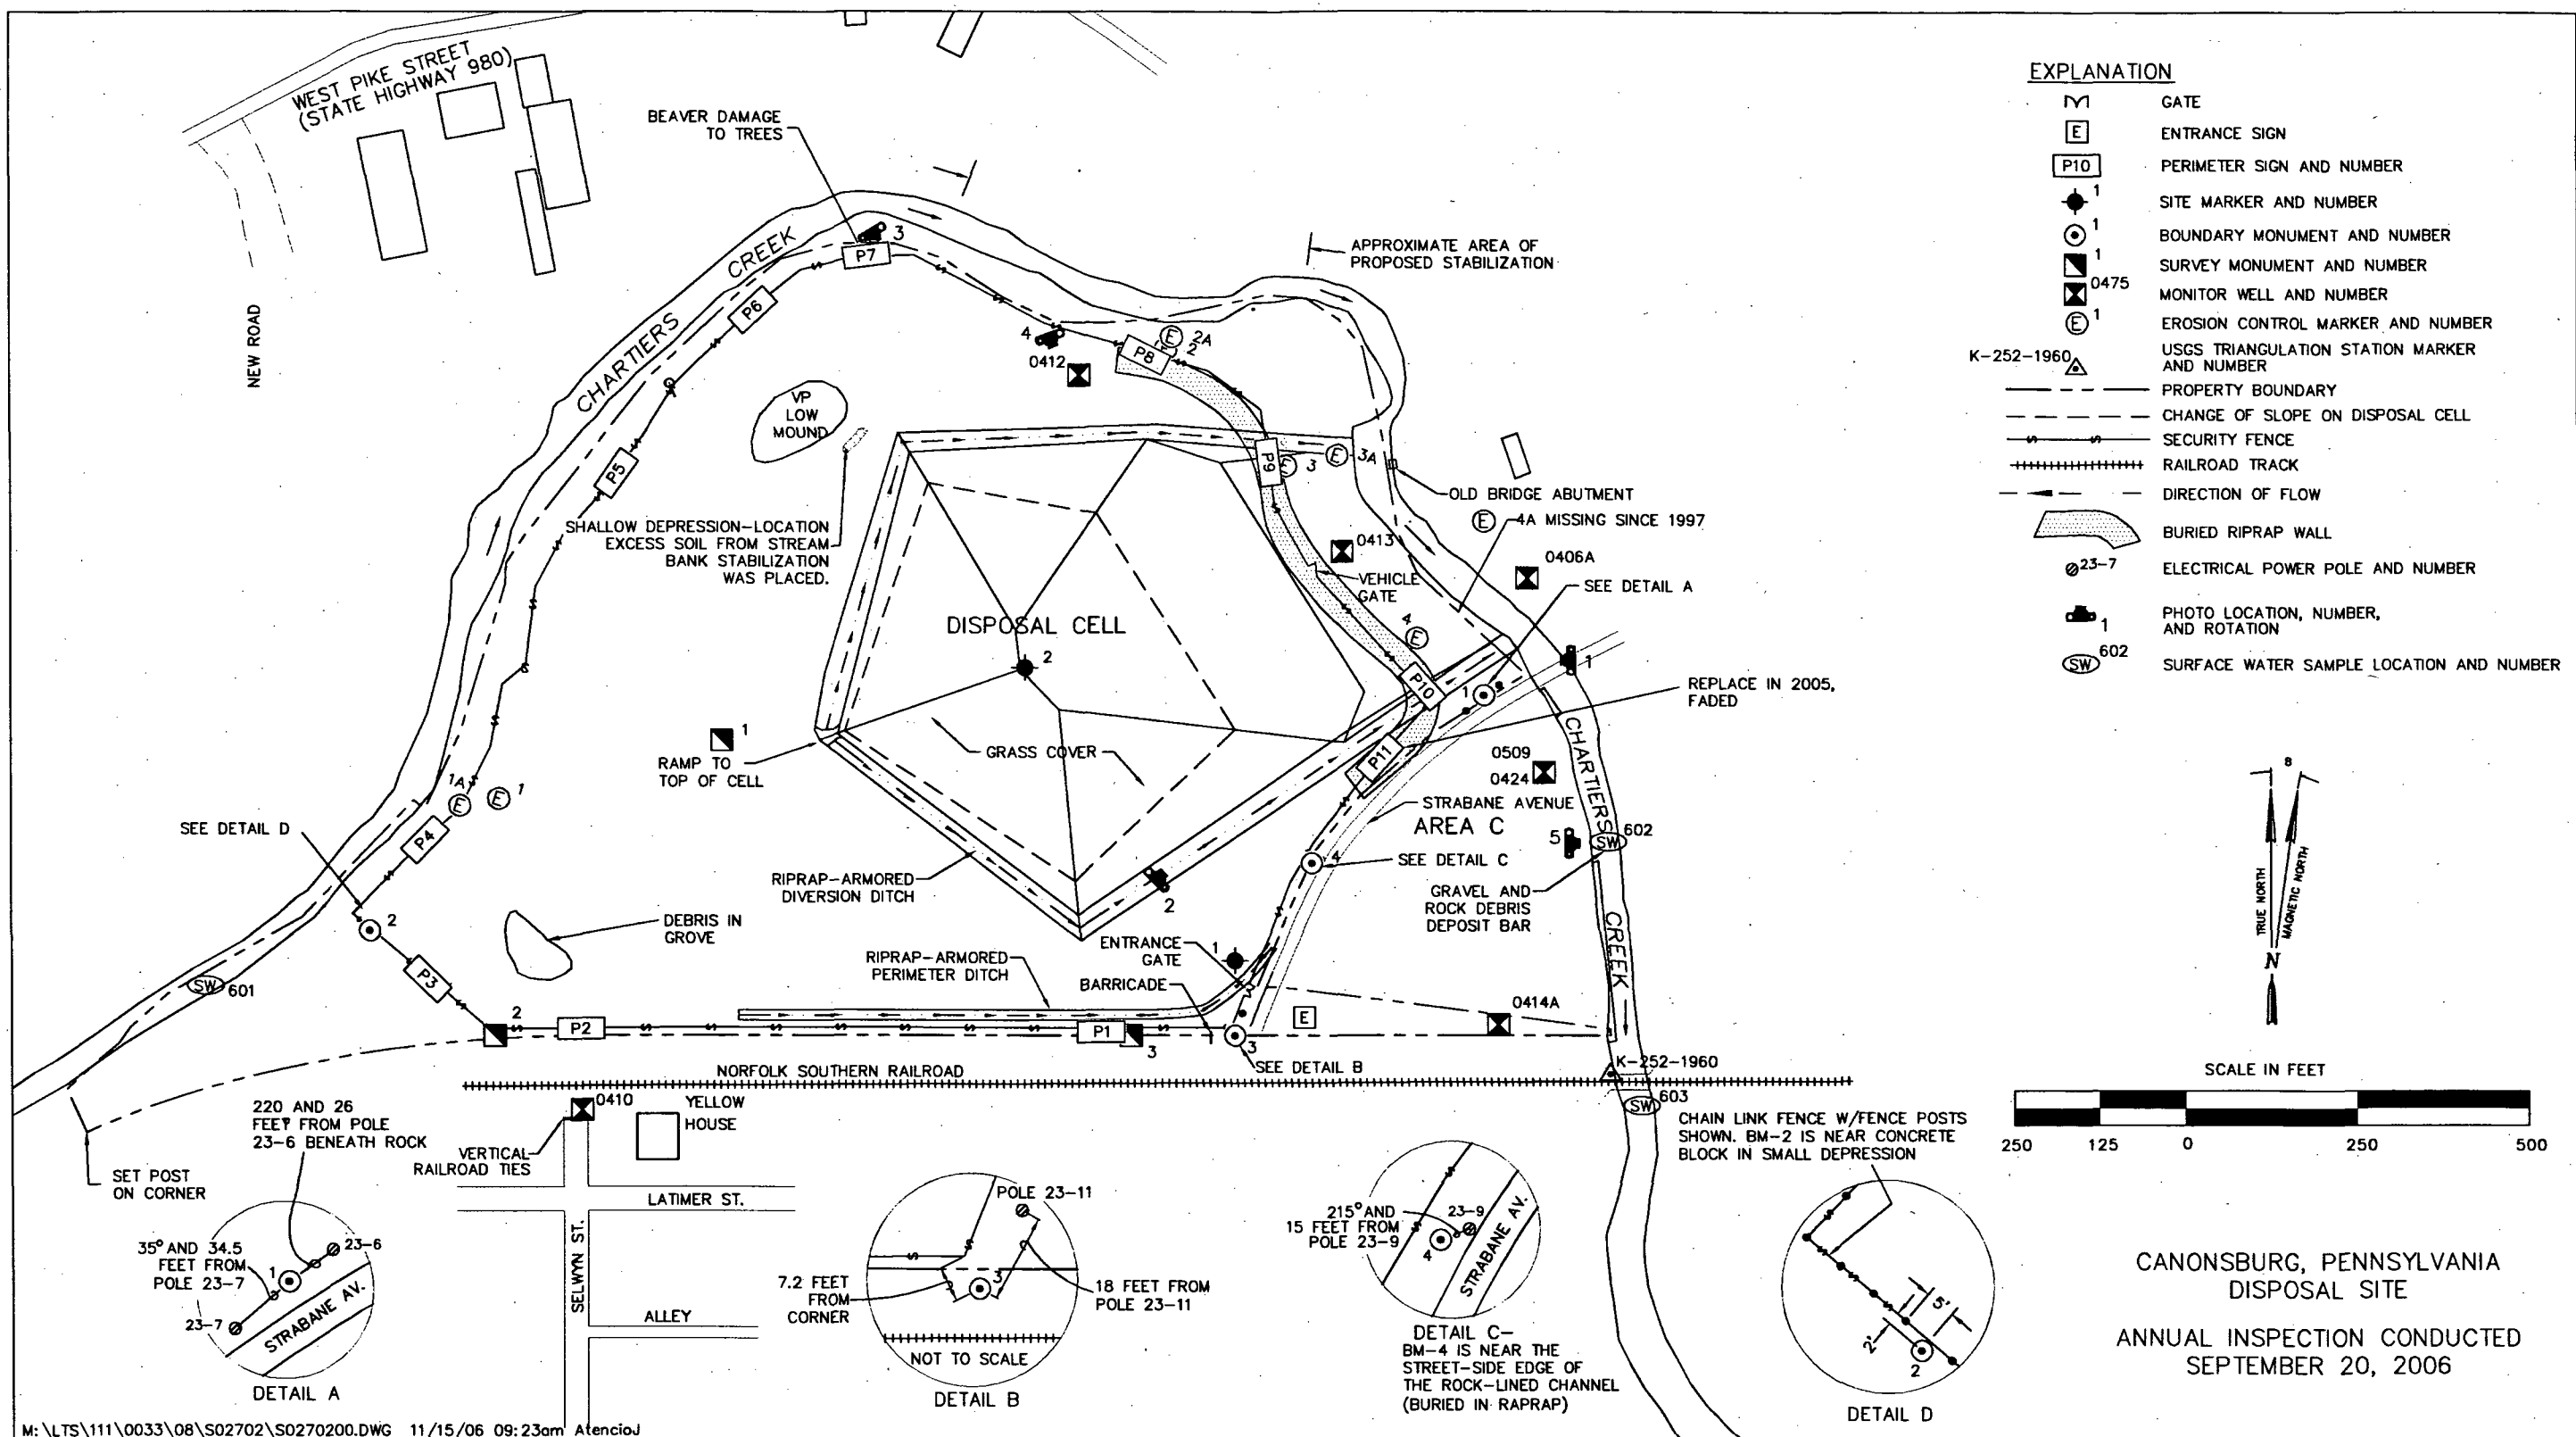
Figure 3-1. 2006 Annual Compliance Drawing for the Canonsburg, Pennsylvania, Disposal Site

Four pairs of erosion control markers (EMCs) were initially installed along the bank of Chartiers Creek. One of these markers, ECM-4A, was lost to erosion in 1997. This marker does not need to be replaced because the other marker in the pair, ECM-4, can be used for reference. Marker ECM-1A, difficult to locate because of thick vegetation, was found using global positioning system (GPS) equipment. ECM-2A was washed out in 2004 by flooding and was reset in 2005. All erosion control markers are in good condition.

**Monitor Wells**—The ground water monitoring network consists of six monitor wells (MW-0406A, MW-0410, MW-0412, MW-0413, MW-0414B, and MW-0424) that are sampled annually in accordance with the LTSP and the Ground Water Compliance Action Plan (GCAP). The wells were secure and in excellent condition.

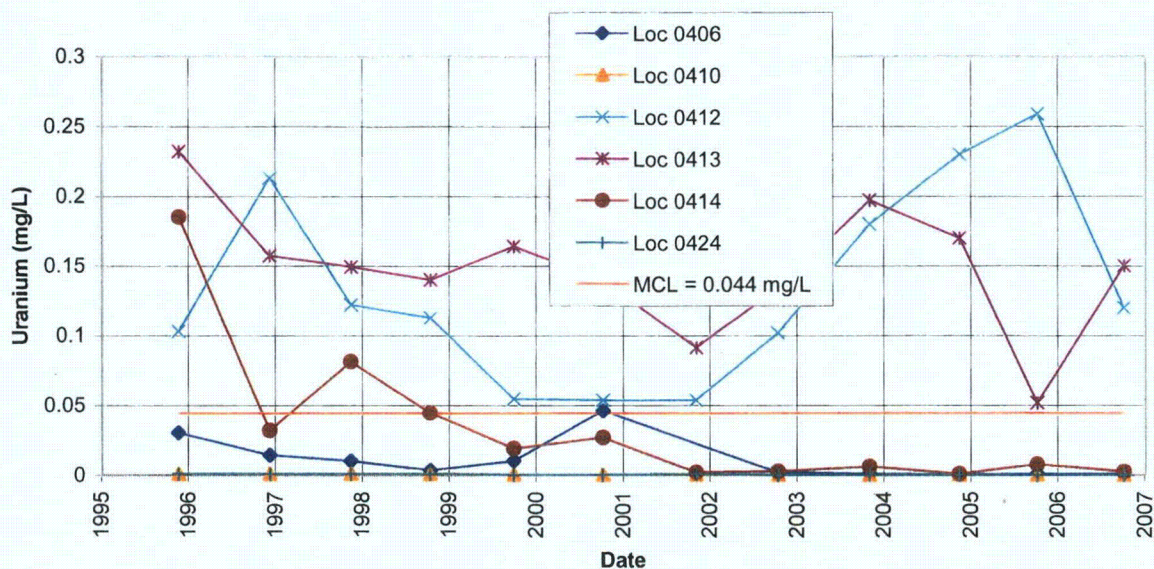
Figure 3-2. Time-Concentration Plots of Uranium in Ground Water at the Canonsburg, Pennsylvania, Disposal Site

Uranium is the analyte of primary concern at this site because of the frequency with which it has exceeded its MCL of 0.044 mg/L in two of the downgradient ground water monitoring wells (MW-0412 and MW-0413). In 2005 and 2006, uranium concentrations in these two wells continued above the MCL, but considerably below the ACL (Figure 3-2). Following a downward trend from 1996 through 1999, concentrations of uranium at well MW-0412 had increased from 2001 through 2005. In 2005, the highest uranium concentration since the LTSP-required monitoring began in 1995 was reported at 0.259 mg/L from this well; however, still significantly below the ACL of 1.0 mg/L. In 2006, the concentration of uranium from this well decreased to 0.12 mg/L. No definitive trend has established in well MW-0412. From 1995 through 2001, uranium concentrations in well MW-0413 displayed a downward trend. Since 2002, uranium concentrations in well MW-0413 have fluctuated but remain below the initial 1995 concentration and have not exceeded the ACL. Uranium concentrations were substantially below the MCL at the rest of the ground water monitoring locations in 2005 and 2006. Uranium concentrations at all surface water sampling locations in Chartiers Creek, although reporting a slight increase in 2006, continue near the laboratory detection limit and have displayed a decreasing trend since 2001 (Figure 3-5).

DOE continues to consider the risk associated with uranium in ground water within the unconsolidated materials and shallow bedrock (defined as the uppermost aquifer for regulatory purposes) beneath the site to be negligible because neither unit is considered a viable aquifer from a water resource perspective, although the zone is capable of discharging to surface water (Appendix A to 10 CFR Part 40). Because the materials are not ideal for aquifer formation and the source of recharge to the shallow units is minimal, sustained yield to a well from these units would be limited. The shallow ground water is not used as a drinking water source in the area, although some domestic water is derived from a few private wells deeper than 100 feet. Institutional controls, in the form of government ownership of the site, prevent access to the ground water directly beneath the site. NRC concurred in deleting ground water use restrictions for Area C in 2003. Most of the residents in the area are connected to a municipal water system, which is supplied by surface water reservoirs upgradient from the site. Chartiers Creek, the discharge point for the shallow ground water beneath the site, is not a source of potable water. Additionally, uranium concentrations reported from samples collected from the creek are near the detection limit and have declined in recent years. Therefore, human health and the environment are adequately protected.

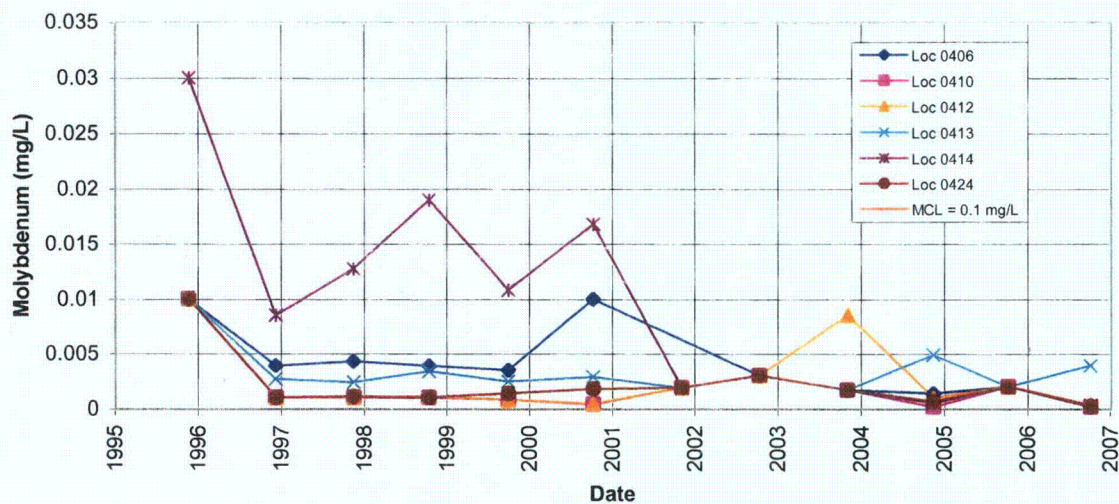
Figure 3-3. Time-Concentration Plots of Molybdenum in Ground Water at the Canonsburg, Pennsylvania, Disposal Site

In 2005 and 2006, molybdenum concentrations in ground water continued well below the MCL at all locations, with values remaining near the laboratory detection limit. Historically, the highest concentrations of molybdenum were reported from well MW-0414 during the initial years of monitoring. Concentrations in this well have decreased significantly in recent years and display an overall decreasing trend (Figure 3-3). In general, molybdenum concentrations at all other wells have remained relatively constant. The maximum concentration of molybdenum reported in 2006 was 0.0039 mg/L at well MW-0413.

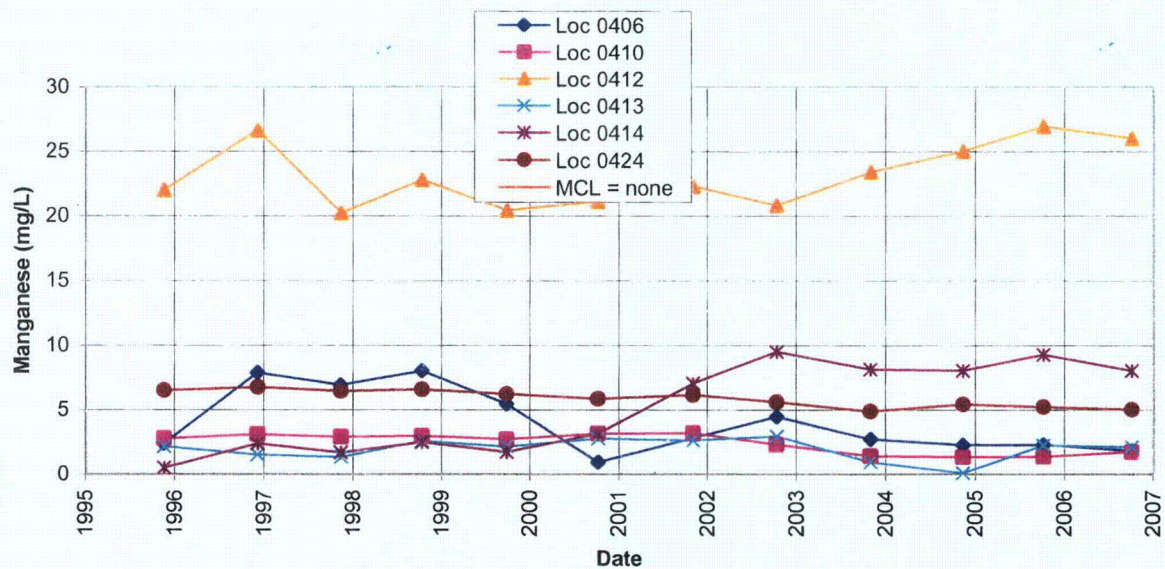
Figure 3-4. Time-Concentration Plots of Manganese in Ground Water at the Canonsburg, Pennsylvania, Disposal Site

Manganese concentrations in ground water continue to exceed the secondary drinking water standard of 0.05 mg/L at all point of compliance wells. In 2004, well MW-0413 had an apparent anomalous manganese concentration of 0.044 mg/L, just below the standard. Otherwise, results from 2005 and 2006 are generally consistent with results from previous years; no increasing or decreasing trends are observed with the exception of well MW-0414 where an overall increasing trend can be observed, which appears to have leveled off in recent years (Figure 3-4). Concentrations of manganese reported from well MW-0412 (26 mg/L in 2006) remain significantly above all other wells. The manganese concentration in the upgradient background well MW-0410 was below all other wells in 2005 and 2006; however, this well had exceeded the concentrations MW-0413 and MW-0414 from 1995 through 1999.

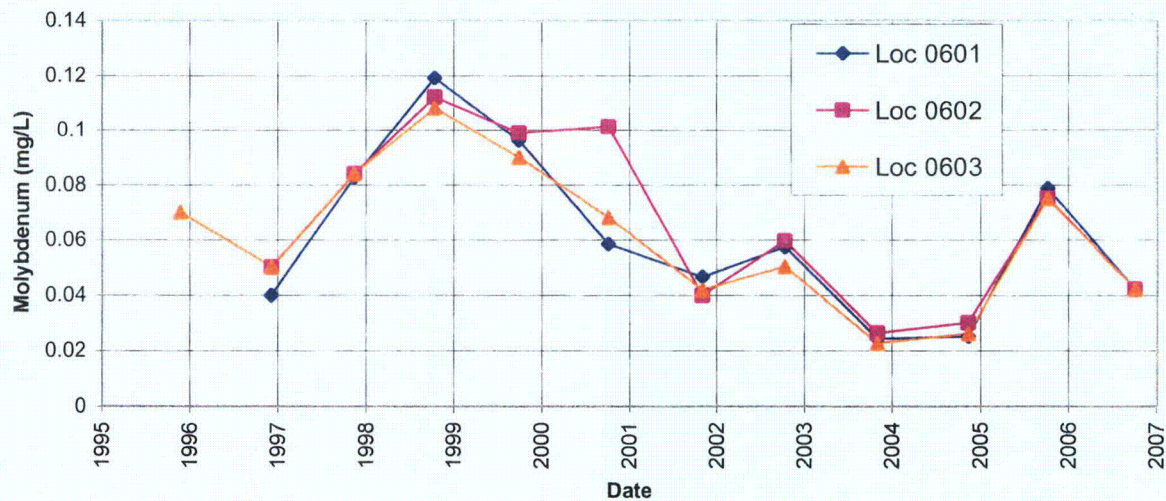
Figure 3-6. Time-Concentration Plots of Molybdenum in Surface Water at the Canonsburg, Pennsylvania, Disposal Site

The concentrations of molybdenum in the Chartiers Creek samples, as in the past, were higher than in ground water samples, though still well below the MCL of 0.1 mg/L. Concentrations at all locations exceeded the MCL in 1998 and again, although only slightly, at location SW-0602 in 2000 (Figure 3-6). Surface water concentrations both upstream and downstream of the site exceed concentrations in ground water. This indicates an ambient or upstream source of molybdenum rather than from site related activities. The surface water quality is indistinguishable between upstream and downstream locations. Molybdenum concentrations in both upstream and downstream locations display an overall decreasing trend, despite a relatively sharp increase at all locations in 2005.

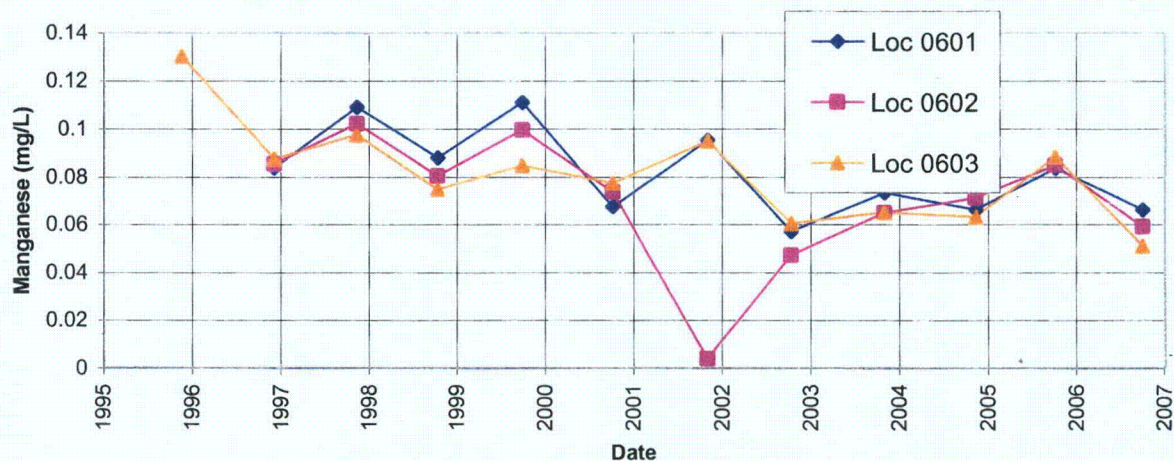
Figure 3-7. Time-Concentration Plots of Manganese in Surface Water at the Canonsburg, Pennsylvania, Disposal Site

Manganese concentrations in surface water in Chartiers Creek (the point of exposure) display an overall decreasing trend at all three locations, although location SW-0602 appeared to have an anomalously low concentration in 2001 (Figure 3-7). With the exception of location SW-0602 in 2001 and 2002, all manganese concentrations in surface water remain above the secondary drinking water standard but well below the EPA risk based guideline of 1.7 mg/L.

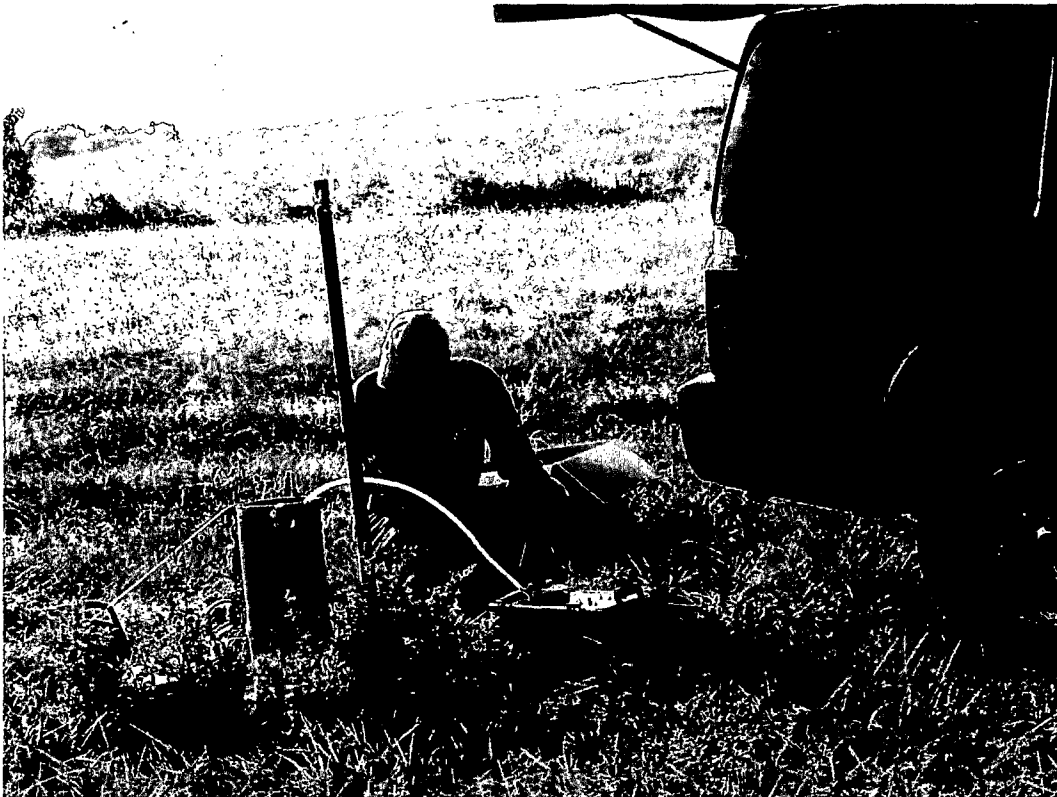
*CAN 9/2006. PL-4. Ground water sampling.*

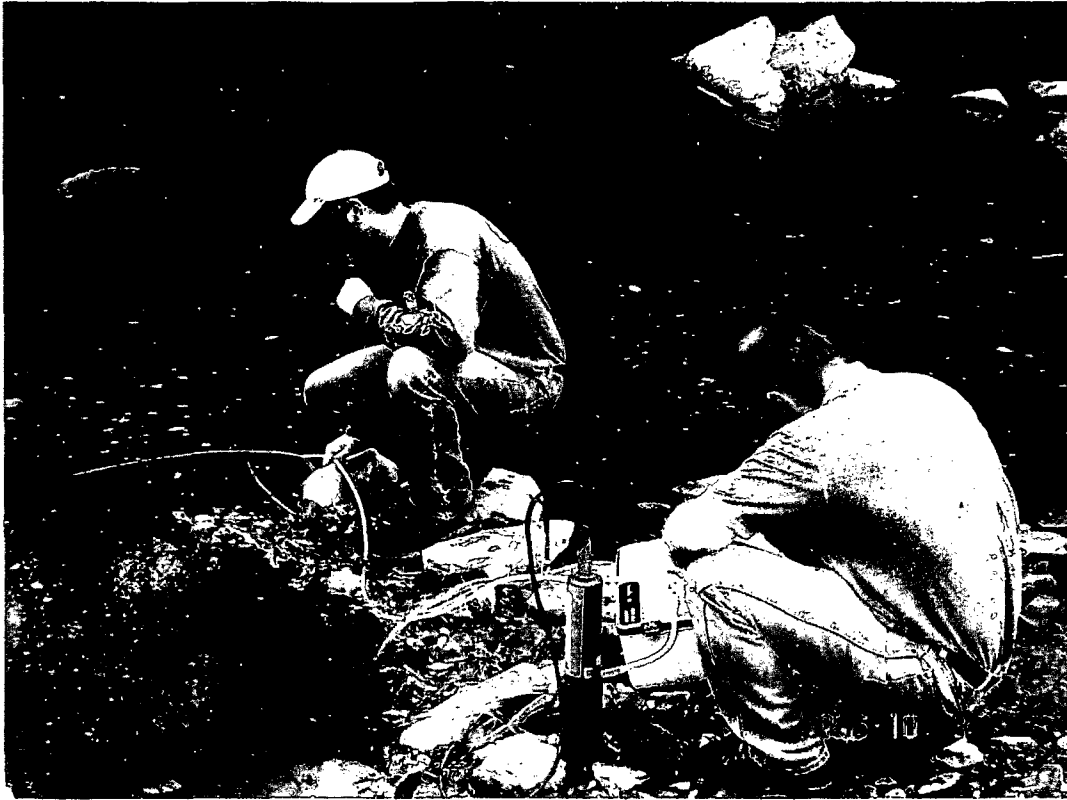
*CAN 9/2006. PL-5. Surface water sampling.*

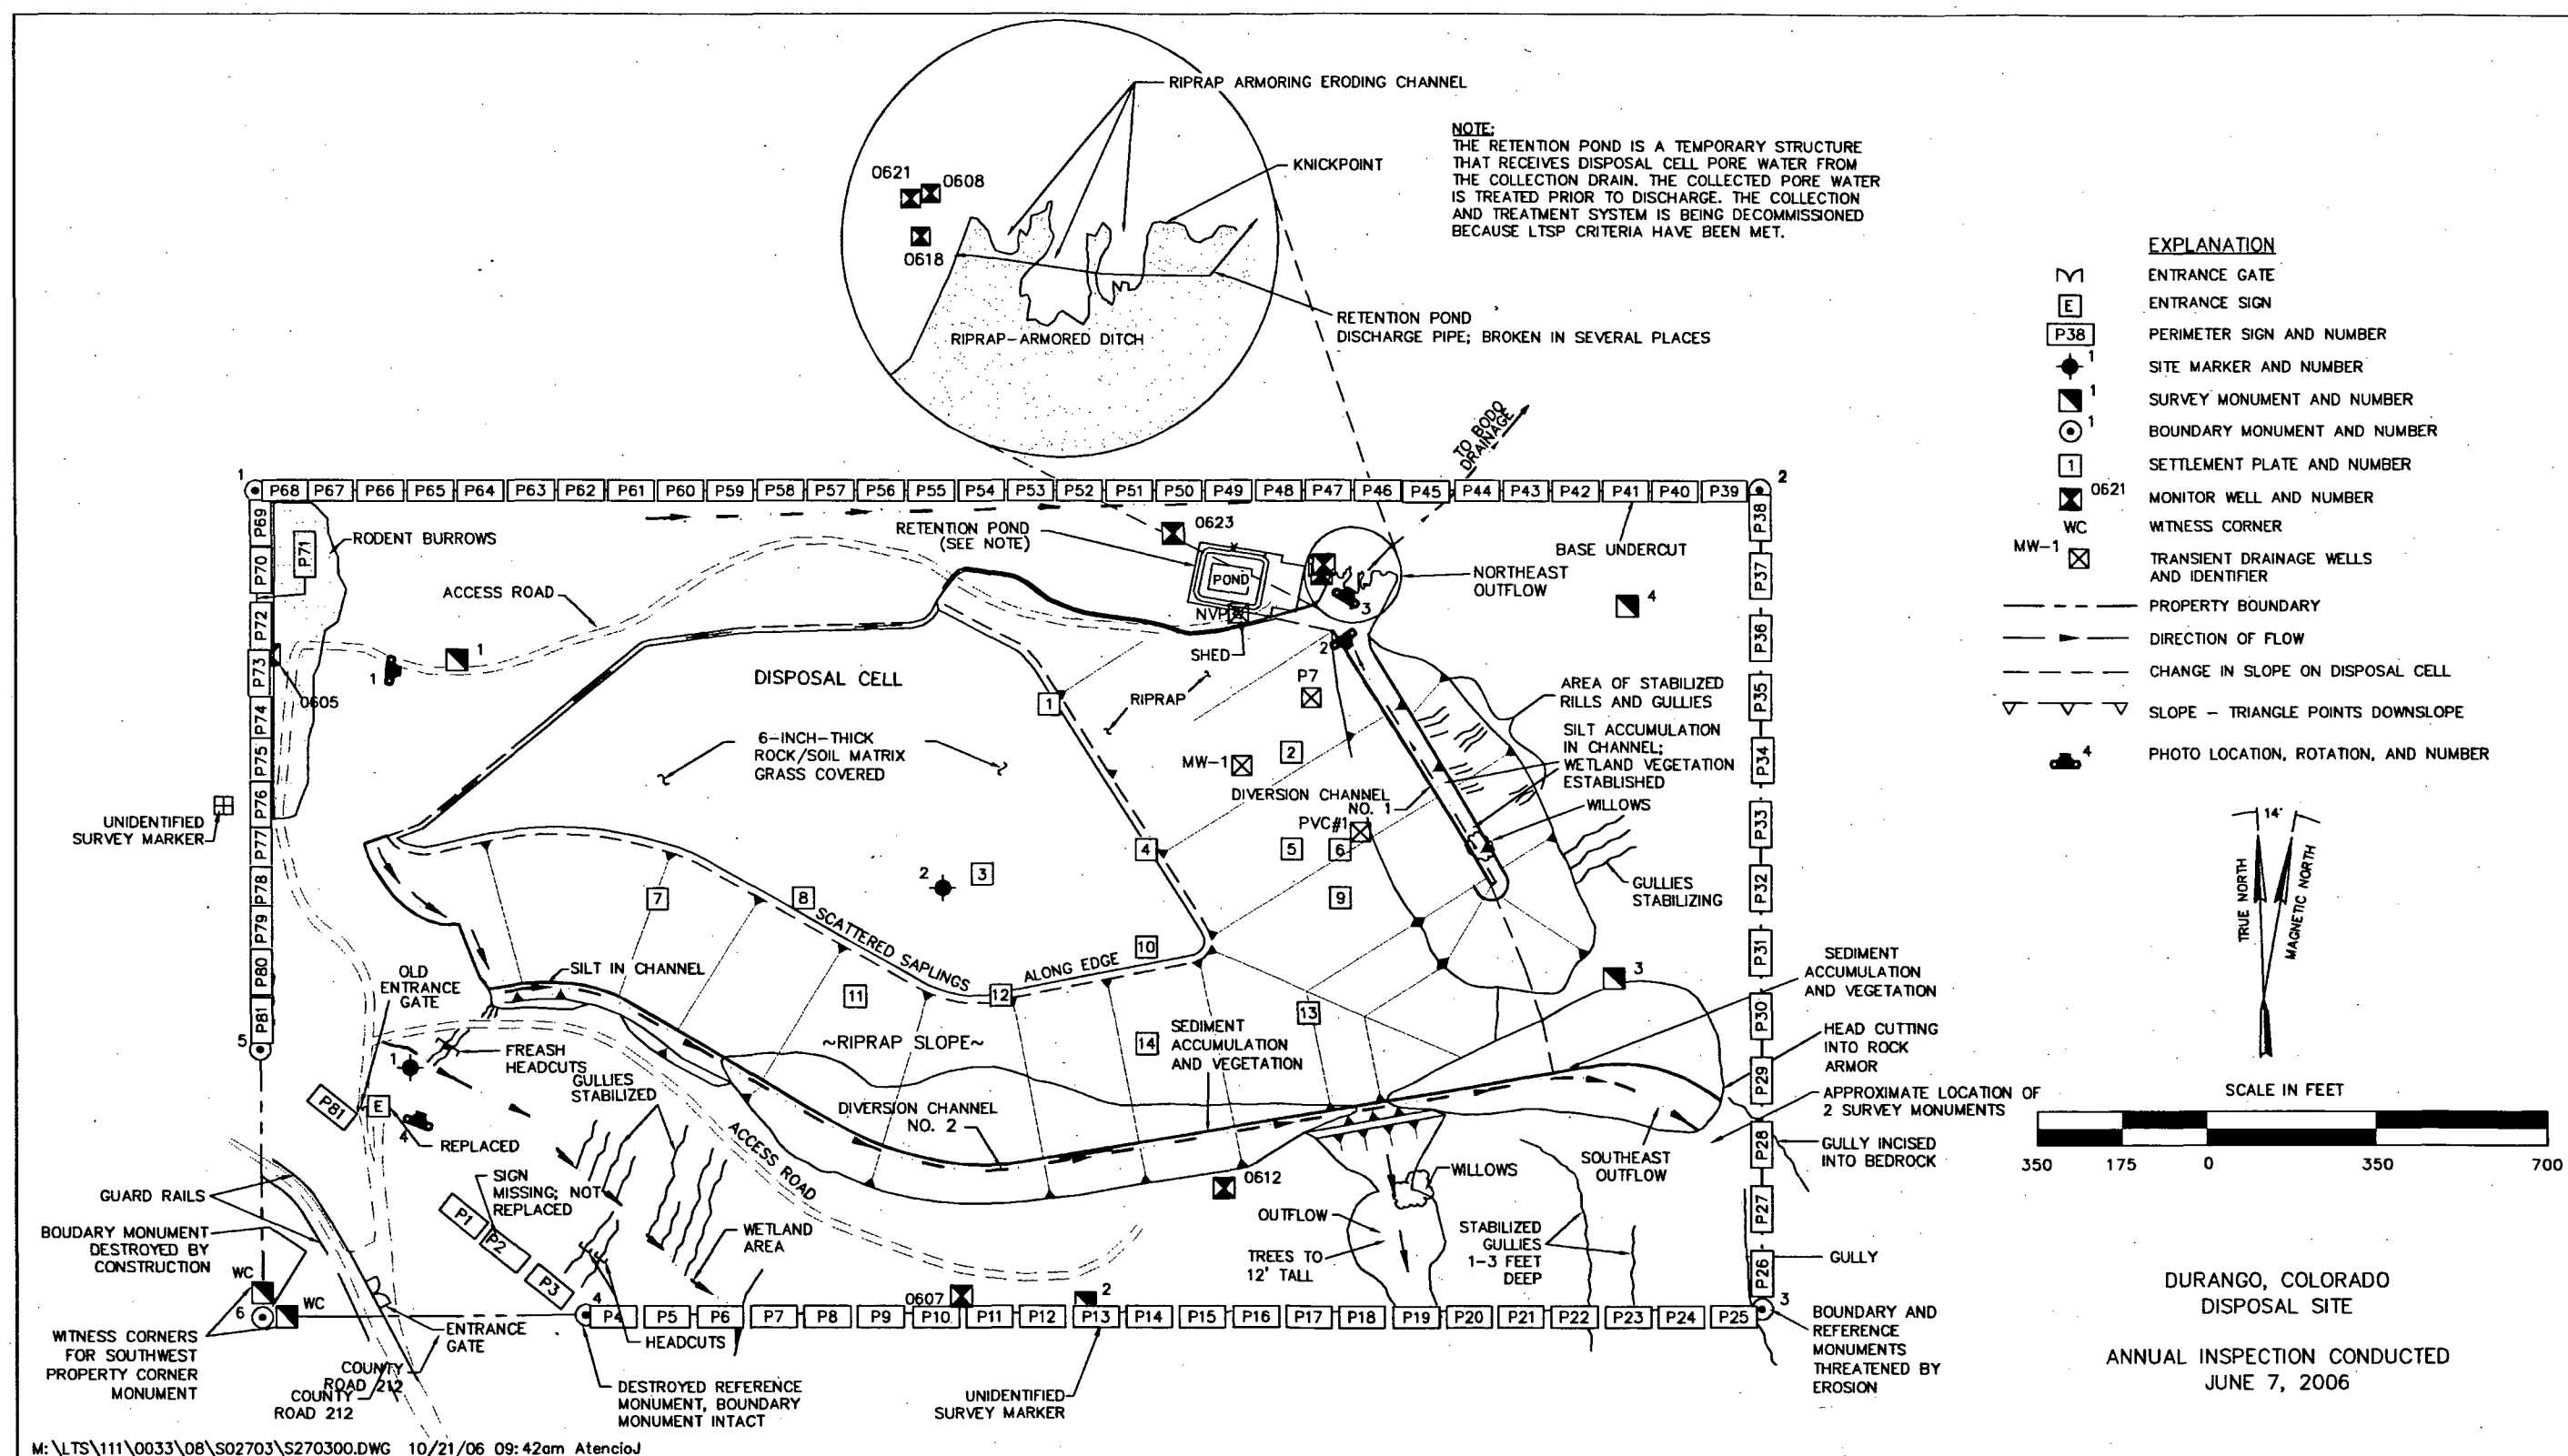
Figure 4-1. 2006 Annual Compliance Drawing for the Durango, Colorado, Disposal Site

**Site Markers, Survey and Boundary Monuments**—Site markers and survey monuments were in good to excellent condition. The site marker near the entrance gate (SMK-1) was slightly damaged by bullets years ago; however, it is legible and in generally good condition. Boundary monument BM-3 and two of its reference monuments are situated in a small gully and threatened by erosion; however, the monuments are currently stable. One of the reference monuments for boundary monument BM-4 is bent to the ground and the cap removed, but BM-4 is intact. No repair to any of these features is currently warranted. Boundary monument BM-6, located at the southwest corner of the site, was missing and presumably was destroyed during pipeline construction associated with the reservoir project. The monument will not be replaced because two witness monuments at that property corner are intact. The remaining boundary monuments were intact and generally in good condition.

**Monitor Wells and Other Wells**—Monitor wells were locked and in good condition. The cap on a drainage system vent well, PVC #1, is cracked but remains functional.
