Subject: 2006 Annual Site Inspection and Monitoring Report for UMTRCA Title I Disposal Sites

# 2006 Annual Site Inspection and Monitoring Report for Uranium Mill Tailings Radiation Control Act Title I Disposal Sites

Work Performed by S.M. Stoller Corporation under DOE Contract No. DE-AC01-02GJ79491  
for the U.S. Department of Energy Office of Legacy Management, Grand Junction, Colorado

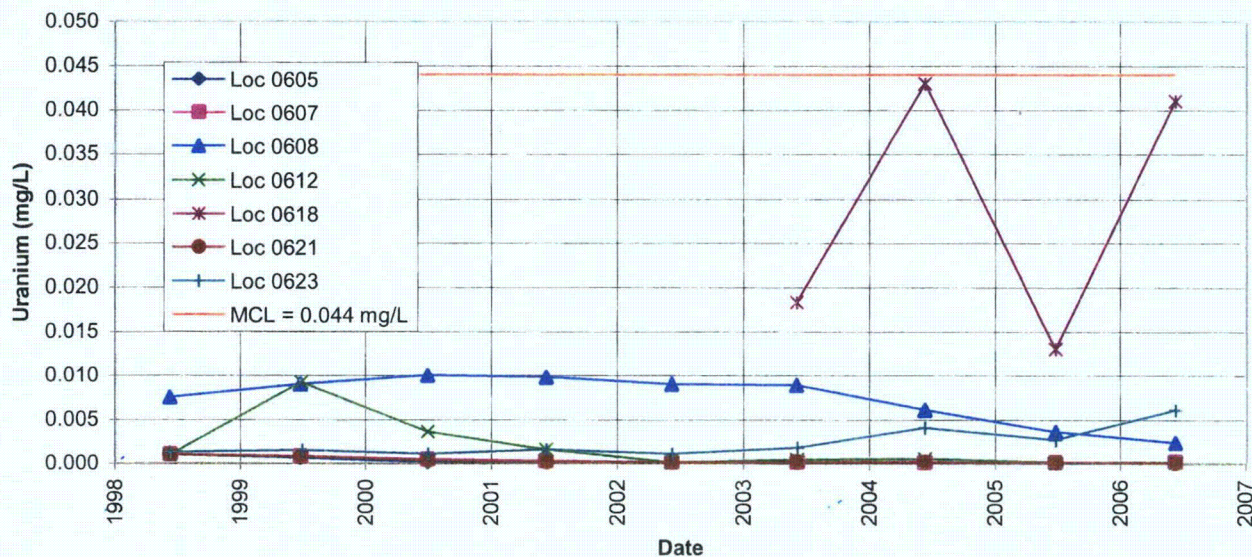
Figure 4-2. Time-Concentration Plots of Uranium in Ground Water at the Durango, Colorado, Disposal Site

As shown on Figure 4-2, the highest uranium concentrations occur in monitor well MW-0618; which continue to oscillate, but remain below the MCL. DOE had considered the concentration in 2004 to be anomalous and suspected the cause of the anomaly to be correlated with the closure

of the collection drain system. However, the uranium concentration of 0.041 mg/L reported in 2006 increased as compared with the previous year and is consistent with the 2004 result. Because only four data points are available for this well, trend analysis is inconclusive for this constituent and additional monitoring is needed.

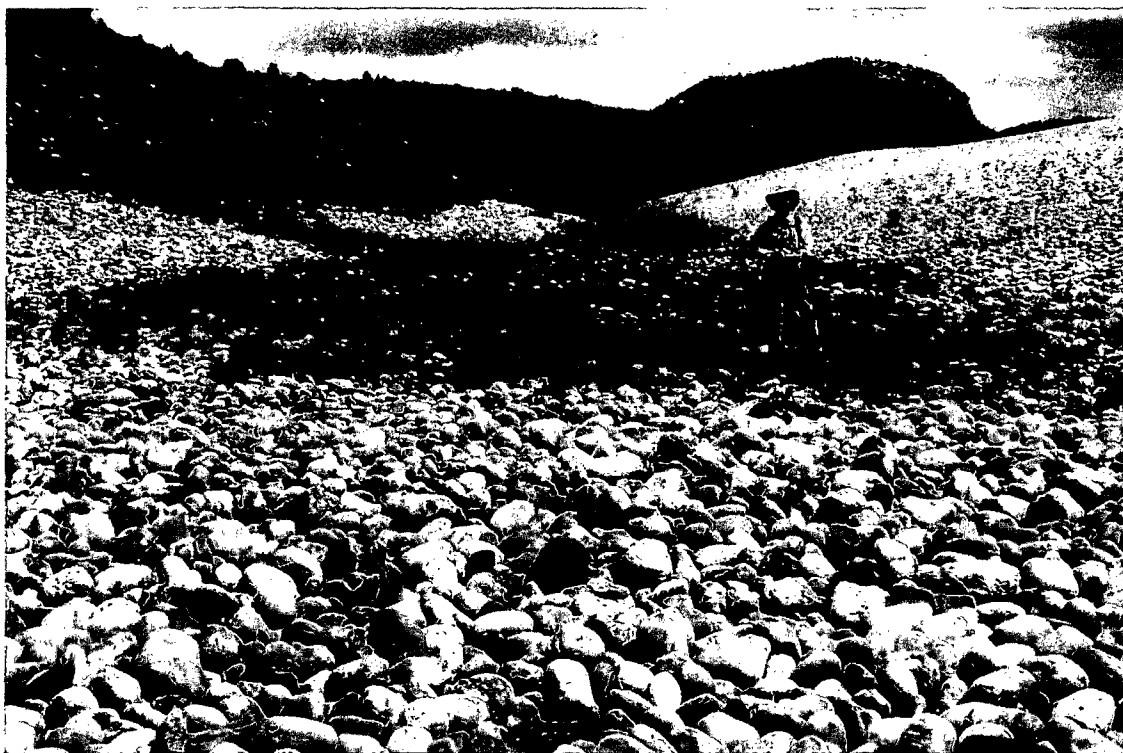
*DUR 6/2006. PL-2. Sediment deposition in Diversion Channel No. 1.*

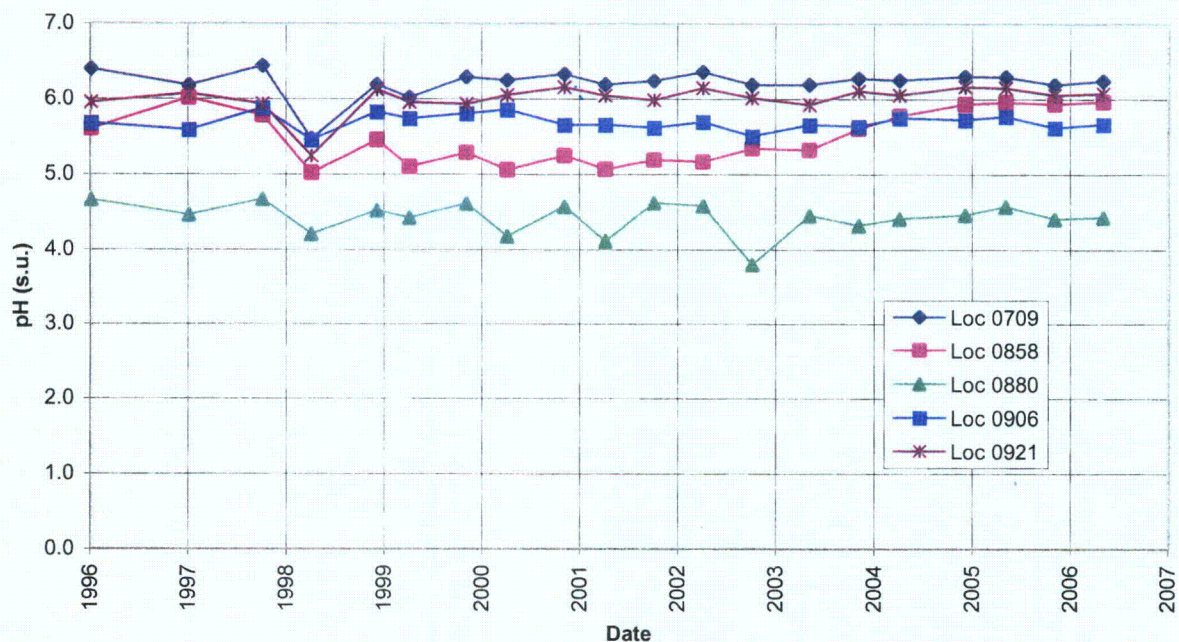
Figure 5-3. pH in Ground Water at Cell Performance Monitoring Locations at the Falls City, Texas, Disposal Site

Levels of pH did not vary significantly from previous results, and have historically shown consistency (within approximately one standard unit of measurement) since late 1998 with one exception. pH at MW-0886 fluctuated approximately two and one-half standard units (s.u.) of measurement (Figures 5-3 and 5-4).

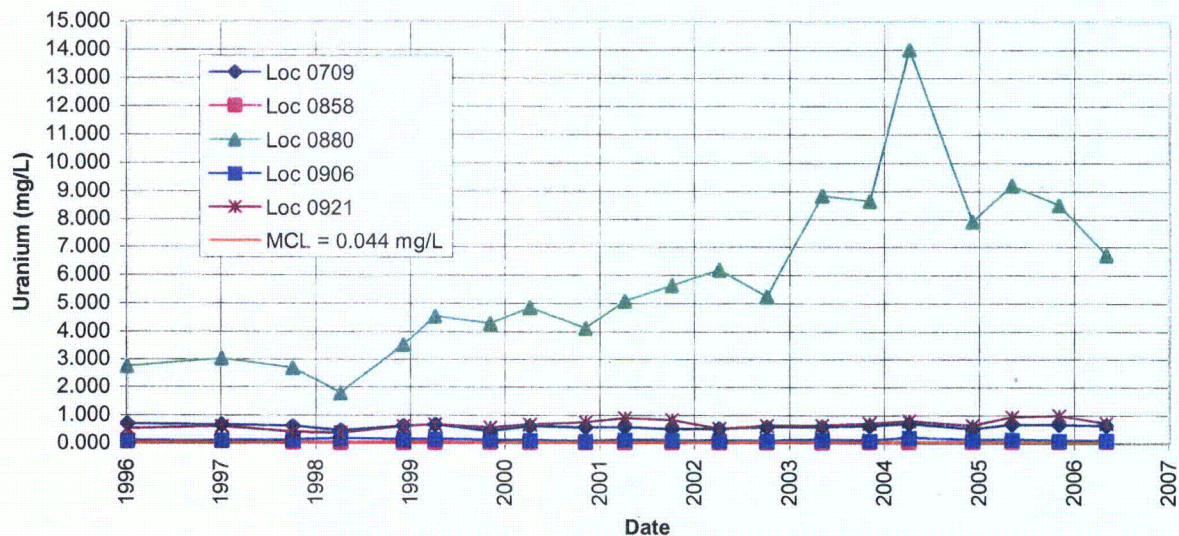
Figure 5-5. Uranium in Ground Water at Cell Performance Monitoring Locations at the Falls City, Texas, Disposal Site

Uranium concentrations in ground water in the vicinity of the disposal cell (i.e., performance monitoring) exceeded the MCL (0.044 milligrams per liter [mg/L]) in all but one monitor well, MW-0858 (Figure 5-5). This is consistent with historical data. The uranium concentrations also continue to be stable in all but one monitor well (MW-0880). The concentration in monitor well MW-0880 continues a recent decreasing trend that began in 2004. However, relative to historical results, an increasing trend still prevails; additional data is needed to determine if the recent decreasing trend will continue at this well. Historically, the concentration of uranium in monitor well MW-0880, which has ranged from 2.74 mg/L to 14 mg/L, is substantially greater than the other wells (all were less than 1.0 mg/L). Although, the sharp increase and maximum concentration reported in April 2004 (14 mg/L) appears anomalous. The overall increase and historical upward trend at MW-0880 may be an indication of (1) transient drainage from the disposal cell resulting from tailings material contained excess moisture at the time of placement, (2) dissipation of a legacy mound of contaminated ground water resulting from the former processing site operations (see Ground Water Level Monitoring section), or (3) the natural redistribution of uranium mineralization. The cause is ambiguous because tailings pore water is very similar chemically to the processing related contamination and ground water at other monitor wells nearby does not show similarly elevated concentrations of uranium. Local ground water is not used for any purpose because of naturally poor quality.

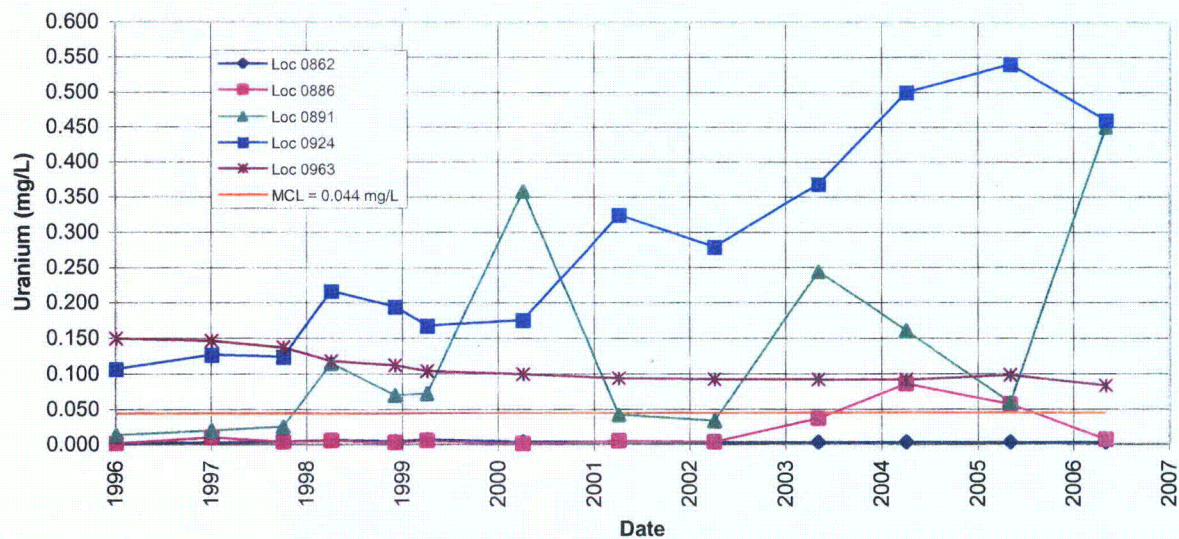
Figure 5-6. Uranium in Ground Water at Compliance Monitoring Locations at the Falls City, Texas, Disposal Site

Uranium concentrations in ground water in the compliance-monitoring network exceeded the MCL in all but two monitor wells, MW-0862 and MW-0886 (Figure 5-6). This is consistent with historical data, except that uranium concentrations in monitor well MW-0886 were reported above the MCL in 2004 and 2005. Additionally, 2006 results reported a sharp increase in the uranium concentration in monitor well MW-0891, from 0.059 mg/L to 0.45 mg/L. Historically, concentrations in this well have fluctuated significantly, above and below the MCL. This well is located approximately a mile from the disposal cell adjacent to a surface water drainage where the ground water level is substantially closer to the ground surface. Although the concentration of uranium in monitor well MW-0924 decreased from the prior two results, the overall increasing trend in uranium concentration in this well is likely the result of naturally occurring uranium because the pH hasn't decreased which would indicate movement of the processing related plume, particularly in this environment where uranium is highly mobile. Additionally, the uranium distribution varies spatially and the wells between well MW-0924 and the cell continue to have low concentrations.

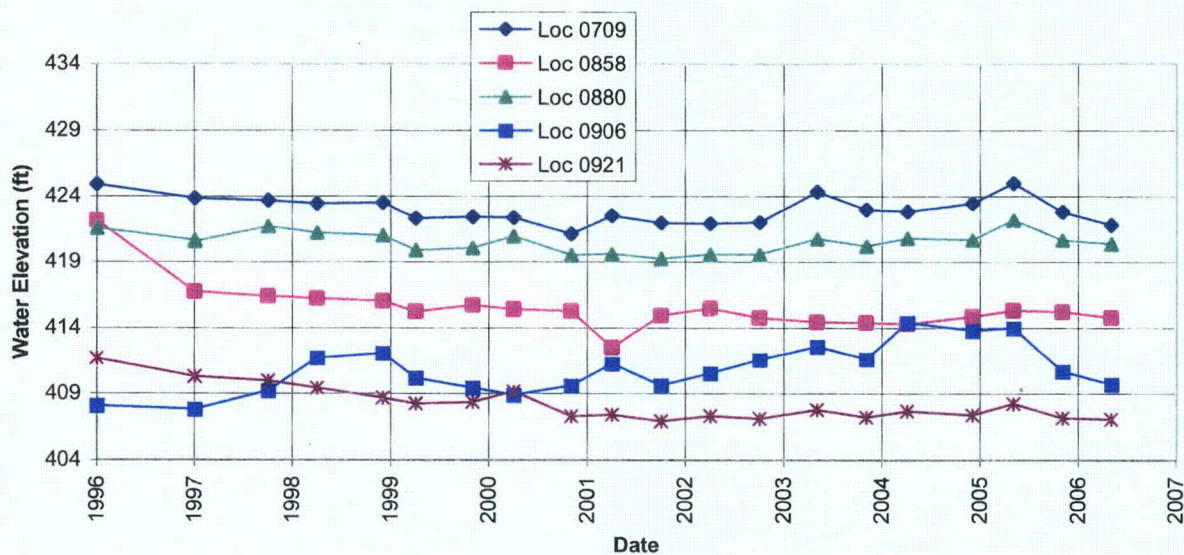
Figure 5-7. Water Level Measurements at Cell Performance Monitoring Locations at the Falls City, Texas, Disposal Site

**Ground Water Level Monitoring**—Ground water levels in the wells near the disposal cell used to monitor cell performance initially declined by several feet for the first few years following construction with one exception: monitor well MW-0906 fluctuated up and down several feet before rising and exhibiting an historical upward trend (Figure 5-7). This well is also the only well displaying an historical slightly upward trend; the remaining wells displayed fluctuations following an initial decline, but historically display a slight downward trend. Monitor well MW-0906 is located directly downgradient of the disposal cell, and the historical slightly upward trend is likely the result of localized mounding from water being shed from the disposal cell, as indicated by more than a five foot increase in the level from initial post-construction levels through May 2005, but also could reflect transient drainage from the disposal cell. More recently (for the last two years), downward levels have been reported in monitor well MW-0906, which is consistent with all other wells, and collectively most likely represents drought conditions that occurred in 2005. Other likely contributors to these recent downward levels include (1) dissipation of the processing site-related ground water mound beneath the disposal cell, and (2) dissipation of transient drainage from the disposal cell. Monitor wells MW-0908 and MW-0916, completed in the unsaturated zone of the Conquista Sandstone, have been dry at the time of sampling since 1996.

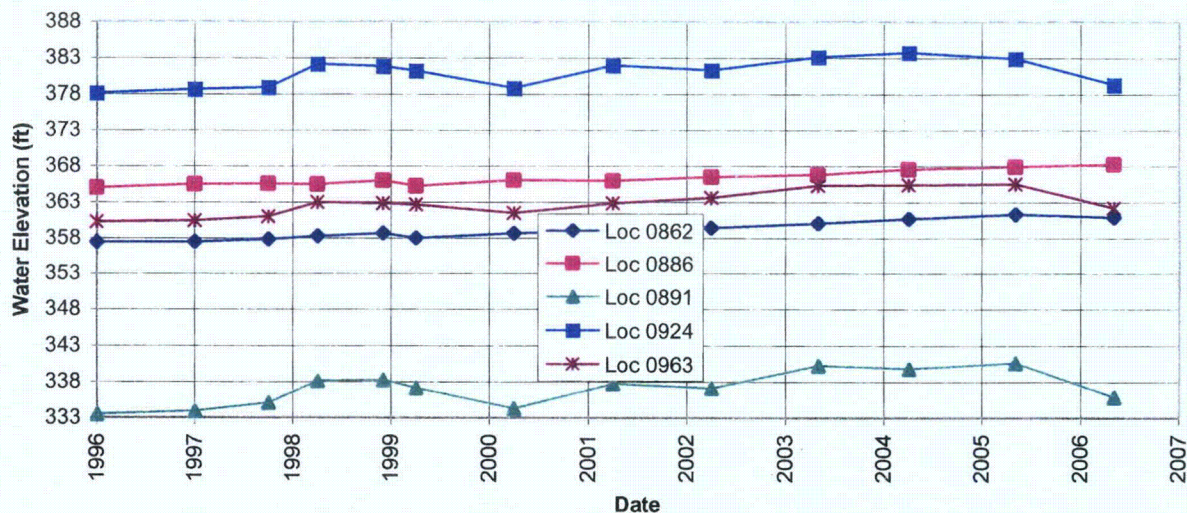
Figure 5-8. Water Level Measurements at Ground Water Compliance Monitoring Locations at the Falls City, Texas, Disposal Site

In contrast, water levels at the ground water compliance monitoring locations have all steadily increased several feet since monitoring began in 1996, indicating a regional effect; although, all but one well (MW-0886) also show recent downward levels, that again, likely represents drought conditions that occurred in 2005 (Figure 5-8).

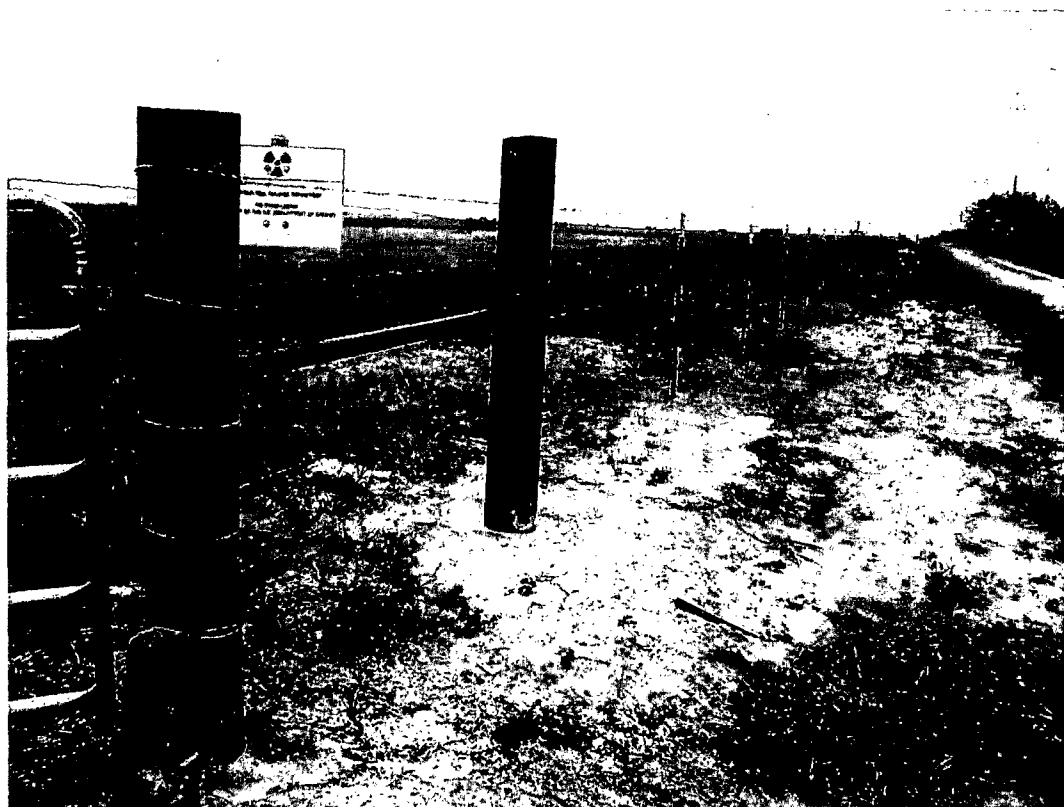
*FCT 1/2006. PL-2. New perimeter fence on northwest property boundary.*

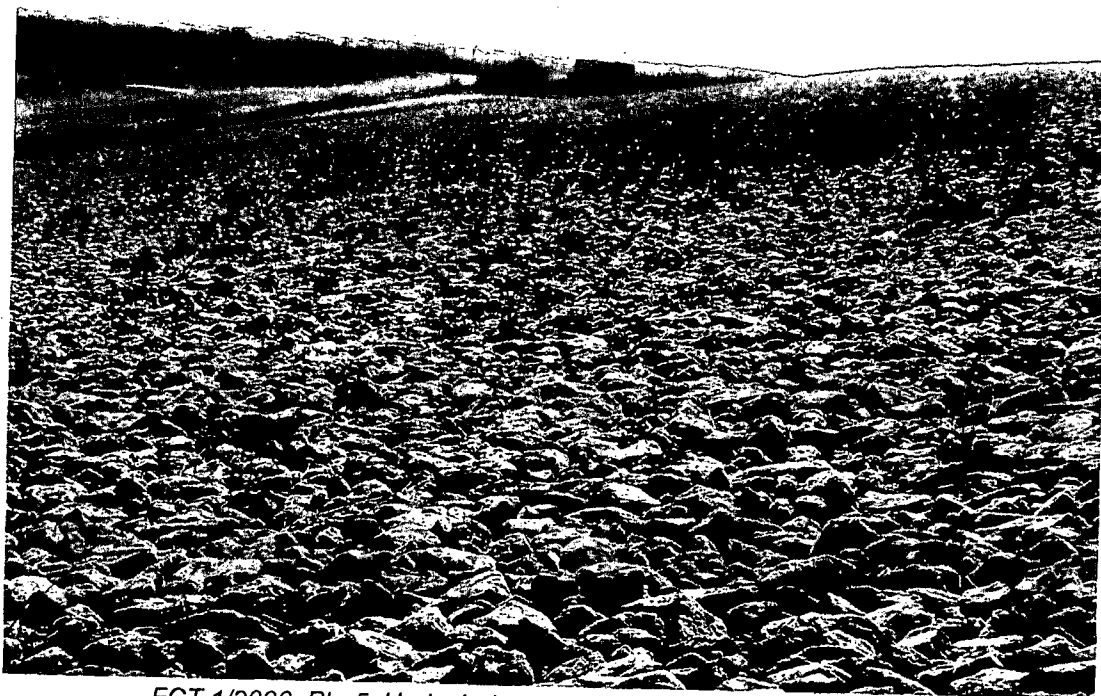
*FCT 1/2006. PL-5. Undesirable vegetation on northeast side slope.*

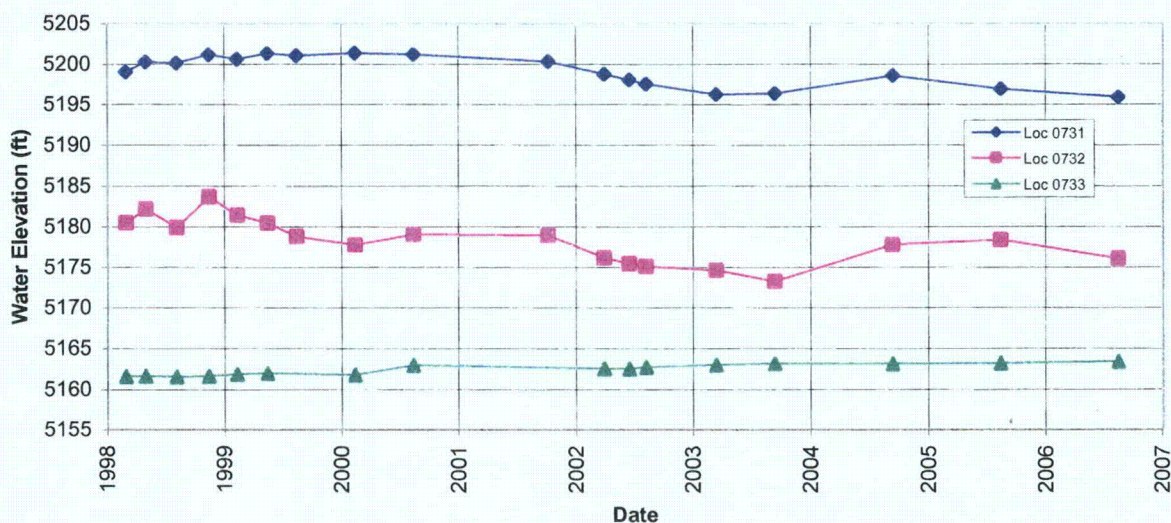
Figure 6-2. Water Level Measurements at the Grand Junction, Colorado, Disposal Site

The water level in the disposal cell well MW-0733 has displayed a steady continual rise, although relatively minor; approximately 2 feet of increase since 1998. In comparison, water levels within the two paleochannels at wells MW-0731 and MW-0732 have displayed a decrease, although more varied and larger; approximately 4 to 5 feet of decrease since 1998. Still the water level in the disposal cell well MW-0733 has remained significantly deeper than water levels in the paleochannels at wells MW-0731 and MW-0732, respectively, since 1998 (Figure 6-2).

On the basis of this information, there is no hydraulic potential for ground water at the base of the disposal cell at well MW-0733 to migrate to the paleochannels at wells MW-0731 and MW-0732.

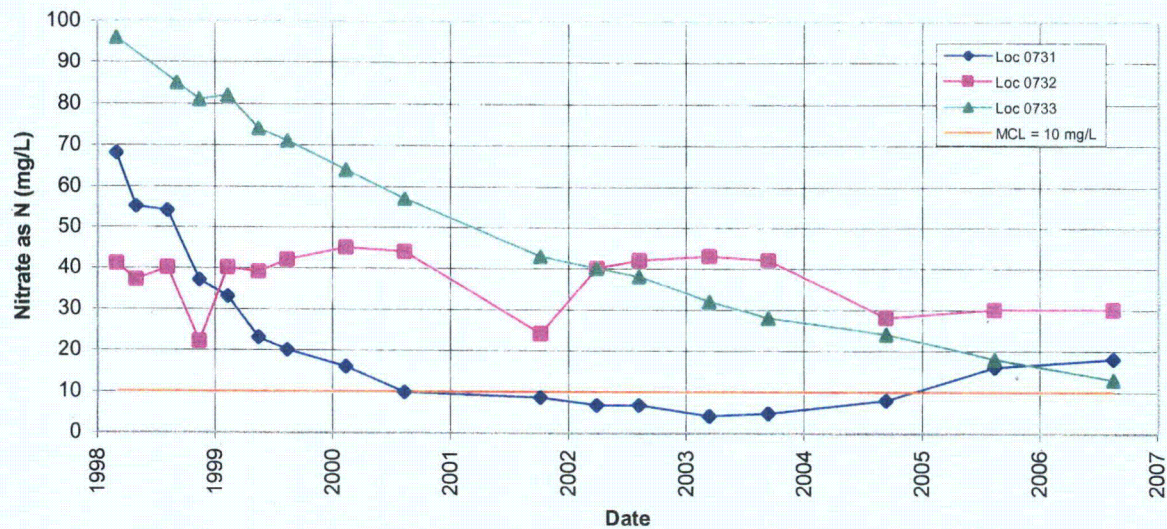
Figure 6-3. Time-Concentration Plots of Nitrate (as N) in Ground Water at the Grand Junction, Colorado, Disposal Site

Nitrate (as nitrogen) concentrations in ground water exceeded the MCL of 10 mg/L in all three monitor wells. Concentrations in well MW-0731, following an initial steep downward trend, remained below the MCL from 2000 through 2004. In 2005, and continuing in 2006, concentrations were above the MCL. Concentrations in well MW-0732, although varied, have consistently remained above the MCL since 1998. Concentrations in well MW-0733 continue a significant downward trend to just slightly above the MCL in 2006 (Figure 6-3). In 2006, the highest concentration of nitrate, 30 mg/L, occurred in paleochannel well MW-0732. Historically, the highest concentration of nitrate (96 mg/L) occurred in 1998 from the disposal cell well MW-0733.

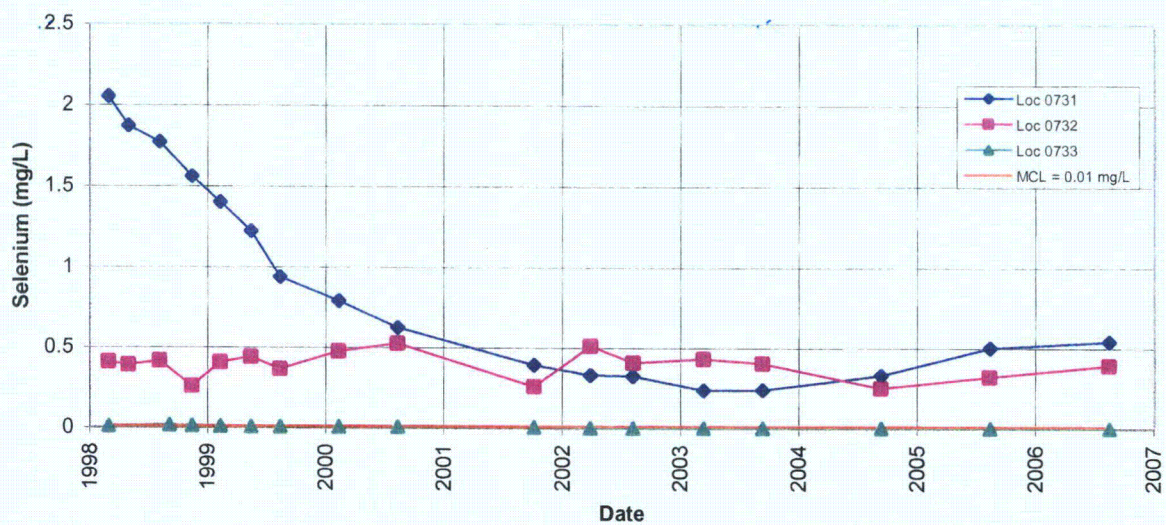
Figure 6-4. Time-Concentration Plots of Selenium in Ground Water at the Grand Junction, Colorado, Disposal Site

Selenium levels continued to exceed the MCL of 0.01 mg/L in both paleochannel wells MW-0731 and MW-0732, and remained well below the standard in MW-0733 in the disposal cell (Figure 6-4). Concentrations in well MW-0731 initially displayed a sharp decreasing trend, with the decreasing trend continuing until 2003, at which time a slight upward trend began. Concentrations in both wells MW-0732 and MW-0733 have remained relatively consistent, although, more fluxuation can be observed in MW-0732. In 2006, the highest concentration of selenium, 0.54 mg/L, occurred in paleochannel well MW-0731 and compares to an historical high of 2.05 mg/L in 1998 from the same well. These concentrations can be expected as selenium levels are typically elevated in sediments of the Mancos Shale in the area.

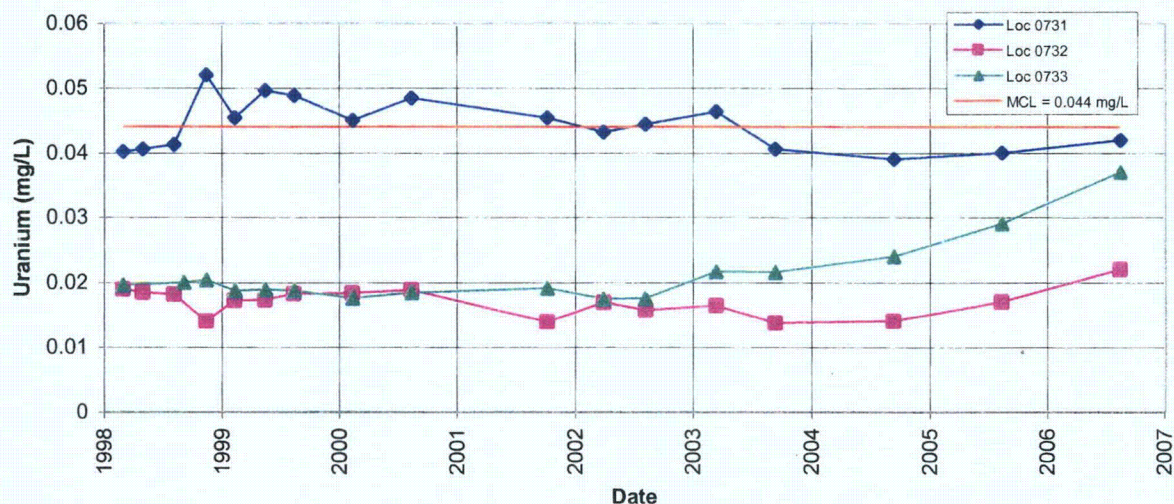
Figure 6-5. Time-Concentration Plots of Uranium in Ground Water at the Grand Junction, Colorado, Disposal Site

Uranium concentrations in ground water were below the MCL of 0.044 mg/L in all three monitor wells (Figure 6-5). Concentrations in wells MW-0732 and MW-0733 remained relatively consistent through 2003, at which time an upward trend began in both wells. Concentrations in

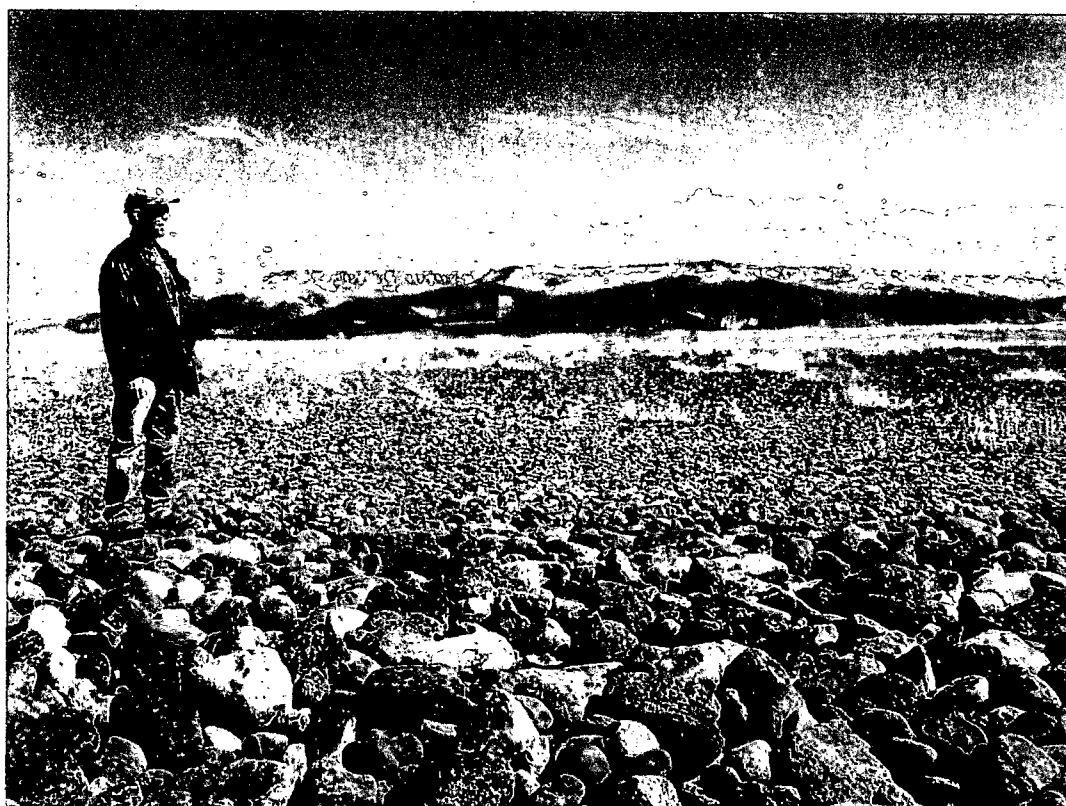
Annual grasses and weeds grow on most of the cell cover (PL-2), and scattered deep-rooted shrubs (primarily four-winged saltbush and rabbitbrush) have been persistent on the cover. The annual grasses and weeds have shallow root systems and do not degrade cell cover performance. As stated in the LTSP, however, the deep-rooted shrubs potentially could pose a threat to the

*GRJ 3/2006. PL-2. Cell top viewed from the southwest corner of the disposal cell.*

6B long-term integrity of the radon barrier and are required to be removed. All the deep-rooted shrubs that were found were cut and their stems were sprayed with herbicide. A preliminary study of the in situ saturated conductivity of the cover materials was conducted at four test locations in 2003 to see if the root systems of four-winged saltbush shrubs increased infiltration through the radon barrier. The results were not definitive and a follow-up investigation of the cover materials may be desirable to determine whether the deep-rooted shrubs need to be removed periodically or if leaving them in place would not change (or would improve) the function of the radon barrier in preventing infiltration of water into and the release of radon gas from the encapsulated materials. Vegetation growth on the cell also would likely provide additional erosion protection. However, unless it is determined that the shrubs can remain, they will be periodically removed.

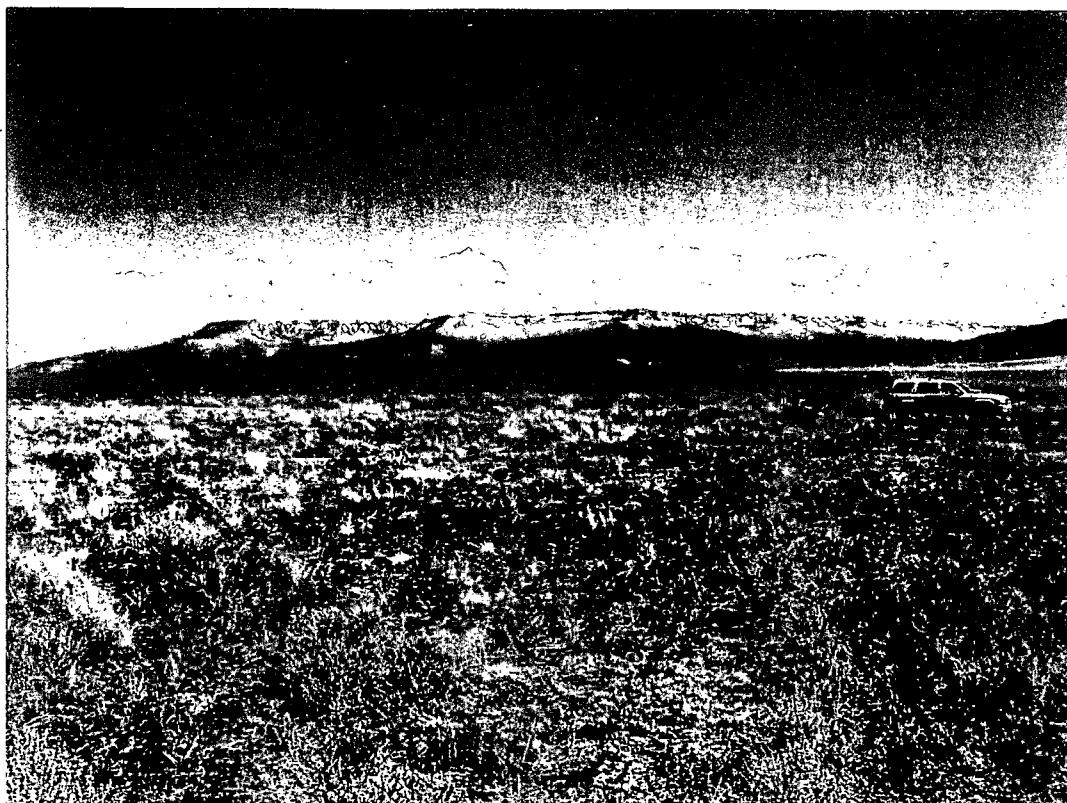
On the south and west sides of the disposal site, between the disposal cell and the perimeter fence, the ground is relatively flat and covered with native vegetation that consists primarily of perennial grasses and small shrubs (PL-5). Unlike the areas north and east of the disposal cell, the areas south and west are mostly undisturbed. No erosion was observed south and west of the disposal cell within the site. A small erosional area was present along the site boundary between the perimeter fence and a wash near the south diversion channel outfall. The gullies in this area were found to be self-armoring with basaltic rock and appeared to be stable.

*GRJ 3/2006. PL-5. Disposal cell viewed from the southwest corner of the disposal site.*

6D Tamarisk is a deep-rooted, water-depleting noxious weed that is recommended for removal in Mesa County. Isolated stands of tamarisk were found growing along the south side and northwest corner of the site and were removed. Although the plants do not threaten the integrity or performance of the disposal cell, they were cut and treated with herbicide to remove the seed source to reduce the chance of the plants from spreading and establishing on the disposal cell.

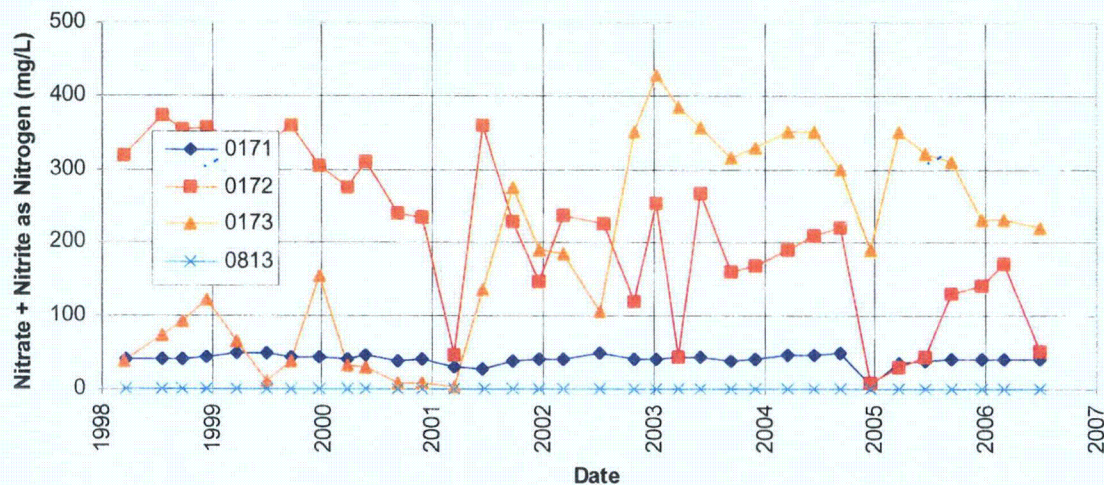
Figure 7-2. Time-Concentration Plots of Nitrate in Ground Water at the Green River, Utah, Disposal Site

Concentrations of nitrate in ground water continued above the MCL of 10 mg/L but are considerably below the proposed ACL of 1,000 mg/L except in well MW-0813, where values continue near the laboratory detection limit (Figure 7-2). Since 1998, concentrations in wells MW-0171 and MW-0813 have remained essentially constant, while there has been a downward trend for well MW-0172 since 1998 and a downward trend for well MW-0173 since the beginning of 2003.

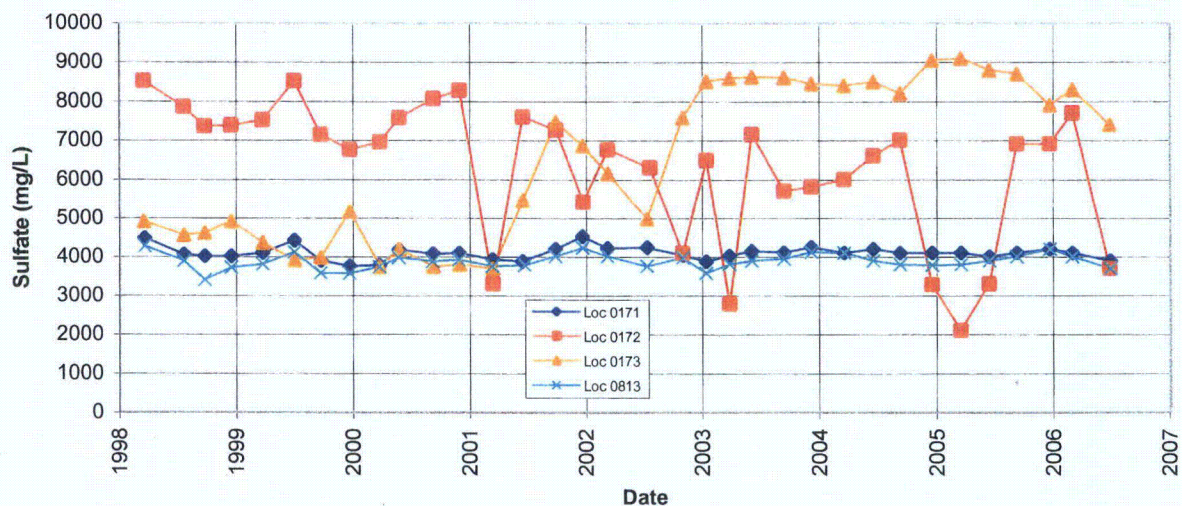
Figure 7-3. Time-Concentration Plots of Sulfate in Ground Water at the Green River, Utah, Disposal Site

Sulfate concentrations in ground water are indicating similar trends as for nitrate (Figure 7-3). Sulfate concentrations have remained relatively constant in wells MW-0171 and MW-0813 since the disposal cell was constructed. Concentrations in wells MW-0172 and MW-0173 have fluctuated substantially since 1998, but there has been an overall downward trend for well MW-0172 since 1998 and a slight downward trend for well MW-0173 since the beginning of 2003.

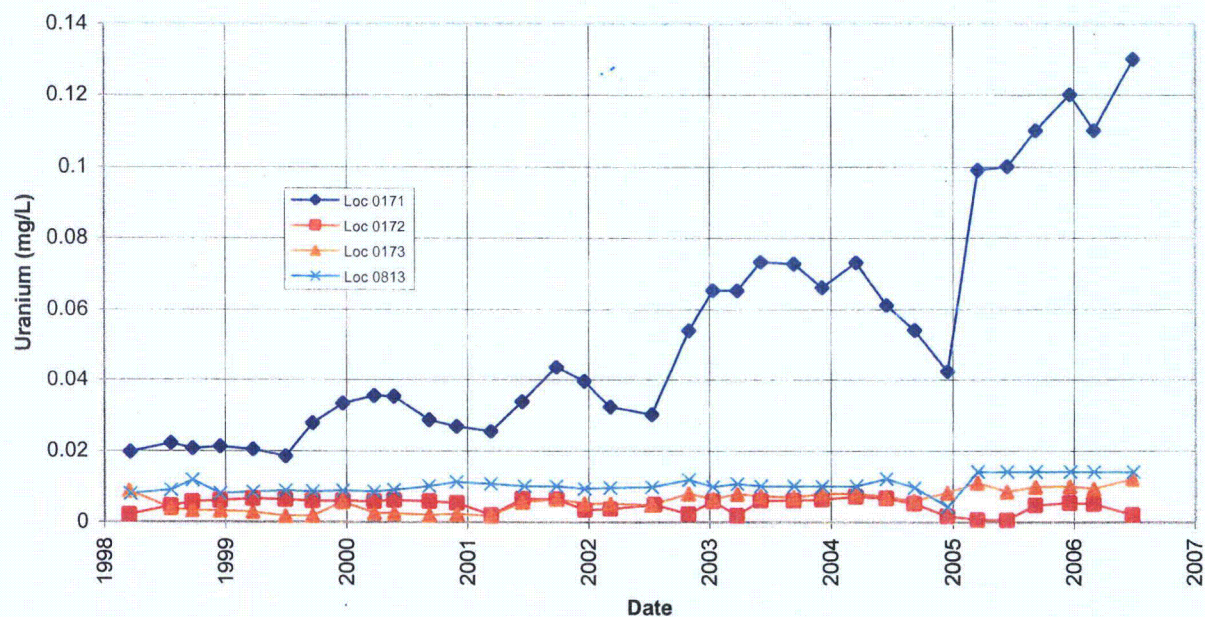
Figure 7-4. Time-Concentration Plots of Uranium in Ground Water at the Green River, Utah, Disposal Site

Uranium concentrations in ground water remain below the MCL of 0.044 mg/L and considerably below the proposed ACL of 4.4 mg/L, and continue to remain essentially constant, in wells MW-0172, MW-0173, and MW-0813. At well MW-0171, however, concentrations exceed the MCL and continue to exhibit an overall upward trend (Figure 7-4). Because uranium is the only constituent of concern in well MW-0171 that has indicated an upward trend, no conclusions regarding the cause of the trend have been reached at this time.

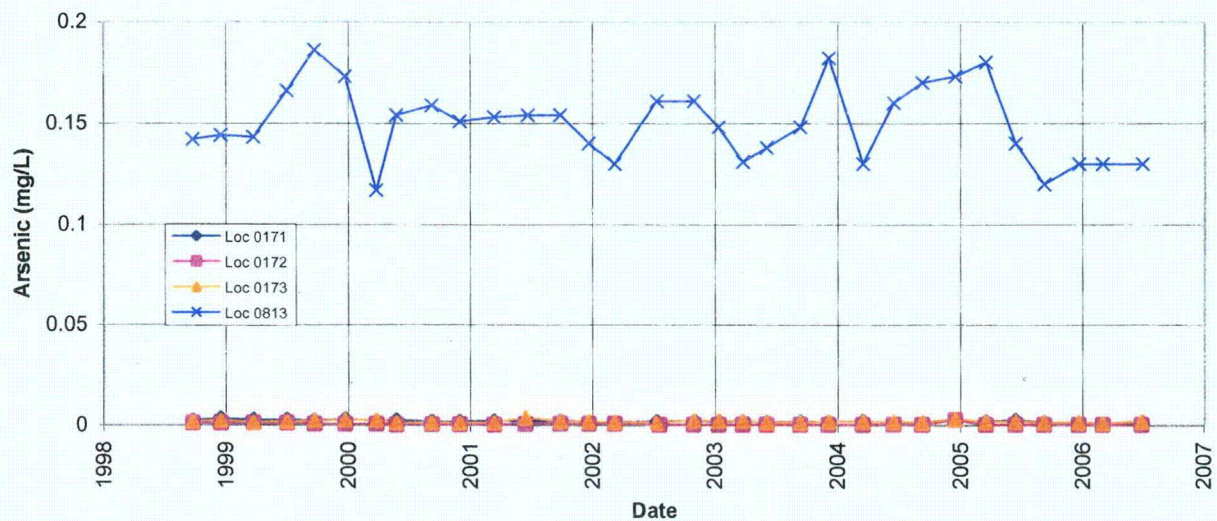
Figure 7-5. Time-Concentration Plots of Arsenic in Ground Water at the Green River, Utah, Disposal Site

Arsenic concentrations in ground water remain below the MCL of 0.05 mg/L and considerably below the proposed ACL of 5.0 mg/L in wells MW-0171, MW-0172, and MW-0173. In well MW-0813, levels have exceeded the MCL over the entire sampling period (Figure 7-5) but are substantially below the proposed ACL. Concentrations in MW-0813 have averaged approximately 0.15 mg/L since 1998 with no apparent trend.

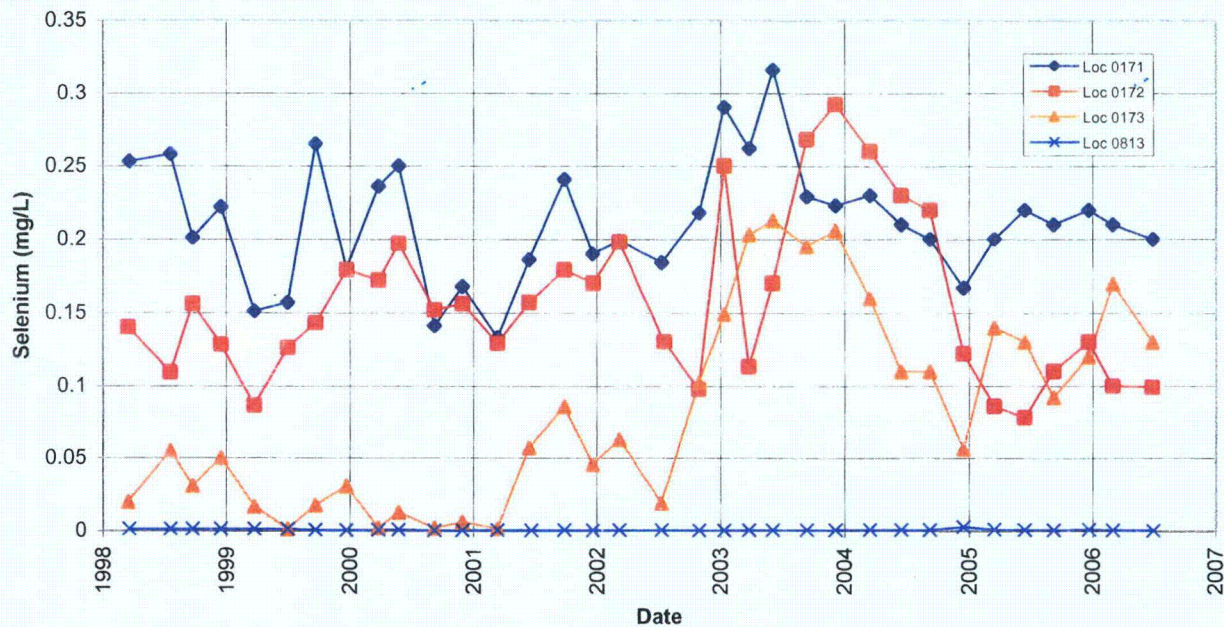
Figure 7-6. Time-Concentration Plots of Selenium in Ground Water at the Green River, Utah, Disposal Site

Selenium concentrations in ground water continued above the MCL of 0.01 mg/L but considerably below the proposed ACL of 1.0 mg/L in wells MW-0171, MW-0172, and MW-0173; concentrations in well MW-0813 remain near the laboratory detection limit (Figure 7-6). Except for MW-0813, there has been considerable variation in selenium concentrations; however, no trends are apparent.

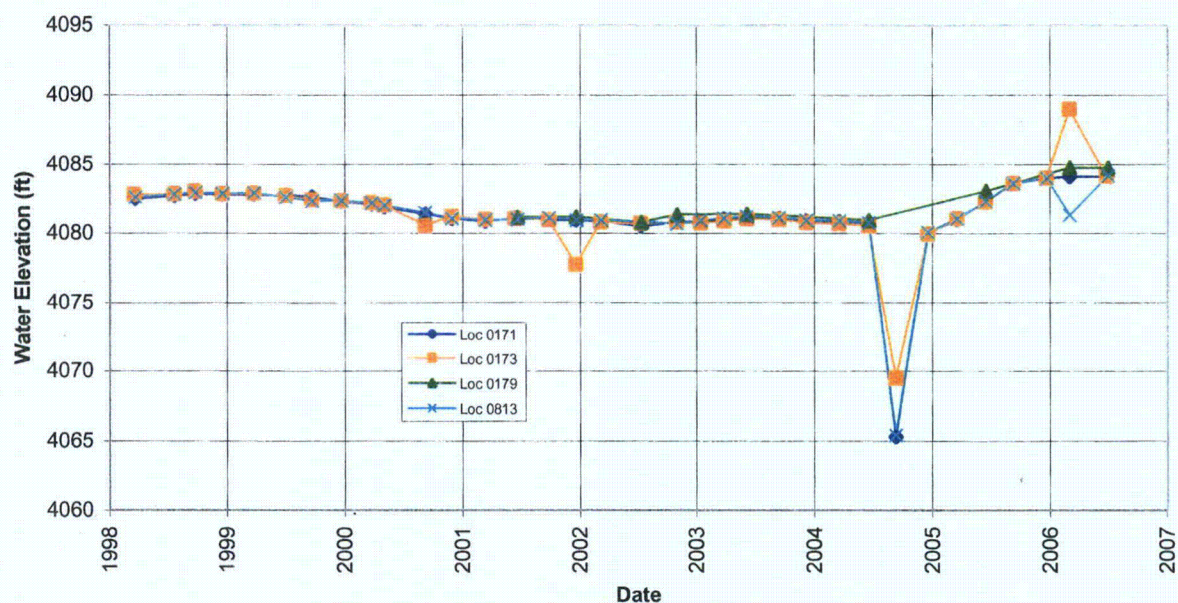
Figure 7-7. Ground Water Elevations at the Green River, Utah, Disposal Site

**Ground Water Level Monitoring**—Ground water levels in several monitor wells adjacent to the disposal cell have been measured manually since 1991, and continually with down-hole dataloggers since 1999. Erroneous manual measurements, likely due to equipment problems, occurred in 2000, 2001, 2004, and 2006 (Figure 7-7)—the continuous measurements indicated essentially no change at those times. Well hydrographs indicate that an overall decrease in the ground water elevation of approximately 2 feet occurred from 1998 through 2004, followed by an increase of approximately 4 feet since then. This increase in ground water elevations is likely a result of recharge caused from the increased regional precipitation that has occurred since late 2004.

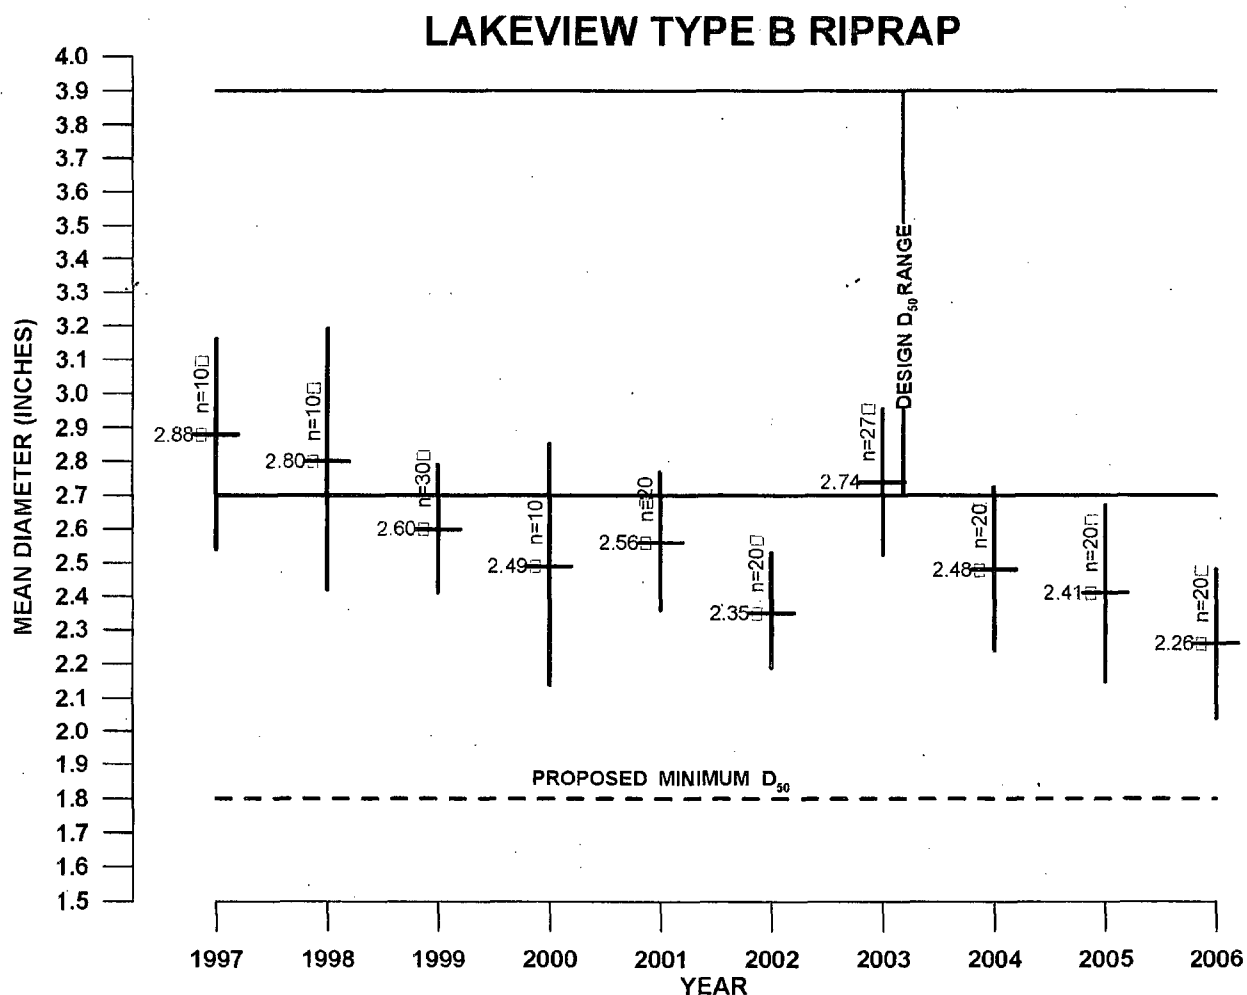
Figure 9-2. Side Slope Riprap Gradation Monitoring Results for the Lakeview, Oregon, Disposal Site

- 9B The original design specified a side slope riprap median rock diameter ( $D_{50}$ ) of 2.7 inches. Subsequent observations indicated that the riprap could degrade to a value less than the designed  $D_{50}$ . To determine if the riprap degradation posed a risk for cell erosion, DOE recalculated the minimum  $D_{50}$  using the U.S. Army Corps of Engineers Hydrologic Modeling System computer model currently accepted by NRC. The recalculated minimum  $D_{50}$  necessary to protect the disposal cell is 1.8 inches. DOE submitted a revised LTSP in 2002 addressing the recalculated minimum  $D_{50}$ ; the plan remains pending NRC approval.

- 9C Annual rock gradation monitoring of side slope riprap was performed for the tenth year during the 2006 inspection (PL-3). Particle size distribution (weight percent) by count data was collected at 20 locations. The 2006 results indicate an average  $D_{50}$  of 2.26 inches with a 95 percent confidence interval between 2.04 and 2.48 inches (Figure 9-2). The mean  $D_{50}$  in 2005 was 2.41 inches. The  $D_{50}$  value measured for 2006 is similar to values measured for most of the previous 5 years: 2001 ( $D_{50} = 2.56$ ), 2002 ( $D_{50} = 2.35$ ), 2003 ( $D_{50} = 2.74$ ), 2004 ( $D_{50} = 2.48$ ), and 2005 ( $D_{50} = 2.41$ ). The average  $D_{50}$  for the previous five years is 2.51.

Detailed measurements of this erosional process began in 1997. Since that time the mean diameter has decreased about 20 percent. The overall trend of  $D_{50}$  rock sizes from 1997 to the present suggests a gradual decrease in size. However, initially (1997 – 1999) the trend appeared to be more rapid than in more recent years. This initial more rapid decreasing trend may be because the basaltic rocks used on the side slope were predisposed to chemical or physical weathering and reacted more quickly to newly imposed surface conditions during the first decade (1989-1999) after cell completion. Therefore, the first decade of rock weathering may have seen the greatest and most rapid loss of rock integrity. The overall decrease in size may represent a minimum decrease in rock size because rock diameters are measured from surface samples and smaller fragments, derived from crumbling rocks, may have fallen into the interstices, thus producing a bias sample. Nevertheless, the current method of rock-size measurement has been performed for the past 10 years and does provide a consistent metric for cover material changes.

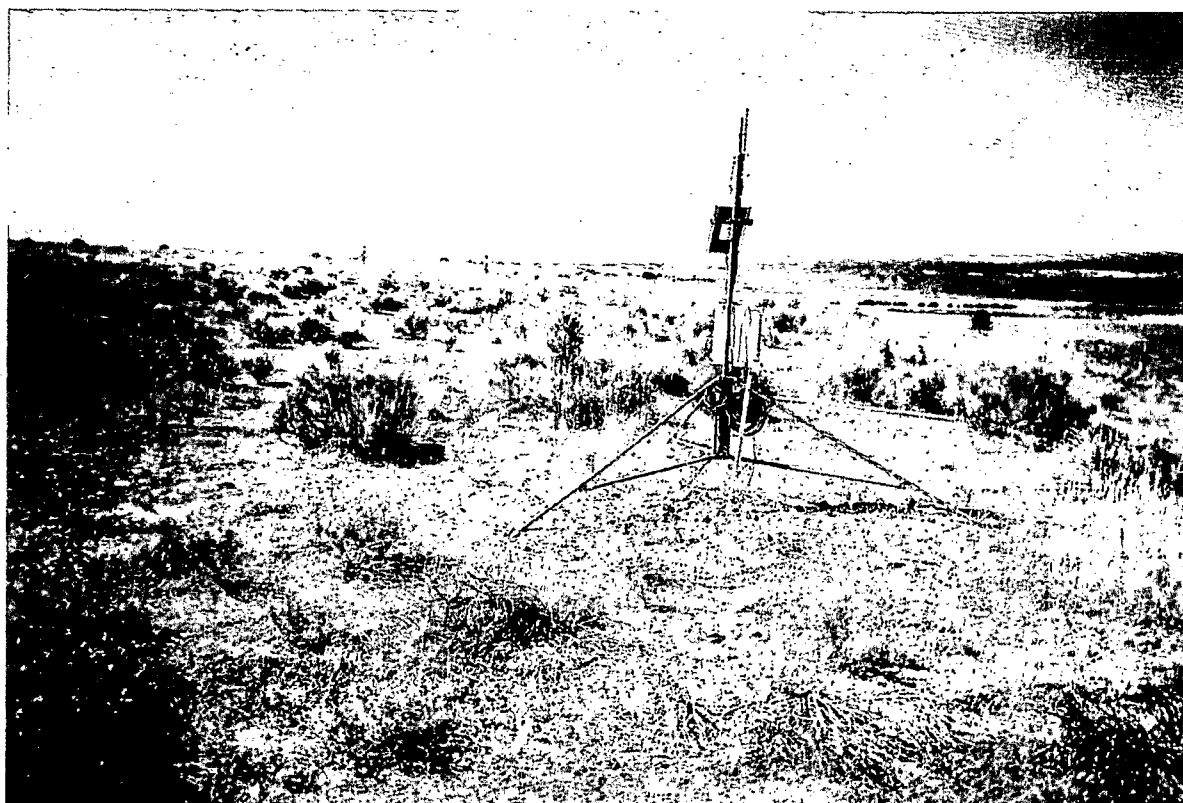
LKV 7/2006. PL-2. Fluxmeters and weather station on the disposal cell top.
