Subject: 2006 Annual Site Inspection and Monitoring Report for UMTRCA Title I Disposal Sites

# 2006 Annual Site Inspection and Monitoring Report for Uranium Mill Tailings Radiation Control Act Title I Disposal Sites

Work Performed by S.M. Stoller Corporation under DOE Contract No. DE-AC01-02GJ79491  
for the U.S. Department of Energy Office of Legacy Management, Grand Junction, Colorado

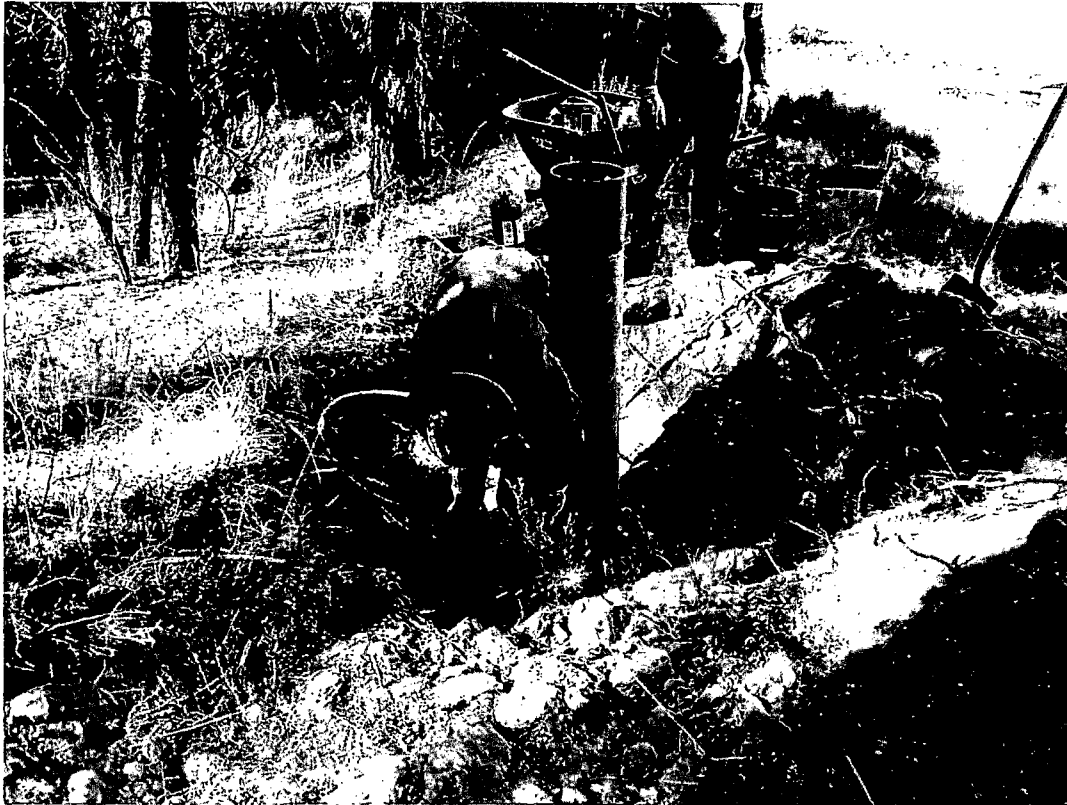
*LOW 7/2006. PL-3. Cutting the surface casing of monitor well MW-0641.*

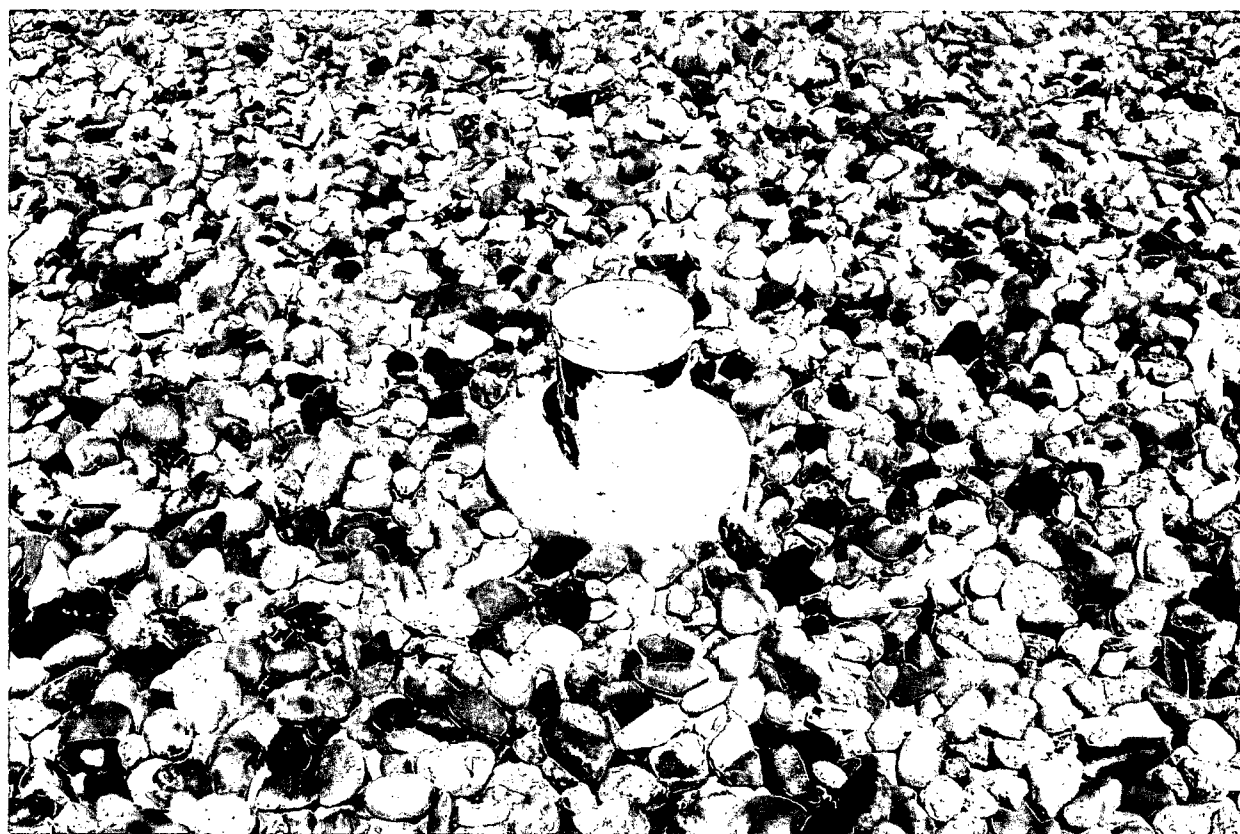
**Settlement Plates**—There are nine settlement plates on top of the disposal cell (PL-2). All were secure and in good condition. No visual evidence of settlement occurring on the disposal cell cover was observed in 2006.

MAY 8/2006. PL-2. Settlement Plate No. 9.

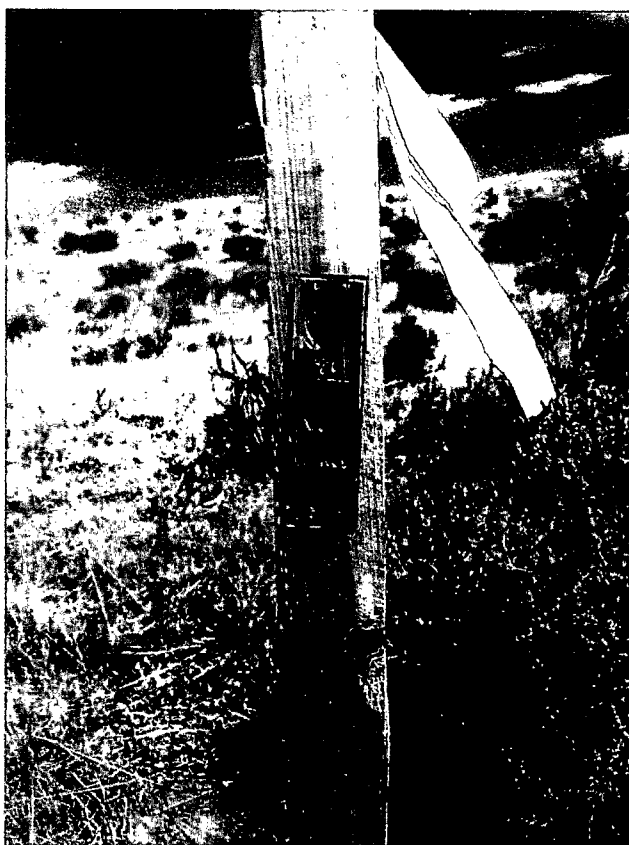
*MAY 8/2006. PL-4. Information plate on a new survey stake located inside the west property boundary.*

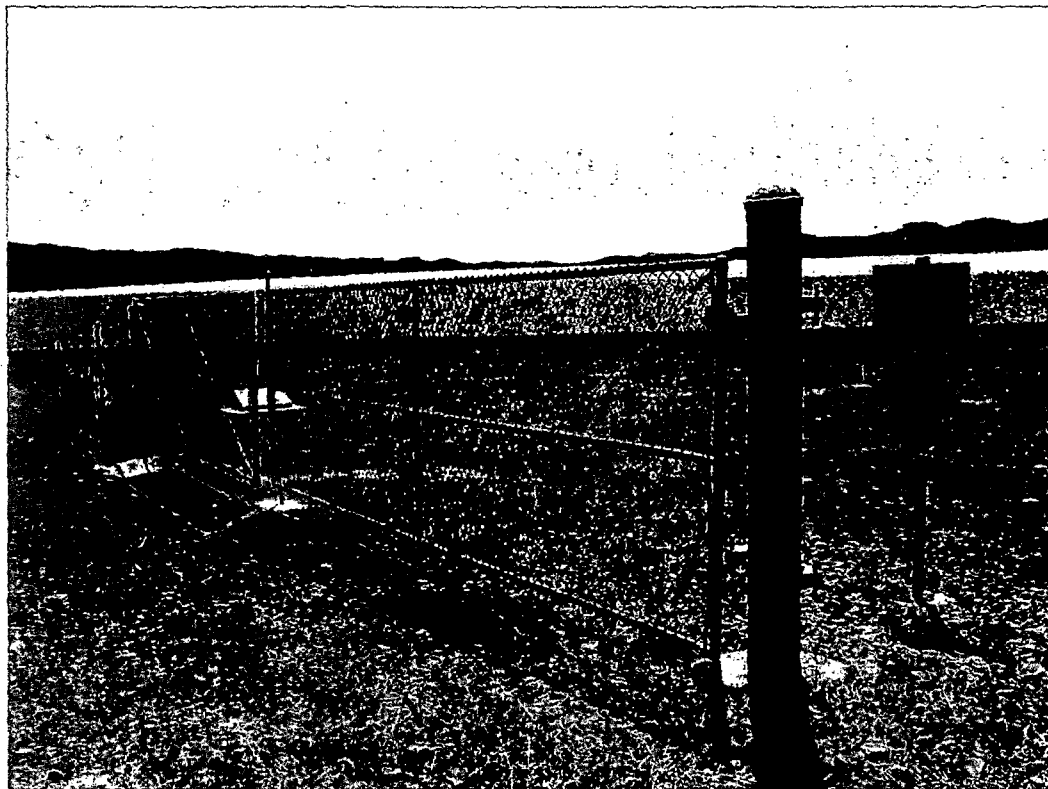
*HAT 4/2006. PL-1. Entrance gate (showing bent center rod) and sign, site marker; disposal cell in the background.*

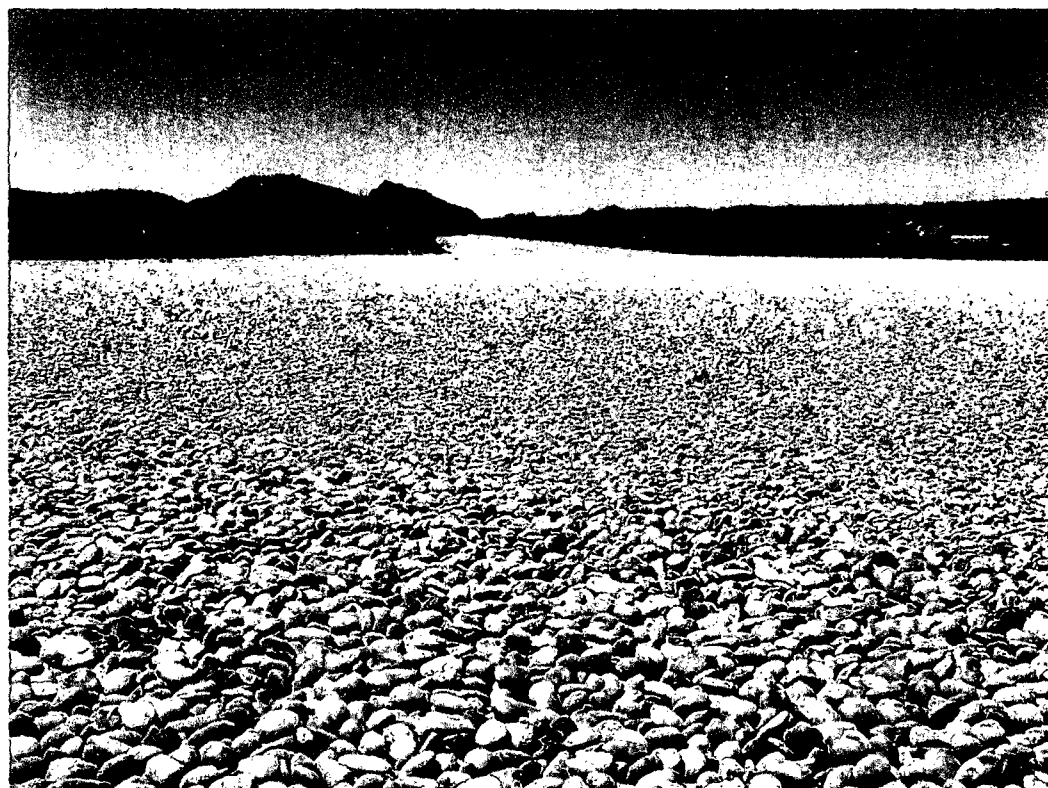
*HAT4/2006. PL-2. View southwest across the cell top from the crest of the east side slope of the cell; south slope of the cell top in the background.*

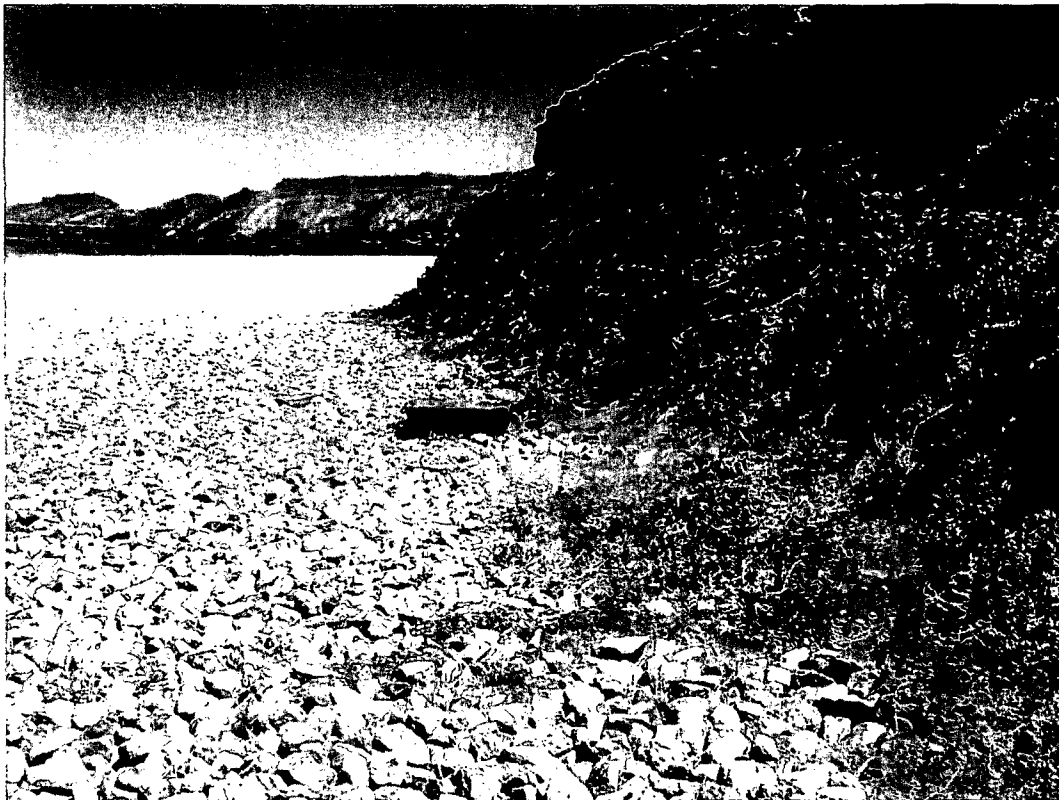
*HAT 4/2006. PL-3. View northeast along the southeast apron showing insignificant accumulation of detritus.*

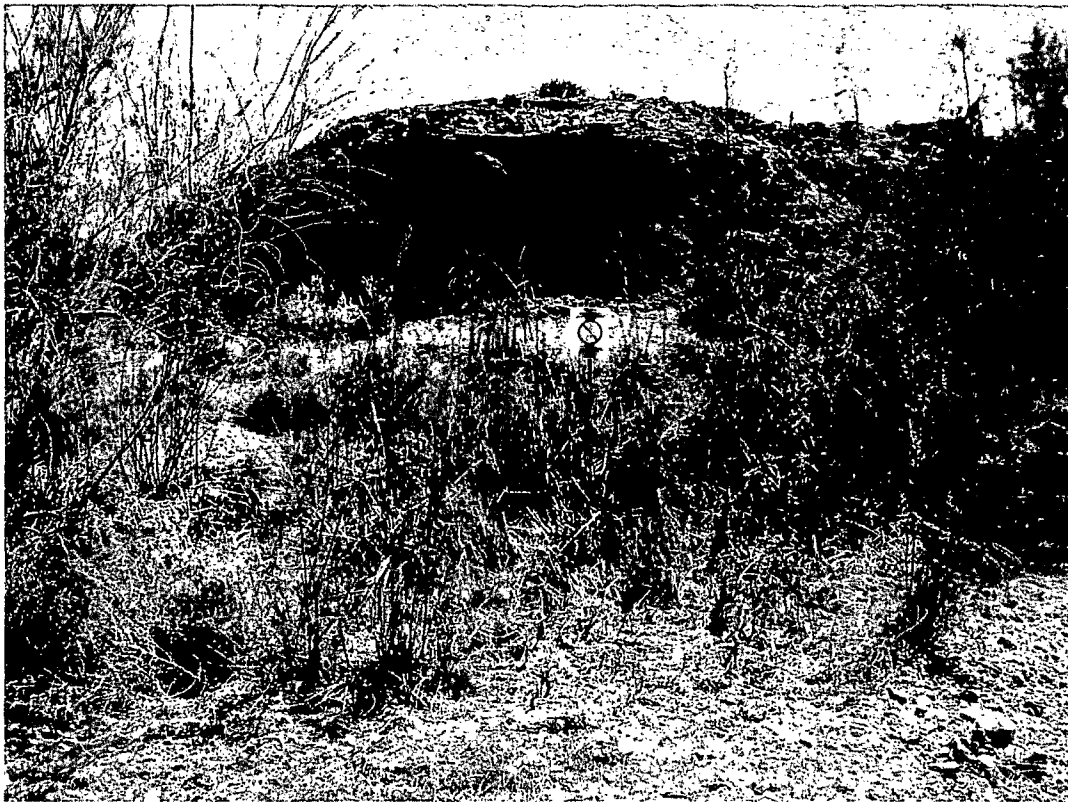
HAT 4/2006. PL-5. Seep 0264.

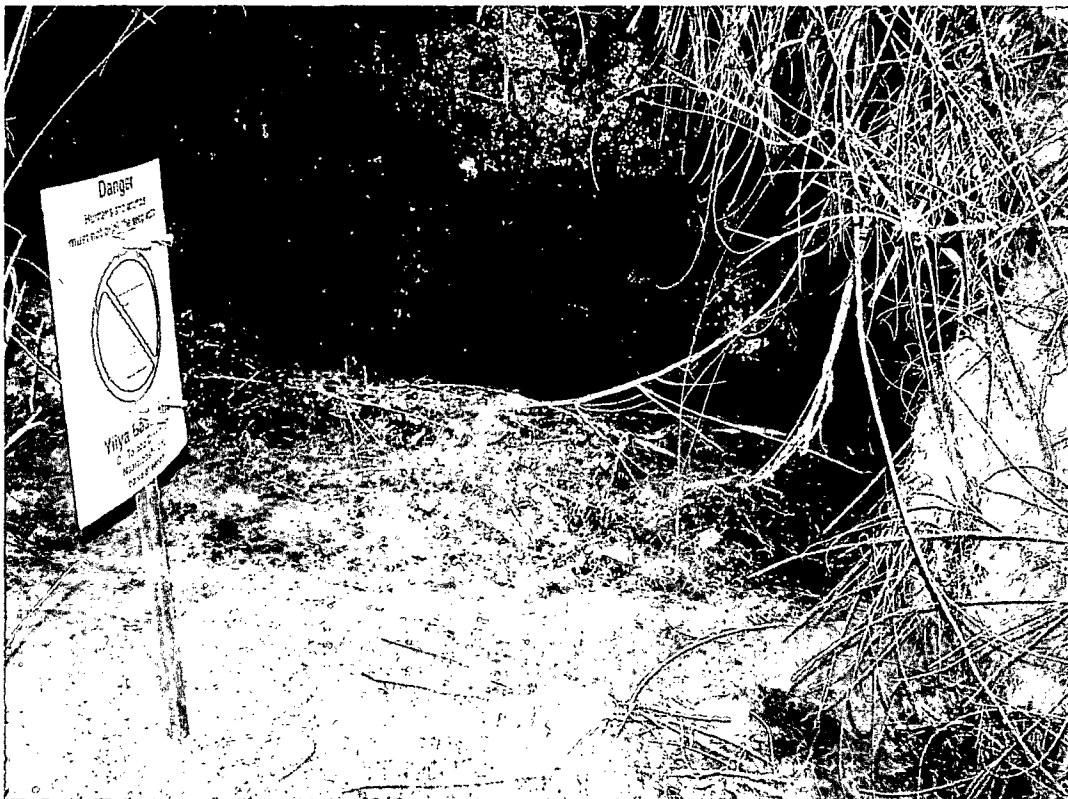
HAT 4/2006. PL-6. Seep 0248.

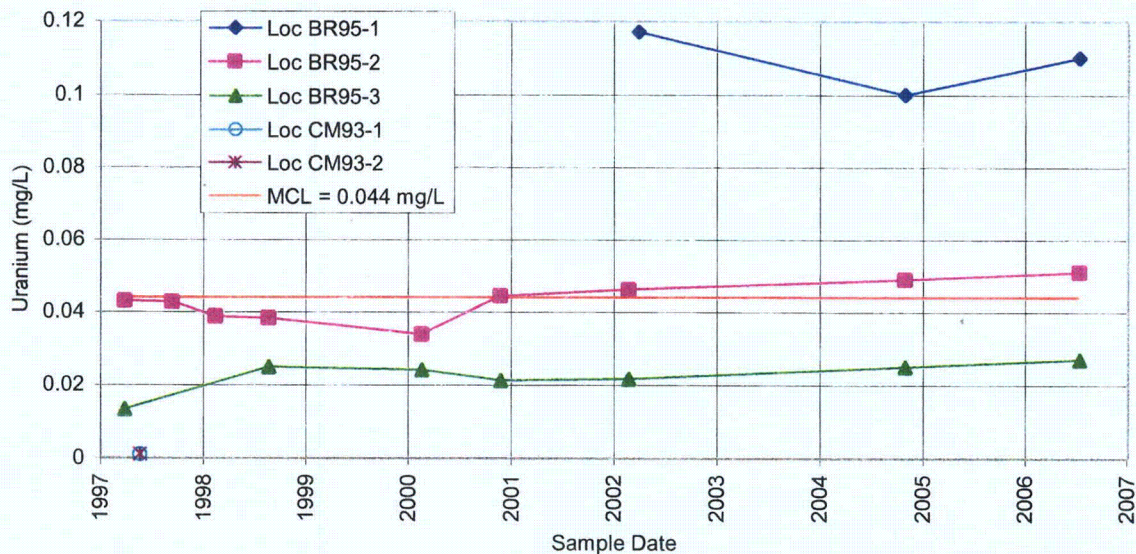
Figure 13-2. Time-Concentration Plots of Uranium in Ground Water at the Naturita, Colorado, Disposal Site

The 2006 uranium concentrations in monitor wells BR95-1, BR95-2, and BR95-3 ranged from 0.027 to 0.11 mg/L (MCL is 0.044 mg/L) (Figure 13-2). Each well indicated very slight increases over the 2004 results that ranged from 0.025 to 0.1 mg/L. Concentrations of uranium in this range are not unexpected at the contact between the Salt Wash Member and the Summerville Formation because uranium mineralization is present in the Salt Wash Member. An indication of the intrinsic mineralization of this ground water is the high level of uranium (2.59 mg/L in April 2001, Umetco result) in seep water approximately 0.5 mile north of the disposal cell. The seep is cross gradient from the disposal cell and represents natural discharge from the Salt Wash/Summerville contact.

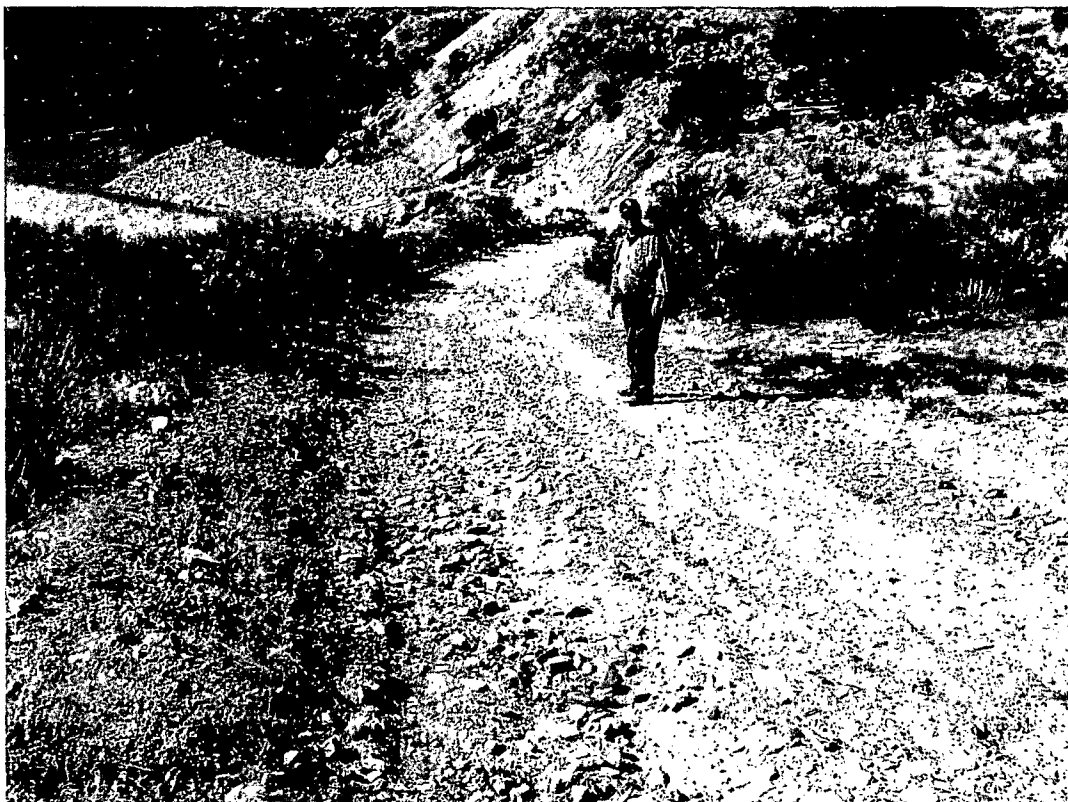
*NAD 4/2006. PL-1. Site access road to monitor wells.*

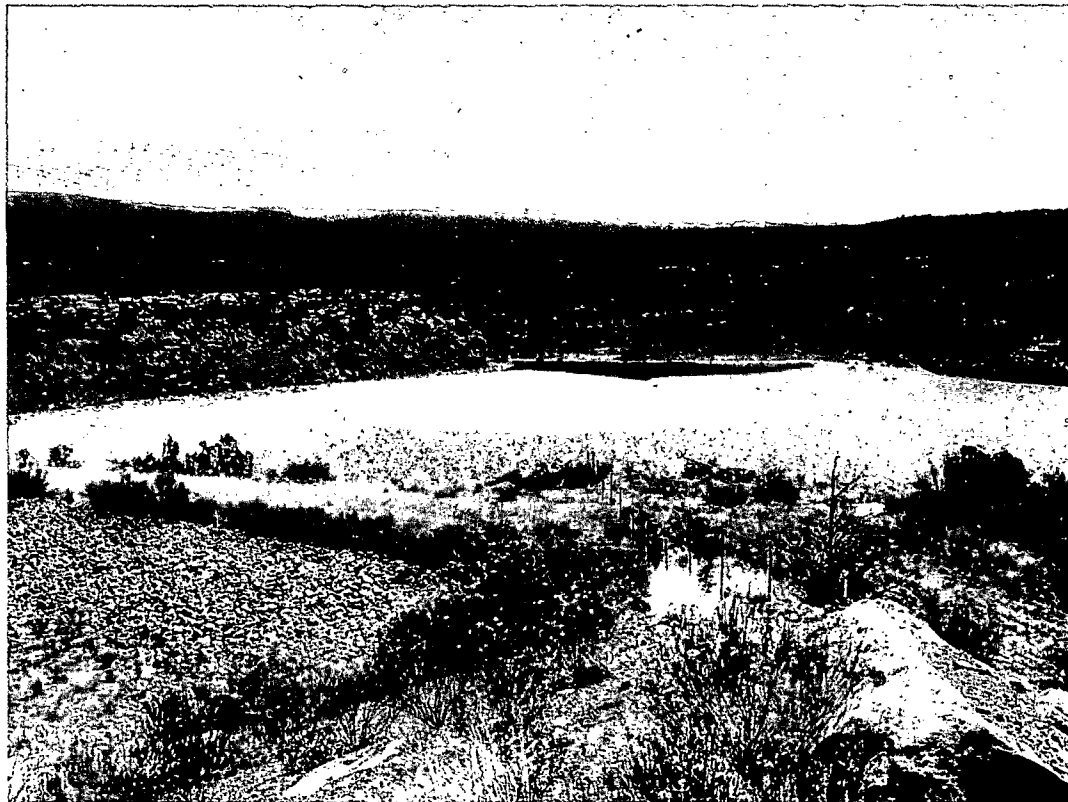
**Top of Disposal Cell and Side Slopes**—The disposal cell was completed in 1998. Rock covers the 2-acre top of the disposal cell and the approximate 8 acres of side slopes (PL-2). The rock is rounded, with larger rock on the side slopes than on the top. The rock-covered surfaces showed no signs of disturbance except on the southwest side of the top surface. This is an area where a standpipe was removed several years ago and the slightly irregular surface is the result of that activity. The remaining portions of the cell top and side slopes of the disposal cell were in excellent condition. No evidence of subsidence, differential settlement, slumping, or other modifying process was noted, and no vegetation was present.

*NAD 4/2006. PL-2. The disposal cell viewed from boundary monument BM-8.*

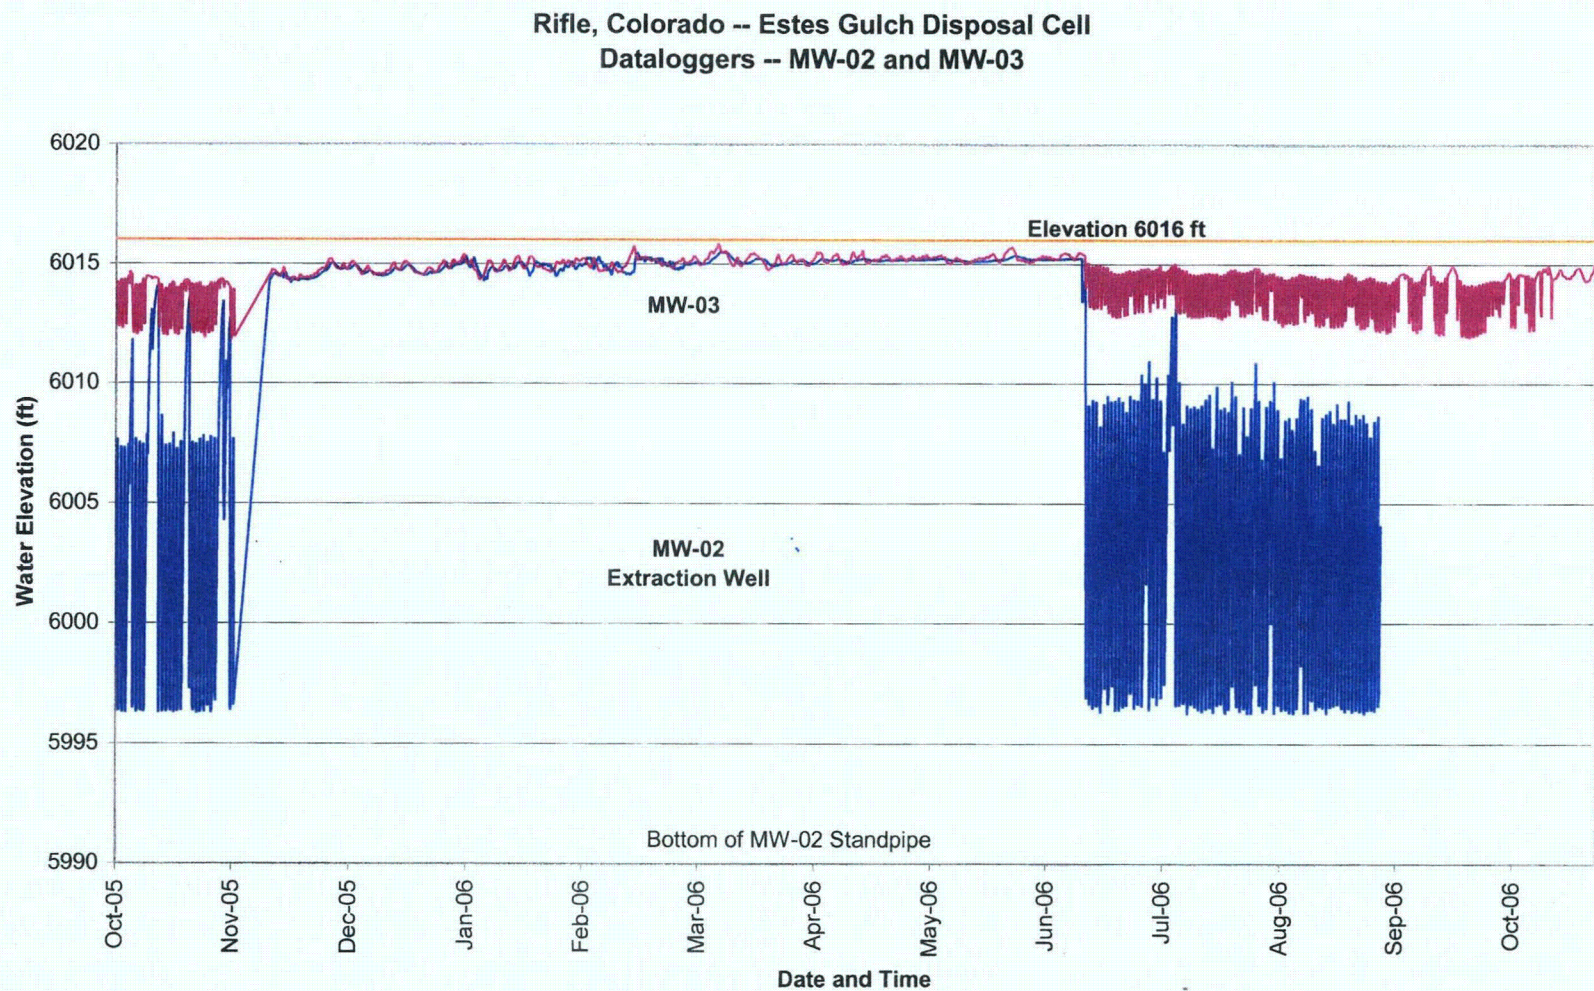
Figure 14-2. Disposal Cell Pore Water Levels in Standpipes MW-02 and MW-03 at the Rifle, Colorado, Disposal Site.

As shown by datalogger measurements (Figure 14-2), over the past year during pumping water levels initially decreased sharply followed by a steadier continuous decline, only rising in correspondence to precipitation events. The water level elevation remained below 6,015 feet in both standpipes. Datalogger malfunction in MW-02 resulted in lost water level data from late August through late October (when the pumps were shut off); because water levels in this well historically have remained significantly below the action level, and also below the water levels recorded in MW-03, there was no concern that the action level had been exceeded. In support of this conclusion, the static water level measurements obtained in both standpipes MW-02 and MW-03 when the pumps were shut off on October 30, 2006, were below the action level. During this period of pumping (early June to late October), fluctuations in the water levels represent typical drawdown and recovery that occurs during pumping on/off cycles. The pumps were shut

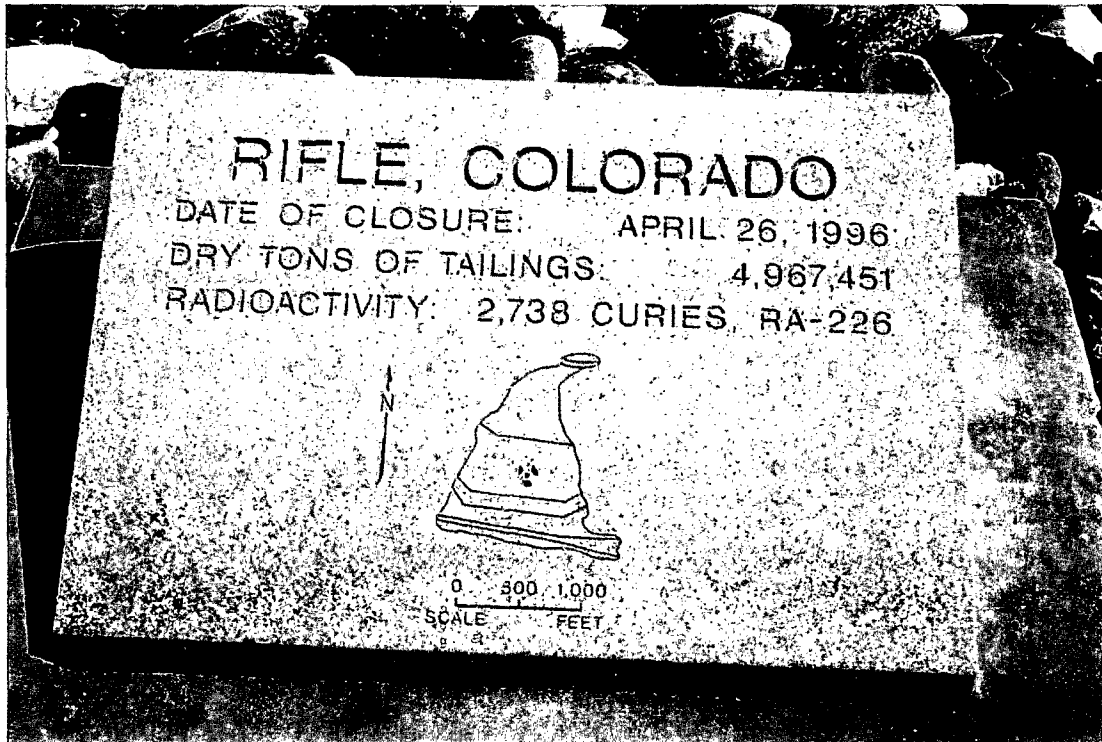
RFL 8/2006. PL-1. Site marker #1 on top of the disposal cell.

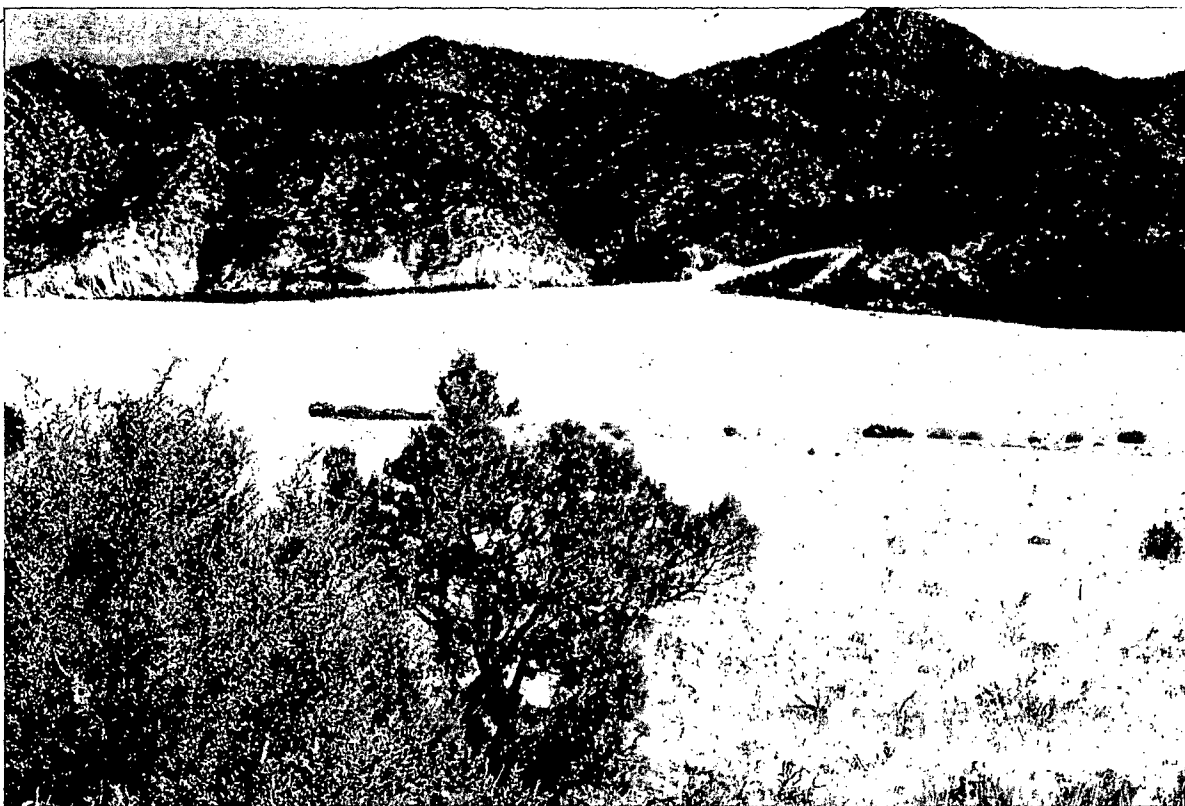
*RFL 8/2006. PL-4. Disposal cell.*

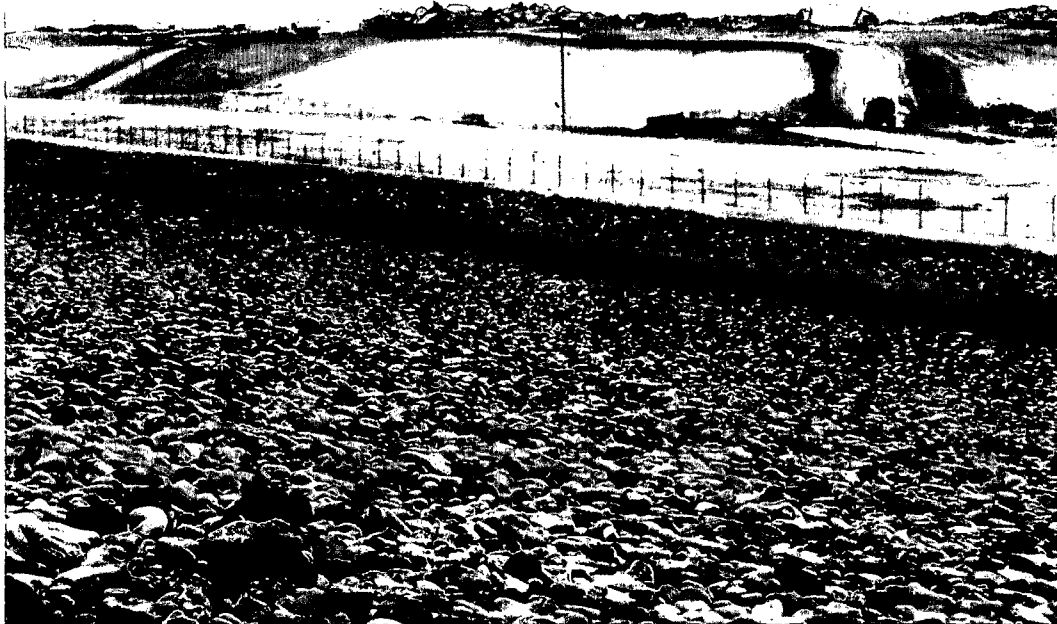
*SLC 3/2006. PL-1. Energy Solutions active waste disposal operations directly west of the site.*

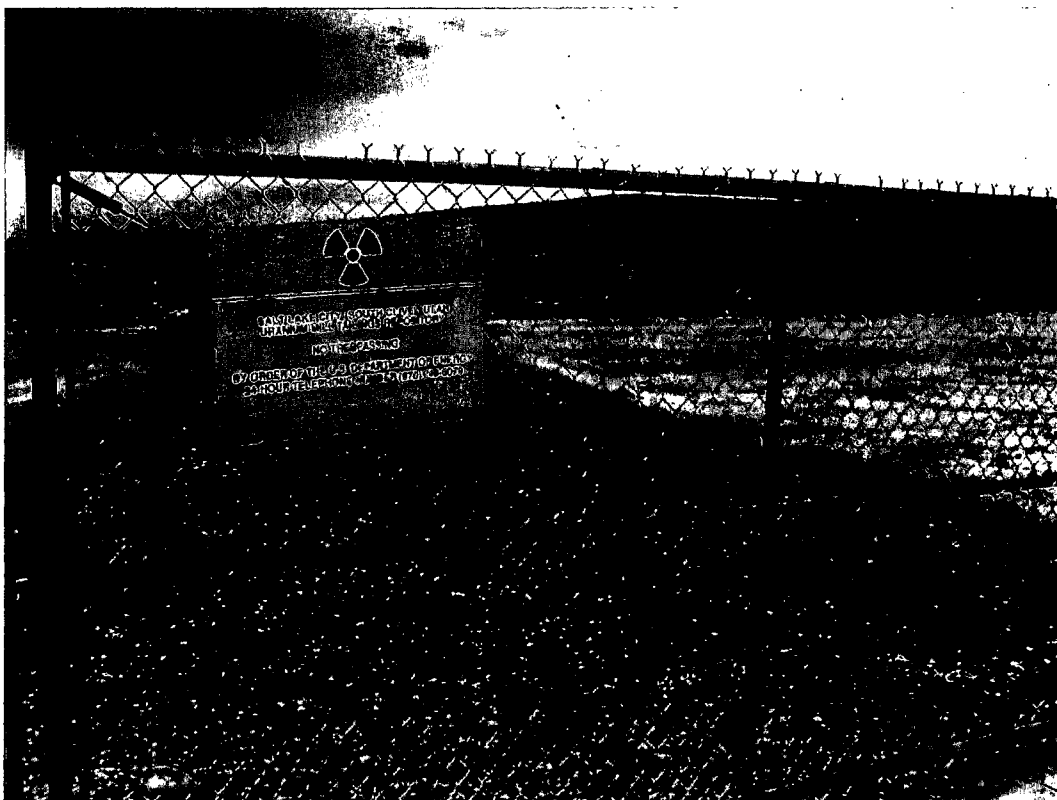
The entrance sign, located on the current entrance gate, was in excellent condition (PL-2). All perimeter signs were present and in good condition.

*SLC 3/2006. PL-2. Entrance sign and gate; disposal cell in background.*

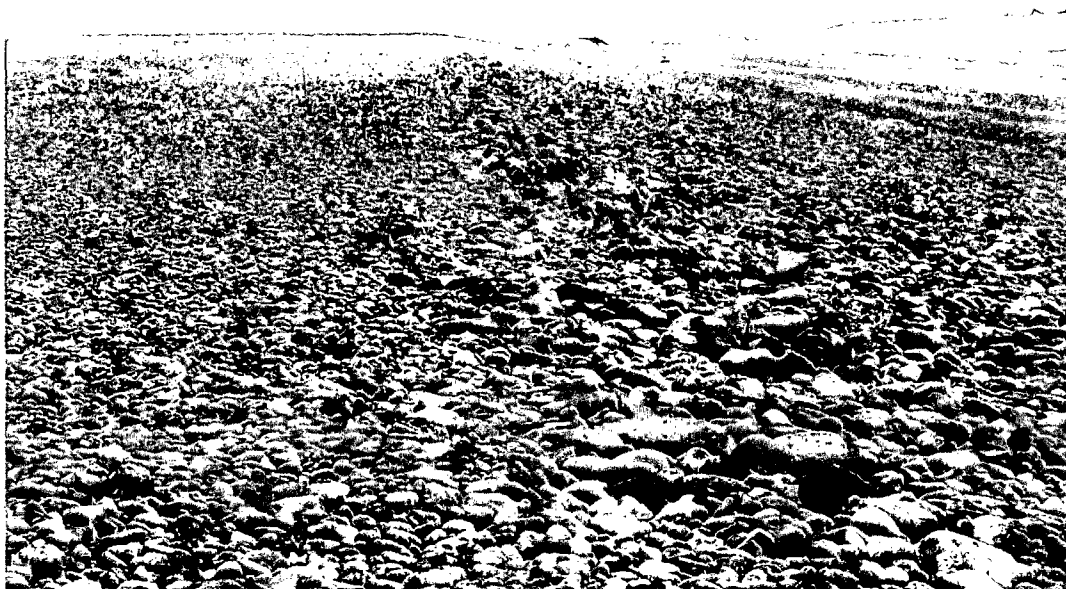
*SLC 3/2006. PL-3. Western portion of the disposal cell top showing west side slope of the cell.*

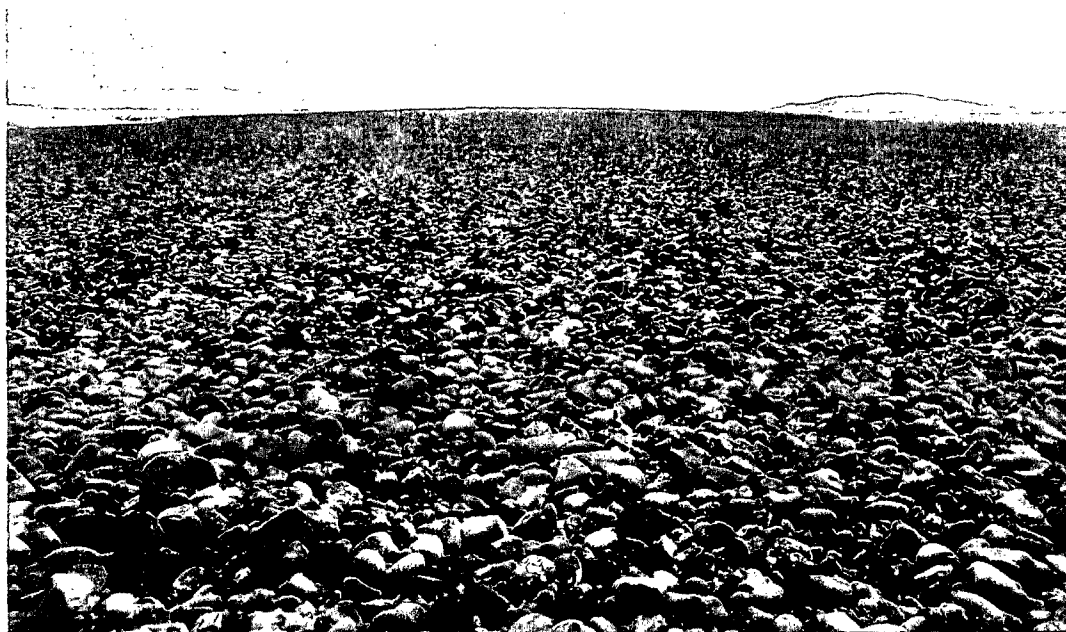
*SLC 3/2006. PL-4. View south from SM2 attempting to show slight depressions in center portion of the disposal cell top.*

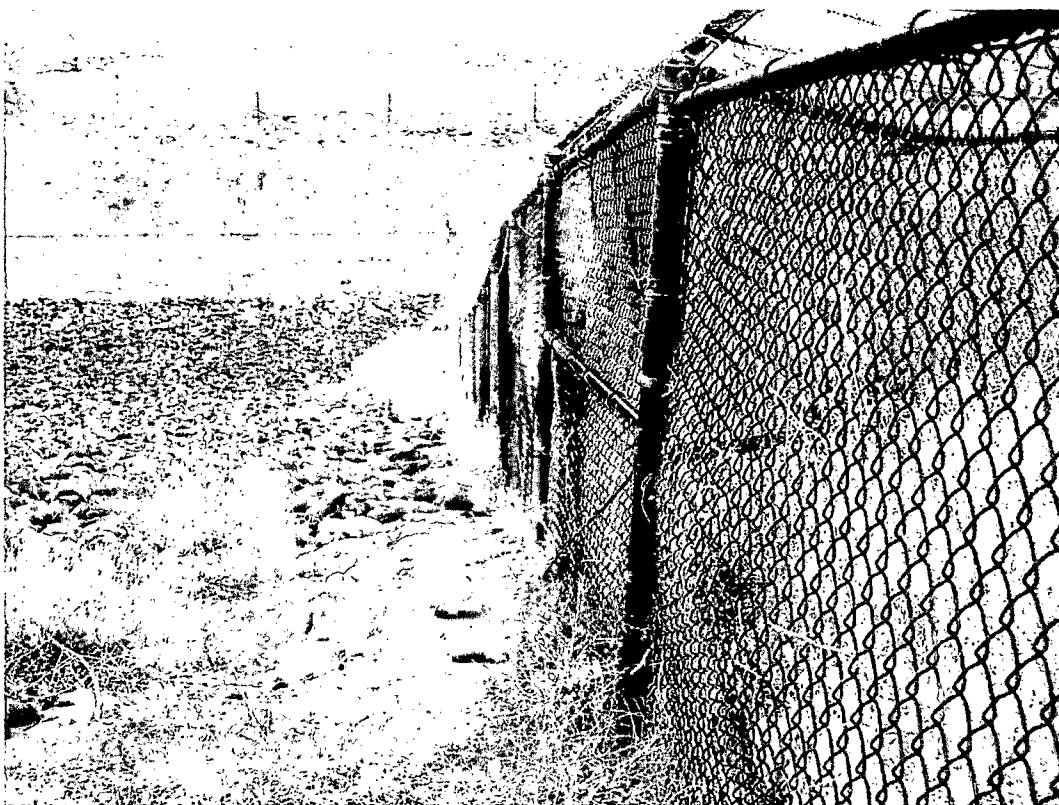
*SHP 6/2006. PL-1. Trash and tumbleweeds along southwestern portion of the perimeter fence.*

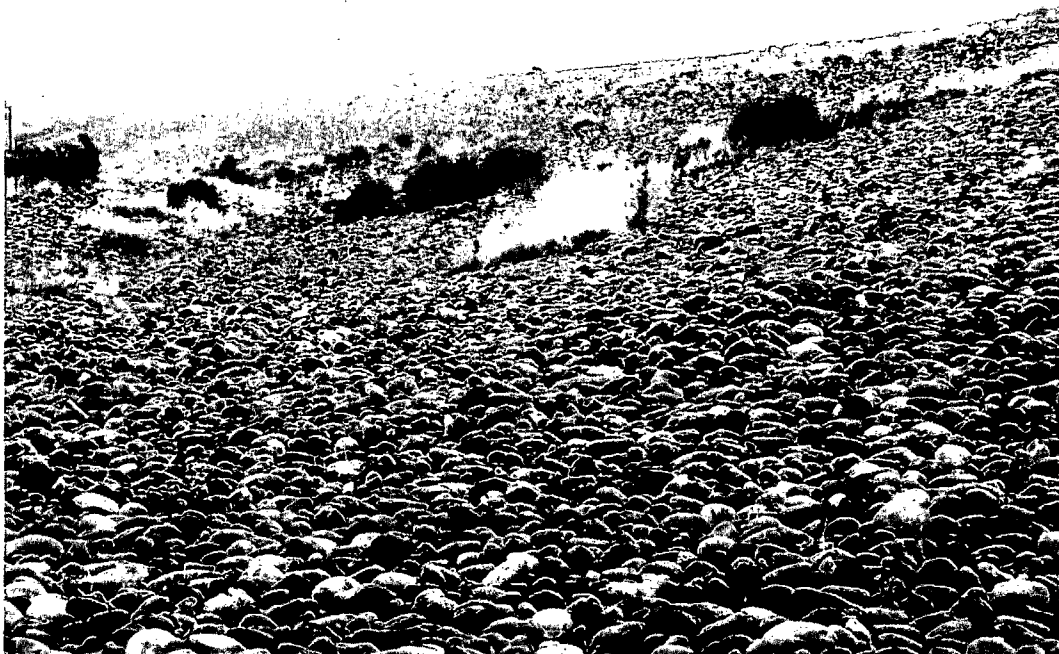
*SHP 6/2006. PL-2. Vegetation on west side of cell.*

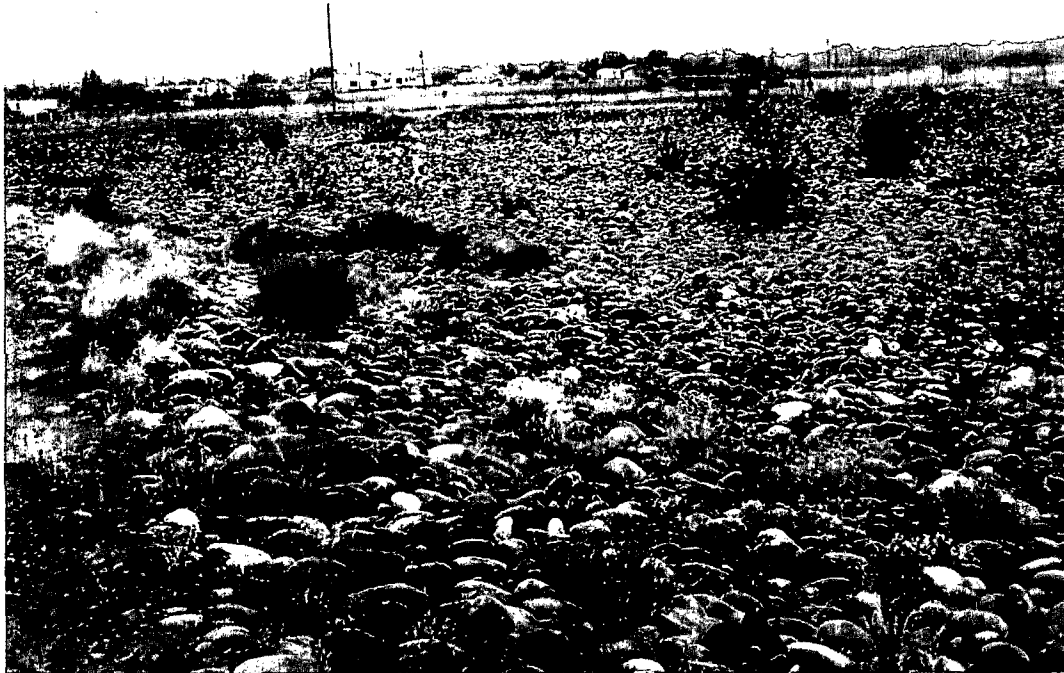
*SHP 6/2006. PL-3. Vegetation in outflow area.*

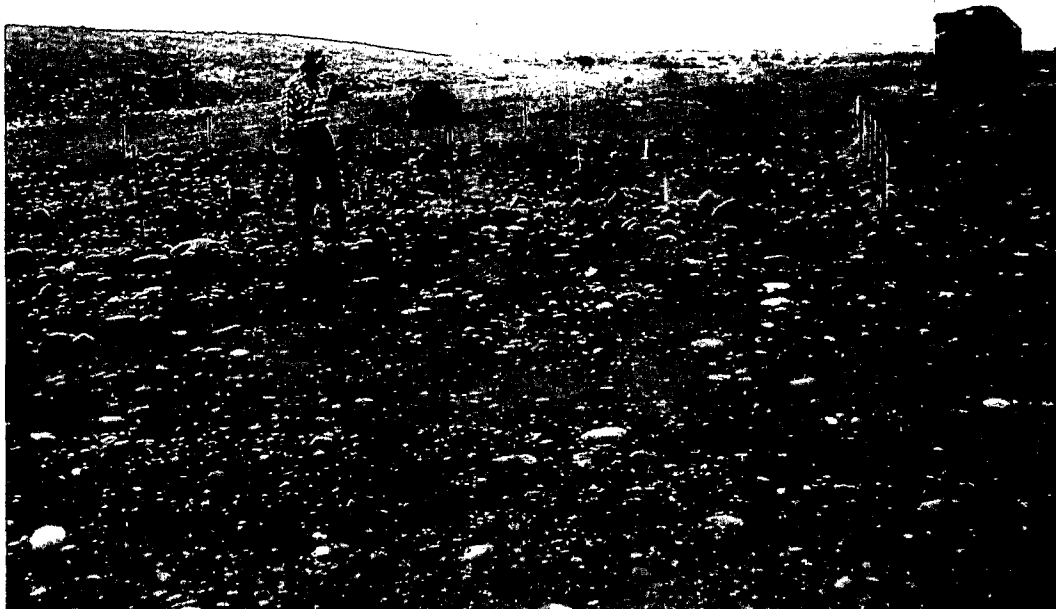
*SHP 6/2006. PL-5. Southern phytoremediation test plot.*

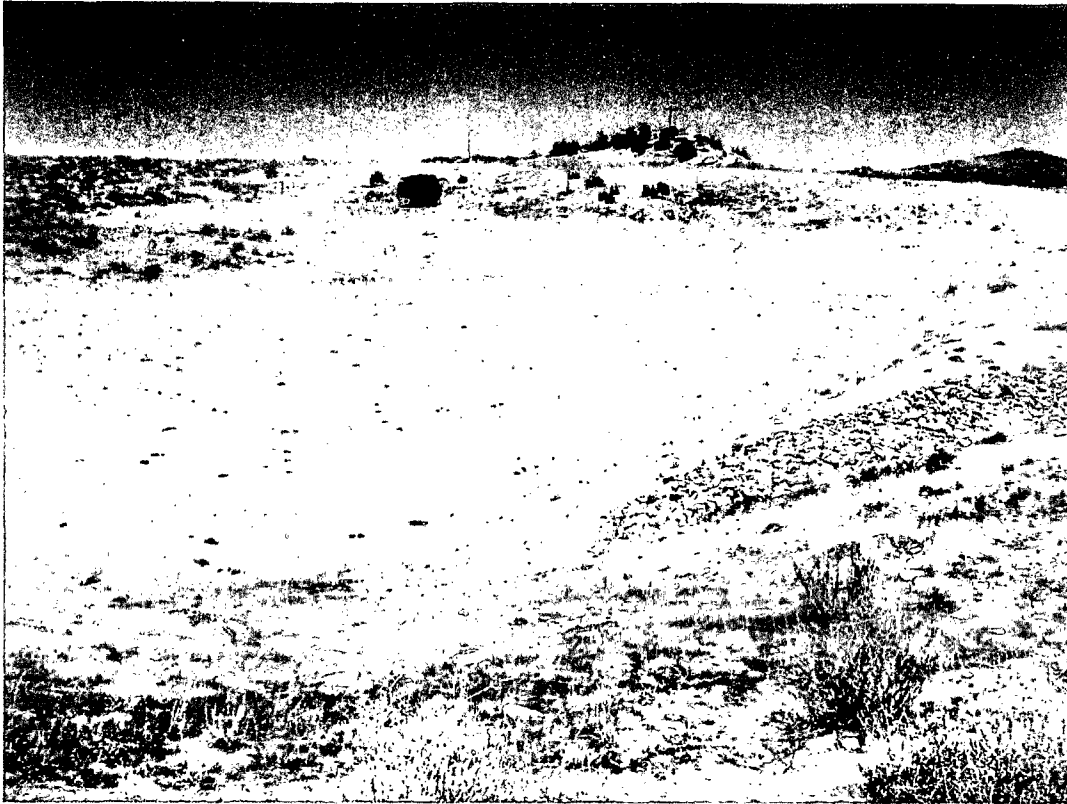
*SRK 4/2006. PL-1. Dry retention pond.*

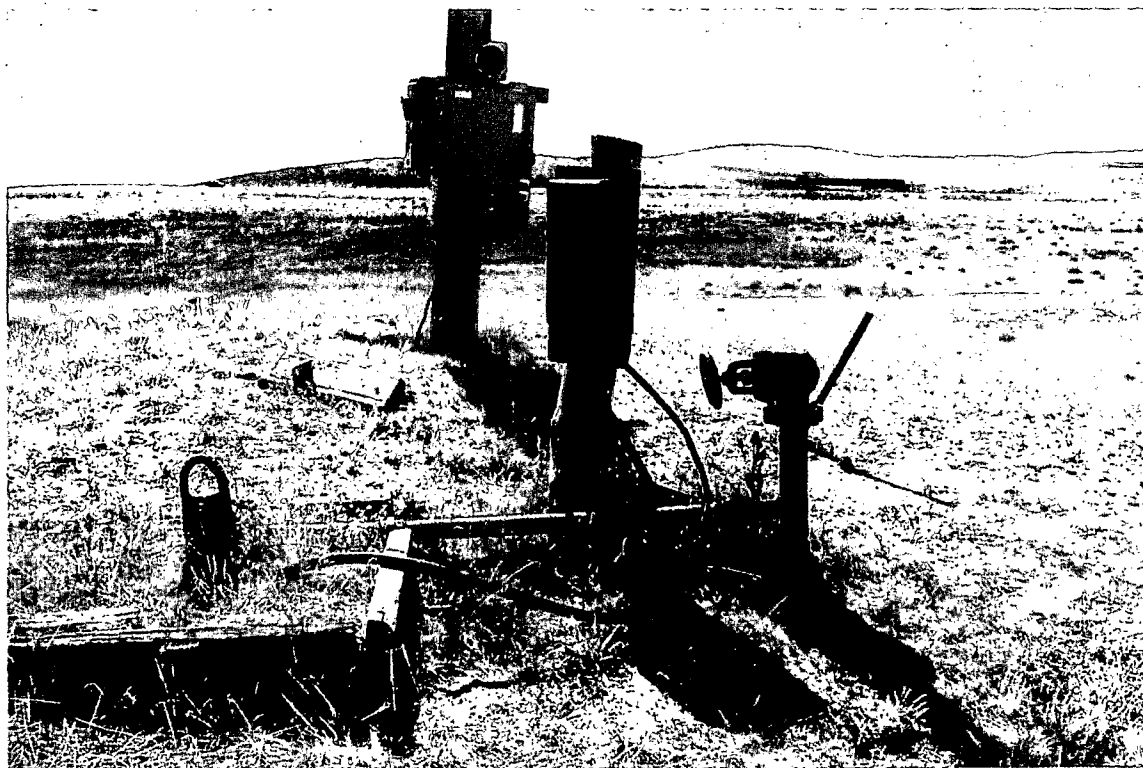
SPK 6/2006. PL-2. Water supply well and PP&L power pole.

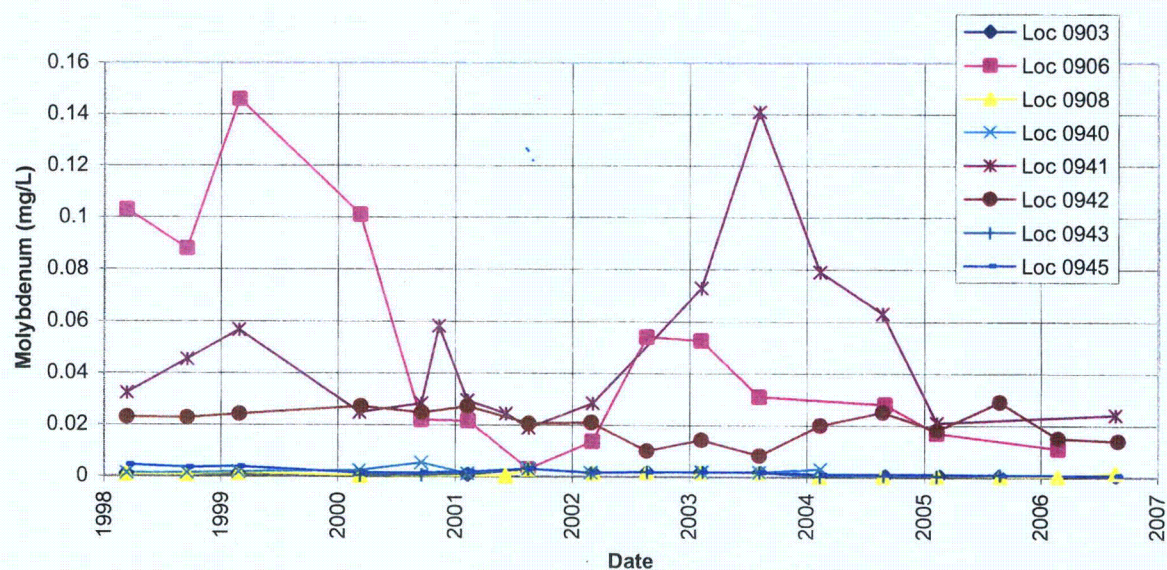
Figure 19-2. Time-Concentration Plots of Molybdenum in Ground Water at the Tuba City, Arizona, Disposal Site

Molybdenum concentrations in ground water were below the MCL (0.01 mg/L) in 2006 in all wells (Figure 19-2). No significant variation from recent results occurred. Concentrations in onsite downgradient wells MW-0906 and MW-0941 fluctuated substantially since 1998; both above and below the MCL. Reported concentrations in these two wells have ranged from 0.01 mg/L to 0.15 mg/L in well MW-0906 and from 0.02 mg/L to 0.14 mg/L in well MW-0941. Overall, concentrations in well MW-0906 display a decreasing trend, whereas concentrations in well MW-0941 display a relatively flat trend line with the exception of an apparent anomalous spike that occurred between 2003 and 2005. The remaining locations have historically shown concentrations below 0.03 mg/L, and the upgradient background well MW-0945 and the off-site downgradient well MW-0903 continue at or near the detection limit.

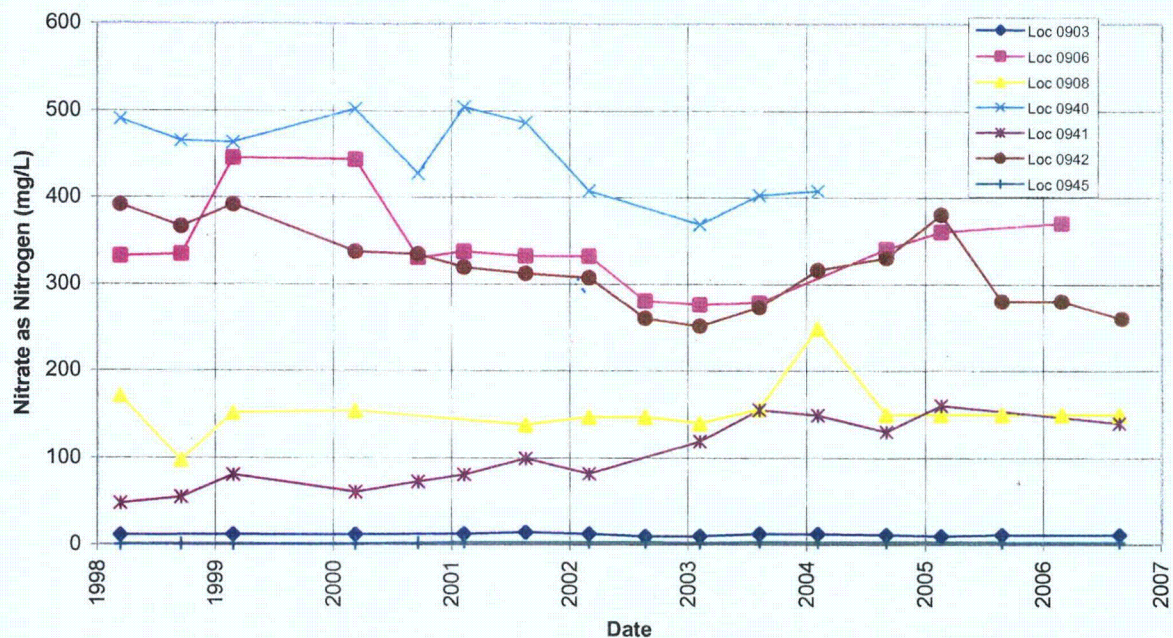
Figure 19-3. Time-Concentration Plots of Nitrate (as N) in Ground Water at the Tuba City, Arizona, Disposal Site

Nitrate concentrations in ground water exceeded the MCL (10 mg/L) in 2006, by an order of magnitude or more, in all onsite monitor wells except the upgradient background well MW-0945 (Figure 19-3). No significant variation from recent results occurred. Historically concentrations in the off-site downgradient well MW-0903 have been close to the MCL and continue this trend in 2006. Concentrations in all wells have remained relatively consistent, except in MW-0941 where a slight upward trend seems apparent. Nitrate concentrations have varied considerably from well to well since 1998.
