Subject: 2006 Annual Site Inspection and Monitoring Report for UMTRCA Title I Disposal Sites

# 2006 Annual Site Inspection and Monitoring Report for Uranium Mill Tailings Radiation Control Act Title I Disposal Sites

Work Performed by S.M. Stoller Corporation under DOE Contract No. DE-AC01-02GJ79491  
for the U.S. Department of Energy Office of Legacy Management, Grand Junction, Colorado

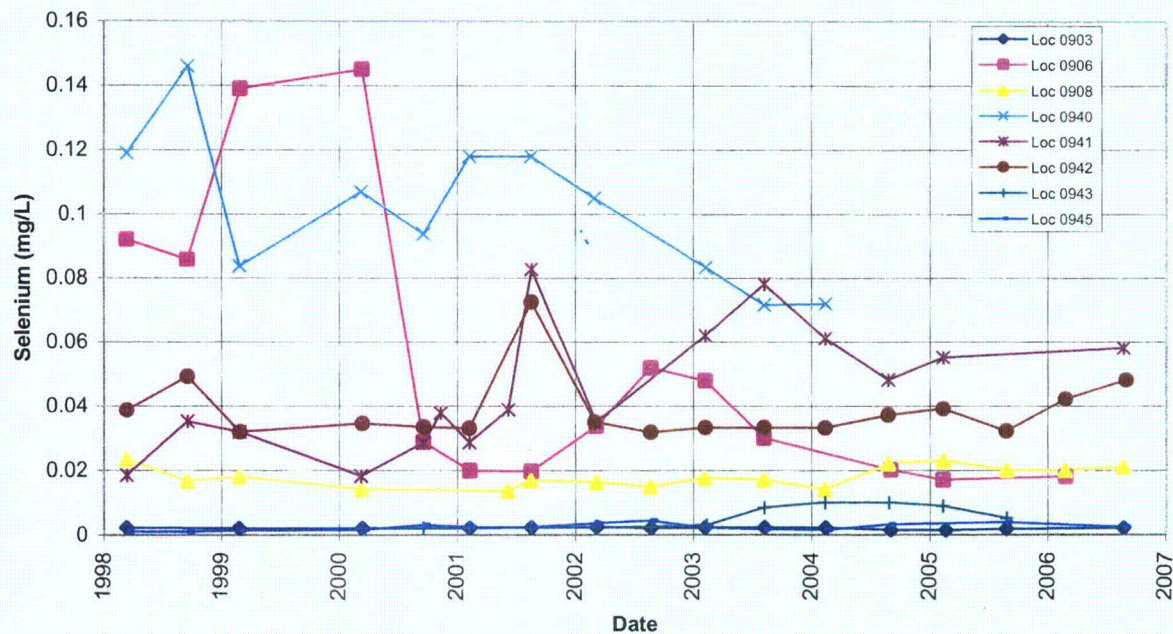
Figure 19-4. Time-Concentration Plots of Selenium in Ground Water at the Tuba City, Arizona, Disposal Site

Selenium concentrations in ground water exceeded the MCL (0.01 mg/L) in 2006 in all wells except the upgradient background well MW-0945 and the off-site downgradient well MW-0903 (Figure 19-4). No significant variation from recent results occurred. Concentrations have remained fairly constant over time in two wells MW-0908 and MW-0942 (with one exception); the remaining on-site wells have fluctuated substantially since 1998.

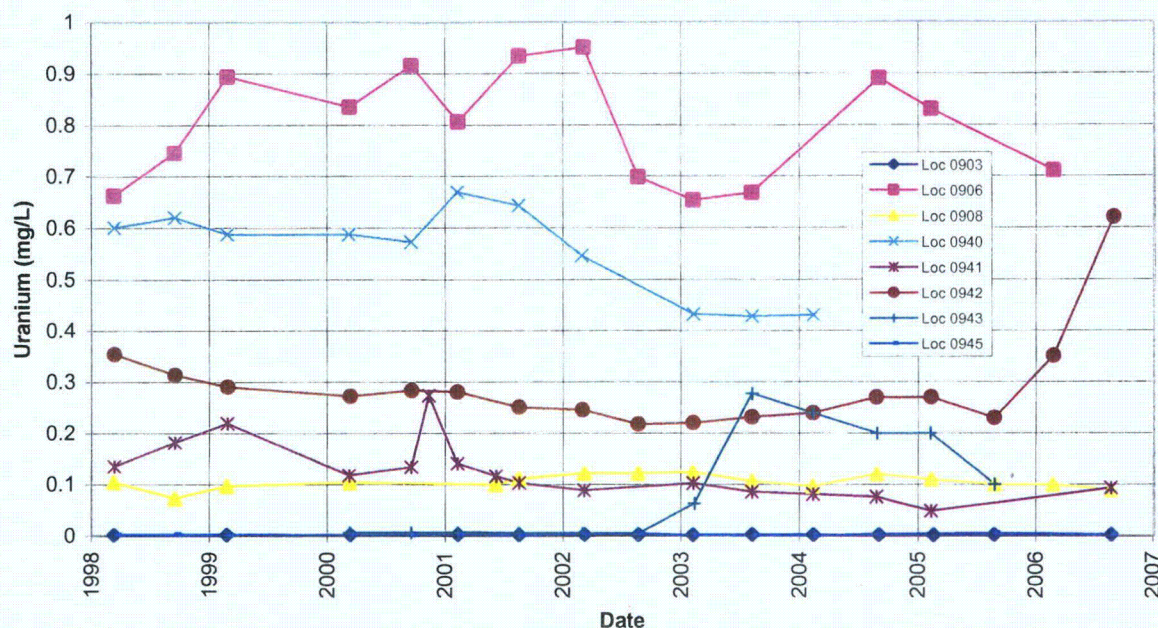
Figure 19-5. Time-Concentration Plots of Uranium in Ground Water at the Tuba City, Arizona, Disposal Site

Uranium concentrations in ground water exceeded the MCL (0.044 mg/L) in 2006 from all wells except the upgradient background well MW-0945 and the off-site downgradient well MW-0903 (Figure 19-5). No significant variation from recent results occurred, with the exception of well MW-0942 where results increased from 0.23 mg/L in August 2005 to 0.62 mg/L in August 2006. This recent increase is historically the highest concentration reported from this well; although, onsite downgradient well MW-0906 continues to report the highest concentrations that since 1998 have fluctuated between 0.65 mg/L to 0.95 mg/L.

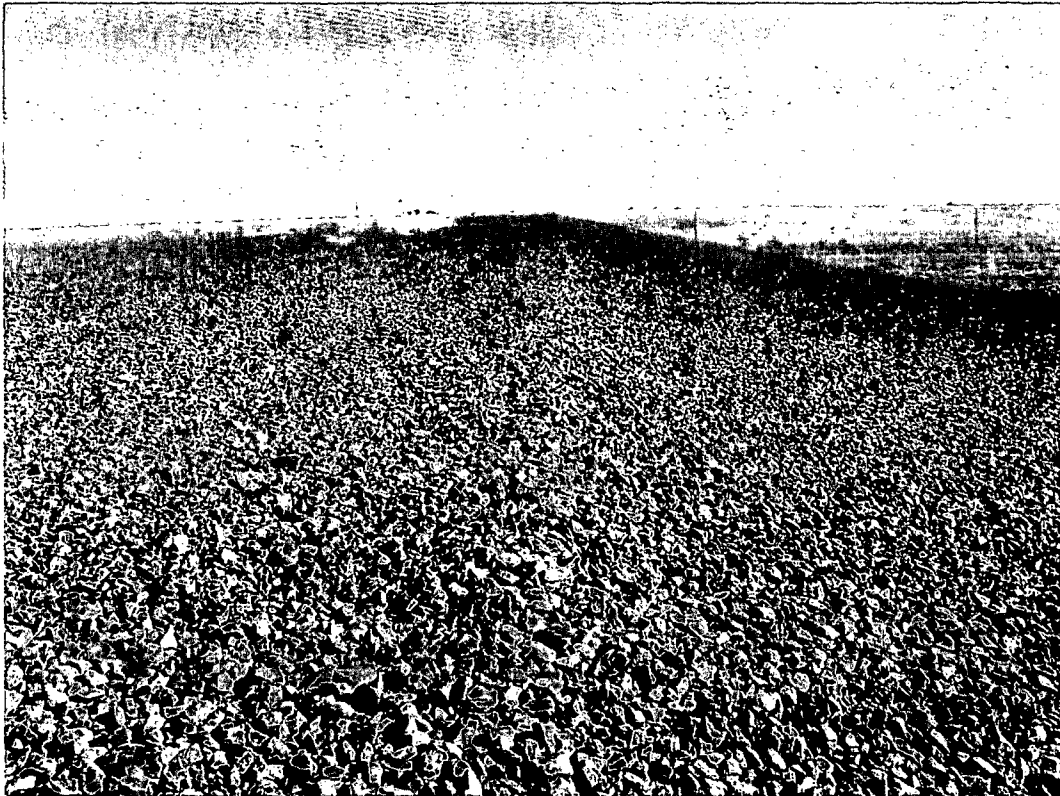
*TUB 4/2006. PL-1. View north along the crest of the east side slope.*

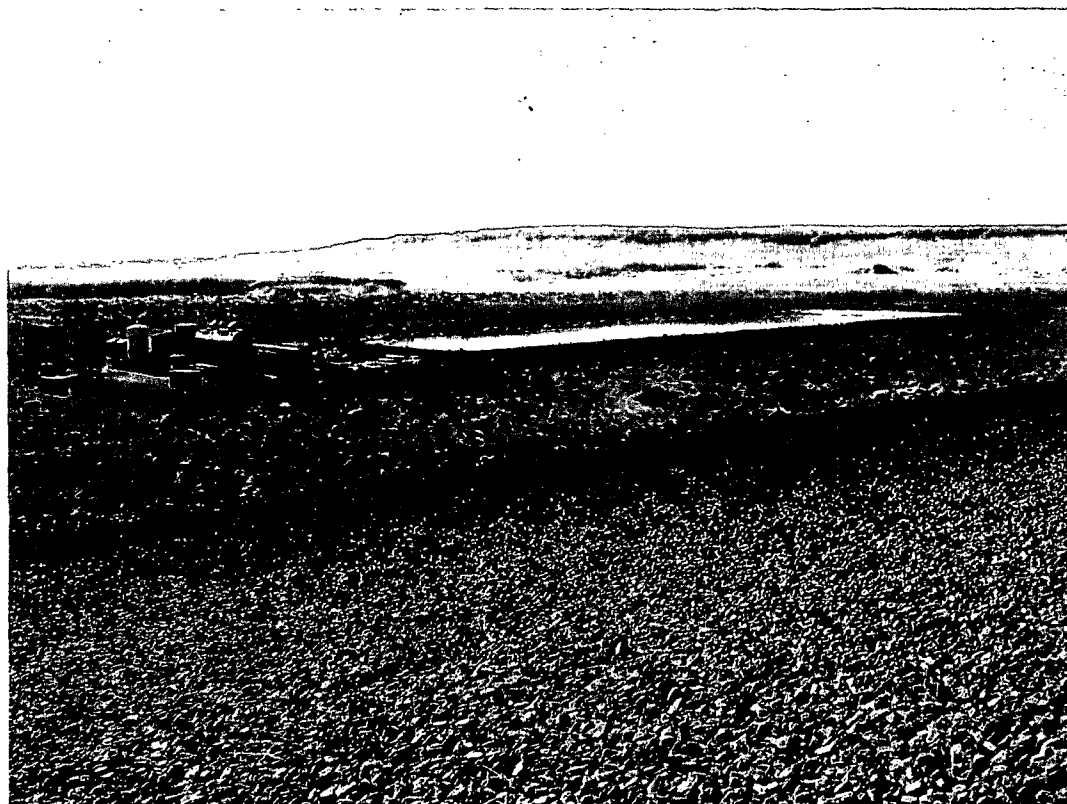
*TUB 4/2006. PL-4. Ground water treatment plant and evaporation pond east of the disposal cell.*

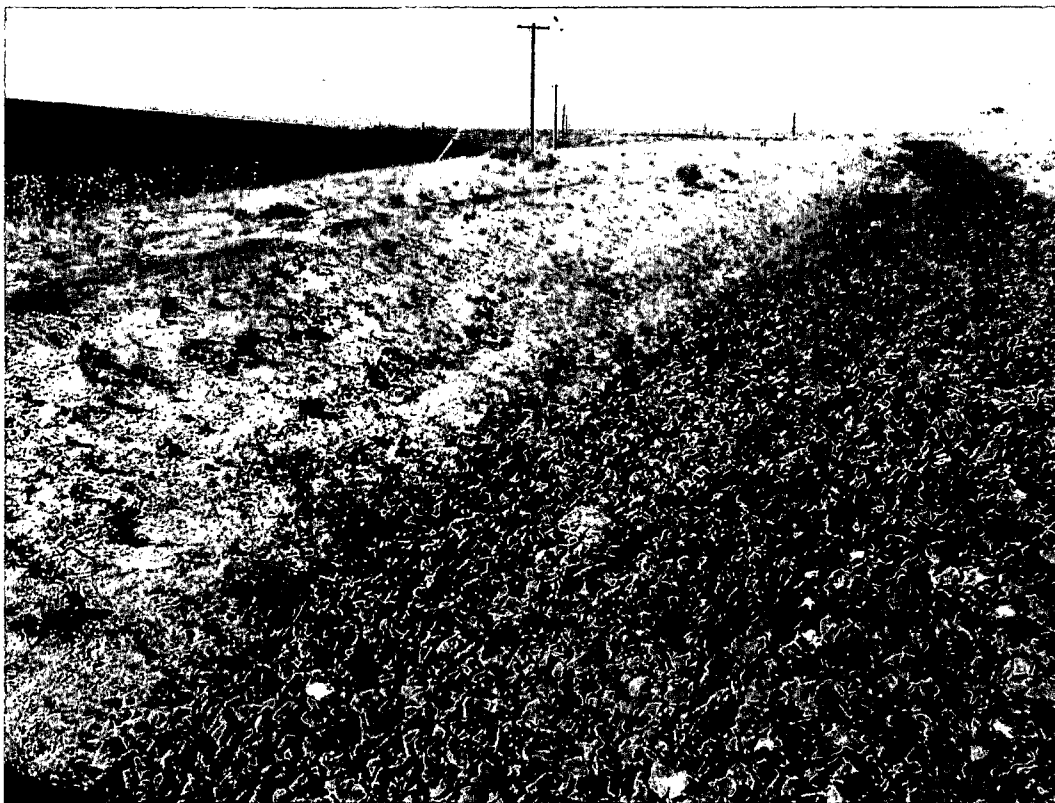
*TUB 4/2006. PL-5. Sand accumulation and vegetation on the south bank of the diversion channel (reference photograph).*
