Operating Experience Feedback Report – Solenoid-Operated Valve Problems

Commercial Power Reactors

U.S. Nuclear Regulatory Commission

Office for Analysis and Evaluation of Operational Data

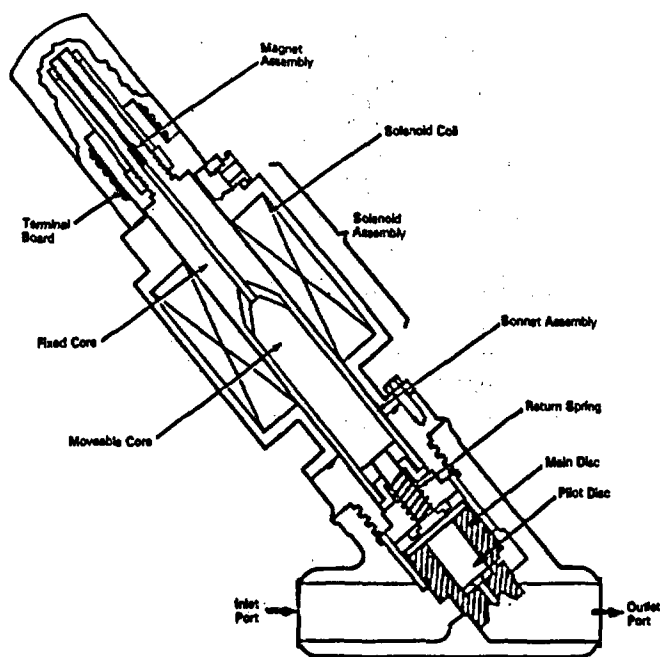
Figure 4 Schematic drawing of a Target Rock pilot-assisted solenoid-operated valve

On the basis of searches of the NRC data bases, at least six plants have observed inadvertent operation of safety-related Target Rock angle-type SOVs as a result of improper valve orientation. As shown in Figure 4, upstream fluid pressure at the inlet port of the angle-type SOV assists valve orientation; upstream fluid pressure at the inlet port of the angle-type SOV assists valve disc seating. However, many licensees also have learned from their own operating experiences and from followup discussions with the SOV manufacturer, that several different models of Target Rock angle-type SOVs used for isolation purposes are "unidirectional." That is, they will experience undesired seat lifting when the backpressure (pressure at the outlet port shown in Figure 4) is only 2 to 5 psi higher than the upstream or inlet pressure. As noted in Target Rock Operation Manual TRP 1571 J (Ref. 42), the manufacturer has been aware of this problem at nuclear plants since 1978. However, in the late 1970's, Target Rock developed an SOV for use as a bidirectional isolation valve (would not open inadvertently as a result of high backpressures). Target Rock considered the inadvertent seat lifting to be an architect engineer/licensee "application problem"—not an SOV problem.* The issue of unidirectional isolation SOVs is addressed in some, but not all, Target Rock SOV users manuals. For example, Reference 43 noted that the unidirectional qualities of the Target Rock angle-type SOVs are described in Target Rock Manual TRP 1571J (Ref. 42), which states that

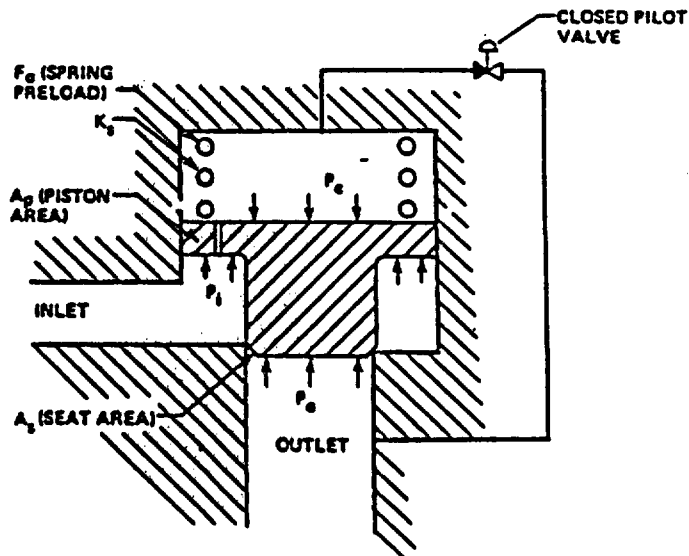
Figure 3. Closed Valve Loadings

Before the analysis can proceed, it is necessary to define what constitutes a severe pressure transient that would be of concern. To do this, we refer to Figure 3, which shows schematically a fully seated hydraulic-assisted, pilot-operated globe valve.

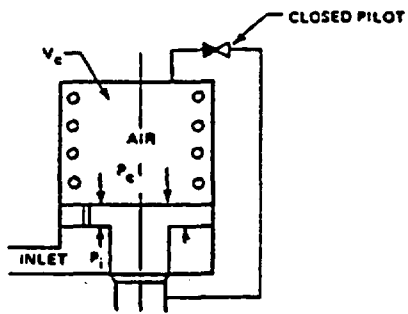
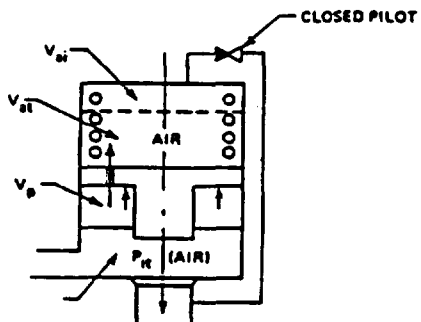
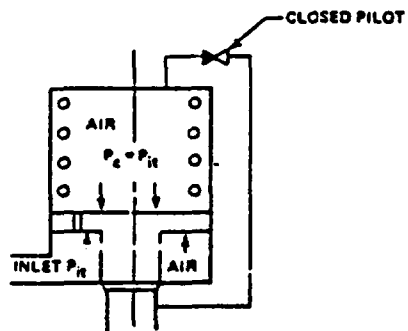
The valve is air-filled and is suddenly exposed to higher pressure air. Figures 4a, 4b, and 4c illustrate what would happen if the valve spuriously opens.

Let V_c be the volume of the control chamber. Therefore, at the force reversal point as shown in Figure 4b,

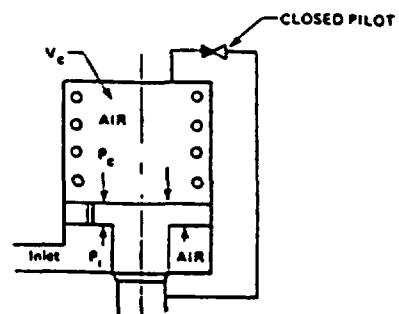
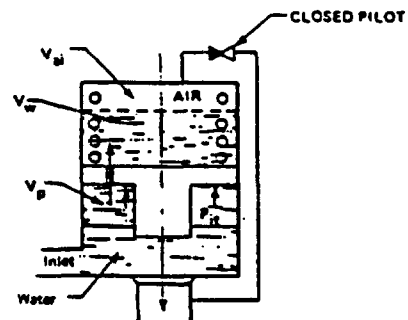
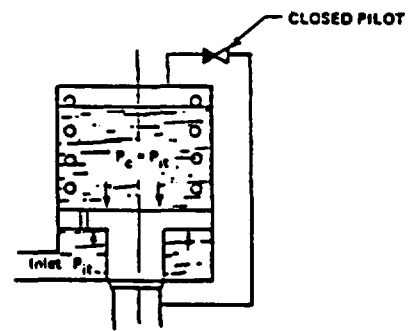
In the water-to-air transient, the valve is air-filled and is suddenly exposed to a step-up higher pressure water. Figures 5a, 5b, and 5c illustrate the valve dynamics. As in the air-to-air case, Figure 5b corresponds to the force reversal point. At this point, the following relationships exist:
