**U.S. Department of Energy
Office of Legacy Management**

2004 Annual Site Inspection and Monitoring Report for Uranium Mill Tailings Radiation Control Act Title I Disposal Sites

December 2004

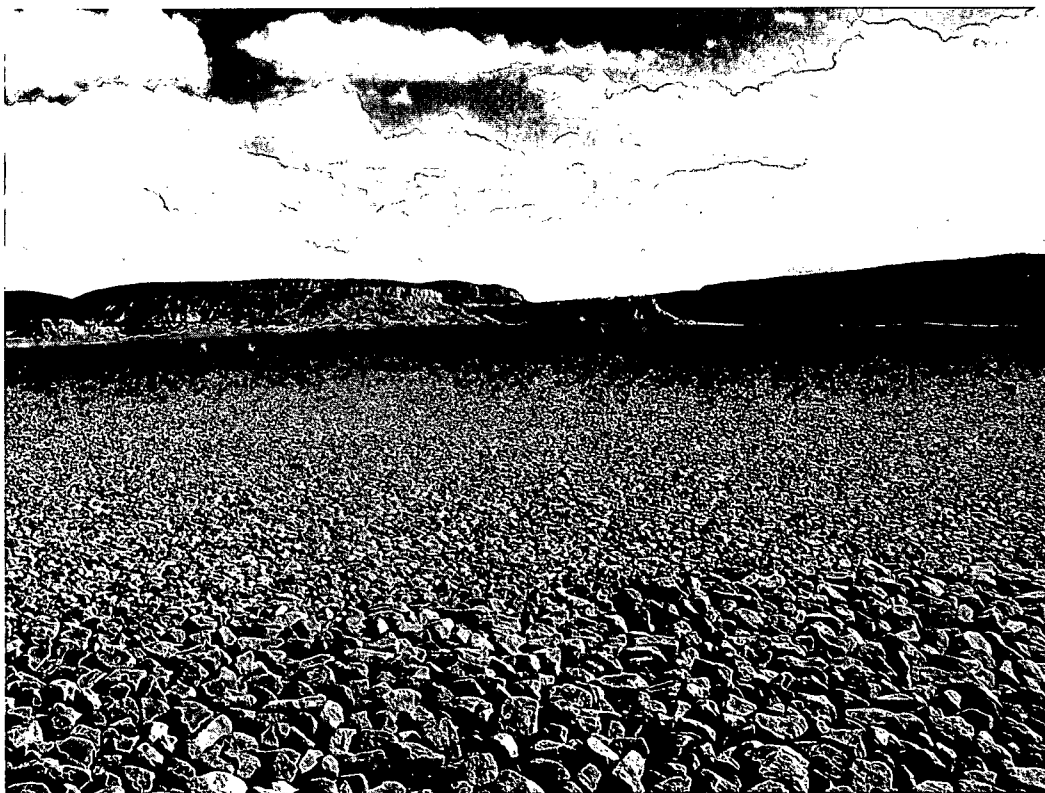
AMB 9/2004. PL-3. View across the disposal cell top. The foreground shows the transition between the smaller top slope riprap and the larger side slope riprap.

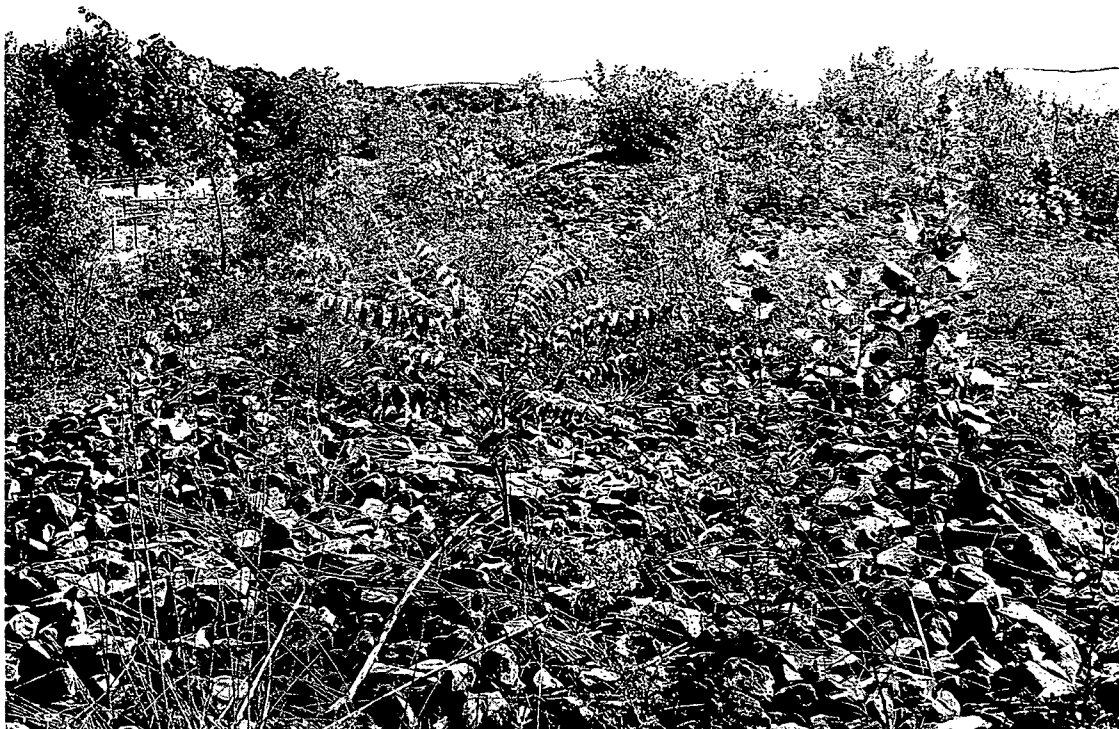
BUR 9/2004. PL-1. Vegetation establishing on top of the disposal cell.

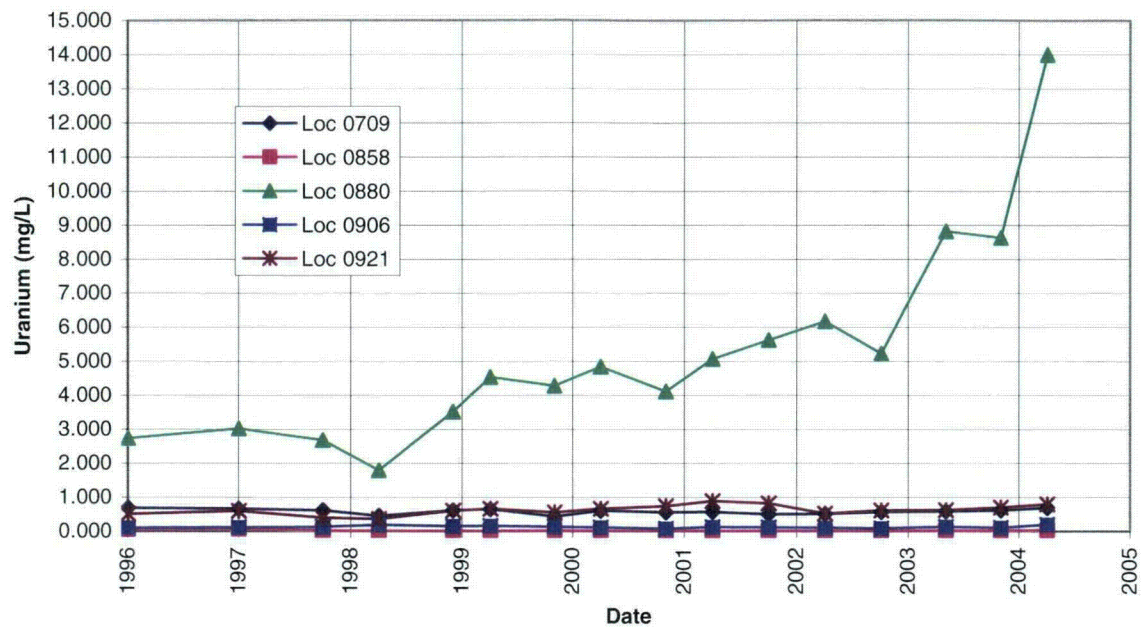
Figure 5-5. Uranium in Ground Water at Cell Performance Monitoring Locations at the Falls City, Texas, Disposal Site

Uranium concentrations in ground water in the vicinity of the disposal cell are consistent with the previous sampling event. The concentration in monitor well MW-0880 continues to be substantially greater than the other wells and continues to increase (Figure 5-5). The increase may be an indication of seepage from the disposal cell, as expected; there is no risk, however, because ground water is not used in the area. As shown on Figure 5-6, uranium in ground water in the compliance monitoring network has varied substantially in two wells (MW-0891 and MW-0924) since 1997 and exceeded the maximum concentration limit of 0.044 mg/L in four wells (MW-0886, MW-0891, MW-0924, and MW-0963). The increasing trend in uranium concentration in MW-0924 cannot be attributed to degradation of the cell because the wells between it and the cell continue to have low concentrations.

5C Monitoring for the designated suite of analytes in ground water does not appear to be an effective means to assess the initial performance of the disposal cell because the area is affected by widespread ambient contamination (naturally occurring uranium mineralization) and uranium exploration and mining activities. Ground water in the uppermost aquifer at the site is in contact with the naturally occurring uranium deposits and associated minerals, and water that might leach from the disposal cell, either through transient drainage or percolation of precipitation through the cover, will be chemically similar and perhaps indistinguishable from ambient and otherwise impacted conditions. DOE is evaluating the ground water monitoring program at the site to determine if protectiveness can be demonstrated with reduced monitoring requirements, such as sampling fewer wells, analyzing fewer constituents, and sampling the cell performance wells annually instead of every 6 months. If so, DOE will revise the LTSP for NRC concurrence. The revised plan would also recommend eliminating pH as an indicator for cell performance.

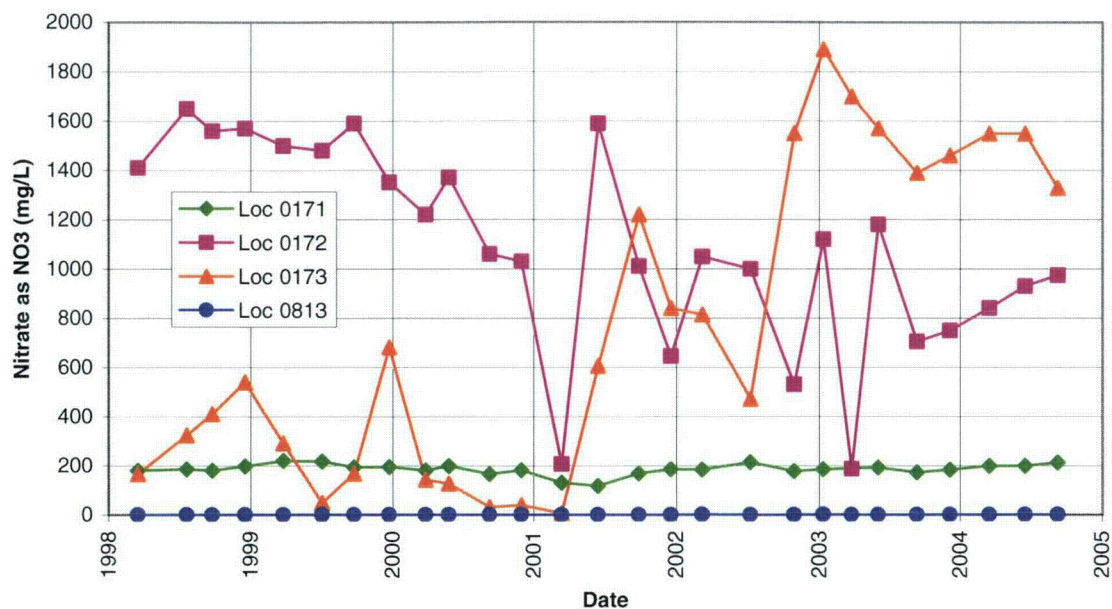
Figure 7-2. Time-Concentration Plots of Nitrate (as NO₃) in Ground Water at the Green River, Utah, Disposal Site

Ground Water Quality Monitoring—Concentrations of nitrate in ground water continued above the proposed concentration limits (Table 7-2) except in well MW-0813, where values were very near the laboratory detection limit (Figure 7-2). Nitrate concentrations fluctuated slightly in well MW-0171, and there was considerable variation in the values for wells MW-0172 and MW-0173.

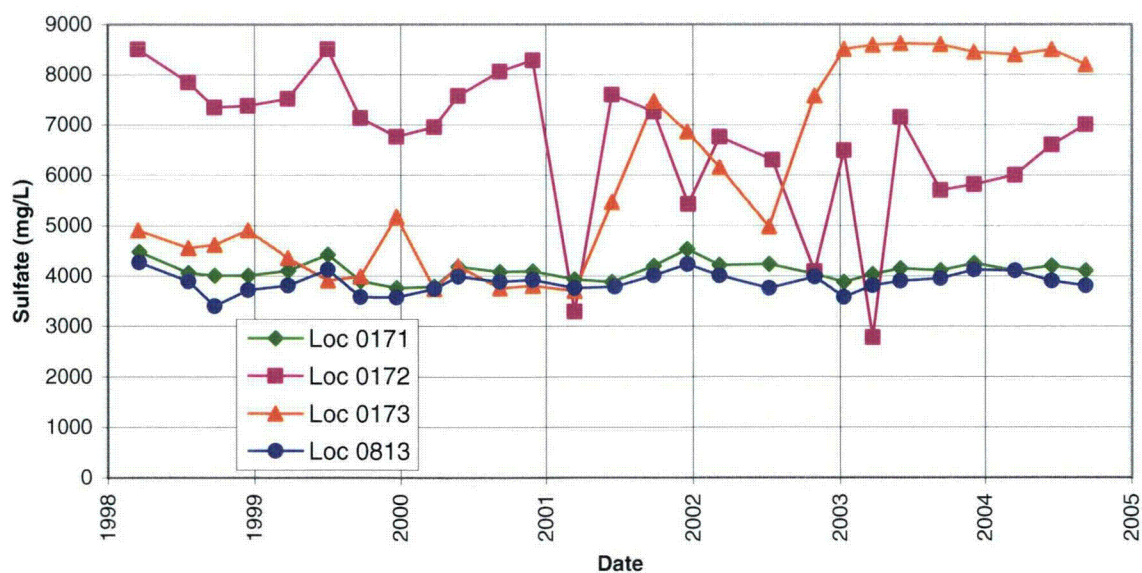
Figure 7-3. Time-Concentration Plots of Sulfate in Ground Water at the Green River, Utah, Disposal Site

Sulfate concentrations in ground water have remained relatively constant in wells MW-0171 and MW-0813 since the disposal cell was constructed (Figure 7-3). Concentrations in wells MW-0172 and MW-0173 have fluctuated substantially since 1998. Concentrations in 2004 continued above the proposed concentration limits (Table 7-2) in wells MW-0171, MW-0172, and MW-0173. Sulfate concentration was below the proposed limit in well MW-0813.

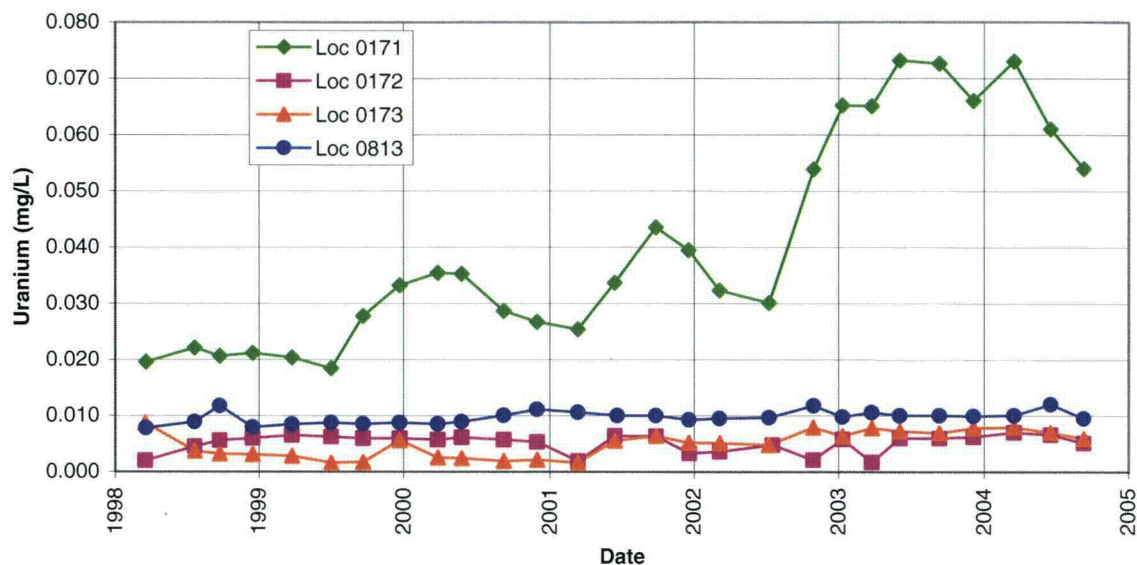
Figure 7-4. Time-Concentration Plots of Uranium in Ground Water at the Green River, Utah, Disposal Site

Uranium concentrations in ground water were below the proposed concentration limits (Table 7-2) in all four point-of-compliance wells from 1995 until 2002, when levels exceeded the maximum concentration limit in well MW-0171 (Figure 7-4). The increasing uranium concentration in MW-0171 may be an indication of seepage from the disposal cell, as expected on the basis of the cell design and construction. Concentrations in the other monitor wells remain fairly constant and at or below 0.010 milligrams per liter.

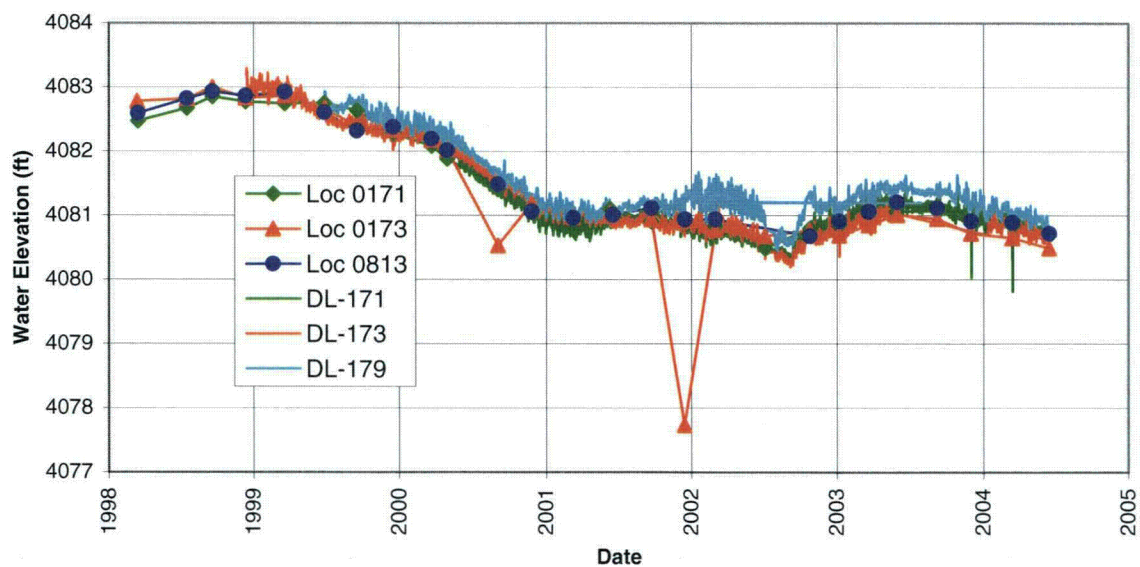
Figure 7-5. Ground Water Elevations at the Green River, Utah, Disposal Site

Ground Water Level Monitoring—Ground water levels in several monitor wells adjacent to the disposal cell have been measured manually since 1991, and continually with down-hole dataloggers since 1999. Well hydrographs indicate an overall decrease in the ground water elevation of approximately 2 feet since 1999 (Figure 7-5).

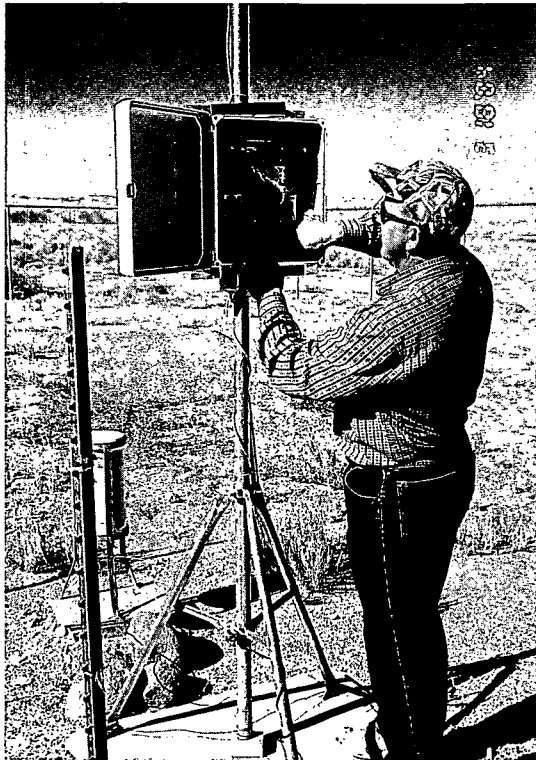
DOE installed a precipitation monitoring station in the west corner of the secured portion of the site in September 2001 to evaluate the relationship between site precipitation and ground water elevations. The data storage module was exchanged at the time of the inspection (PL-2). The station was in excellent condition.

GRN 3/2004. PL-2. Exchange of the data storage module at the disposal site precipitation gage.

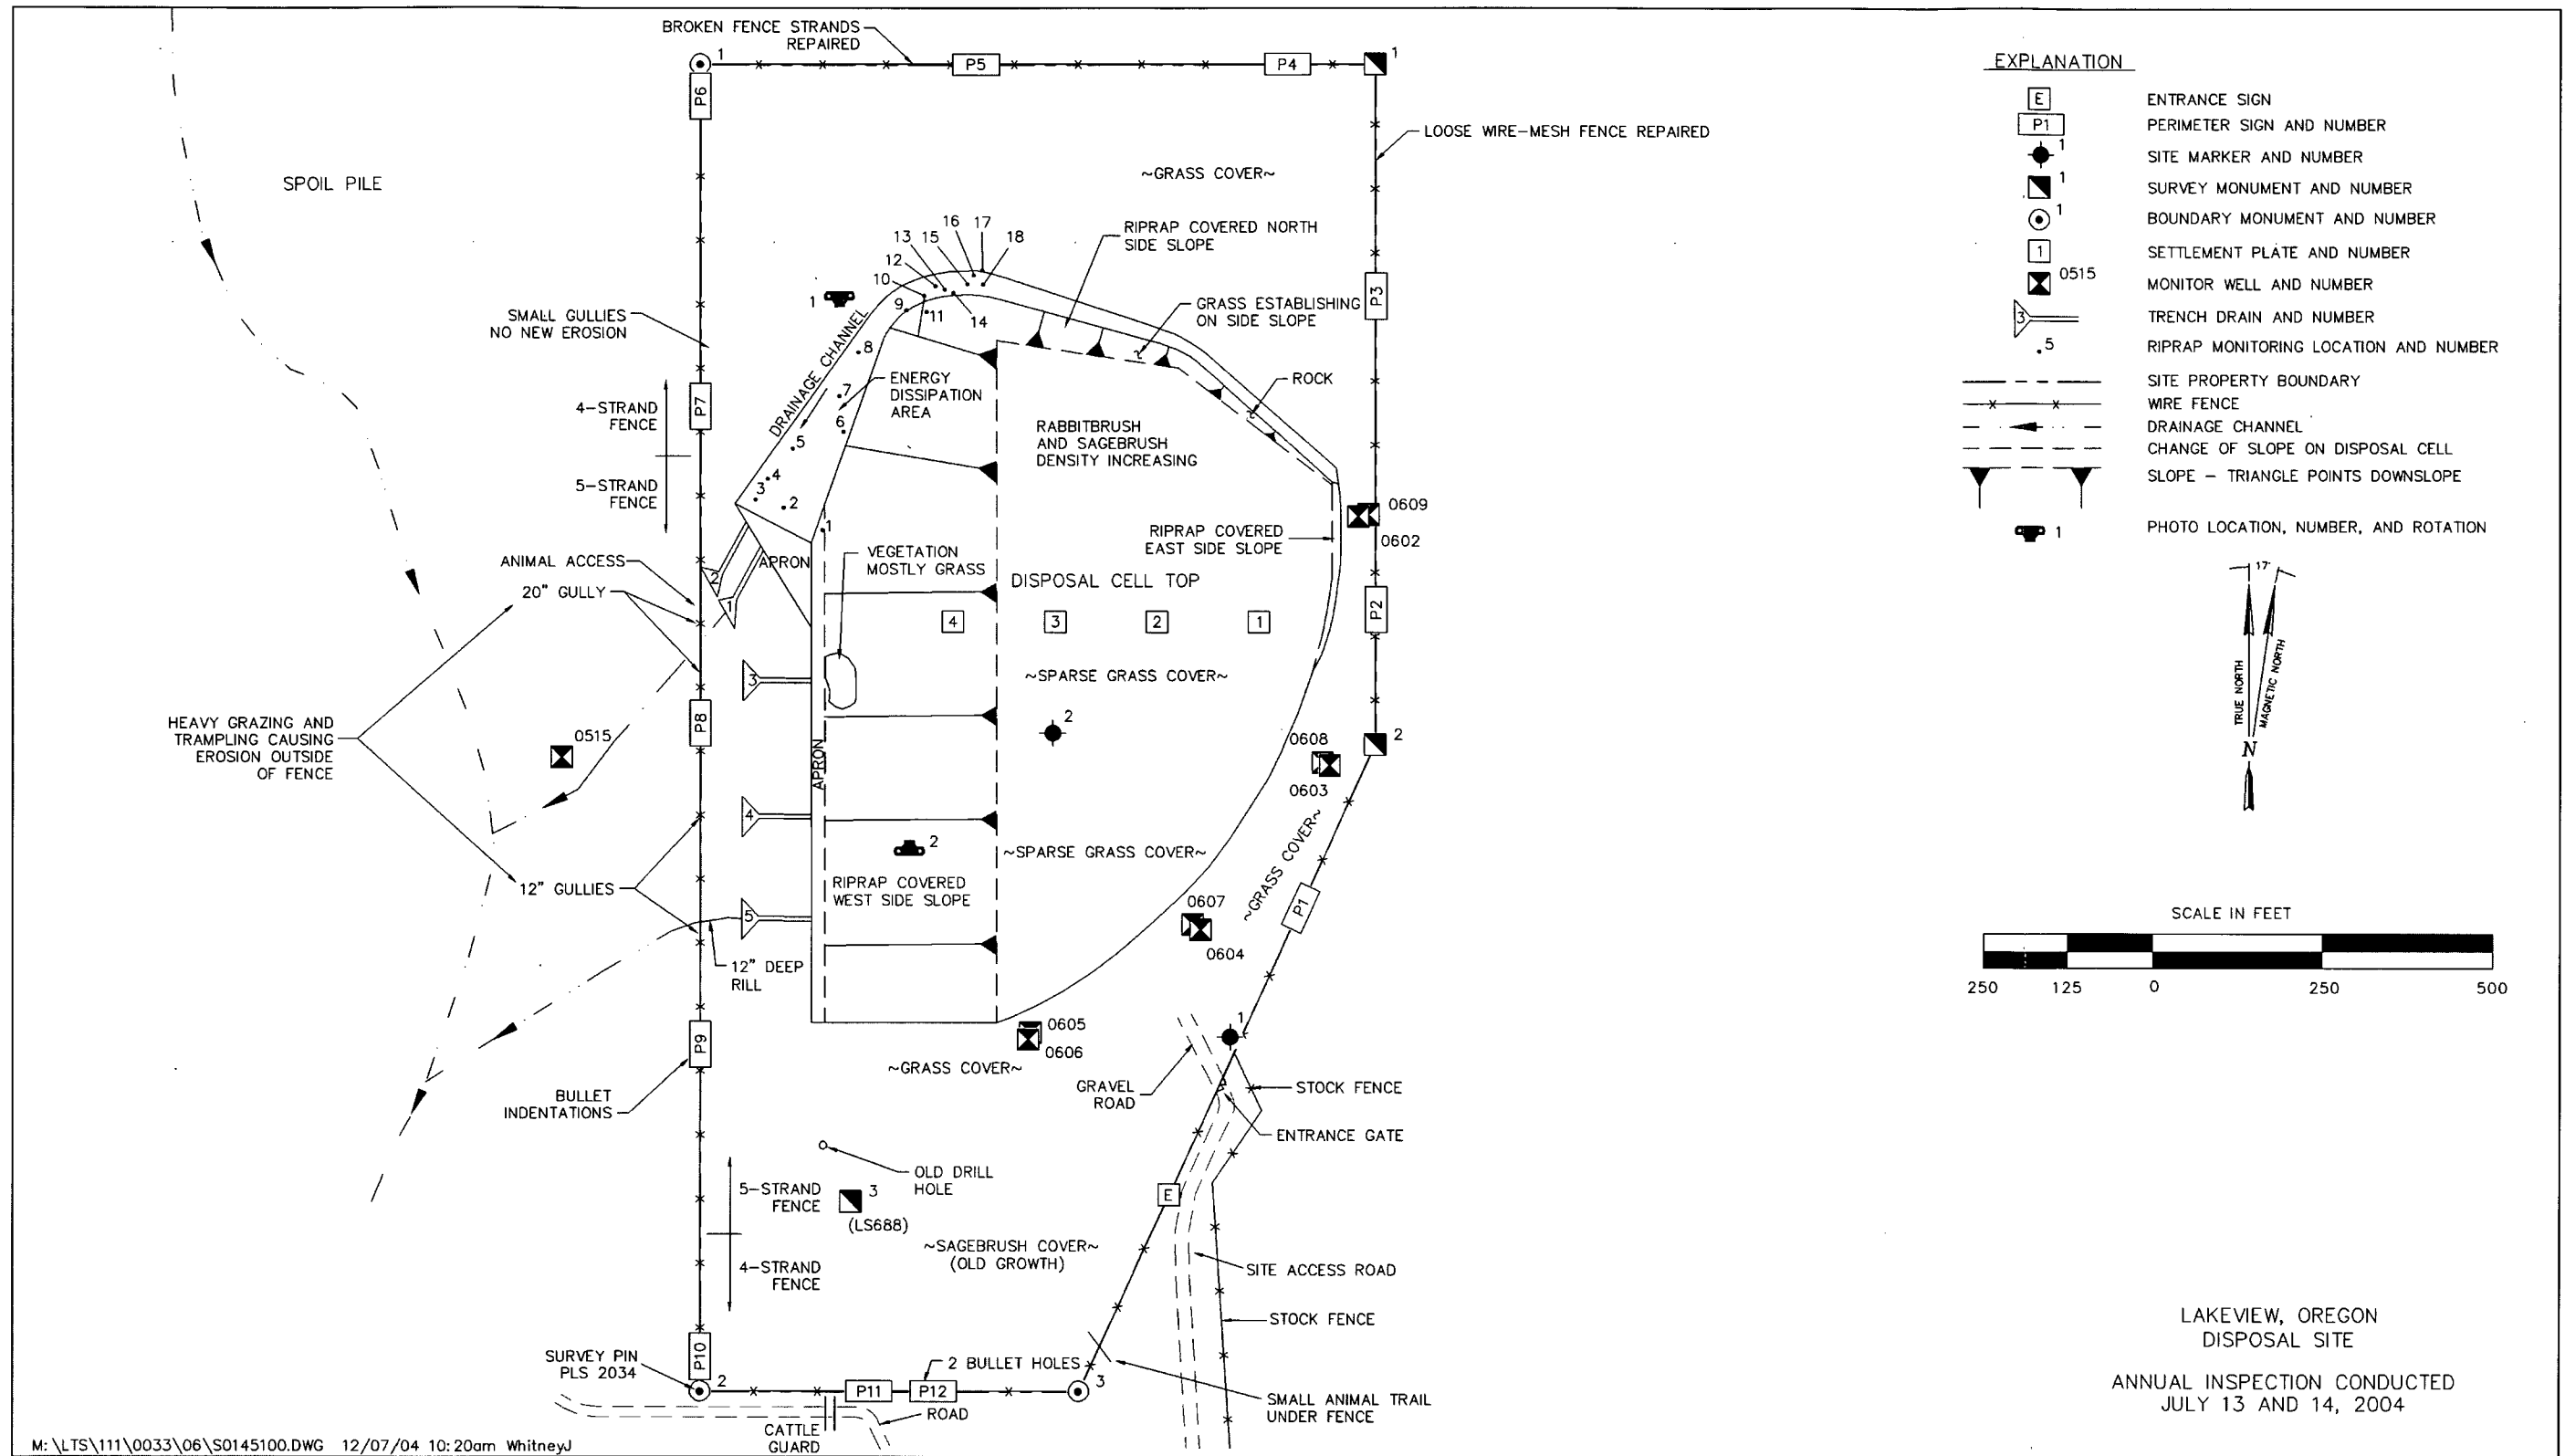
Figure 9-1. 2004 Annual Compliance Drawing for the Lakeview, Oregon, Disposal Site

Side Slopes of the Disposal Cell and Adjacent Drainage Channel, Aprons, and Trench Drains—The general appearance of the riprap-covered features is good (PL-1). The grooves left by construction equipment during installation of the west side slope cover are still parallel and show no sign of slumping or movement (PL-2).

Standing water observed during past inspections was absent from the large depression in the lower end of the drainage channel. Water is a concern because inundation may accelerate deterioration of the large riprap due to freeze-thaw processes and secondary mineralization or alteration.

DOE will continue annual gradation tests at the Lakeview disposal cell to ensure that the side slopes of the cell are protected from erosion. If it becomes apparent that the riprap is continuing to deteriorate and that the measured D_{50} will eventually fall below 1.8 inches, DOE, in consultation with NRC, will evaluate alternatives and take corrective action, as necessary.

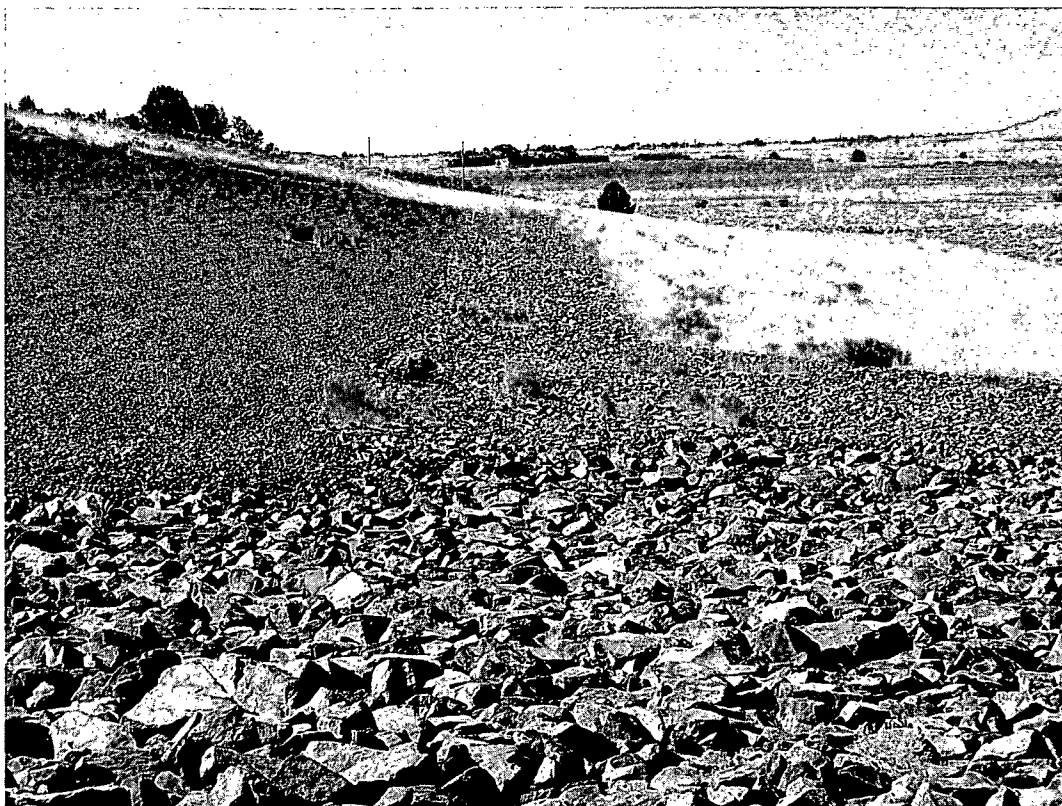
LKV 7/2004. PL-1. View of the west side slope and apron. The energy dissipation area of the drainage channel is in the foreground.

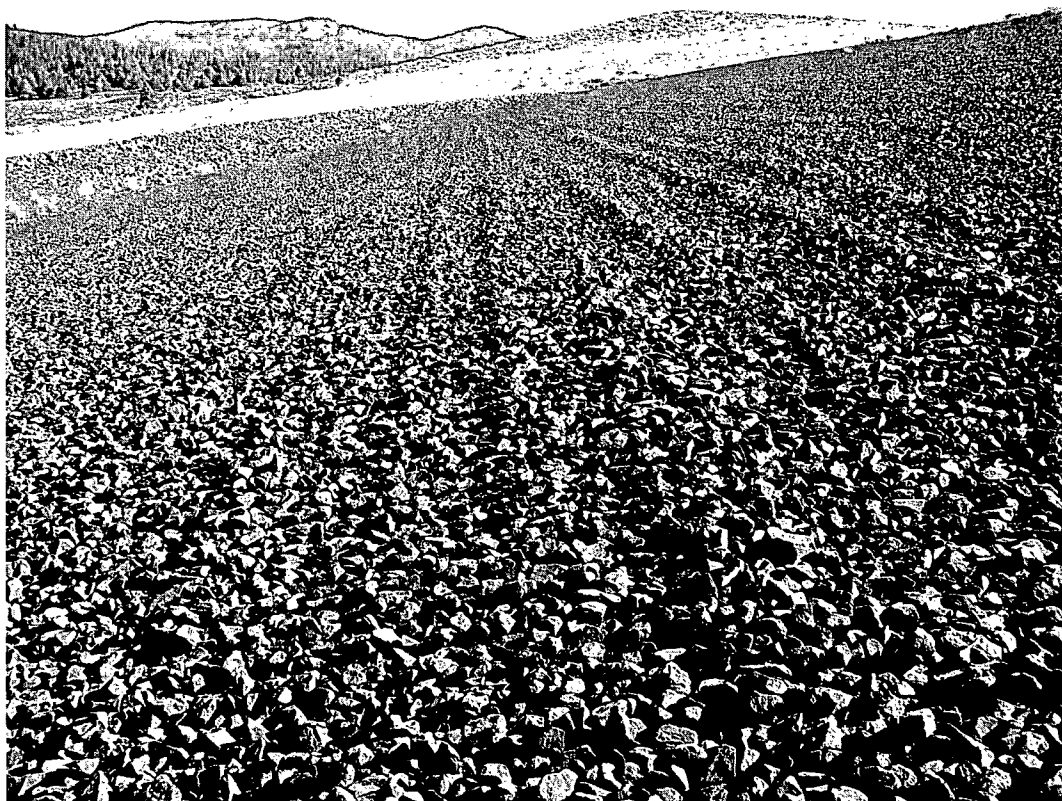
LKV 7/2004. PL-2. Original construction textures on the west side slope are still parallel, indicating no slumping along the slope.

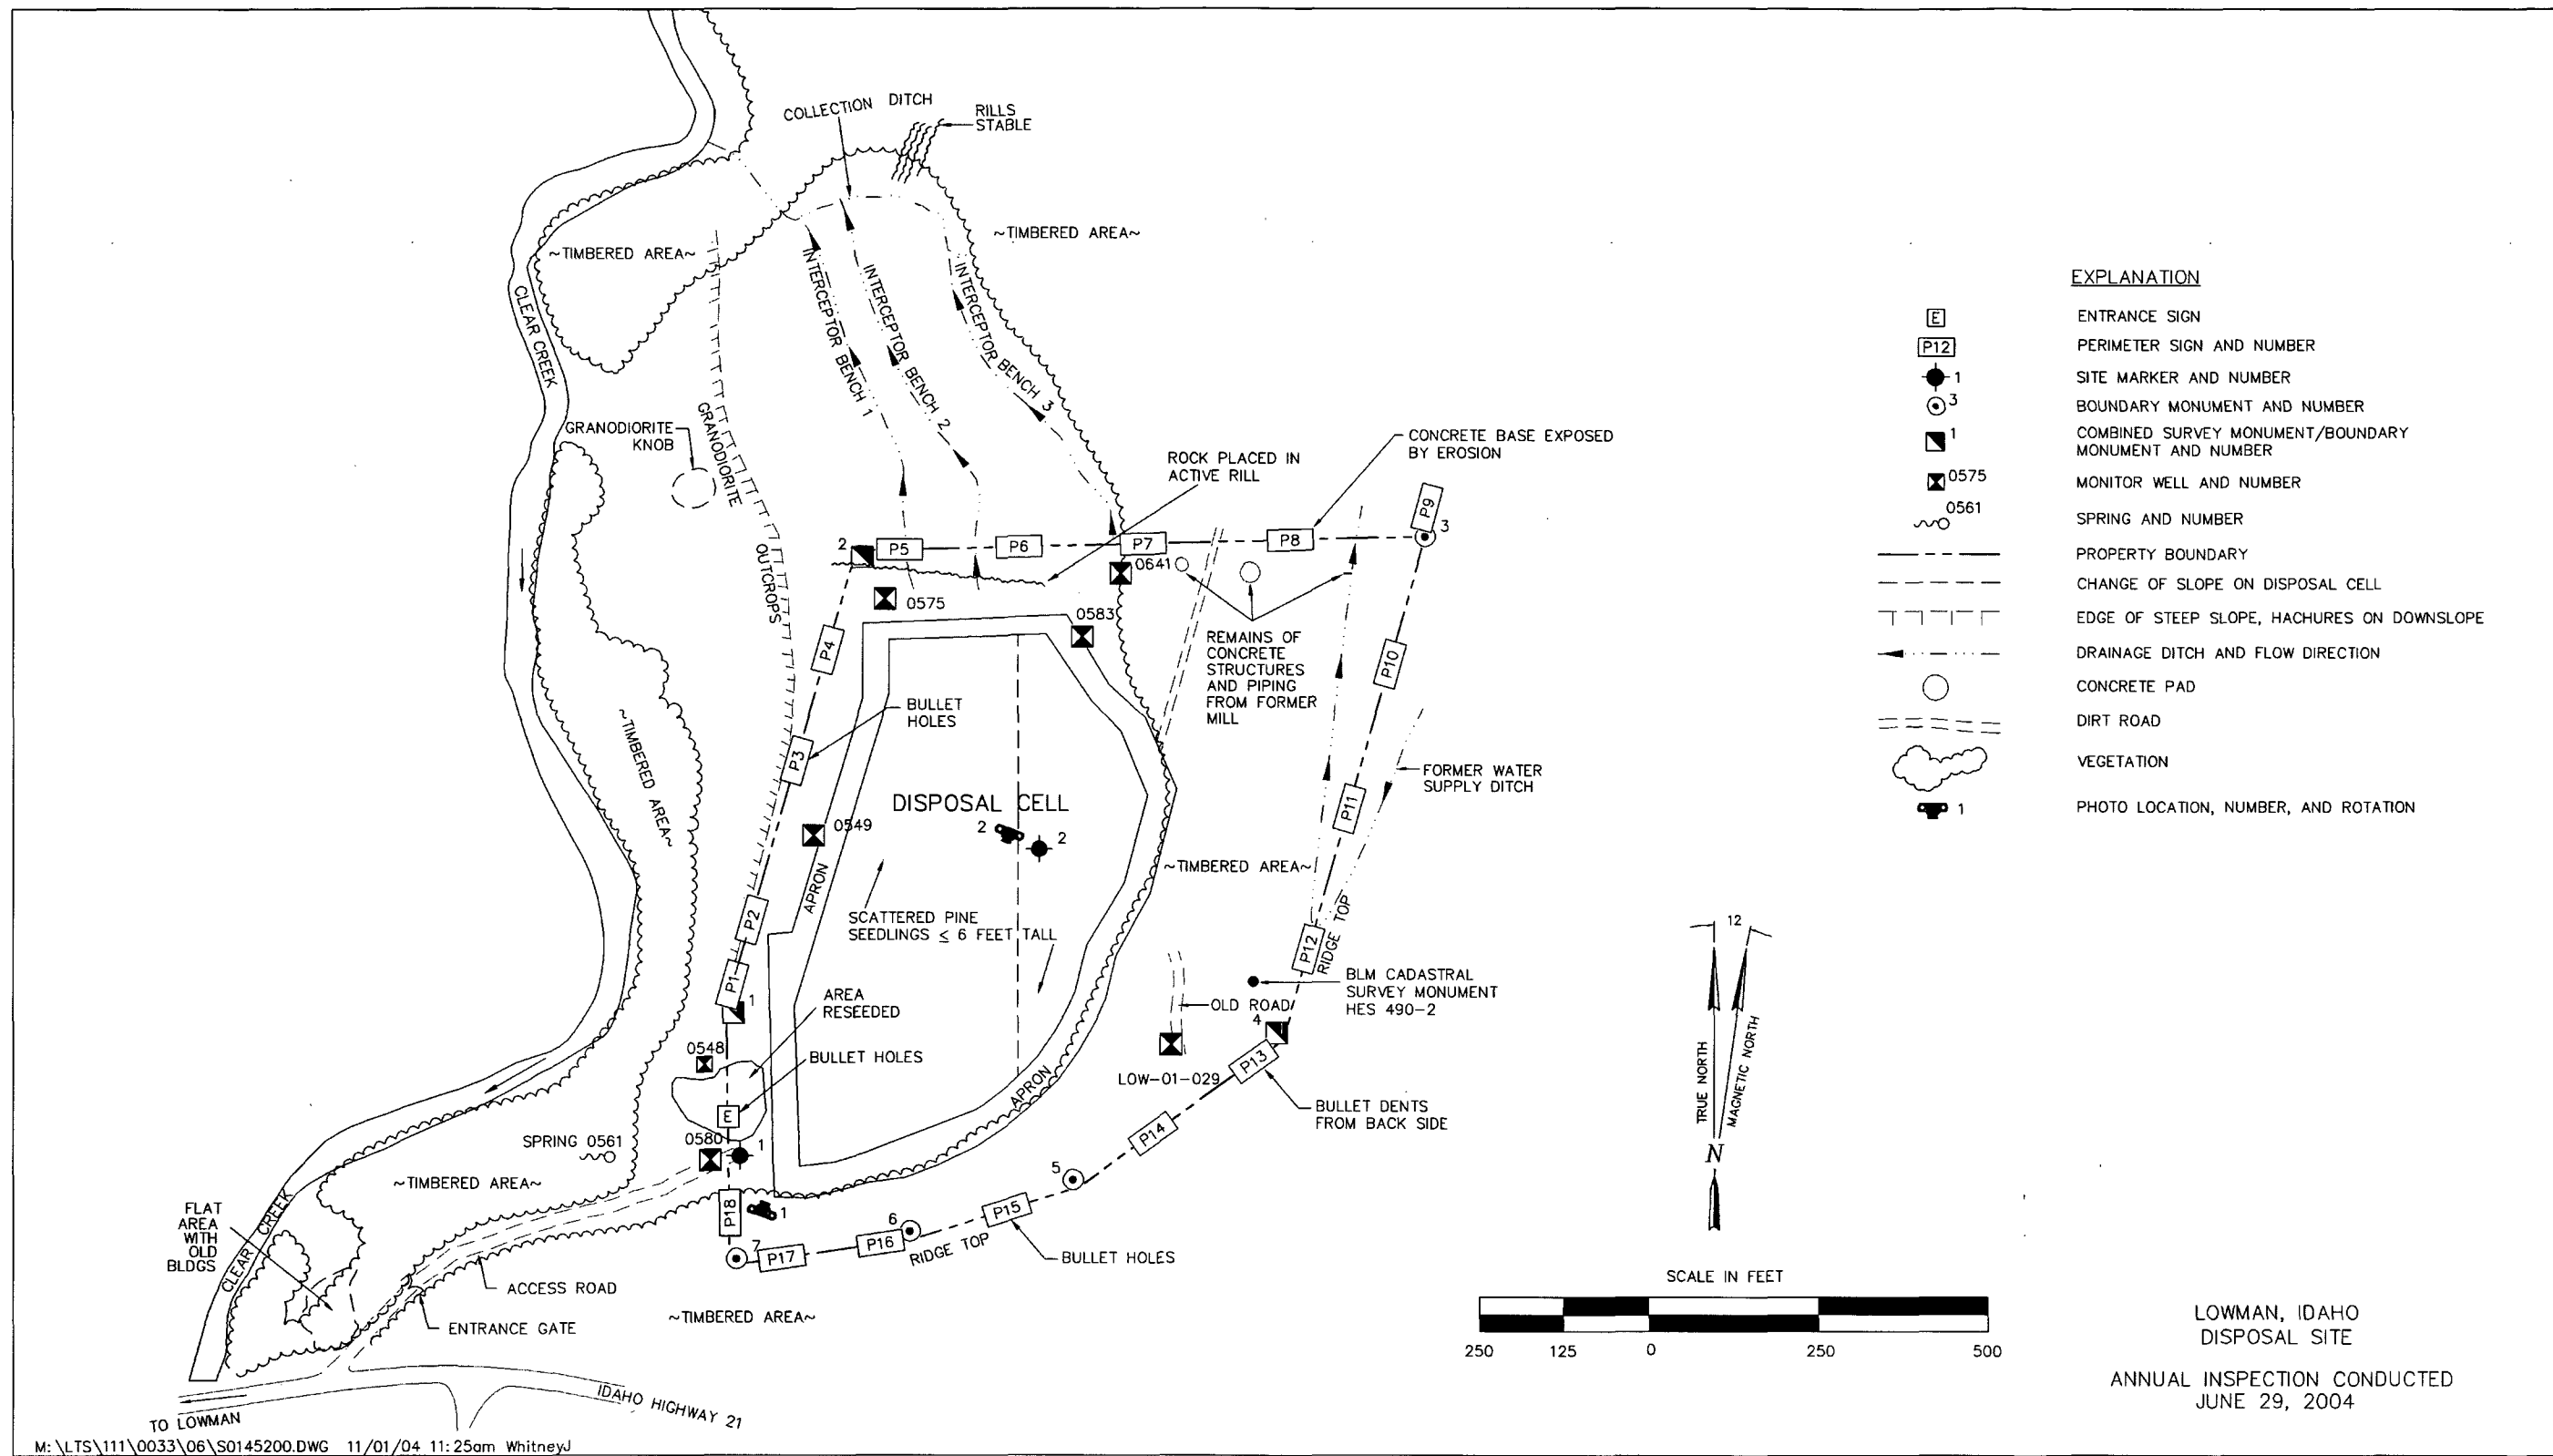
Figure 10-1. 2004 Annual Compliance Drawing for the Lowman, Idaho, Disposal Site

Area Between the Disposal Cell and the Site Boundary—The steep slopes east and south of the site were stable with well-established ponderosa pine and grasses. One active erosion rill no more than 8 inches in depth was discovered along the north boundary of the site near perimeter signs P5 and P6. The rill had cut across the berms of the lower two interceptor benches. Once runoff flow within the rill reaches the granodiorite outcrop west of the site, it is dispersed and causes no further downcutting. Rock was placed in the rill in October 2004 to retard erosion. DOE will continue to monitor this area for erosion.

- 10B Infestations of several species of noxious weeds continue to be a concern for DOE on and adjacent to the site. Two applications of herbicide in 2003 significantly reduced the weed population, but two more applications were needed in 2004 in a continuing effort to control the weeds. An area approximately 1 acre in size in the southwest corner of the site had become barren as a result of herbicide applications. This area was reseeded with desirable perennial species in October 2004 to help prevent future infestations by noxious weeds.

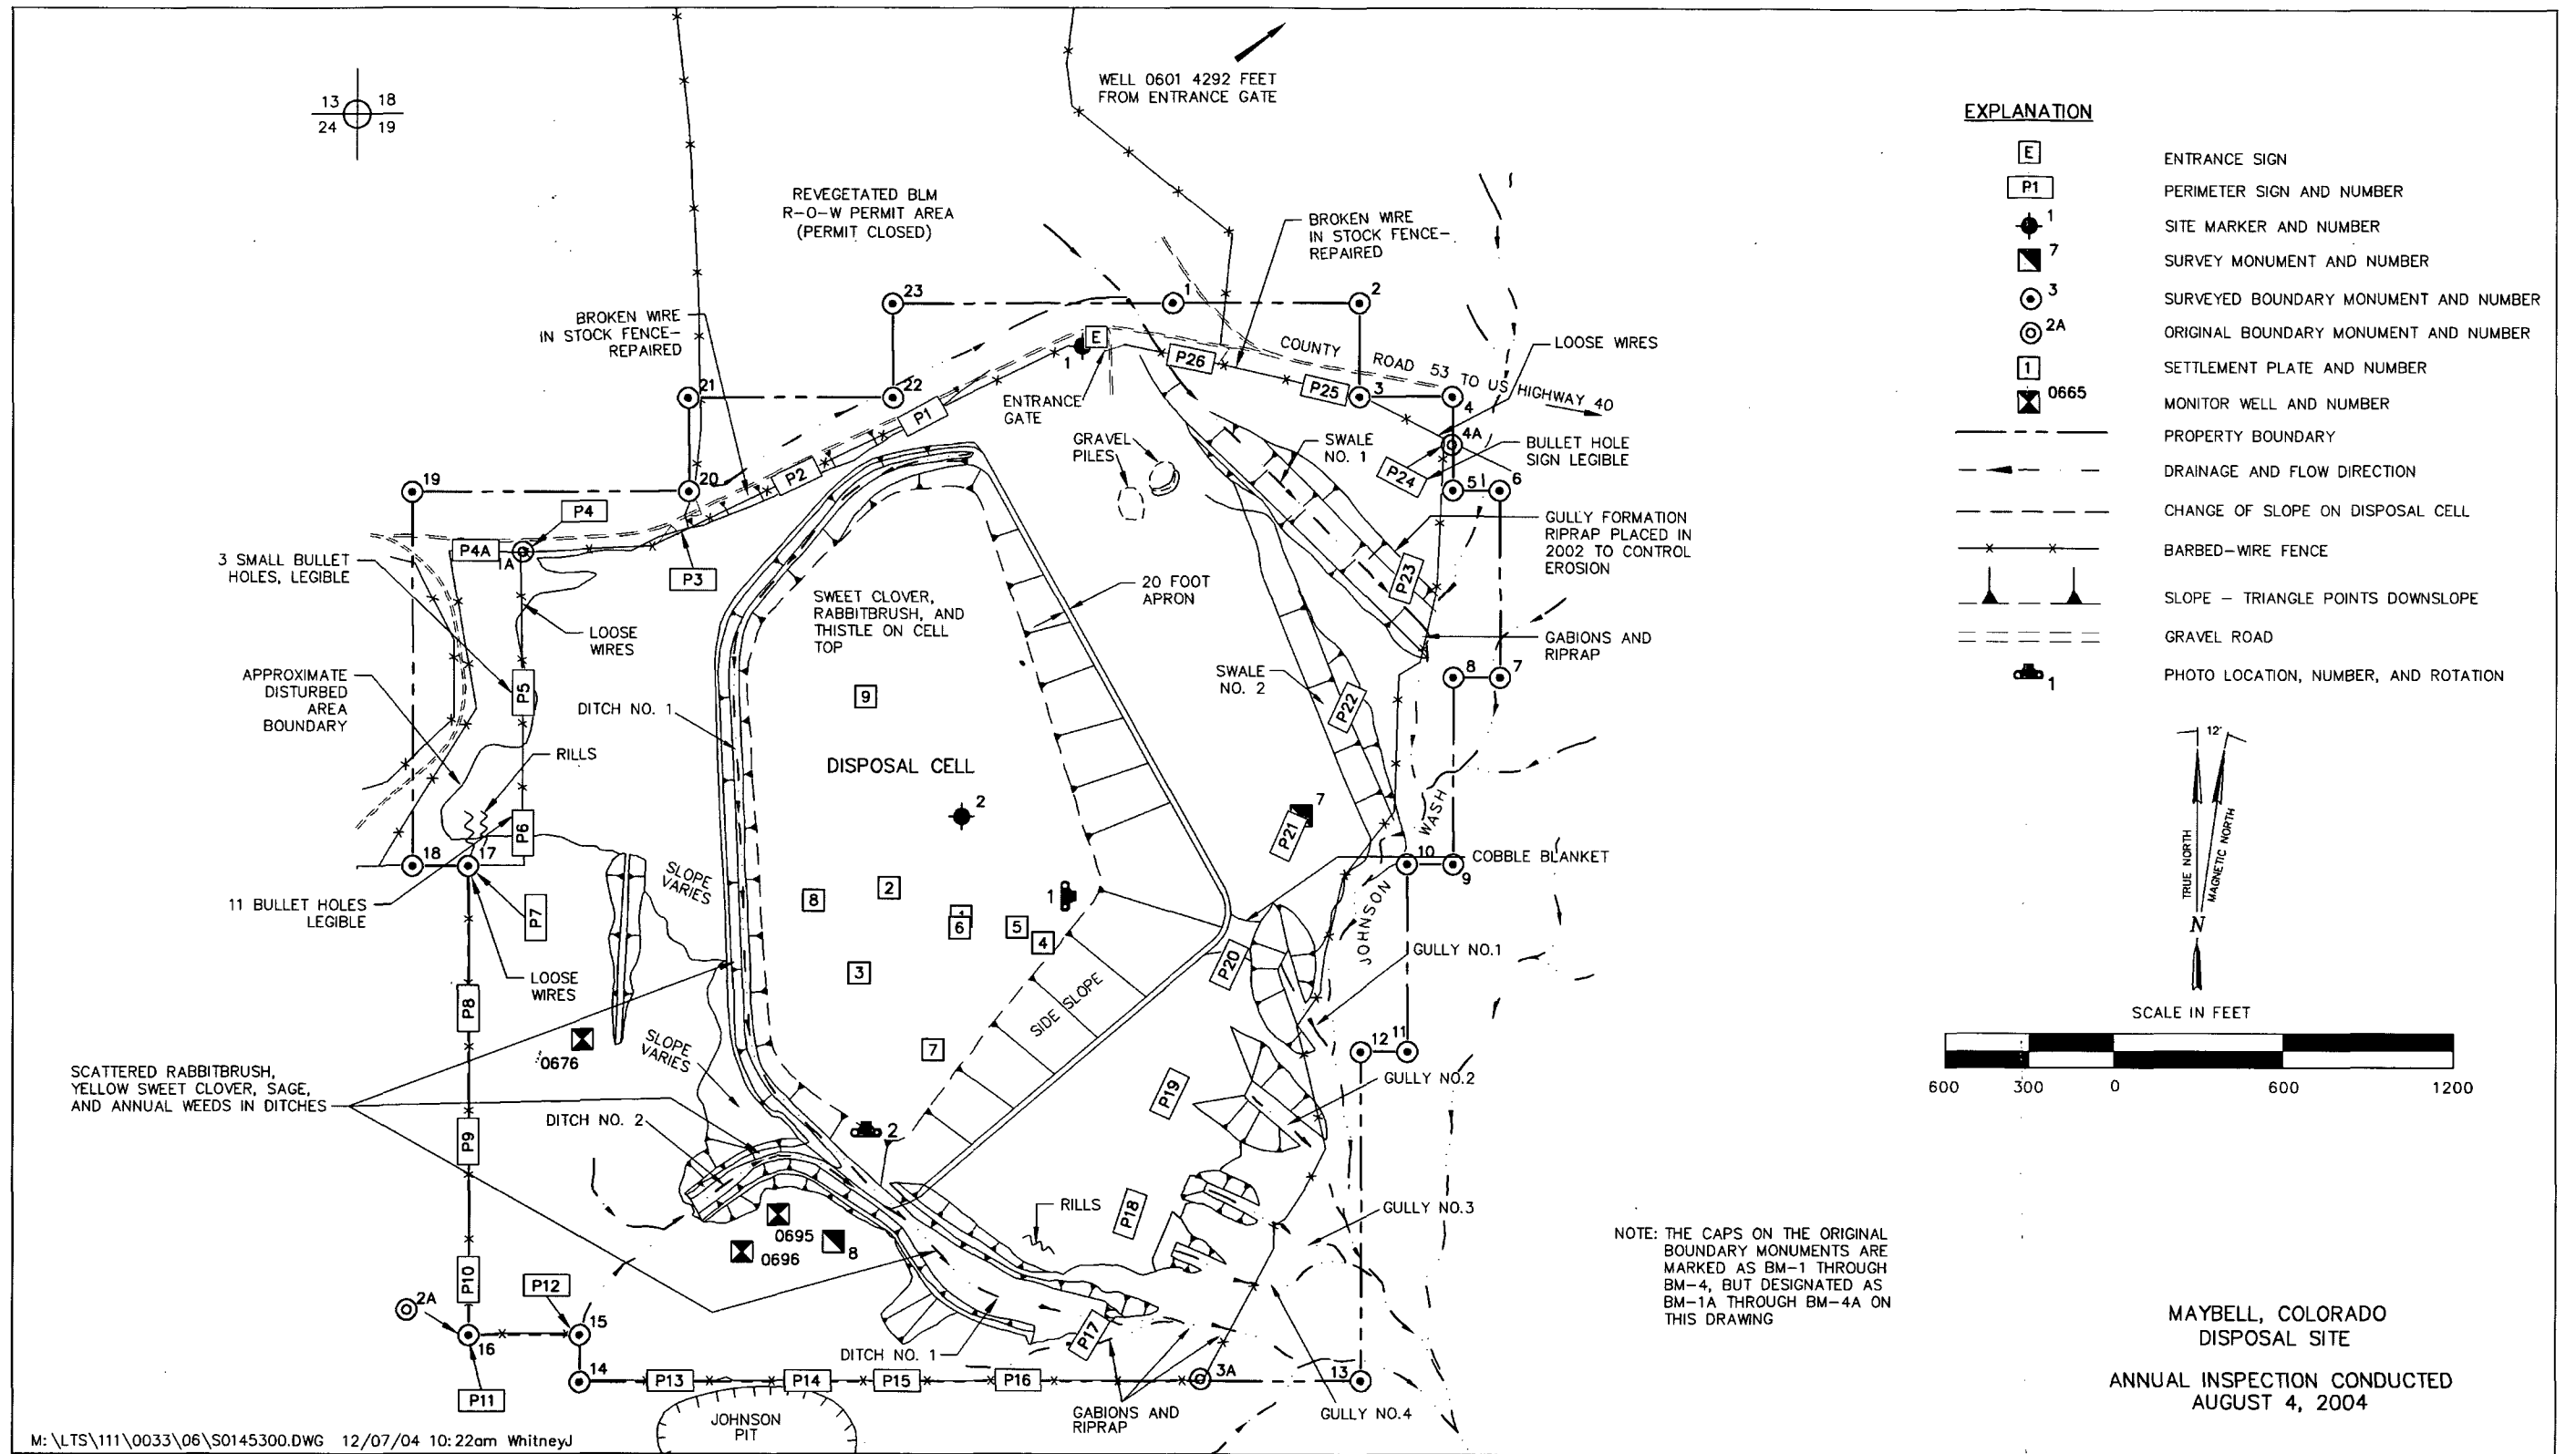
Figure 11-1. 2004 Annual Compliance Drawing for the Maybell, Colorado, Disposal Site

Disposal Cell—The disposal cell is armored with rock for erosion protection and was in excellent condition (PL-1). No evidence of slumping, settling, erosion, or rock degradation was noted.

Patches of plants consisting of deep-rooted species, grasses, and annual weeds were observed on the cell top and side slopes (PL-2). Deep-rooted woody plants were cut and their stems were treated with herbicide, and patches of unidentified thistle were sprayed with herbicide. Previously treated areas showed no evidence of new growth.

In accordance with the LTSP, inspectors looked for seeps on the east corner and southeast side slopes because large quantities of slimes were encapsulated in this portion of the cell. The east corner of the cell is a topographic low point for draining a portion of runoff from the cell. No moisture was evident on the surfaces of the side slopes, but runoff water often is present in the apron at this location. The cobble blanket at the toe of the east corner supports wetland vegetation and other annual and perennial plants.
