**U.S. Department of Energy
Office of Legacy Management**

2004 Annual Site Inspection and Monitoring Report for Uranium Mill Tailings Radiation Control Act Title I Disposal Sites

December 2004

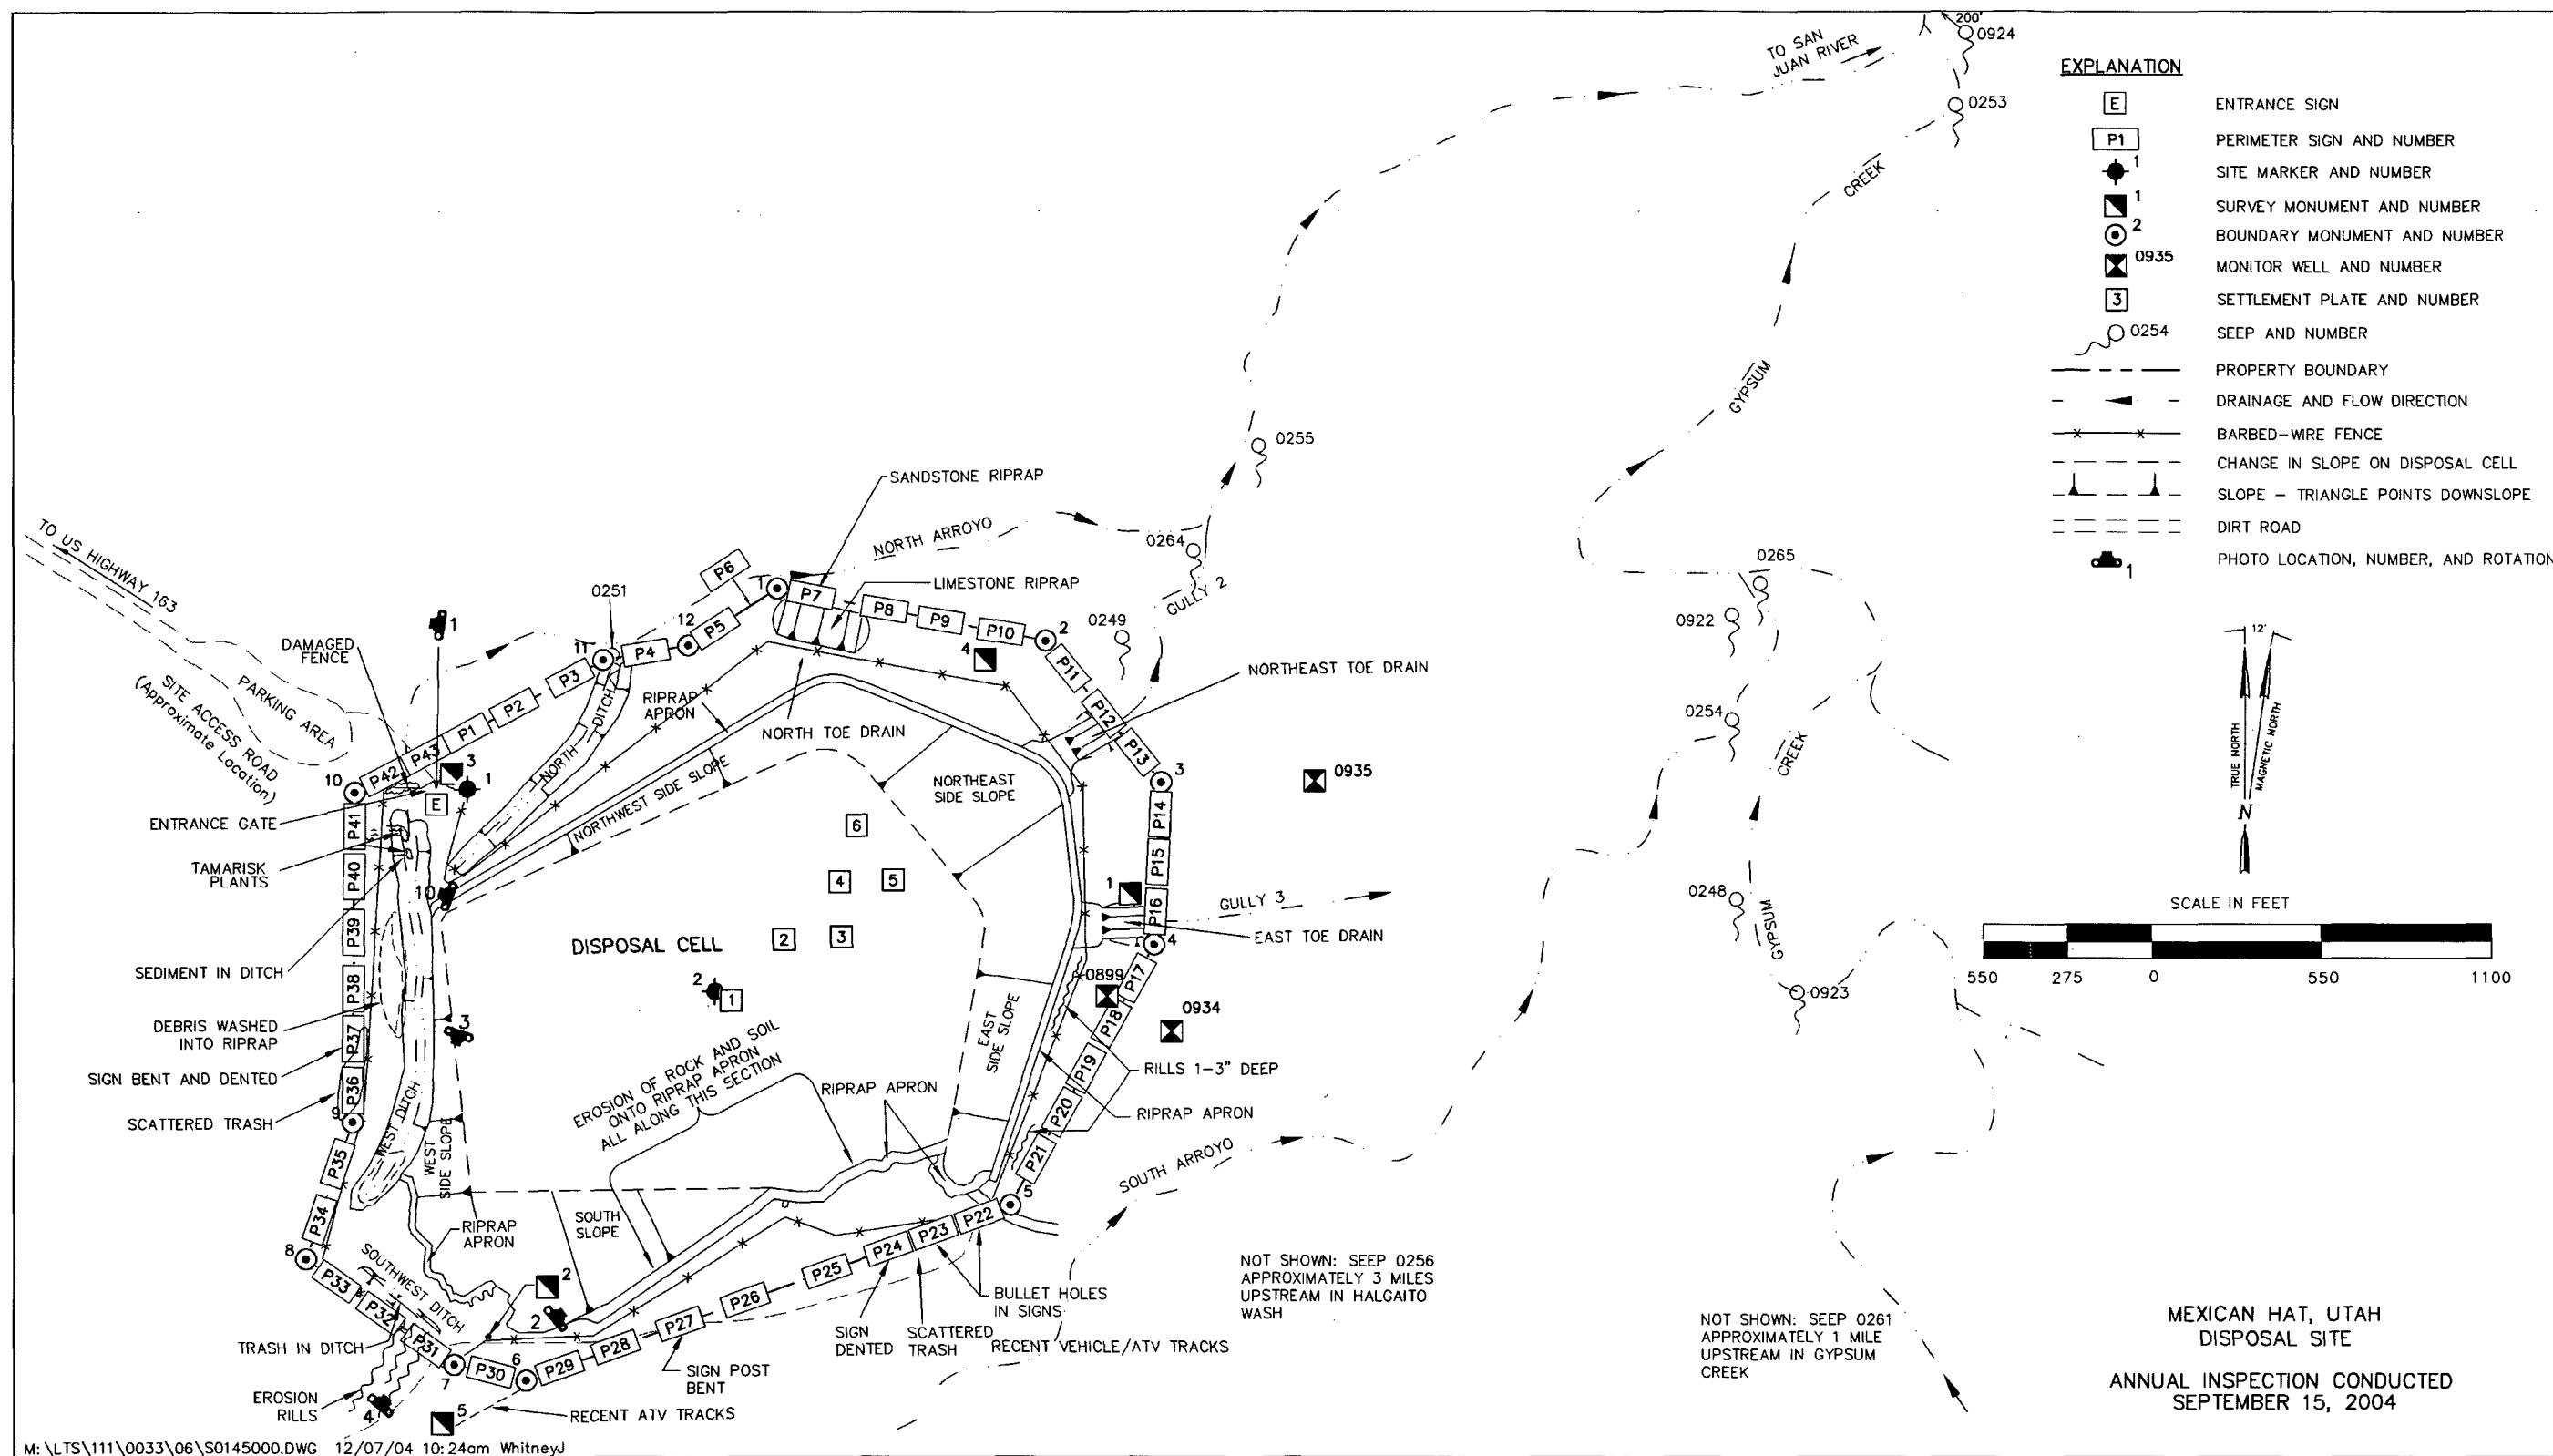
Figure 12-1. 2004 Annual Compliance Drawing for the Mexican Hat, Utah, Disposal Site

A section along the south apron has been closely monitored for several years because rock and soil have sloughed off the adjacent steep hill slope onto the apron. Based on comparisons with photographs from the previous inspection, there was no apparent increase in accumulation of the red sandstone and soil along the south apron (PL-2). There was no evidence of channel erosion in this area, and the sloughed material has not filled the void spaces in the apron riprap beyond the toe of the hill slope. It is anticipated that a minor amount of unstable rock from the hill slope will, over time, continue to fall onto the apron; however, the amount of material that will eventually accumulate on the edge of the apron in this area will have no detrimental impact on the performance of the apron or the disposal cell.

Off-site upgradient areas continue to erode and transport sediment onto the site and into the channels of West Ditch and Southwest Ditch. Plant growth, primarily annual weeds, is establishing where the sediment has accumulated in West Ditch (PL-3). The sediment

accumulation and plant growth have not affected the performance of these diversion structures, and the rate of sedimentation is expected to diminish as the upgradient landscape stabilizes. Tamarisk, a deep-rooted noxious plant, is growing at the outlet of West Ditch. These plants will be removed.

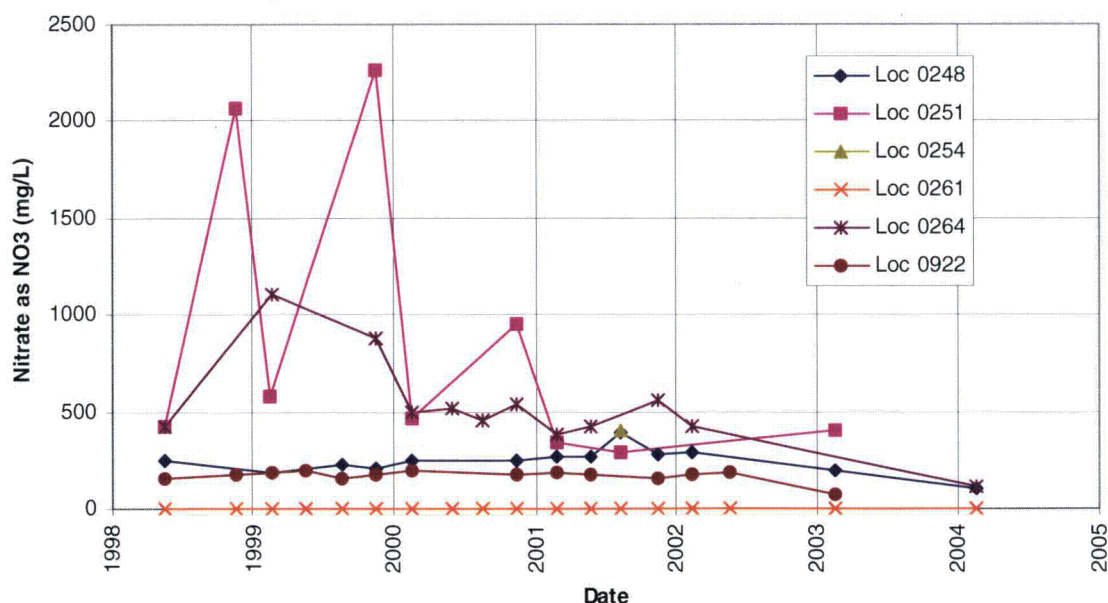
Figure 12–2. Time-Concentration Plots of Nitrate (as NO_3) in Seep Water at the Mexican Hat, Utah, Disposal Site

Concentrations of nitrate continue to decrease, with 110 mg/L in the North Arroyo seep and 100 mg/L in the Gypsum Creek seep (Figure 12–2). Concentrations in the background seep remain below 1 mg/L.

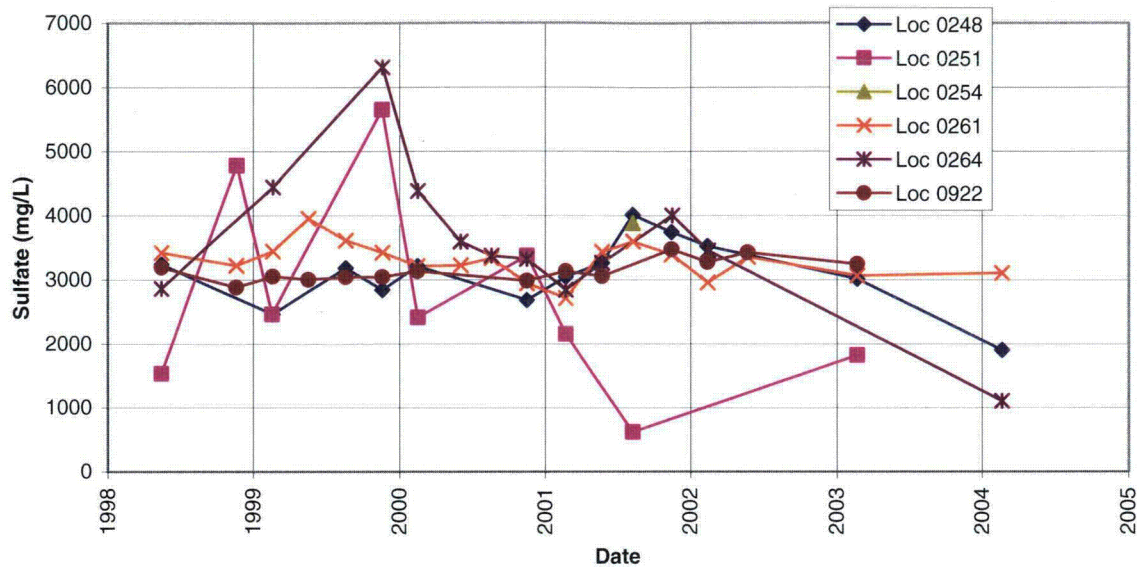
Figure 12-3. Time-Concentration Plots of Sulfate in Seep Water at the Mexican Hat, Utah, Disposal Site

Sulfate concentrations similarly have decreased in the North Arroyo seep and in the Gypsum Creek seep to less than 2,000 mg/L (Figure 12–3). Concentrations in the background seep remained relatively steady at 3,000 mg/L.

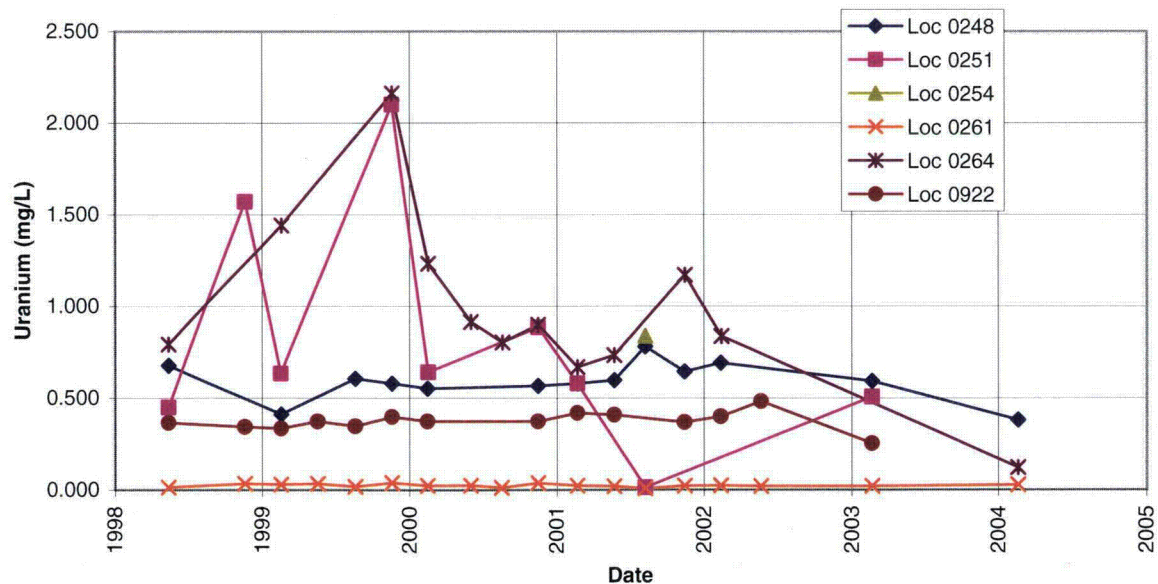
Figure 12-4. Time-Concentration Plots of Uranium in Seep Water at the Mexican Hat, Utah, Disposal Site

Concentrations of uranium in the North Arroyo seep decreased to 0.120 mg/L, and in the Gypsum Creek seep to 0.380 mg/L (Figure 12–4). Background levels at seep 0261 have remained relatively constant at approximately 0.025 mg/L for the past several years.

Results of monitoring in 2004 show that concentrations of all target constituents are generally decreasing in the North Arroyo and Gypsum Creek seeps. No trends of increase in concentrations are evident that would suggest degradation of the disposal cell cover.

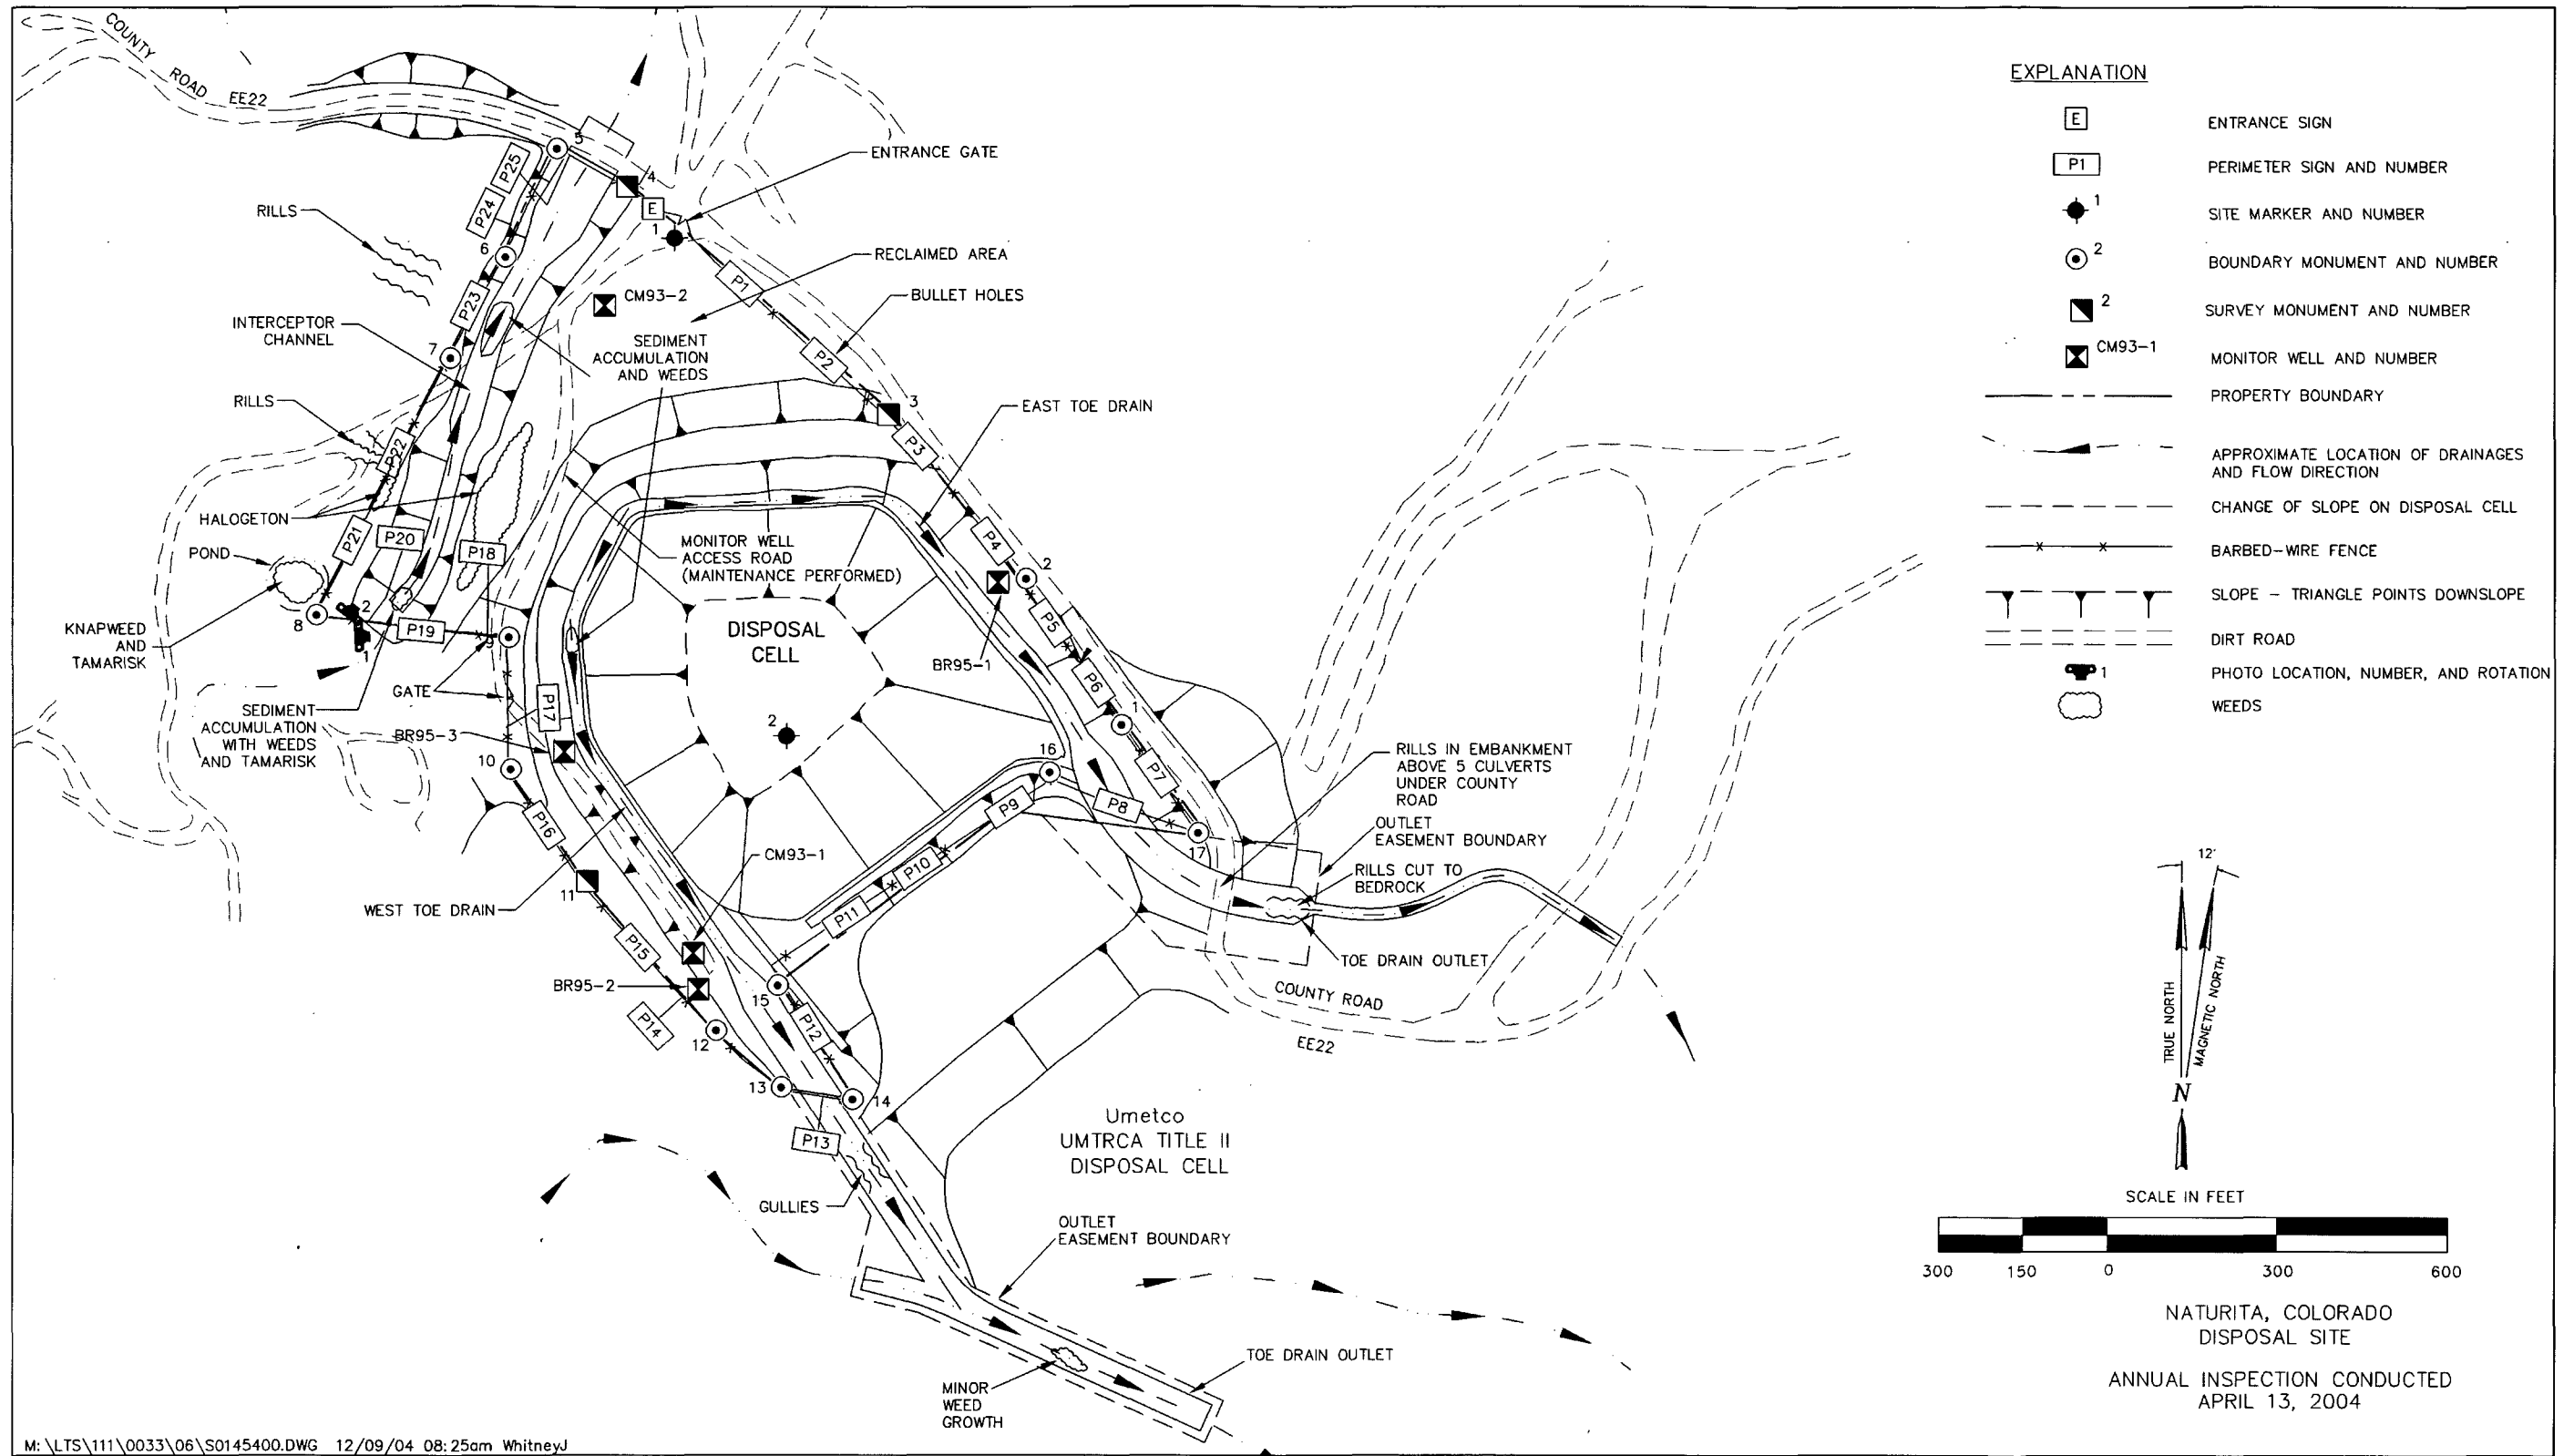
Figure 13-1. 2004 Annual Compliance Drawing for the Naturita, Colorado, Disposal Site

Top of Disposal Cell and Side Slopes—Rock covers the 2-acre top of the disposal cell and the approximate 8 acres of side slopes (PL-1). The rock is rounded, with larger rock on the side slopes than on the top. The cell top and side slopes of the disposal cell were in excellent condition. No evidence of subsidence, differential settlement, slumping, or other modifying process was noted, and no vegetation was present.

Toe Drains and Outlets—Two riprap-filled toe drains collect water from the cell side slopes and divert it to the southeast. The toe drain on the west side of the cell exits through a channel quarried through the sandstone wall of the Burbank Pit and into a deep canyon leading to the San Miguel River. Some sediment has accumulated in the upper end of the west toe drain allowing weeds to grow. The east toe drain extends through the adjacent Umetco UMTRCA Title II disposal site and crosses beneath County Road EE22 through five culverts. Minor erosion of loose material has occurred in the drains, but the underlying sandstone bedrock limits further erosion. A small volume of water was flowing in this toe drain, probably due to recent rains and snowmelt. Noxious weeds observed in 2003 adjacent to the east toe drain (halogeton) and adjacent to the west toe drain (Russian knapweed) were not evident in 2004.

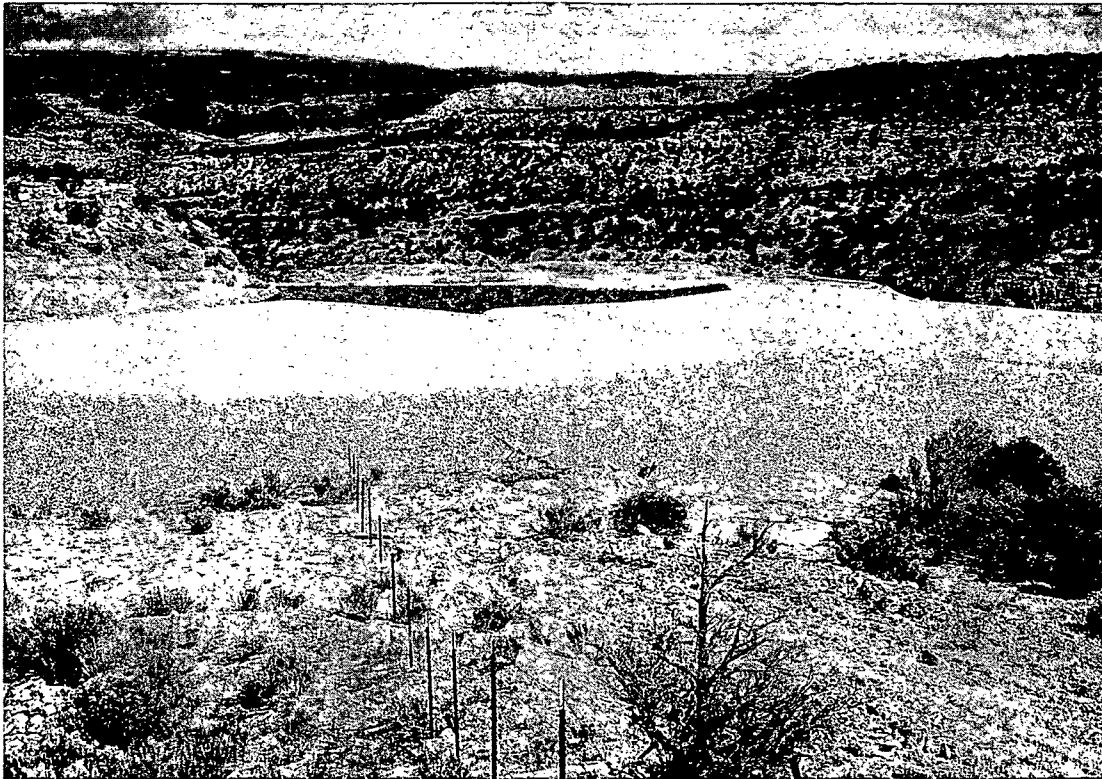
NAT 4/2004. PL-1. East view of the disposal cell.

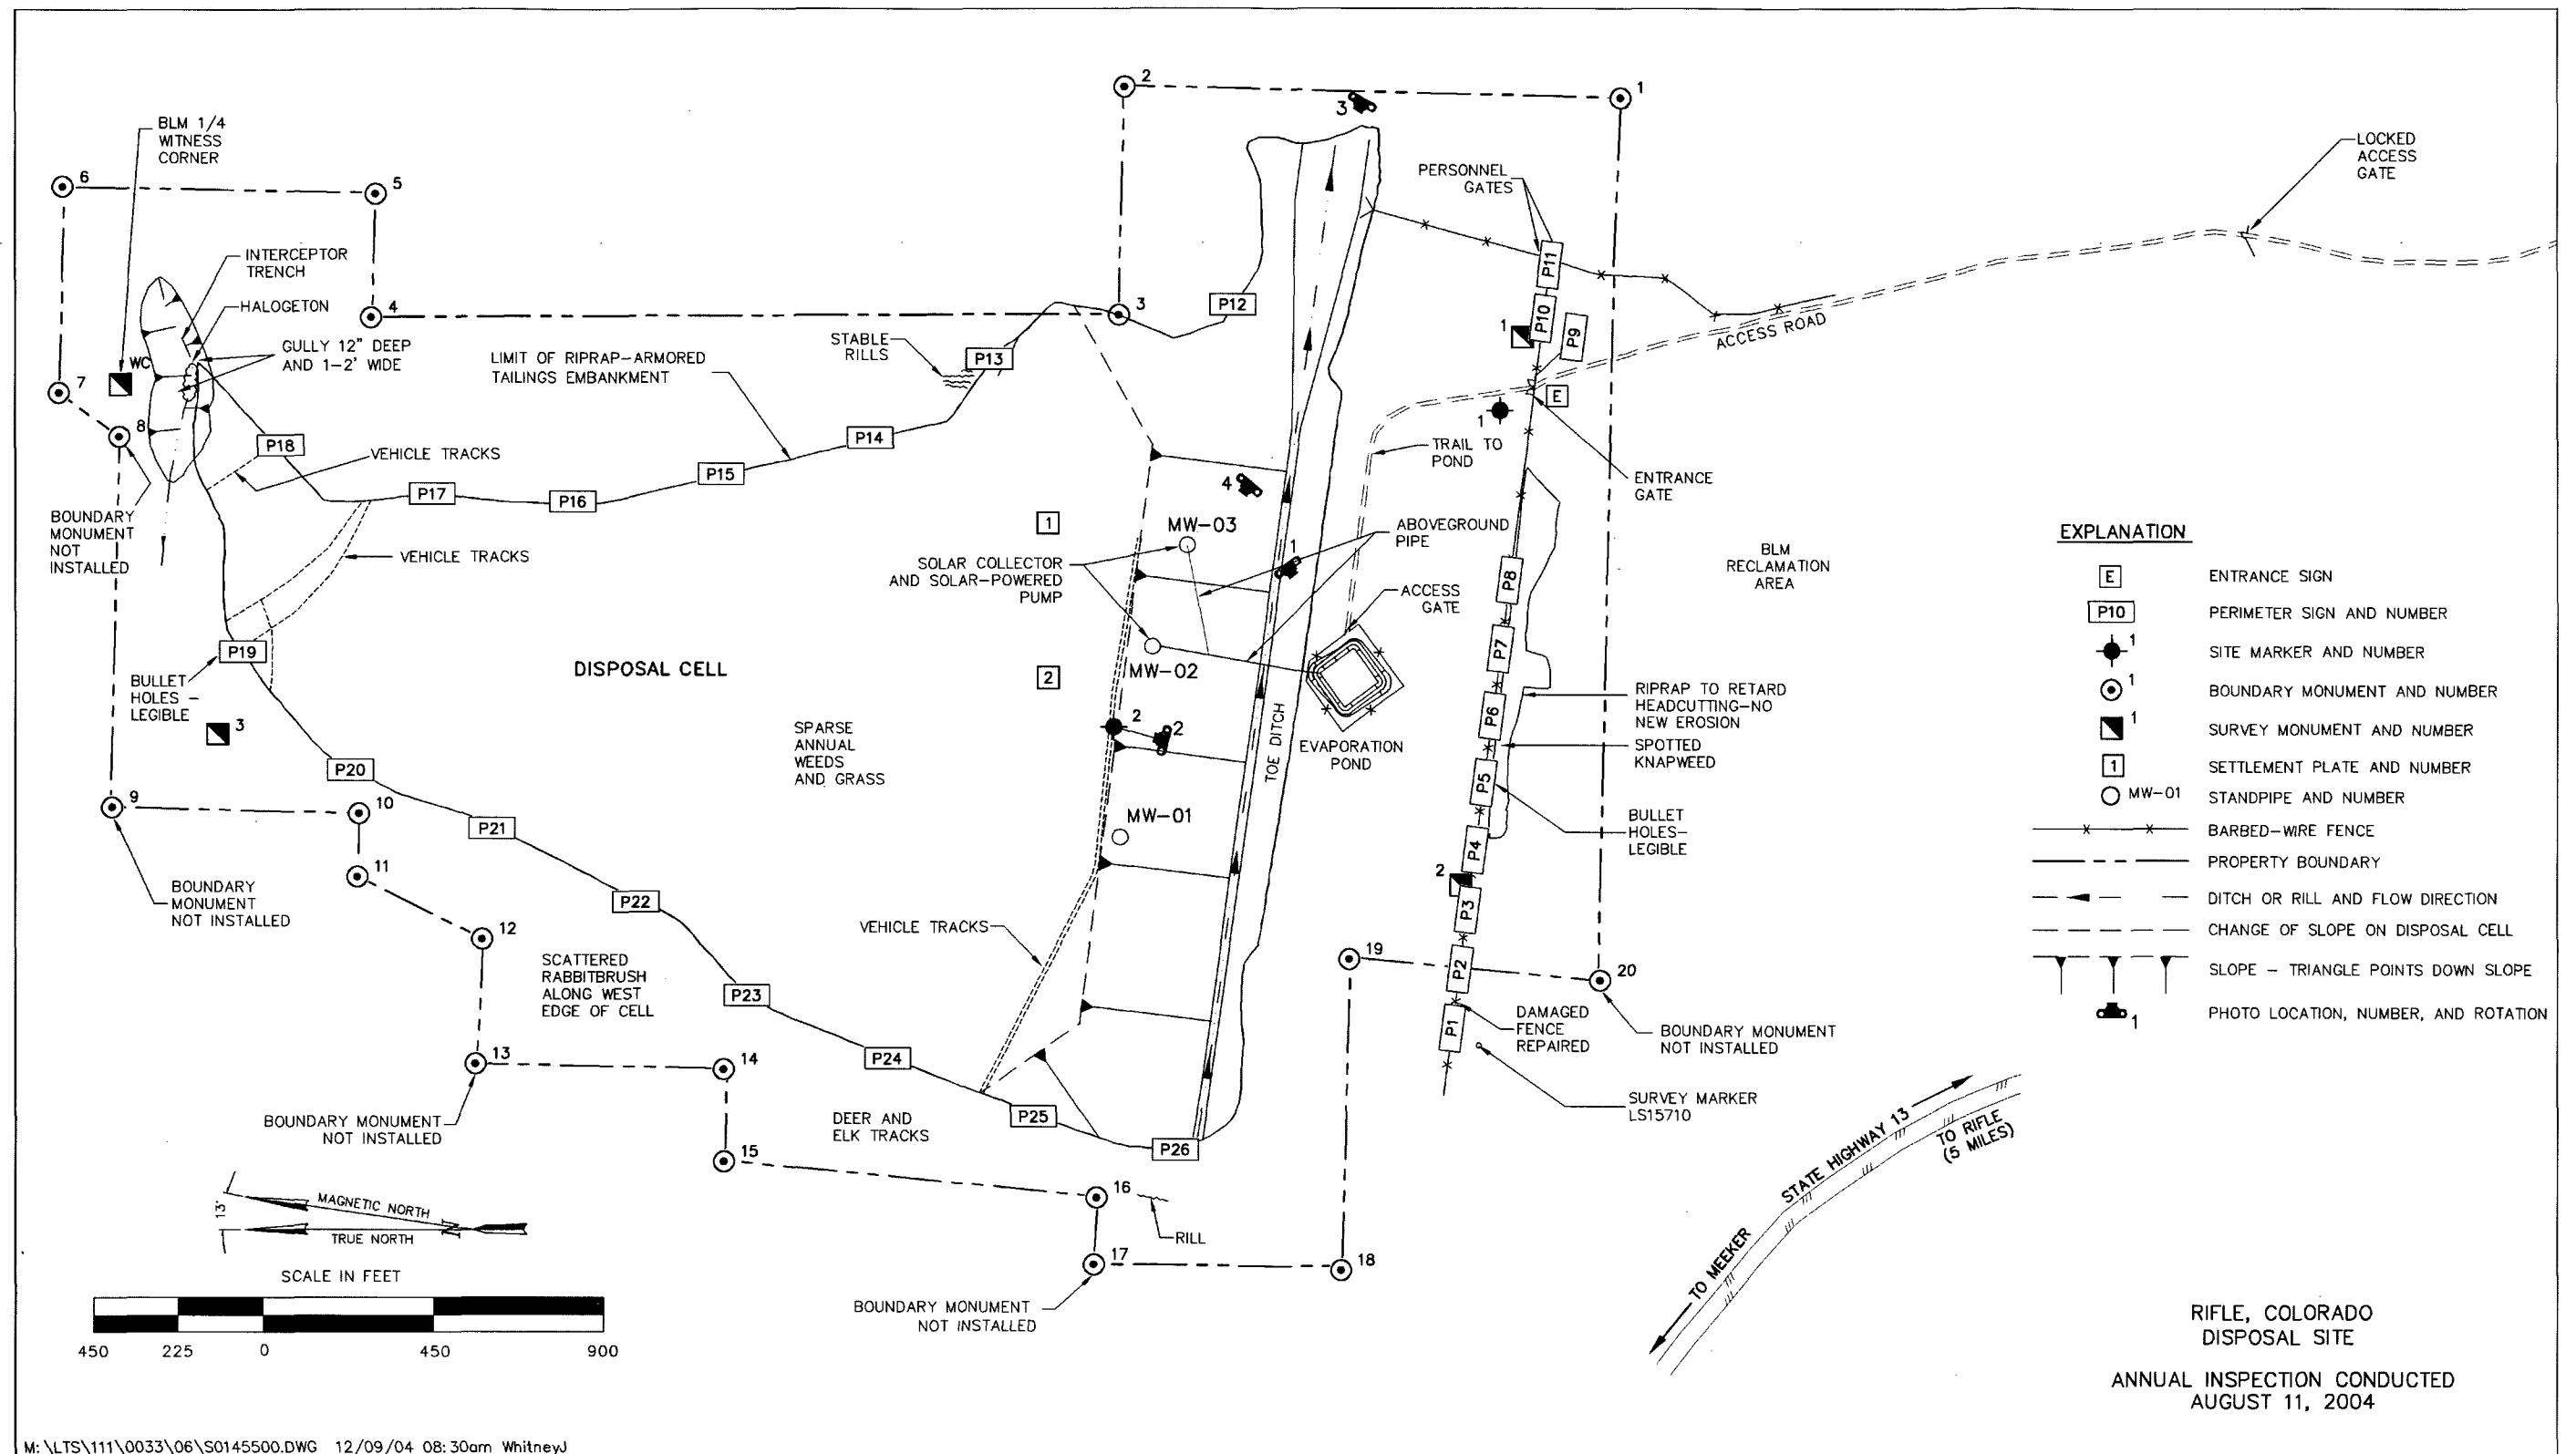
Figure 14-1. 2004 Annual Compliance Drawing for the Rifle, Colorado, Disposal Site

Disposal Cell and Interceptor Trench—Rock armor covering the 71-acre disposal cell was in excellent condition (PL-2). No evidence of subsidence, differential settlement, or slumping was noted. Only isolated clumps of grass and annual weeds were growing on the cell top.

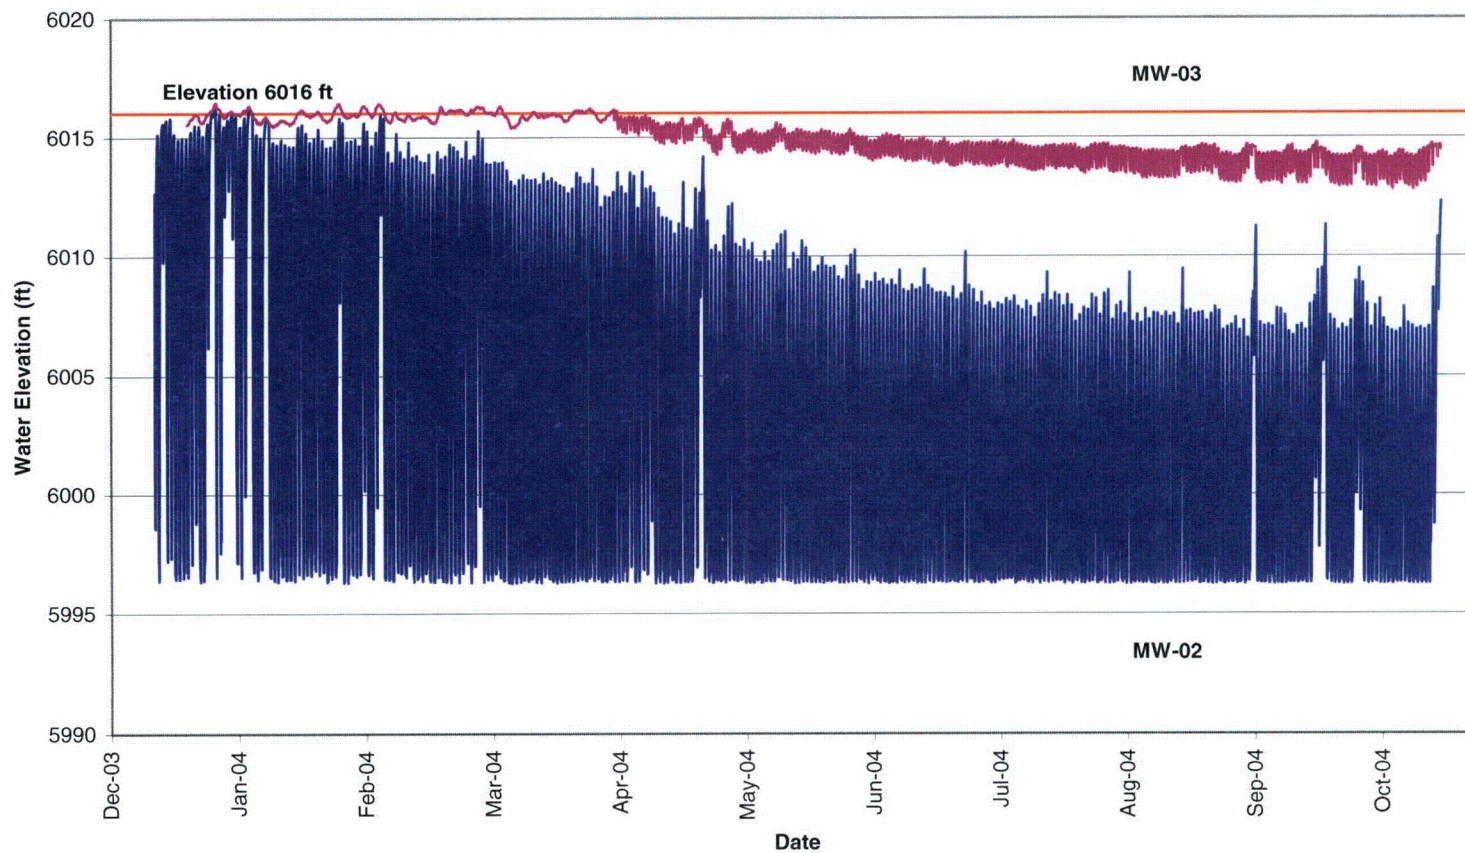
Figure 14-2. Water Levels in Standpipes MW-02 and MW-03 at the Rifle, Colorado, Disposal Site

At the time of the inspection, the pump in MW-02 was operating at about 1 gallon per minute (gpm) and the pump in MW-03 was operating at about 4 gpm. As shown by datalogger measurements (Figure 14-2), water levels steadily decreased in the past year, and the water level elevation has remained below 6,015 feet in both standpipes since June 2004. Fluctuations in the water levels represent drawdown and recovery during pumping cycles. The pumps are shut off for the winter because of reduced evaporation rates during that time.

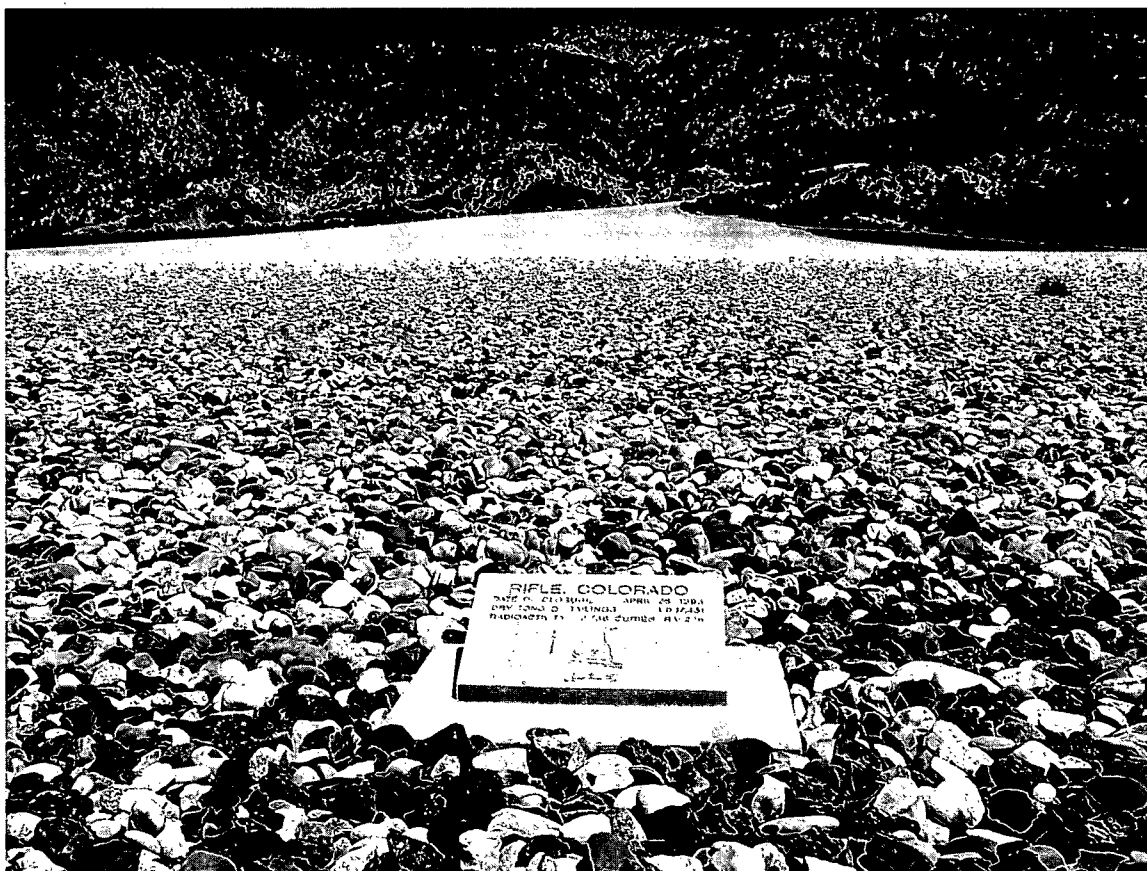
RFL 8/2004. PL-2. Site marker SMK-2 and the disposal cell cover.

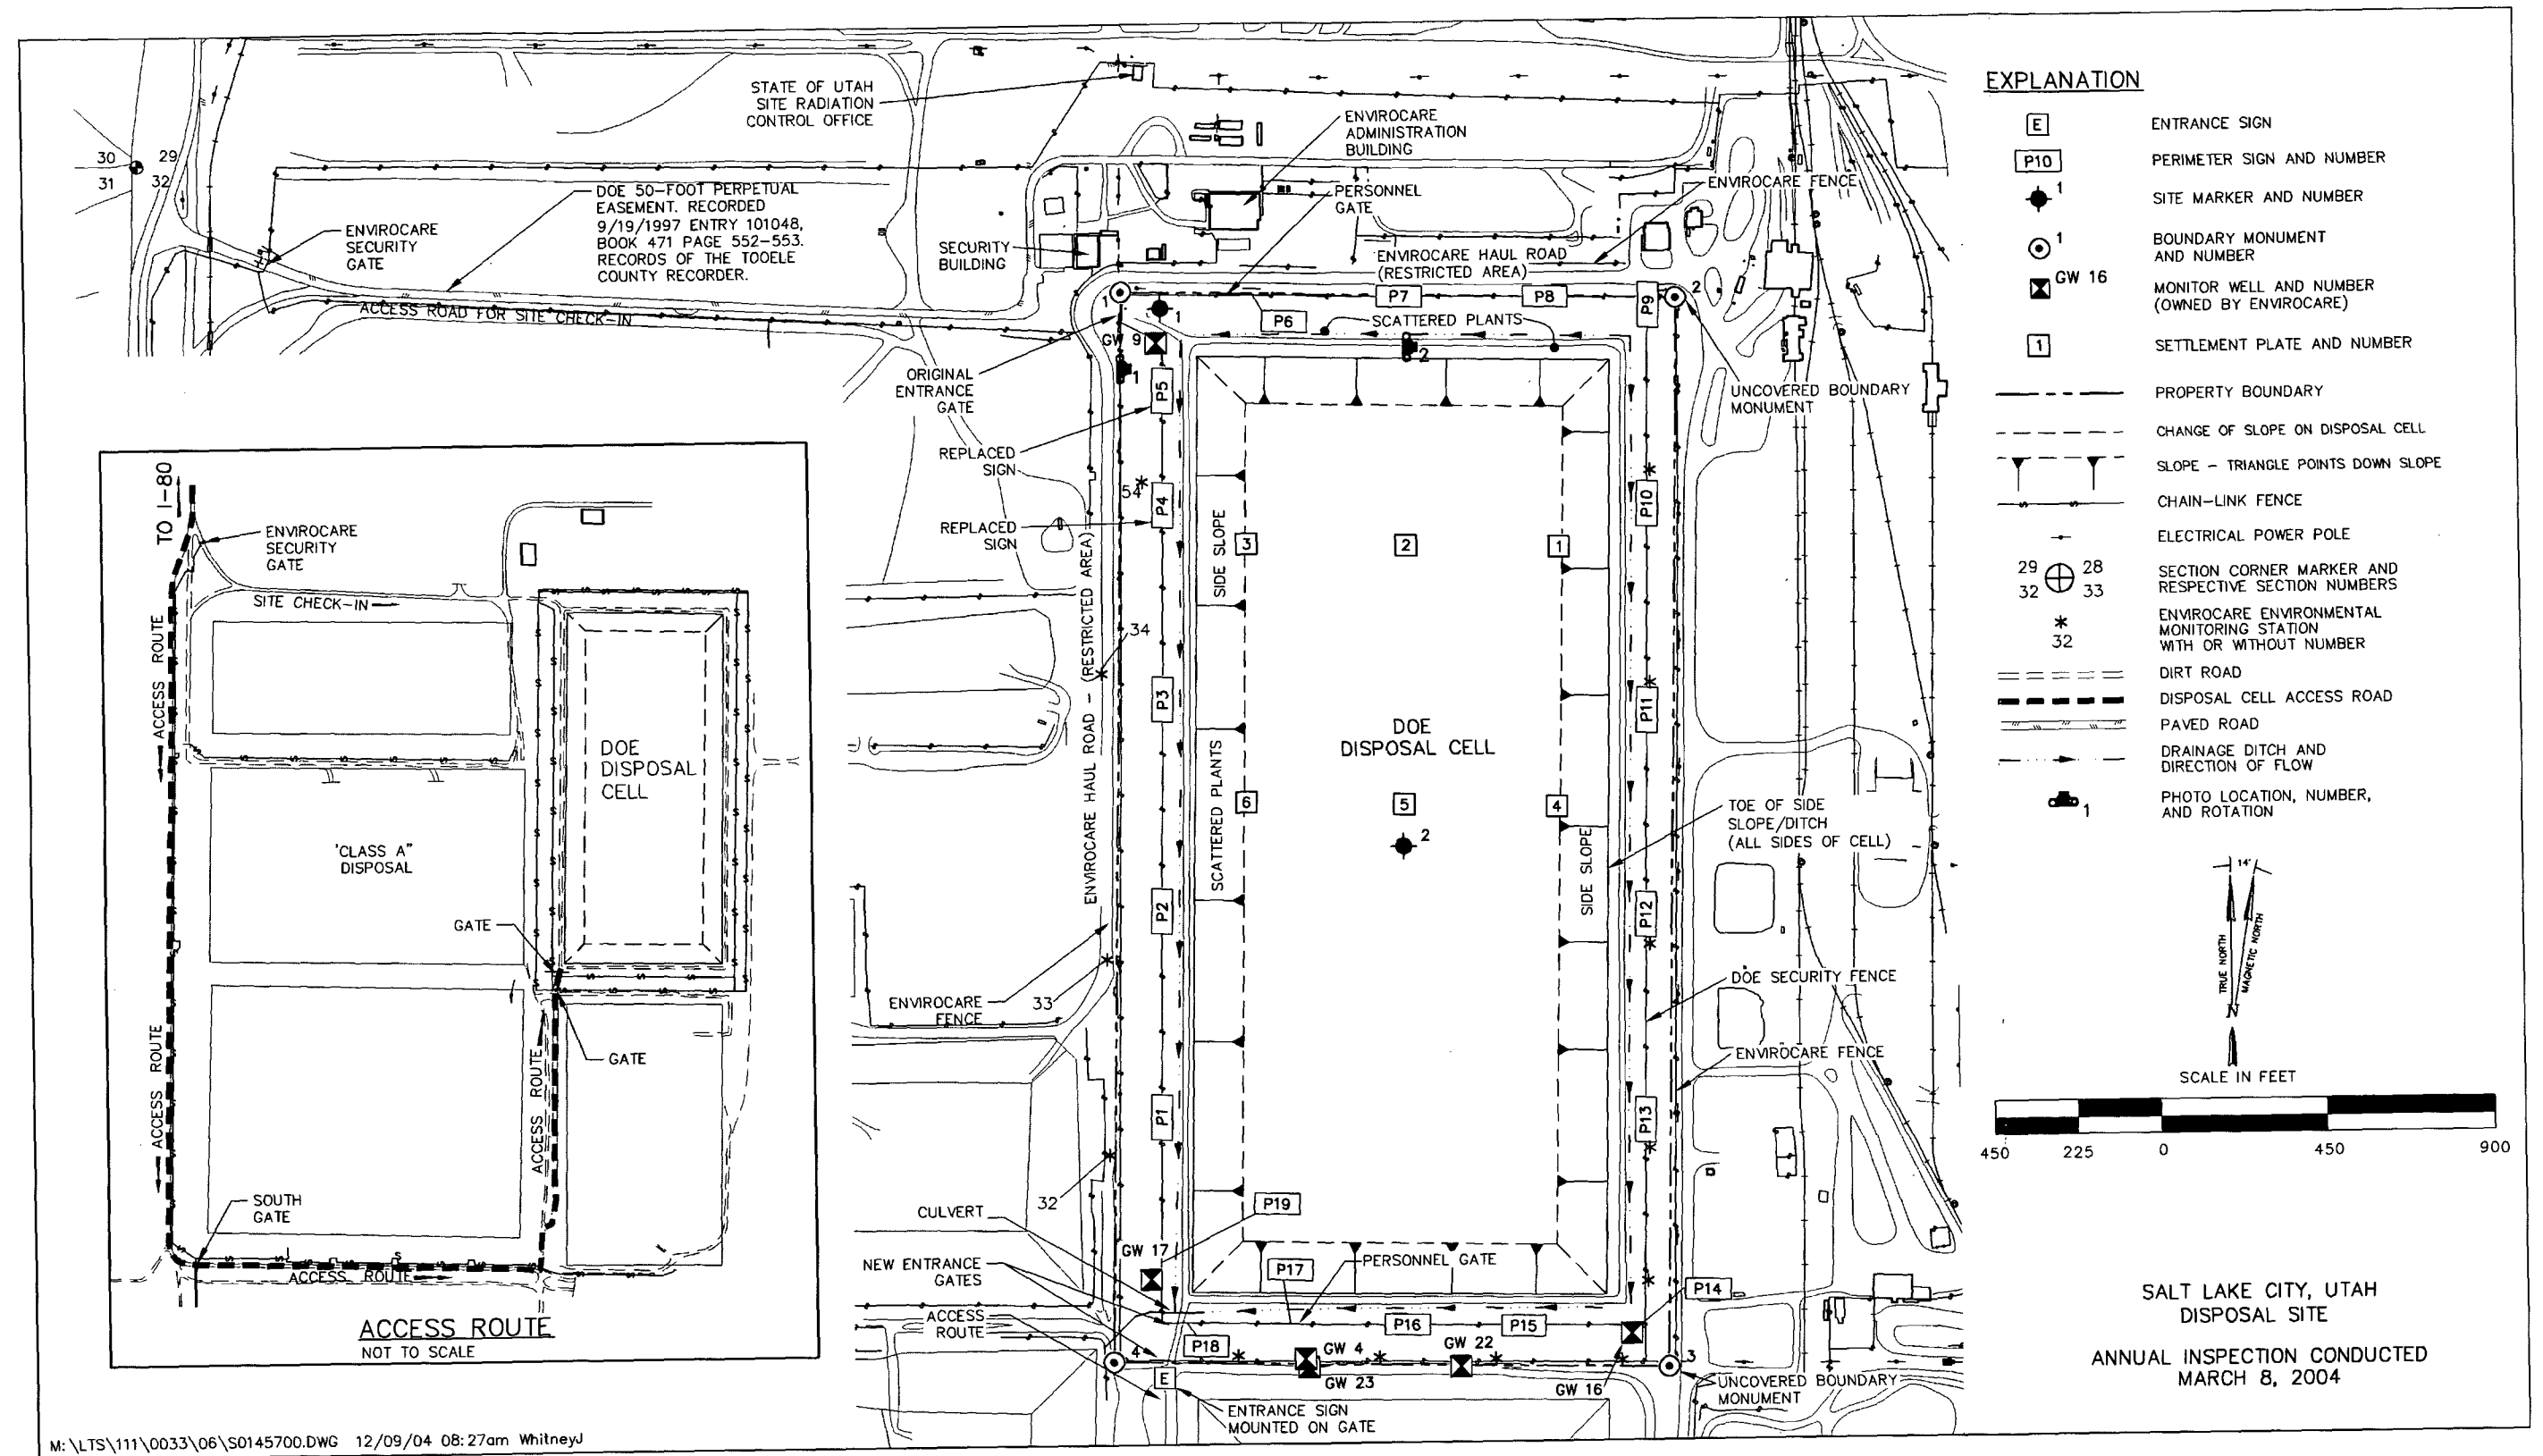
Figure 15-1. 2004 Annual Compliance Drawing for the Salt Lake (South Clive), Utah, Disposal Site

Top and Side Slopes of the Disposal Cell—The top and side slopes of the disposal cell are armored with riprap and were in excellent condition. Inspectors found no evidence of settling, slumping, or instability on the side slopes. Sparse vegetation was present on the side slopes but currently does not pose a problem.

Area Between the Disposal Cell and the Site Boundary—The area between the toe of the disposal cell and the security fence was inspected. Water was present in the toe drain along the southeast corner of the cell. All perimeter ditches were in good condition. Minor plant encroachment has occurred in the northern and southern ditches, however these plants do not degrade the function of the ditches (PL-2).
