**U.S. Department of Energy
Office of Legacy Management**

2004 Annual Site Inspection and Monitoring Report for Uranium Mill Tailings Radiation Control Act Title I Disposal Sites

December 2004

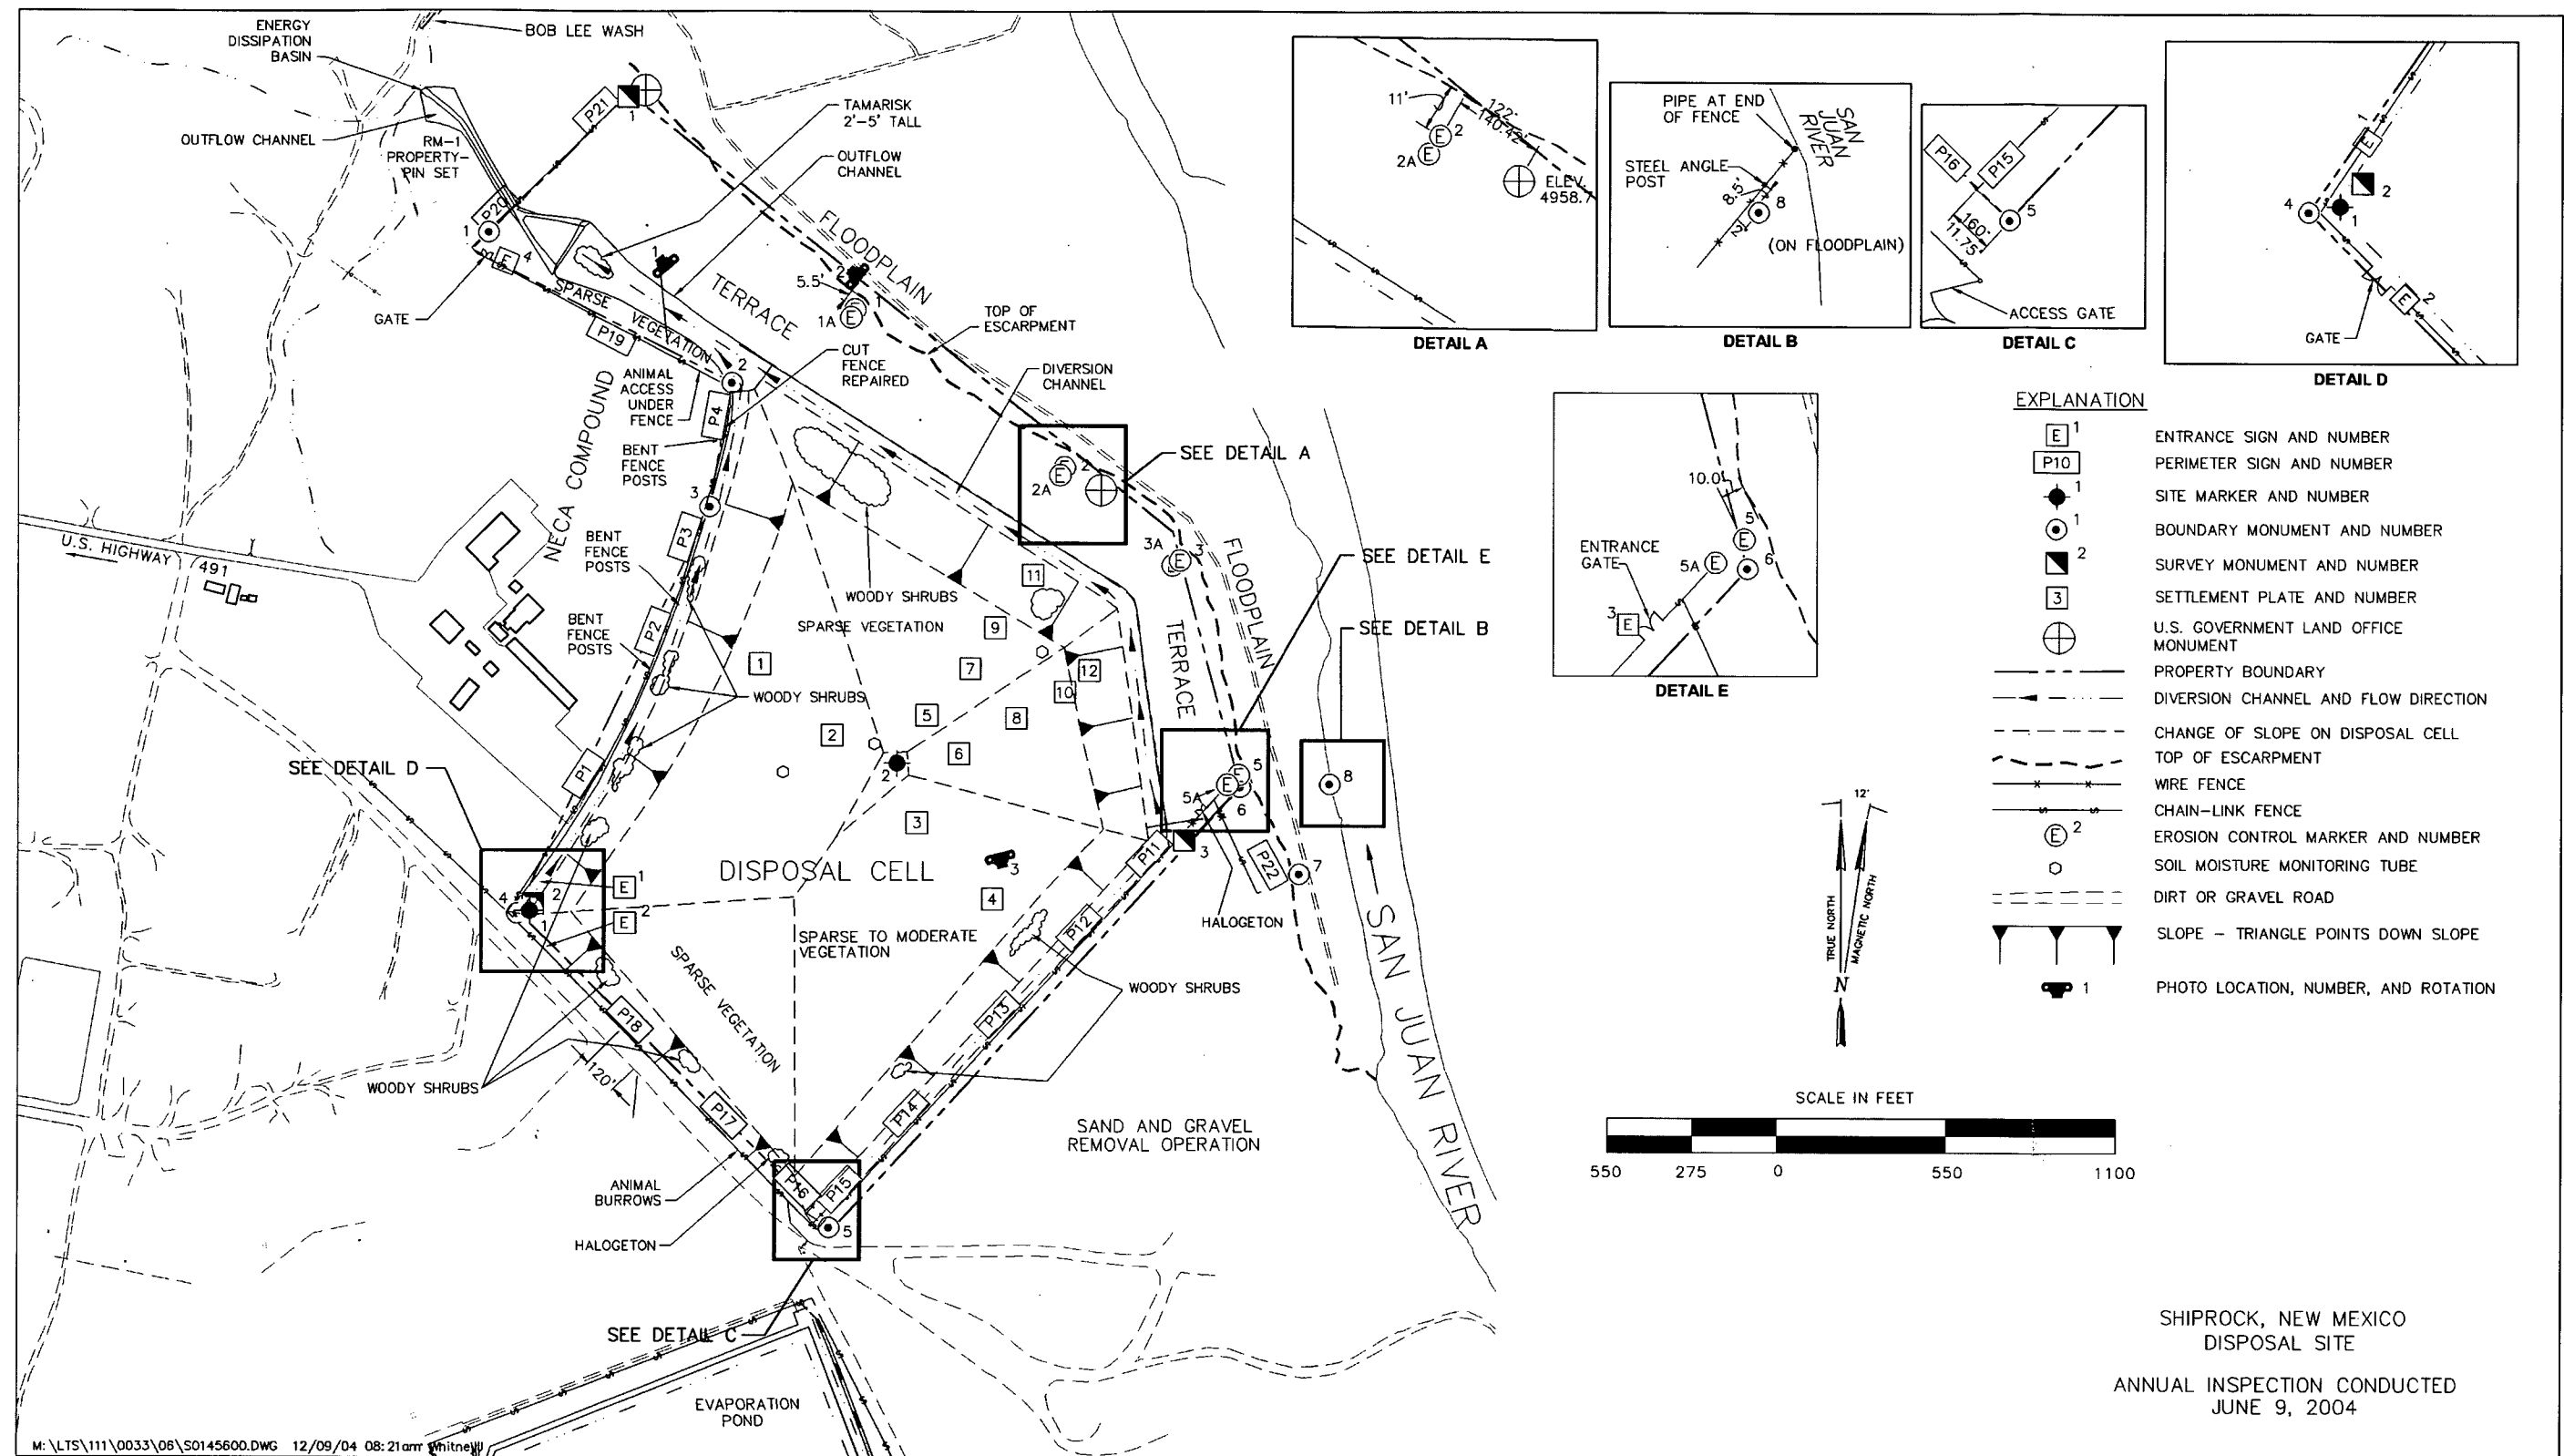
Figure 16-1. 2004 Annual Compliance Drawing for the Shiprock, New Mexico, Disposal Site

Disposal Cell, Diversion Channels, and Outflow Channel—The top and side slopes of the cell, covered with rock riprap, were in good condition. No evidence of settling, erosion, or animal burrowing was found.

16C Significant vegetation growth has been noted during past inspections on the cell top and the east, northeast, and northwest side slopes. These areas were sprayed in June 2004 in a continuing effort to reduce the seed source and control future plant encroachment on the disposal cell. Numerous patches of annual grasses and weeds were present on the cell top and the side slopes,

and the population of woody shrubs growing on the cell side slopes continues to increase. DOE is currently studying the effect of plant encroachment on the cell to evaluate the need for vegetation control.

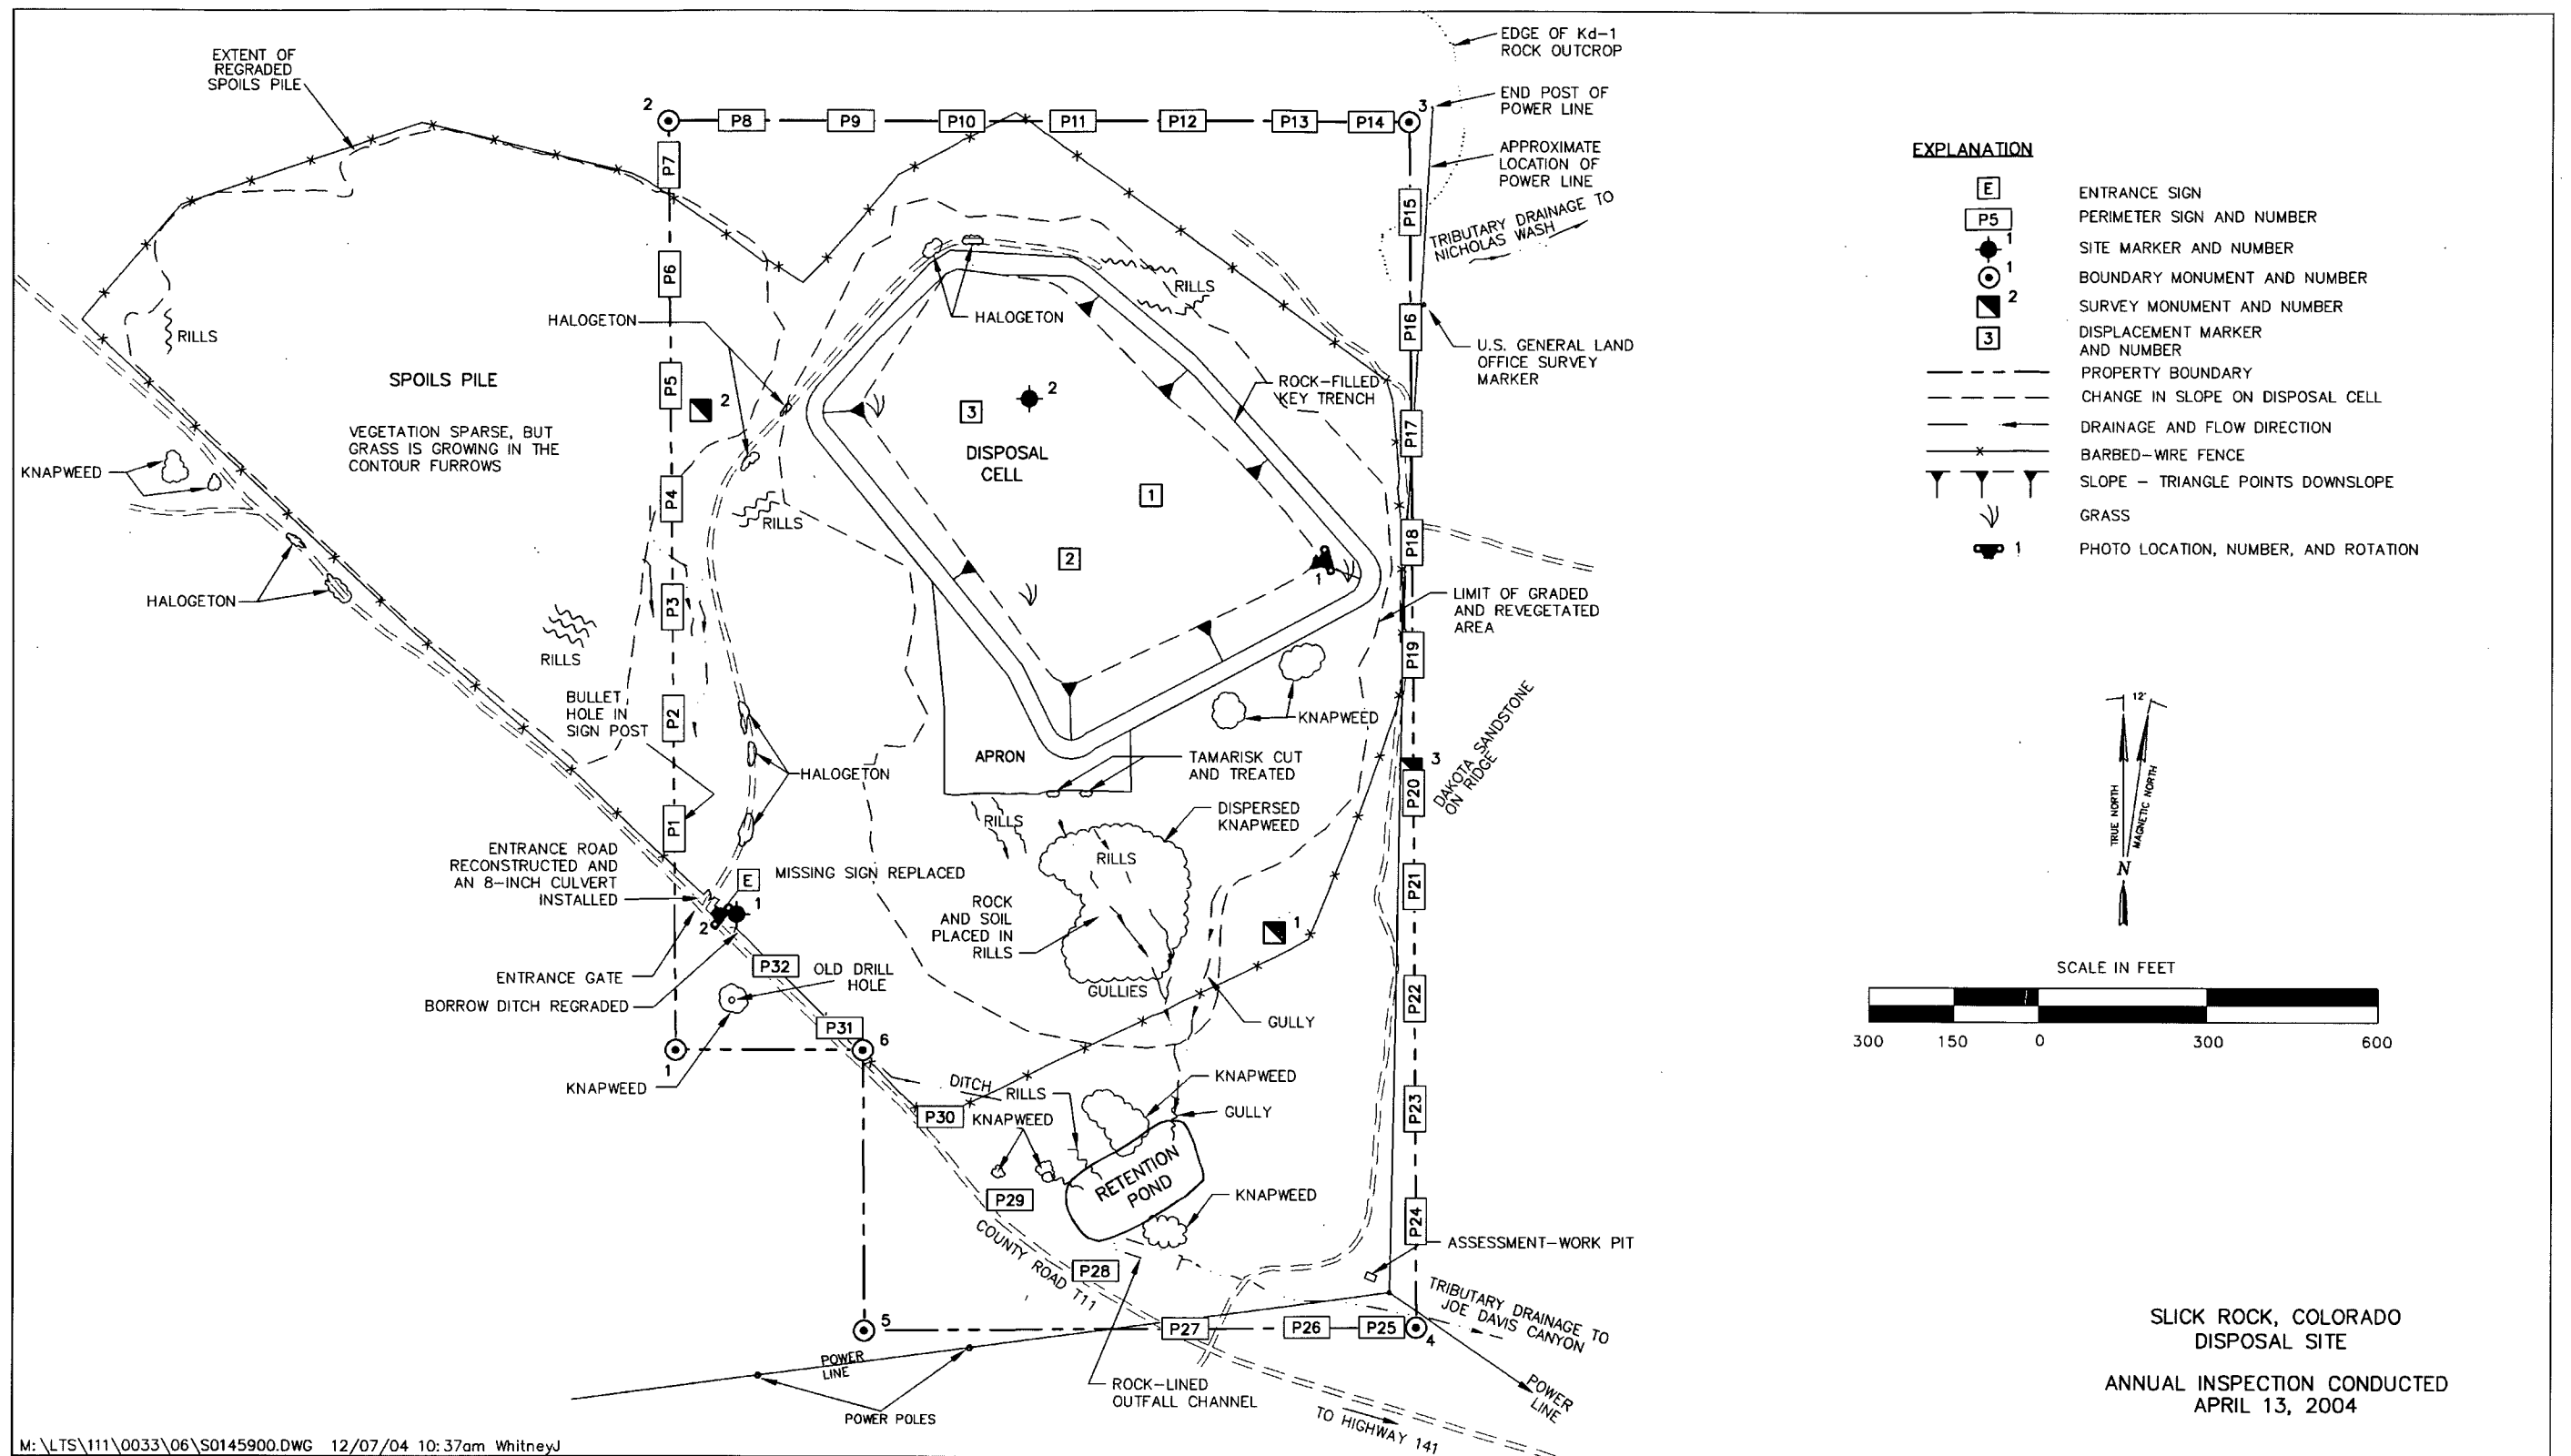
Disposal Cell, Side Slopes, Key Trench, and Apron—Rock covering the disposal cell, key trench, and apron is rounded cobble- and pebble-sized material. The rock was in excellent condition. No evidence of settling, slumping, or erosion was seen on any of the rock-covered surfaces of the disposal cell (PL-1).

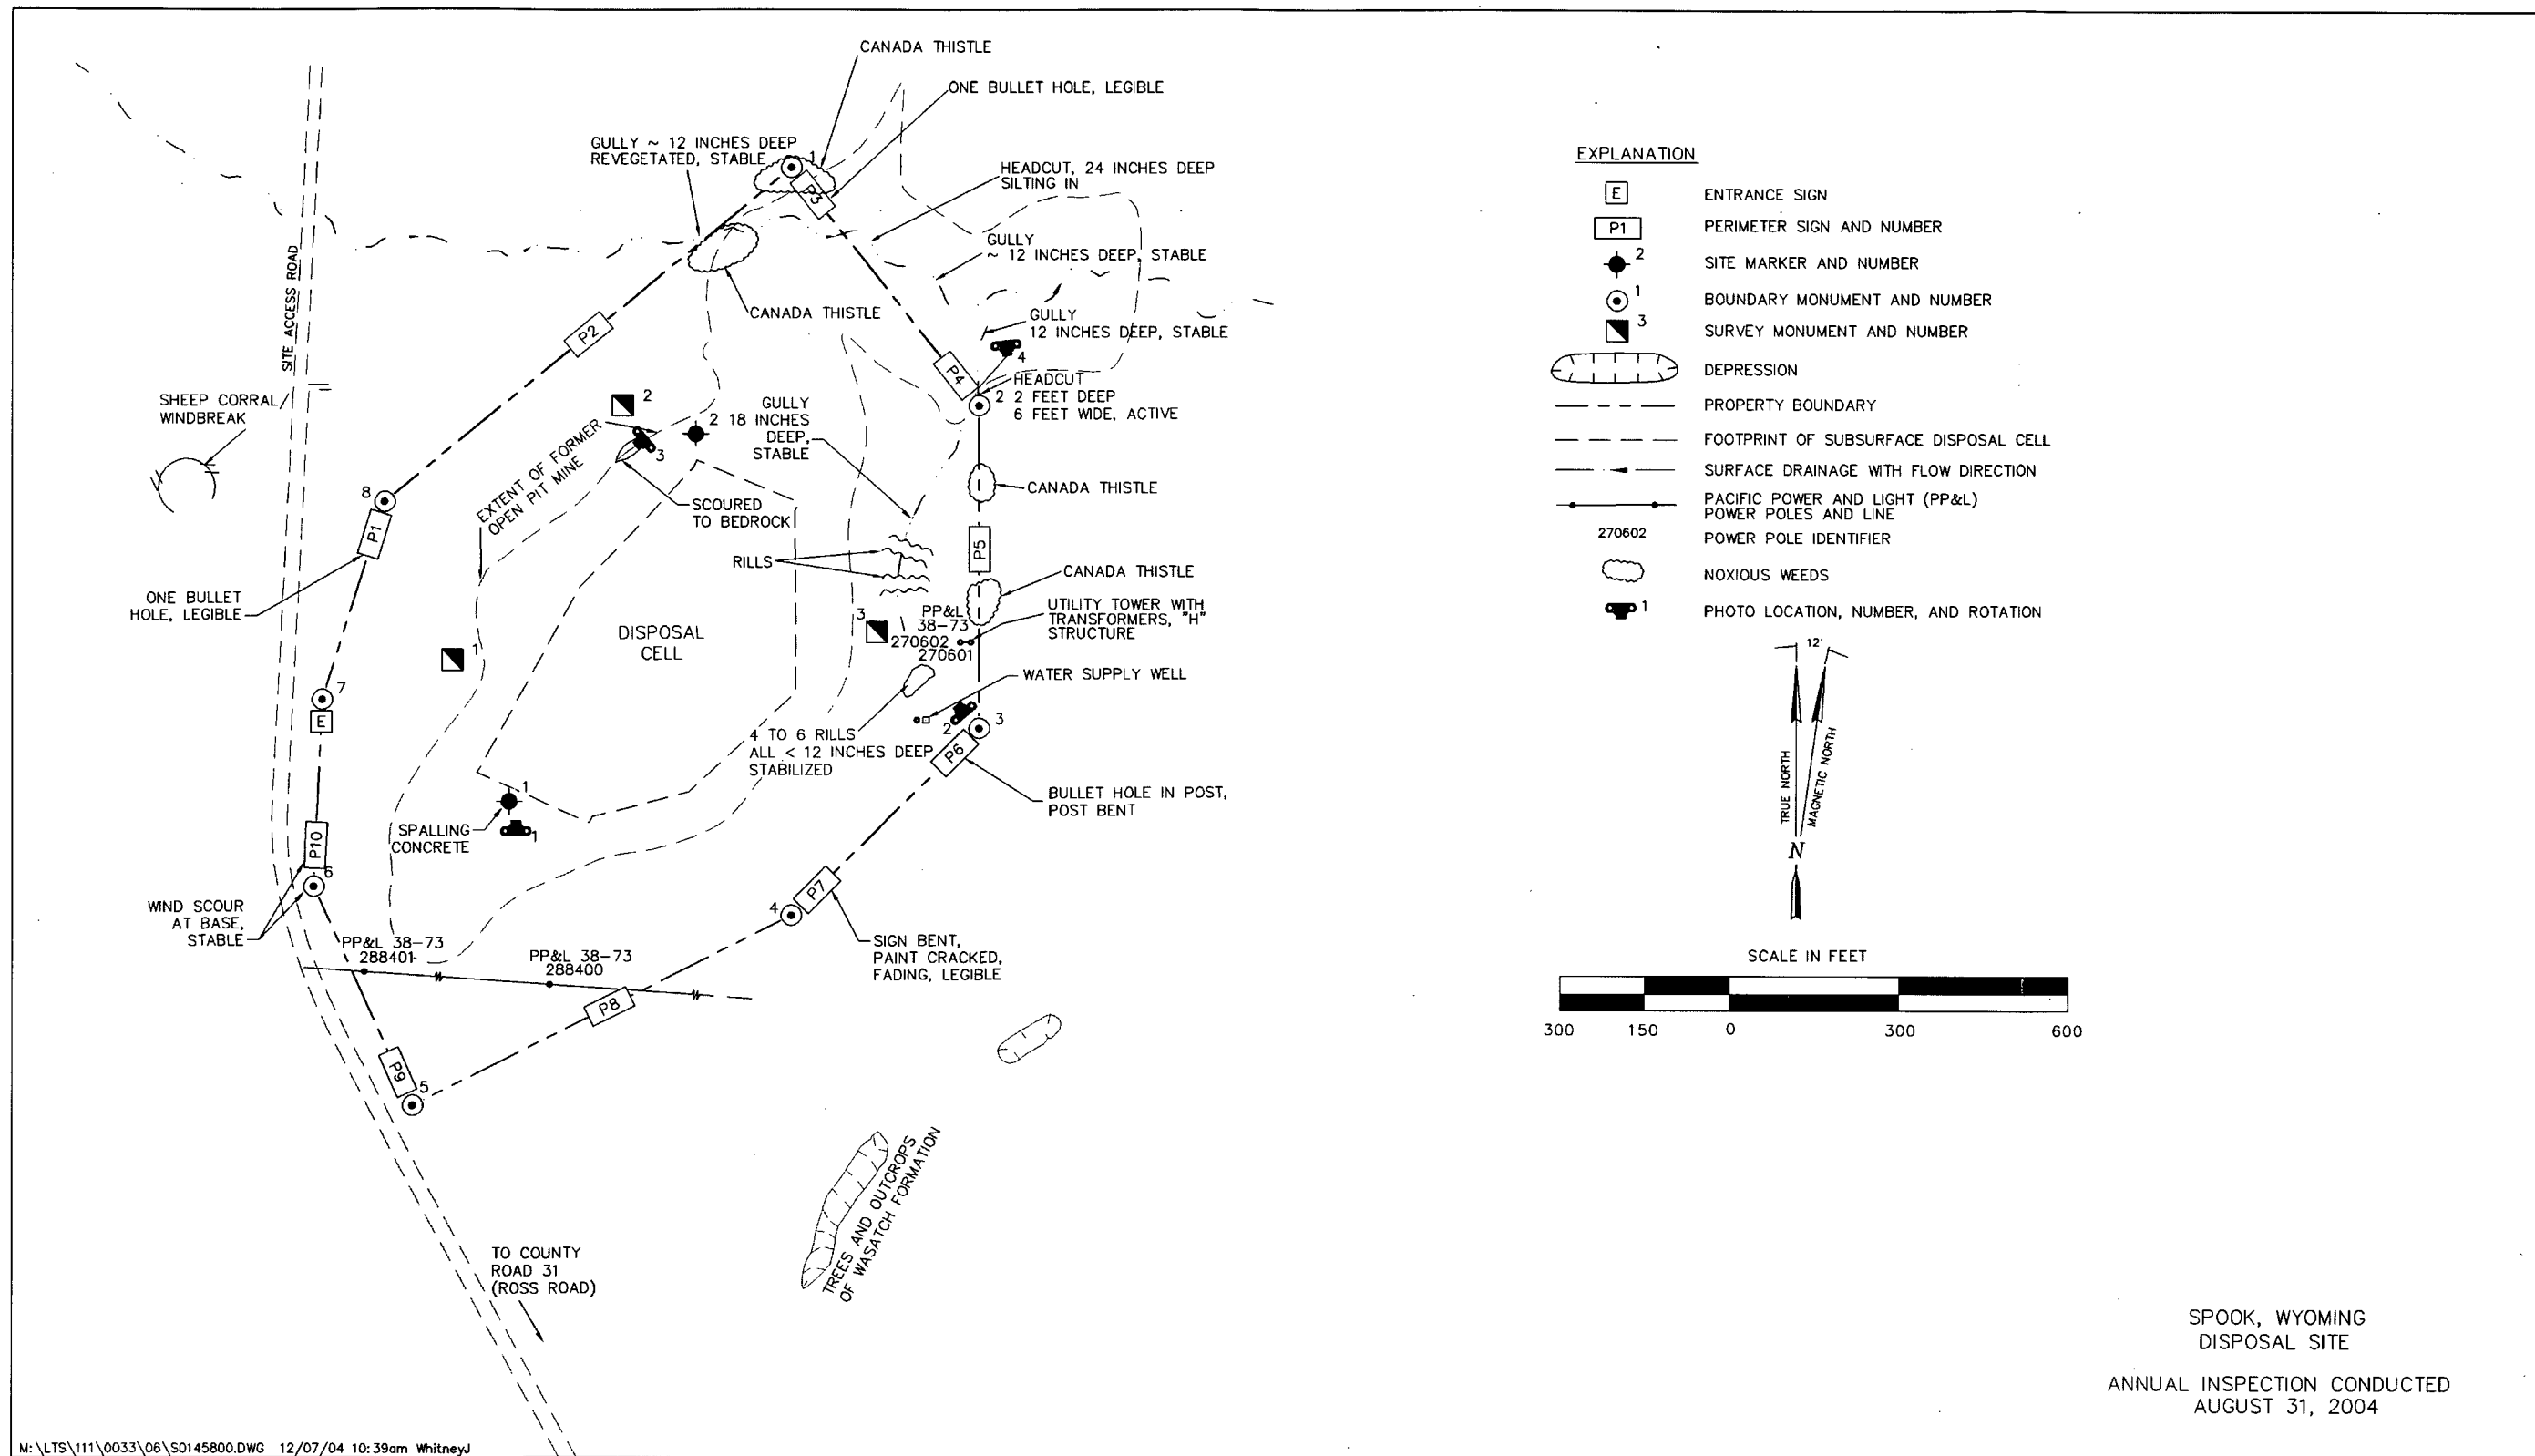
Figure 18-1. 2004 Annual Compliance Drawing for the Spook, Wyoming, Disposal Site

The site, located in north central Converse County, Wyoming, was inspected on August 31, 2004. Results of the inspection are described below. Features and the photograph locations (PLs) mentioned in this report are shown on Figure 18-1. The number in the left margin of this report refers to items summarized in the Executive Summary table.

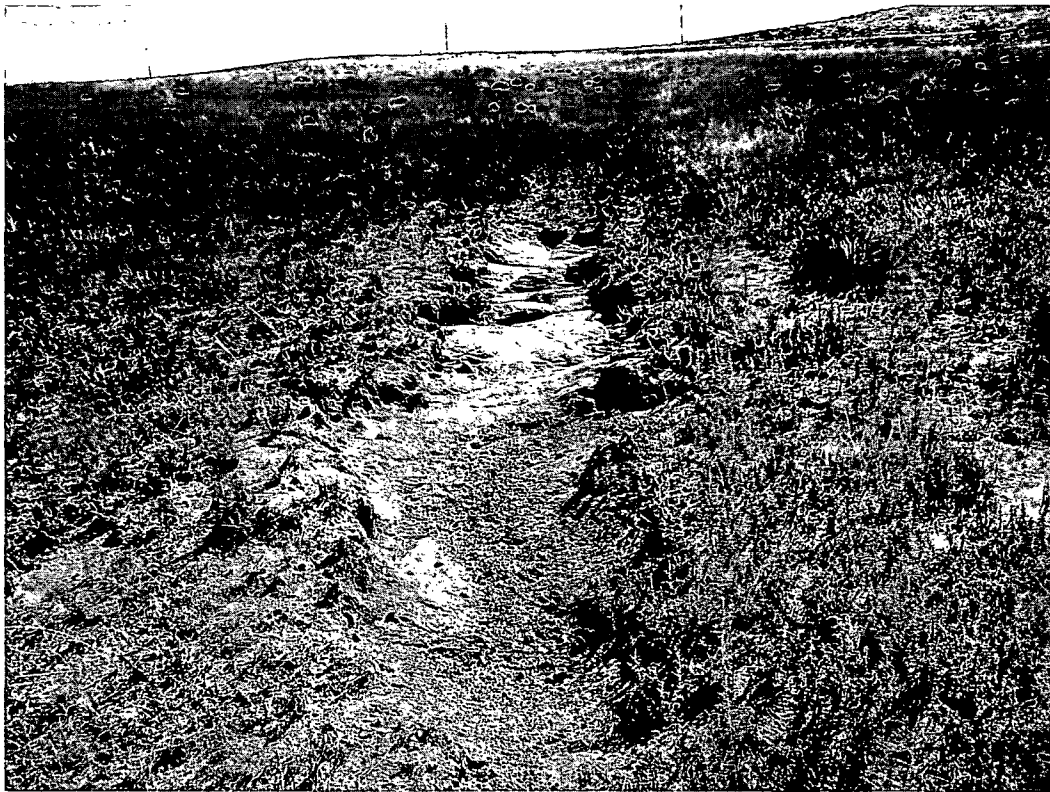
Most erosion features observed during previous inspections within the property boundary have stabilized, as indicated by vegetation growing in the channels. A gully has scoured to bedrock in the northwest portion of the site (PL-3) and several small rills were noted along the east side of the site, but these erosion features are not adversely impacting the site.

SPK 8/2004. PL-3. Erosion feature scoured to bedrock adjacent to the cell cover.

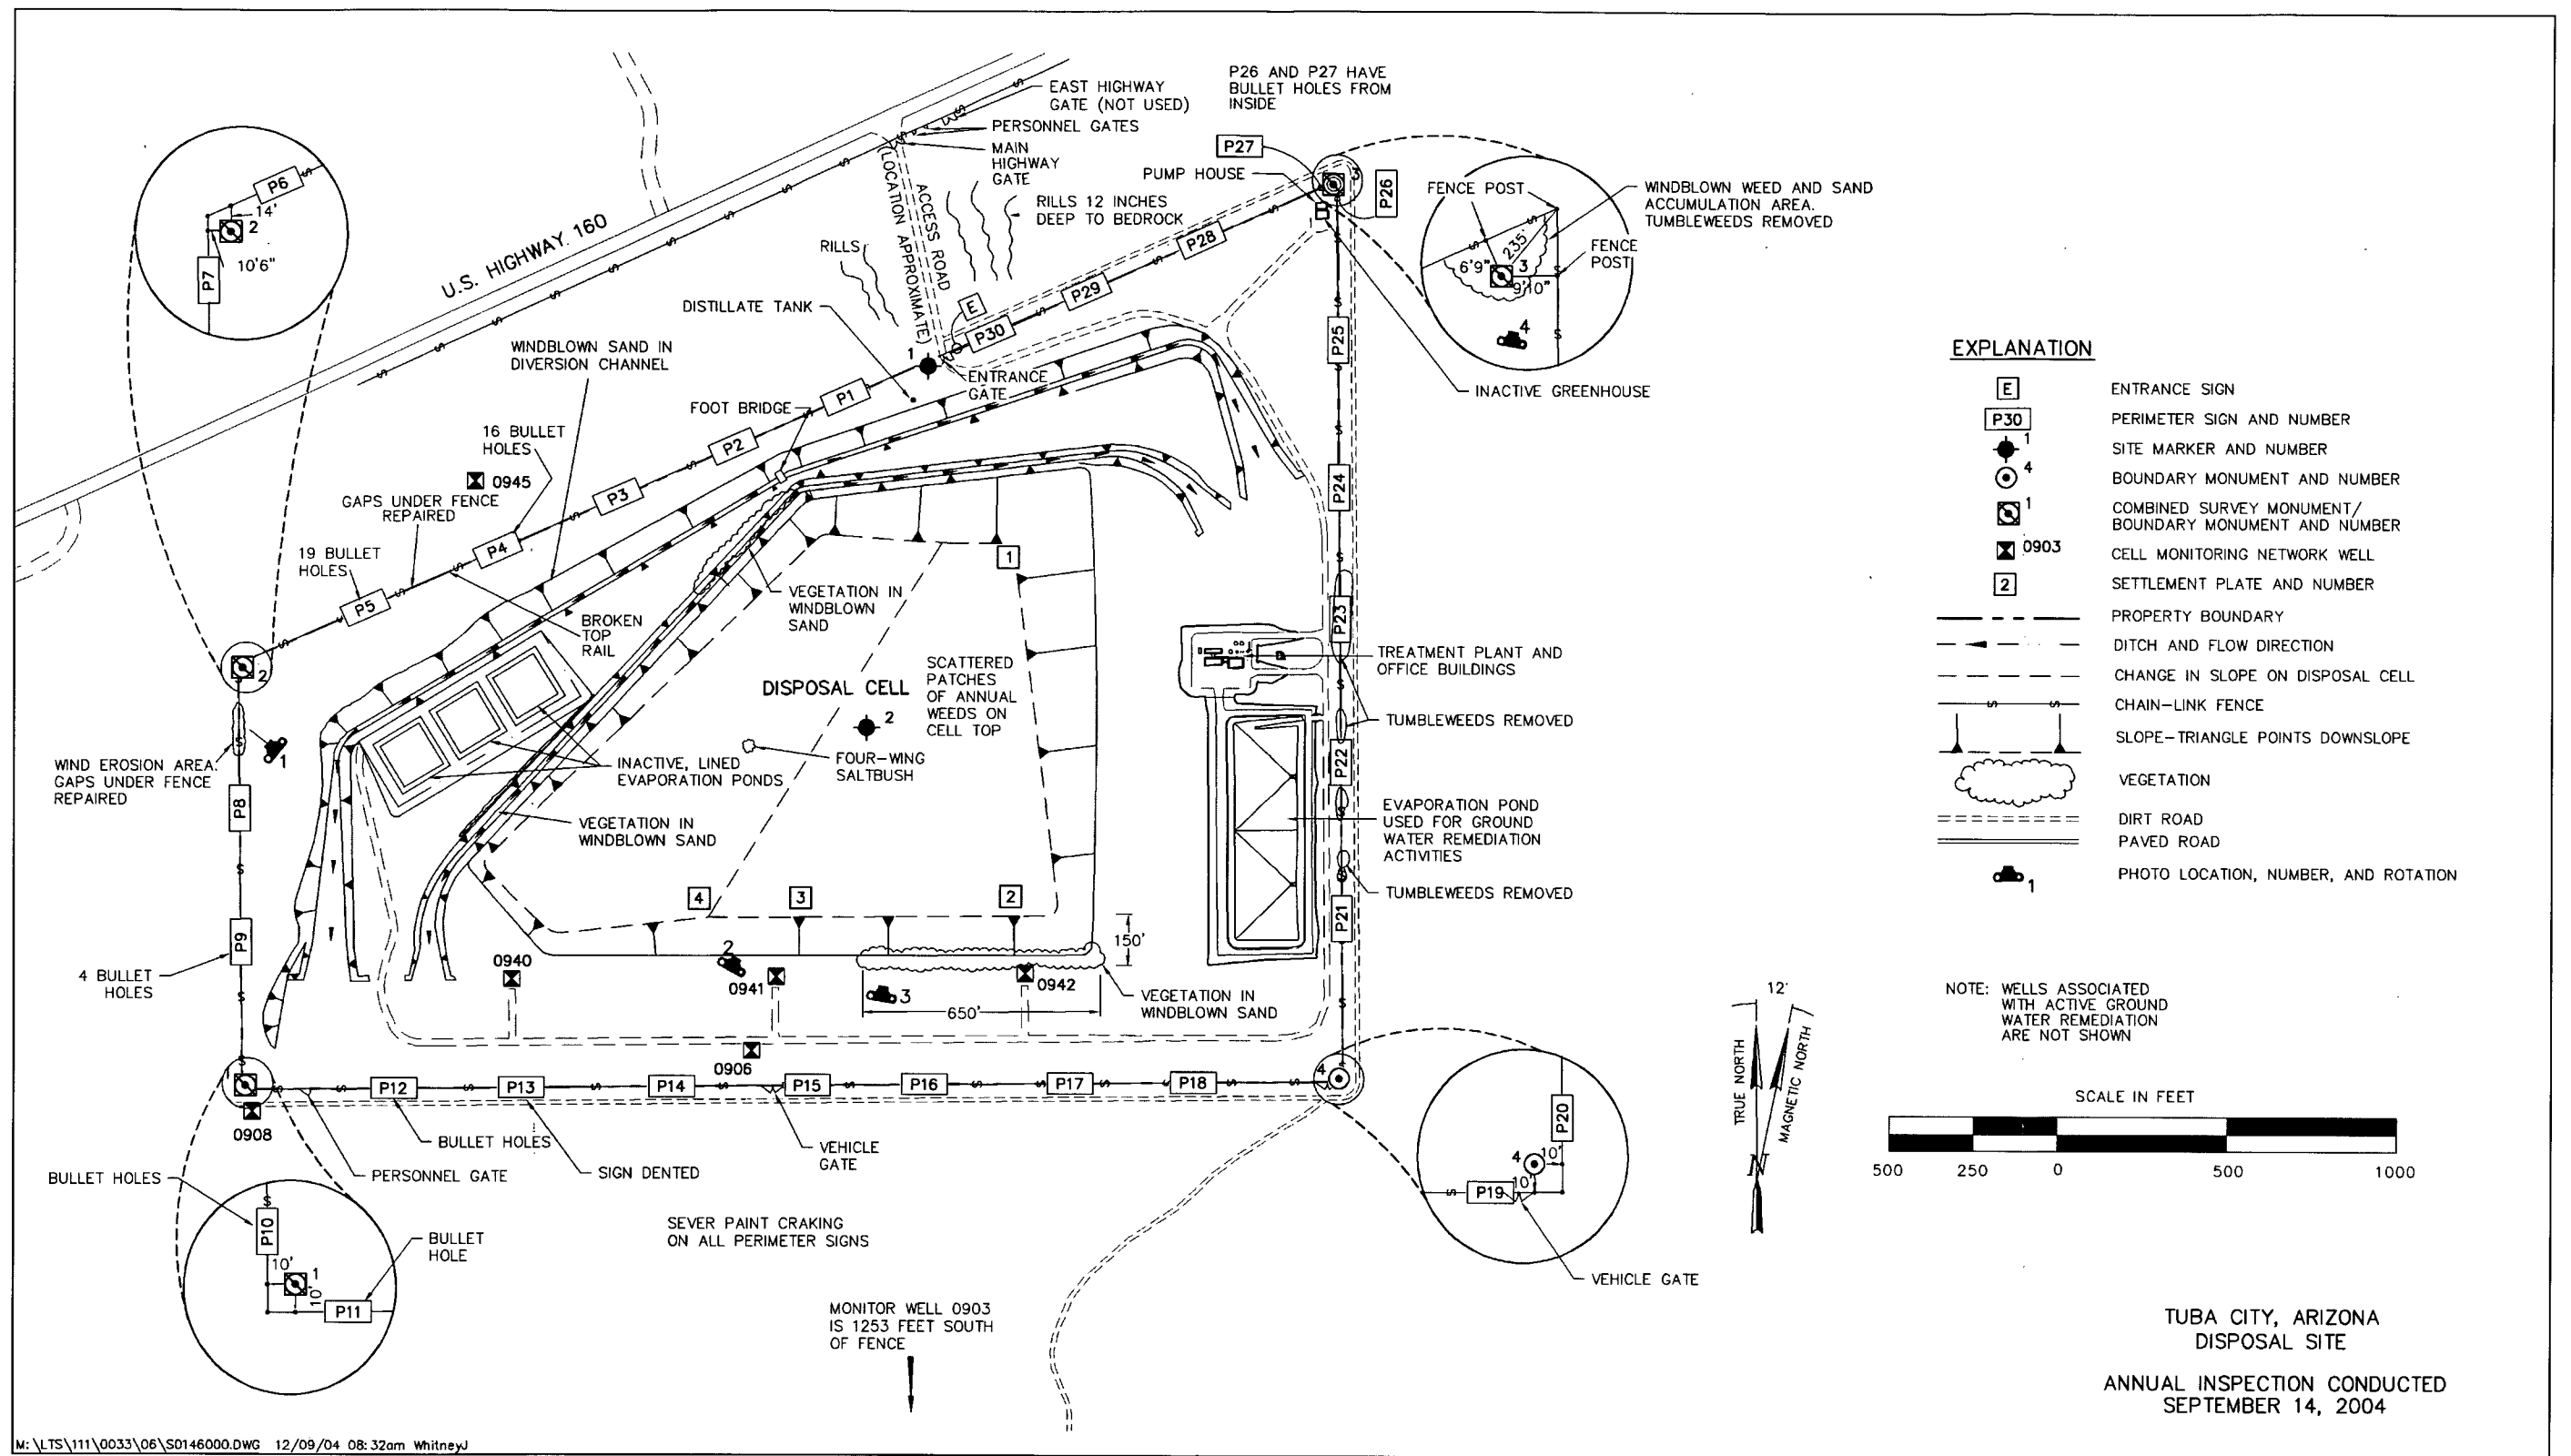
Figure 19-1. 2004 Annual Compliance Drawing for the Tuba City, Arizona, Disposal Site

The site, located east of Tuba City, Arizona, was inspected on September 14, 2004. Results of the inspection are described below. Features and photograph locations (PLs) mentioned in this report are shown on Figure 19-1. Numbers in the left margin of this report refer to items summarized in the Executive Summary table.
