UNITED STATES OF AMERICA
NUCLEAR REGULATORY COMMISSION

(License Renewal for the Oyster Creek
Nuclear Generating Station))

Docket No. 50-0219-LR

**CITIZENS' INITIAL STATEMENT REGARDING RELICENSING OF OYSTER
CREEK NUCLEAR GENERATING STATION**

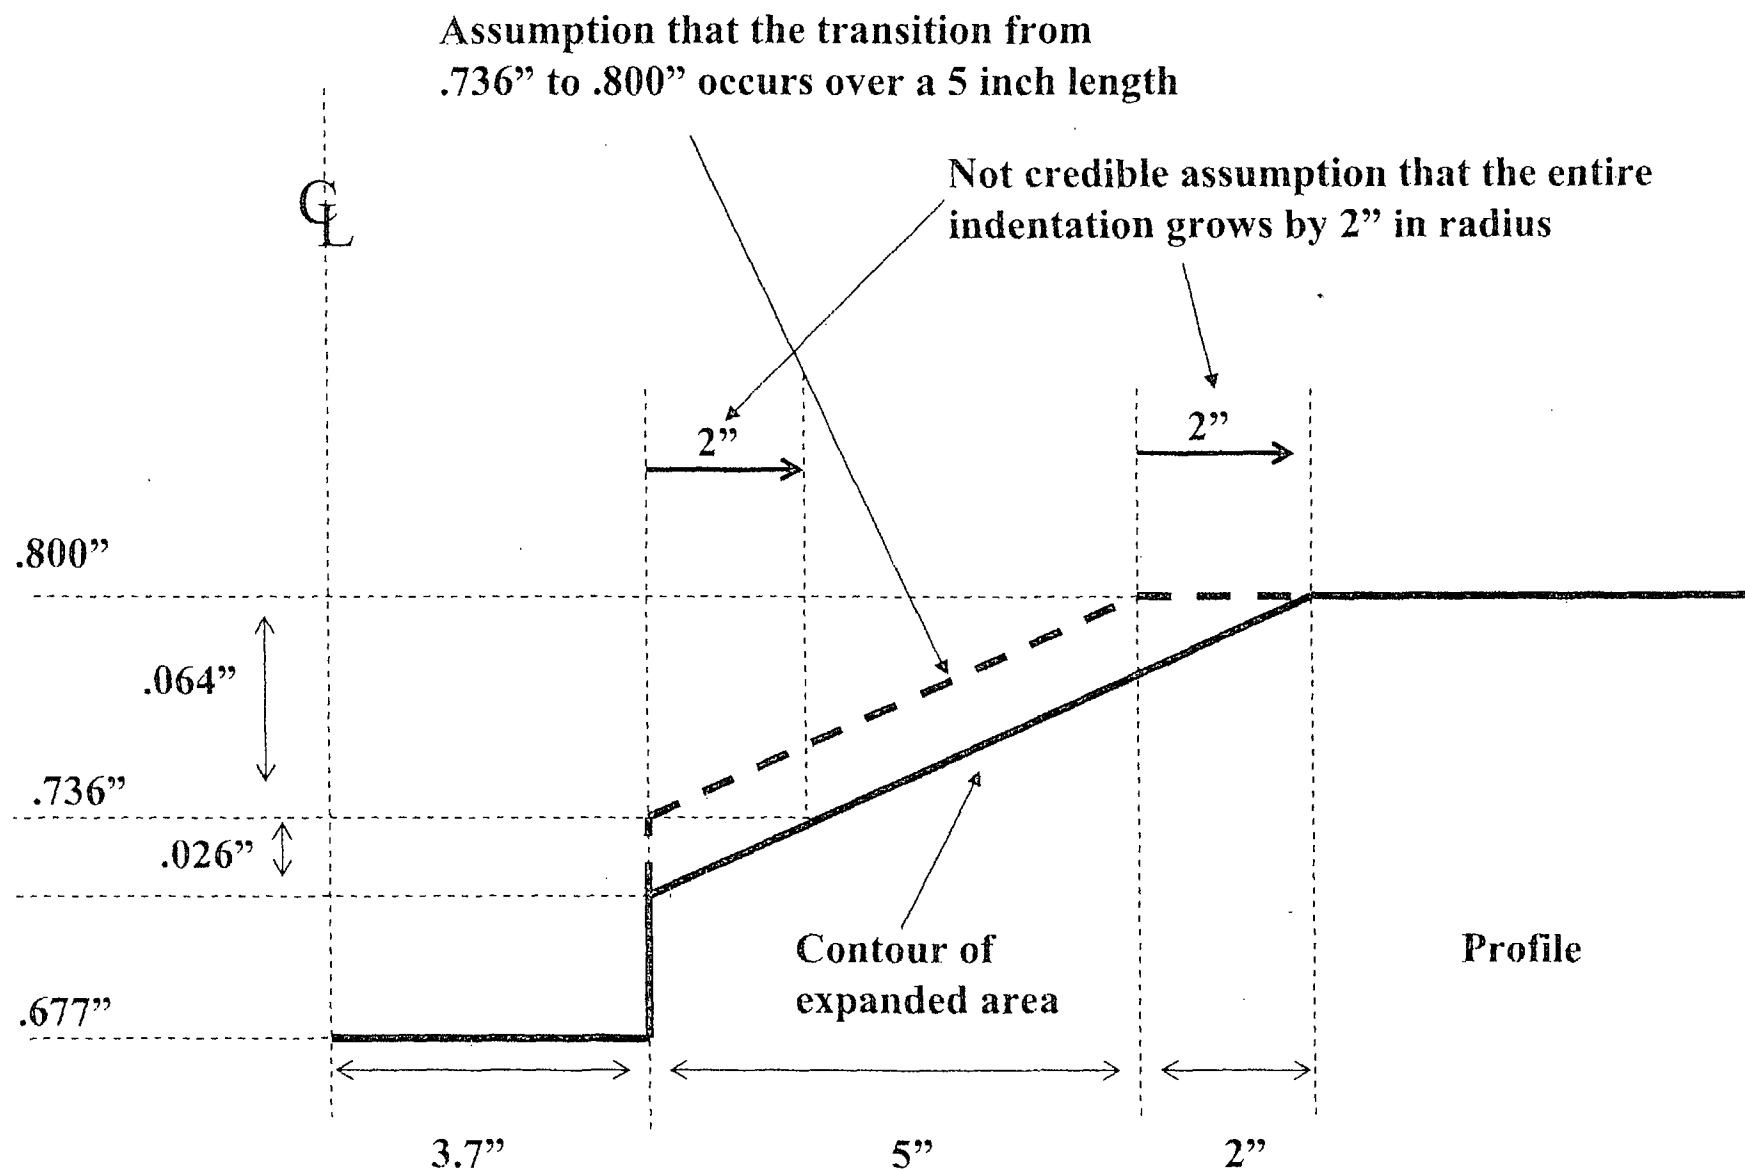
Regardless, by expanding the radius of the indentation by 2", the diameter of the indentation would increase by 4", for a total diameter of 21.7" (this is larger than Dr. Hausler's memo which mentions 17.4" diameter). I have created Figure 3 to show the increase of the radius of the hypothetical indentation by 2".

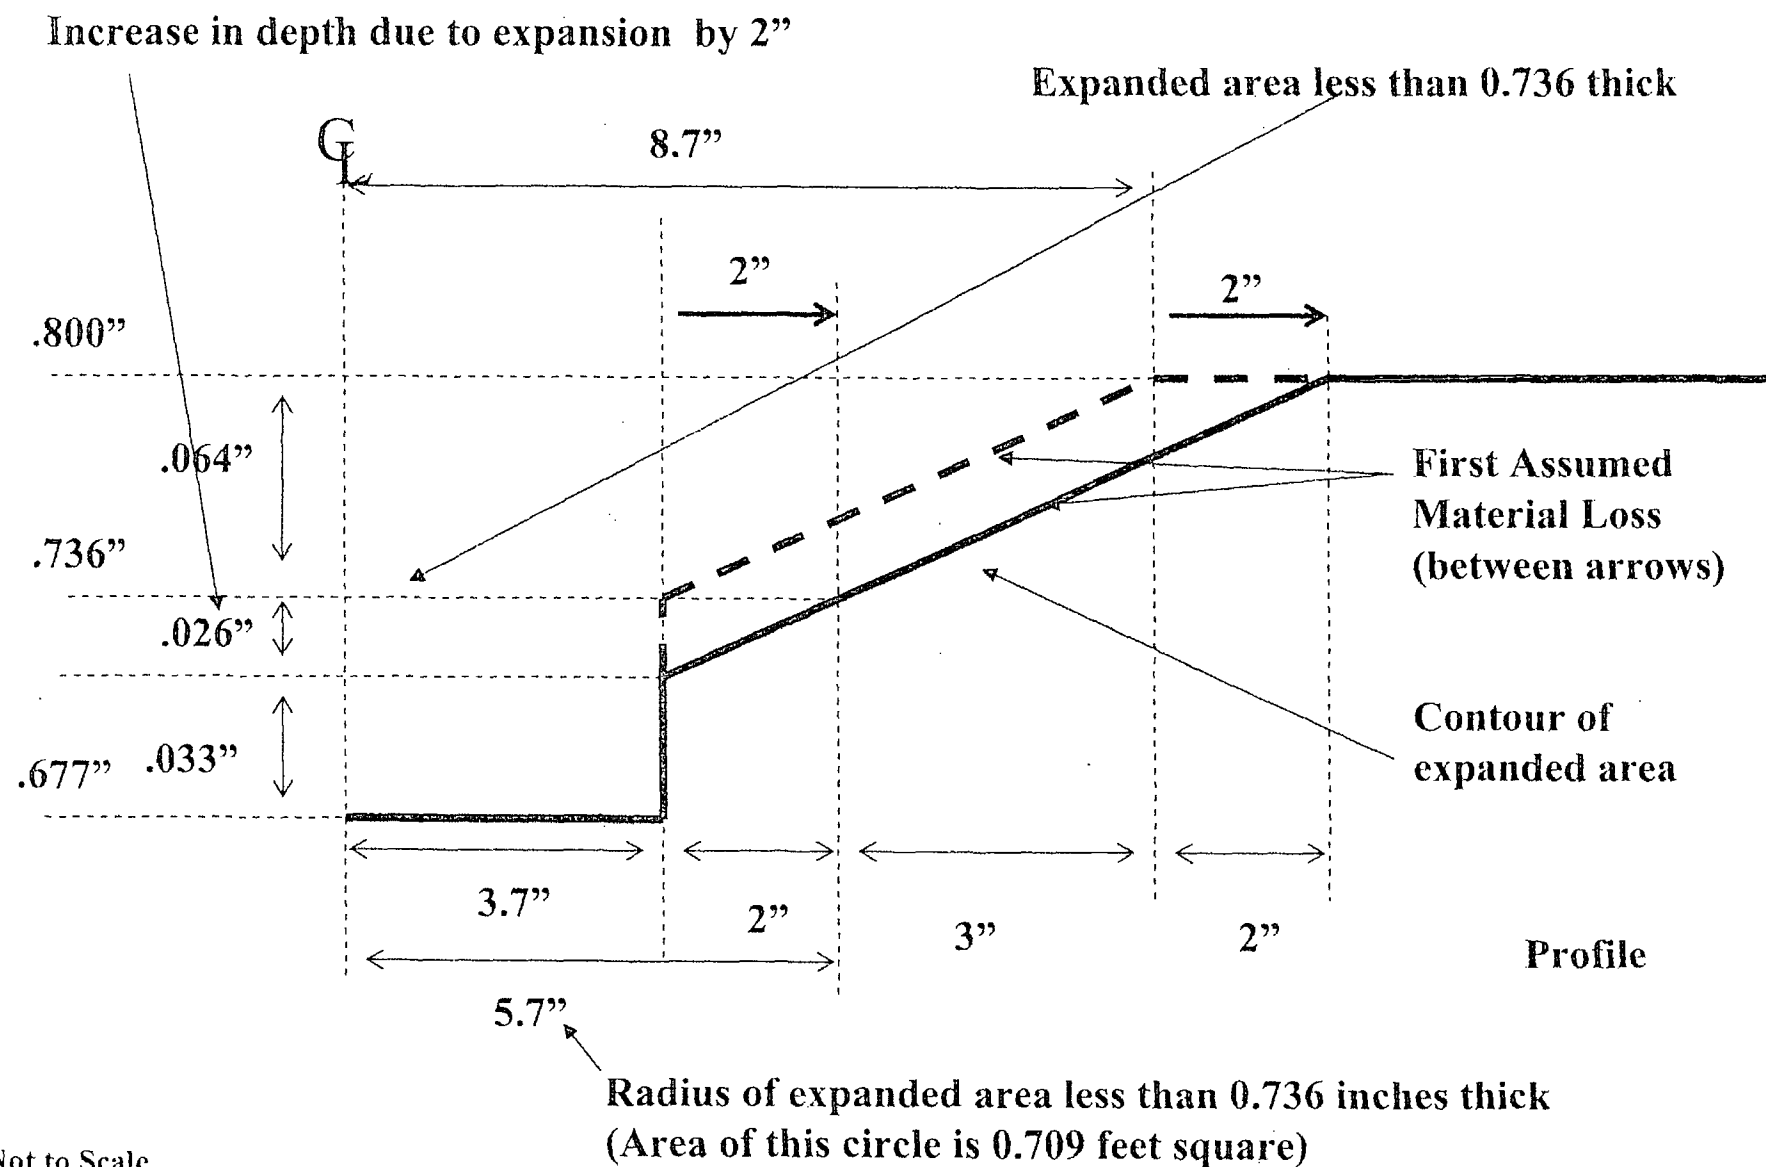
Figure 4

34. First, this conclusion is proved false by Dr. Hausler's own model. The radius of the expanded area less than 0.736" (shown on Figure 4) is 5.7". Simply calculating the area of a 5.7" radius circle results in 0.709 square feet. This value is significantly less than the 1.6 square foot value that Dr. Hausler offers.

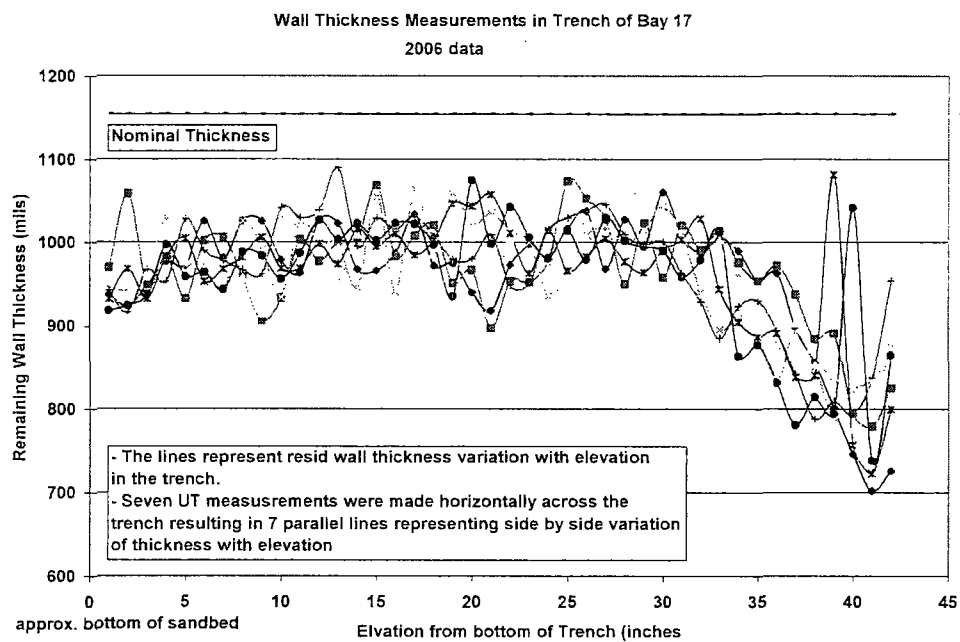
In Figure 3 an effort is being made to compare the average remaining wall thickness from trench measurements (averaged over the horizontal direction) with the average of the 6 by 6 grid measurement from the inside and the direct UT measurements from the outside. Also graphed in this figure are the averages of the outside measurements for the three zones for which data are reported (Ref. 5). What one can see is that the averages for the grid and the trench data overlap quite well at the same elevation. However, the average outside measurements are significantly lower at comparable elevations.⁴⁾ This is probably because the choice of location for the external measurements was deliberately biased towards thin spots.

Comparison of Various Thickness Measurements in Bay 17
2006 data

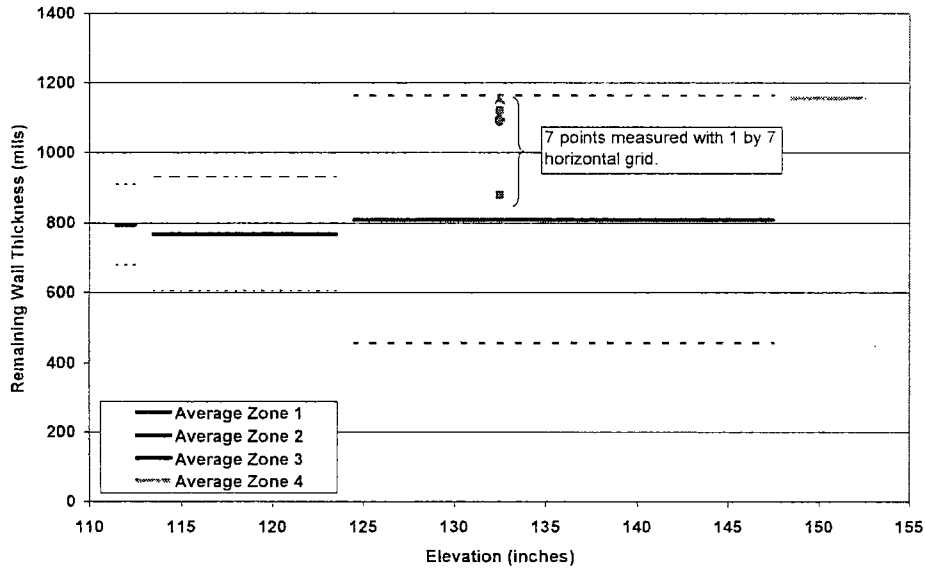
Figure 7

It was found that there is no significant effect of the time (Fig.7a). While there is a decrease of 19 mils between 1992 and 2006, this difference is not statistically significant within the variability of the data. The differences between the zones, however are significant. Zone 2 is by far the most corrosive zone. When the bays are compared, one finds as expected that some bays have experienced little corrosion in contrast to others. The importance of these observations is obvious: they point again to the fact that the intensity of corrosion is a clear function of elevation and bay. Hence, averaging data and generalization may lead to doubtful conclusions.

Statistical Analysis of all External UT Measurements

Figure 7a: Comparison between measurements I 1992 and 2006 show no significant difference. The mea 1992 and 2006 show a bias of 0.018 inches, but the bias is statistically not significant despite of the many points. Fig. 7b: The comparison between the "zones" (elevations) is significant. Zones 1 is significantly different from zones 2 and 3. For zone 4 there are not enough data for statistical significance. Fig. 7c: So bays, red ones, are significantly different from the black ones.

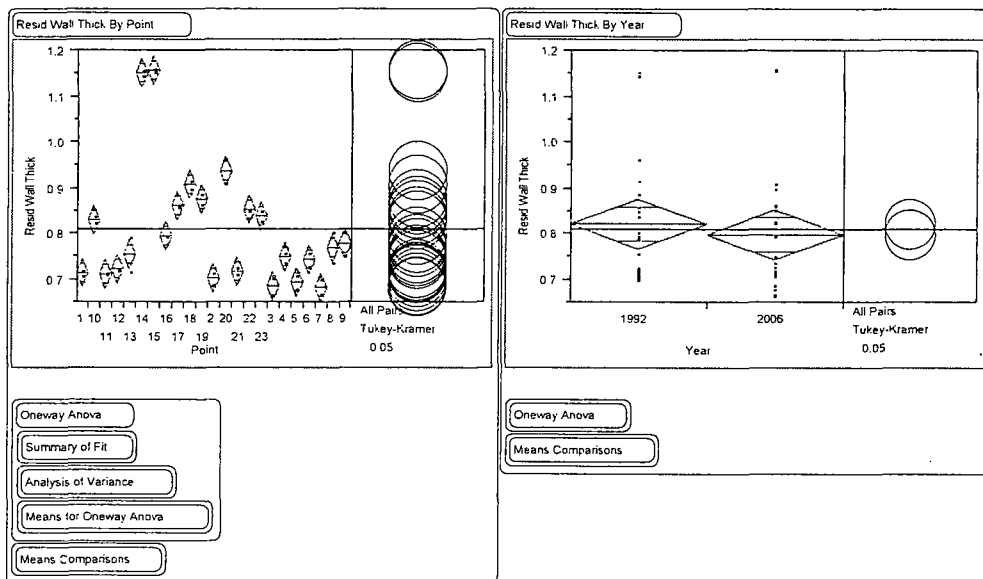
In 2006 the validity of some of the external UT measurements was explored by measuring around the nominal original locations. These data were statistically evaluated in Figures 8, 9, 10 for Bays 15, 1 and Bay 19. The additional data collected in Bays 19 and 15 had been identified as “up” or “down”, hence additional data sets

Figure 10: External UT measurements in Bay 19

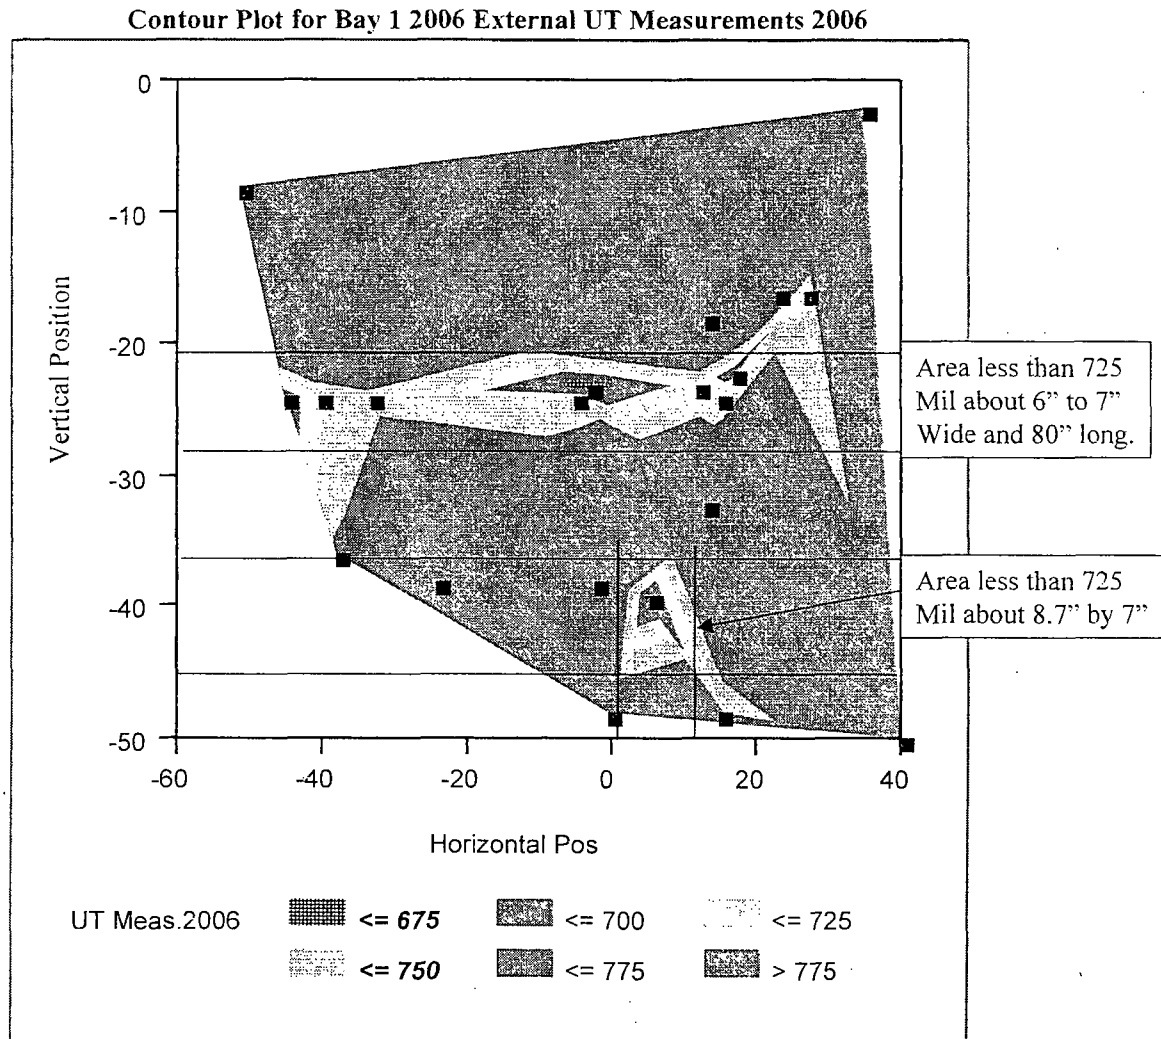
Figure 3 shows the contours for Bay 1 obtained with the data from the 2006 inspection. The general shapes are the same as in Figure 2 except that here we have sizeable areas with residual wall thicknesses below 725 mils. The unexpected thing is

Bay 1 Remaining Wall thickness
External UT Measurements 2006

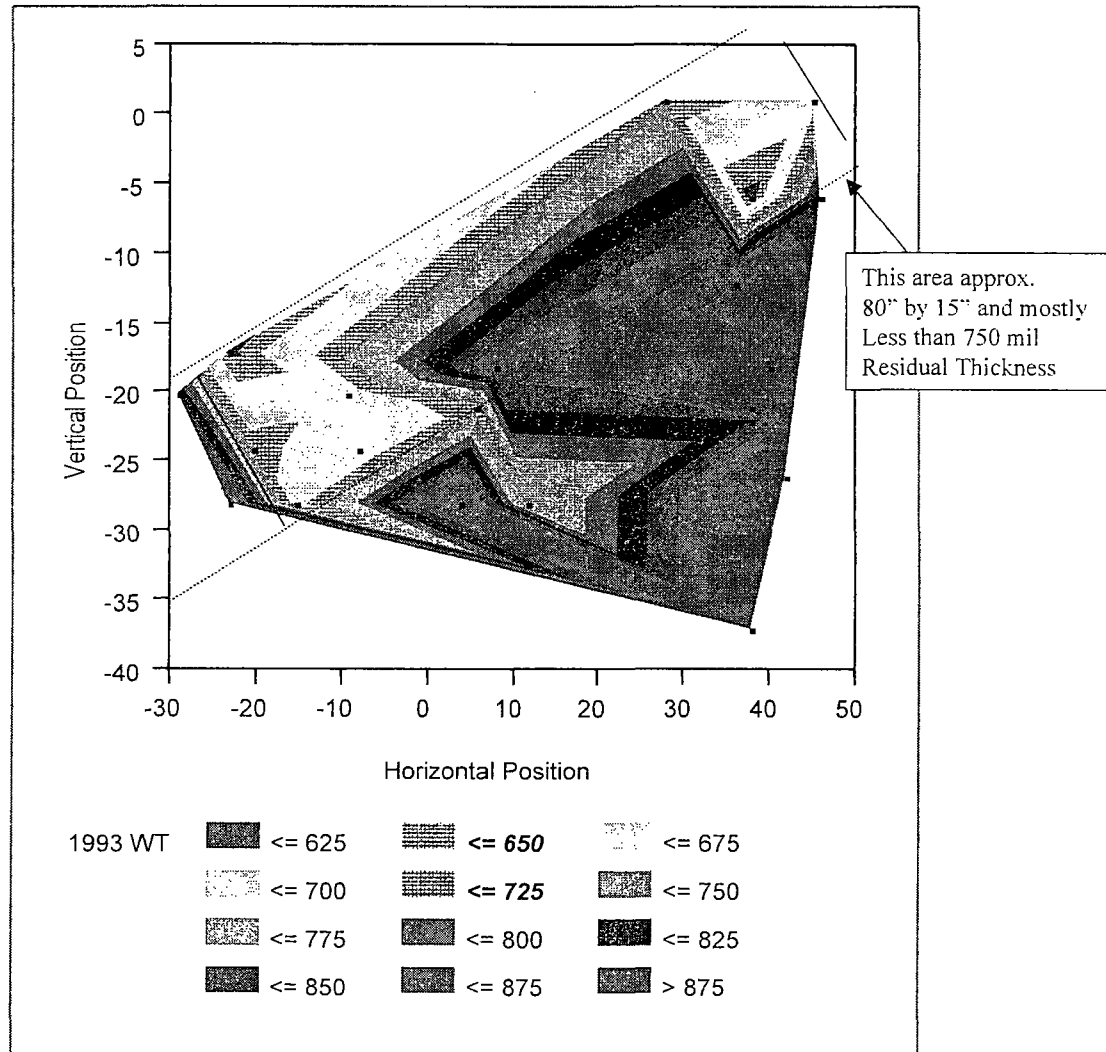
Figure 4

Figures 4 and 5 show the contours for Bay 13, 1992 and 2006 data, respectively. Here large areas exist with wall thicknesses below 700 mils and at least two seemingly unconnected areas where the residual wall thickness is less than 650 mils. It could be argued that those heavily corroded areas are less than 1 square foot and therefore are still acceptable according to the 636 mil criterion. However, the heavily corroded area on the left hand side (-20 , -20) has not been further explored. One therefore does not know whether it might extend further. Similarly, the area on the right ($(40, -7)$), clearly showing a fairly deep pit, was not further explored and was not even measured in 2006. While in Bay 1 the bathtub ring was at elevation -20 to -25 (from the reference point) in Bay 13 there is no clearly prominent bathtub ring. This may be because it was not there, but it may also be because the measurements were not extended toward elevation -15 and -10 . We are therefore left with a great uncertainty as to the true extension of the damage in this Bay.

Bay 13 Remaining Wall Thickness
External UT Measurements 1992/1993

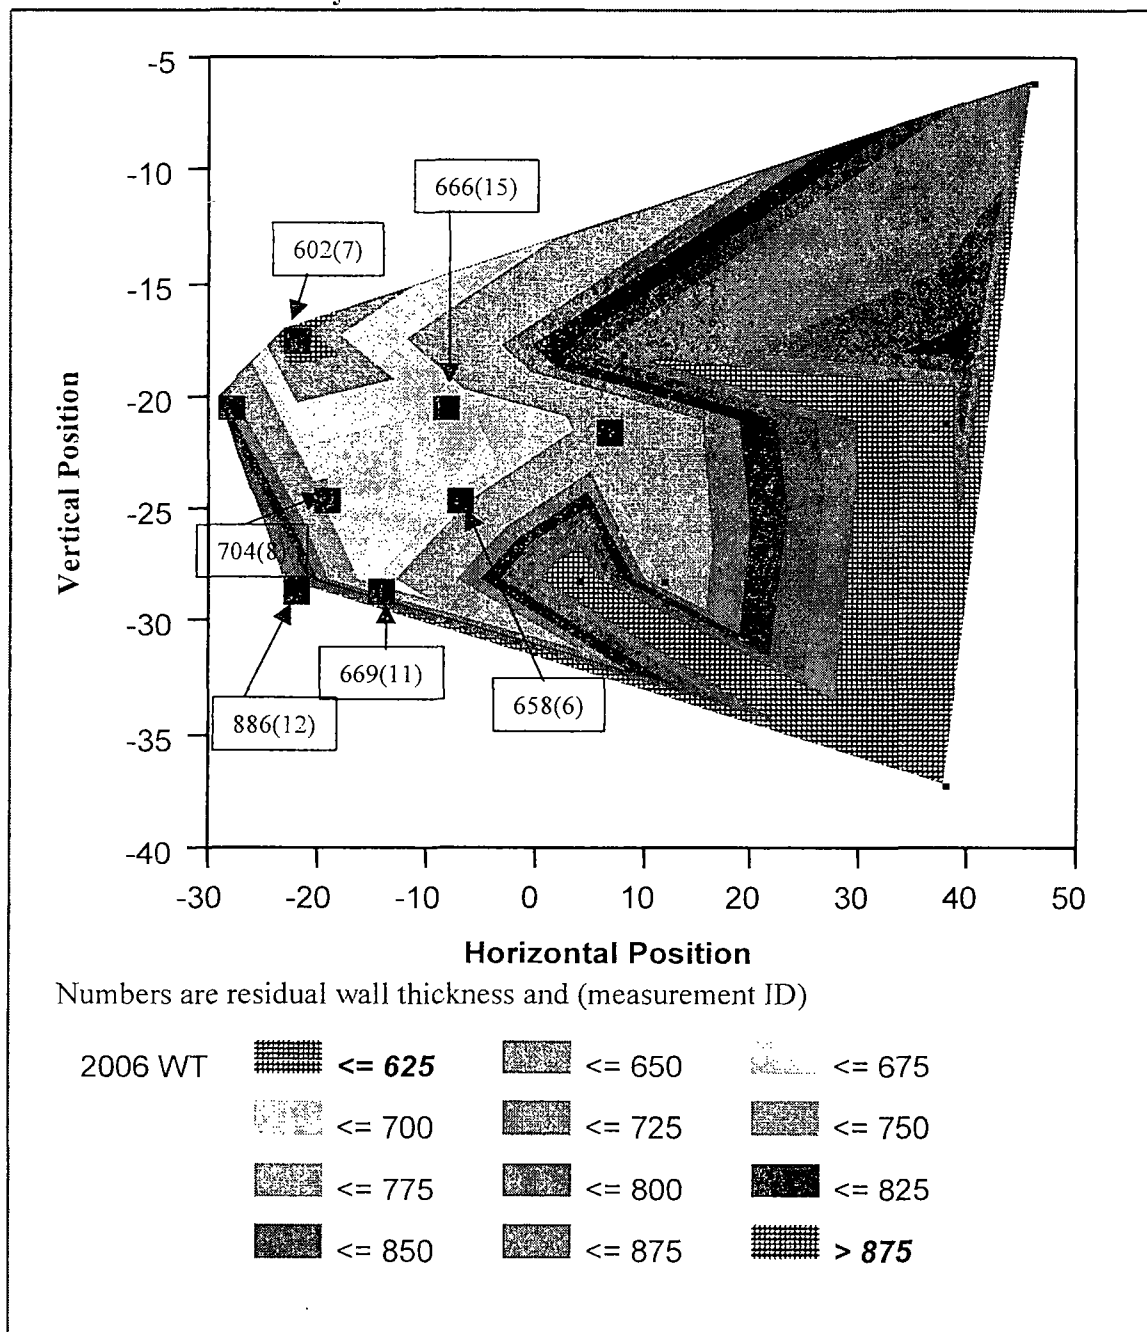
Figure 5

Bay 13 Remaining Wall Thickness
External UT Measurements 2006

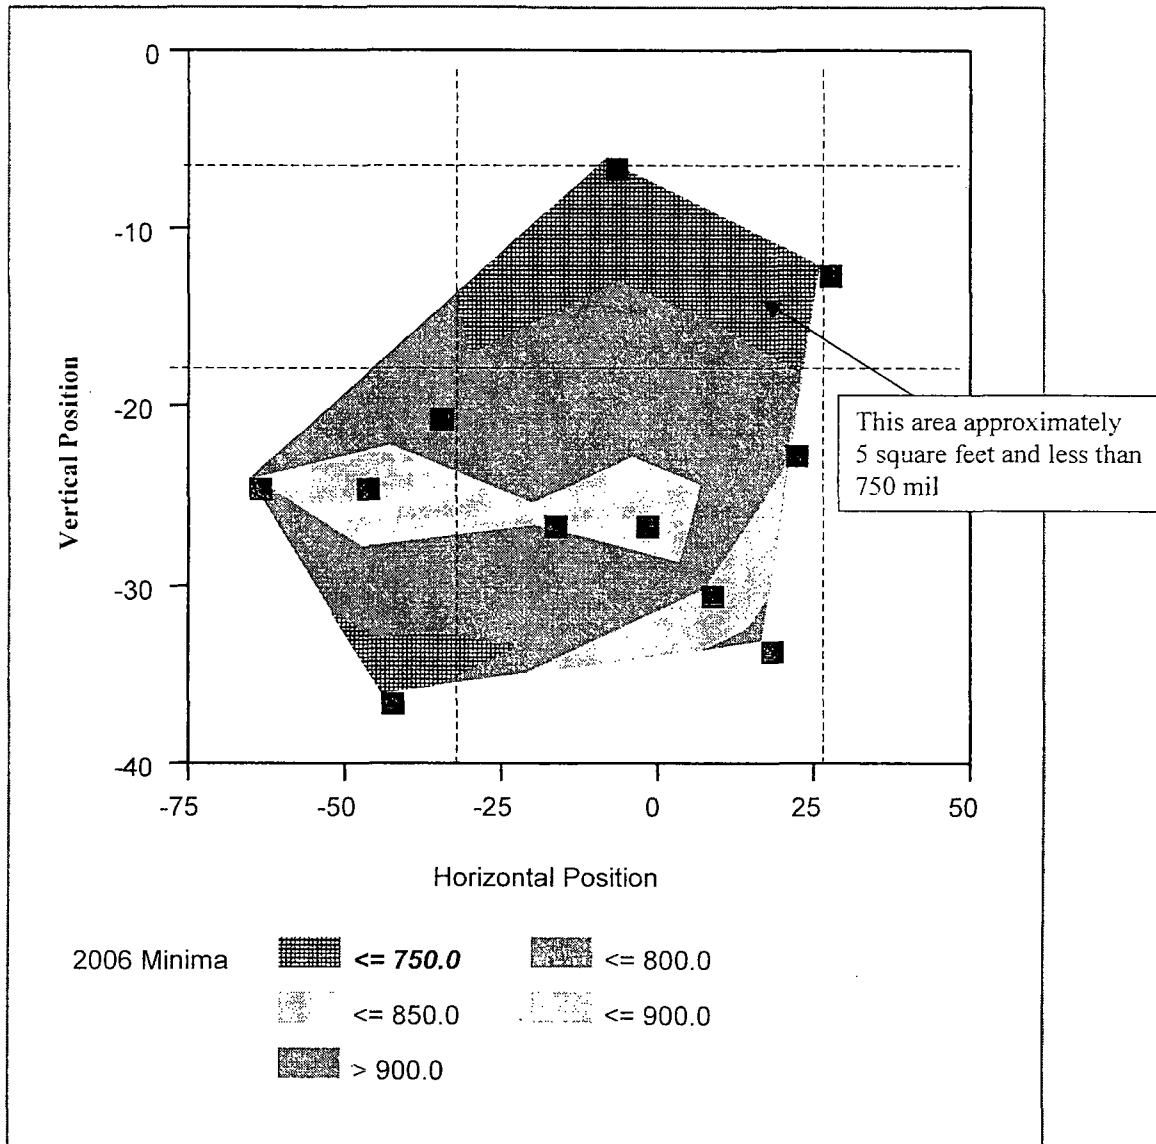
Figure 6 shows the contours for Bay 15. There is a heavily corroded area at elevation -10 with an extension of 1 ft by about 4.5 feet. However, this area was explored only with 2 measurements and was not extended beyond about 2 feet either side of the centerline. It appears that the majority of the measurements occurred in the non-corroded zones. Interestingly there appears some serious corrosion near the sandbed bottom, but the occurrence was not further explored either.

Contour Plot for Bay 15 2006 External UT Measurements

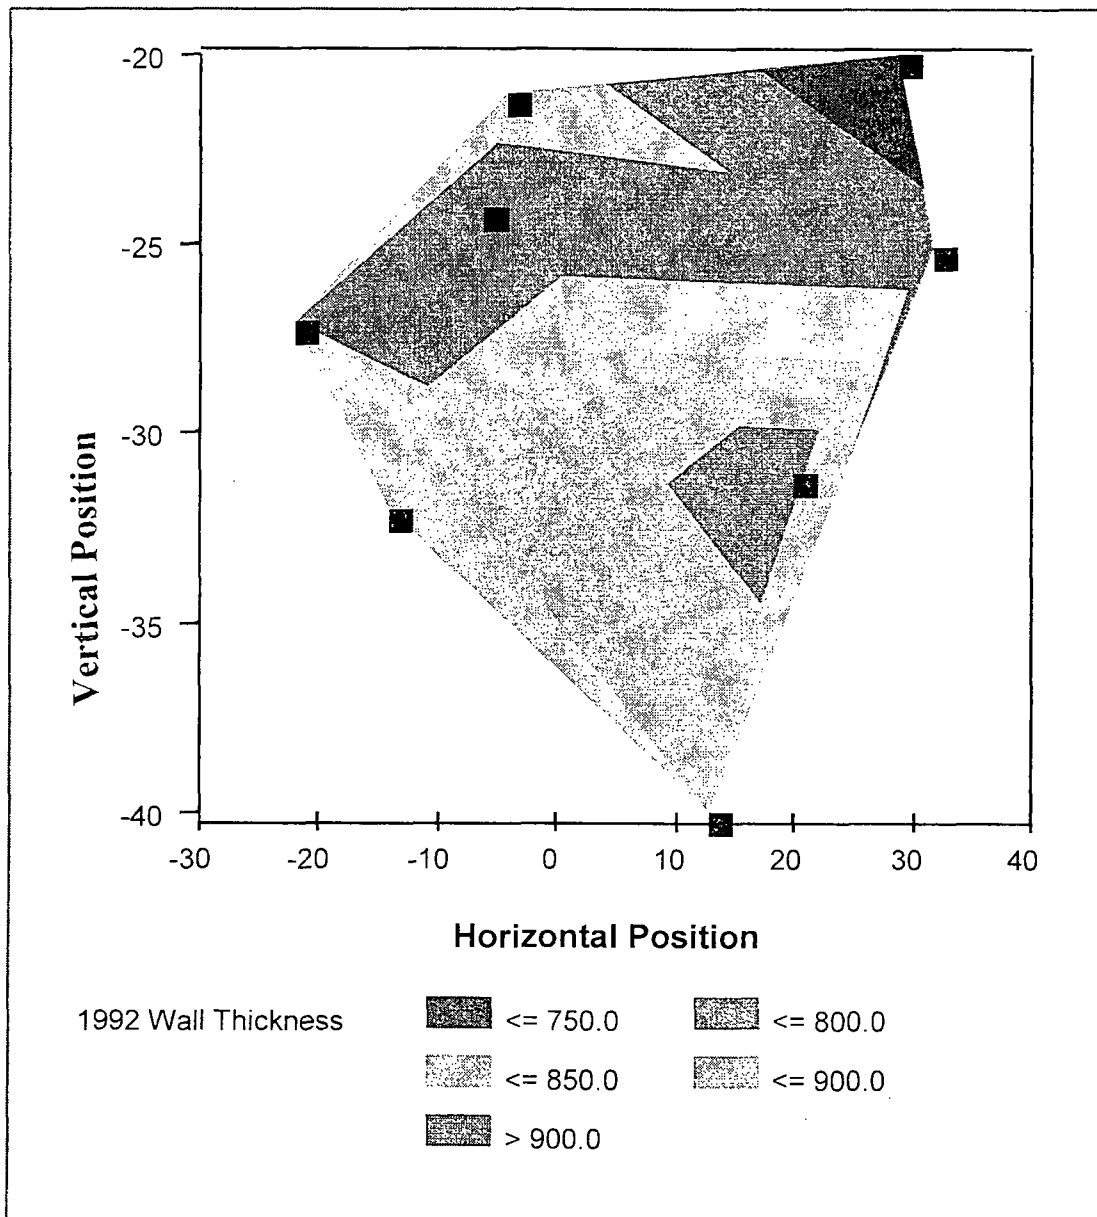
Figure 7 shows the contours for Bay 11. Again there is a suggestion of severe corrosion at elevation -20 and no further exploration into the bathtub ring area. Once again, the extent of this area is highly uncertain because it was not further defined by additional UT measurements.

Figure 7
 Contour Plot for External UT 1992 Data Bay 11
