**NEW ENGLAND COALITION, INC.'S (NEC) SUPPLEMENT TO OPPOSITION
TO ENTERGY'S MOTION FOR SUMMARY DISPOSITION OF NEW
ENGLAND COALITION CONTENTION 3 (STEAM DRYER)**

SECOND DECLARATION OF ULRICH WITTE

INR-IVVI-VYR26-07-10- Steam Dryer Interior HB-V04

Indication Notification Report

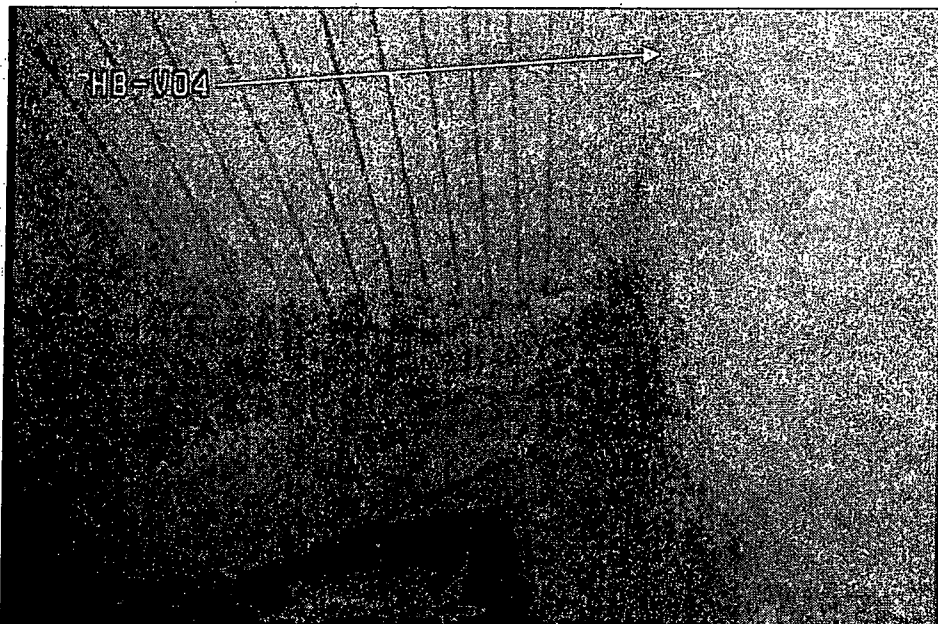
This 2007 photo shows the interior of the dryer and the location of HB-V04 vertical weld.

One new indication was found adjacent to weld HB-V04, located on bank B at the 0° end and is labeled as the 3rd indication on INR-IVVI-VYR26-07-10 Rev.1 (Reference 2). This indication is of similar appearance, orientation and size as those previously seen. Because of this it is being treated similar to those indications identified in RFO25. The remainder of indications on the steam dryer listed as References 1-10 were previously identified and show no signs of growth. These indications are acceptable to leave as is per GE evaluation GENE-0000-0047-2767 (Reference 11) performed in RFO25. Therefore, the one new indication described above is the only one requiring an evaluation.

The new indication was evaluated by Code Programs, see the attached document. The evaluation accepts the indication as is with no repair required. The steam dryer will be inspected per the same scope in RFO27 and RFO28 per letter BVY 04-097, therefore the area of this indication will be inspected again during the next two outages.

The dryer unit end plates flaw assessment is based on the following factors: (1) it is a highly redundant structure and there is no structural consequence of the cracking and (2) postulated significant flaw extension leading to the flaw reaching the full section of the channel geometry would not create the opportunity for loose parts. Field experience supports this as-is operation decision in the context that the indications will be re-inspected at the next outage. It is recommended that the new visual indication given in Reference 2 be accepted as is. Repair is not recommended.

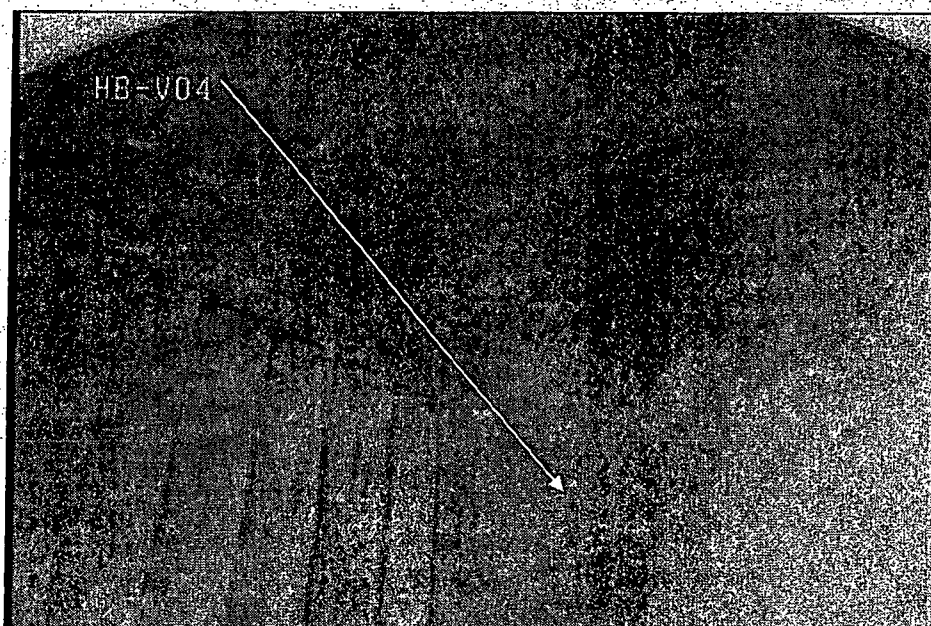
This 2007 photo shows the top of the vane bank (on the left) and the end panel (on the right) and the vertical weld in the center

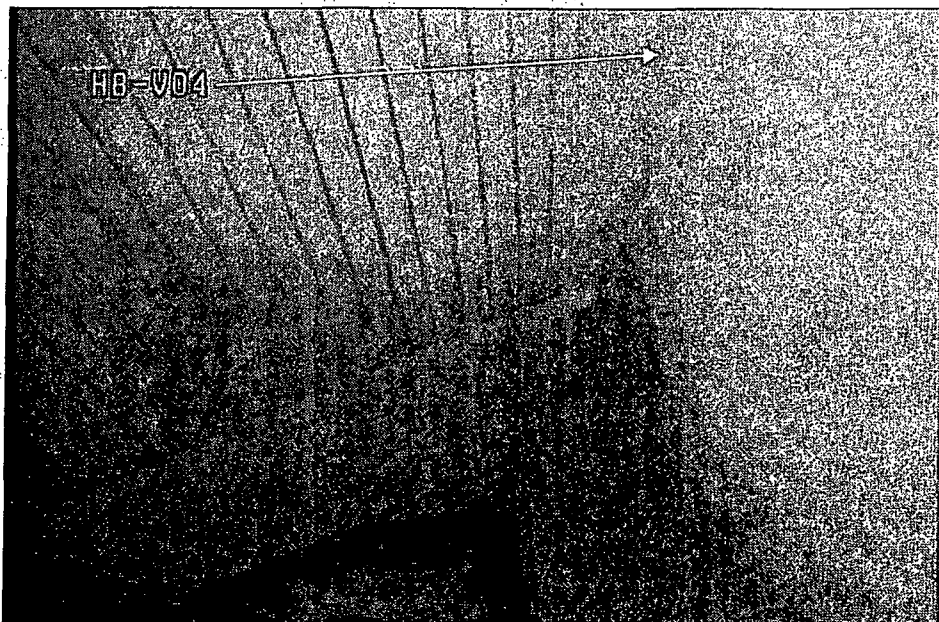
This 2007 photo shows the interior of the dryer and the location of HB-V04 vertical weld.

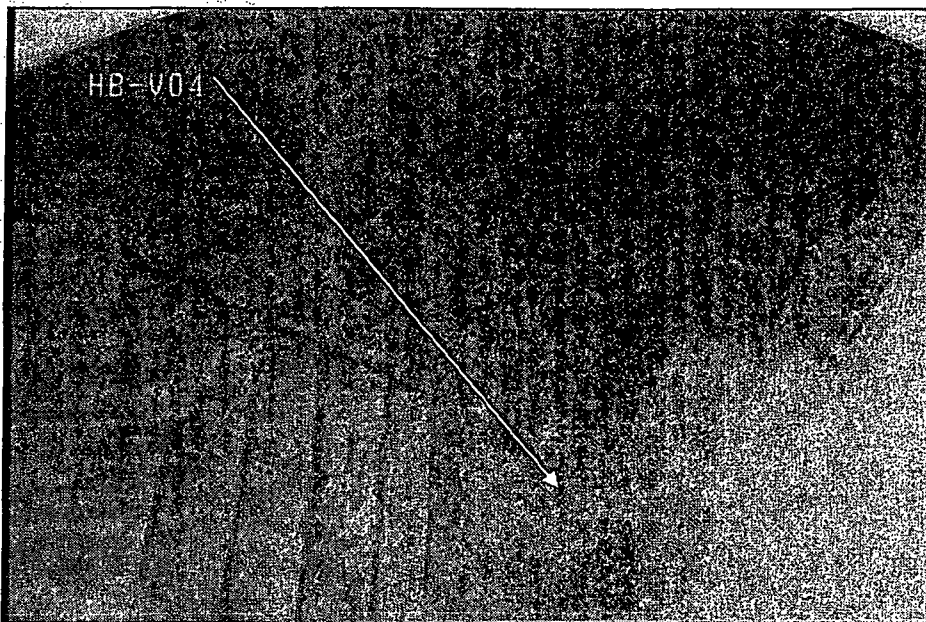
This 2007 photo shows the top of the vane bank (on the left) and the end panel (on the right) and the vertical weld in the center
