Annual Site Inspection and Monitoring Report for Uranium Mill Tailings Radiation Control Act Title I Disposal Sites

**Interim Annual Report for the Period
October 1, 1997 Through December 31, 1997**

April 1998

**Prepared by
MACTEC Environmental Restoration Services, LLC
Grand Junction, Colorado**

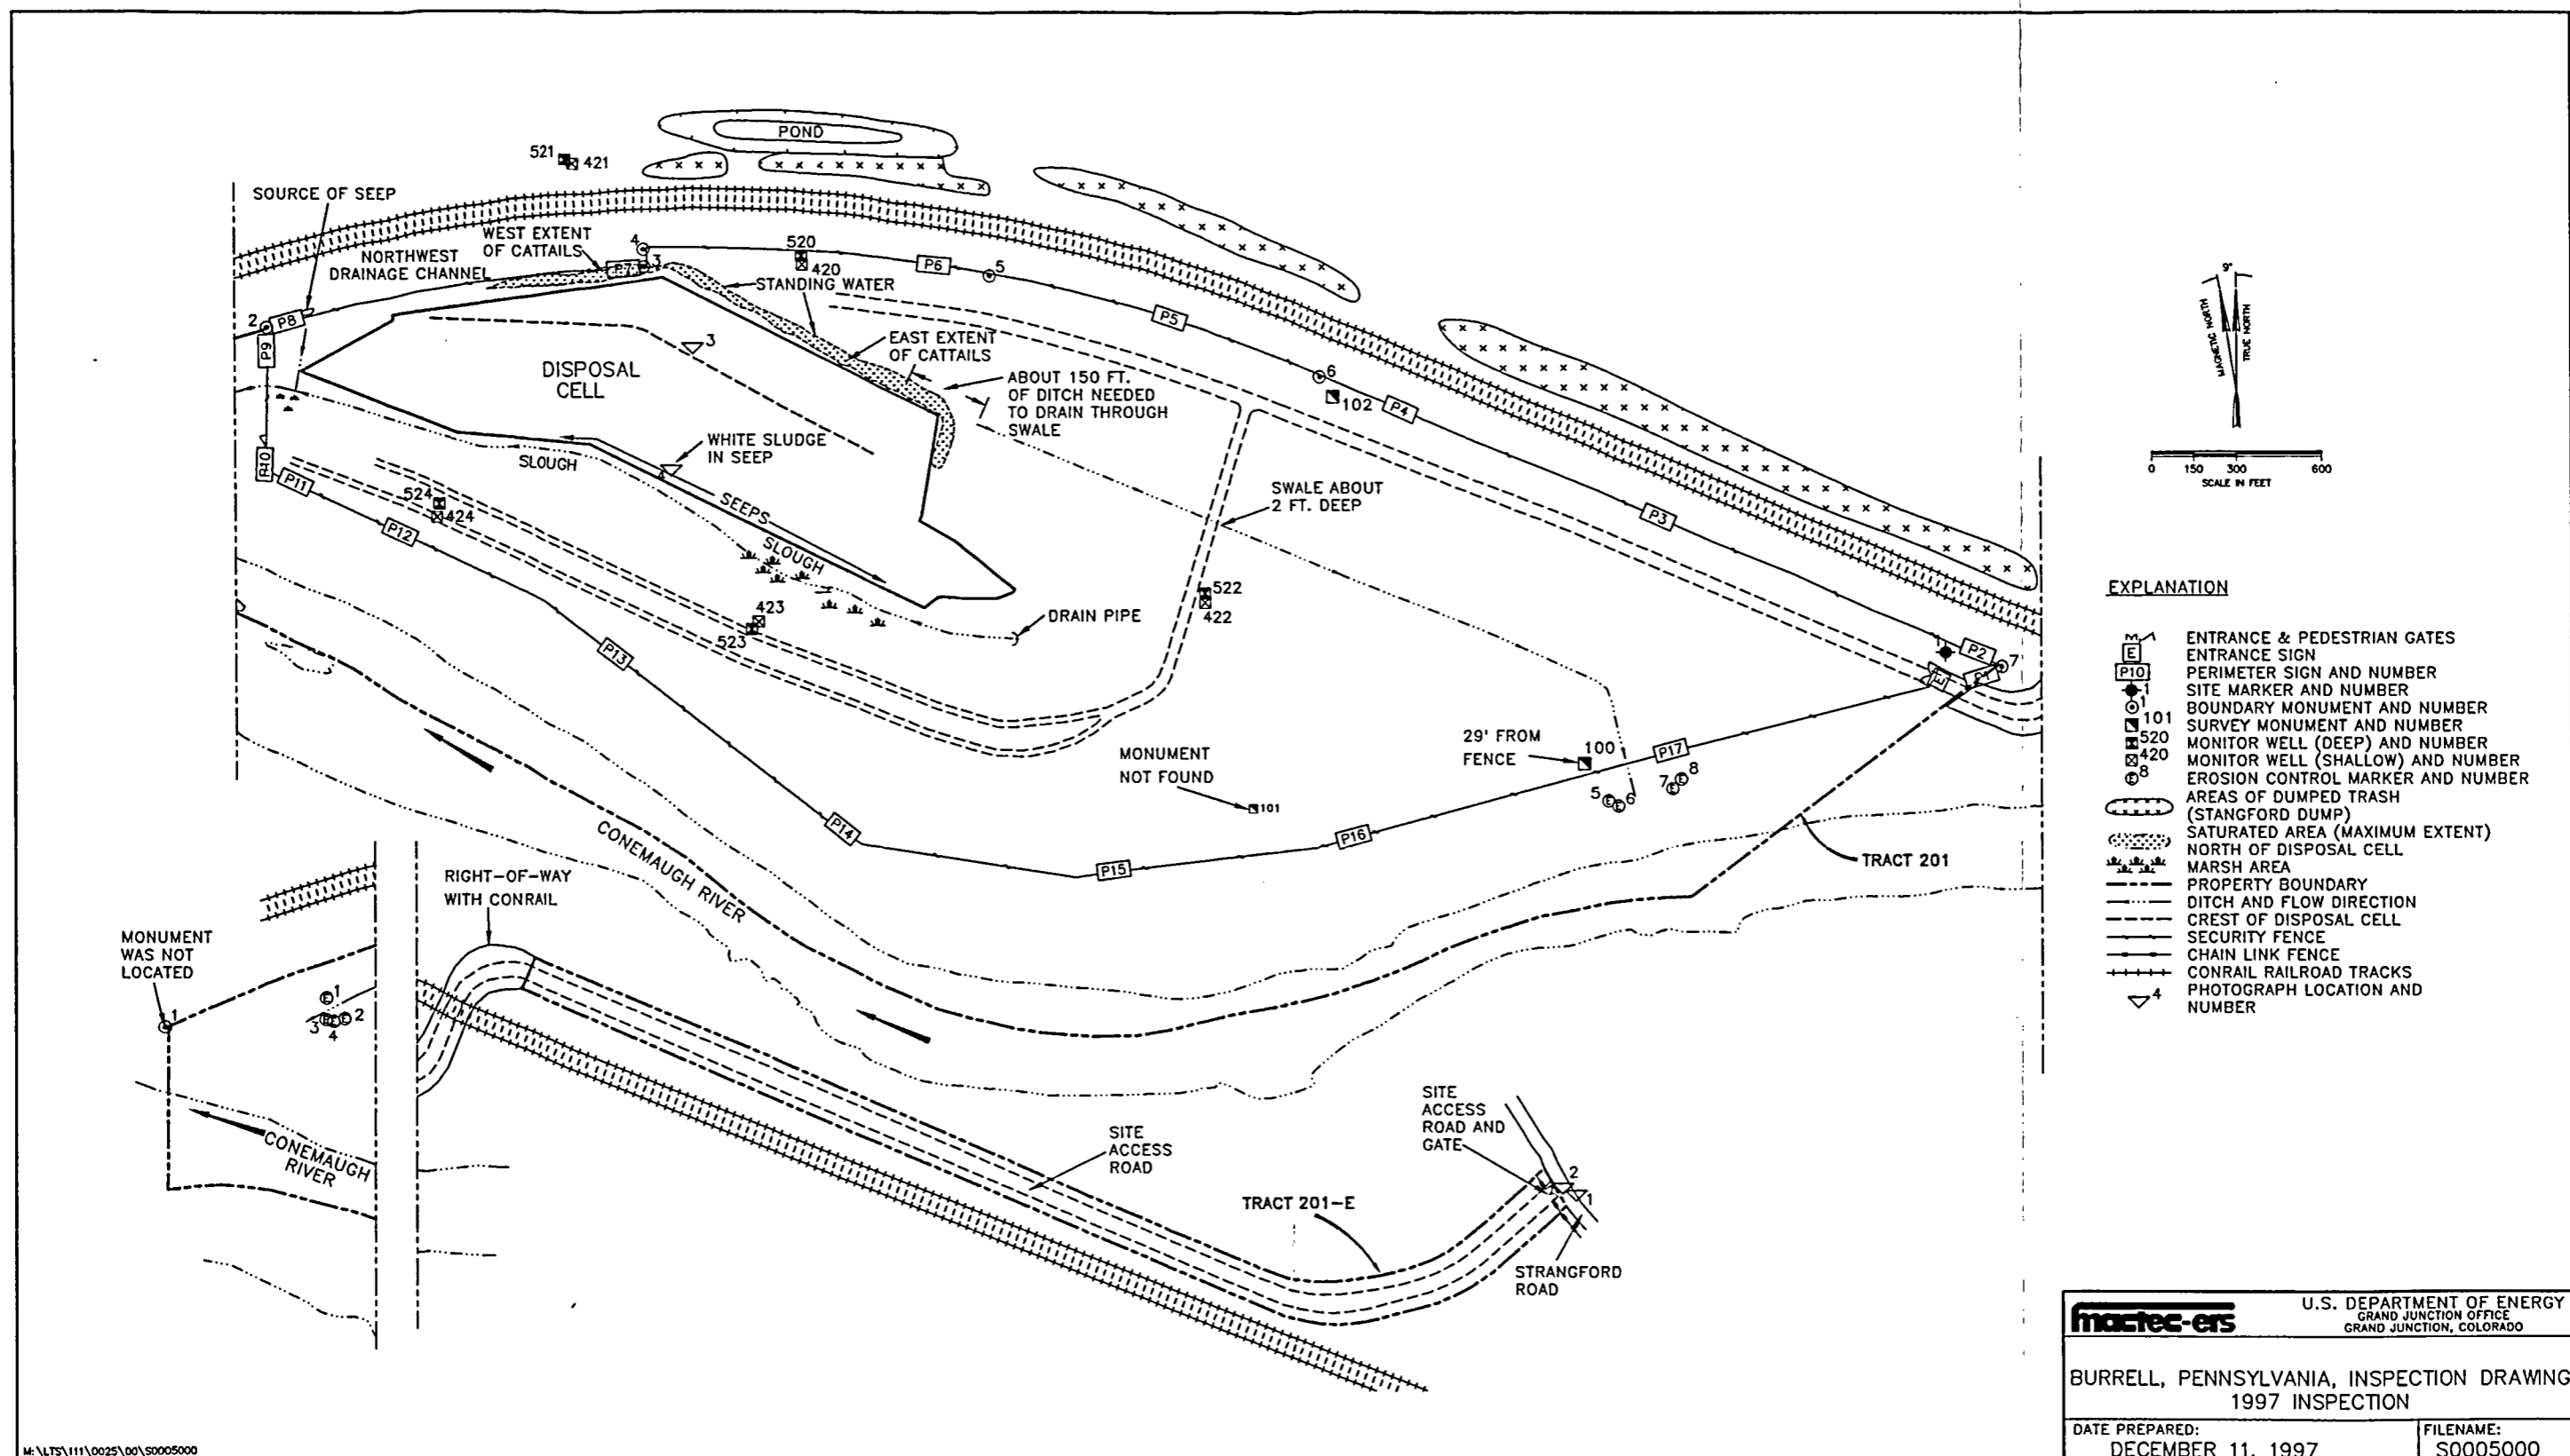
The site was inspected by the LTSM Program on November 19, 1997. The site was determined to be in excellent condition. In the descriptions that follow, photographs included in the report are referred to by photograph location (PL) number. The prefix for the site (i.e., BUR for Burrell) appears before the PL number. Site features are shown in Figure 3-1.

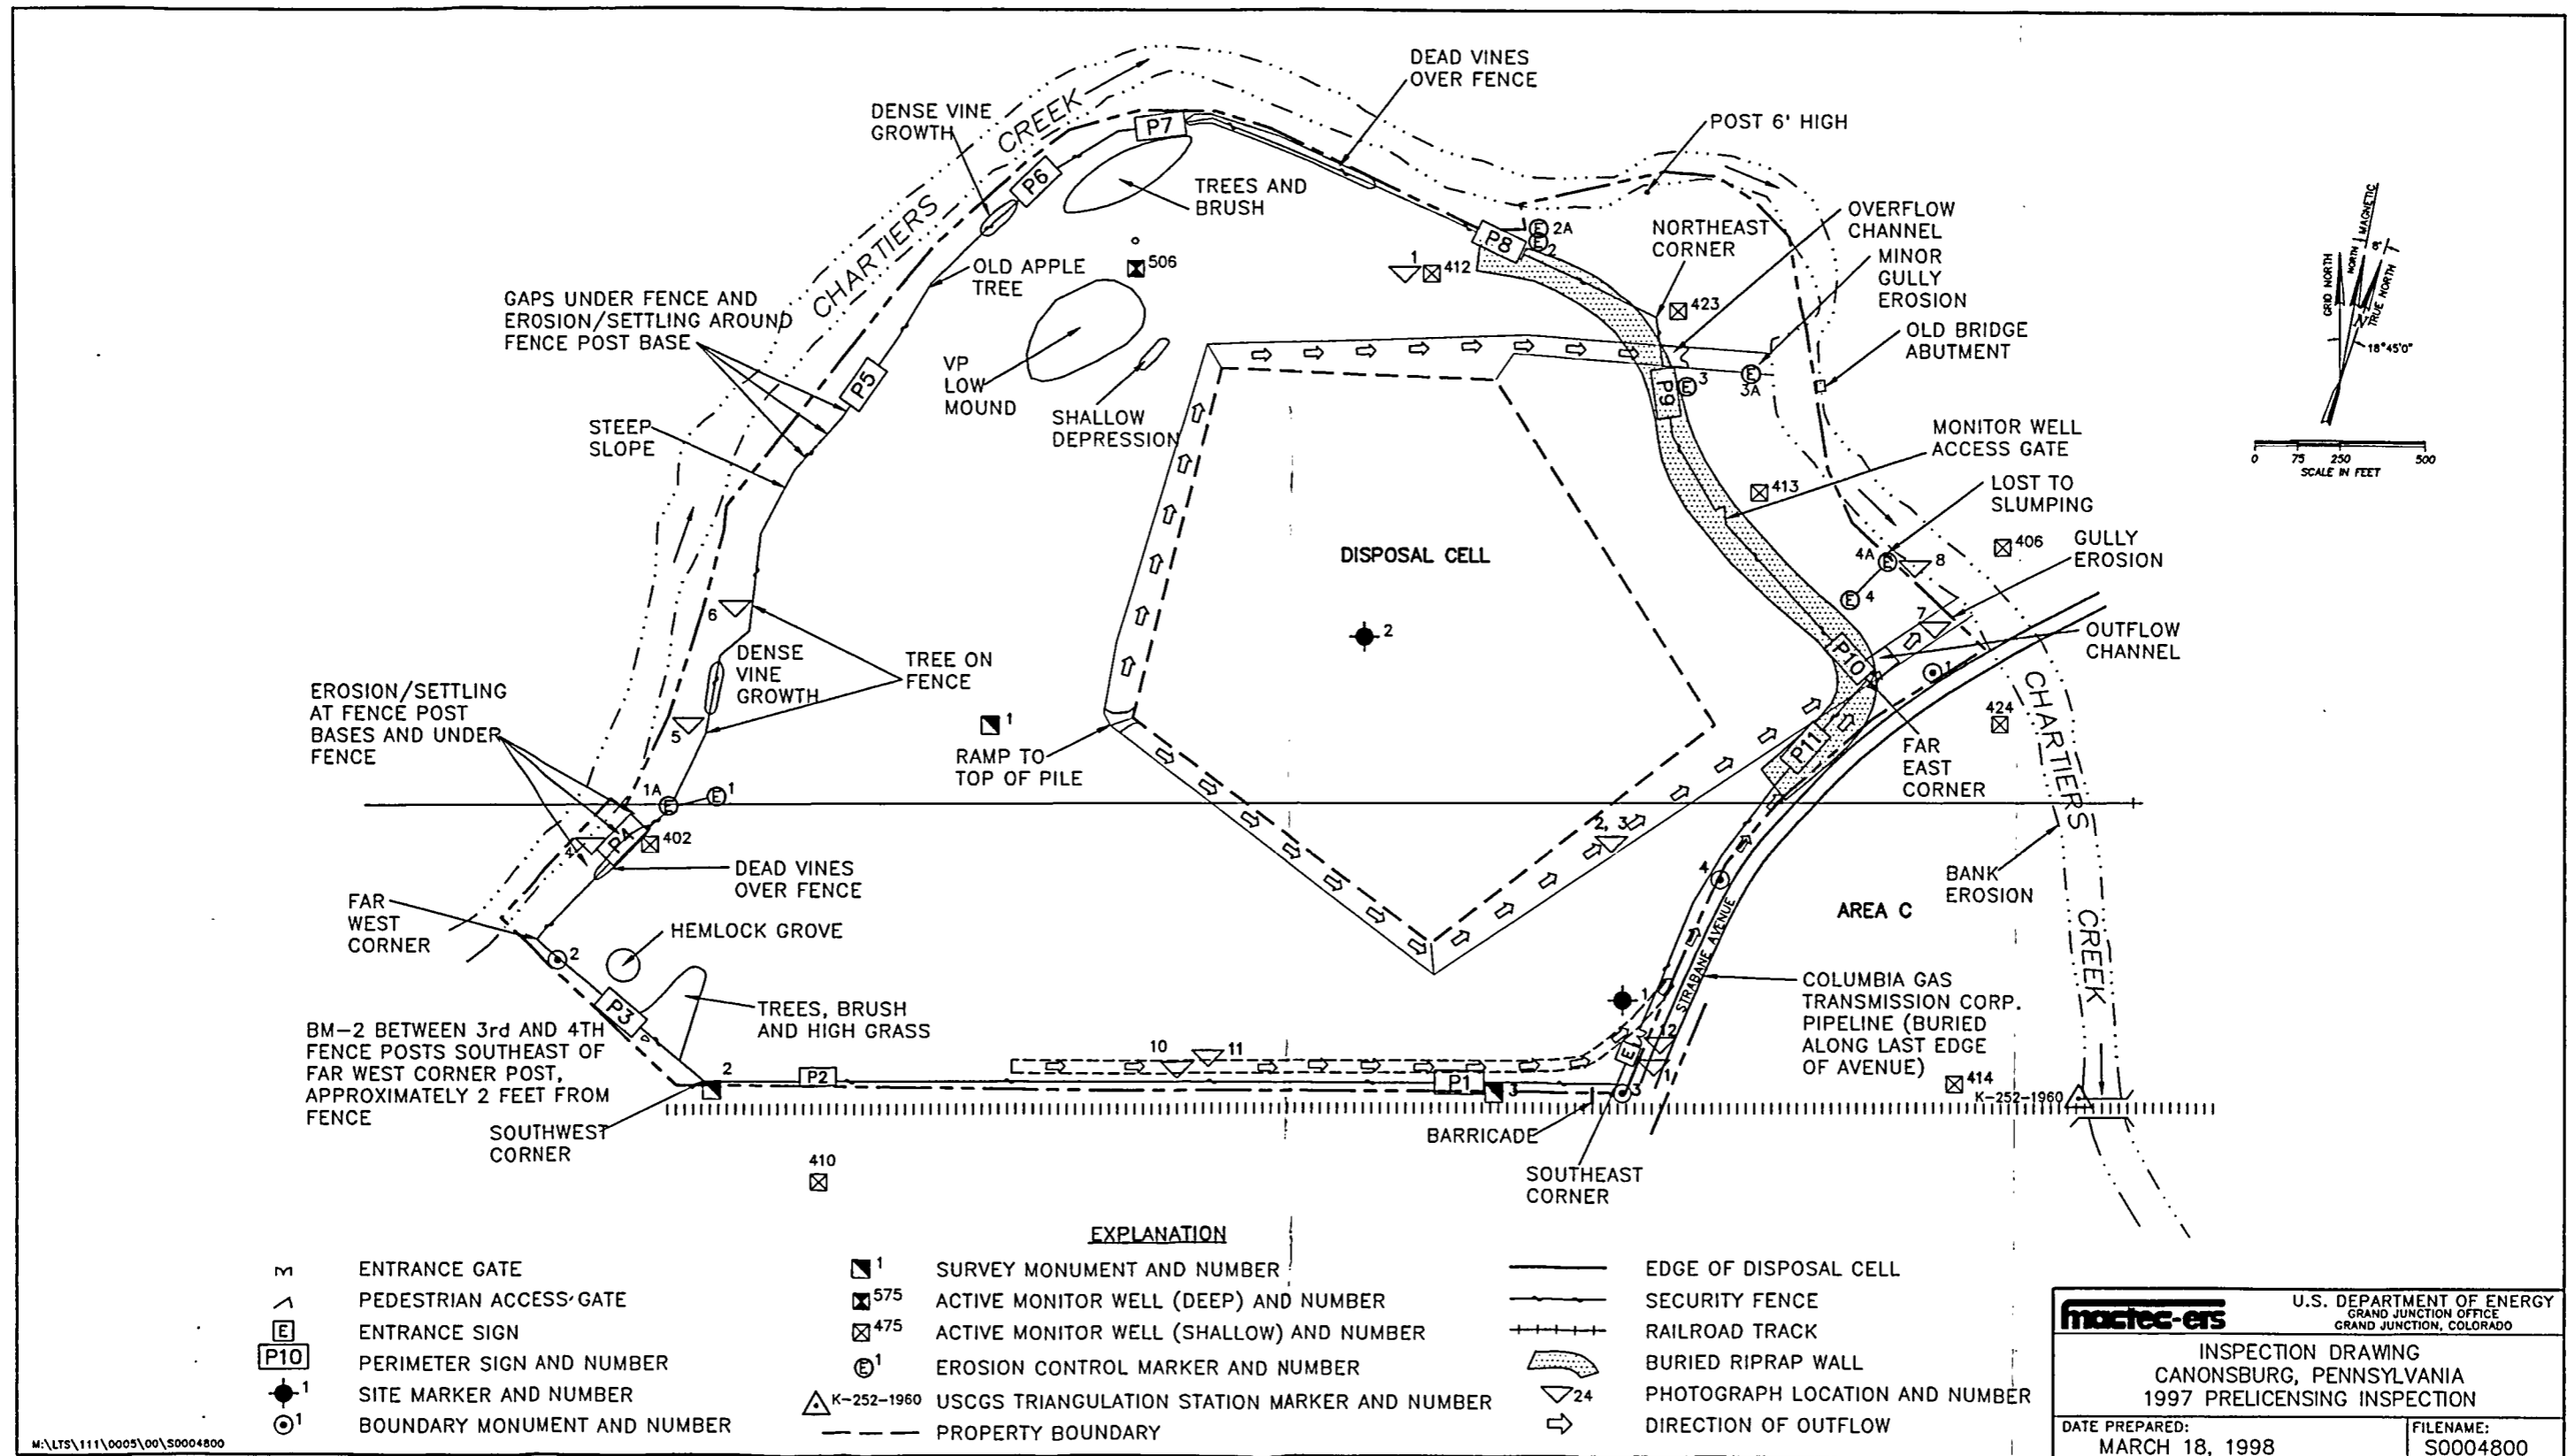
Figure 4-1

Locations of all sampling points mentioned in this report are shown in Figure 4-1.
