Subject: Braidwood Station, Unit 1, 60-Day Response to First Revised NRC Order
EA-03-009, "Issuance of First Revised NRC Order (EA-03-009) Establishing Interim
Inspection Requirements for Reactor Pressure Vessel Heads at Pressurized Water
Reactors"

A1R12 Reactor Vessel Head Visual Inspection Results

**“Braidwood Unit 1 – A1R12
Reactor Vessel Head Penetration Examination
April 2006”**

WDI-PJF-1303195-FSR-001

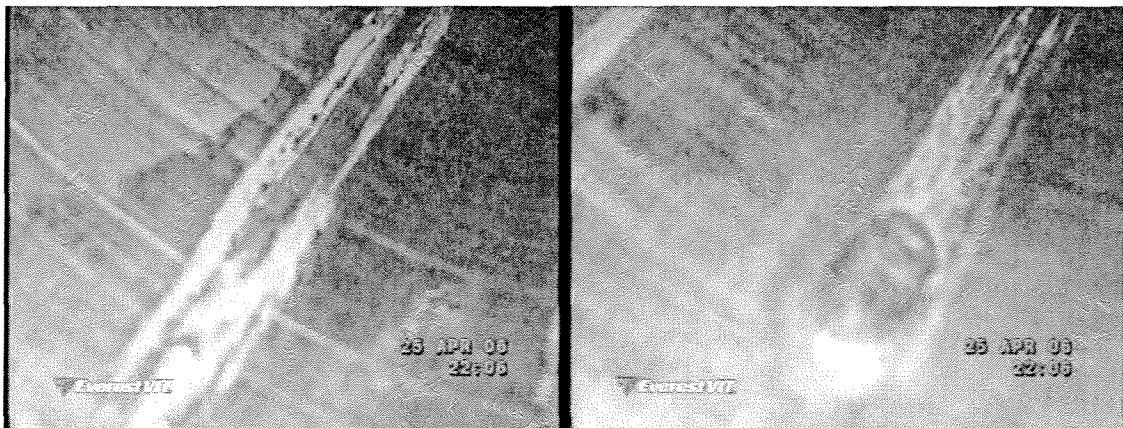
* During inspection of penetration 74, the open housing scanner shoe lifted off from approximately 0 to 60 degrees, just above the weld. An informational boroscope video recording was performed via manual jump to view the areas of concern. The pictures below show these areas; with the picture on the left showing small deposits and the picture on the right showing a larger deposit. A letter was transmitted to Exelon under CCE-06-41 which contains the NDE coverage evaluation and crack growth assessment for a sub surface flaw. Between ECT and UT, there was enough coverage to preclude the existence of any surface connected indications on the ID. Since ID coverage has been obtained, primary water stress corrosion cracking (PWSCC) is not a concern. Available leak path results showed no suspect areas. Per CCE-06-41, the valid assumption for a crack in this region would be due to fatigue, which exhibits much slower crack growth rates relative to that due to PWSCC. Refer to CCE-06-41 for more information on this.
