Appendix D2

ESEM and SEM/EDS Data for Test #2, Day-30 Fiberglass in High- and Low-Flow Zones

Appendix D3

ESEM and SEM/EDS Data for Test #2, Day-30 Drain Collar Fiberglass

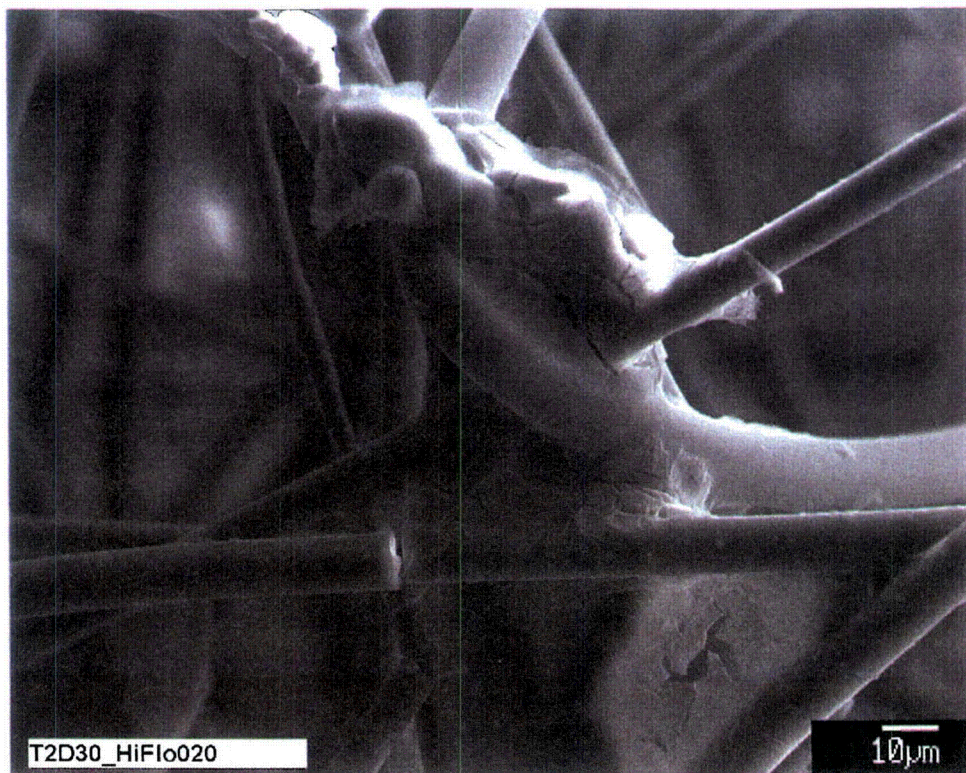
Figure D2-7. SEM image of a higher magnification for a Test #2, Day-30 high-flow exterior fiberglass sample. (T2D30_HiFlo020)

The results from the chemical composition analysis for T2D30EDS13 are given in Table D2-1.

Element	Mass%	Atomic%	ZAF	Z	A	F
C	0.000	0.0000	6.0057	1.0404	5.7730	0.9999
O	68.212	77.9670	0.7076	0.9928	0.7128	1.0000
Na	15.750	12.5283	1.5604	1.0448	1.4934	1.0001
Si	7.284	4.7427	1.3779	0.9953	1.3873	0.9980
P	4.750	2.8046	0.8298	1.1782	0.7048	0.9993
Cl	2.197	1.1335	1.1025	1.0478	1.0529	0.9993
Ca	1.806	0.8239	1.0120	1.0156	0.9965	1.0000

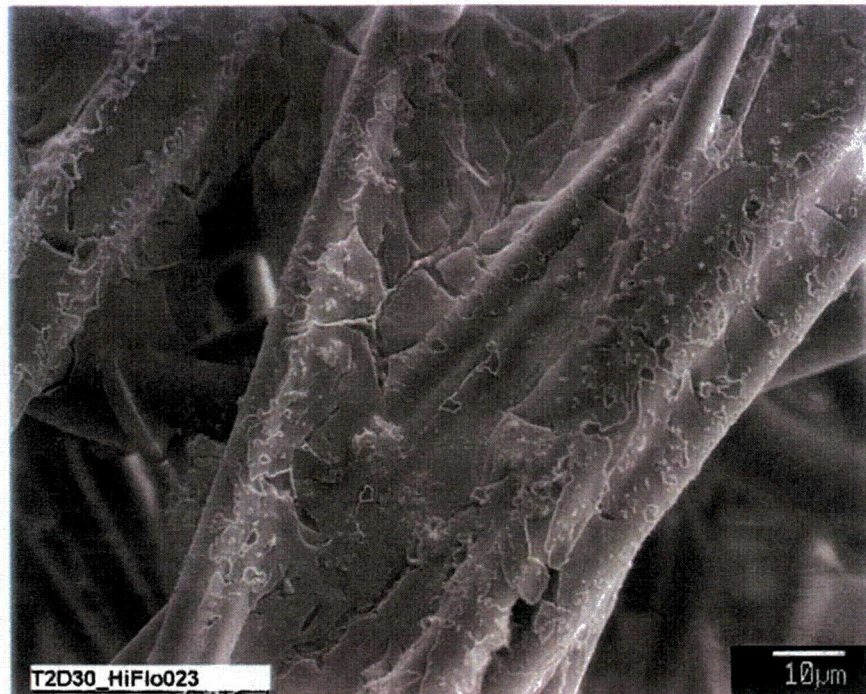
Figure D2-11. SEM image at 1000× magnification for a Test #2, Day-30 high-flow interior fiberglass sample. (T2D30_HiFlo023)

The results from the chemical composition analysis for T2D30EDS14 are given in Table D2-2.

Element	Mass%	Atomic%	ZAF	Z	A	F
C	0.000	0.0000	3.8510	1.0451	3.6851	0.9999
O	85.150	90.8939	0.5770	0.9974	0.5785	1.0000
Na	4.620	3.4320	1.8017	1.0498	1.7160	1.0002
Si	6.368	3.8722	1.3235	1.0003	1.3239	0.9994
P	1.246	0.6870	0.7999	1.1842	0.6756	0.9999
Ca	2.616	1.1148	0.9886	1.0213	0.9680	1.0000

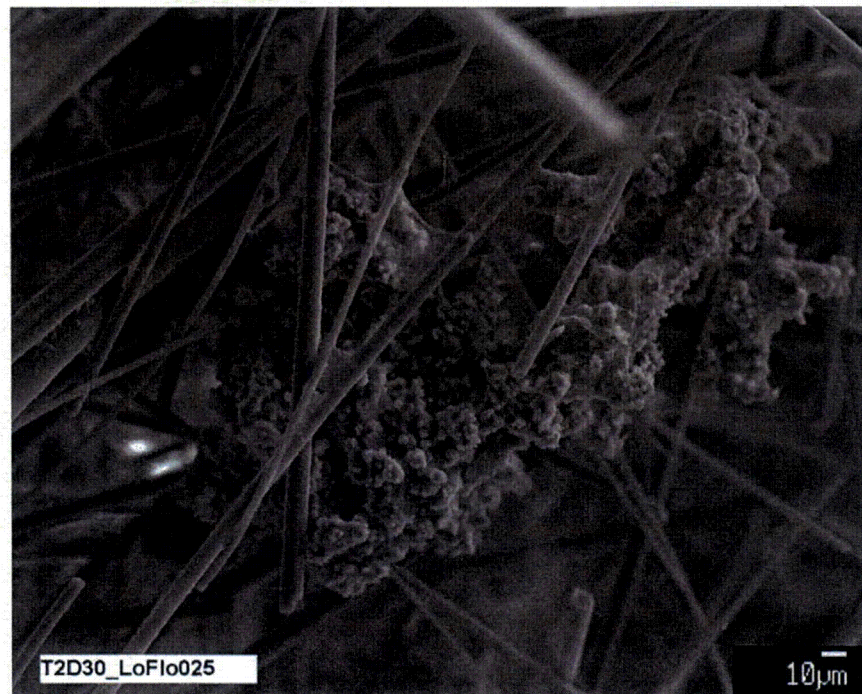
Figure D2-14. SEM image for a Test #2, Day-30 low-flow interior fiberglass sample. (T2D30_LoFlo025)

Figure D2-15. EDS counting spectrum for the particulate deposits or growth on fiberglass, as shown in Figure D2-14. (T2D30EDS15-Particle on Lowflow Interior)

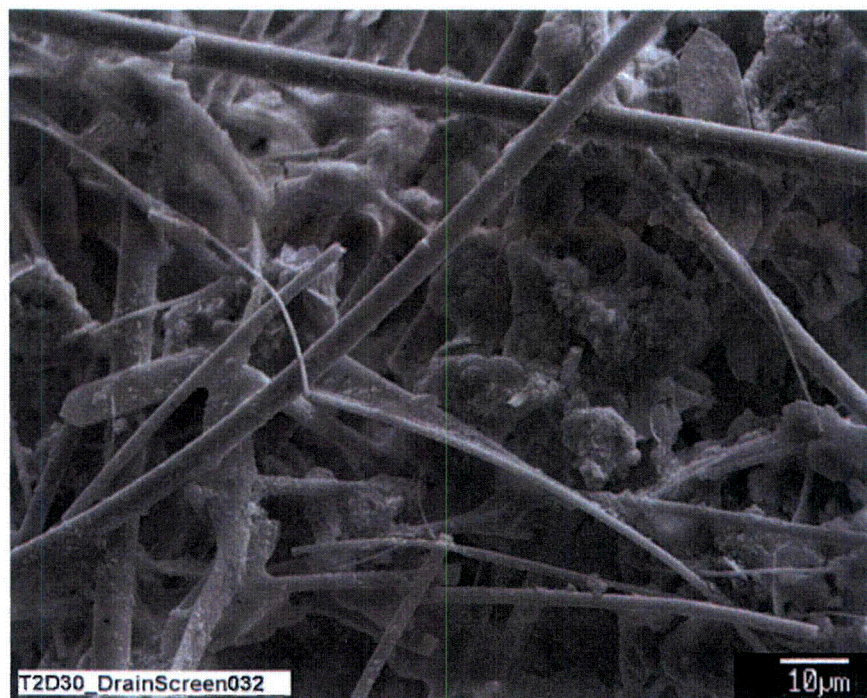
- Figure D3-5. EDS counting spectrum for the center of the image shown in Figure D3-4. (T2D30EDS16~Drain Screen Side Center of Image 032)..... D3-8
- Figure D3-6. EDS counting spectrum for the film between fibers shown in Figure D3-4. The film is rich in silicon, oxygen, aluminum, sodium, and calcium. (T2D30EDS17~Drain Screen Side Film on Fiber Glass)..... D3-10

Figure D3-4. SEM image at 1000× magnification for a Test #2, Day-30 fiberglass sample on the drain collar next to the drain screen. (T2D30_DrainScreen032)

Figure D3-5. EDS counting spectrum for the center of the image shown in Figure D3-4.
(T2D30EDS16~Drain Screen Side Center of Image 032)

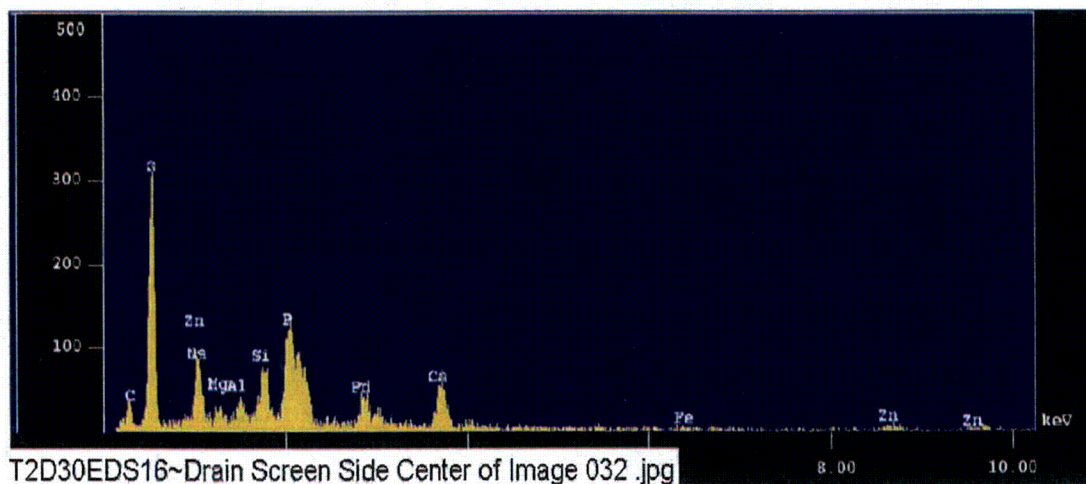
The results from the chemical composition analysis for T2D30EDS16 are given in Table D3-1.

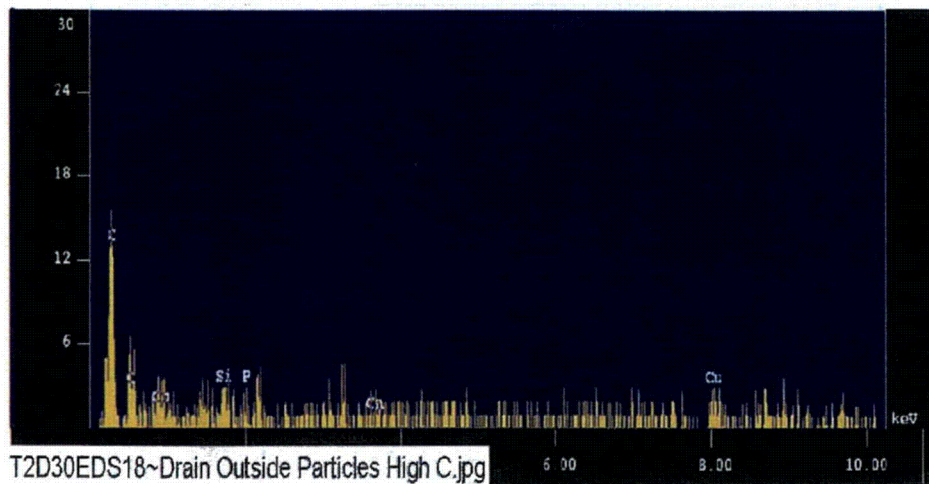
Figure D3-11. EDS counting spectrum for deposits or growth on fiberglass. The deposits contain a significant amount of carbon. (T2D30EDS18~Drain Outside Particles High C)

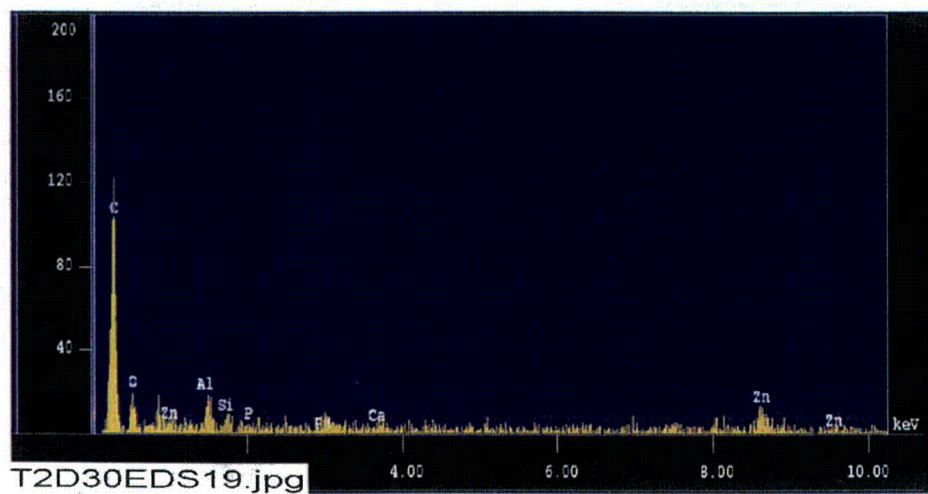
Figure D3-12. EDS counting spectrum for a deposit or growth on fiberglass. The deposit contains a significant amount of carbon. (T2D30EDS19)

The results from the chemical composition analysis for T2D30EDS19 are given in Table D3-3.

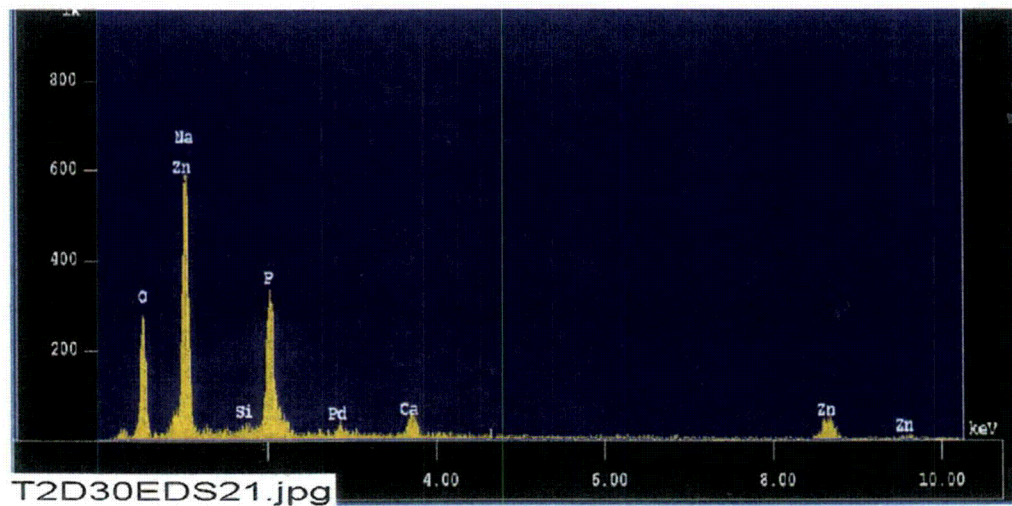
Figure D4-2. EDS counting spectrum for the bright particle on the lower-left side of Figure D4-1. (T2D30EDS21)

The results from the chemical composition analysis for T2D30EDS21 are given in Table D4-1.

Element	Mass%	Atomic%	ZAF	Z	A	F
O	35.828	61.5751	1.0317	0.9179	1.1240	1.0000
Na	2.043	2.4438	1.5945	0.9209	1.7289	1.0014
P	19.372	17.1970	0.9581	1.1032	0.8685	0.9999
Ca	3.013	2.0671	0.9537	0.9240	1.0329	0.9993
Zn	39.743	16.7170	1.1826	1.1840	0.9988	1.0000

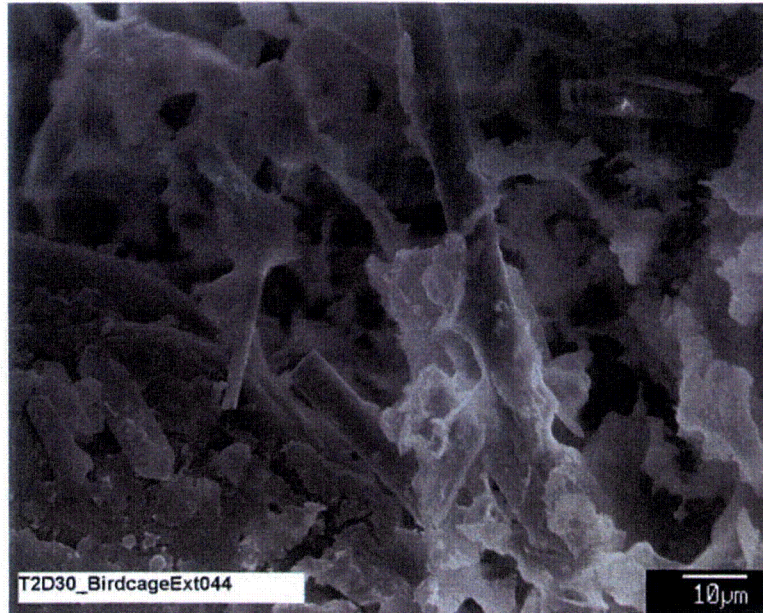
Figure D4-5. SEM image of a higher magnification for a Test #2, Day-30 exterior fiberglass sample within the birdcage. (T2D30_BirdcageExt044)

Figure D4-6. EDS counting spectrum for the crystal-shaped deposit at the lower-left side of Figure D4-5. (T2D30EDS22)
