UNITED STATES OF AMERICA
NUCLEAR REGULATORY COMMISSION
ATOMIC SAFETY AND LICENSING BOARD

(License Renewal for Oyster Creek Nuclear
Generating Station)

**AMERGEN ENERGY COMPANY, LLC
REBUTTAL STATEMENT OF POSITION**

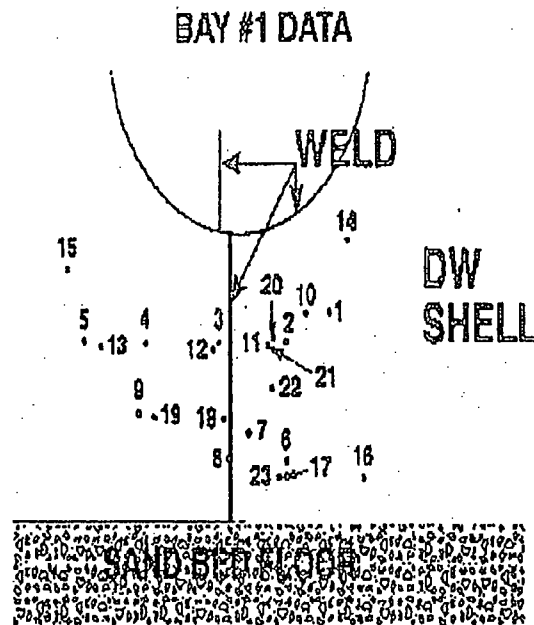
Figure 10

Bay 1 Data - Table 1

The inspection focused on the thinnest areas of the drywell, even if it was very local, i.e., the inspection did not attempt to define a shell thickness suitable for structural evaluation. The shell appears to be relatively uniform in thickness except for a band of corrosion which looks like a "bathtub" ring (see Fig. 10). Beyond the bathtub ring on both sides, the shell appears to be uniform in thickness at a conservative value of 0.800 inches. Measurements 14 and 15 confirm that the thickness above the bathtub ring is at 1.154 inches starting at elevation 11 feet, 00 inches. Below the bathtub ring the shell is uniform in thickness where no abrupt changes in thicknesses are present. Thickness measurements below the bathtub ring are all above 0.800 inches except location 7 which is very local area.

Locations 1, 2, 3, 4, 5, 10, 11, 12, 13, 20, and 21 are confined to the bathtub ring as shown in Figure 10. An average value of these measurements is an evaluation thickness for this band as follows;

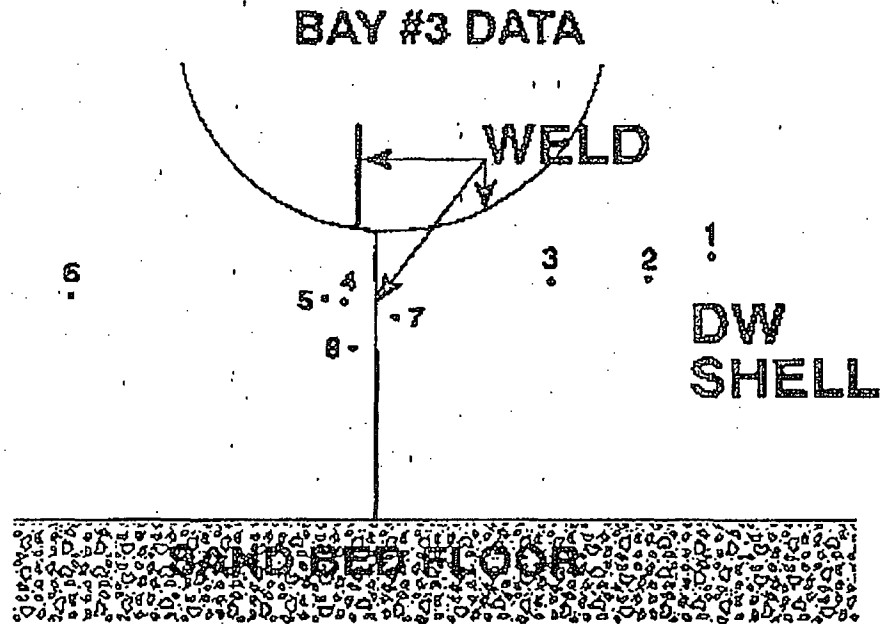
Figure 11

Bay 3 Data - Table 3

The outside surface of this bay is rough, similar to bay one, full of dimples comparable to the outside surface of a golf ball. This observation is made by the inspector who located the thinnest areas for the UT examination. Eight locations were selected to represent the thinnest areas based on the visual observations of the shell surface (see Fig. 11). These locations are a deliberate attempt to produce a minimum measurement. Table 3 shows measurements taken to measure the thicknesses of the drywell shell using a D-meter. The results indicate that all of the areas have thickness greater than the 0.736 inches.

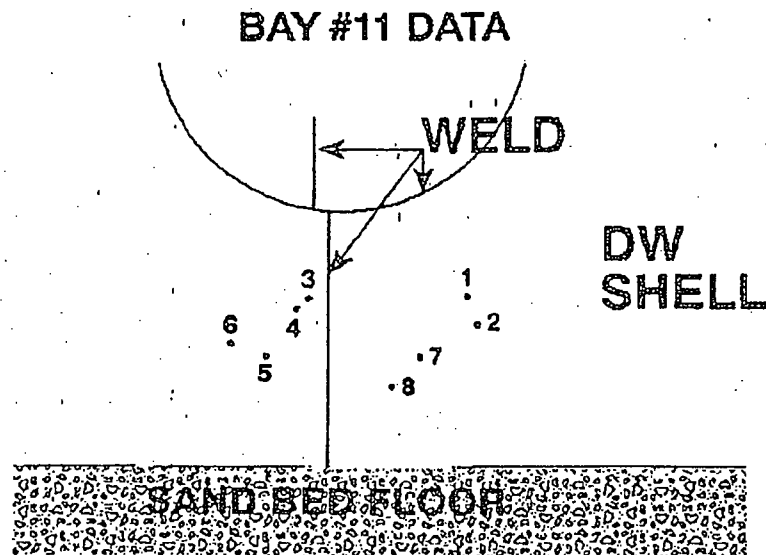
Figure 15

Bay 11 Data - Table 7

Eight locations were selected to represent the thinnest areas based on the visual observations of the shell surface (see Fig. 15). These locations are a deliberate attempt to produce a minimum measurement. Table 7 shows readings taken to measure the thicknesses of the drywell shell using a D-meter. The results indicate that all of the areas have thickness greater than the 0.736 inches, except one location. Location 1 as shown in Table 8, has a reading below 0.736 inches. Observations indicate that this location was very deep and not more than 1 to 2 inches in diameter. The depth of area relative to its immediate surrounding was measured at 8 locations around the spot and the average is shown in Table 8. Using the general wall thickness acceptance criteria described earlier, the evaluation thickness for location 1 was found to be above 0.736 inches as shown in Table 8.

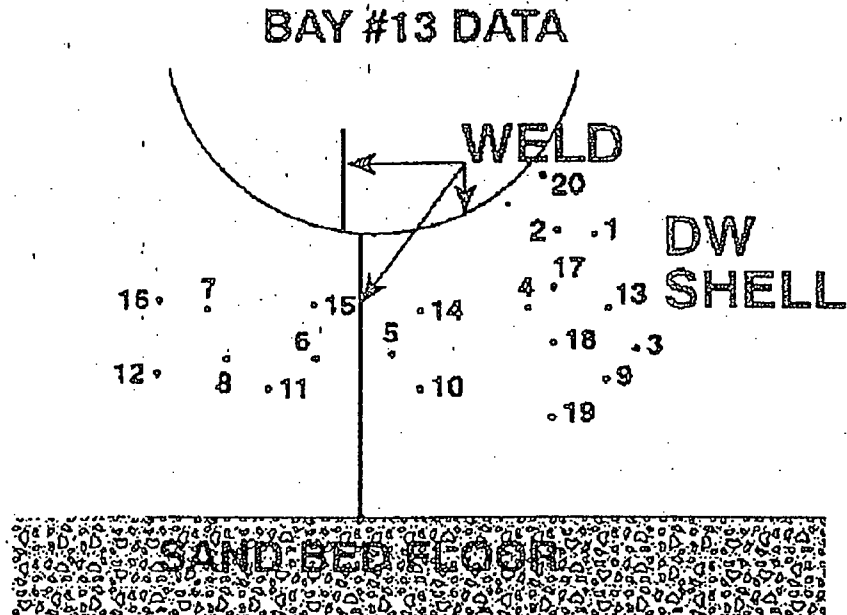
Figure 16

Bay 13 Data - Table 9

Locations 5, 6, 7, 8, 10, 11, 14, and 15 are confined to the bathtub ring as shown in Figure 16. An average value of these measurements is an evaluation thickness for this band as follows:

The inspector suspected that some of the above locations in the bathtub ring were over ground. Subsequent locations with suffix A, e.g. 5A, 6A, were located close to the spots in question and were ground carefully to remove the minimum amount of metal but adequate enough for UT examination as shown in Figure 16. The results indicate that all subsequent measurements were above 0.736 inches. The average micrometer readings taken for these locations confirm the depth of measurements at these locations. In spite of the fact that the original readings were taken at heavily ground locations, they are the one used in the evaluation.

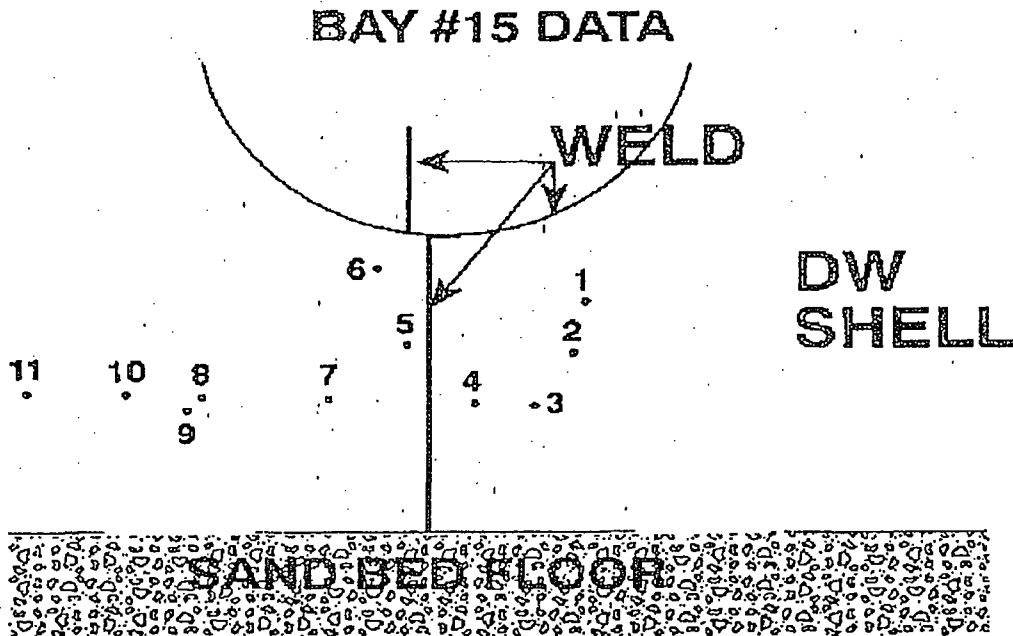
Figure 17

Bay 15 Data - Table 11

Eleven locations were selected to represent the thinnest areas based on the visual observations of the shell surface (see Fig. 17). These locations are a deliberate attempt to produce a minimum measurement. Table 11 shows readings taken to measure the thicknesses of the drywell shell using a D-meter. The results indicate that all of the areas have thickness greater than the 0.736 inches, except one location. Location 9 as shown in Table 11, has a reading below 0.736 inches. Observations indicate that this location was very deep and not more than 1 to 2 inches in diameter. The depth of area relative to its immediate surrounding was measured at 8 locations around the spot and the average is shown in Table 11. Using the general wall thickness acceptance criteria described earlier, the evaluation thickness for location 9 was found to be above 0.736 inches as shown in Table 12.

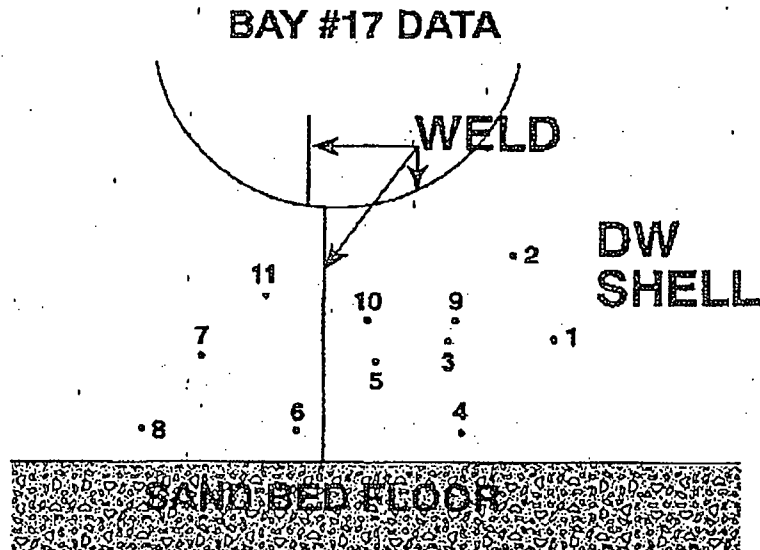
Figure 18

Bay 17 Data - Table 13

Eleven locations were selected to represent the thinnest areas based on the visual observations of the shell surface (see Fig. 18). These locations are a deliberate attempt to produce a minimum measurement. Table 13 shows readings taken to measure the thicknesses of the drywell shell using a D-meter. The results indicate that all of the areas have thickness greater than the 0.736 inches, except one location. Location 9 as shown in Table 13, has a reading below 0.736 inches. Observations indicate that this location was very deep and not more than 1 to 2 inches in diameter. The depth of area relative to its immediate surrounding was measured at 8 locations around the spot and the average is shown in Table 13. Using the general wall thickness acceptance criteria described earlier, the evaluation thickness for location 9 was found to be above 0.736 inches as shown in Table 14.

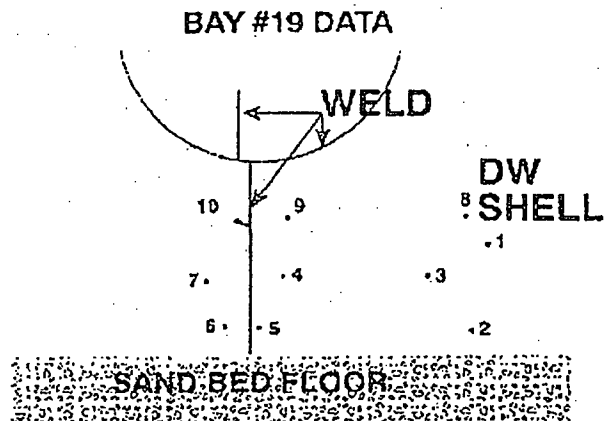
Figure 19

Bay 19 Data - Table 15

Ten locations were selected to represent the thinnest areas based on the visual observations of the shell surface (see Fig. 19). These locations are a deliberate attempt to produce a minimum measurement. Table 15 shows readings taken to measure the thicknesses of the drywell shell using a D-meter. The results indicate that all of the areas have thickness greater than the 0.736 inches.
