# James A. FitzPatrick Nuclear Power Plant

**ACRS License Renewal Subcommittee Presentation  
September 5, 2007**

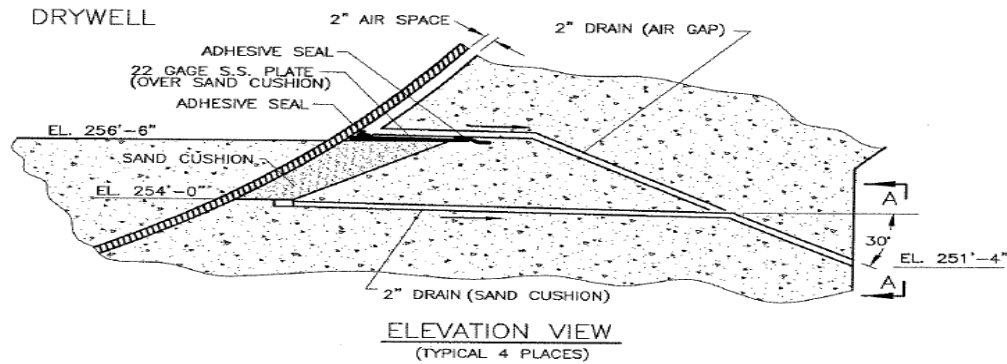
**SAND CUSHION & AIR GAP DRAIN LINE DETAILS**

- Sand Cushion Inspections. No Evidence of Moisture (Boroscopic Inspection).
- Visual Inspection of Interior Drywell Caulk Seal.
- Drywell Interior Coating System (Carbozinc 11 and Dupont Corlar Epoxy) Inspection IAW IWE Program during RFO.

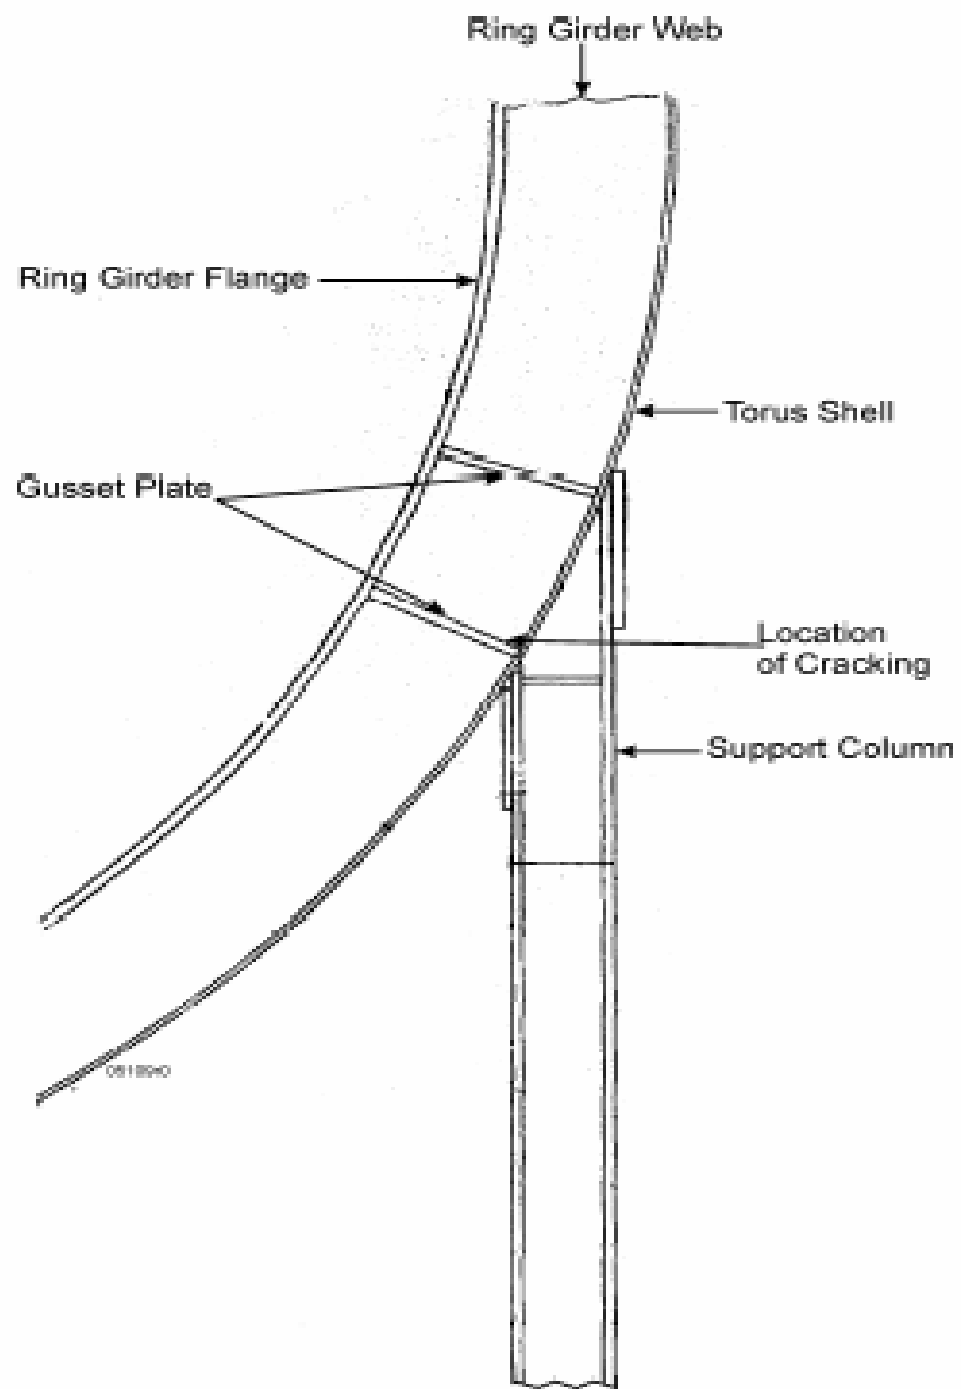
Torus Leak 2005

- Torus shell through-wall leak reported in June 2005
- Leak was located in same bay as HPCI Steam Discharge pipe near ring girder gusset plate weld
- ASME Section XI code repair performed in July 2005 by removing the flaw and adding a circular repair plate
- Root cause of flaw was vibration fatigue from HPCI steam condensation oscillation loading
