BVPS Unit No. 1

Containment Liner Corrosion Report

CR 06-01122, Dated February 20, 2006

Report Date: March 14, 2006

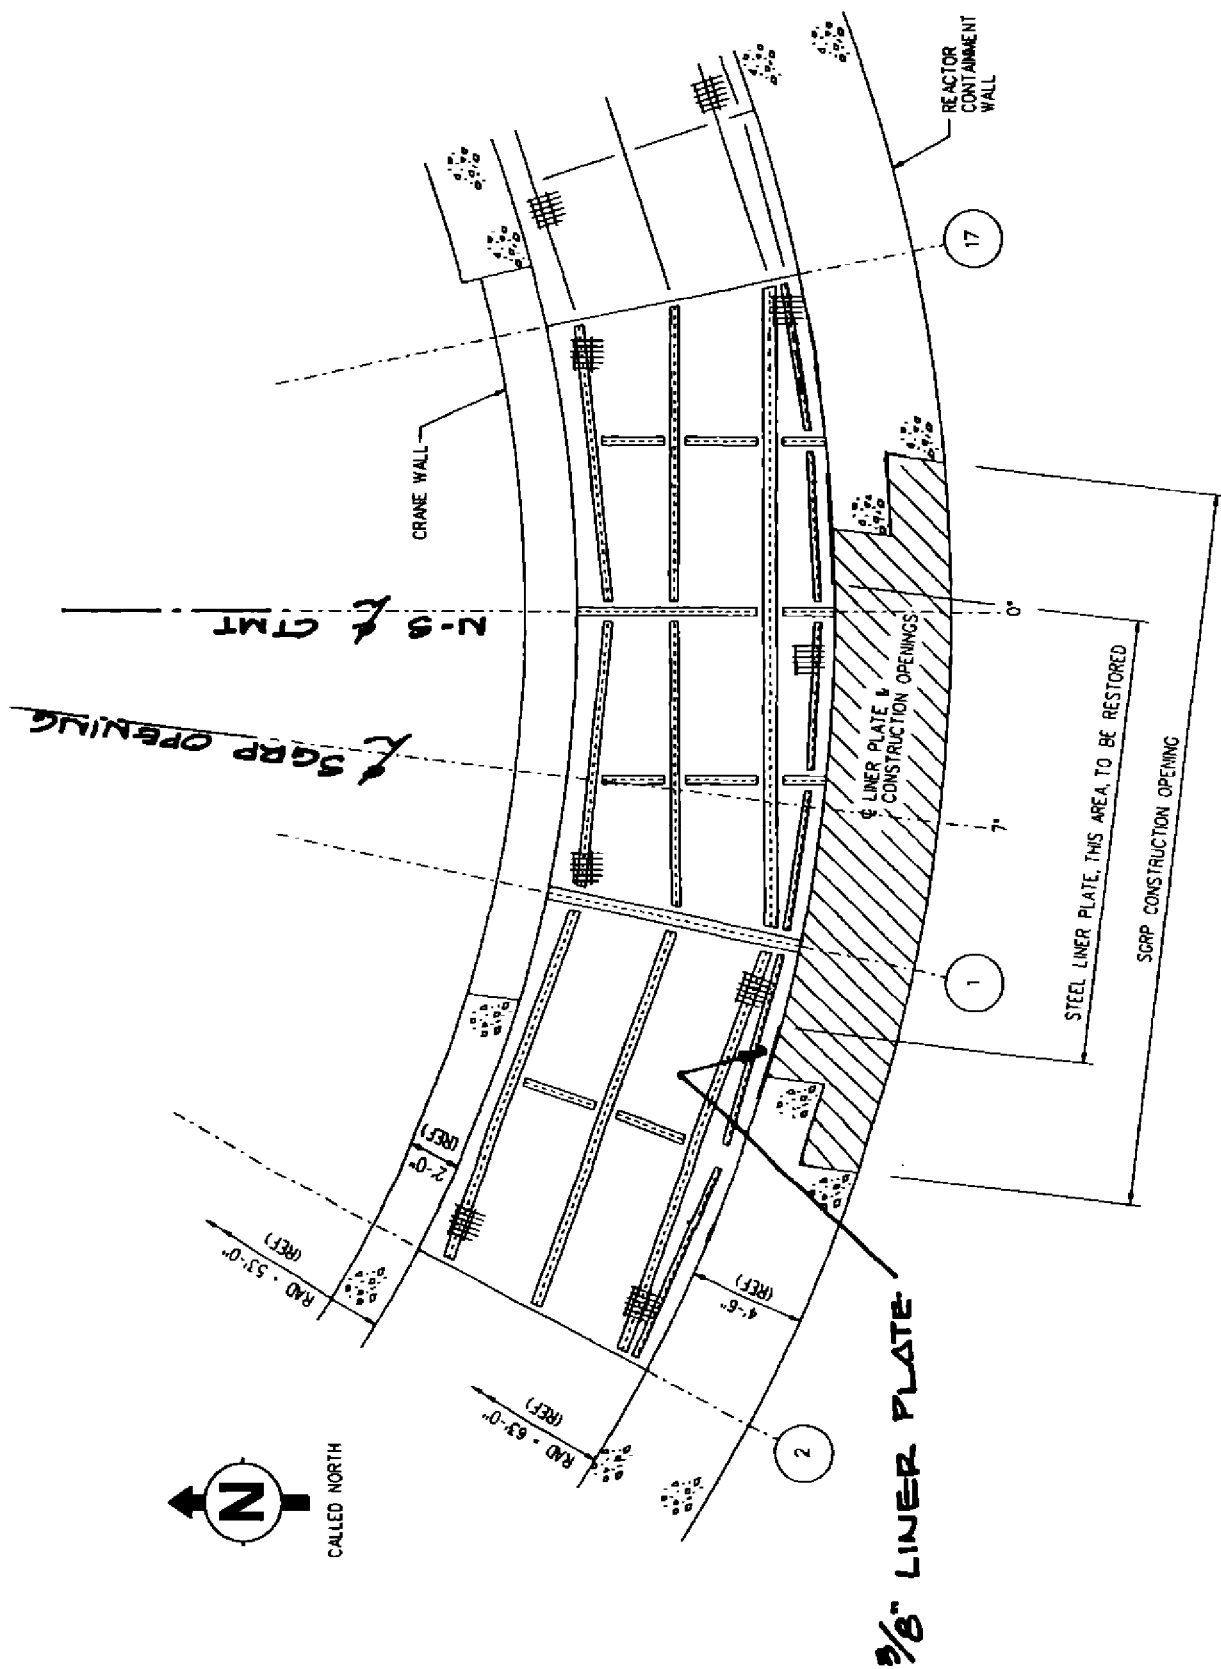
PARTIAL PLAN - EL 767'-10"

LOCATION OF SGRP OPENING

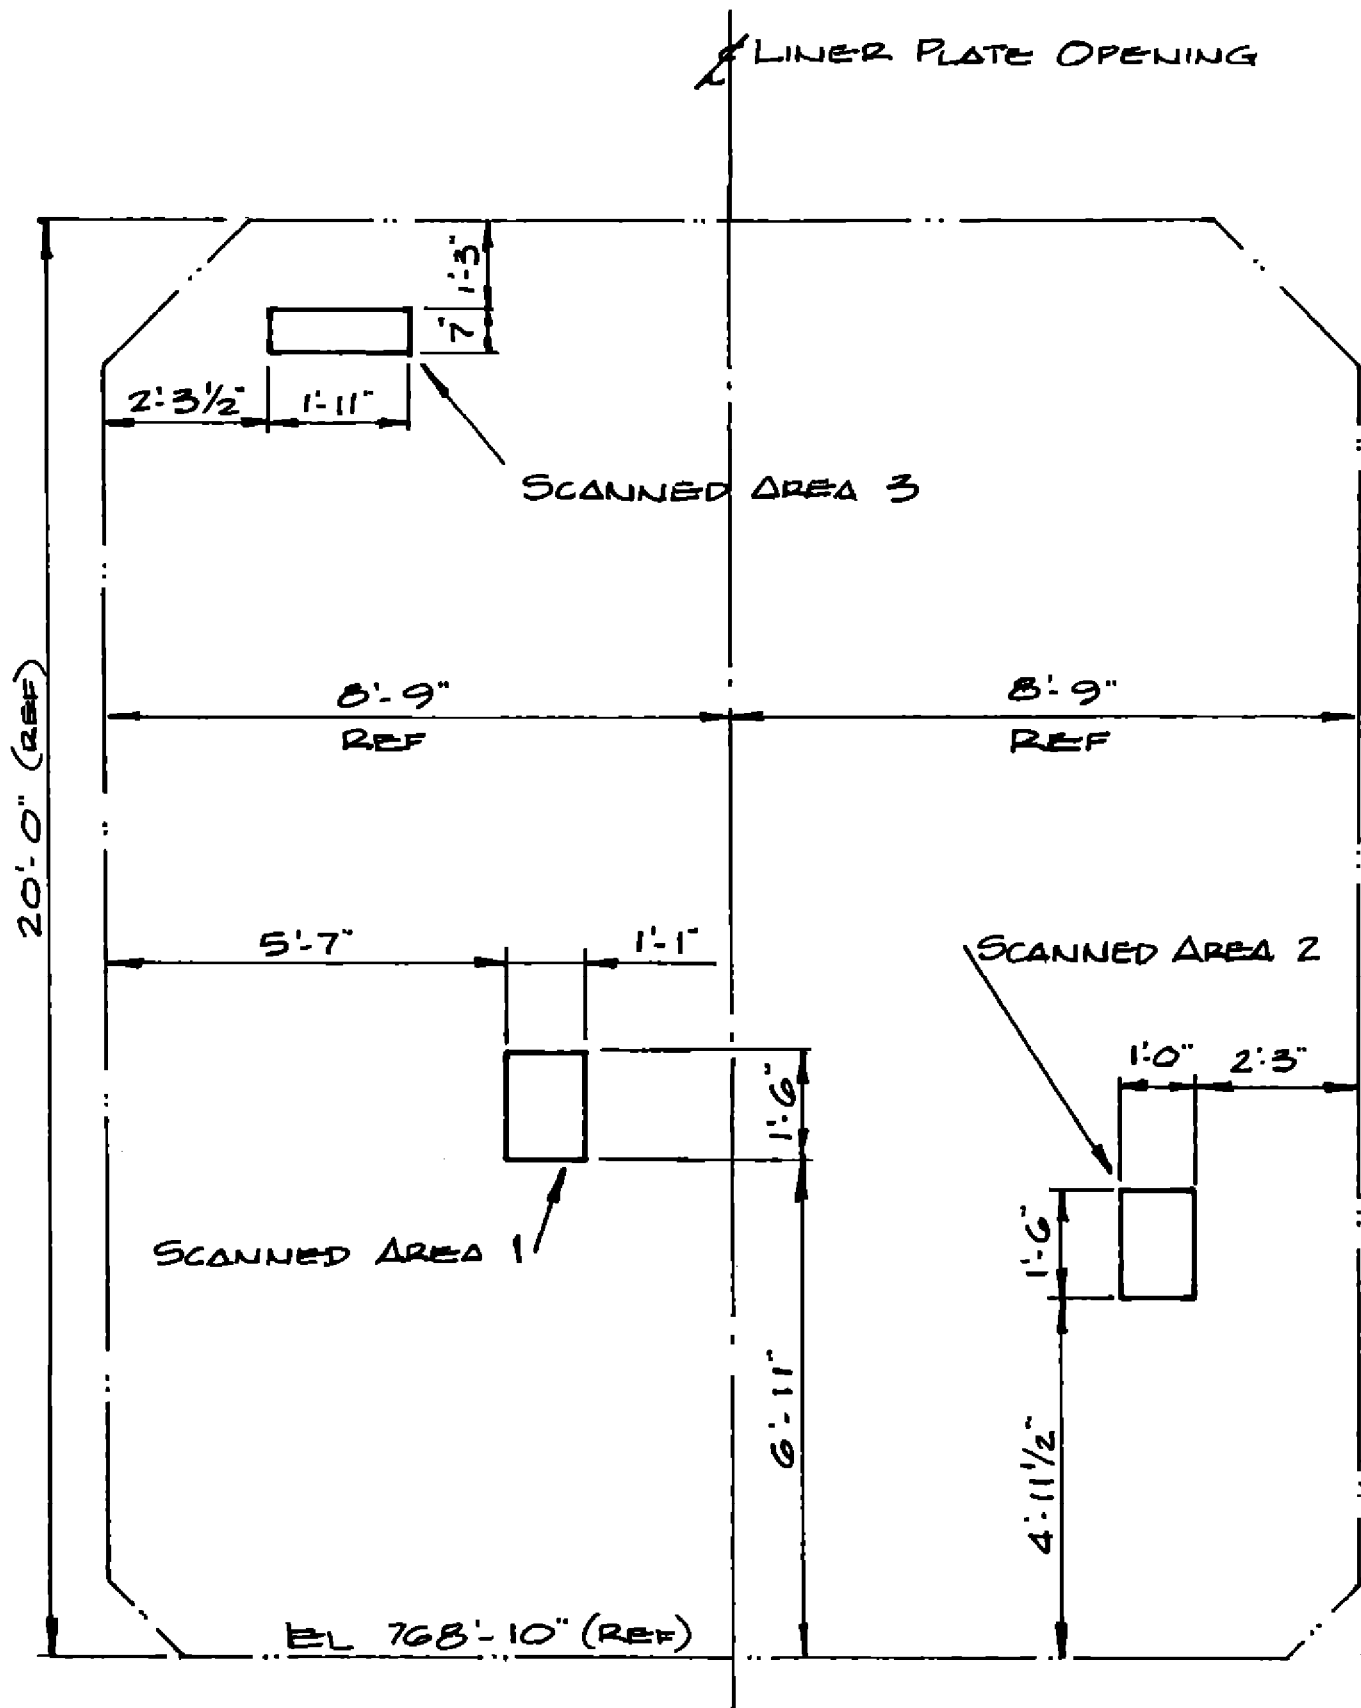
ELEVATION
 LOOKING NORTH FROM OUTSIDE CTMT.
 $\frac{3}{8}" \times 1'-0"$
 LOCATIONS OF CORROSION AREAS

Three areas of corrosion were identified on the concrete side of the steel containment liner. The areas of corrosion were contained on the removed doorway plate section. The remaining exposed area of liner plate exhibited no corrosion areas. The corrosion consisted of general surface corrosion and pitting corrosion. These as-found conditions were documented in CR 06-01122.

The sections of the liner removed for analysis were replaced with new plate material. The process and procedures, including inspection and NDE, were the same as those used for reinstallation of the liner plate cut from the construction opening.
