LAB NO.: M06074	WORK TRACKING NO.: 14878	PAGE 58 OF 78
PLANT & UNIT: BEAVER VALLEY #1	PART: CONTAINMENT MATERIALS	DATE: 3/9/2006

MATERIAL ANALYSIS REPORT

Beaver Valley Unit 1
Engineering Assessment Report
1 R 17 Exterior Containment Liner Corrosion

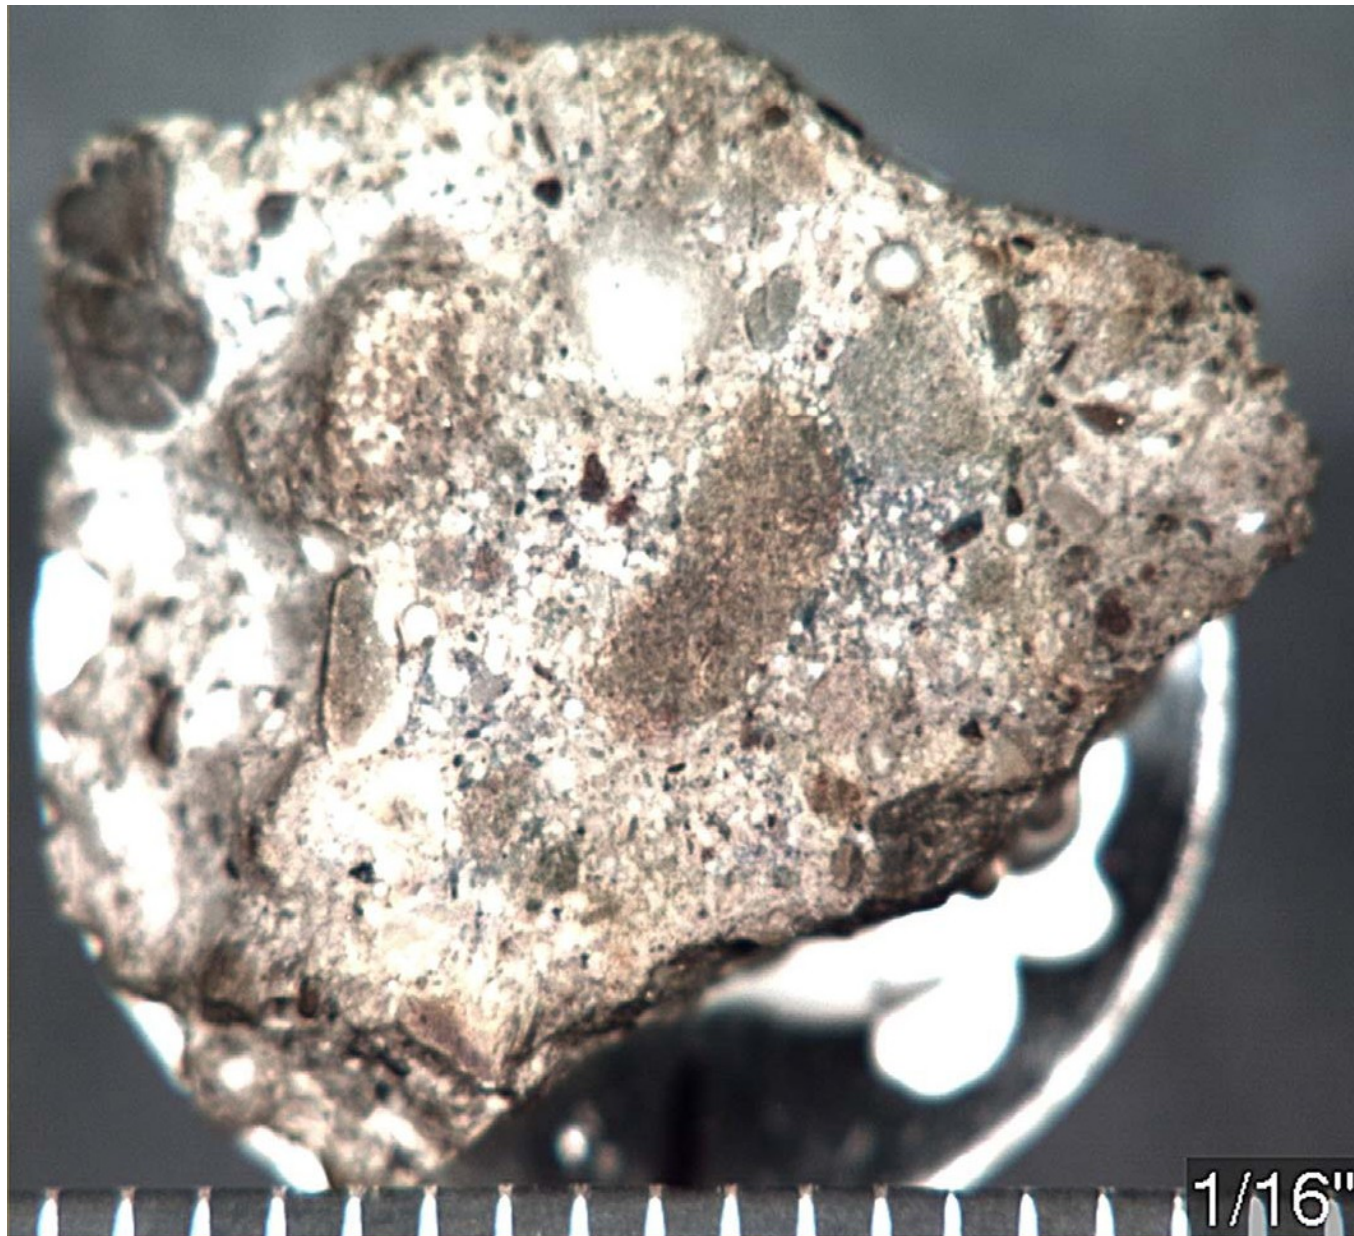
FIGURE 40, CONCRETE SAMPLE #1, 1ST (“LARGE PIECE”) FOR SEM STUDY.
REMOVED FROM THE BACK (RE-BAR SIDE) AND GROUND FLAT FOR ANALYSIS.

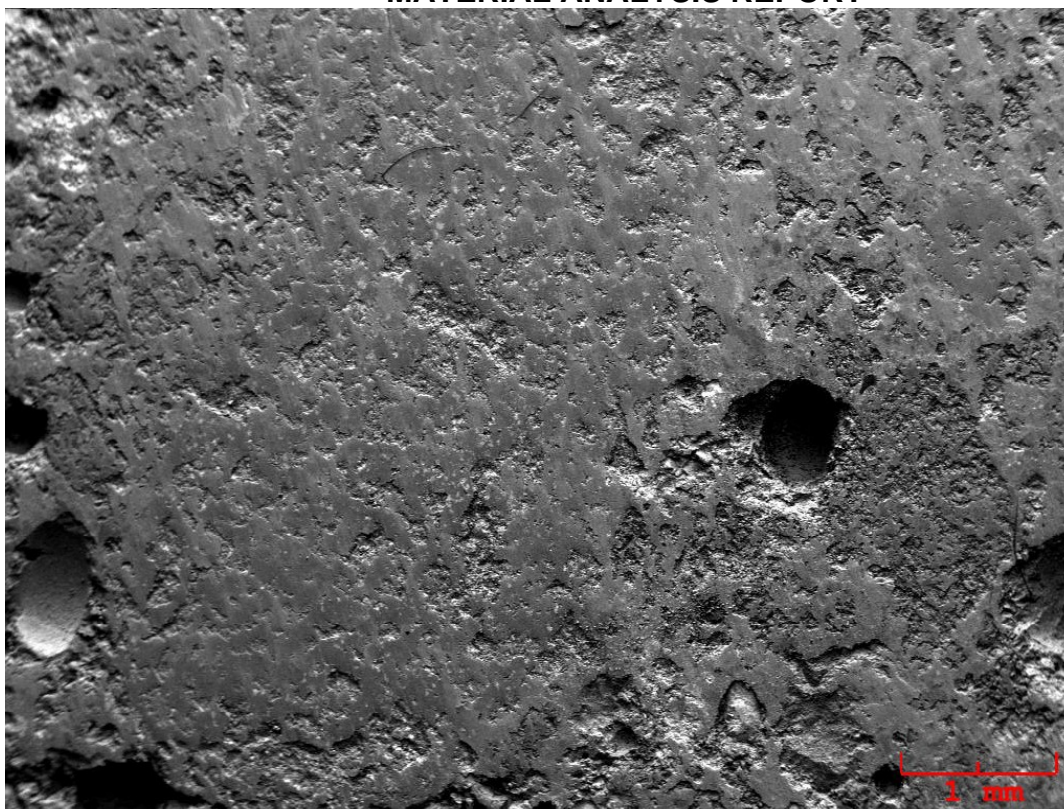
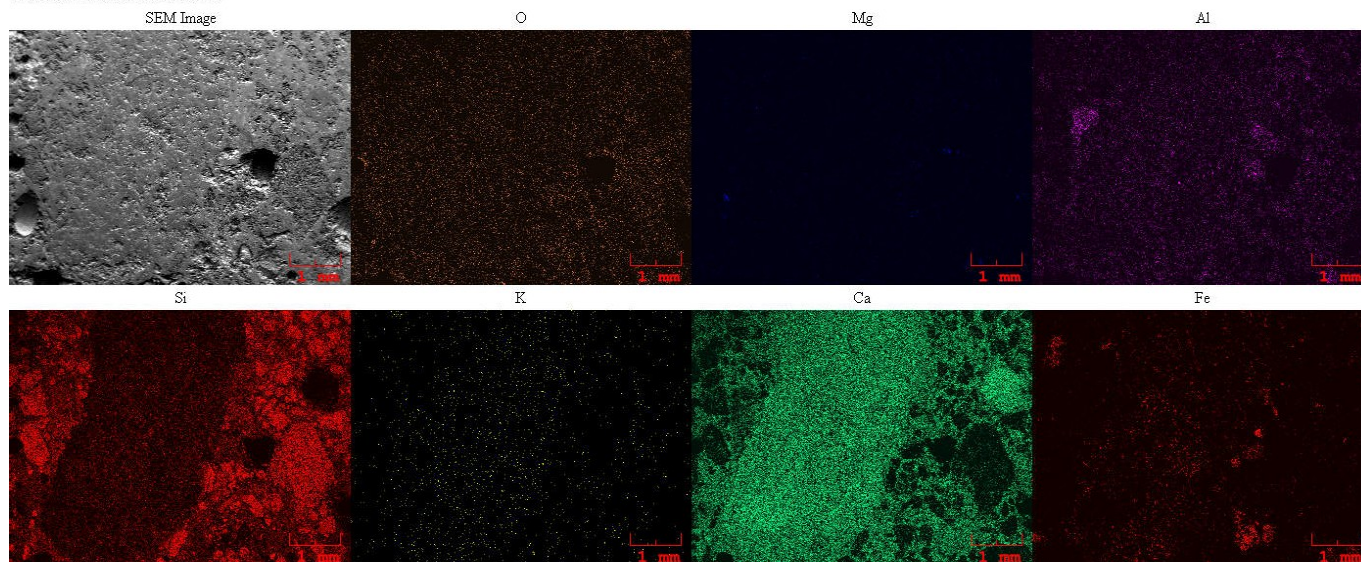
Concrete, #1, Area A, taken at 35x
SEM Image

FIGURE 41, CONCRETE SAMPLE #1, 1ST (“LARGE PIECE”), AREA “A” SEM-EDS ELEMENTAL DOT-MAP.

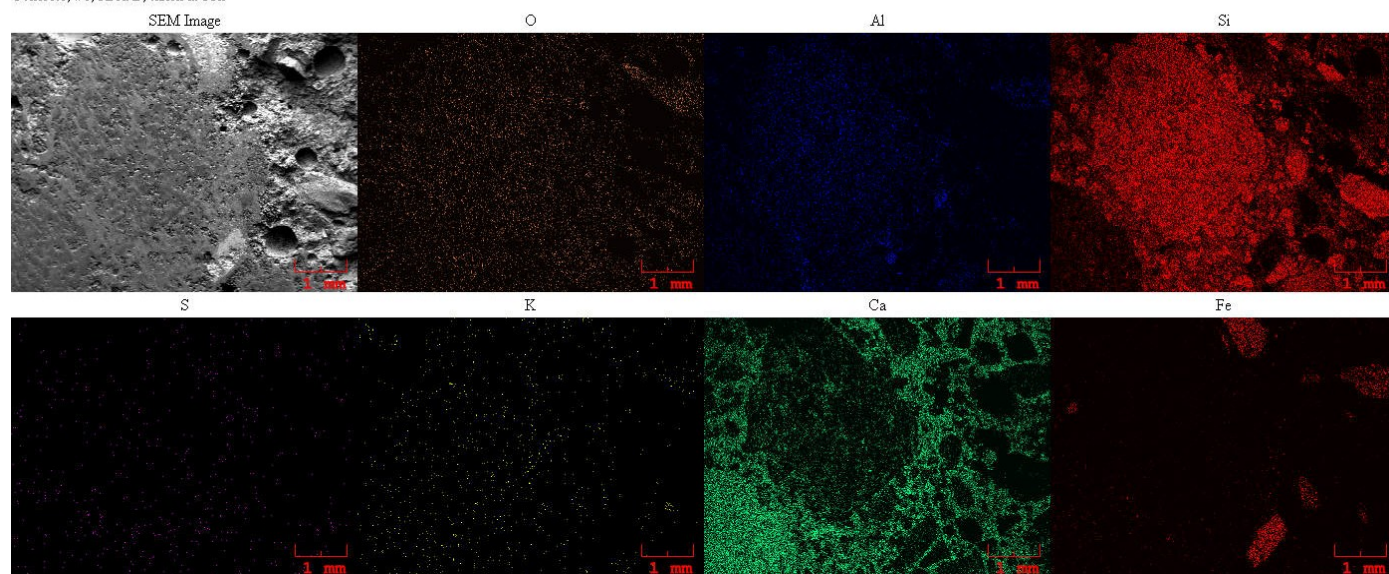
Concrete, #1, Area B, taken at 35x

FIGURE 42, CONCRETE SAMPLE #1, 1ST (“LARGE PIECE”), AREA “B” SEM-EDS ELEMENTAL DOT-MAP.

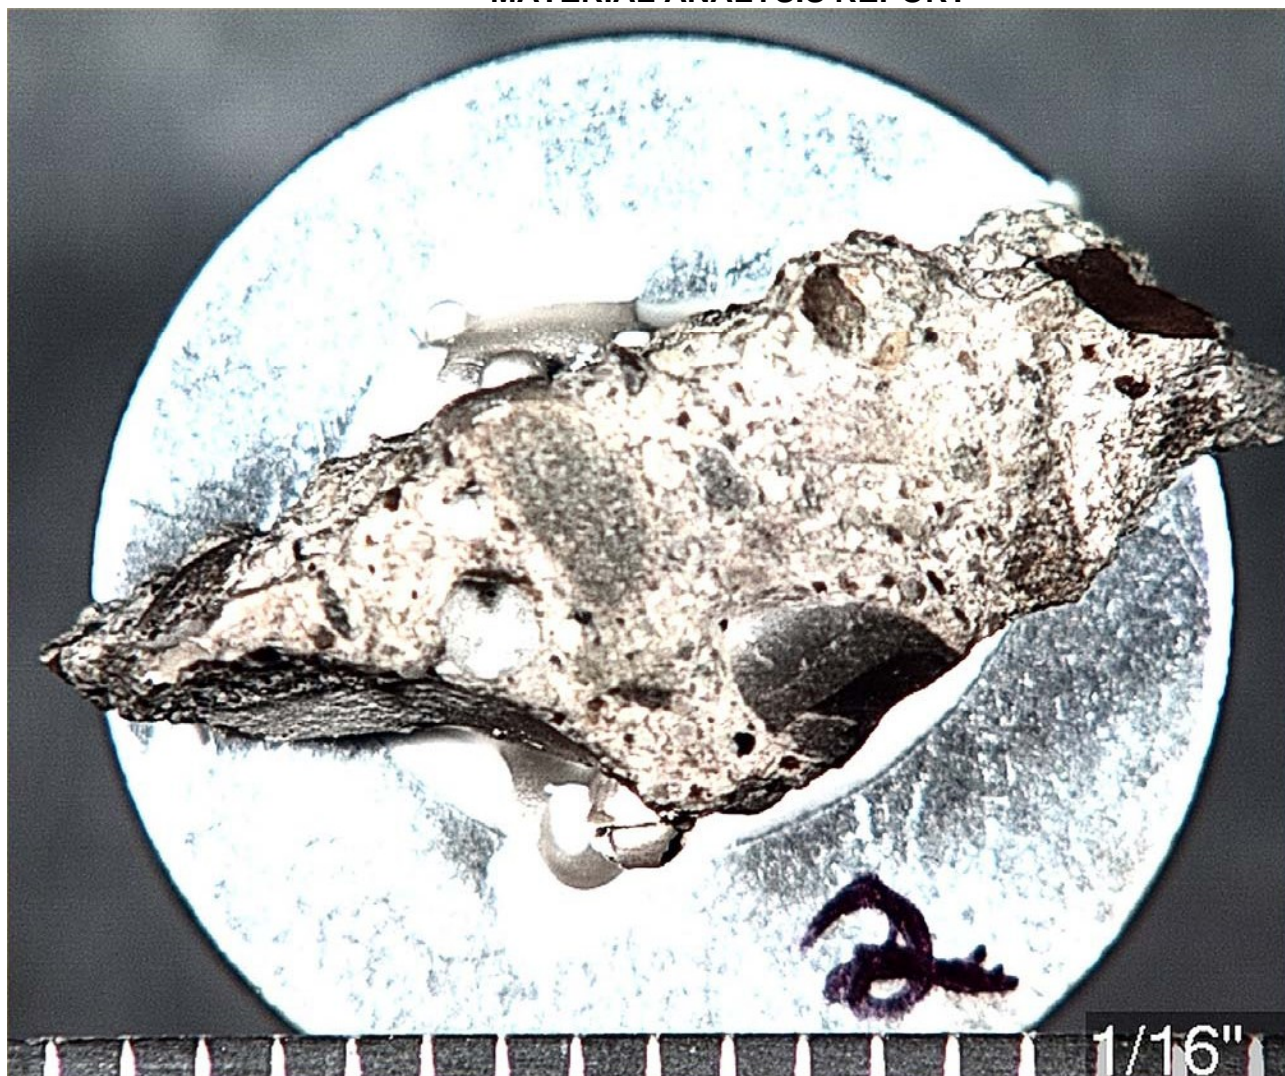
FIGURE 43, CONCRETE SAMPLE #2, “SMALL PIECE” FOR SEM STUDY.
REMOVED FROM THE END OF THE “SMALL PIECE” AND GROUND FLAT FOR ANALYSIS.

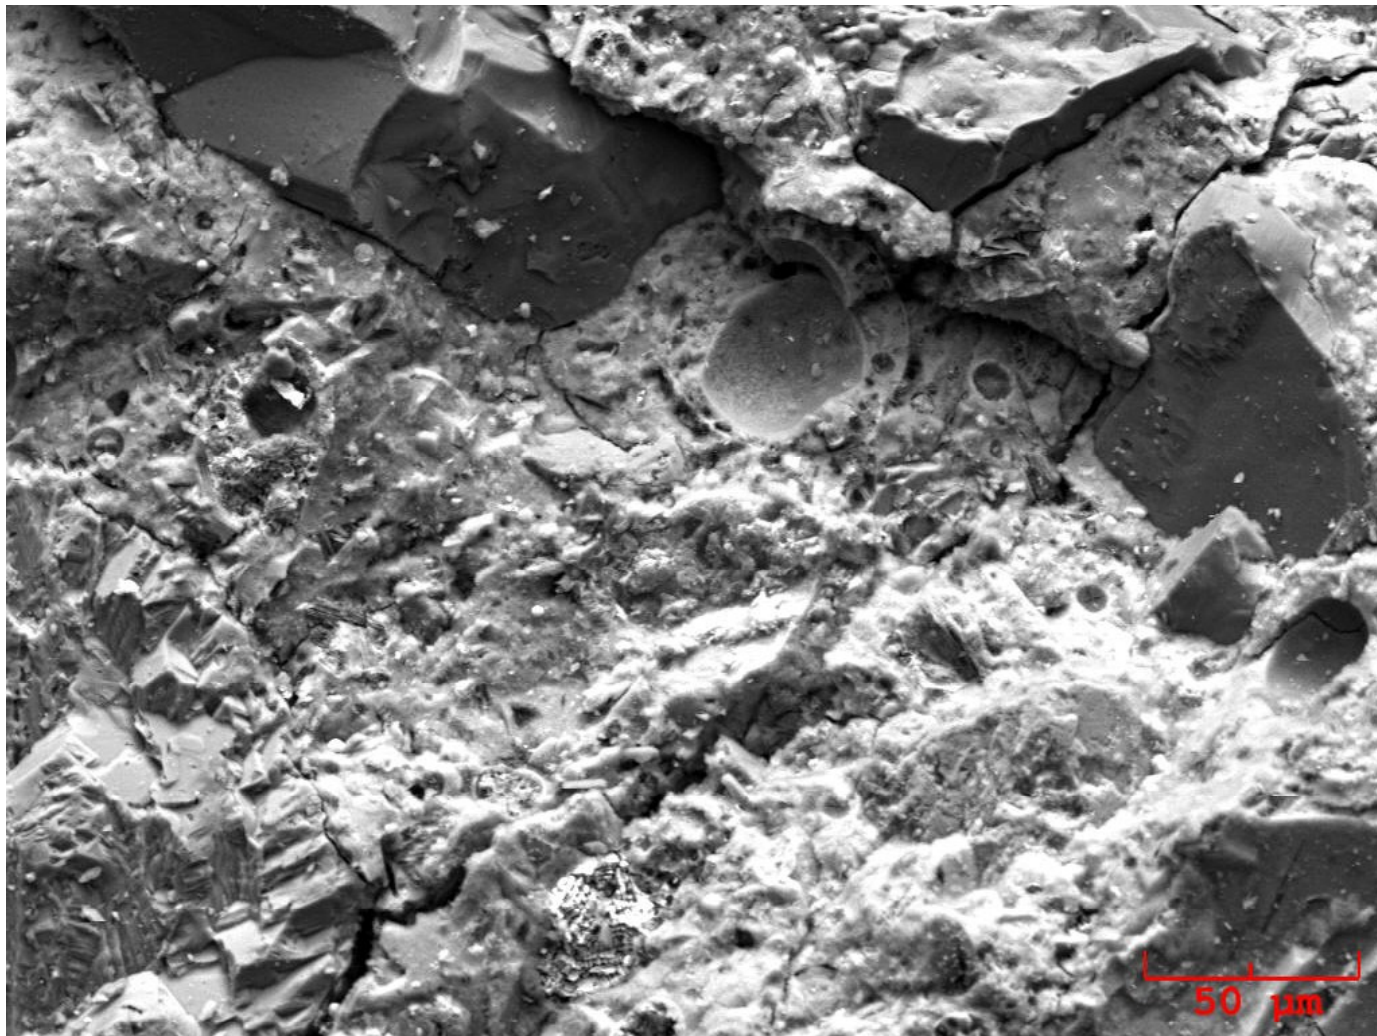
FIGURE 44, CONCRETE SAMPLE #2, “SMALL PIECE”, AREA “A” DETAIL IN THE SEM.

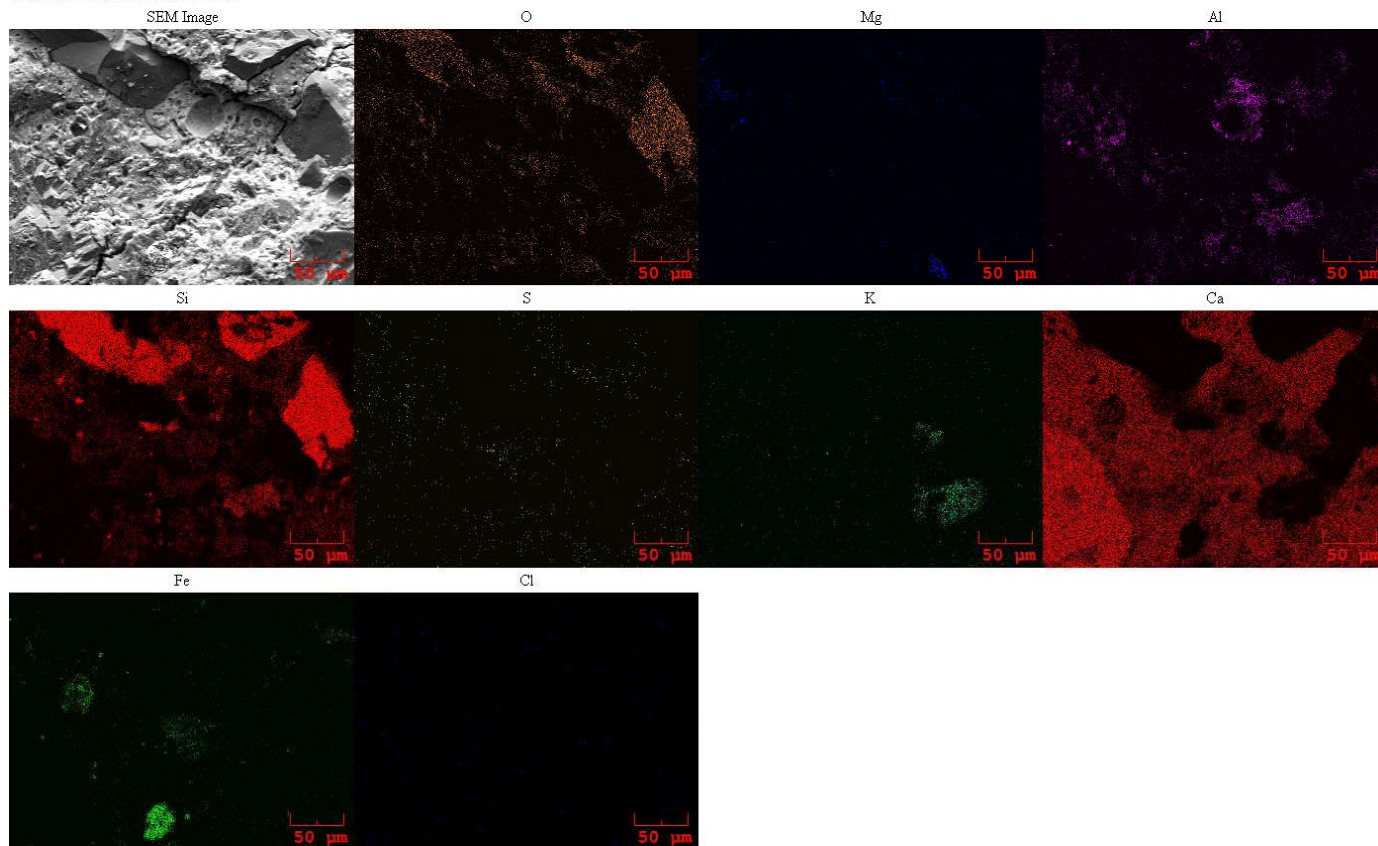
Concrete, #2, Area A, Maps at 750x

FIGURE 45, CONCRETE SAMPLE #2, “SMALL PIECE”, AREA “A” SEM-EDS ELEMENTAL DOT-MAP.

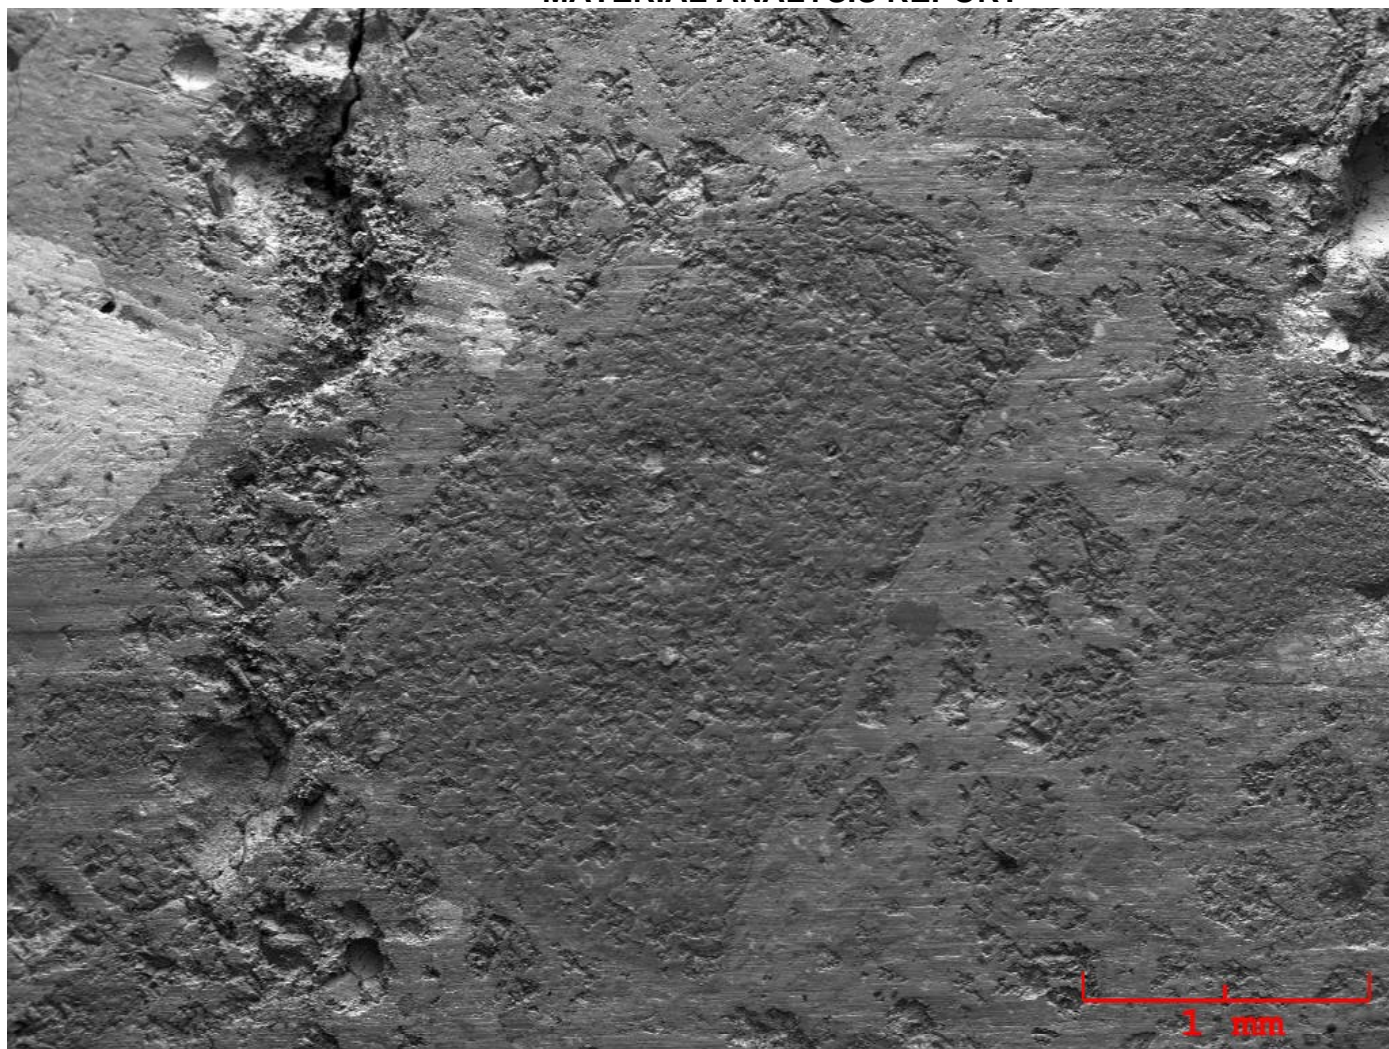
FIGURE 46, CONCRETE SAMPLE #2, "SMALL PIECE", AREA "B" DETAIL IN THE SEM.

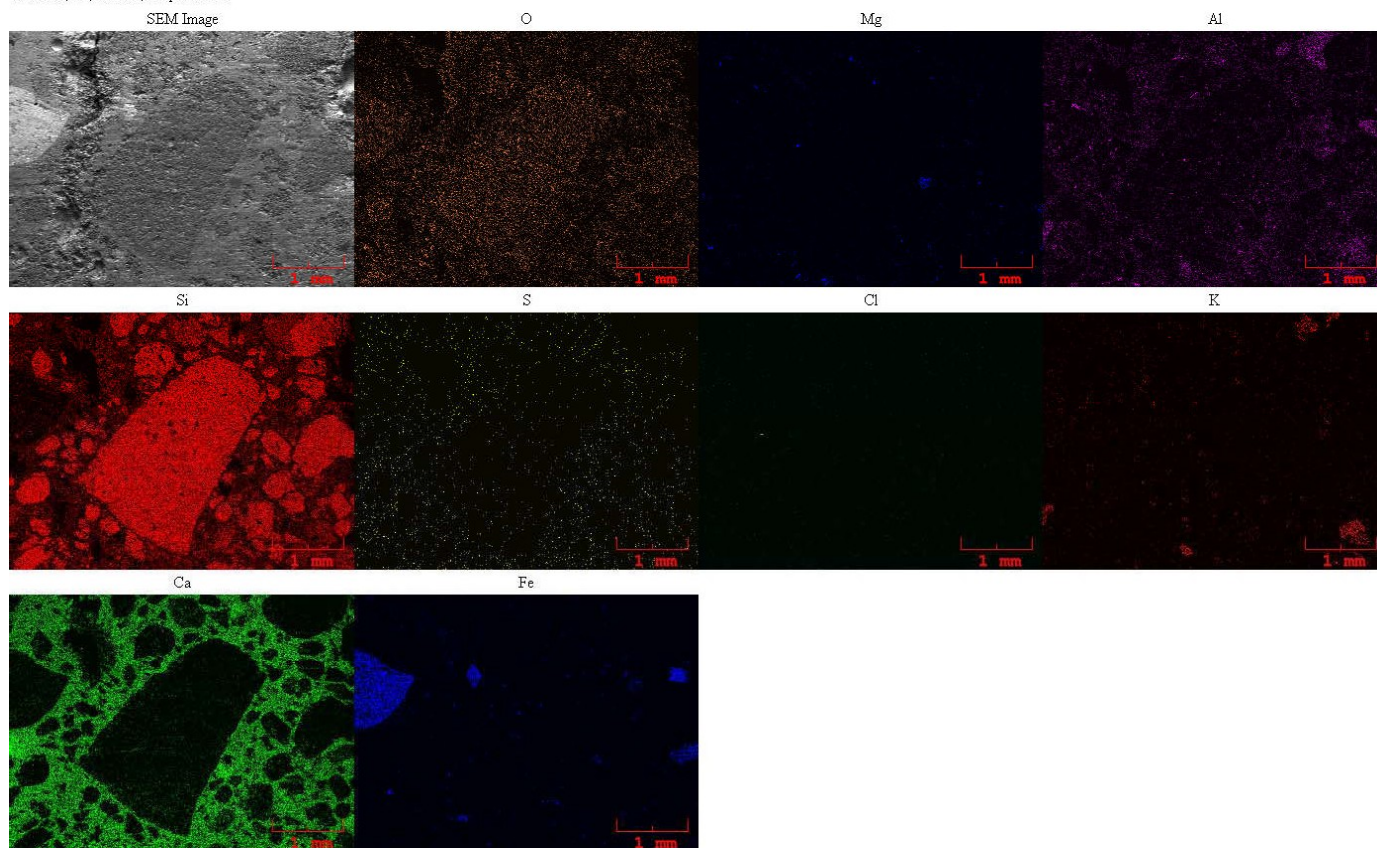
Concrete, #2, Area B, Maps at 50x

FIGURE 47, CONCRETE SAMPLE #2, “SMALL PIECE”, AREA “B” SEM-EDS ELEMENTAL DOT-MAP.

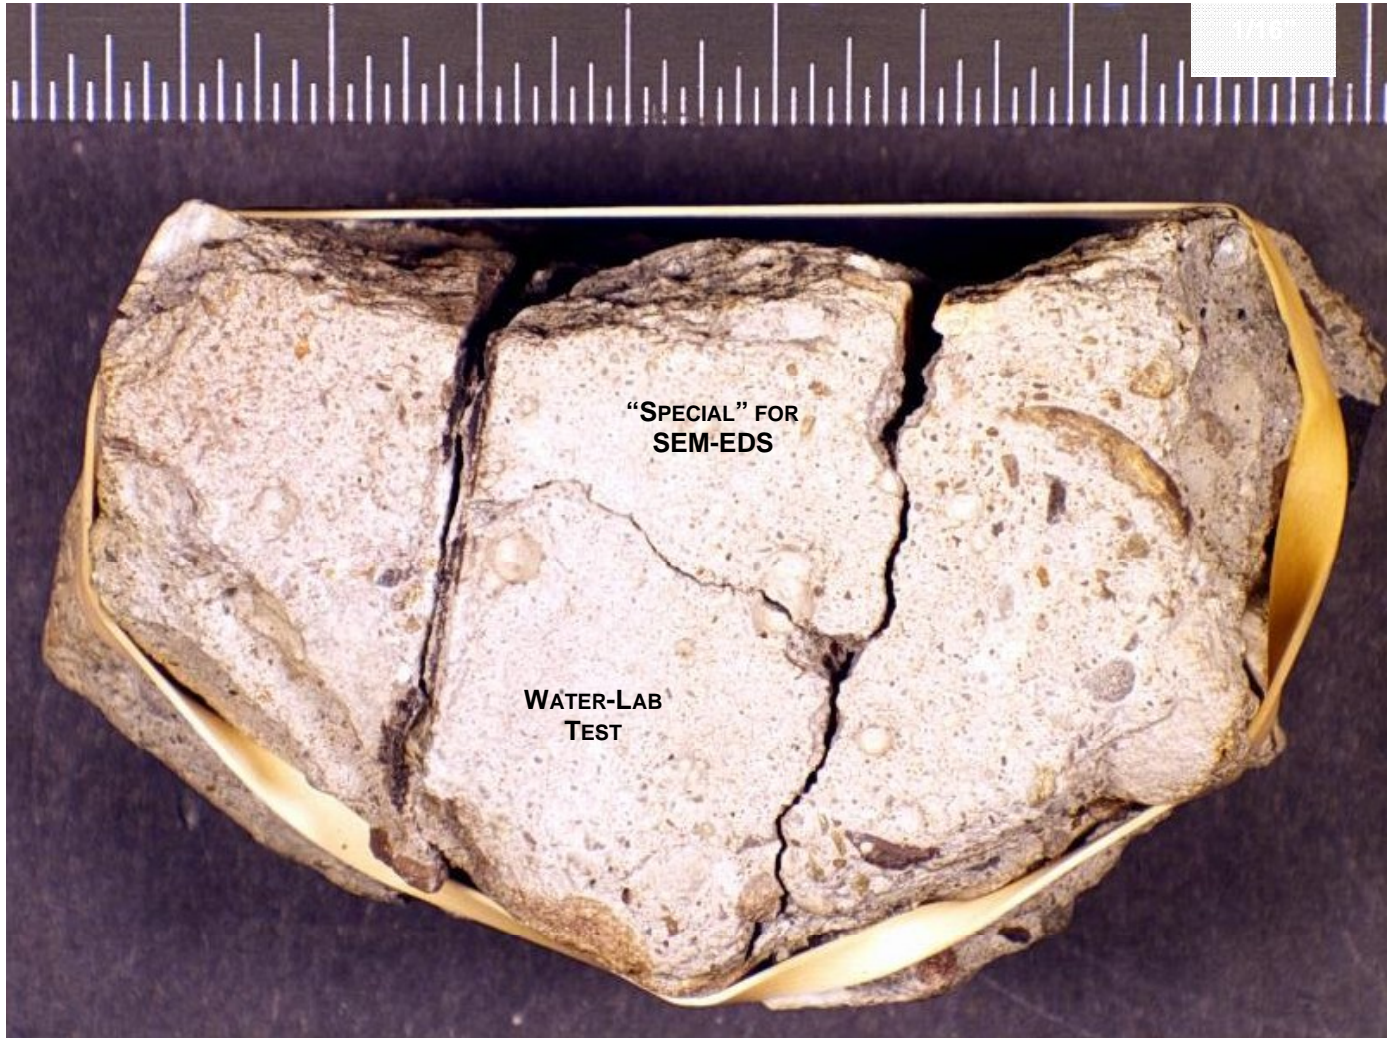
FIGURE 48, CONCRETE SAMPLE #1, ("LARGE PIECE"), BROKEN FOR TESTS, AS-MARKED.
NOTE: THE WATER LAB TEST SAMPLE WAS FOR WATER-SOLUBLE CL.

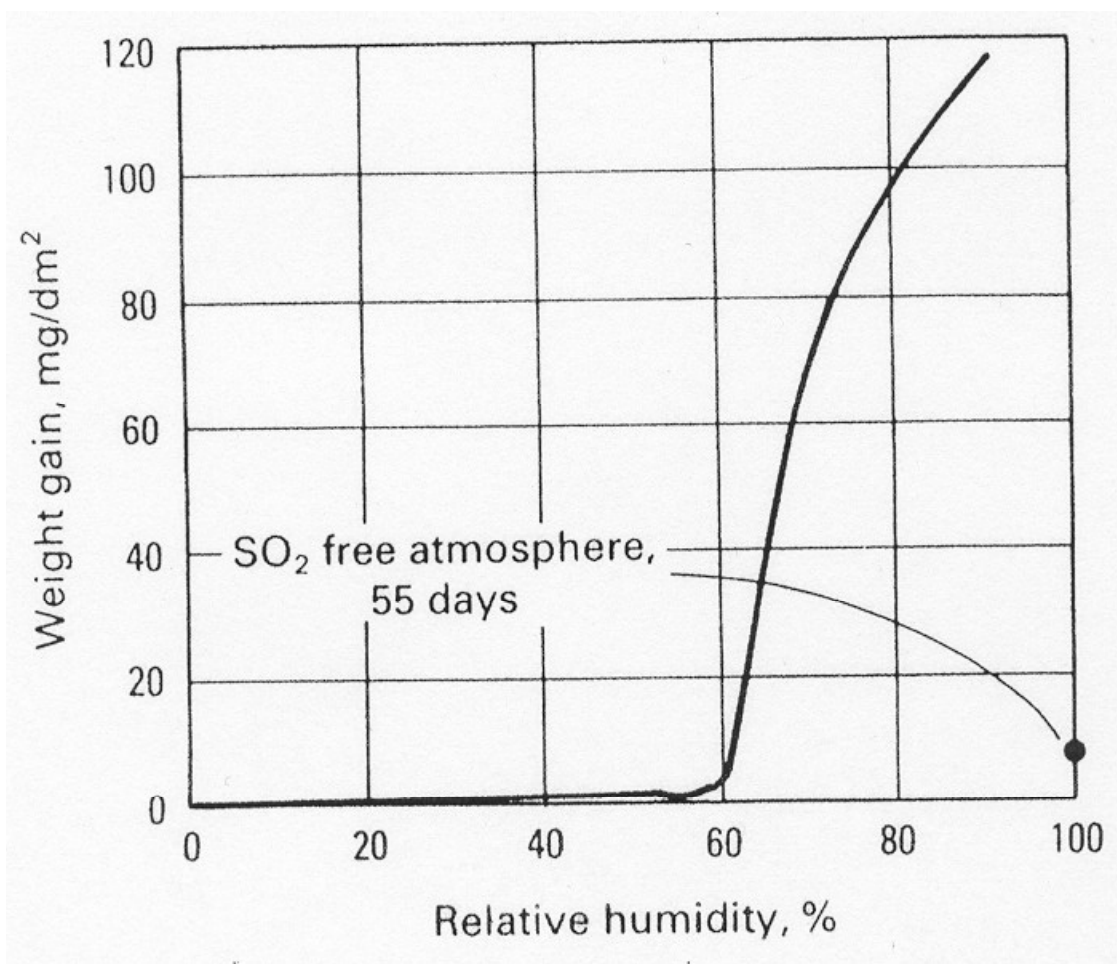
Studies have shown that the duration of wetness, although an important factor, cannot be considered in isolation when estimating corrosion rates. An excellent example of this fact is demonstrated in Figure 1, in which the weight gain of iron is plotted as a function of the relative humidity for 55 days of exposure in an atmosphere containing 0.01% sulfur dioxide. In the lower right hand corner of Figure 1 is the major corrosion rate for iron exposed for the same time in a sulfur-dioxide-free atmosphere at 99% relative humidity. The increase in the corrosion rate produced by the addition of sulfur dioxide to the atmosphere is substantial. In addition, the figure above shows a critical value near 60% relative humidity.¹⁹

Figure 1. Effect of Relative Humidity and Atmospheric Pollution on the Rusting of Iron

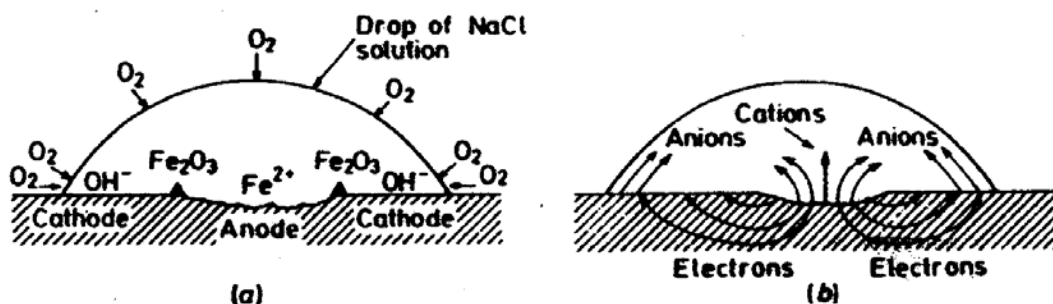
Figure 2. Oxygen Concentration Cell
