II. Second Investigation

1. Purpose

The purpose of this report is to provide results of additional investigation of I type mockups and boat samples collected from the U3B and U3A RSGs.

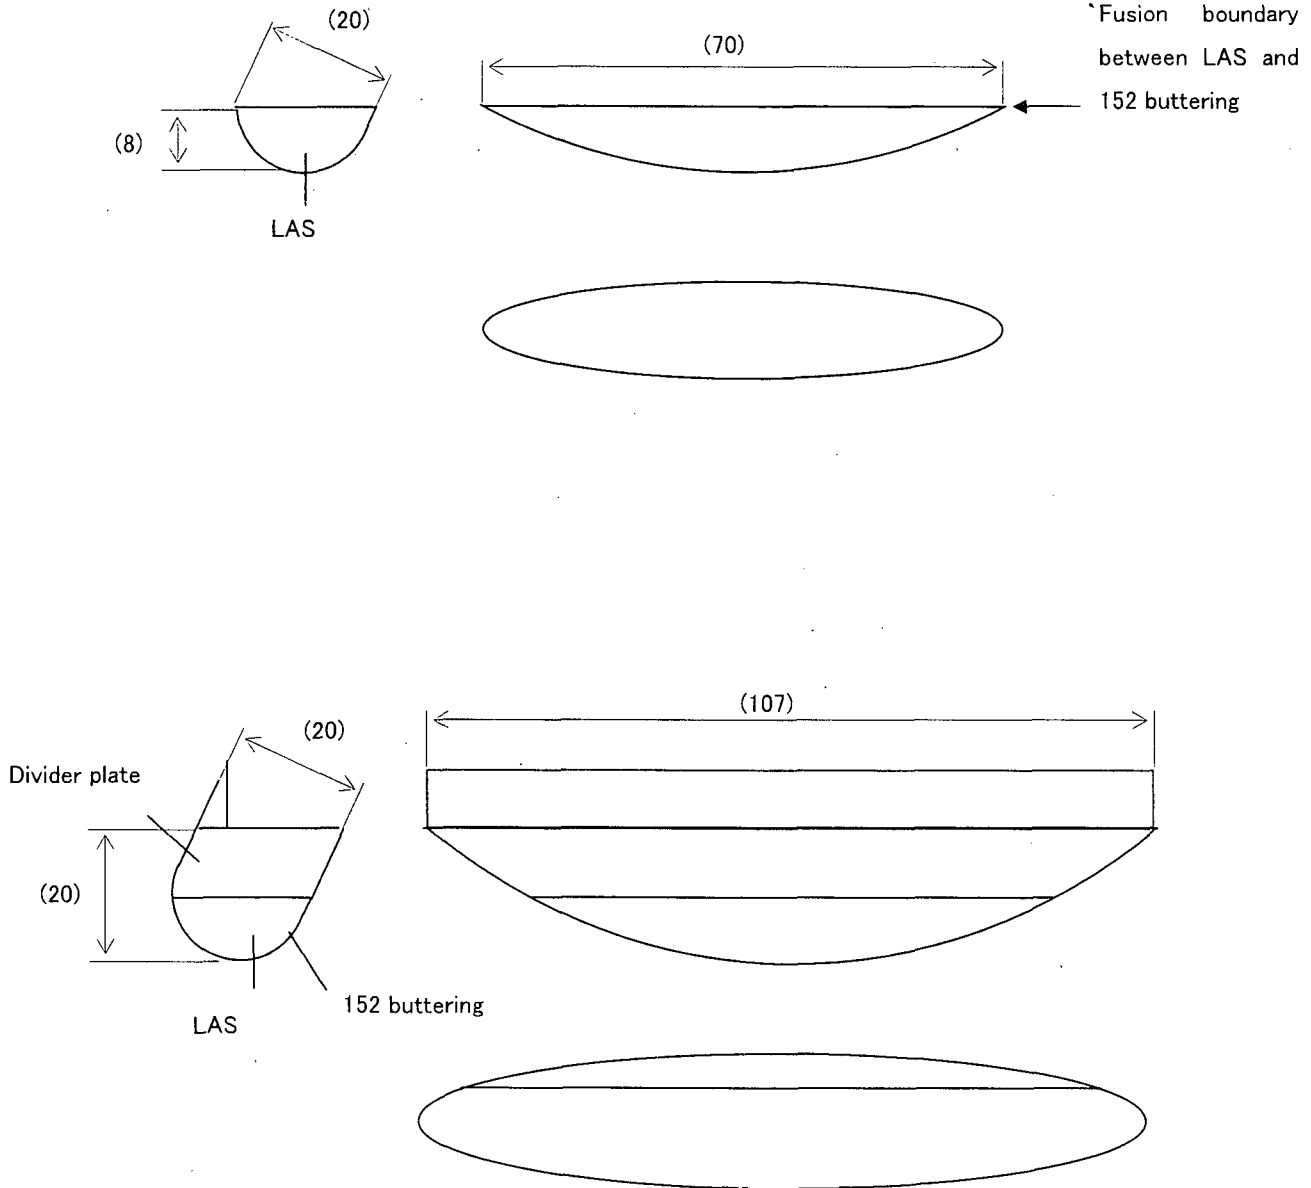
Figure A.44(2) The collecting location and schematic illustration of boat samples.
(schematic illustration of boat samples)

2 boat samples were additionally collected from Unit 3A RSG at the location as shown in Figure A.44. The detail of the each sample was shown in Table A.5.

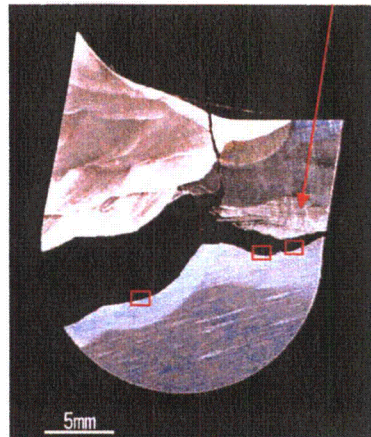
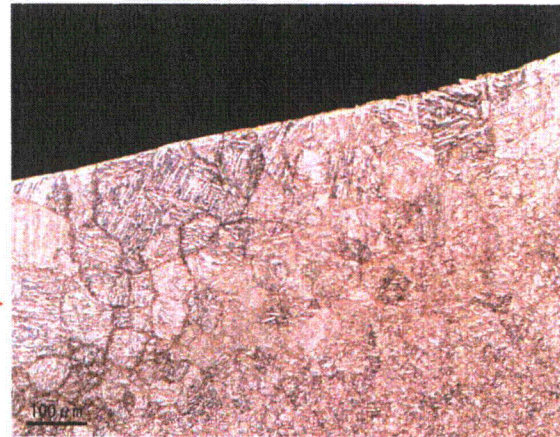
The HAZ of 152 buttering tends to reveal larger grains (mean grain size was about 0.1mm) compared with HAZ of stainless steel clad (mean grain size was 0.02mm to 0.01mm). It was considered that the HAZ of stainless steel clad was refined by heat input of 2nd layer welding.

Sample A, HAZ by 152 buttering (SMAW)
Grain size number: 4, Grain size: 0.088mm

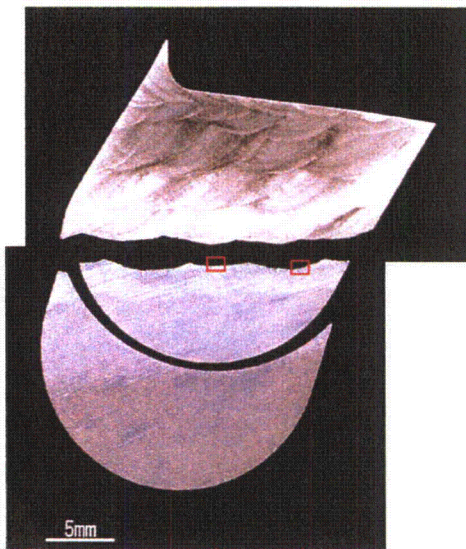
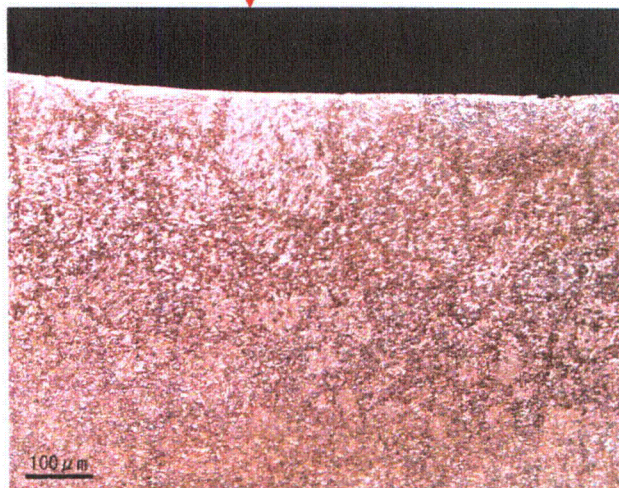
Sample B, HAZ by 152 buttering (SMAW)
Grain size number: 3, Grain size: 0.125mm

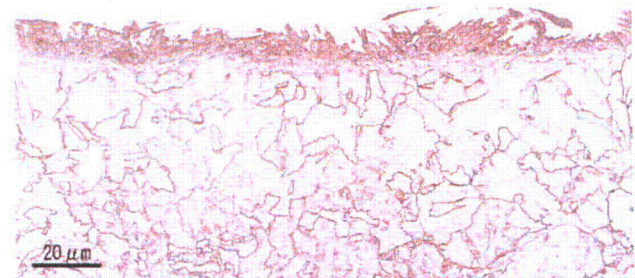
Sample C, HAZ by Stainless steel (ESW)
Grain size number: 9.5, Grain size: 0.013mm

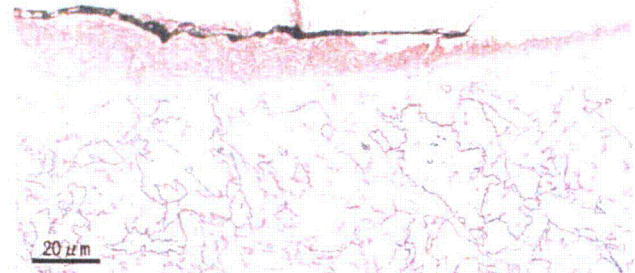
Sample C, HAZ by Stainless steel (ESW)
Grain size number: 9, Grain size: 0.0193mm

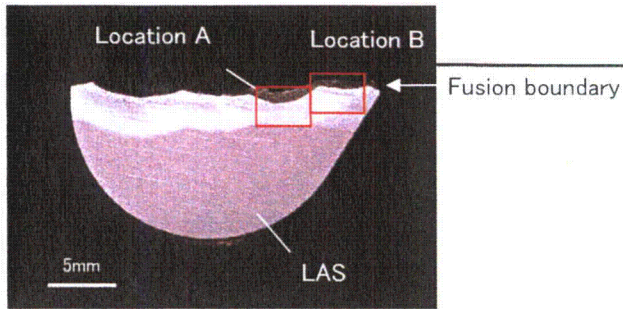
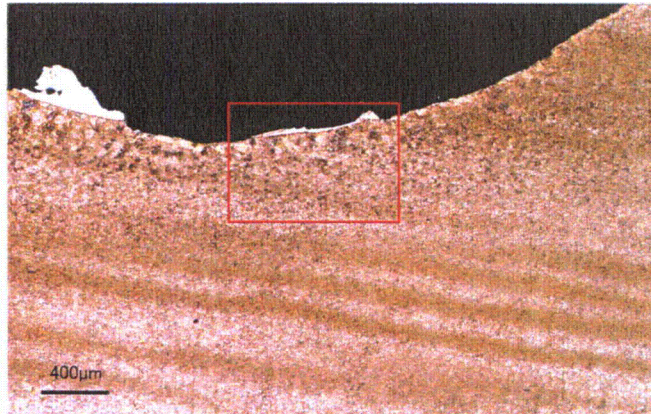
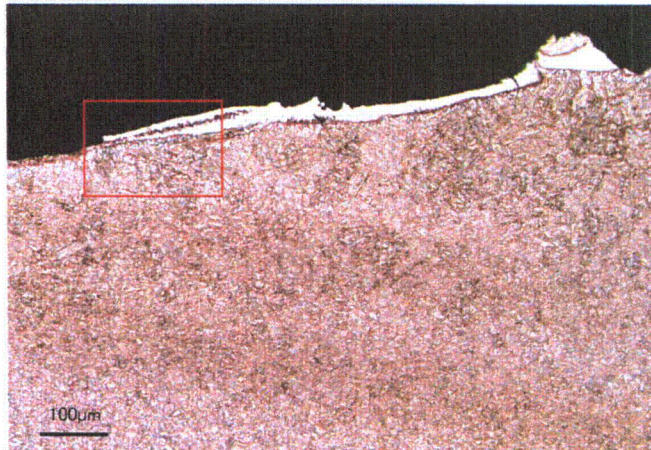
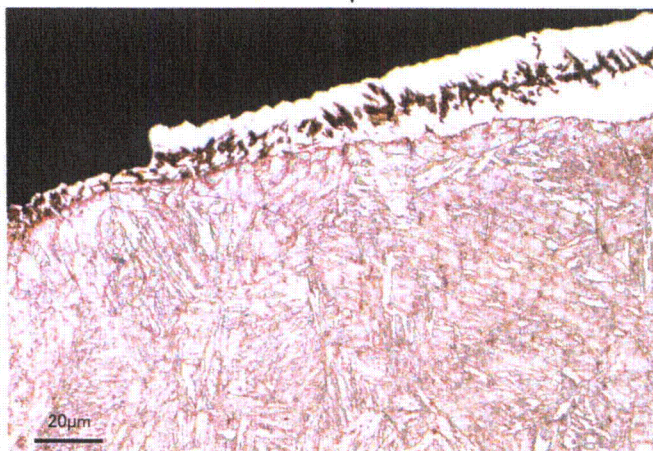
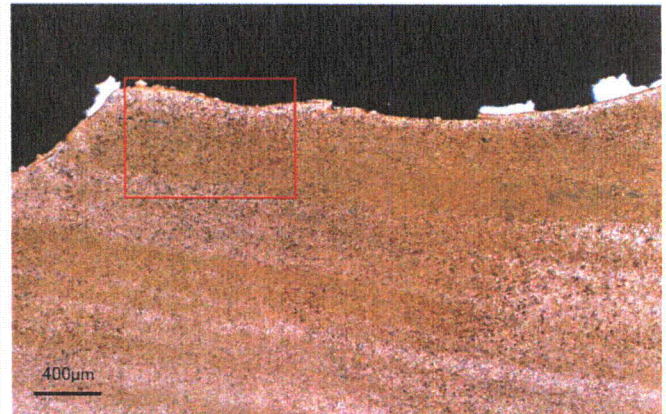
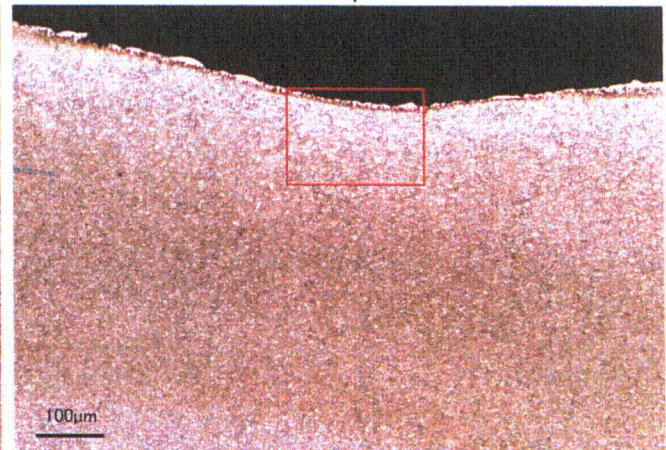
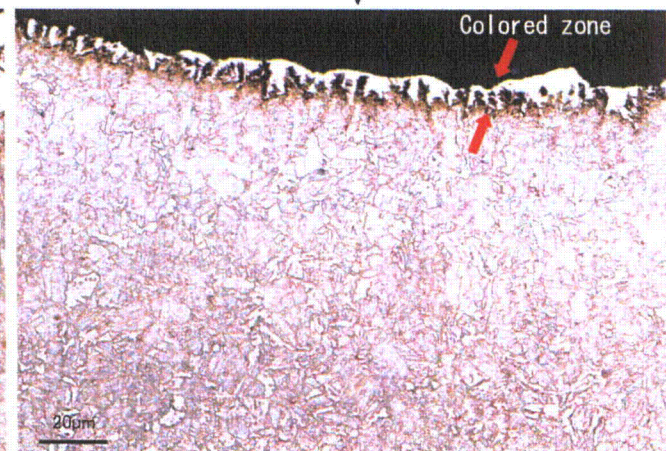
Figure A.48(1) Macro structure and micro structure of cross section of sample F

Figures A.48 show macro-structures and micro-structures of cross section of sample F. The separation occurs along the fusion boundary between 152 weld metal and LAS base metal. In higher magnification pictures, the crack paths seem to be similar to the boat samples collected from U3B; crack path in LAS or crack path in the weld metal locate adjacent to the fusion boundary. Any micro-cracking in HAZ was not observed in the cross section.

- 1) Sample F revealed similar rough fracture surface as observed in U3B.
- 2) The separation occurs in LAS or in weld metal adjacent to fusion boundary.
- 3) Micro-cracking in HAZ was not observed in the cross section.
- 4) The grain size distribution of HAZ of 152 buttering was almost similar to those of boat samples collected from U3B. There were both coarse grained region and small grained region in HAZ of 152 buttering.

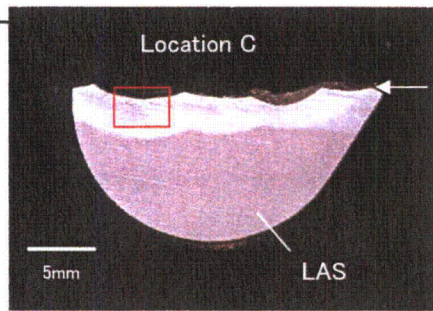
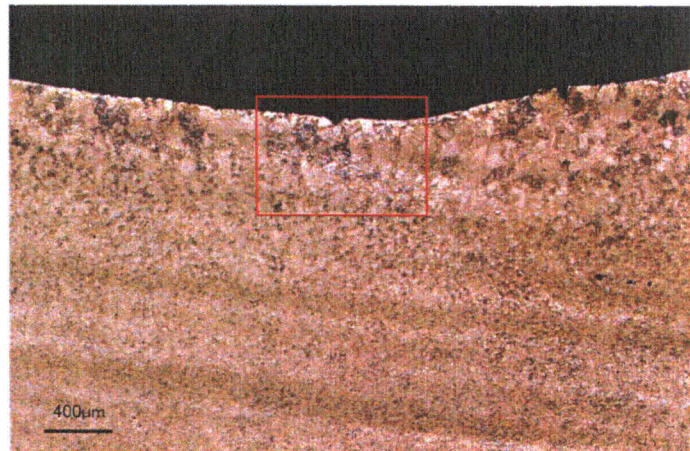
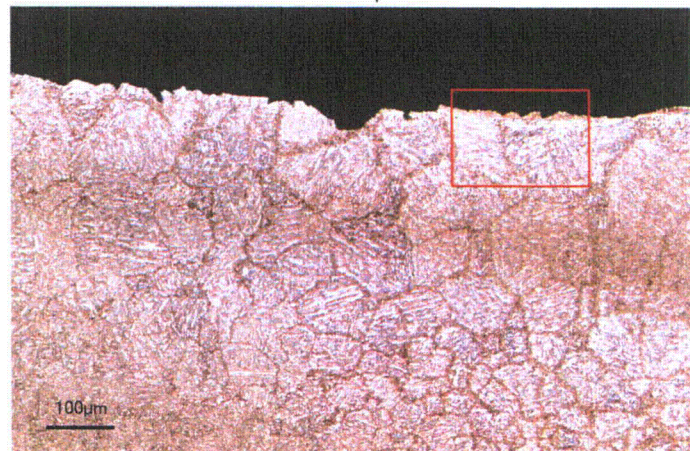
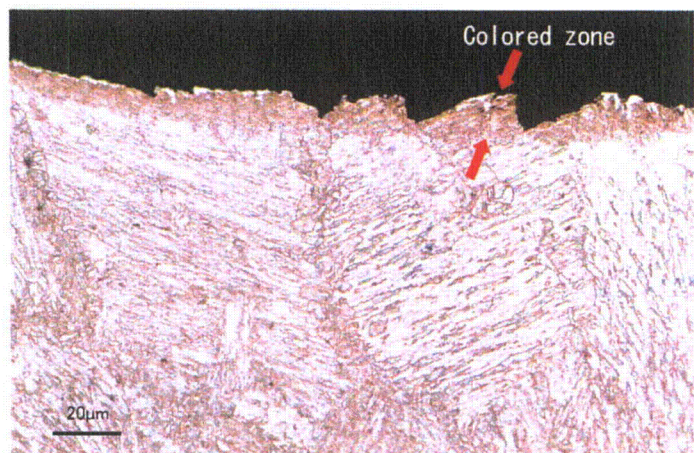
Figure A.48(2) Macro structure and micro structure of cross section of sample F

Weld metal	Welding process	Grain size number/ Grain size measured			Mean grain size
		10.5/ 0.009mm (Location A)	5/ 0.063mm (Location B)	3.5/ 0.105mm (Location C)	
152	SMAW				0.059mm

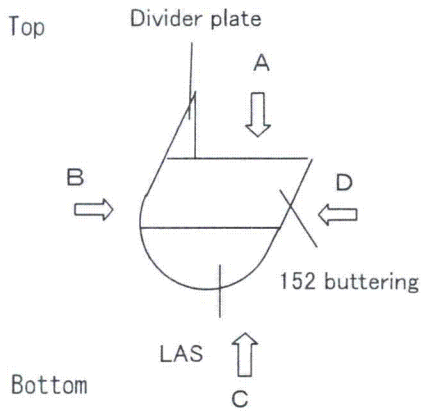
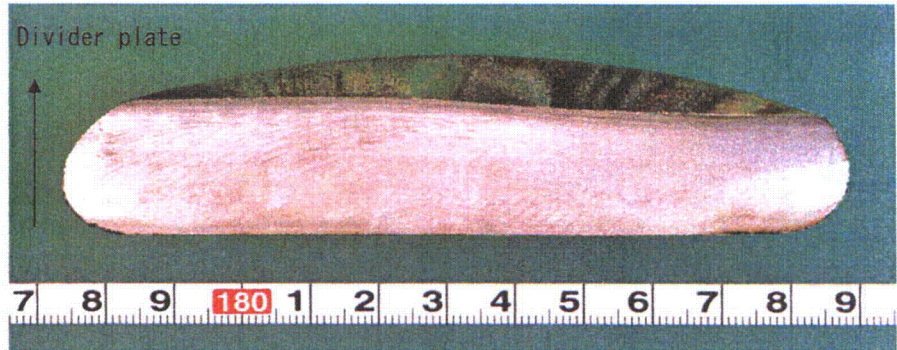
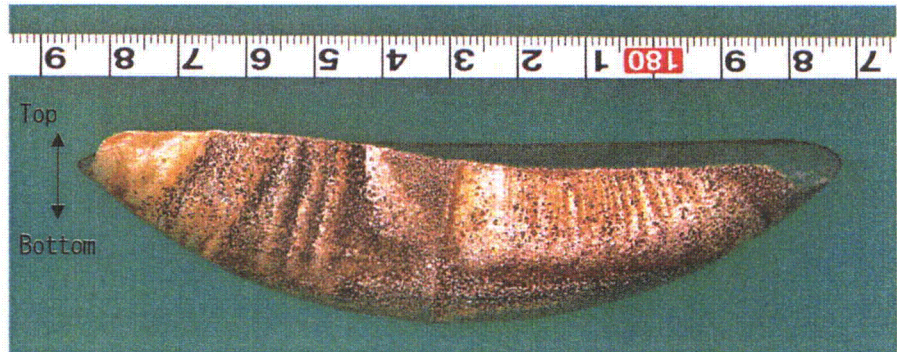
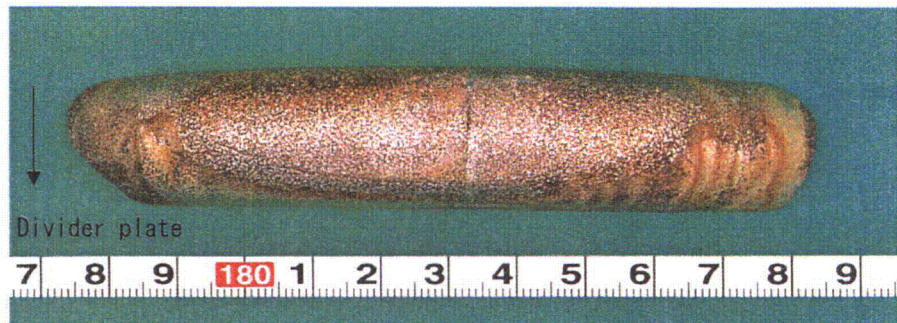
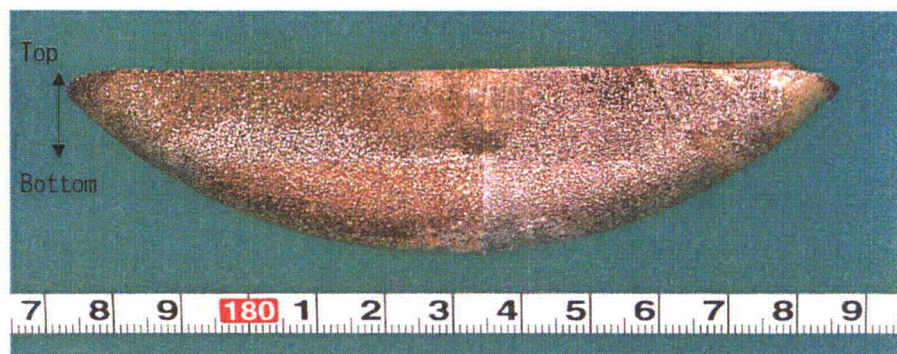
Figure A.50 Appearance of boat sample G

Figure A.50 shows appearance of boat sample G collected from 152 buttering area without separation in U3A. The sample contains low alloy steel and 152 buttering. Any surface cracks were not observed.

- 1) Any surface cracks were not observed.
- 2) Any micro-cracking or defect were not observed in HAZ in cross section.
- 3) There were both coarse grained region and small grained region in HAZ of 152 buttering. Mean grain size of the HAZ of 152 buttering was approximately 0.1mm.
- 4) The 152 buttering revealed high hardness (HV440 to 480) in colored zone adjacent to the fusion boundary as observed in boat samples collected from U3B.

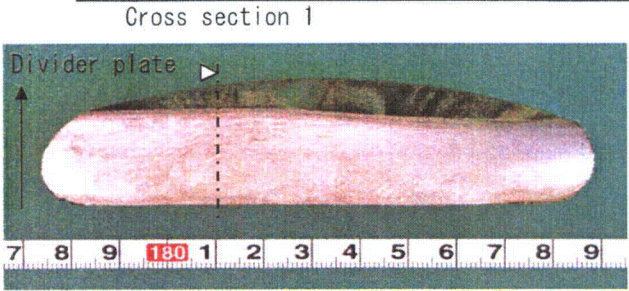
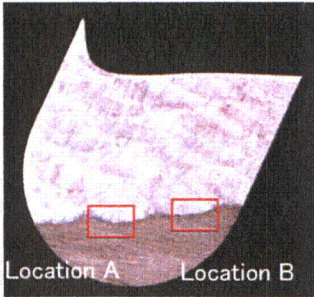
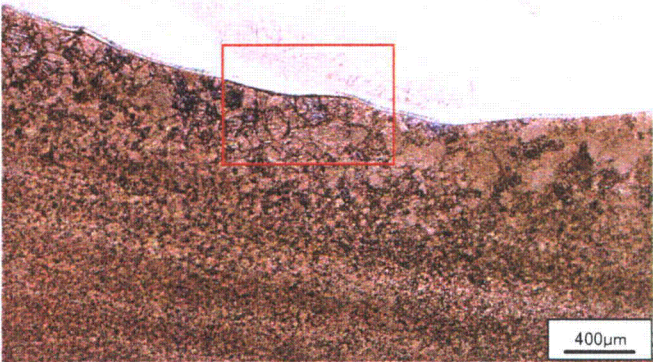
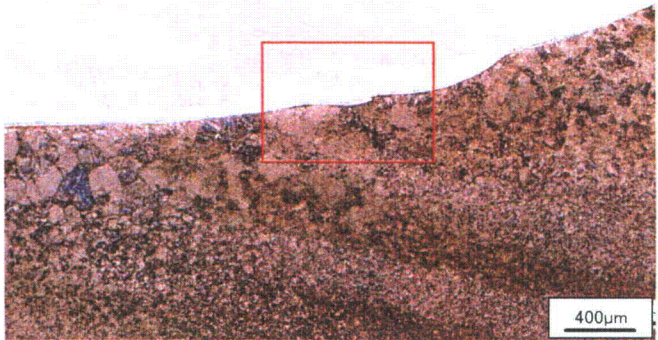
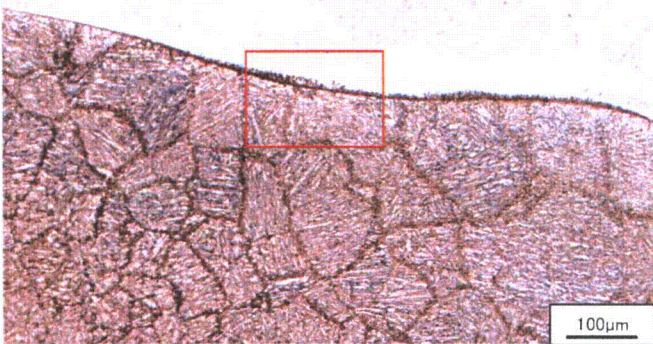
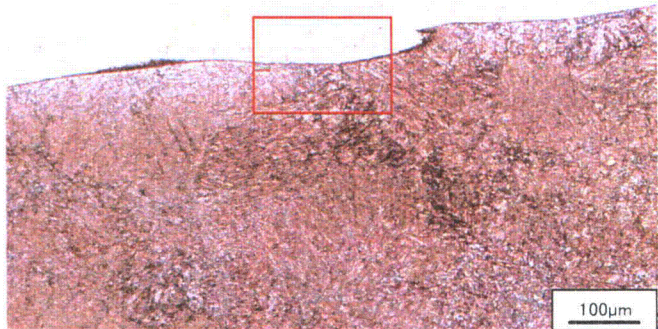
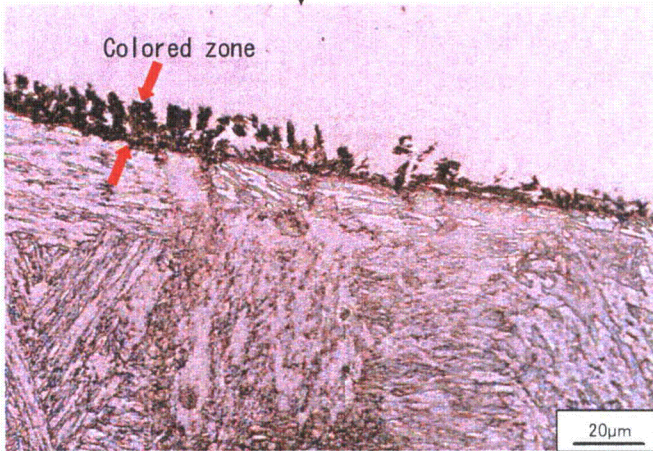
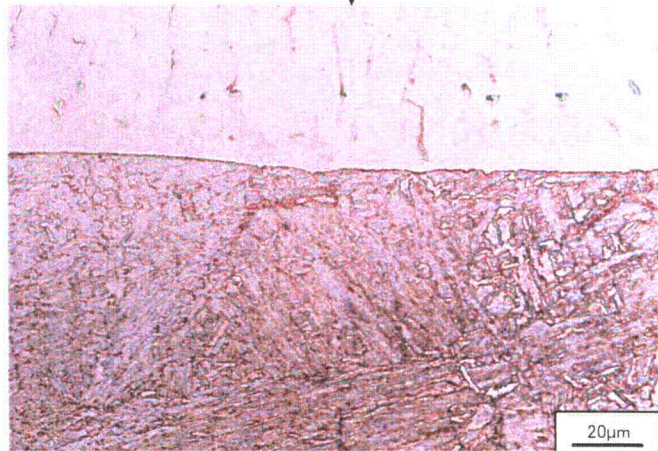
Figure A. 51(1) Macro structure and micro structure of cross section 1 of sample G

Figures A.51 show macro-structures and micro-structures of cross section of sample G. Any separations were not observed. The micro structure of sample G was similar to that of sample F and those of boat samples collected from U3B. Any micro-cracking or defect were not observed in HAZ.

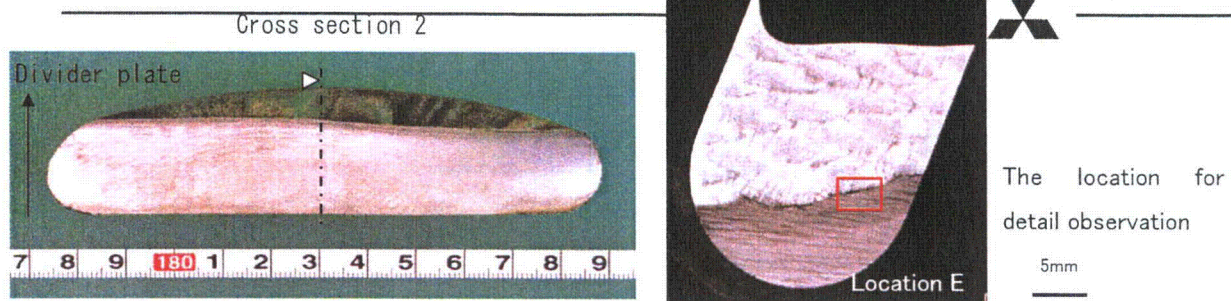
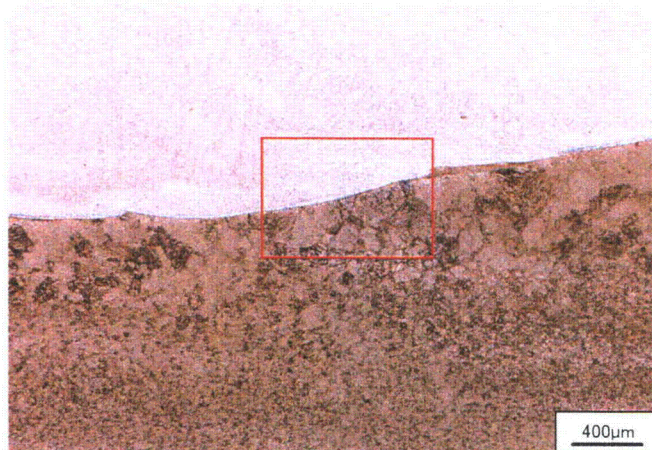
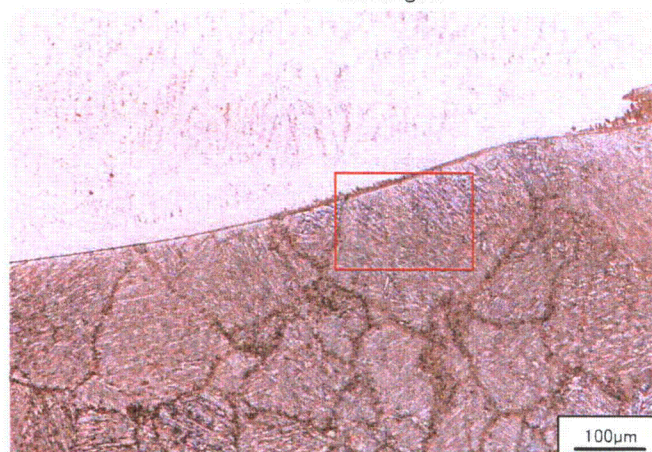
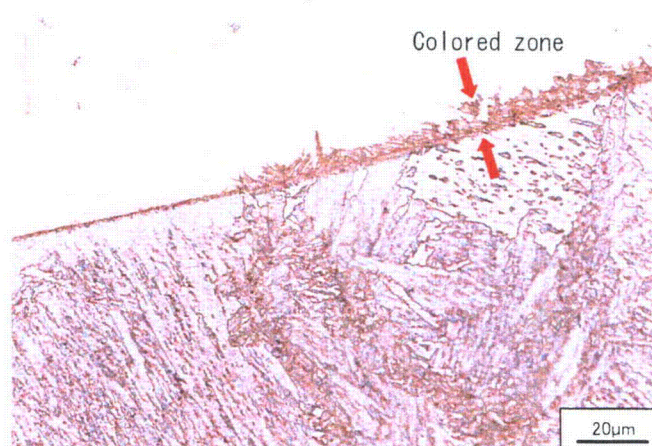
Figure A. 51(3) Macro structure and micro structure of cross section 2 of sample G

Detail observation of location E

Table A.9-1 The results of grain size measurement in HAZ of sample G

Weld metal	Welding process	Grain size number/ Grain size measured			Mean grain size
		3.5/ 0.105mm (Location A)	3/ 0.125mm (Location B)	—	
152	SMAW	10.5/ 0.009mm (Location C)	4.5/ 0.074mm (Location D)	2.5/ 0.148mm (Location E)	0.096mm
		2.5/ 0.148mm (Location F)	5/ 0.063mm (Location G)	—

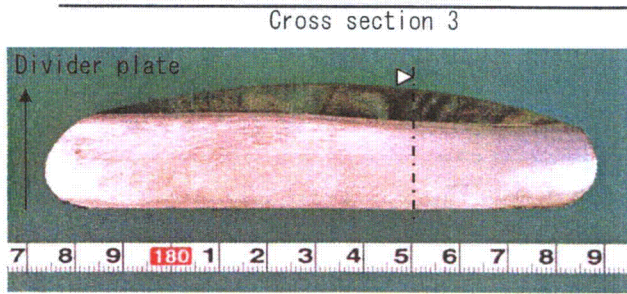
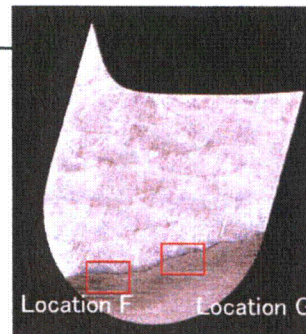
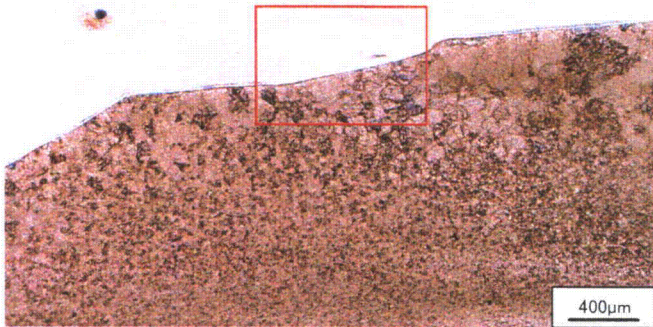
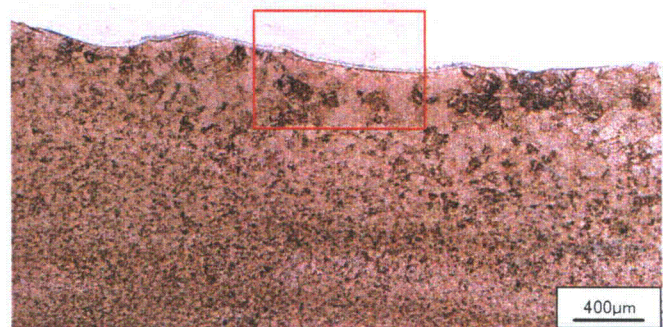
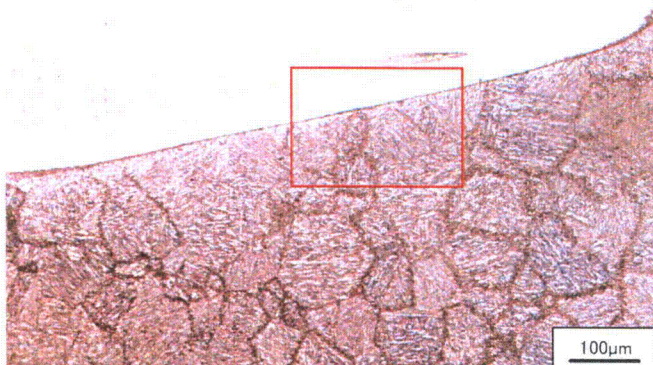
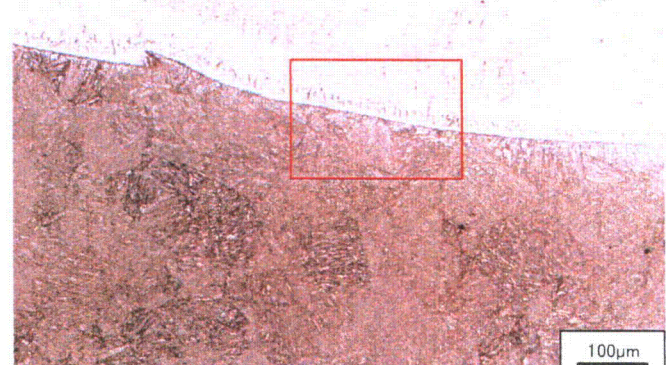
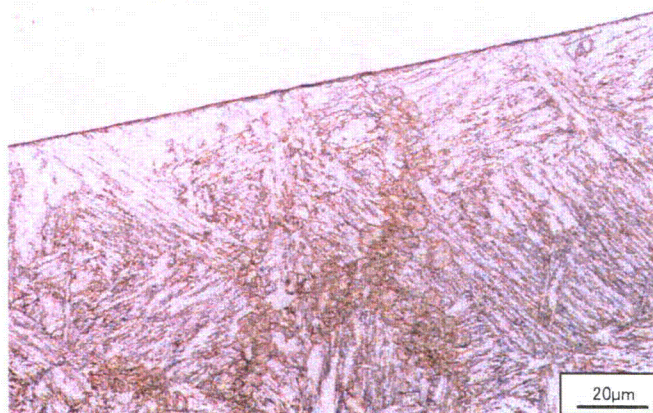
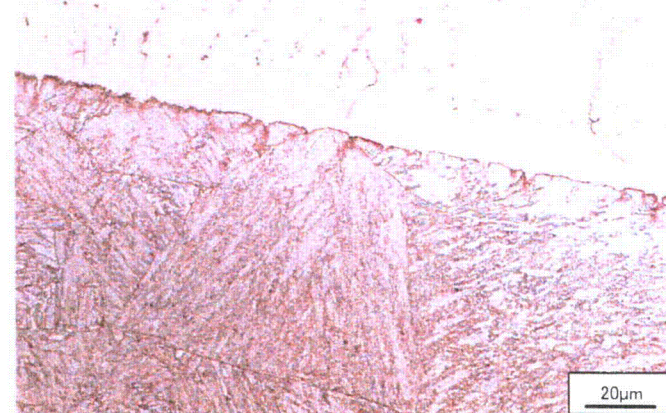
Figure A. 51(4) Macro structure and micro structure of cross section 3 of sample G

Detail observation of location F

Detail observation of location G

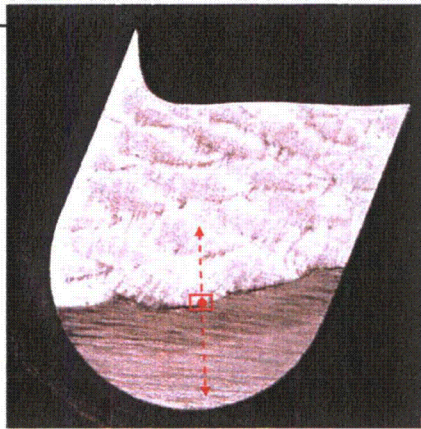
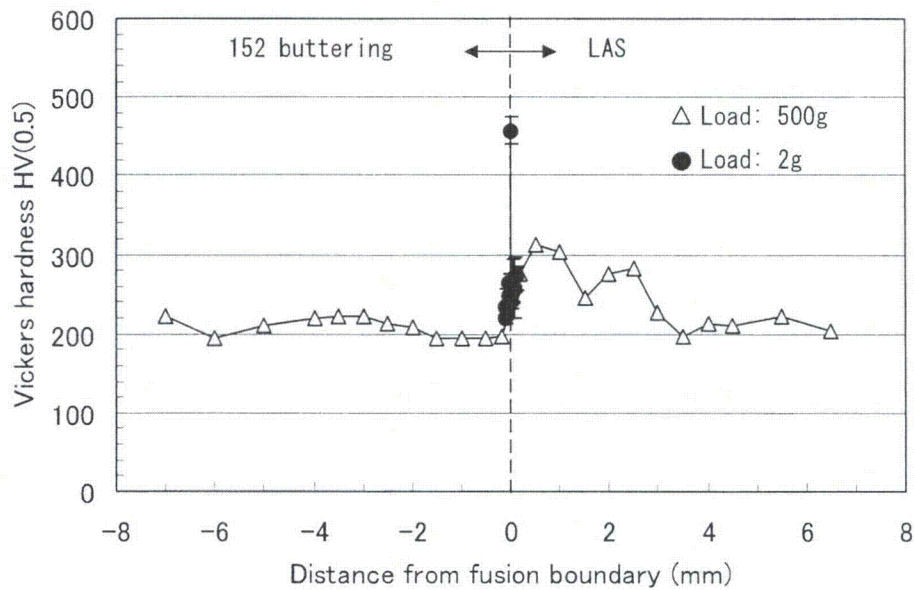
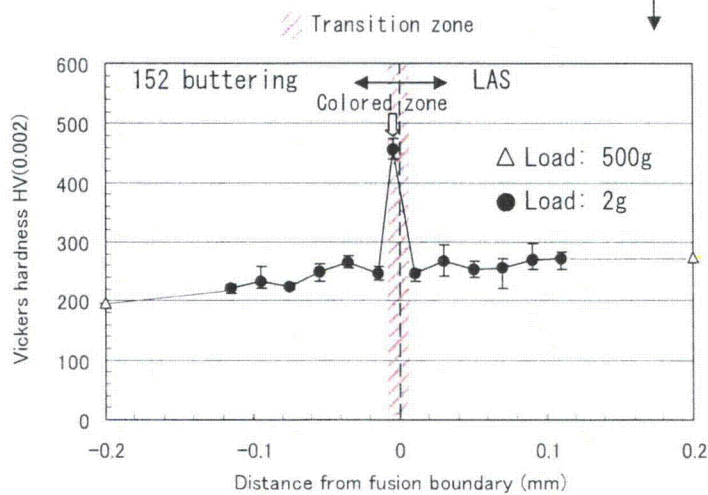
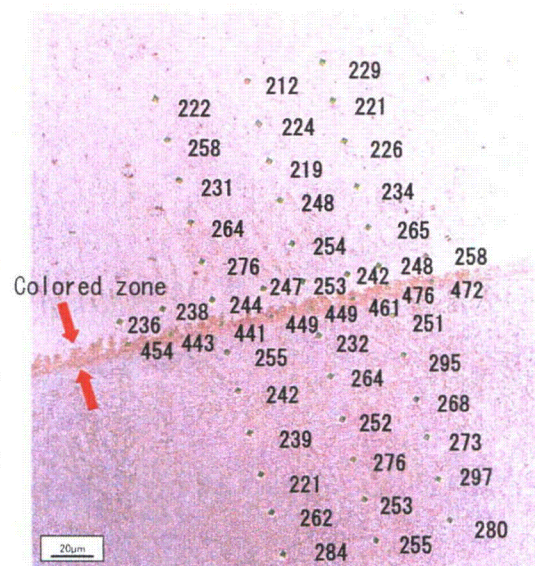
Figure A.52 Vickers hardness of cross section of sample G

The location for hardness
test (cross section 2)

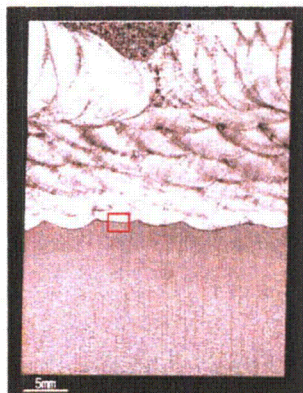
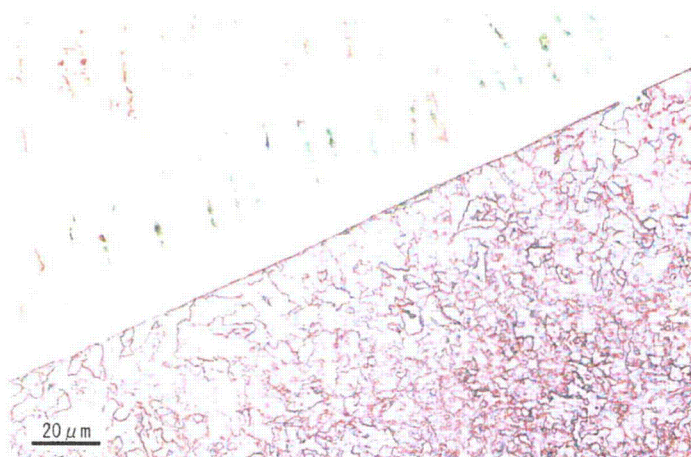
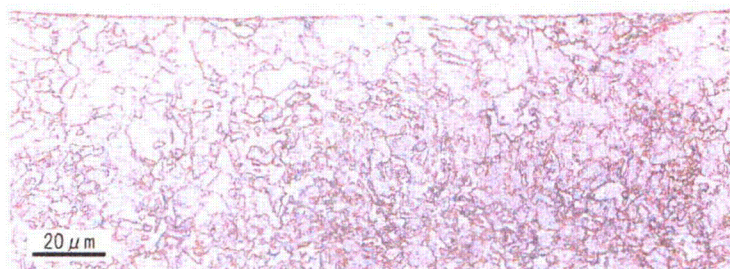
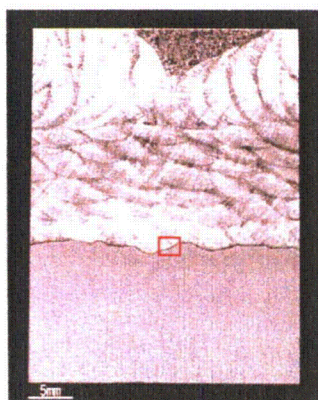
Figure A. 53(1) Microstructure of the cross section of LAS in I type model (after 152 buttering)

TP.2-2, ESW + Gouging + grinding + 152 buttering (SMAW)
Grain size number: 10.5, Grain size: 0.009mm

TP.3-1, ESW + Machining + 152 buttering (SMAW)
Grain size number: 10.5, Grain size: 0.009mm

- (1) Metallurgical structure observed near the fusion boundary of the mockup to which gouging was applied was similar to that observed near the fusion boundary of Unit 3, but were found to have a smaller grain size than the as-built (boat/strip) samples. It is considered that this was because grain refining occurred in the I-Type samples under the heat input during application of the second layer of the butter, because the distance between the butter/base metal fusion boundary and the second layer of the butter was smaller on the I-Type samples than on the actual RSGs.

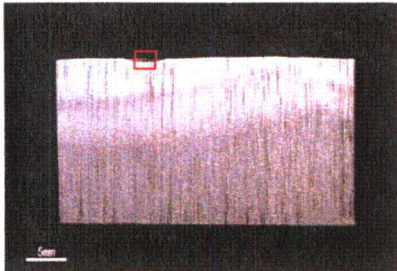
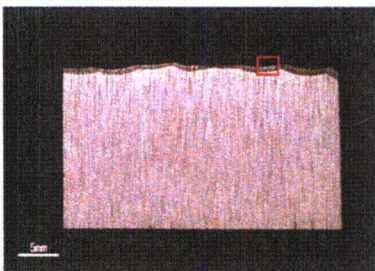
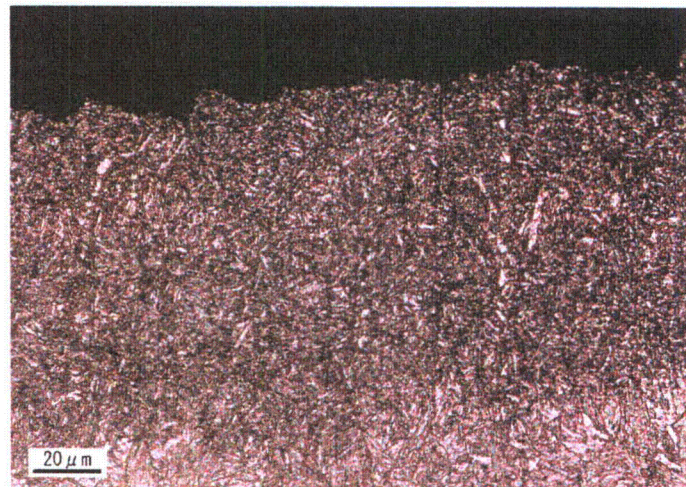
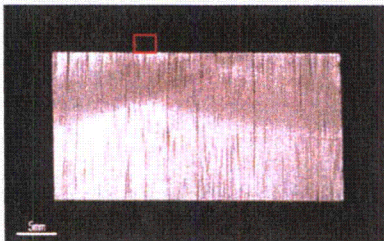
Figure A. 53(2) Microstructure of the cross section of LAS in I type model (before 152 buttering)

TP.2-1, ESW + Gouging + grinding
Grain size number: 13, Grain size: 0.004mm

TP.4-2, As gouging
Grain size number: 14, Grain size: 0.003mm

TP.3-1, As machining
Grain size number: 10, Grain size: 0.011mm

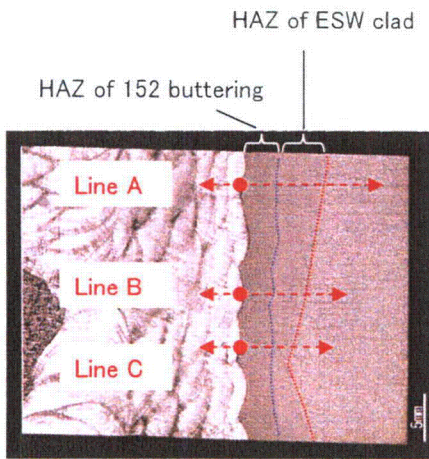
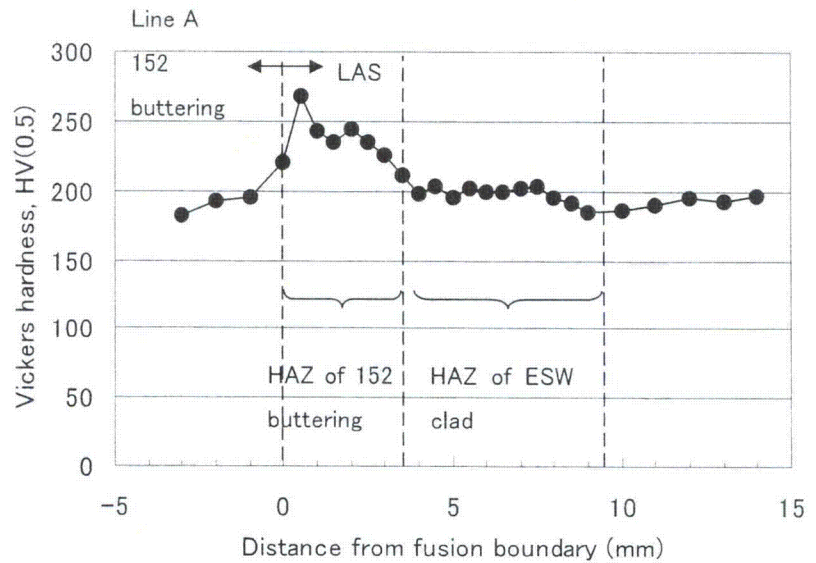
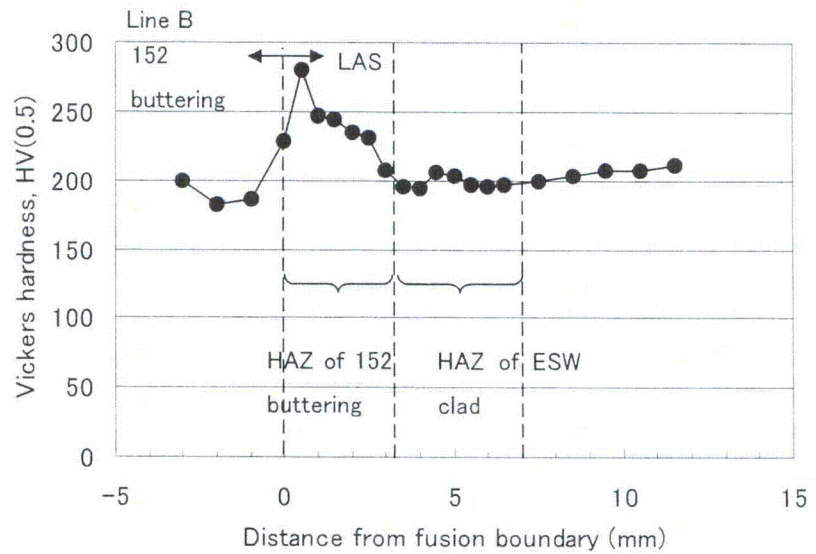
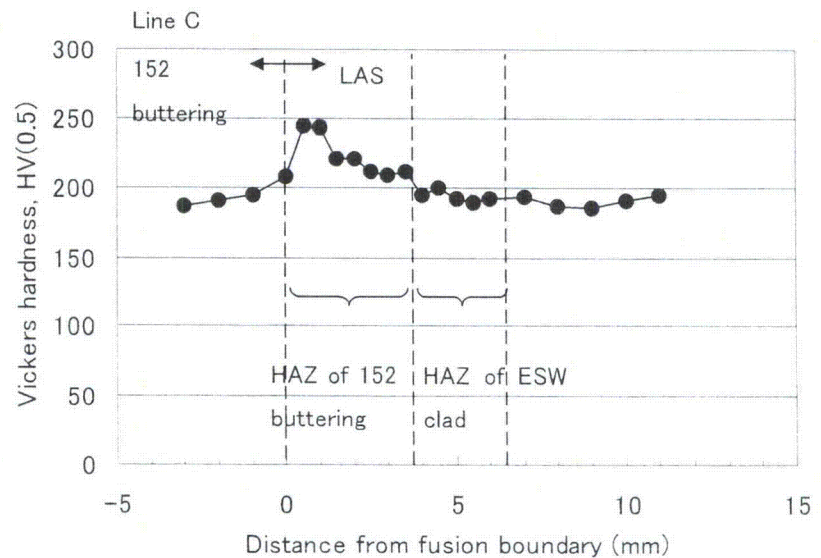
Figure A. 54(1) Vickers hardness of cross section of I type mockup 2-2

Hardness measurement location

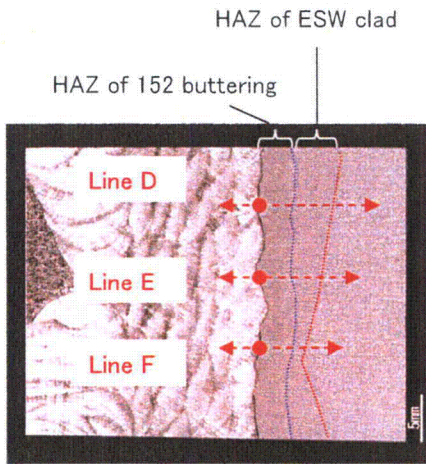
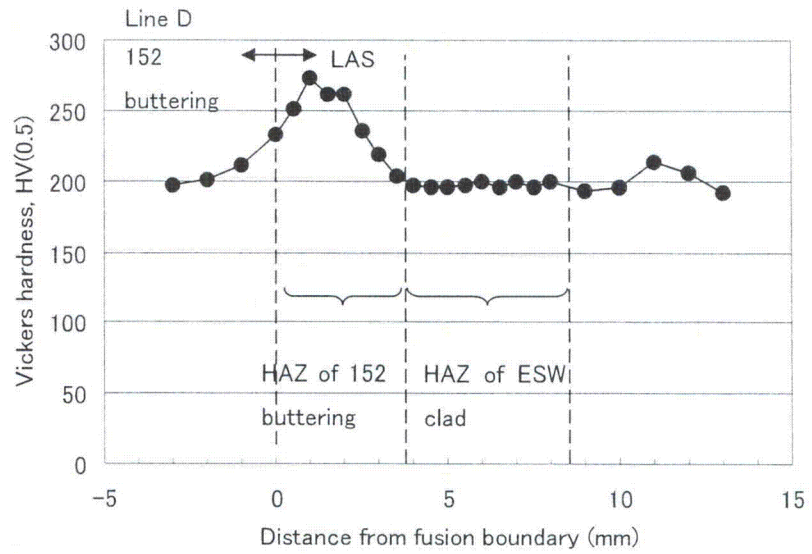
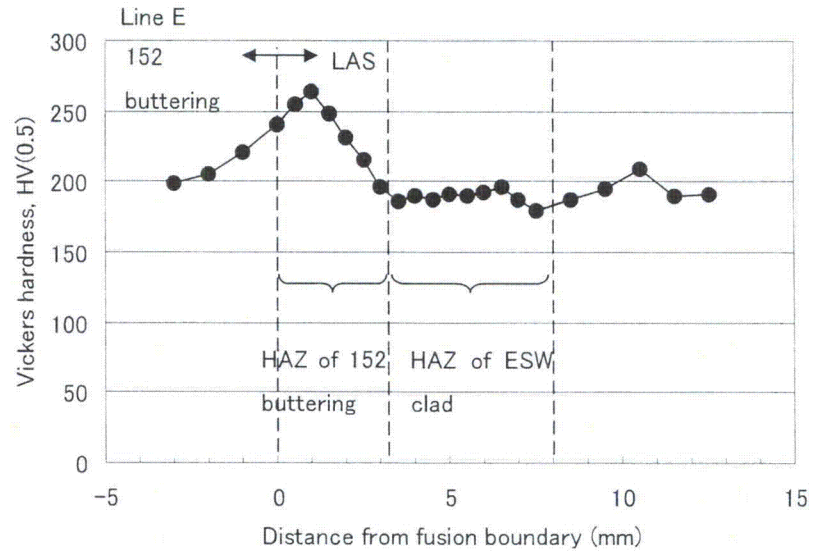
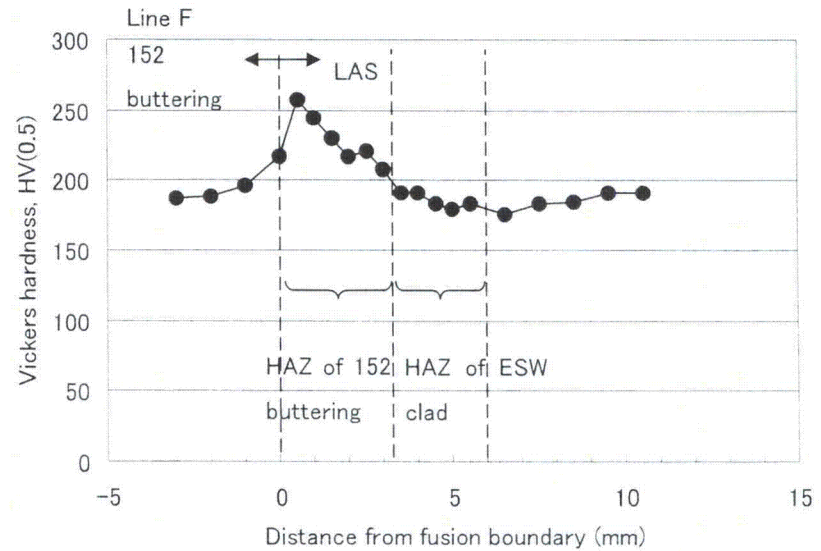
Figure A. 54(2) Vickers hardness of cross section of I type mockup 3-2

Hardness measurement location

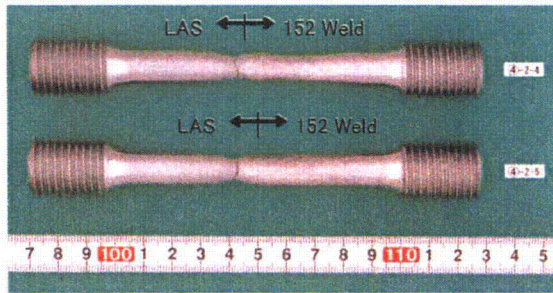
Fig.D.4 Photograph of smooth specimen after test (Sample ④-2)

As shown in Fig.D.4, smooth specimens were broken at LAS base metal and fracture at boundary between LAS and 152 buttering did not occur. As shown in Fig.D.5, notched specimens were broken at notch but all fracture surfaces showed ductile feature and brittle fracture surface which was observed in the actual SG was not observed.

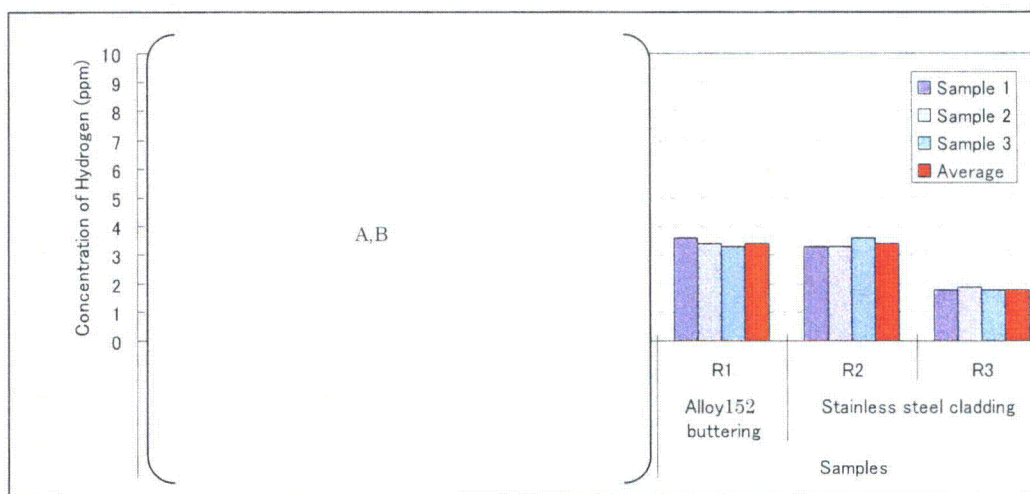
Figure I.4 Results of Measurement

- Concentration of trapped hydrogen was confirmed to be about [A,B] in the mockups. This result is the equivalent of the established value.
- As for the influence on residual hydrogen by the post-heat, no significant difference in the mockups was observed, though the heat treatment conditions such as temperature for Unit-2 and 3 were different.
- Hydrogen remained in alloy 152 buttering and stainless steel cladding at Unit-3A RSG.

The hydrogen concentration was approximately 3 ppm in alloy 152 buttering and stainless steel cladding (SMAW), and approximately 2 ppm in stainless steel cladding (ESW).

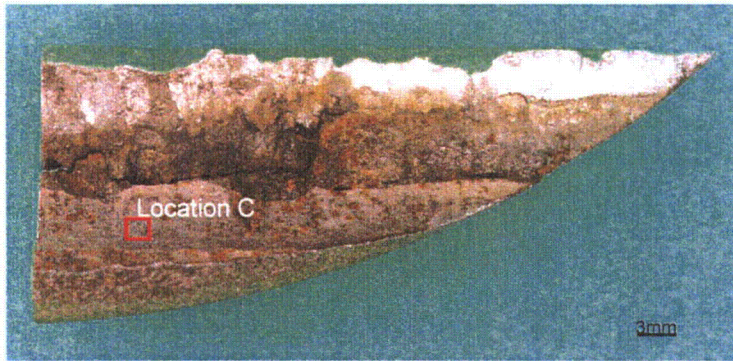
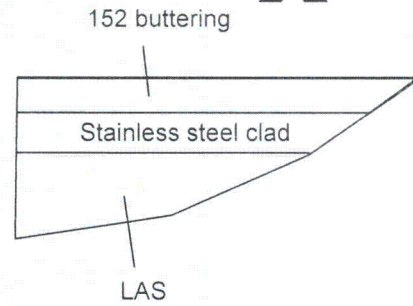
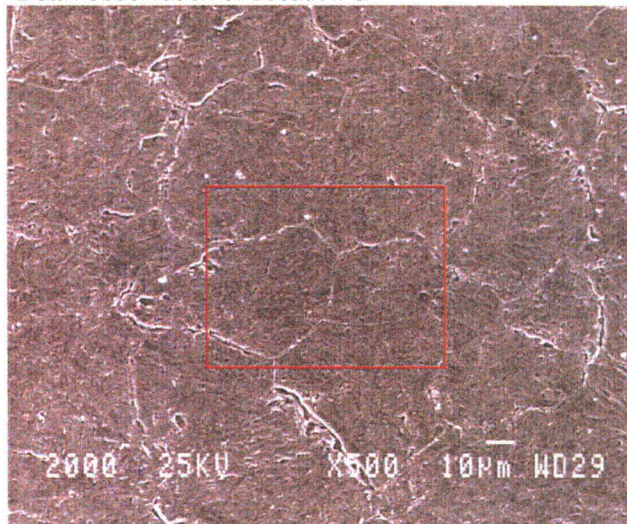
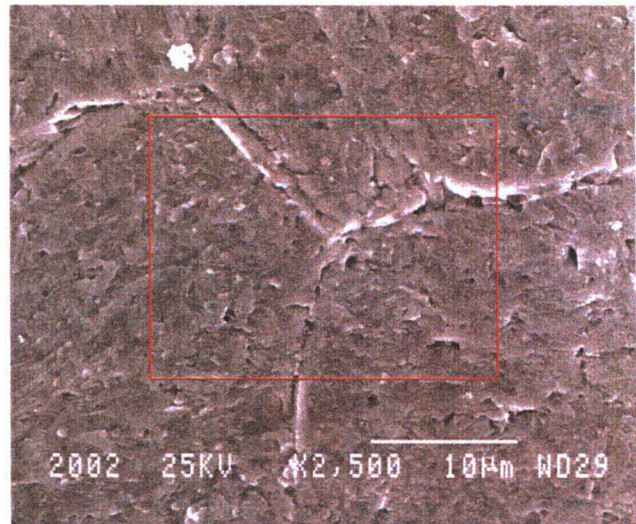
Figure S.2(1) SEM pictures of the fracture surface of the boat sample
(Sample A, TP A-1, location C)

Figures S.2 shows the SEM pictures of the fracture surface of sample A, B and C at high magnification.

It was observed that the separation between low alloy steel and 152 buttering reveals indented surface which was like martensitic lath structure at high magnification, though relatively flat fracture surface was observed at low magnification (Figure S.2(1), S.2(2) and S.2(3)). At high magnification, the separation between low alloy steel and 152 buttering appeared with similar fracture surface morphology to hydrogen-induced transgranular cracking in its feature as shown in Figure S.2(5)(a) for reference.

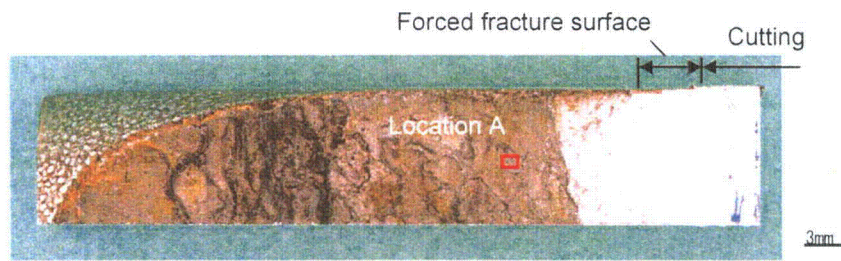
Figure S.2(4) SEM pictures of the fracture surface
(Sample C, TP C-1, location A)

Fracture surface of the separation between low alloy steel and stainless steel clad reveals relatively smooth surface at high magnification (Figure S.2(4)). It is assumed that the separation between low alloy steel and stainless steel clad appeared with similar fracture surface morphology to hydrogen-induced intergranular cracking in its feature at high magnification as shown in Figure S.2(5)(b) for reference.
