II. Second Investigation

1. Purpose

The purpose of this report is to provide results of additional investigation of I type mockups and boat samples collected from the U3B and U3A RSGs.

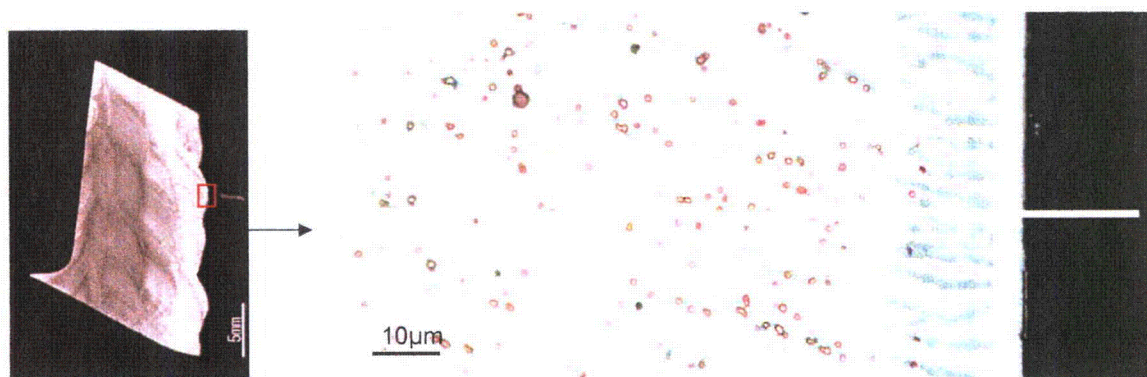
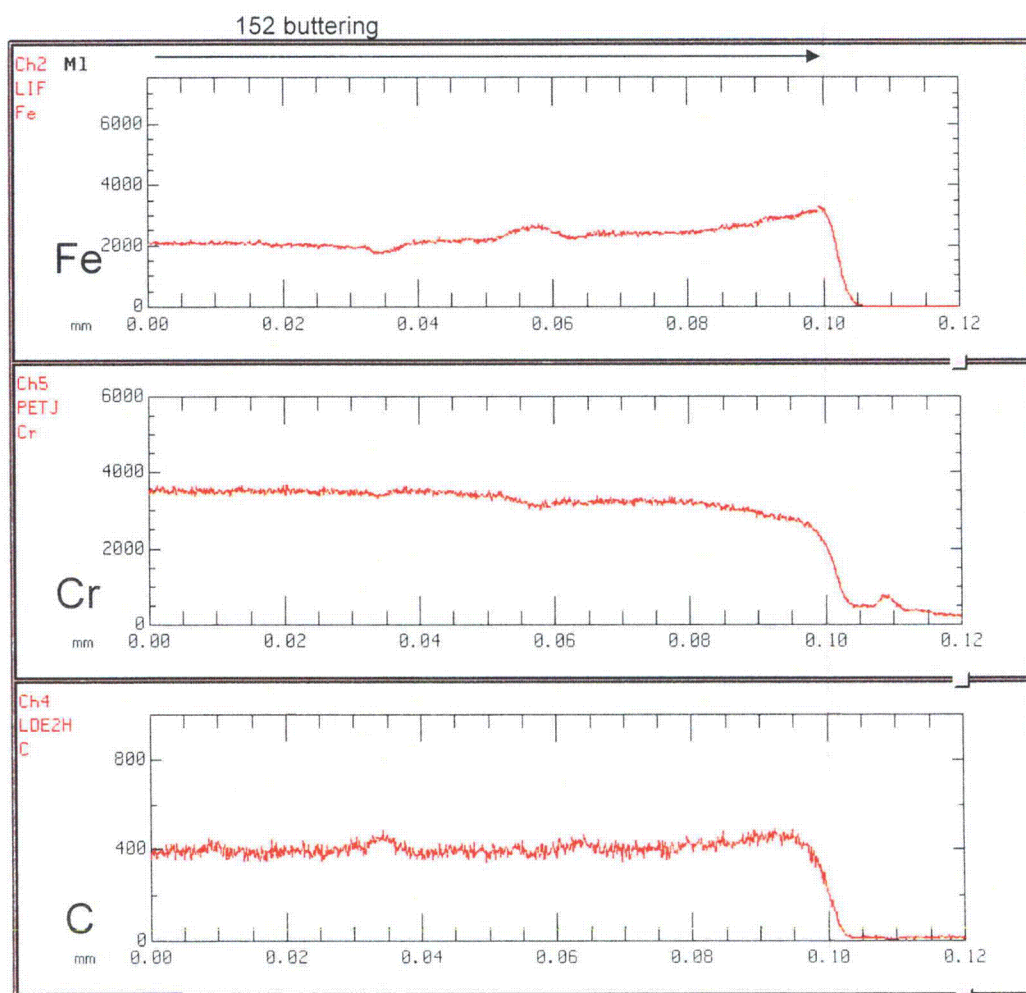
Figure S.3(1) EPMA line analysis across fusion boundary (sample B, 152 buttering side)

Figures S.3 shows the results of EPMA line analysis across fusion boundary in the cross section of sample B. Component variations was observed in 152 buttering adjacent to the separation.

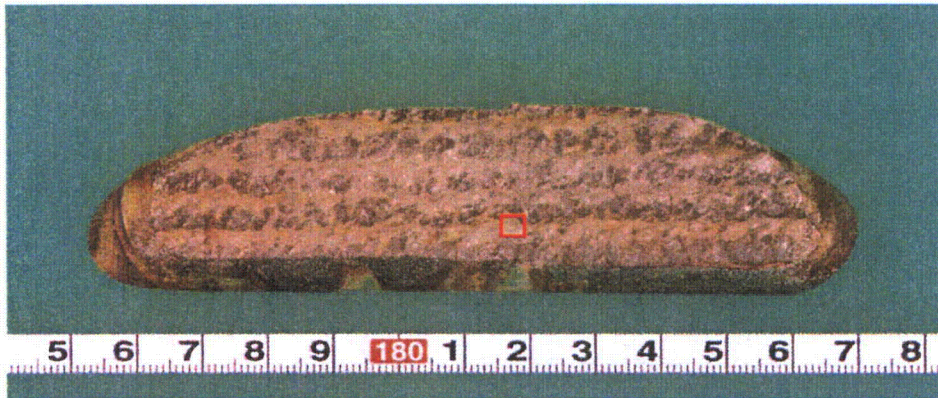
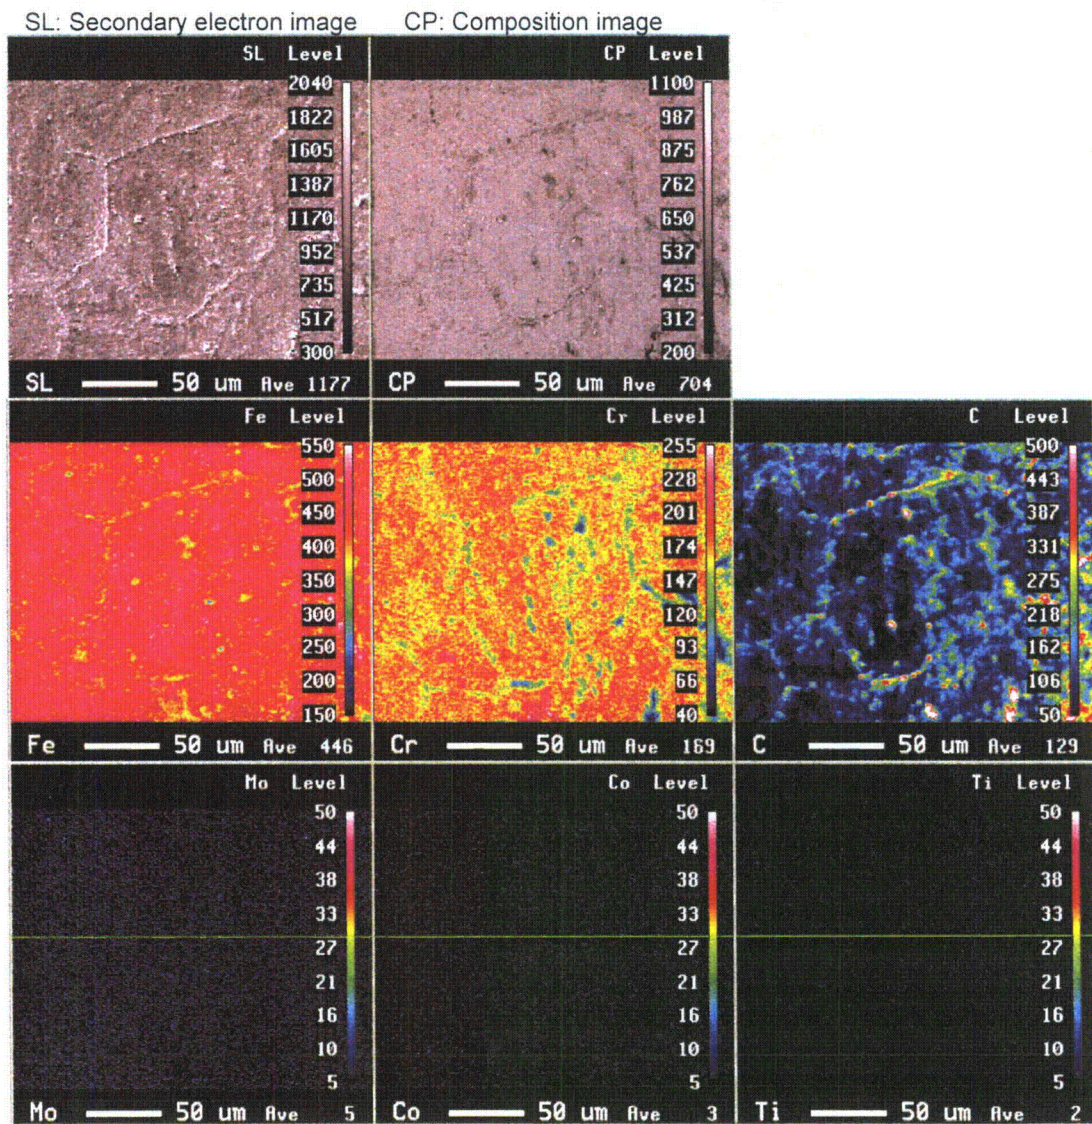
Figure S.4(1) Compositional mapping by EPMA on the fracture surface

- 1) At high magnification, the fracture surface of separation between low alloy steel and 152 buttering appeared to be like martensitic lath structure.
- 2) At high magnification, the fracture surface of separation between low alloy steel and stainless steel clad reveals relatively smooth surface.
- 3) Component variations were observed in 152 buttering adjacent to the separation.
- 4) It was observed that there was a certain level of compositional distribution of Fe, Cr and C at the fracture surface.
