RE: License No. SUB-1010, Docket No. 040-08027
License Condition 47, Final Groundwater Corrective Action Plan (CAP)

CORRECTIVE ACTION PLAN REPORT

Sequoyah Fuels Corporation

June 14, 2010

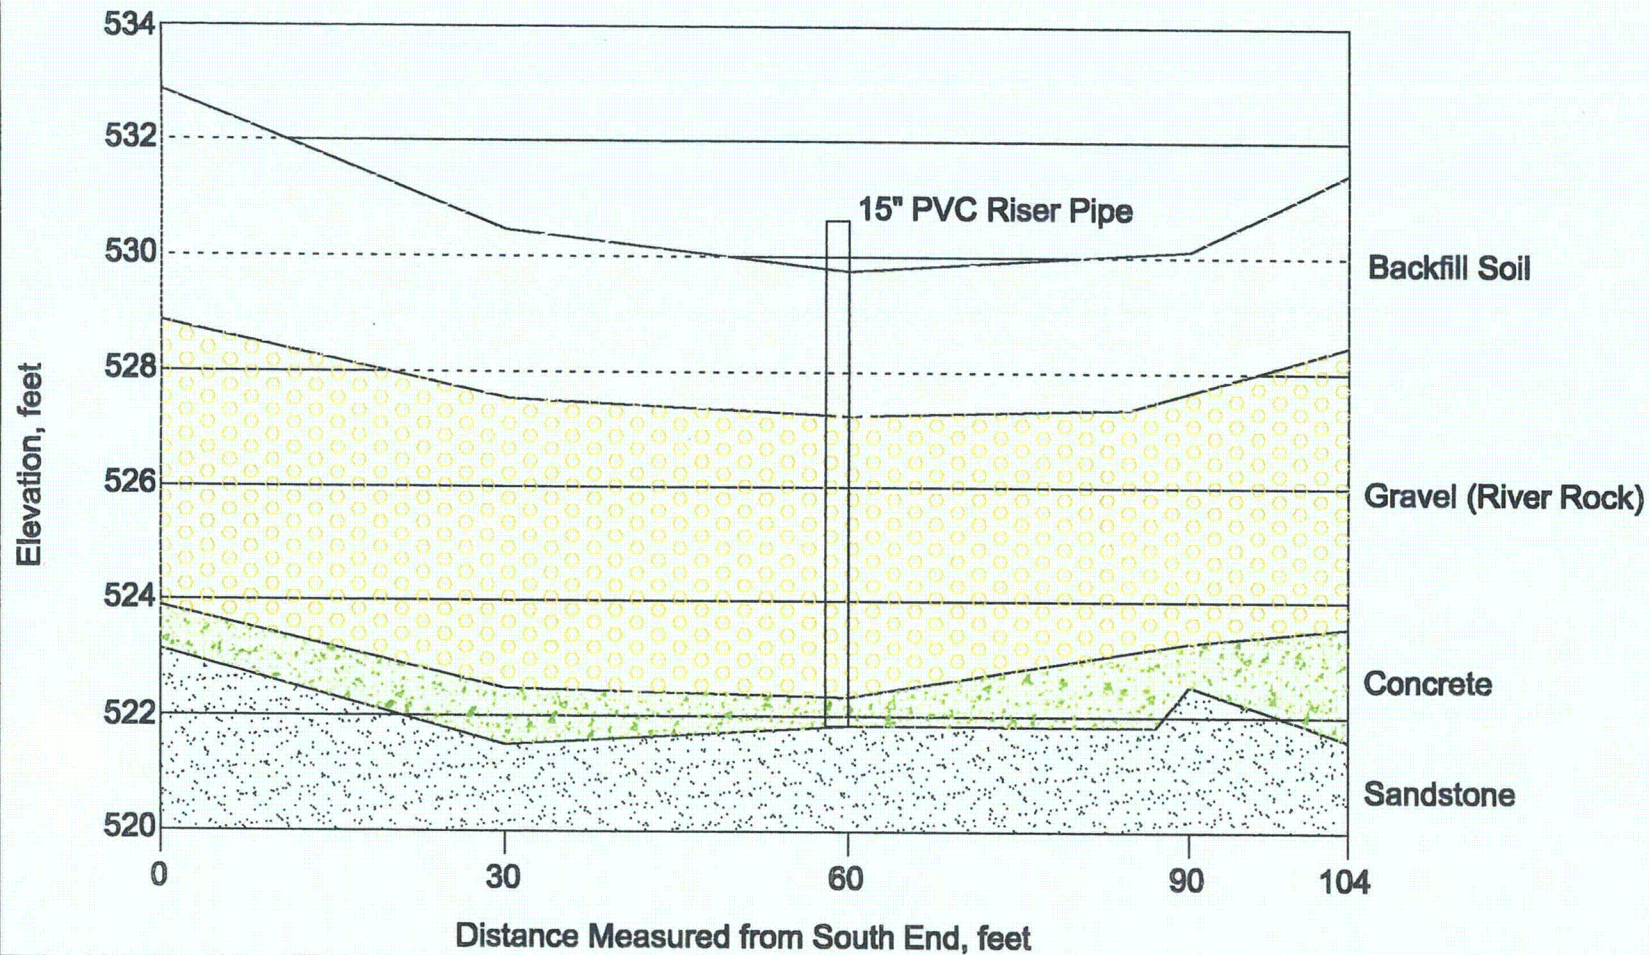
Figure No.6

Figure 6 shows a profile of the 005 Collection Trench. The layers from bottom to top consist of geo-fabric, synthetic liner, concrete, gravel, synthetic liner, geo-fabric and back fill soil. Figure 7 shows the placement of synthetic liner and geo-fabric over the gravel and around the riser pipe. The geo-fabric and liner were wrapped from the bottom along the west side of the trench and over the top of the gravel. The east side of the trench was left open to allow water to drain into and collect in the gravel contained in the trench. A pump placed into the riser pipe permits water to be pumped out of the containment system.

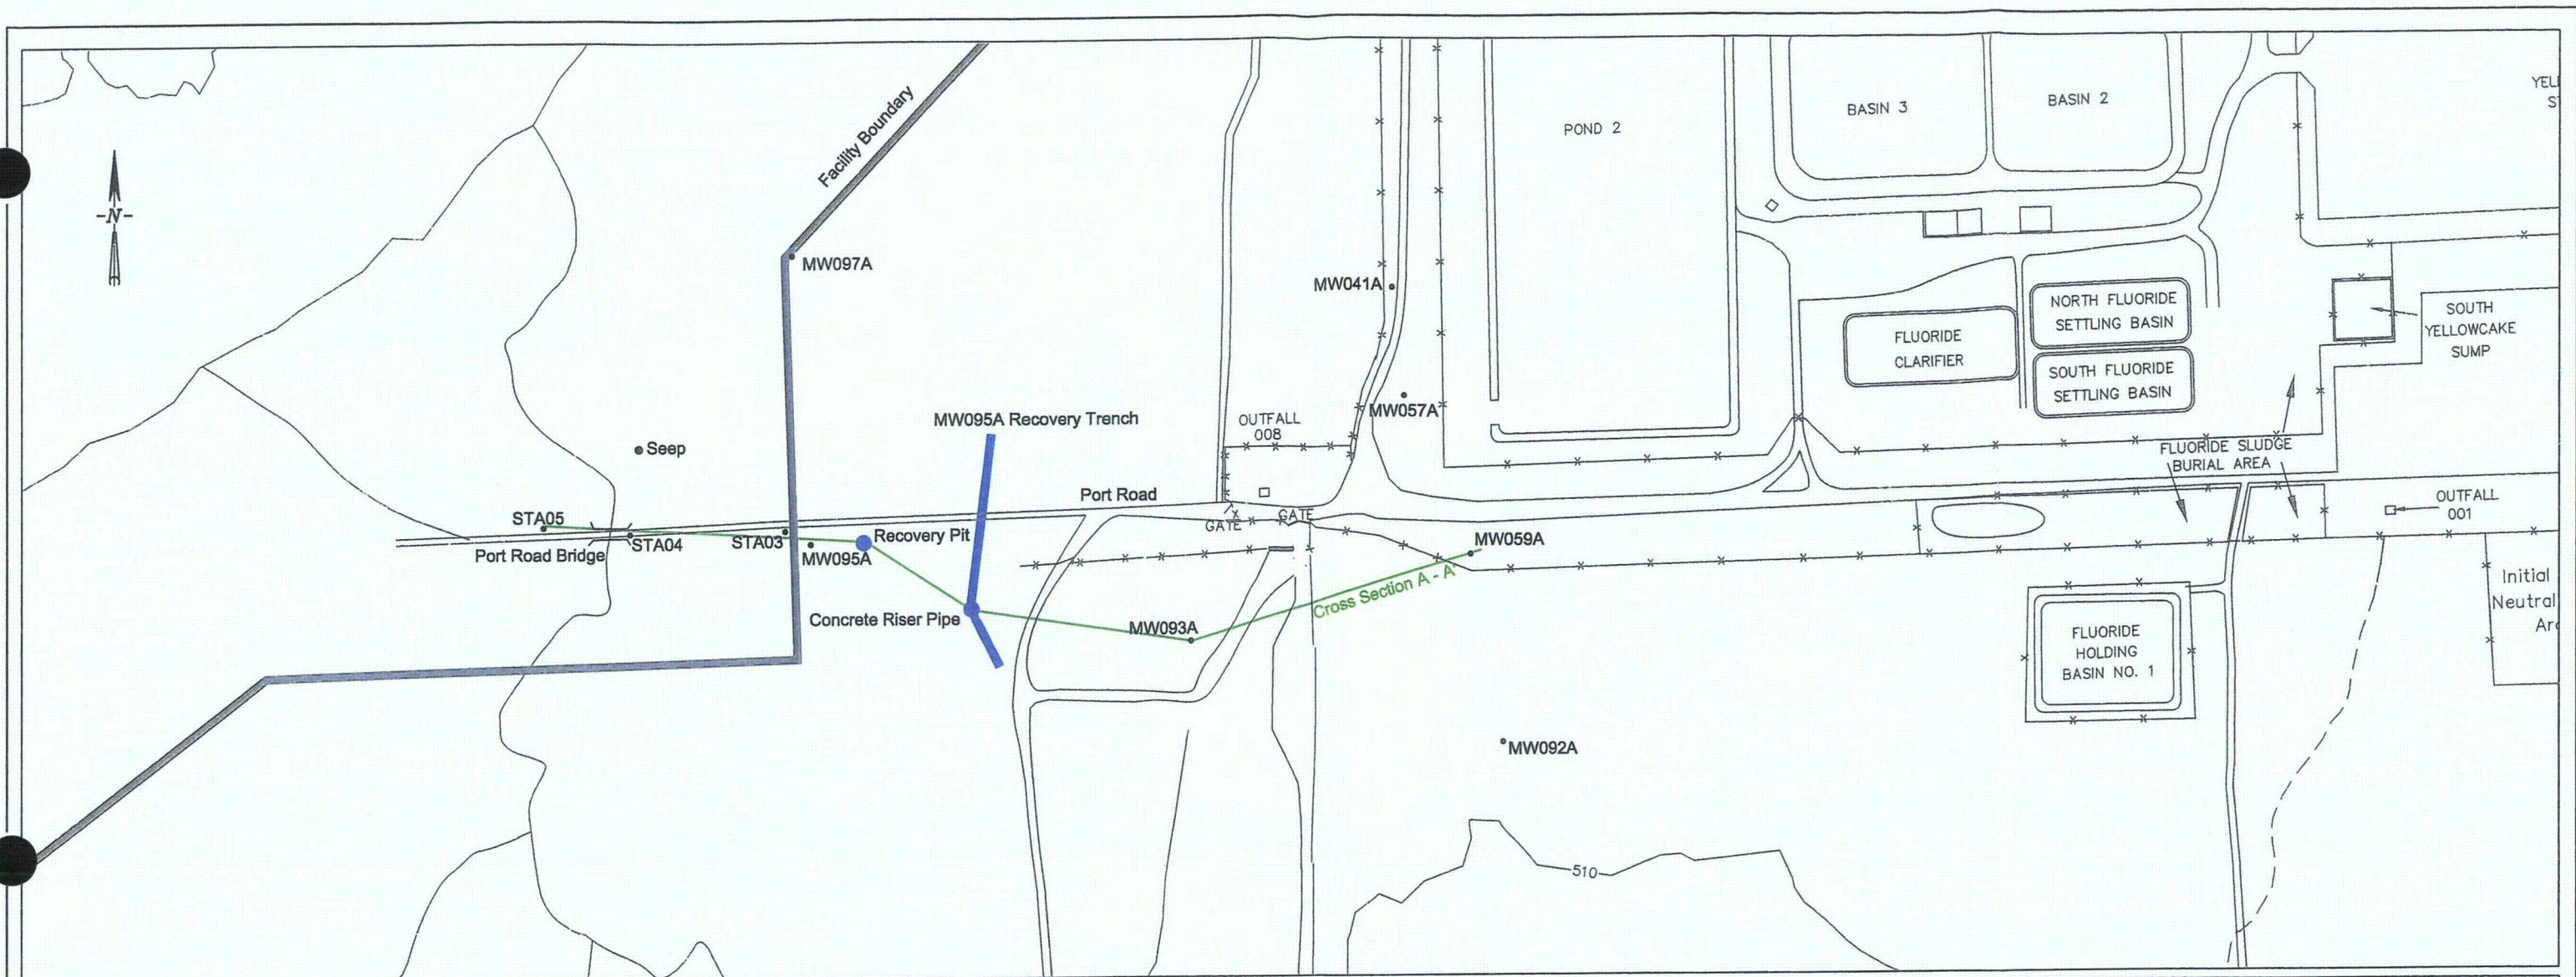
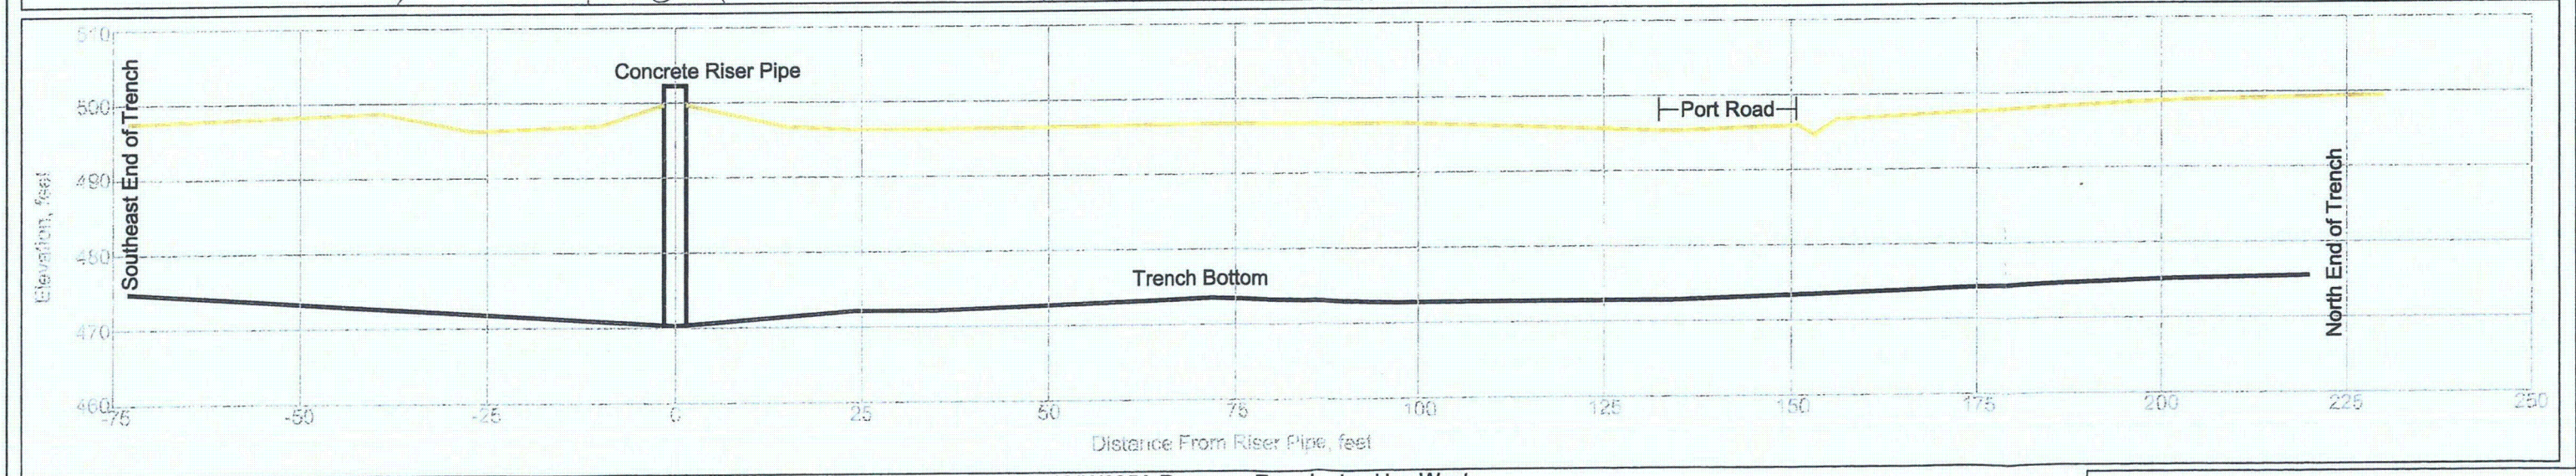
Title: Trench Location and Profile	
Prepared By: SFC	Filename: Figure1B.dwg
Reviewed by: CM	Figure No. 1
Date: 06/03/2003

On November 4, 2002 trenching began north of MW093A and proceeded west towards MW095A. The location of this trench is shown on Figure 1. The excavation was fairly shallow until moving west of the 008 Pipeline, where a significant depth change at WP09 as the edge of the sandstone was reached. Black shale was first encountered after dropping off the edge of the sandstone. Significant sandy seams that were several feet thick began to appear west of the 008 pipeline at WP11. The sandy seams observed near WP11 were dry. The first seepage and pooling of water was observed at WP12. At this location there was 8 to 10 feet of sandy soil above the bedrock surface. Significant amounts of sand continued to be observed west of WP12. Because of the amount of sand, the trench caved in several hours after excavation. The trench was stopped due to cave-in problems at WP15. Black shale was observed at the excavation near WP15. Significant water was flowing into the trench, including a significant amount from the west. The water was coming from the sand that was above the black shale layer. Rather than continuing the trench west a pit was excavated at WP16. The pit collected a significant amount of water, approximately 2 feet, within an hour after excavation. Water samples were collected from near WP12, WP15 and WP16. Analyses indicate that significantly elevated concentrations of nitrate and arsenic are present in the groundwater seeping into the trench. The results are included in Table 1.

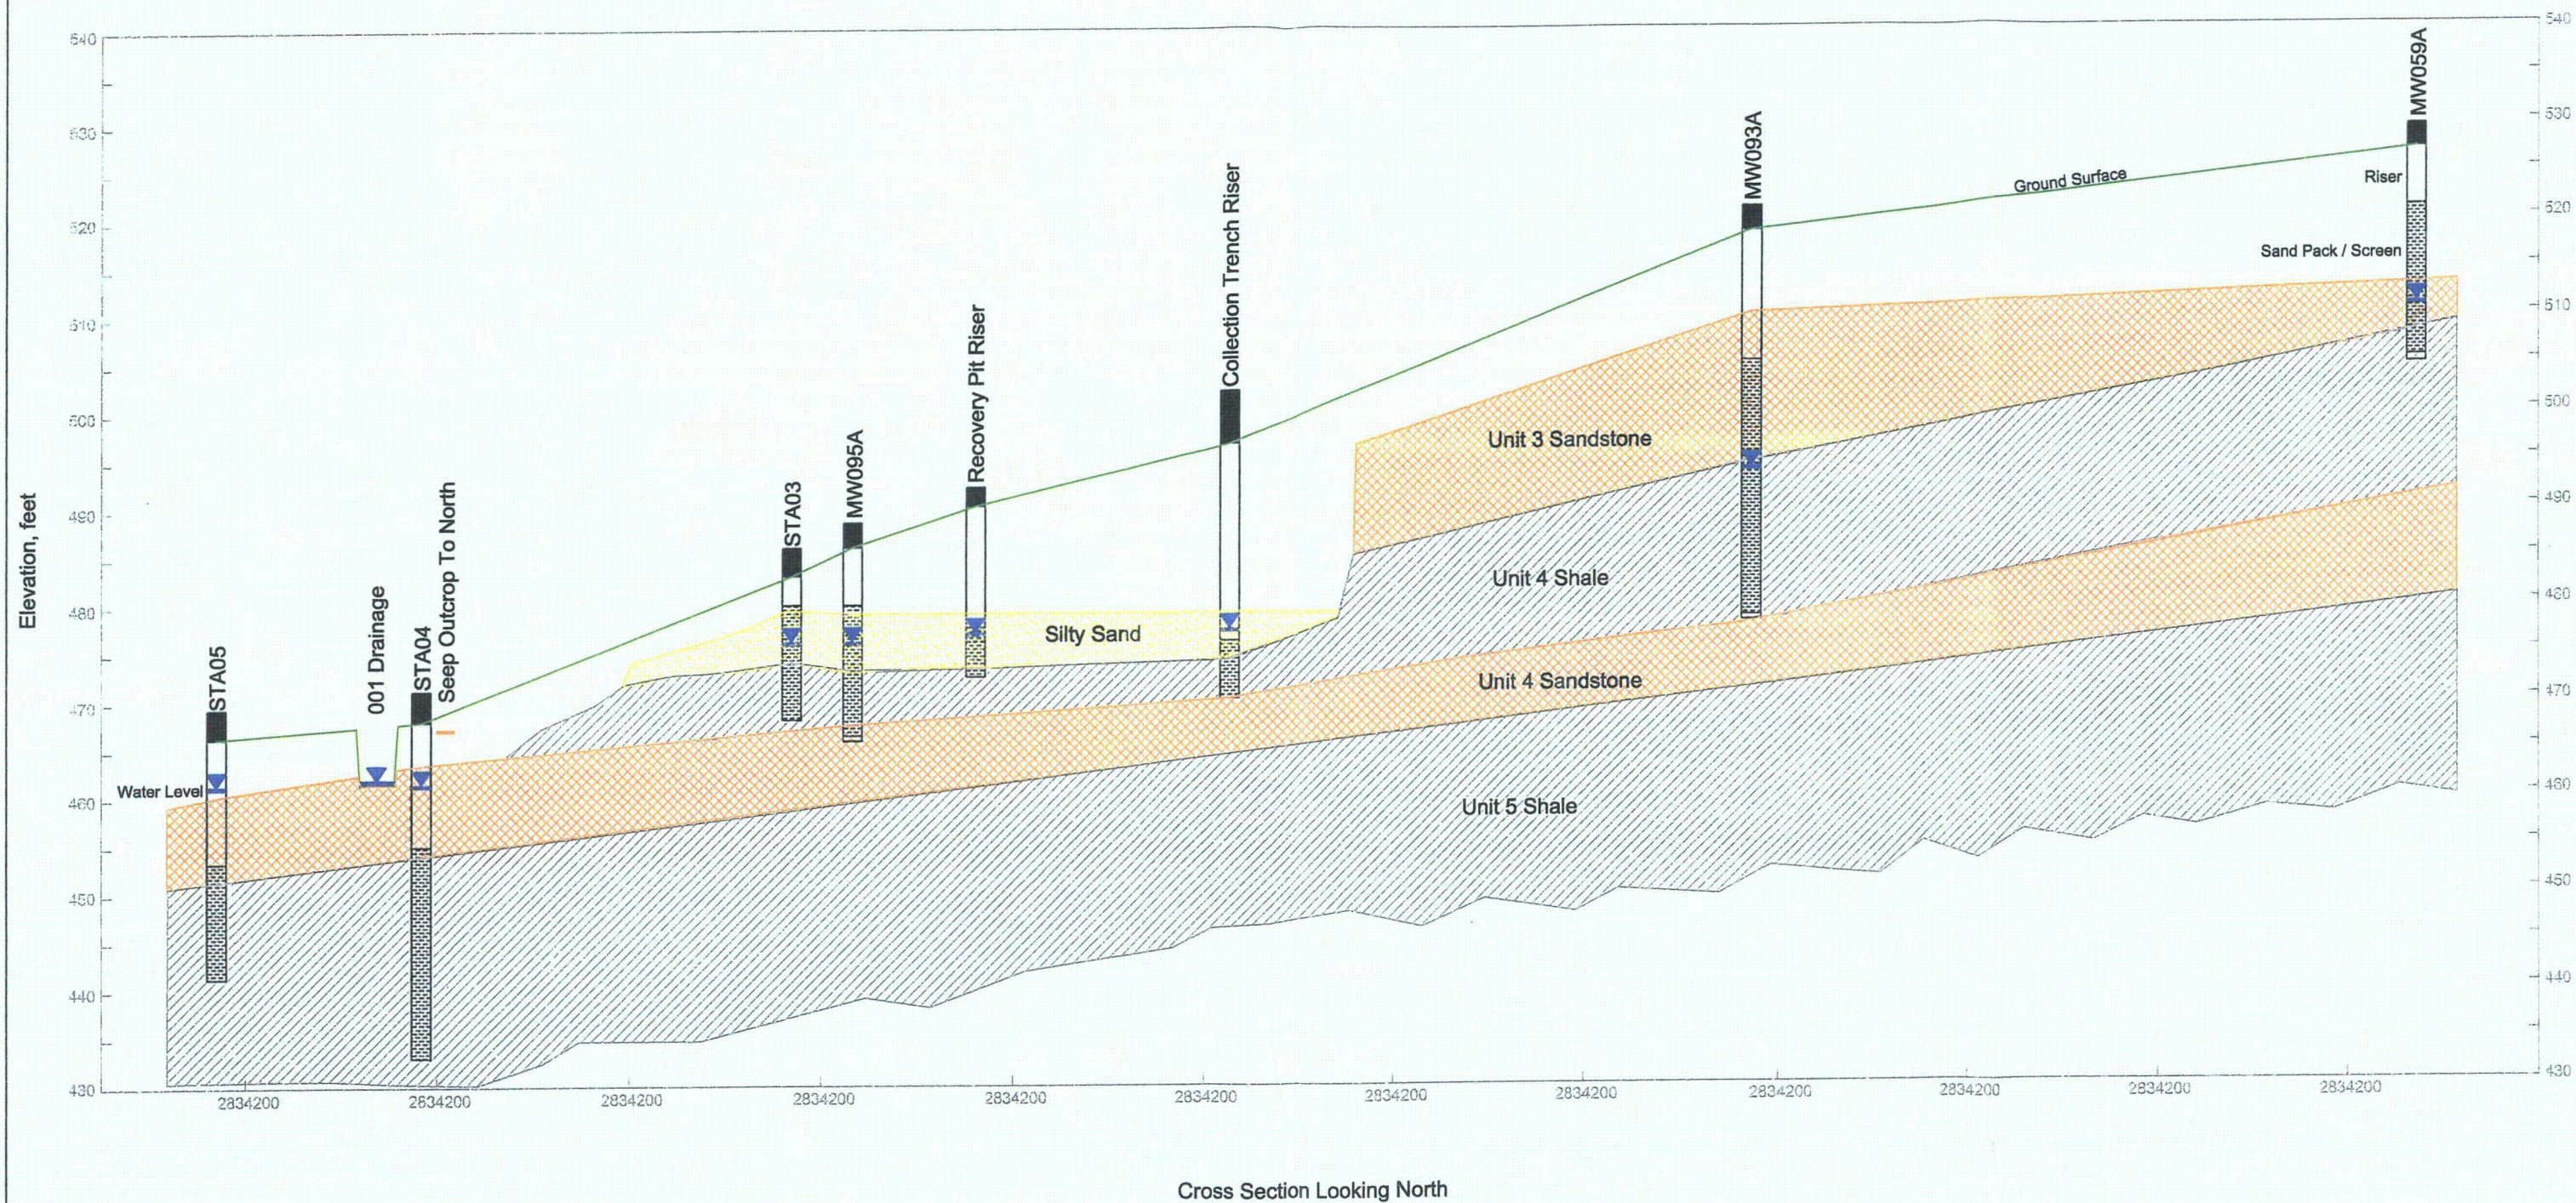
SEQUOYAH FUELS CORPORATION Monitor Well MW095A Trench Installation	
Title: Cross Section A - A'	
Prepared By: SFC	Filename: Figure2C.dwg
Reviewed by: CM	Figure No. 2
Date: 06/11/2003

A cross section has been prepared to show the geology of the area where the collection trench and recovery pit were installed. The location of this cross section (Cross Section A-A') is shown in Figure 1. The cross section has been included as Figure 2. Most of the water in this area appears to be contained in a silty sand layer above unit 4 shale. A picture take of the shale and silty sand near the location where the concrete riser was installed in the collection trench is included as Figure 3.

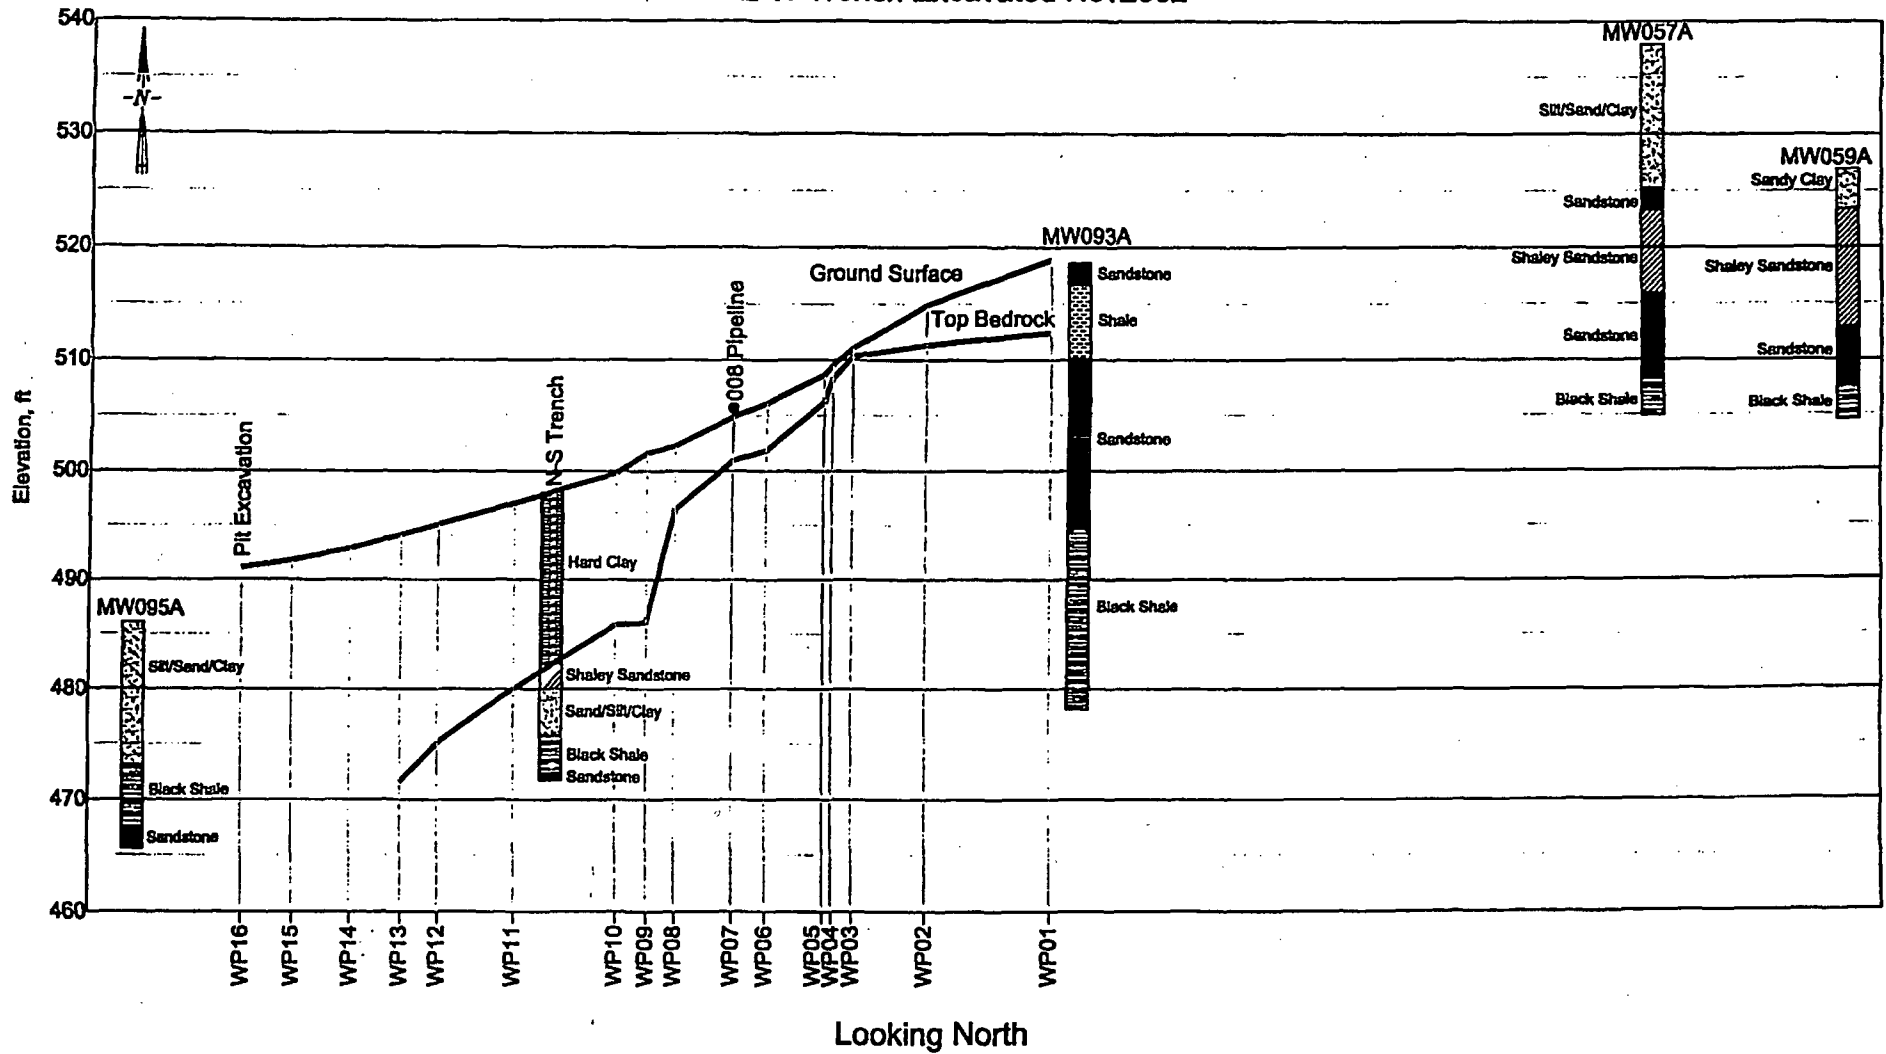
Figure 3
E-W Trench Excavated Nov2002

The East-West Trench and pit at the west end of the trench were completed on November 6, 2002. GPS readings were taken at each way point (WP) and the distances measured between each way point. A cross-section of the East-West Trench showing the ground and bedrock surfaces is attached as Figure 3. Figure 3 also includes a summary of the lithology identified for several monitoring wells and the profile of the North-South Trench. The trench was back filled several days later. The pit was left open so that the water could be pumped out. Analysis of samples collected of water from the trench indicated the groundwater at the west end of the East-West Trench contains significantly elevated levels of nitrate and arsenic. The pathway connecting to the source of contamination with the impacted water near the west end of the East-West Trench was not identified. Therefore, a determination was made that an additional trench should be excavated in a North-South direction intersecting the East-West Trench.

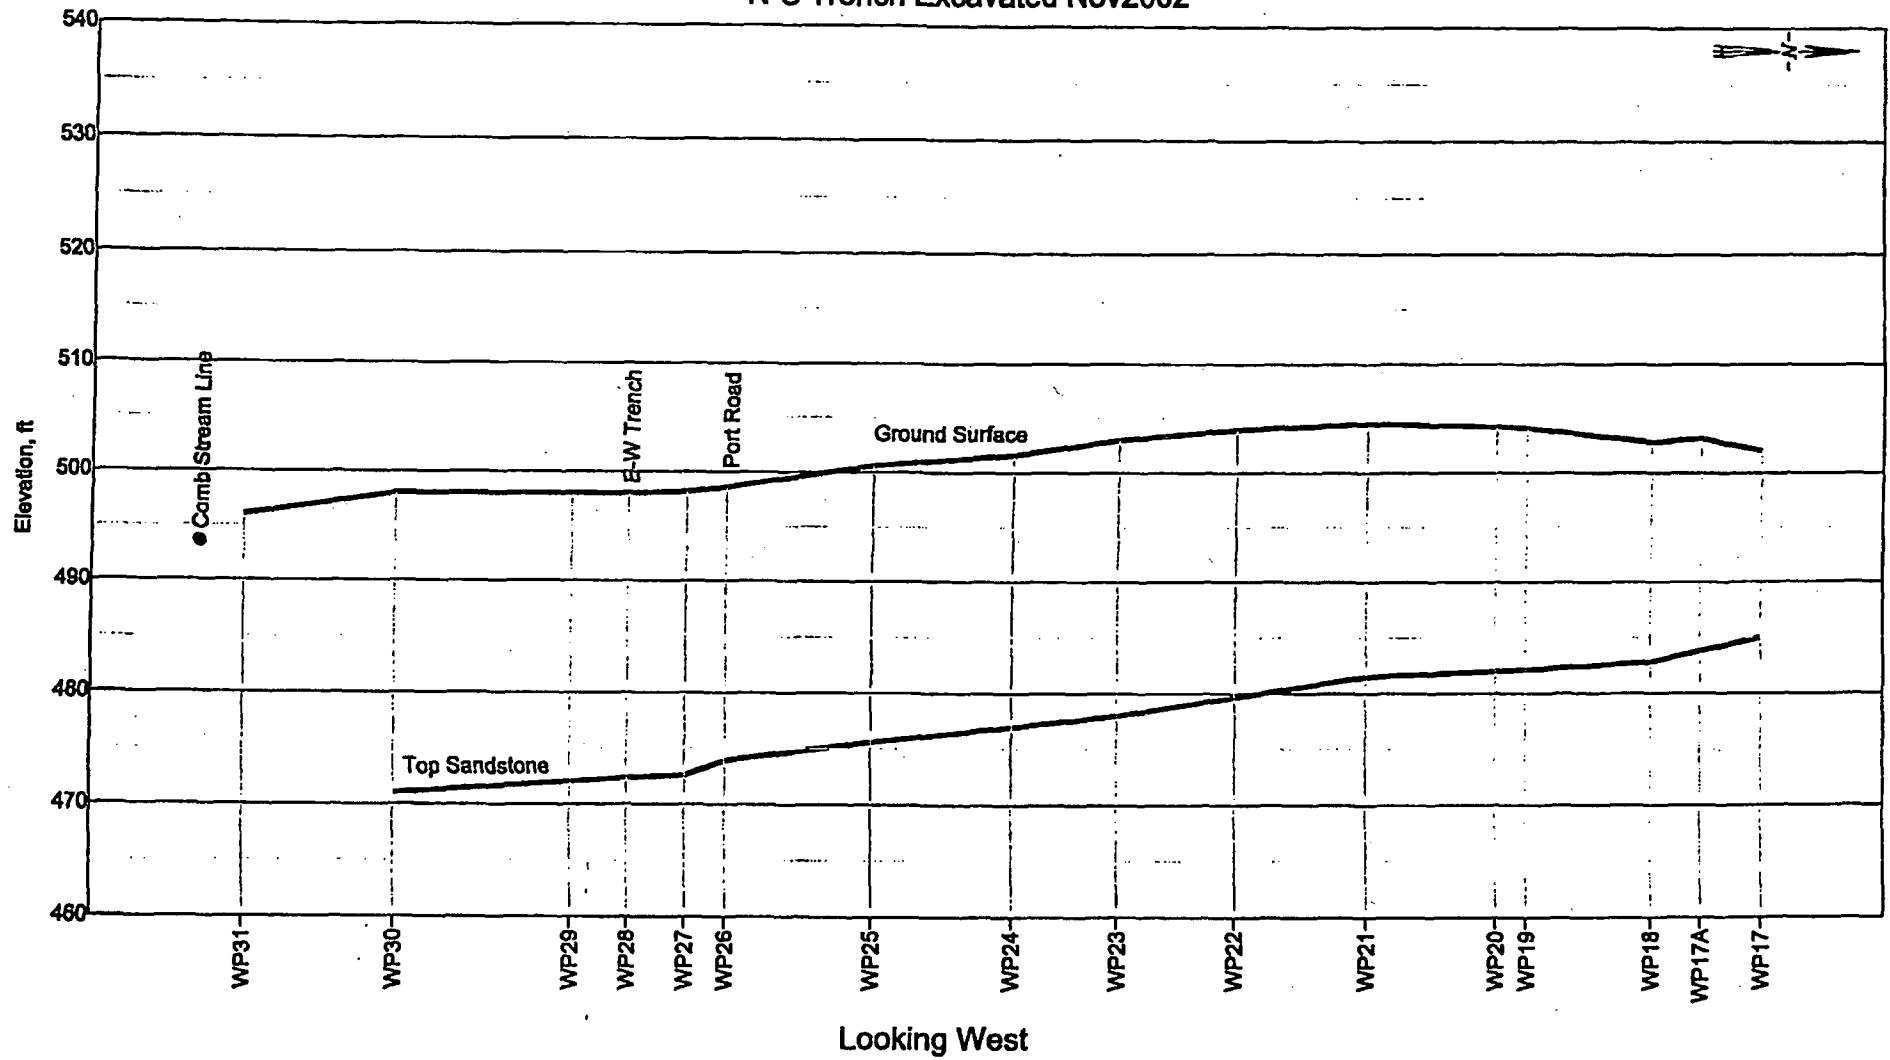
Figure 4
N-S Trench Excavated Nov2002

More water began to be observed at WP22. The black shale above the sandstone was getting thicker and several small puddles began to form in the trench bottom. The black shale layer was about 11 feet thick at WP22, with the total depth of the trench being approximately 22 feet. At WP 23 the black shale layer was 11 feet thick and the trench depth was 25 feet. At WP 24 a fairly hard layer of stone was hit at about 13 feet deep. After about 10 feet the sandstone was removed with the track-hoe. Discussions with the track-hoe operator indicated that this layer of fairly hard sandstone had been present for most of the excavation. The layer is about a foot thick. More water was observed as the excavation continued to the south. Standing water was present in the trench several hours after the excavation. The excavation continued to WP25 on November 13, 2002. The bottom of the excavation appears to be in the black shale and may not be on top of sandstone. The black shale could be slowly removed but was hard and difficult to excavate. A significant amount of water collected in the trench at WP25.

the southwest because of the location of the 008 Pipeline and ended near the 001 Pipeline. The 001 Pipeline was buried only 1 to 2 feet below the surface. The sandstone surface drops from the north to south end of the North-South Trench about 14 feet in elevation. A cross-section of the East-West Trench showing the ground and sandstone surfaces is attached as Figure 4. Water samples were collected at WP22, WP23, WP25, WP26, WP28, WP29, WP30 and WP31. The analyses for these samples are included in Table 1.

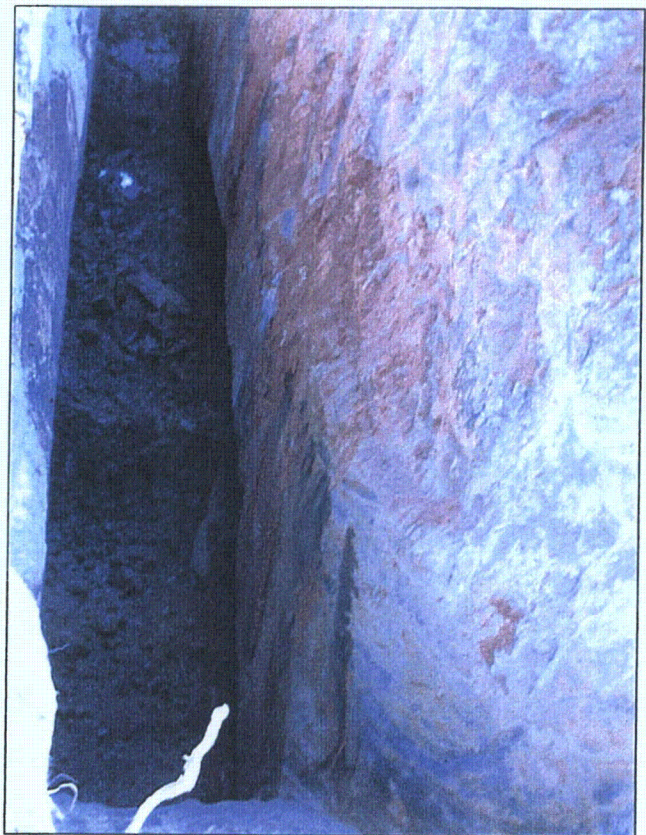
Picture 2

Picture 2: West end of East-West Trench. Note amount of sandy soil encountered.

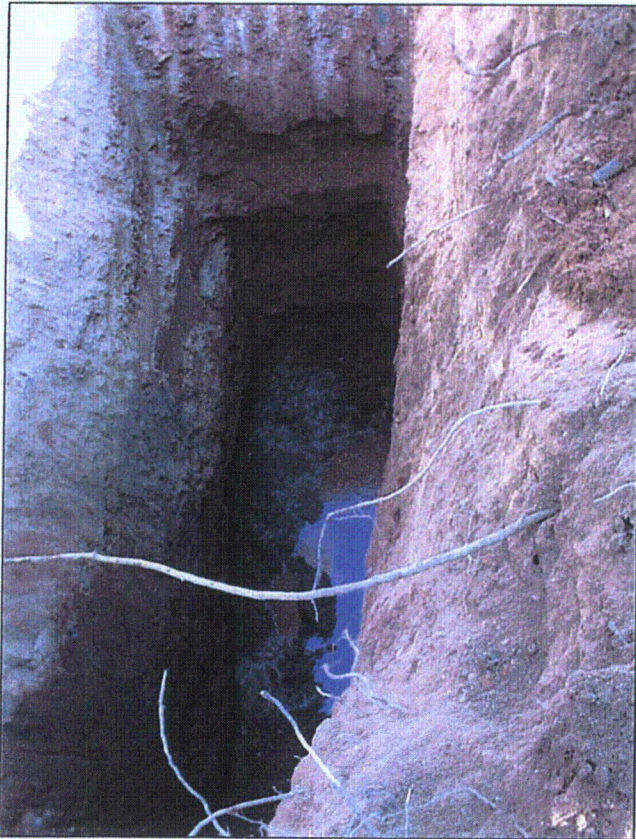
Picture 3

Picture 3: Pit excavated at west end of East-West Trench. Water filling bottom from sandy type soil.

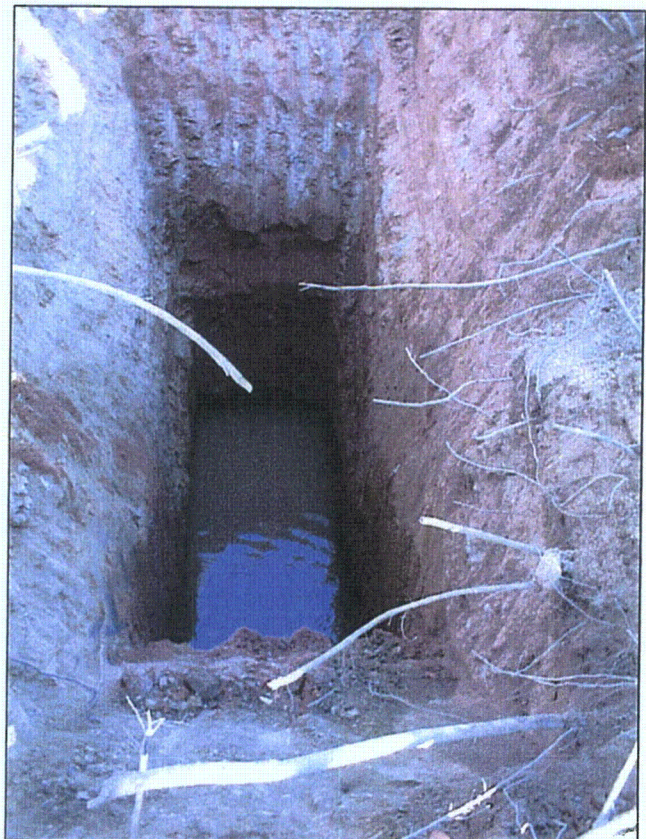
Picture 4

Picture 4: Pit excavated at west end of East-West Trench. Significant amount of water collected in a few hours.

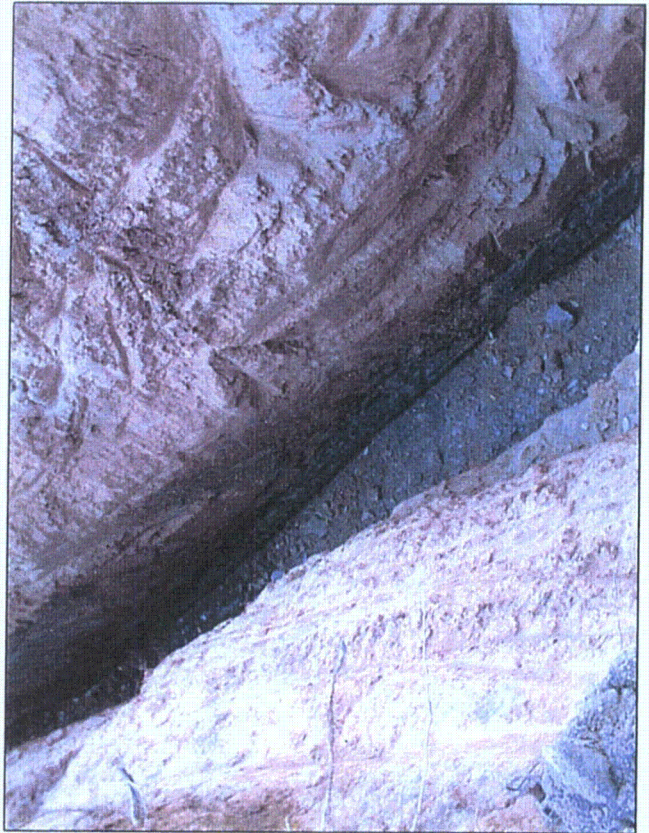
Picture 5

Picture 5: Looking east a MW095A with Pit and East-West Trench in background.

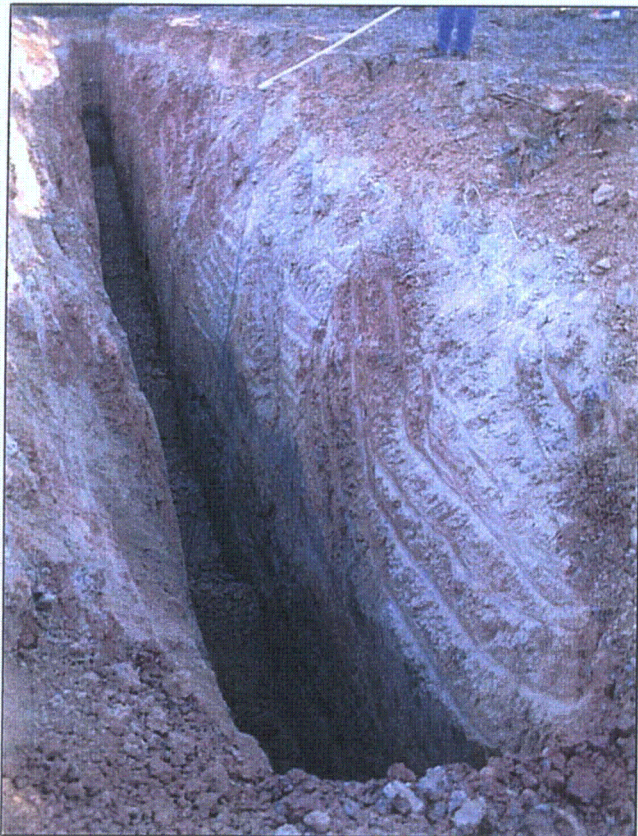
Picture 6

Picture 6: North end of North-South Trench. Small amount of water but mostly dry. Note black shale layer approximately 2 feet thick at bottom of trench.

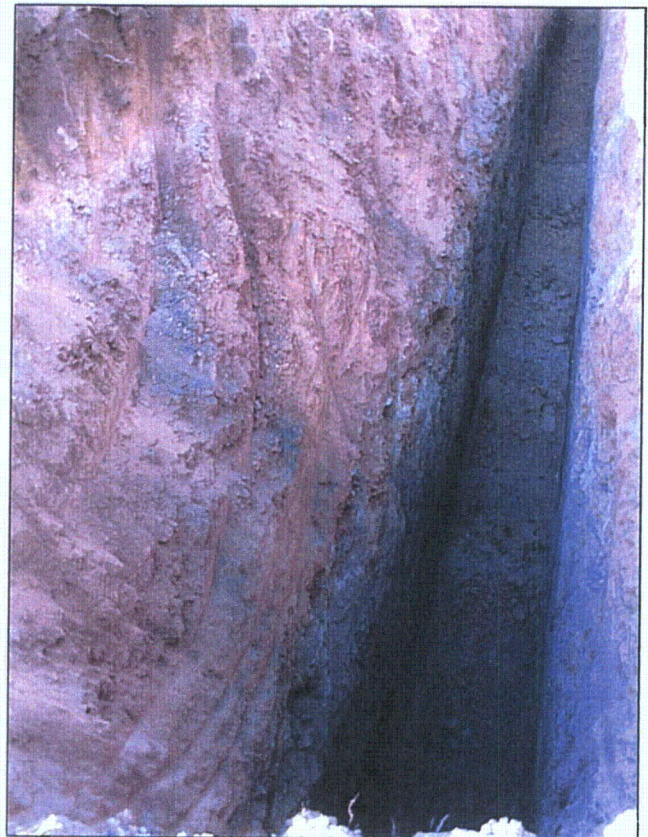
Picture 7

Picture 7: Looking north at north end of North-South Trench. Note that black shale layer becomes thicker and increases in thickness to about 5 feet. Excavation to top of very hard surface believed to be sandstone.

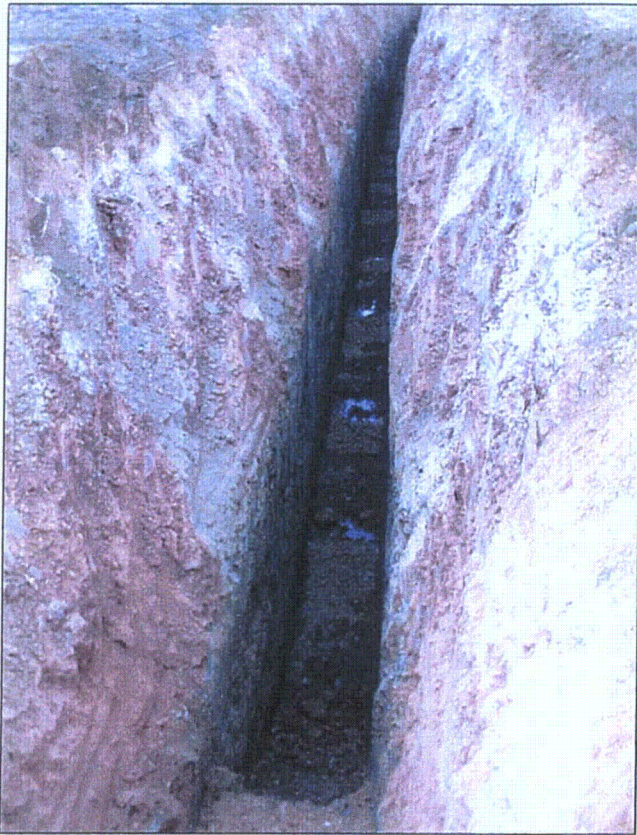
Picture 8

Picture 8: North-South Trench with no water present.

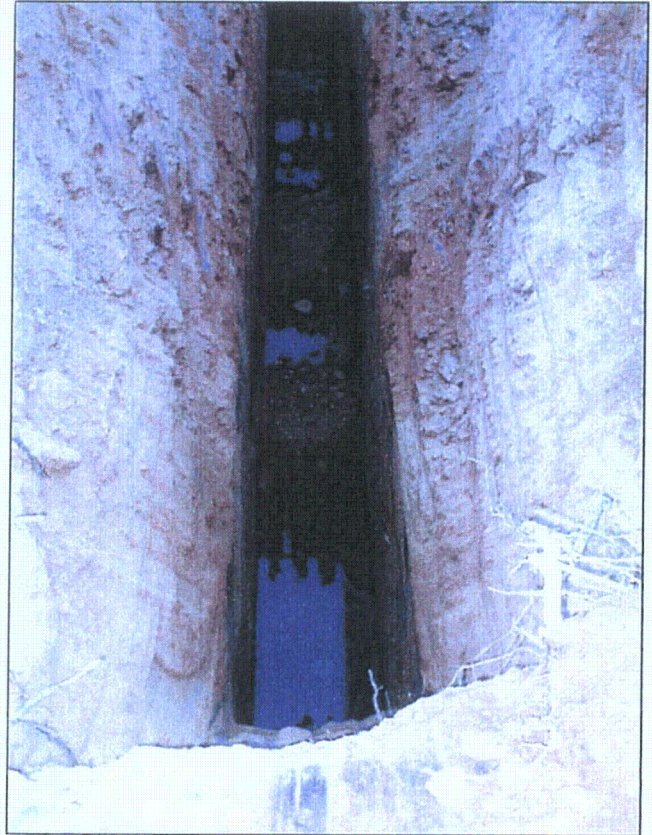
Picture 9

Picture 9: North-South Trench at about same location as Picture 8 showing water that collected in a few spots overnight.

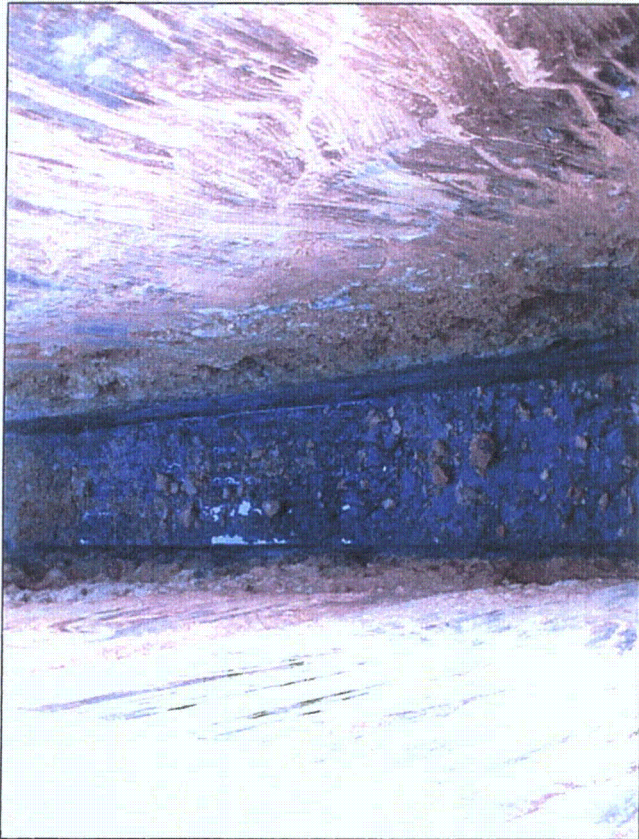
Picture 10

Picture 10: North-South Trench north of Port Road. More water collecting at this location overnight.

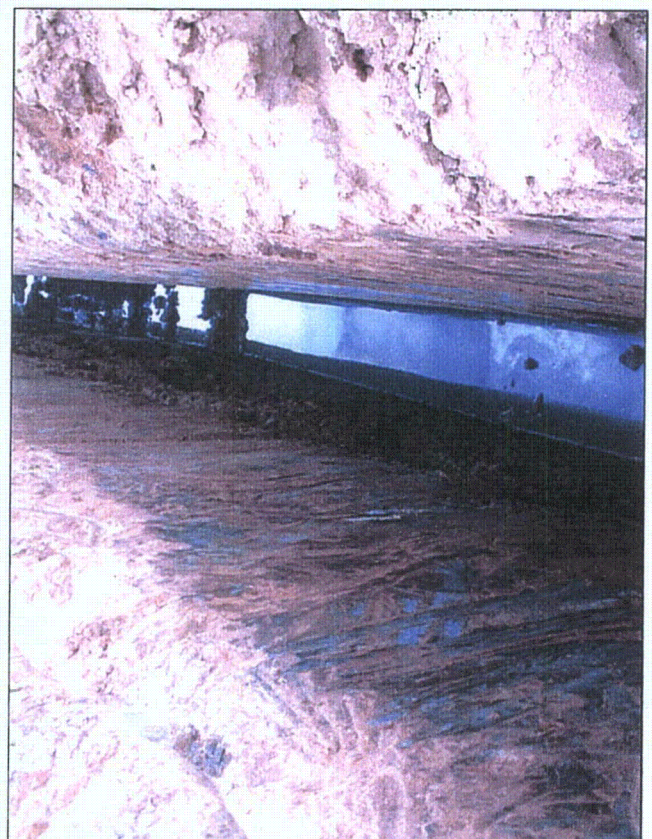
Picture 11

Picture 11: North-South Trench at Port Road. Water seeping into trench shortly after excavation.

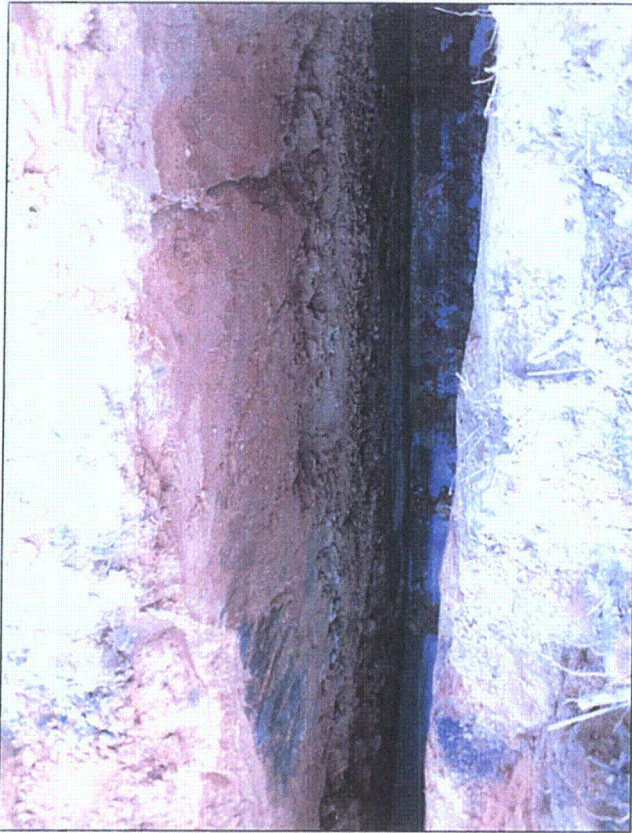
Picture 12

Picture 12: North-South Trench. Much more water collecting in trench. Water appears to be coming from black shale layer, not sandy soil above shale.

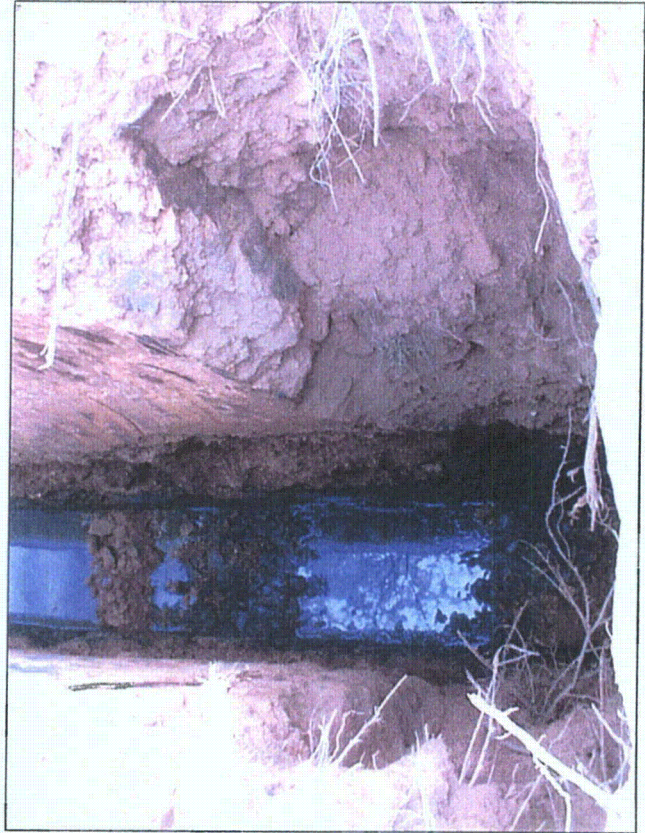
Picture 13

Picture 13: Looking at west bank of North-South Trench excavation. From bottom there is a black shale, sandy/gravel layer, thin sandstone layer, hard clay and topsoil.

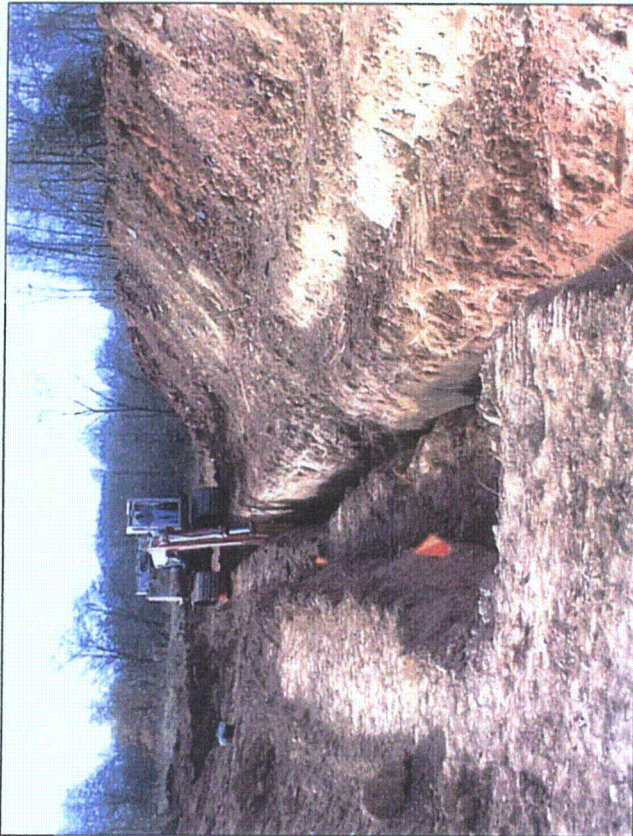
Picture 14

Picture 14: North-South Trench at intersection with East-West Trench – looking north. North-South Trench is about 4 feet deeper than East-West Trench.

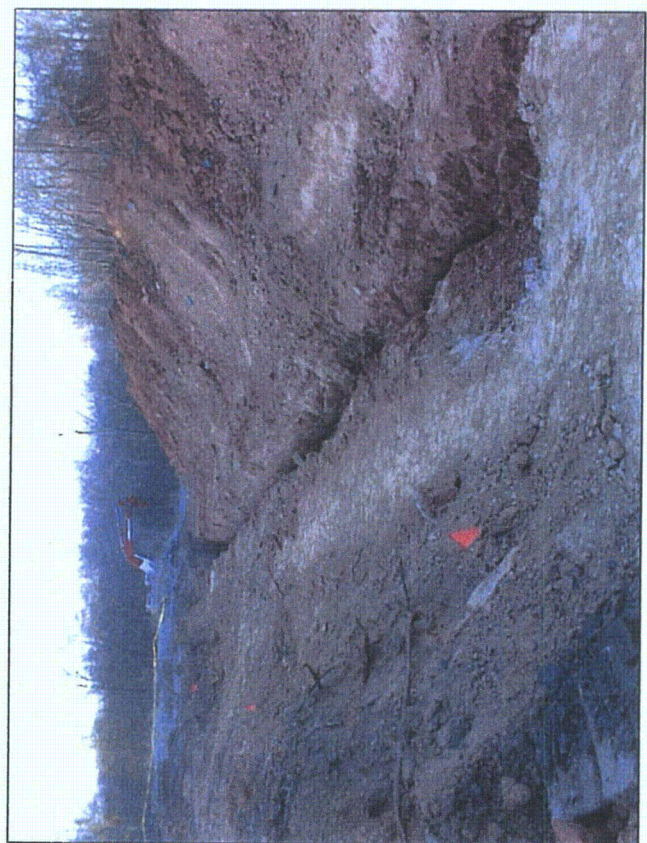
Picture 15

Picture 15: Looking south at North-South Trench excavation south of Port Road.
