Pressurized Water Reactor  
B&W Technology  
Crosstraining Course Manual

Chapter 15.0

Rancho Seco Loss of ICS Power

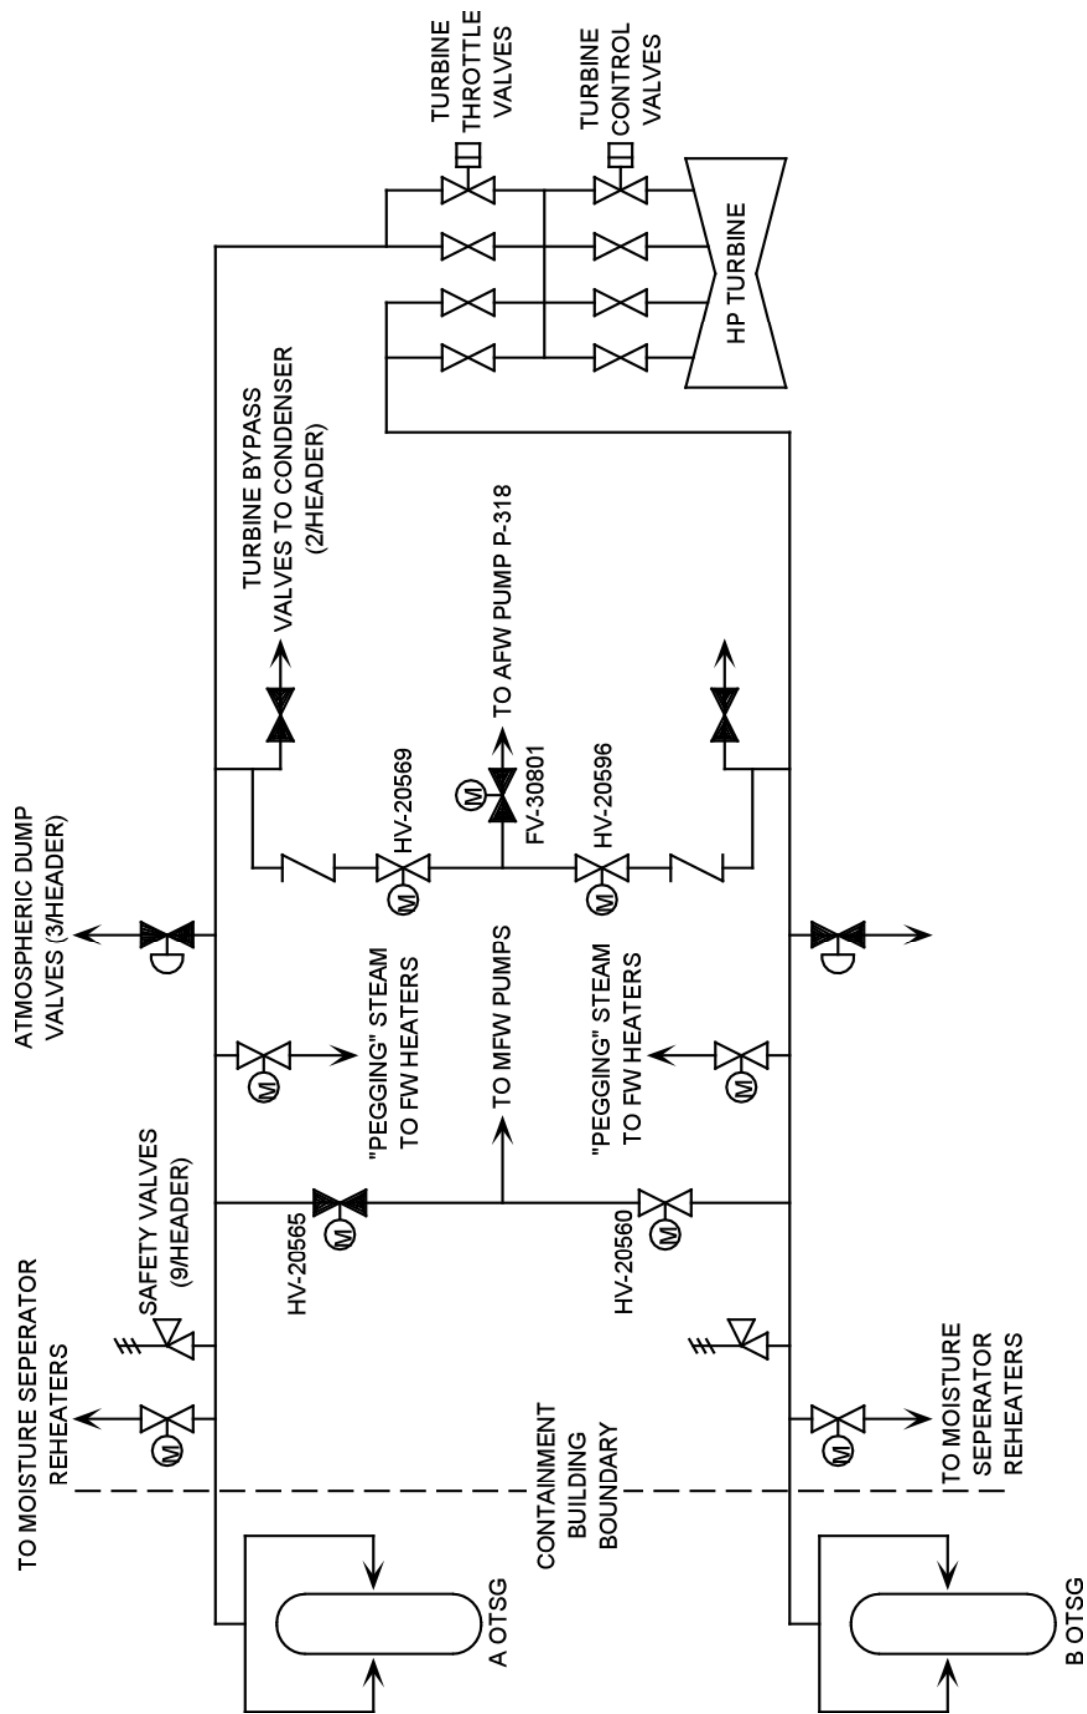
Figure 15-2 Main Steam System

The main steam system (Figure 15-2) supplies steam from the once-through steam generators (OTSGs) to the turbine-generator, the turbine driven main feedwater pumps, the dual drive auxiliary feedwater pump, and other plant auxiliary systems. Three atmospheric dump valves (ADV) and two turbine bypass valves (TBV) are installed on each header to remove excess reactor coolant system energy during a turbine trip or load rejection. The valves have a total capacity of 50 percent, with equal amounts of heat removal capacity available by dumping steam to the atmosphere or bypassing steam to the condenser. These valves are controlled by the ICS. Rancho Seco normally operates with four of the six ADVs manually isolated to prevent overcooling following a reactor trip.

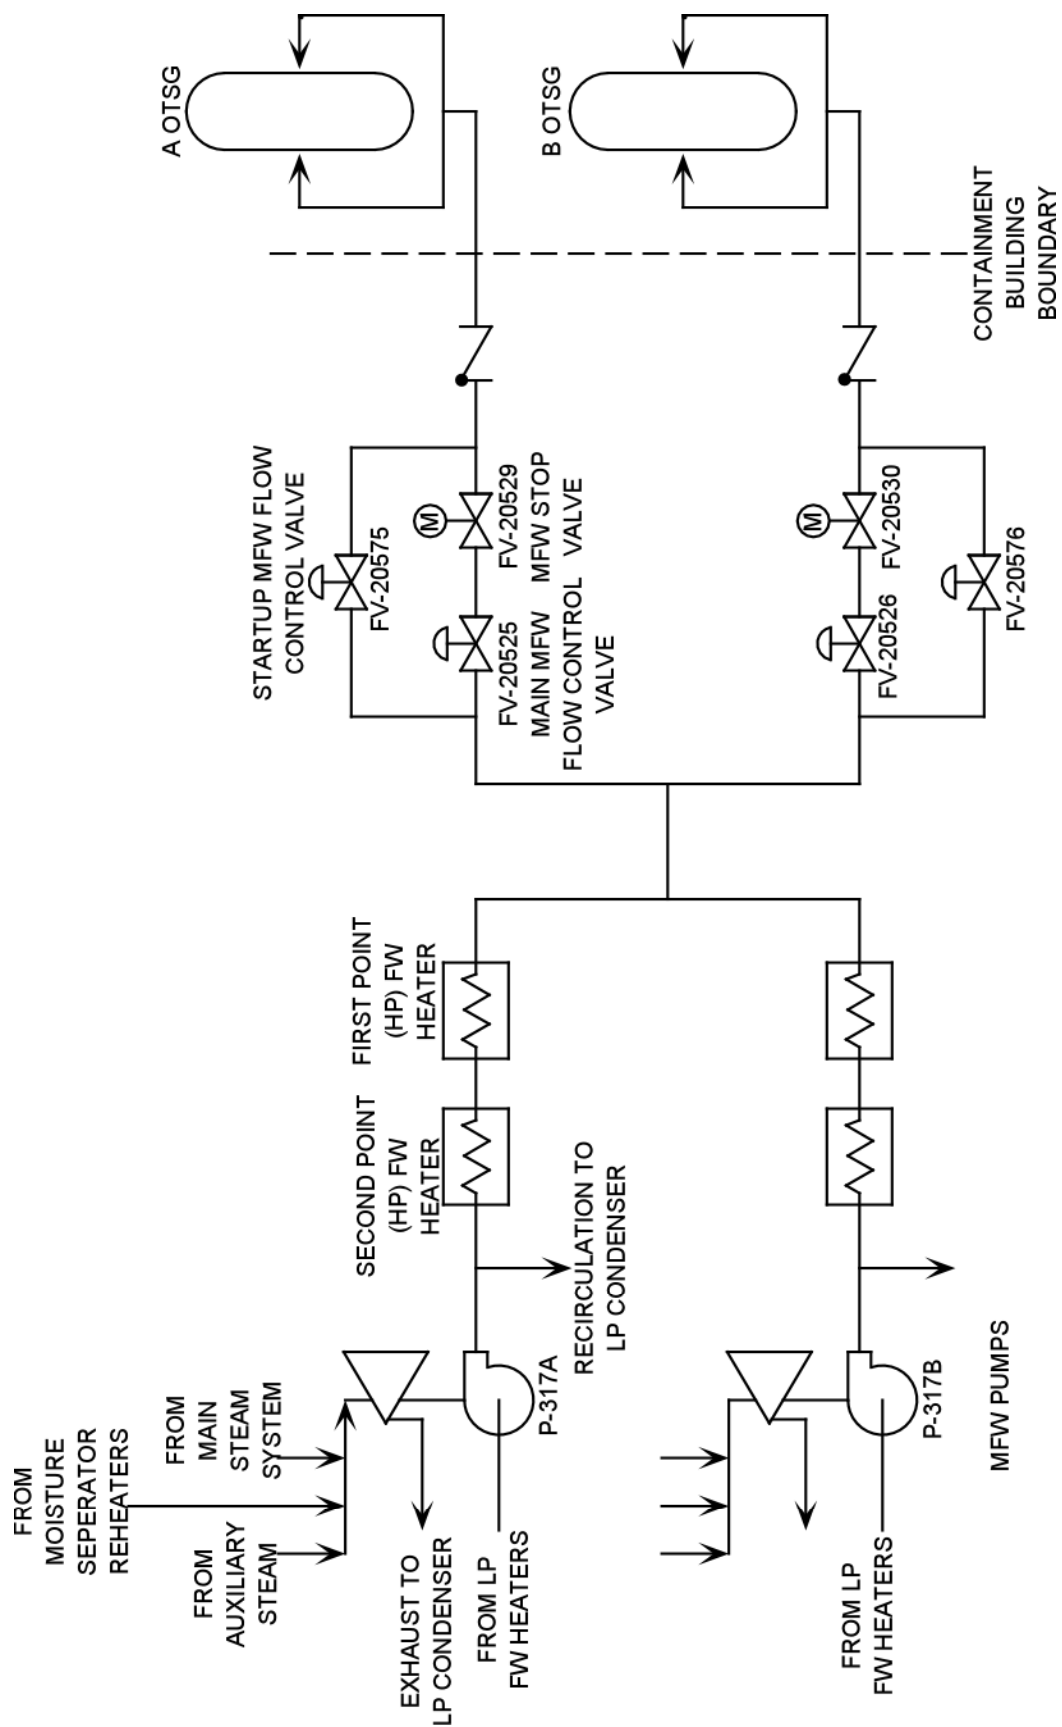
Figure 15-3 Main Feedwater System

The discharge of the turbine driven main feedwater pumps (Figure 15-3) is routed to the OTSGs via high-pressure feedwater heaters, startup feedwater regulating valves, and the main feedwater regulating valves and their associated block valves. As previously stated, the main feedwater pump speed, the startup regulating valves, and the main feedwater regulating valves are controlled by the ICS.

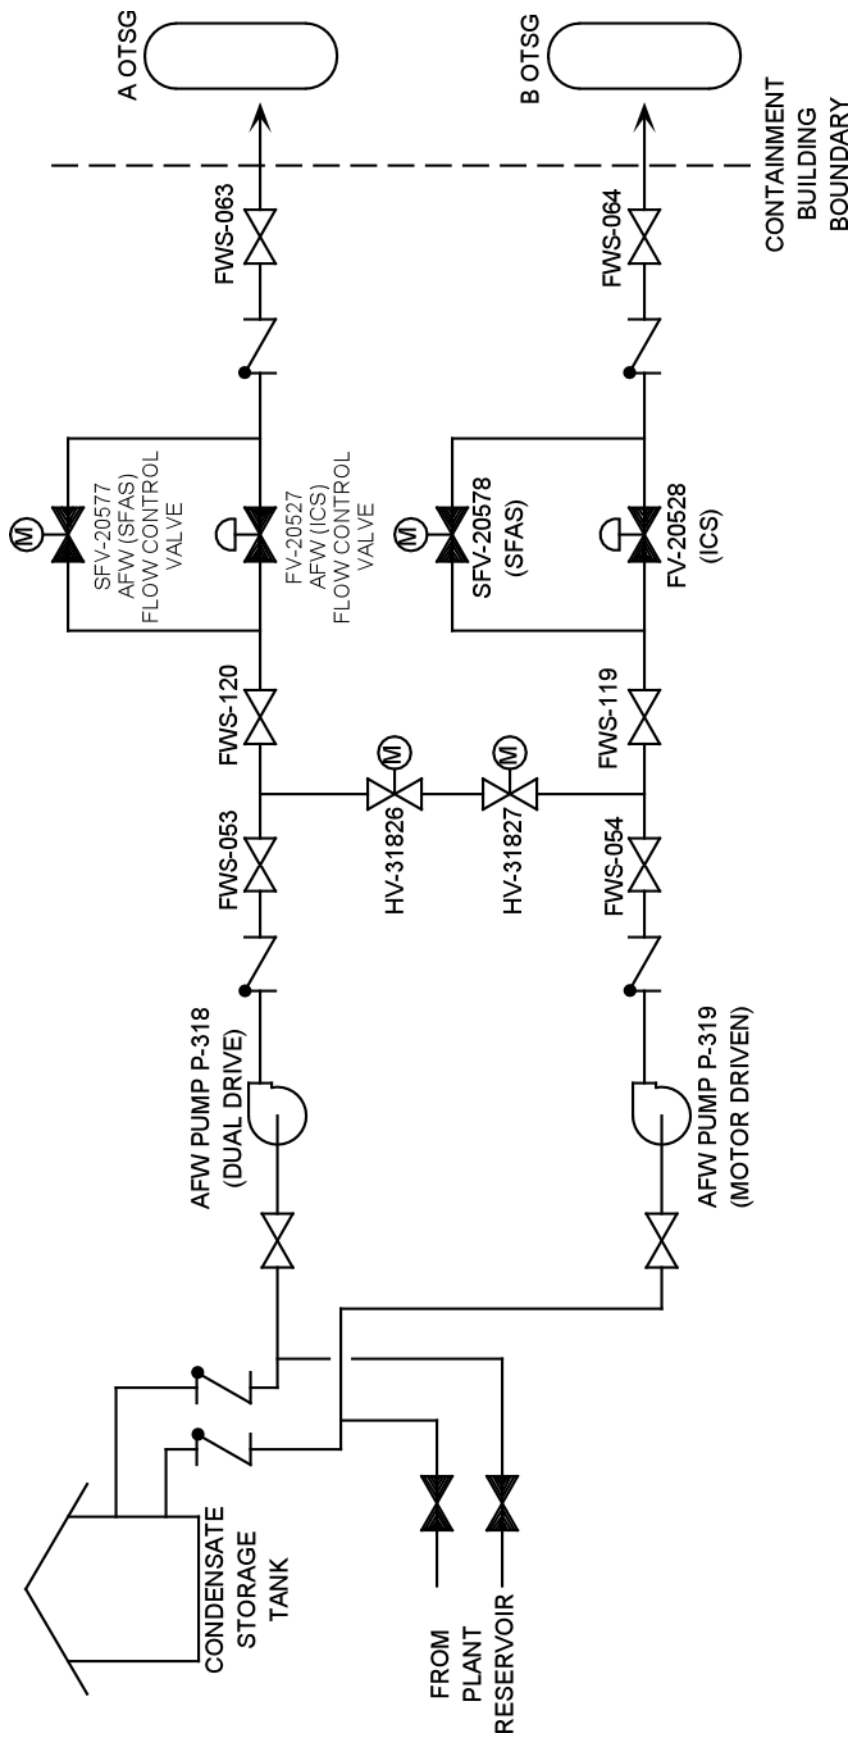
Figure 15-4 Auxiliary Feedwater System

The auxiliary feedwater (AFW) system is shown in Figure 15-4 and consists of redundant pumps and flowpaths to each steam generator. One of the two pumps is motor driven, and the other pump is dual driven. The dual driven pump is powered by a turbine on one end of the pump shaft and a motor on the other end. The pumps normally receive suction from the condensate storage tank (CST). Auxiliary feedwater flow to the steam generators is controlled by parallel valves in each supply line. One of the two valves receives a signal from the ICS, and the second valve receives a signal from the safety features actuation system (SFAS).

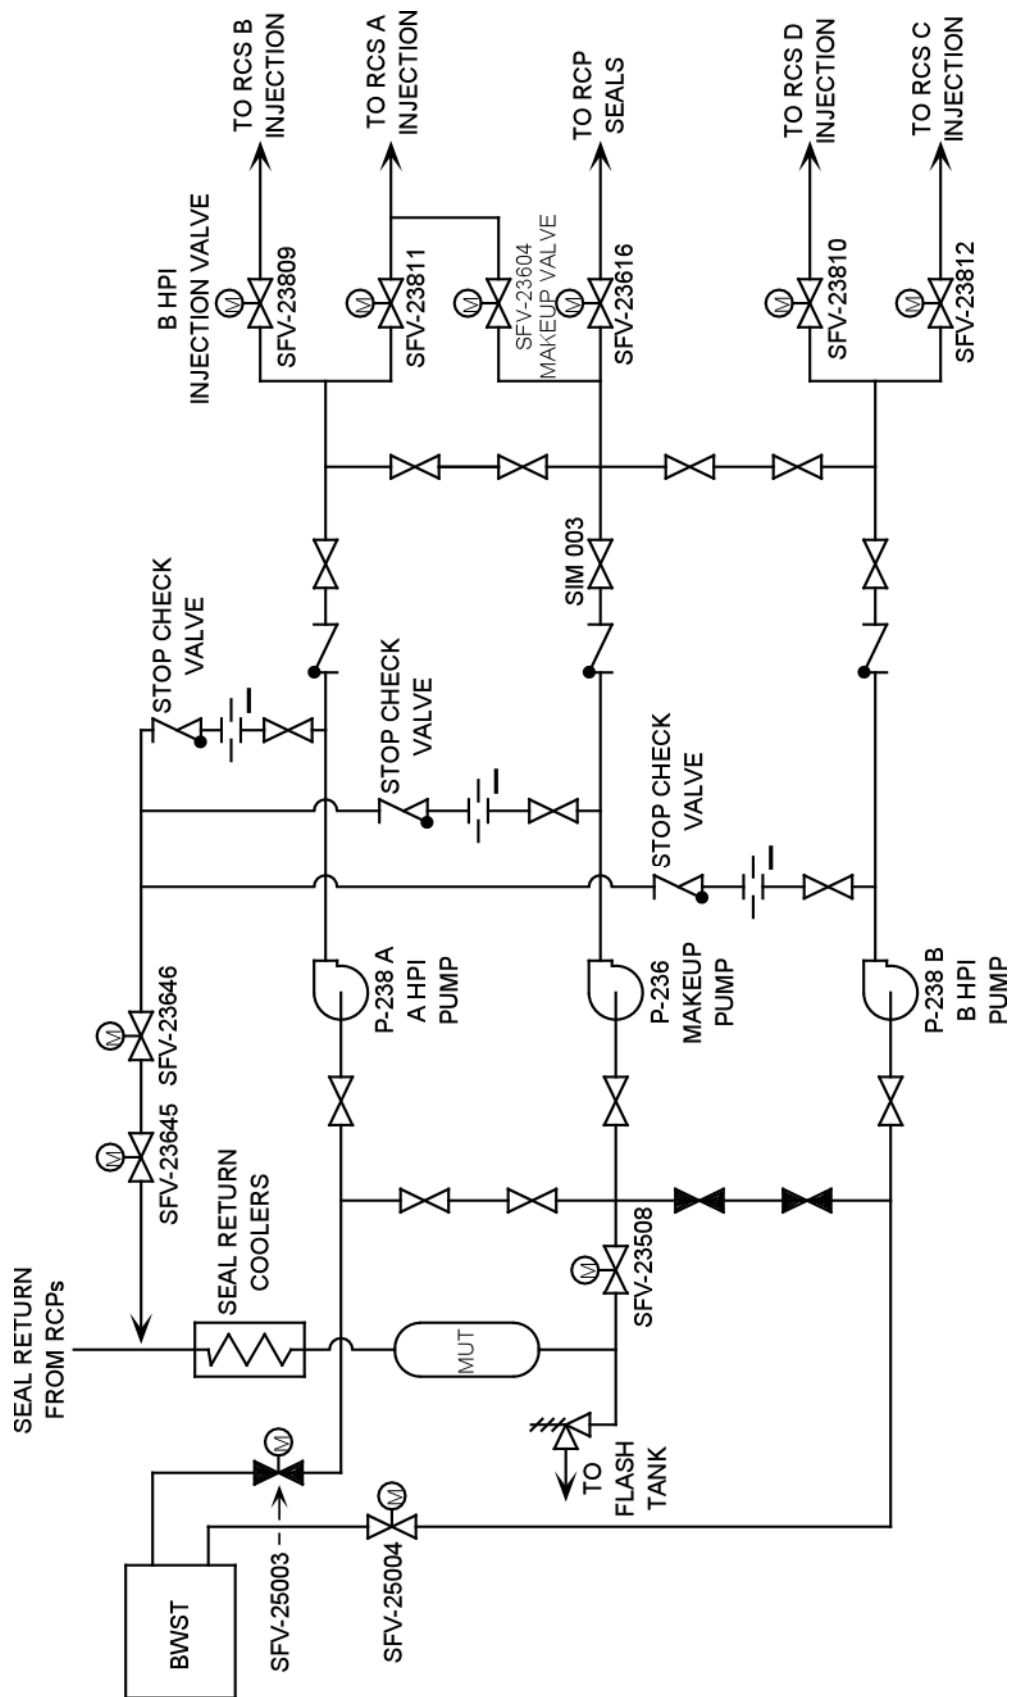
Figure 15-5 High Pressure Injection System

The high-pressure injection system (Figure 15-5) is typical of the 177 FA high-pressure injection (HPI) systems. As shown, the pumps normally receive suction from the makeup tank and discharge to an RCS cold leg via the makeup flow control valve. If an emergency core cooling actuation signal is received, the following changes will occur in the system:
