Characterization of Flaws in U.S. Reactor Pressure Vessels

Validation of Flaw Density and Distribution
in the Weld Metal of the PVRUF Vessel

Pacific Northwest National Laboratory

U.S. Nuclear Regulatory Commission
Office of Nuclear Regulatory Research
Washington, DC 20555-0001

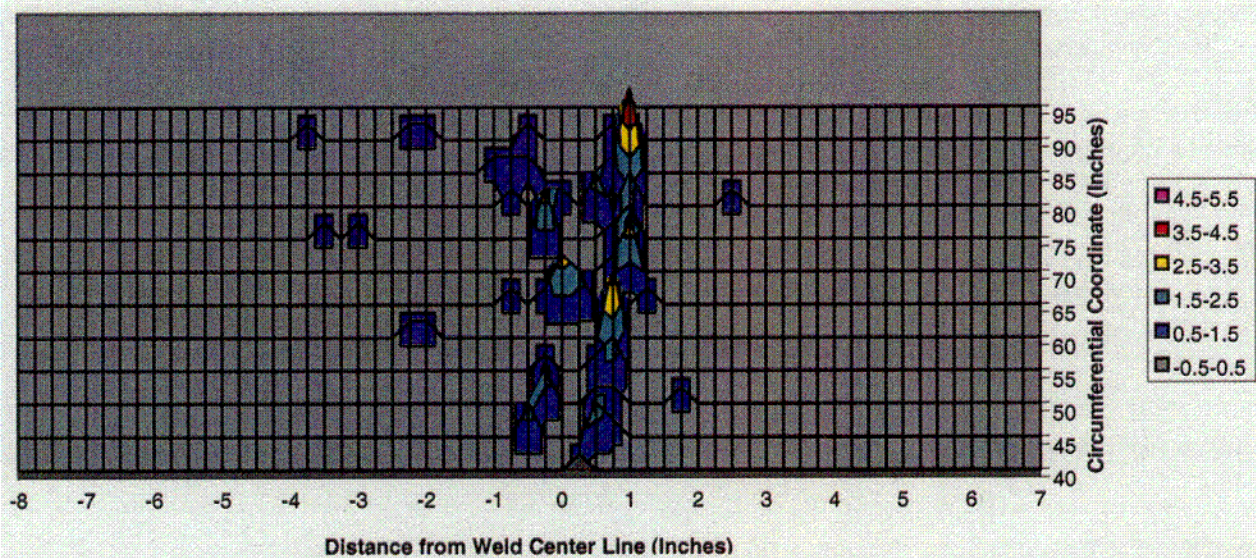
Figure 2.1 Plan View, Flaw Indication Frequency in PVRUF Block 5-1

Figure 2.1 shows the plan view of the indication density for Block 5-1, one of the approximately 1800-kg (4000-lb) PVRUF specimens. Block 5-1 is typical of other PVRUF material in that the indication density is greatest on the weld fusion line. First, these data show that the small flaws are neither random nor associated with the

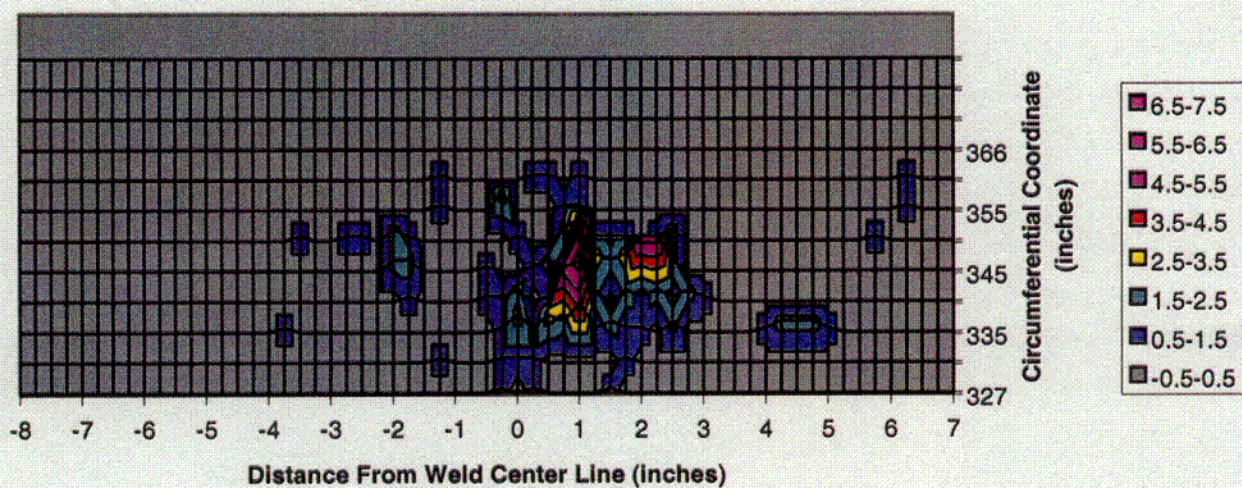
Figure 2.2 Plan View, Indication Frequency in PVRUF Specimen 5-7

Figure 2.2 shows the plan view of indication density for Block 5-7. This material contained a significant density of indications in the base metal. Data confirmed the presence of mid-wall inclusions in the base metal of this specimen. These indications were not associated with one of the axial welds present in this material.

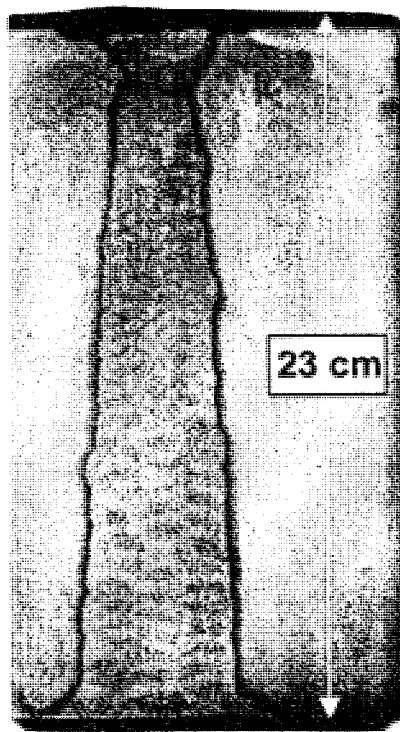
Figure 2.4 Weld Cross Section for Beltline (Lower-to-Intermediate Shell) Weld

After the PVRUF specimens were received at PNNL, it was possible to confirm the weld cross section and the volume of weld metal inspected. Figure 2.4 shows the weld cross section for a specimen from the beltline weld of the PVRUF vessel. This photograph was taken after the weld specimen was polished and acid-etched. The weld is shown to be single Vee in design. The top of Figure 2.4 shows the cladding layer as a dark band that is somewhat thicker over the weld than over the base metal. The cross-sectional area of the weld metal within the near-surface zone (25 mm from the wetted [inside] clad surface) is 4.9 cm². The cross-sectional area of the weld outside the near-surface zone is 73 cm².

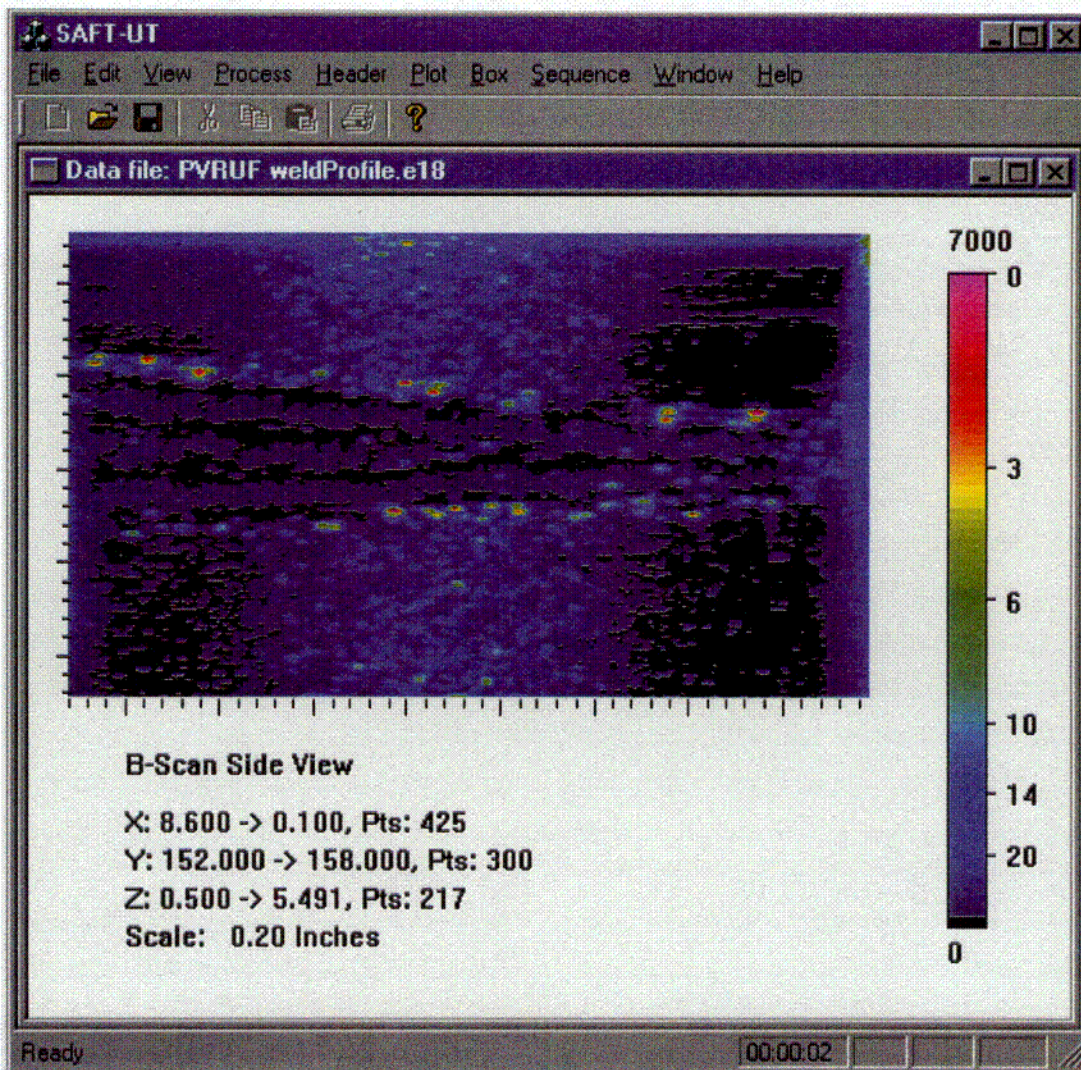
The weld-normal ultrasonic testing of PVRUF material confirmed an elevated concentration of flaw indications on the fusion surfaces of the structural weld with the base metal plate. Figure 3.1 shows the weld profile of the PVRUF vessel's beltline weld as it lies on its side during weld-normal testing with the transducer insonifying from the surface at the top of Figure 3.1. The weld back-gouge is on the right side. The weld profile is made evident by the ultrasonic energy returned from the numerous small flaws on the fusion surface.

Figure 3.1 Side View of Weld-Normal Ultrasonic Test Showing Weld Profile as Evidenced by Small Flaw Indications

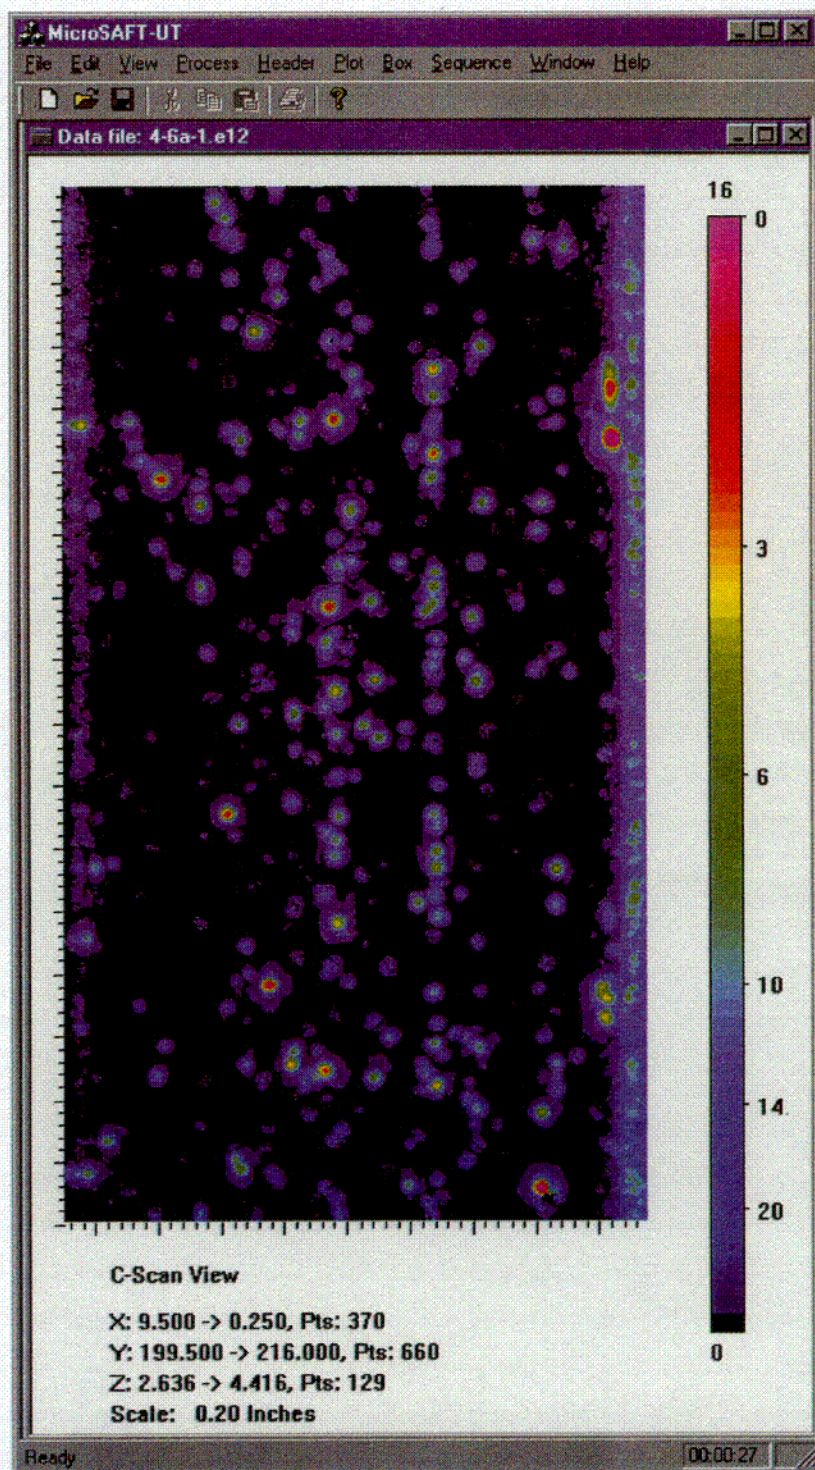
Flaw indications in the machine-made weld metal were confirmed to be small. Figure 3.2 shows the top view of a weld-normal ultrasonic inspection. The major portion of the flaw indications produce circular shapes whose image sizes are determined more by the SAFT-UT system resolution (3 mm using a 5-MHz, 6-mm diameter transducer) than by the size and shape of the small flaws. The cladding is on the right side of Figure 3.2, and the vessel OD is on the left side. The weld-normal flaw indications are not randomly distributed in that some weld passes, as shown by a long line of indications in Figure 3.2, contain more small flaw indications than other weld passes.

Figure 3.2 C-scan (top view) Image of Small Flaw Indications on the Weld Fusion Surface, from Weld-Normal UT Inspection

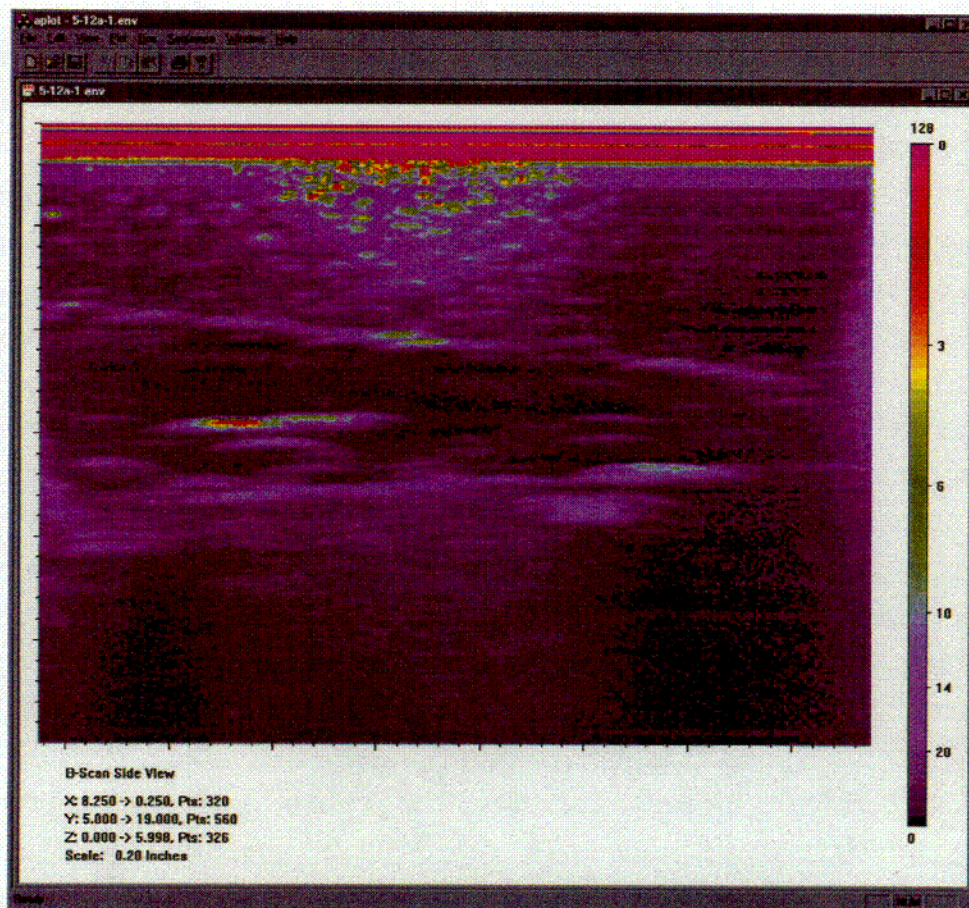
A minor number of flaw indications was found between the weld beads of the machine-made weld metal. Figure 3.3 is similar to Figure 3.1 except that in this case a flaw indication is evident within the weld instead of along the fusion surface.

The validation work confirmed that consecutive weld passes can produce a cluster of vertically oriented small flaws. Figure 3.4 shows the results of weld-normal testing of the internal welding flaw indication shown in Figure 3.3. In this case, the cladding (not shown) is on the left side of the figure. The distance between the flaw rows of indications is 10 mm. The weld bead size is also 10 mm, and these data show that consecutive weld passes can contain flaw indications at the same circumferential location.

Figure 3.3 UT Image Showing Weld Profile with Weld Flaw Indication

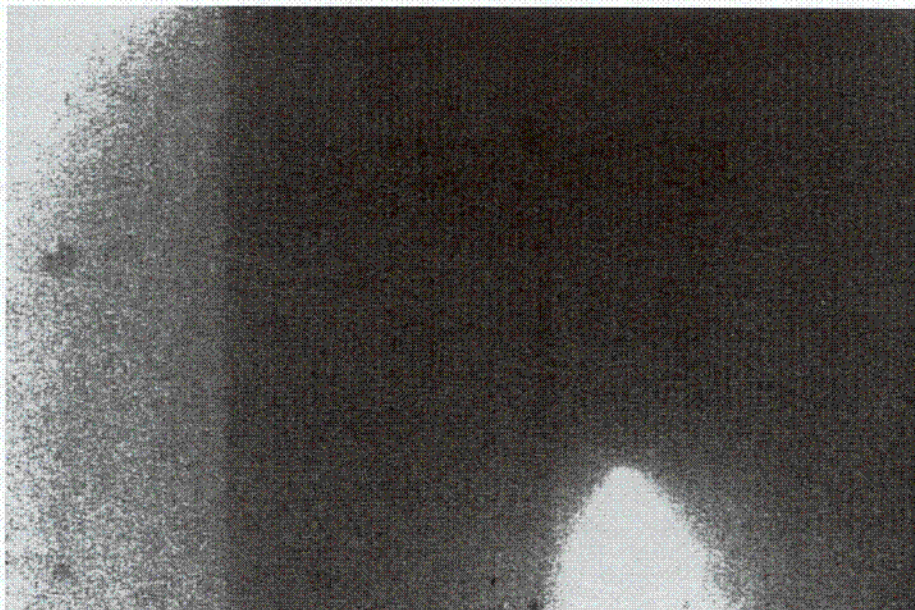
Figure 3.16 Digitized Image of Radiograph of 25-mm Plate 5-1AB-7 Location 2. RT indication did not reproduce in digitized image but is evident in original radiograph.

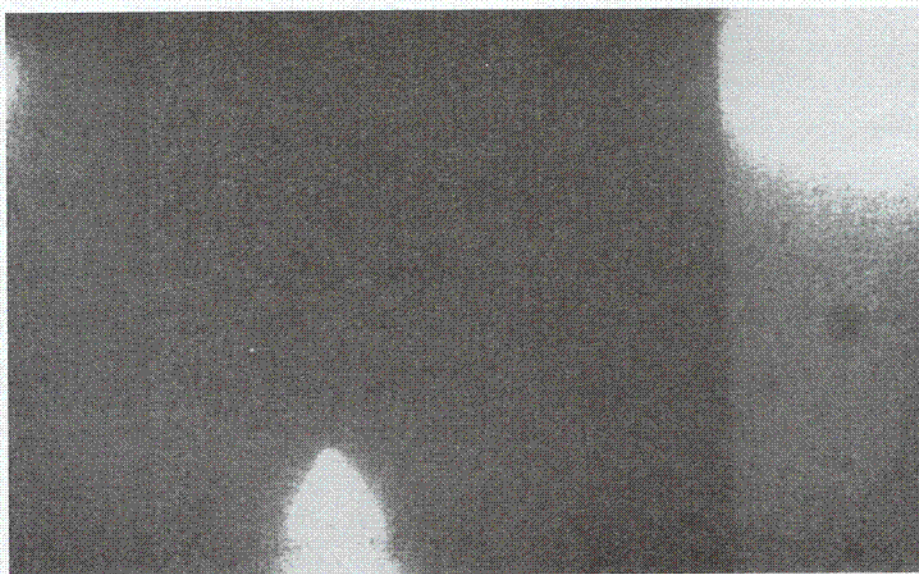
Figure 3.18 Digitized Image Radiograph of 25-mm Plate 5-1ab-9 Location 2. No RT indication was found at this location.

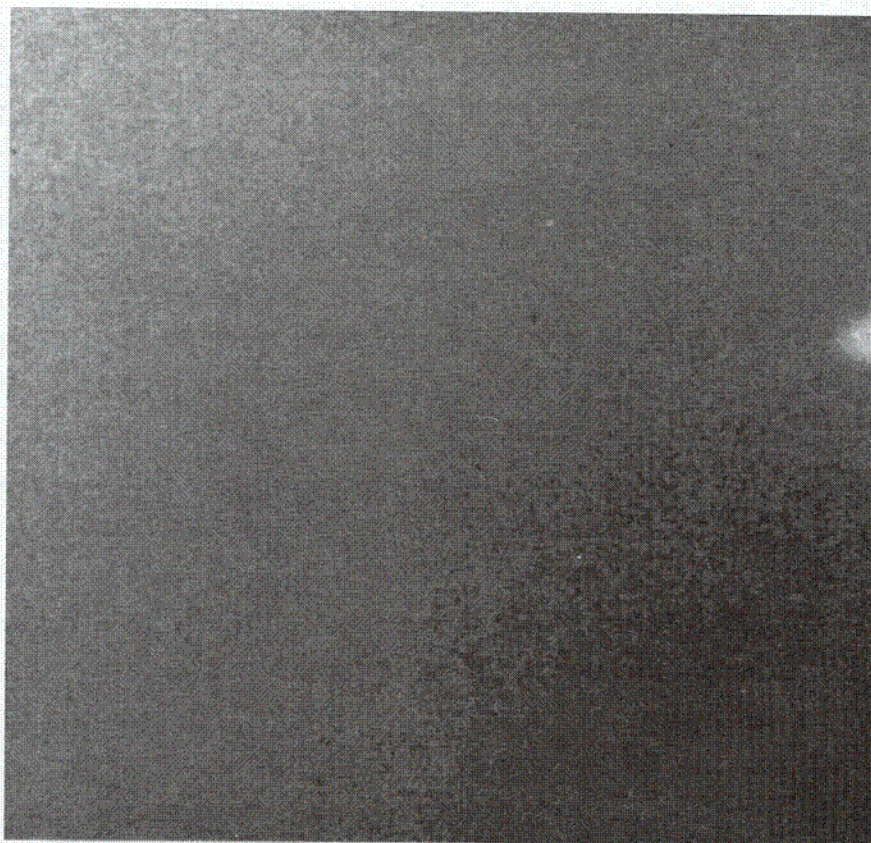
Figure 3.22 Digitized Image of Radiograph of 25-mm Plate 5-1AB-12
Location 3. No RT indication was detected in this radiograph.

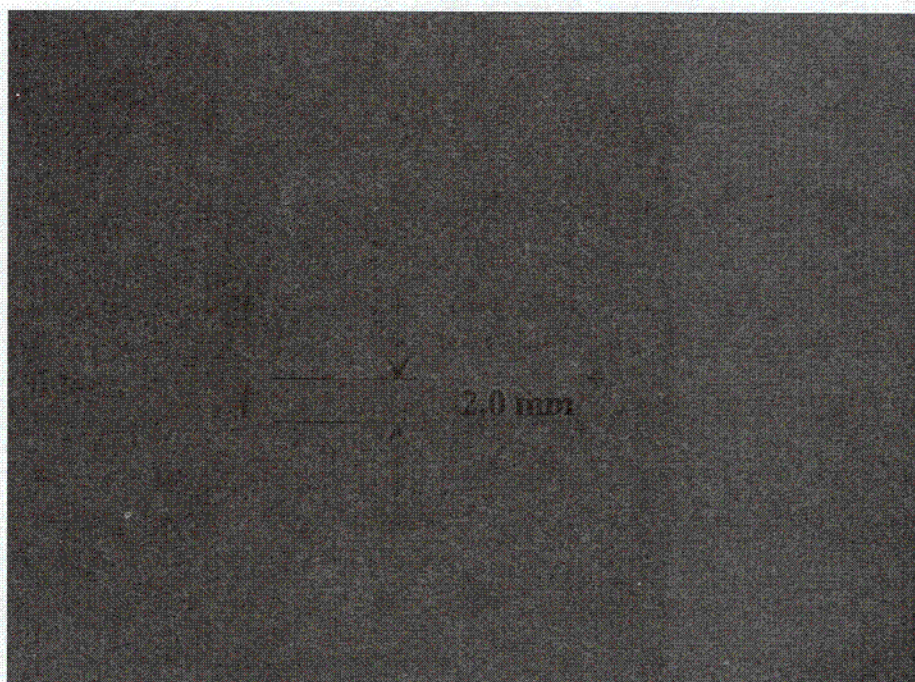
Figure 3.44 Digitized Image of Radiograph of 25-mm Plate 5-12BA-3
Location 2. No RT indication was detectable at this location.

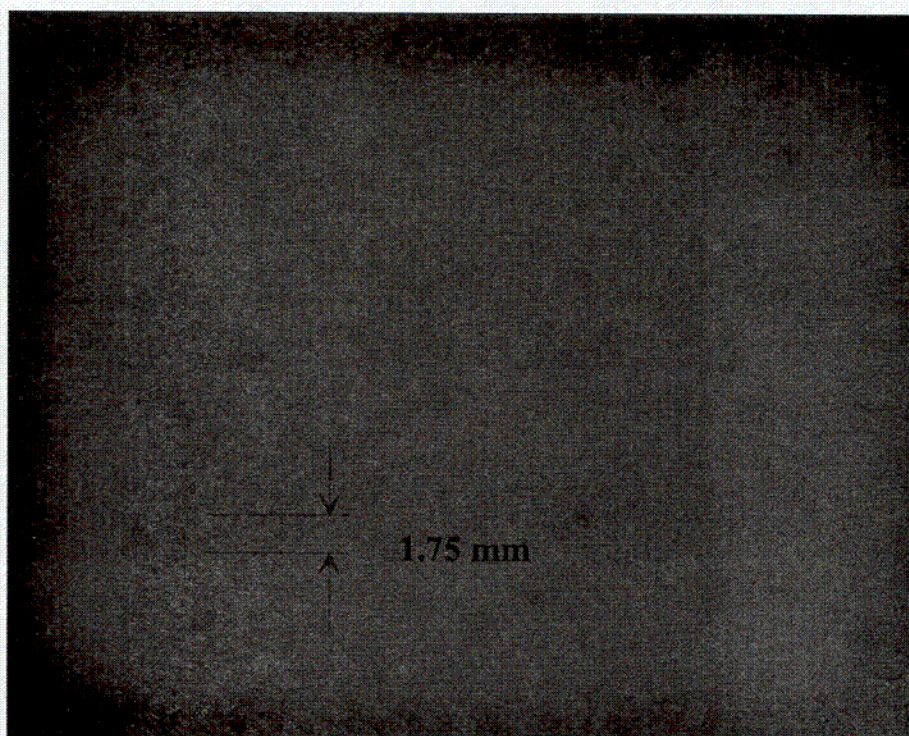
Figure 3.48 Digitized Image of Radiograph of 25-mm Plate 5-12BA-10. No RT indication was detectable at this location.

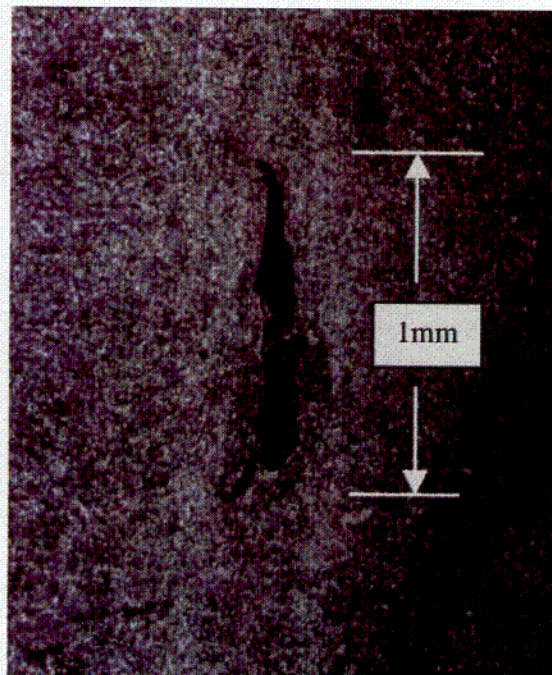
Figure 3.51 Micrograph of 25-mm Cube Showing Location of Fusion Surface Flaw

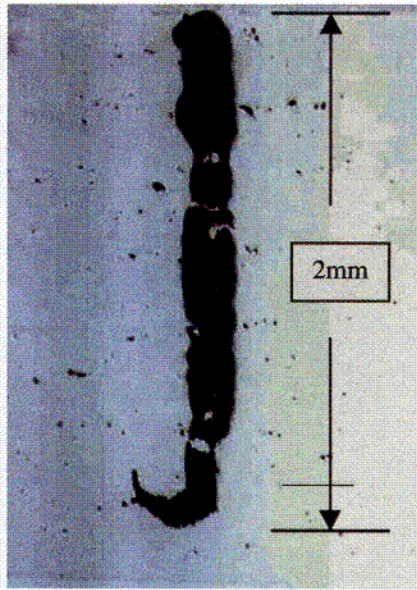
Figure 3.52 Micrograph of Fusion Surface Flaw Before Maximum Extent as Polished and Etched

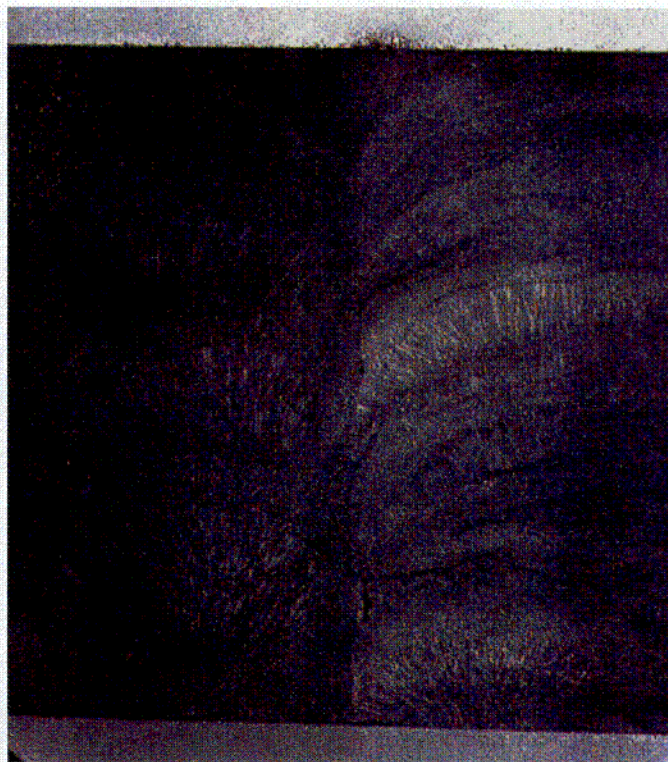
Figure 3.53 Micrograph of 2-mm Flaw at Maximum Extent as Machined

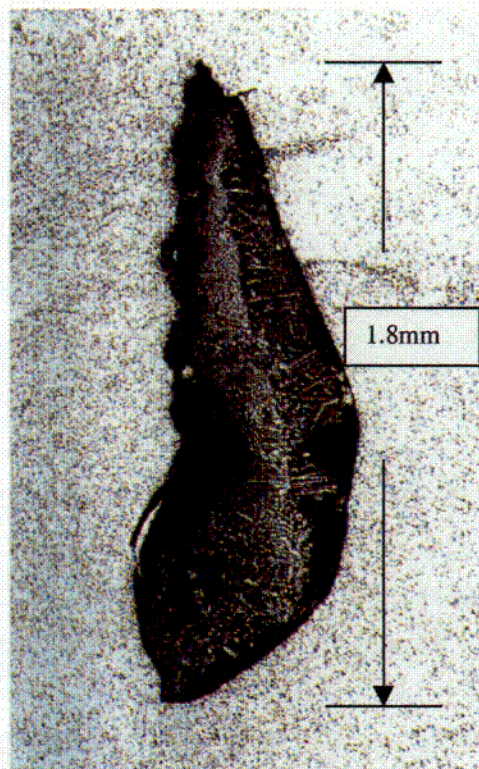
Figure 3.55 Micrograph of a Cross-Section of One Weld Flaw from the Large Cluster. The through-wall extent of the flaw is 2.5 mm. The flawed area contains slag. Tails are visible on both flaw ends.

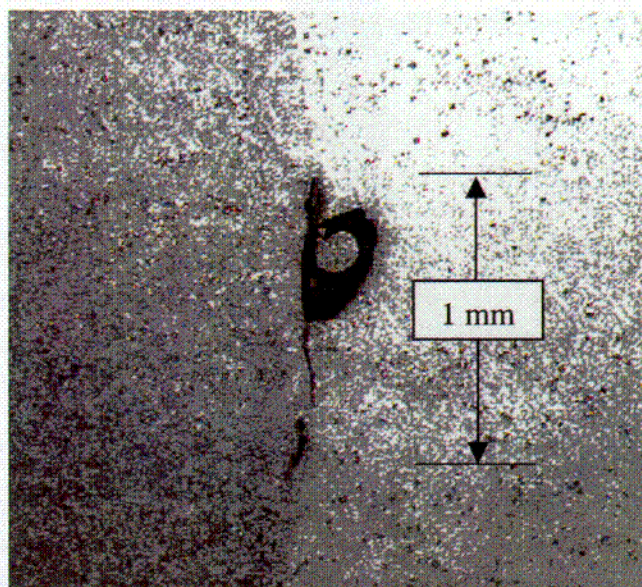
Figure 3.56 Micrograph of Flaw from the Cluster Shown in Figure 3.54. Flaw is shown to be inter-run slag.

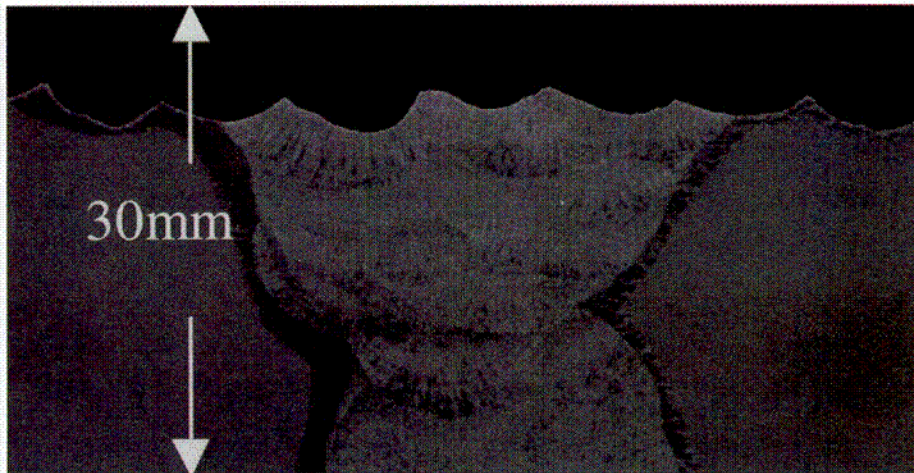
Figure 3.57 Micrograph of Small Flaw Shown in Figure 3.56. Flaw has vertical extent of 0.8 mm and planar features between the weld beads.

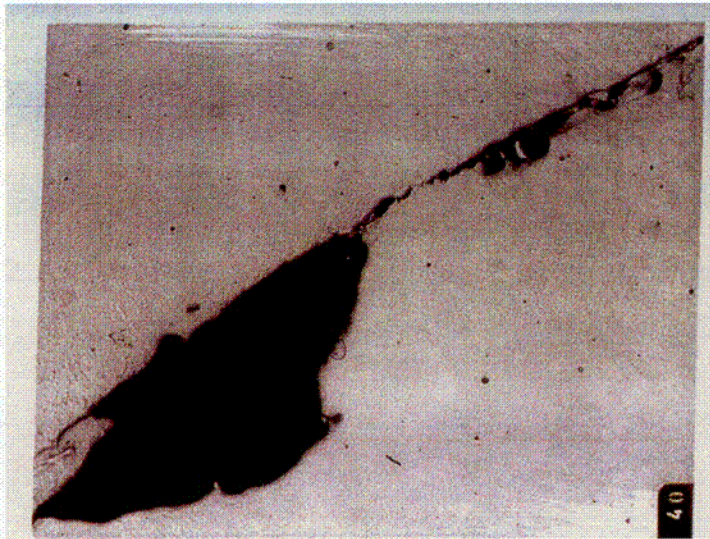
Figure 3.63 shows a micrograph of the cube exposing a complex flaw associated with the first tandem arc weld passes. This figure shows a lack of fusion with slag on the weld side wall and a horizontal inter-run lack of fusion/contamination above the first tandem weld passes. Figure 3.64 shows a micrograph of a magnified portion of the lack of side-wall fusion with slag.

Figure 3.63 Micrograph of Cube 5-10EB1-IIbIIc Showing Complex Flaw Above First Tandem Arc Weld Passes

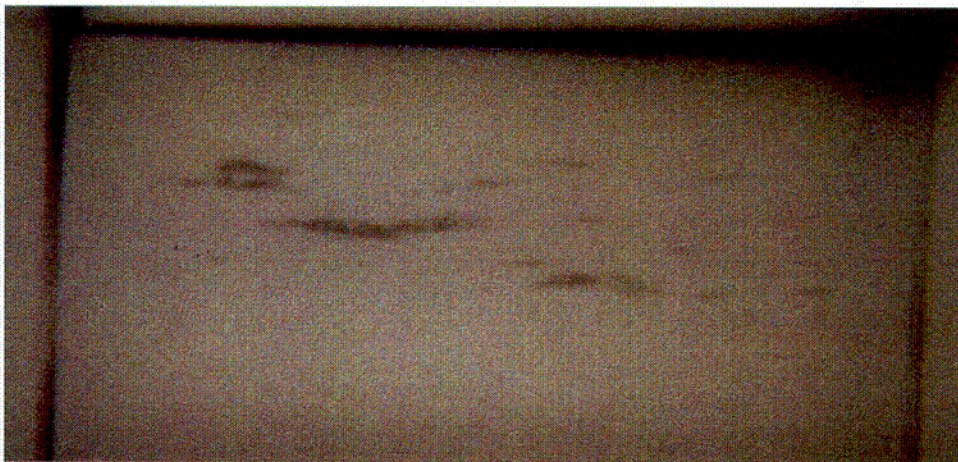
Figure 3.81 shows the results of a radiographic test of a Volume 1 base-metal flaw indication. The RT flaw indication is characterized as a mid-wall lamination cluster. The through-wall extent of the cluster is 8 mm. This mid-wall lamination cluster is shown in the distribution table for the base metal in Chapter 4.

Figure 3.81 Digitized Image of Radiograph Showing of Base Metal Lamination Cluster. Vessel through-wall direction is oriented vertically in the image. Vessel elevation is oriented horizontally in the image.
