MONTICELLO NUCLEAR GENERATING PLANT
Docket No. 50-263 License No. DPR-22

Submittal of Cycle 2 Startup Report

MONTICELLO NUCLEAR GENERATING PLANT
CYCLE 2 STARTUP REPORT

JULY, 1973

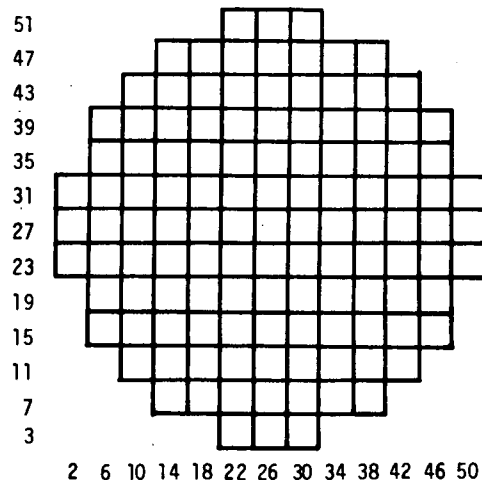
FIGURE 1
MONTICELLO CORE CONFIGURATION AT THE BEGINNING OF CYCLE 2

Core preparations for startup testing included certain calibration and verification steps. Following control rod drive maintenance and fuel movement, all control rods were stroked; scram timing was checked and adjusted as necessary in the cold condition. Six control rods were scrammed in the hot condition to verify the preestablished correlation between hot and cold scram times. After all in-core work was completed, the core was scanned by underwater television for proper fuel assembly orientation, curtain location, fuel assembly seating and general core condition. The individual fuel assembly serial numbers were checked to confirm fuel accountability records. The core was verified to be assembled as shown in Figure 1.
