**Subject: June 2011 Inspection Report & Compliance Concerns  
Cameco Resources, Permits 603 & 633**

**PERMITS 603 & 633 INSPECTION REPORT  
JUNE 2011  
DISTRICT 1/LAND QUALITY DIVISION**

**COMPANY:** Cameco Resources Incorporated

**LOCATION:** North of Glenrock, Converse County (Smith-Highland Ranch Uranium Project)

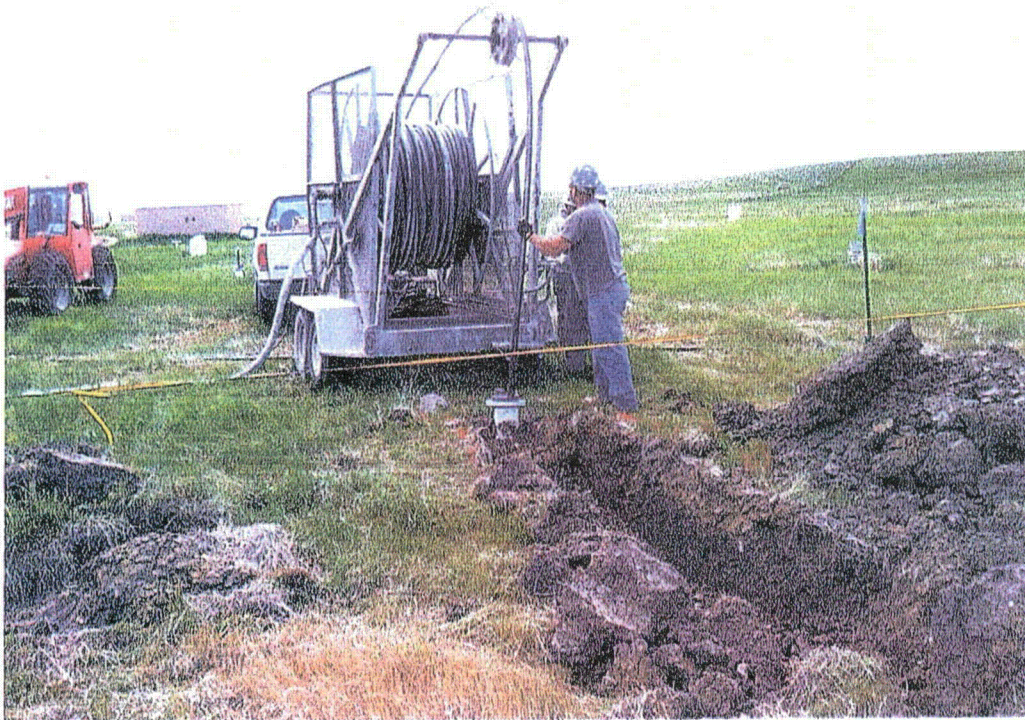
- 1 A mud pit is dug to contain the water displaced from the well and the clean-out water from the hose reel. (see *Fig. 6*)
- 2 A measured amount of water is added to the mixing tub (see *Fig. 7*).

Figure 6 Hose reel and mud pit.

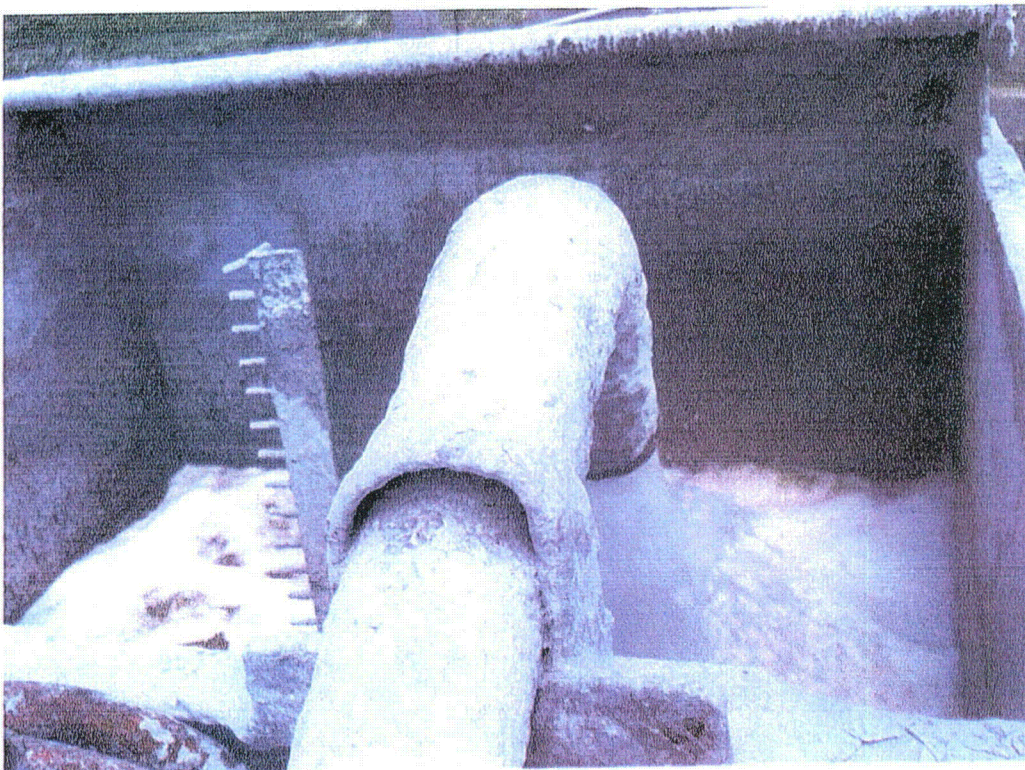
Figure 7 Adding water to the mixing tub

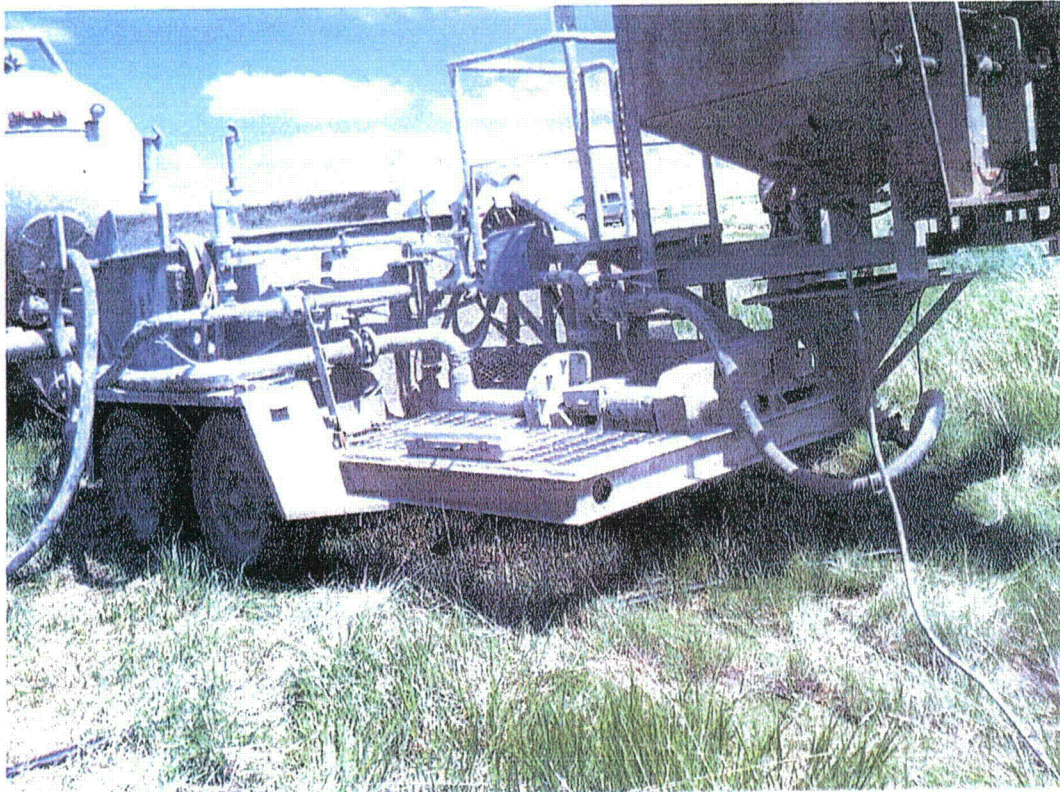
- 3 A hopper of dry cement is moved to the mixing unit and added with a cyclone mixer attached to the mixing unit (see *Fig. 8*).
- 4 The cement mixture is then added to the mixing tub (see *Fig. 9*).

Figure 8 Adding cement to the cyclone mixer

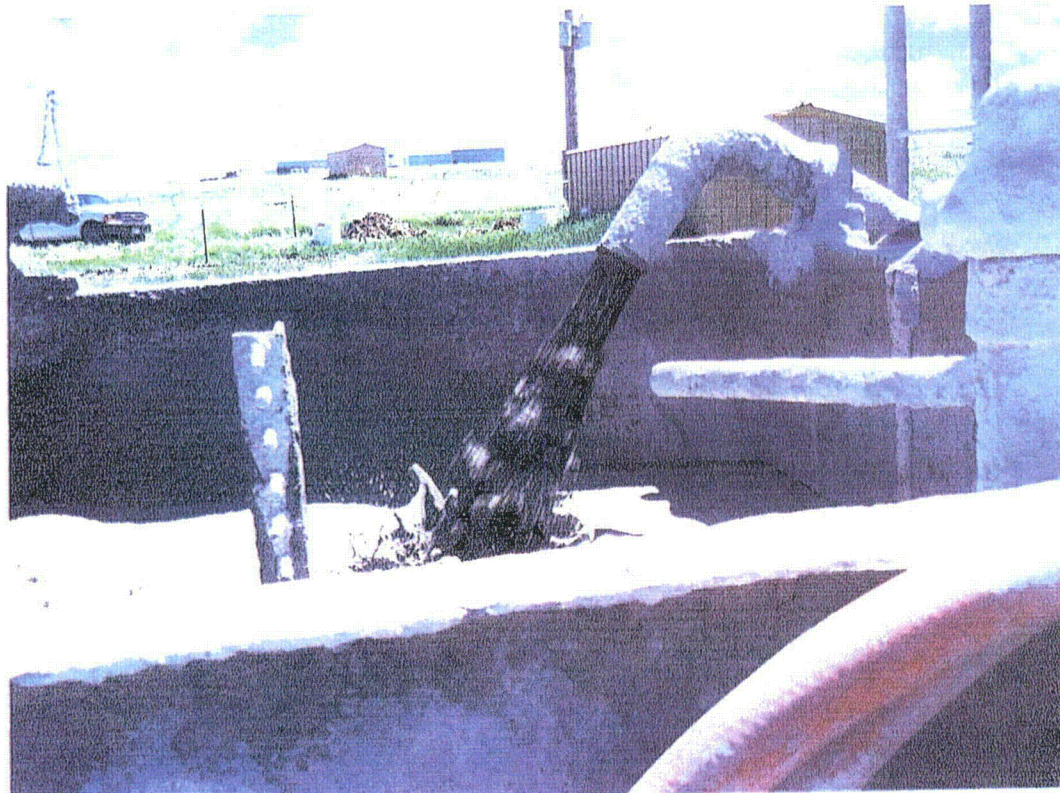
Figure 9 Adding cement to the mixing tub

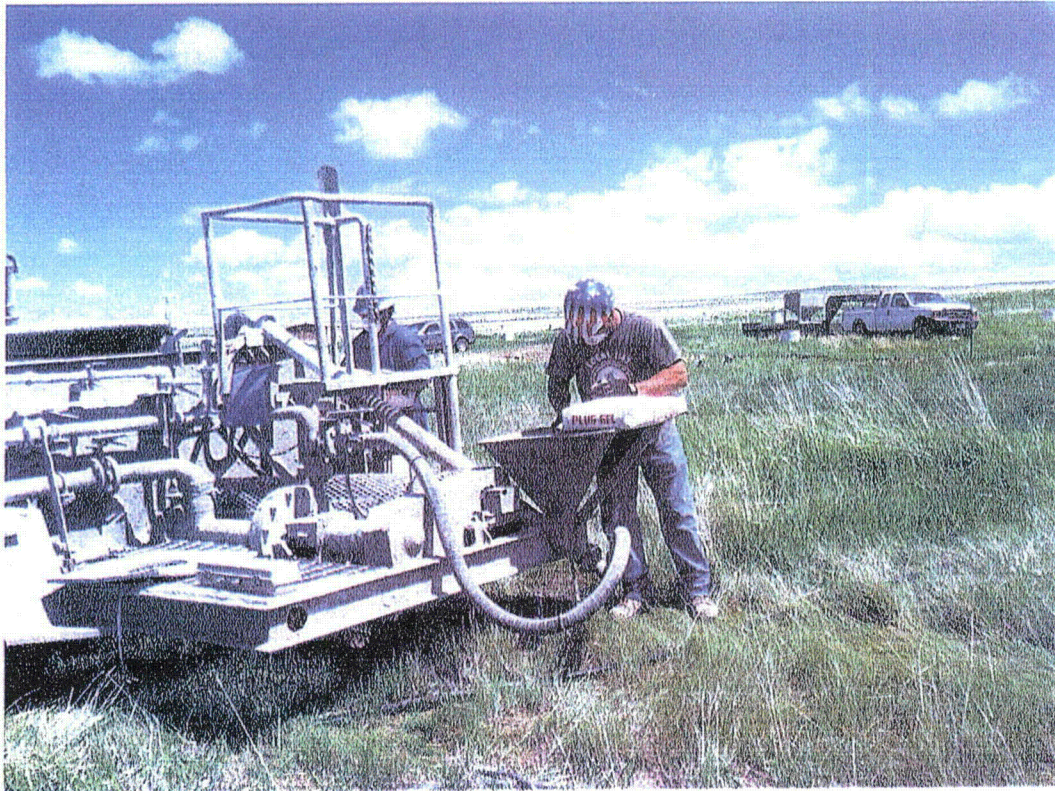
- 5 For this well to get the correct cement/bentonite mixture, six sacks of plug gel (bentonite) is added to the cyclone mixer and the mixing tub (see *Fig. 10*). The pickup truck with the flatbed and a hopper of cement is in the background of this picture.

Figure 10 Adding bentonite to the cyclone mixer.

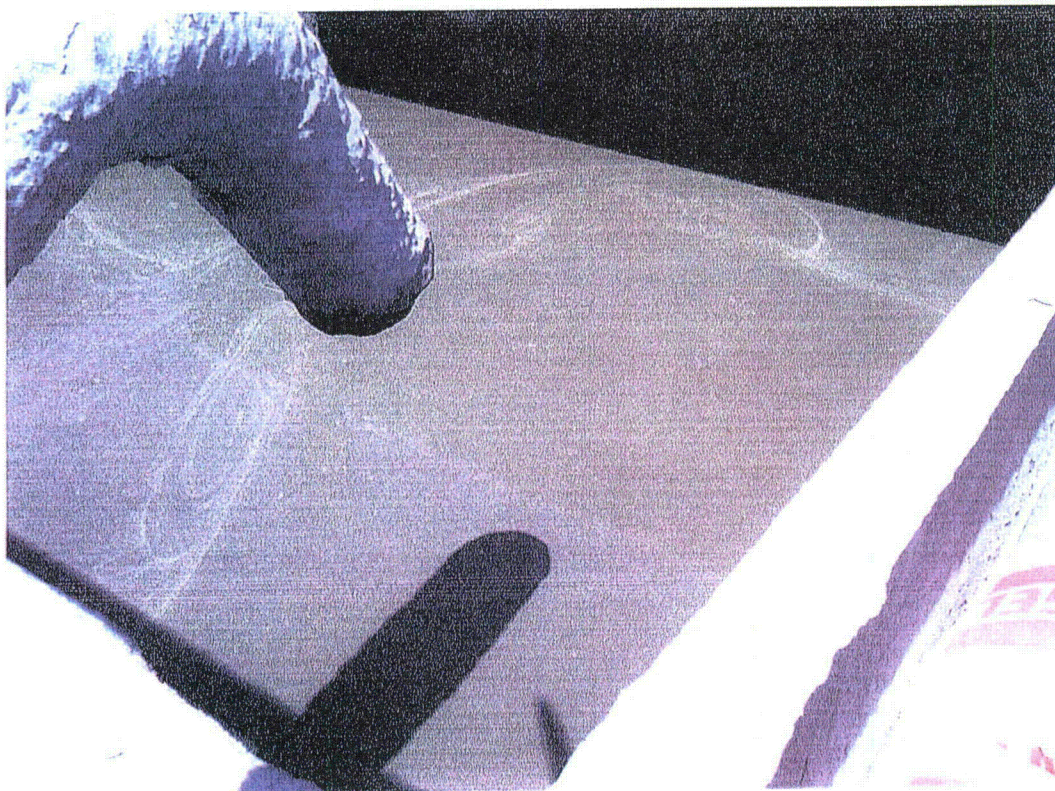
- 6 The cement and bentonite are mixed in the mixing tub until the desired consistency is achieved (see *Fig. 11*).
- 7 A mud weight is measured with a mud scale (see *Fig. 12*).

Figure 11 Cement/bentonite mixture

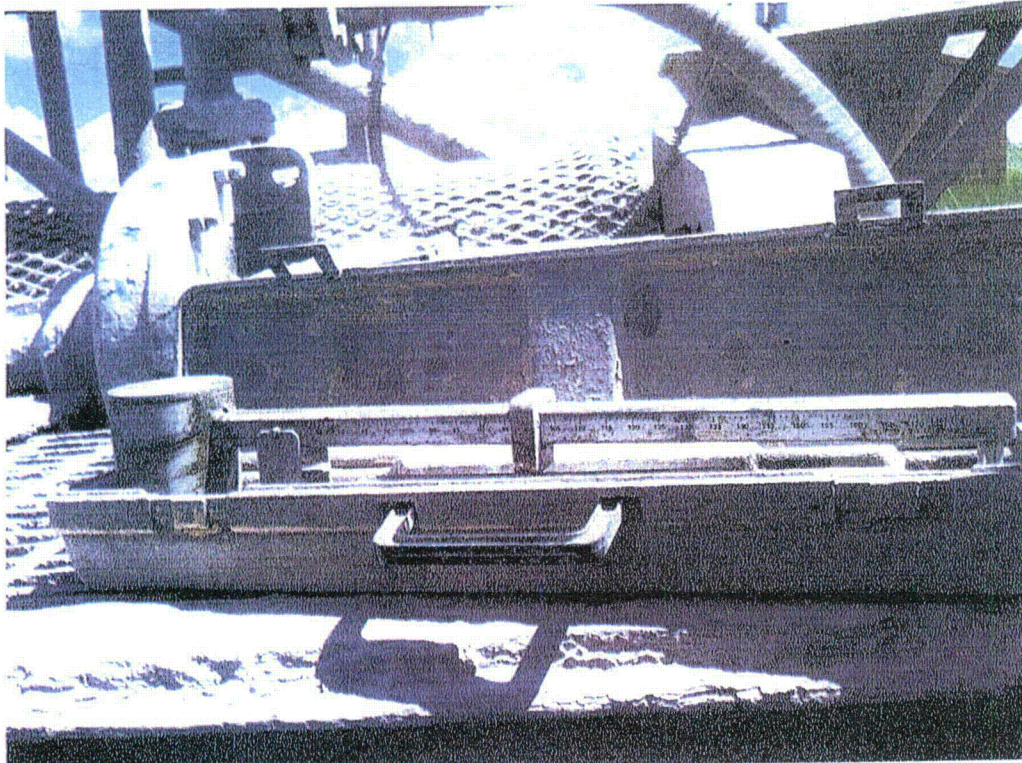
Figure 12 Mud weight scale

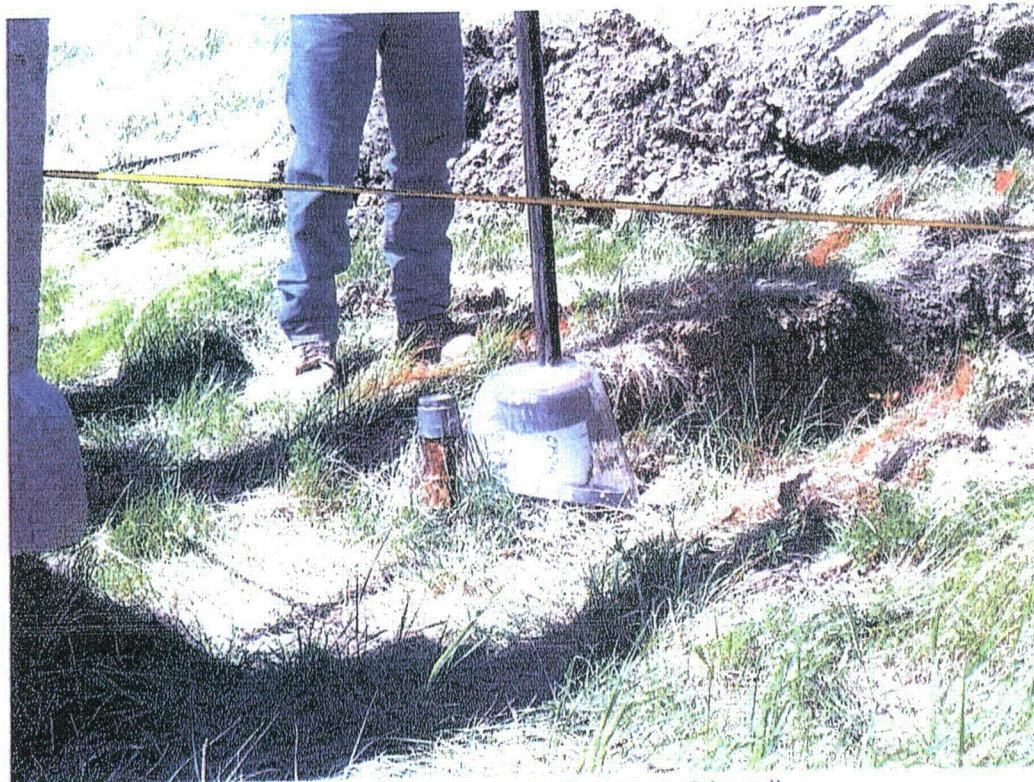
- 8 When the correct mud weight is determined, the mixture is pumped through the hose reel and displaces the water in the well from the bottom to the top (see *Fig. 13*).

Figure 13 Pumping the cement/bentonite mixture to the bottom of the well

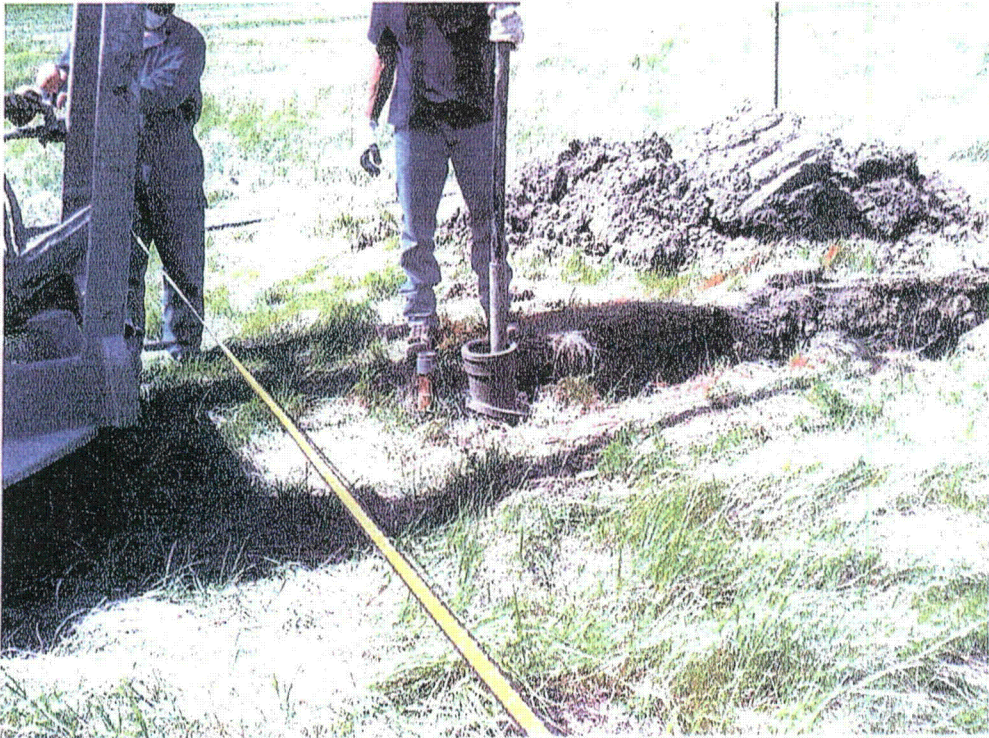
- 9 As the cement bentonite mixture is added to the well, the hose is gradually removed and the well is filled to the top of the casing with cement allowed to settle and refill (see *Fig. 14*).

Figure 14 Removing the hose as the well fills with cement
