**SUBJECT: BYRON UNIT 2 - NRC SPECIAL INSPECTION TEAM (SIT)
REPORT 05000455/2012008**

The special inspection reviewed the circumstances surrounding the January 30, 2012, electrical insulator failure in the Byron switchyard that resulted in a Unit 2 automatic reactor trip and Notice of Unusual Event emergency declaration.

Report No.: 05000455/2012008

Facility: Byron Station, Unit 2

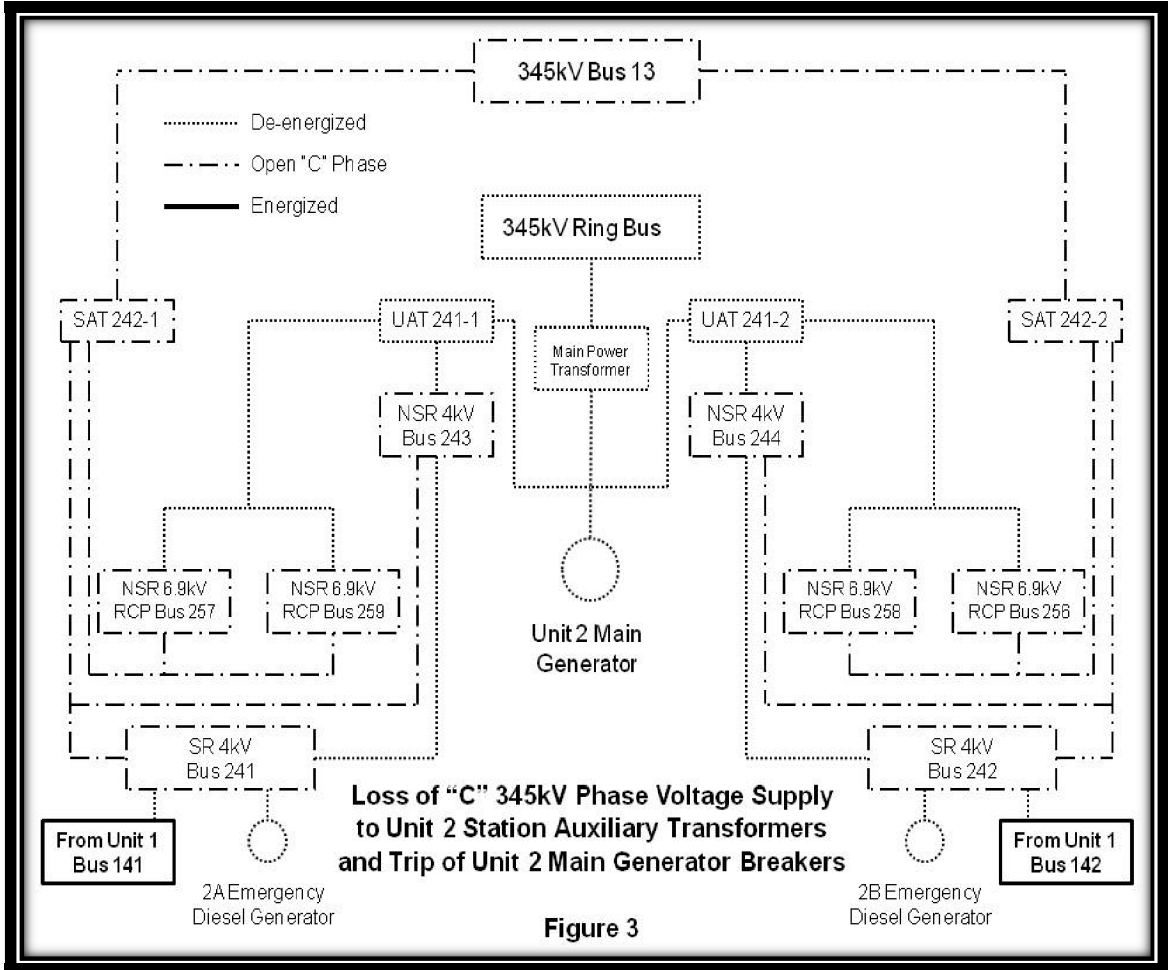
On January 30, 2012, at 10:01 a.m., Byron Unit 2 automatically tripped from full power due to an undervoltage condition on 6.9kV Bus 258 and Bus 259 that supply power to two of the four RCPs. The undervoltage condition was caused when the “C” phase insulator stack for the Unit 2 SAT revenue metering unit broke and part of the insulator fell to the ground (Picture 1).

The broken insulator that was providing vertical support for the “C” phase conductor resulted in the conductor breaking and isolating the “C” phase 345kV supply to the Unit 2 SATs. This type of “open” failure did not result in a desired protective logic actuation for the SATs or switchyard ring bus. The SAT protective relays were designed to trip during a fault or overcurrent condition, neither of which occurred. The differential relays were

designed to detect the differential current between the input and output current on a phase-to-phase basis. In this case, both input and output currents were zero, therefore the SAT feeder breakers did not trip open. With only the “A” and “B” phases energized, the Unit 2 SATs continued to supply degraded 6.9kV power to NSR Bus 258 and Bus 259, and degraded 4kV power to SR ESF Bus 241 and Bus 242.

The inspectors determined that the loss of the incoming 345kV "C" phase to the Unit 2 SATs was caused by an open "C" phase conductor. The conductor opened when an insulator stack that provided vertical support to the "C" phase conductor failed.

As part of the licensee's immediate corrective actions, the failed insulator was replaced and the SATs were assessed for damage. In addition, the licensee implemented a number of compensatory actions to raise awareness of the design vulnerability and to provide additional annunciator response instructions for the control room operators. These compensatory actions included the following:

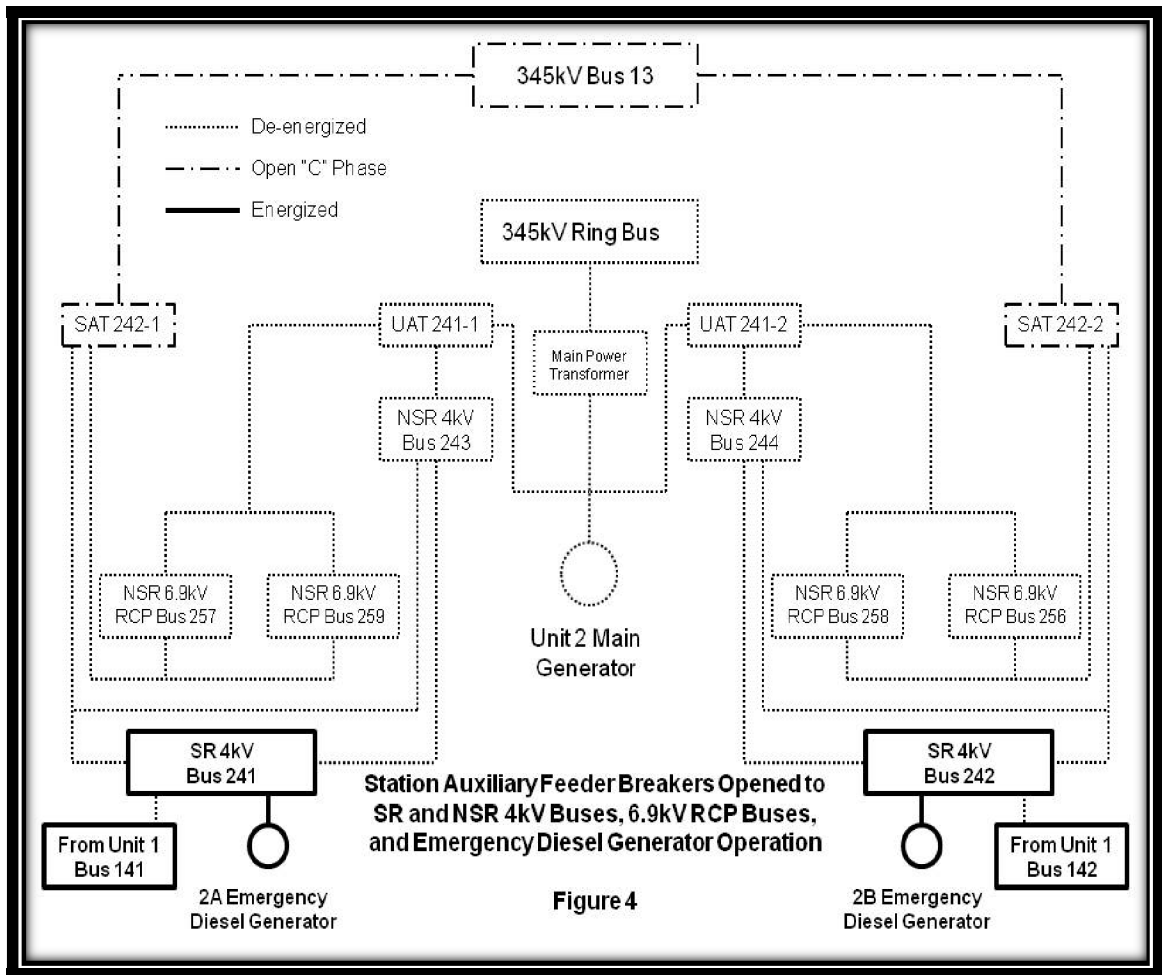
Operators noted that there were no abnormal alarms lit associated with safety-related ESF power and the associated Bus 241 and Bus 242 "bus alive lights" were lit. The 4kV ESF bus voltages indicated 4kV for the ESF buses. However, when the bus voltage selector switch was switched from monitoring the A-B phase voltage to the B-C and C-A phase voltages, a potential undervoltage condition was immediately identified as both the B-C and C-A phase voltages indicated about 2.5kV. An auxiliary operator was subsequently dispatched to the Unit 2 SATs and reported seeing smoke from both SATs.

Based upon the operators' general understanding of an electrical issue resulting in equipment failing to run, lower than expected B-C and C-A phase voltages on the SR 4kV buses, and the report of smoke from the Unit 2 SATs, operators concluded that the voltage on the safety-related buses and condition of the Unit 2 SATs was not acceptable and at about 10:09 a.m. (8 minutes into the event) opened the SAT feeder breakers supplying offsite power to the SATs. After opening these breakers, the undervoltage logic was satisfied, and an ESF undervoltage protection signal was processed for Bus 241 and Bus 242. Accordingly, both DGs started and sequenced safety-related equipment onto Bus 241 and Bus 242, restoring normal plant shutdown components and systems, including RCP seal injection and seal cooling.
