Response to NRC Bulletin No. 87-01  
"Thinning of Pipe Walls in Nuclear Power Plants"

Consolidated Edison Company of New York, Inc.  
Indian Point Unit No. 2  
Docket No. 50-247  
September 11, 1987

Metallurgical Analysis Summary Report

Sample Description: 6 inch spool piece between the level control valve (LCV-1103) and the isolation valve from Feedwater Heater No. 26C to the Heater Drain Tank.

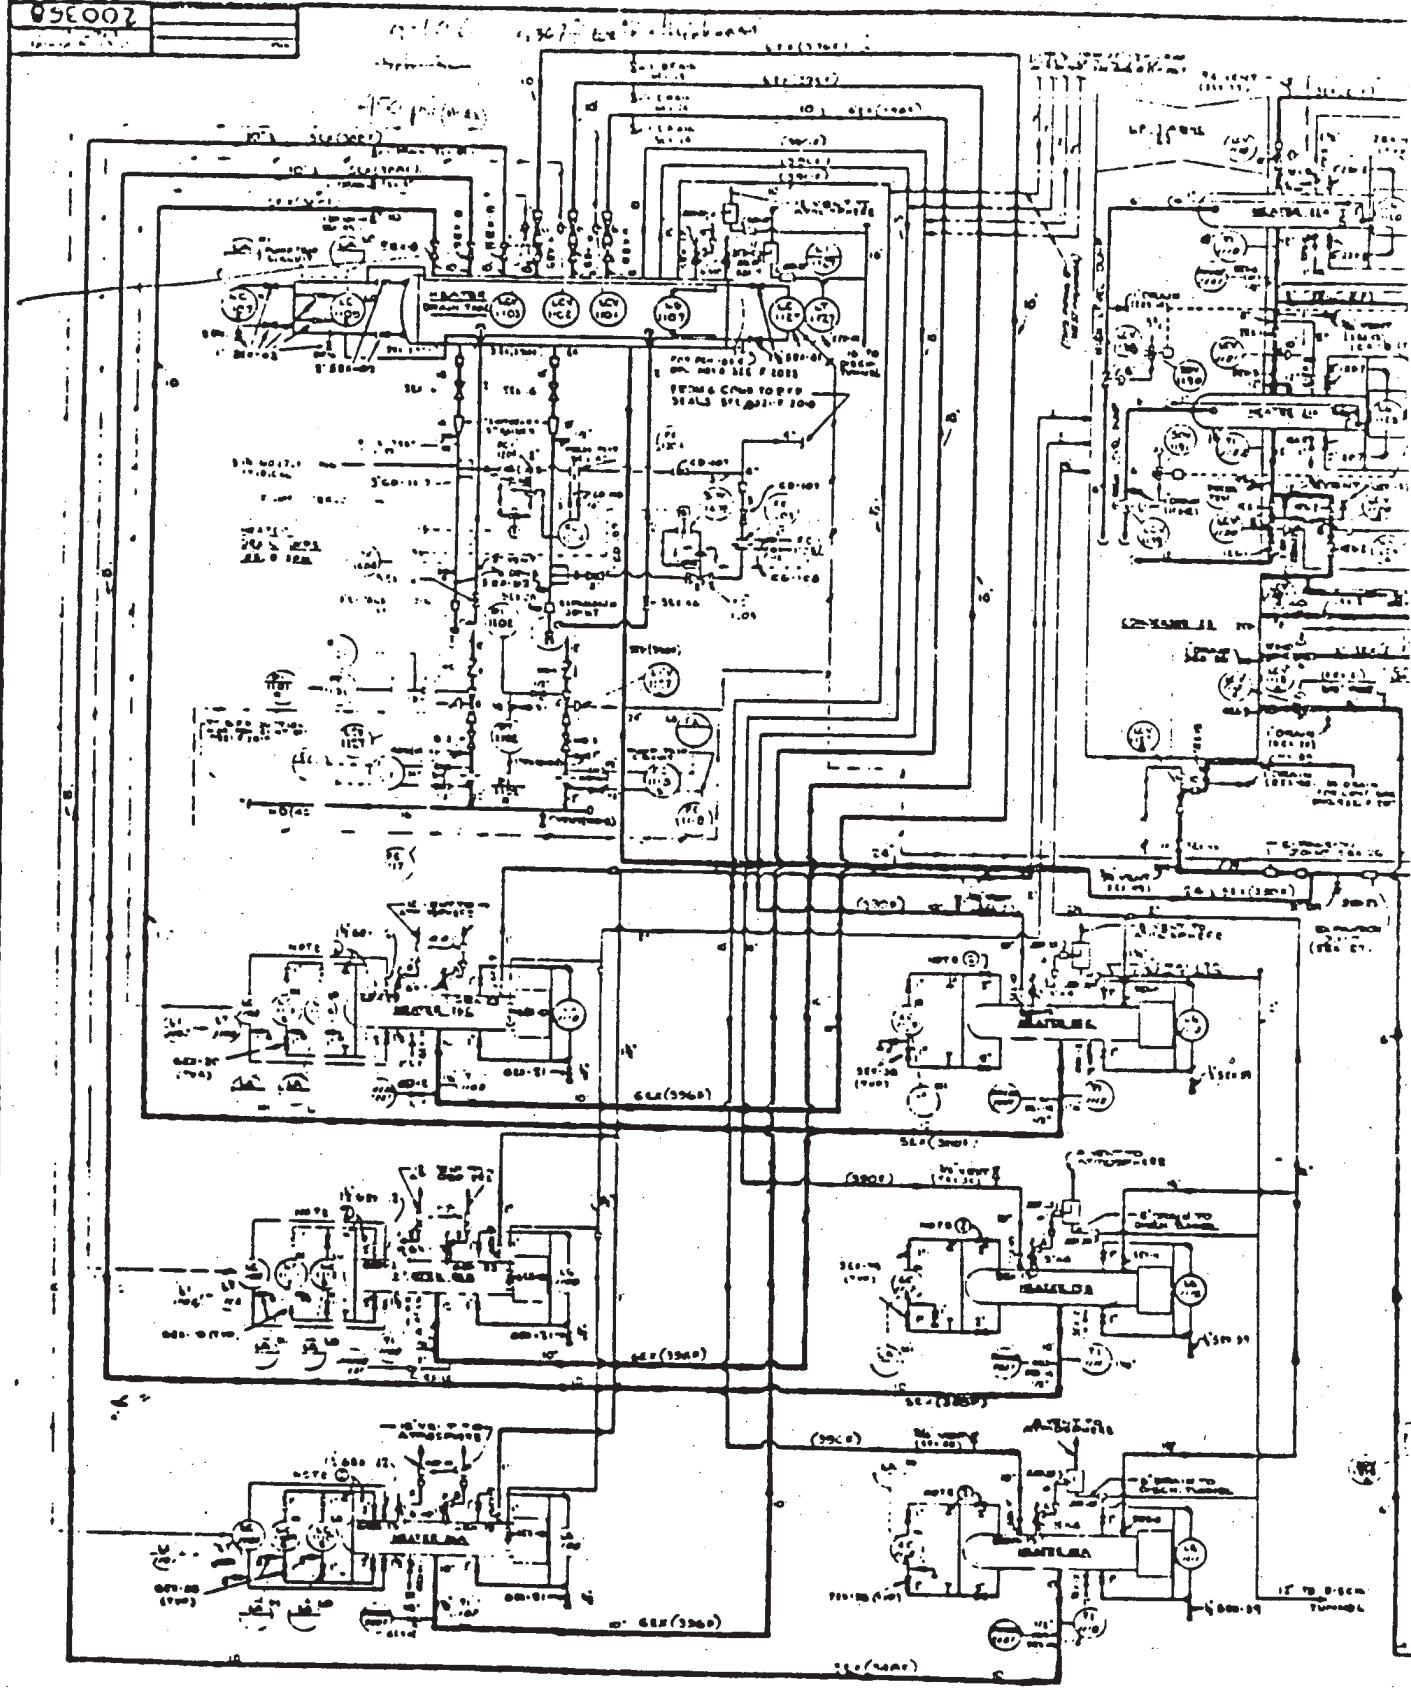
05E002

CLASS D-2  
PREFIX 6EX  
PRESSURE 450 psig  
TEMP. OF 450

UNITED ENGINEERS & CONSTRUCTORS INC. PAGE 18A  
 Westinghouse Electric Corporation  
 Indian Point Generating Station-Unit No. 2  
 Consolidated Edison Company of New York
