Calc No.: F10503-R-001
Title: Transformer Internal Pressure
Evaluation

The photographic report ST02/11 summarizes Trench's and Siemens' investigation on the failed bushing serial number 05F9080-04 originally installed in phase B of TR#21 at Indian Point Nuclear station.

Problem Statement (object/deviation format): 21 Main Transformer Failed

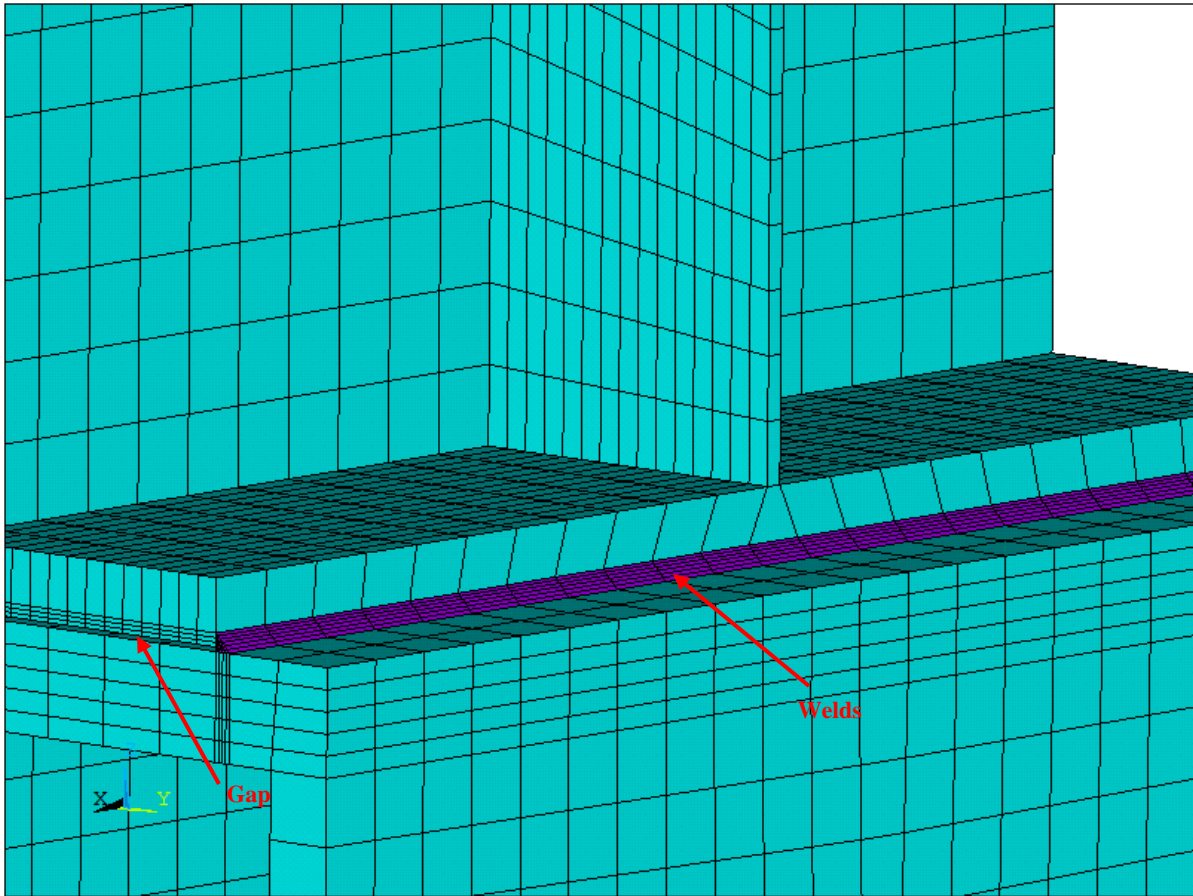
Fig. B.2: Close-up sketch of gap and weld region along transformer wall.

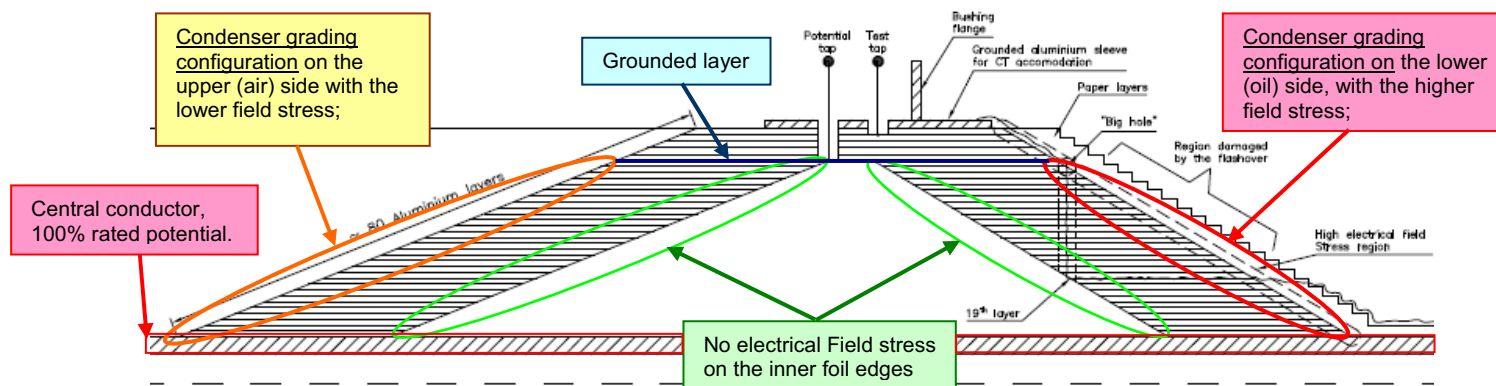
Sketch 1. View of the longitudinal half section of the condenser core, showing the main elements and detail of the regions with capacitive grading.

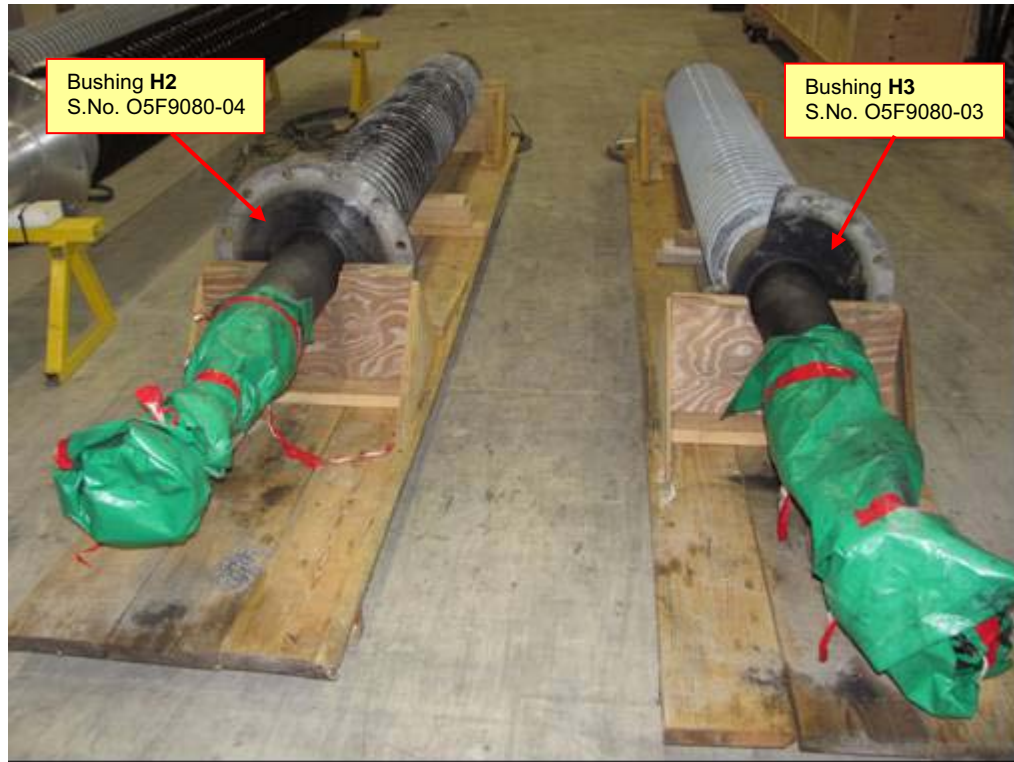
Picture 1: General view of the bushings as received from the Indian Point site;

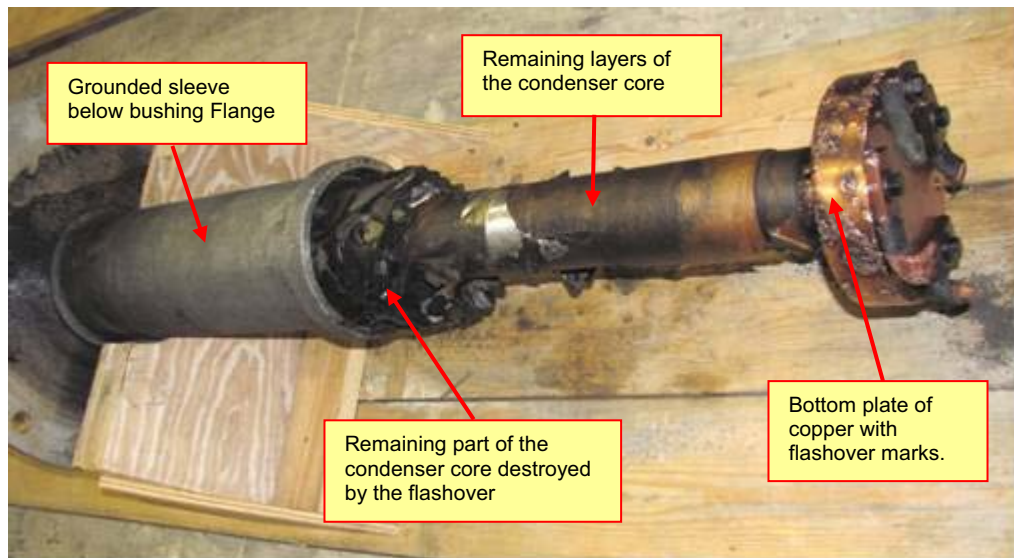
The first bushing inspected was the one installed on the terminal H2 of the transformer Unit #21. The location of the failure was determined to have occurred on the oil immersed (lower-end) side of the bushing, causing an explosion and subsequent transformer tank rupture and fire (see **Technical Report ST 19/10**).

Picture 2: General view of the **H2** bushing showing the bottom part destroyed by the flashover;

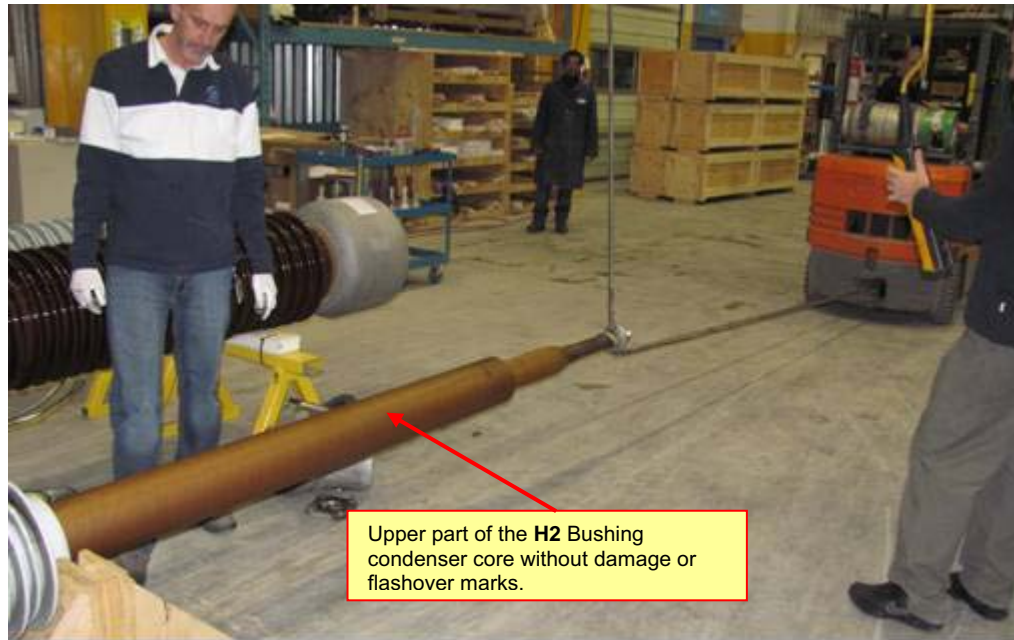
Picture 3: H2 bushing core being extracted from the porcelain body & flange.

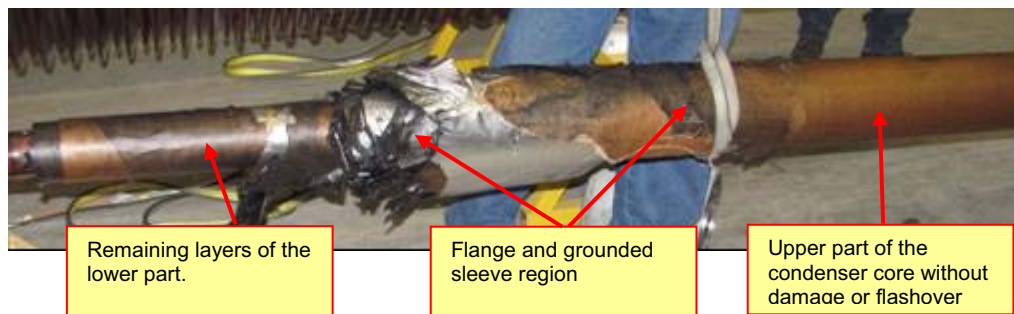
Picture 4: Bushing H2: Major parts of the condenser core after extraction.

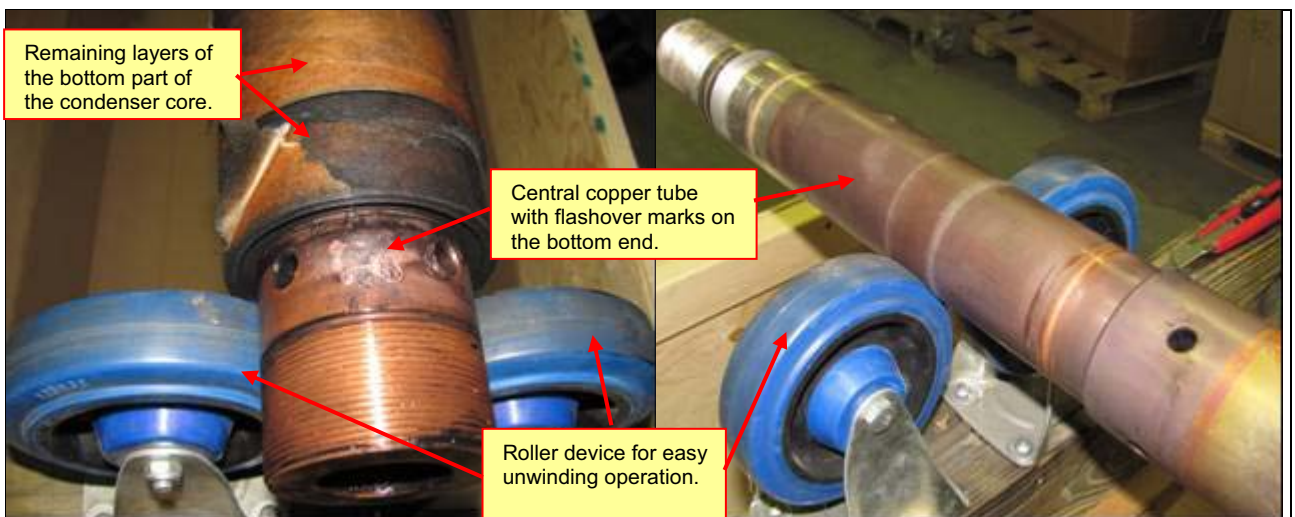
Picture 5: Bushing H2 installed on the device for unwinding the condenser core.

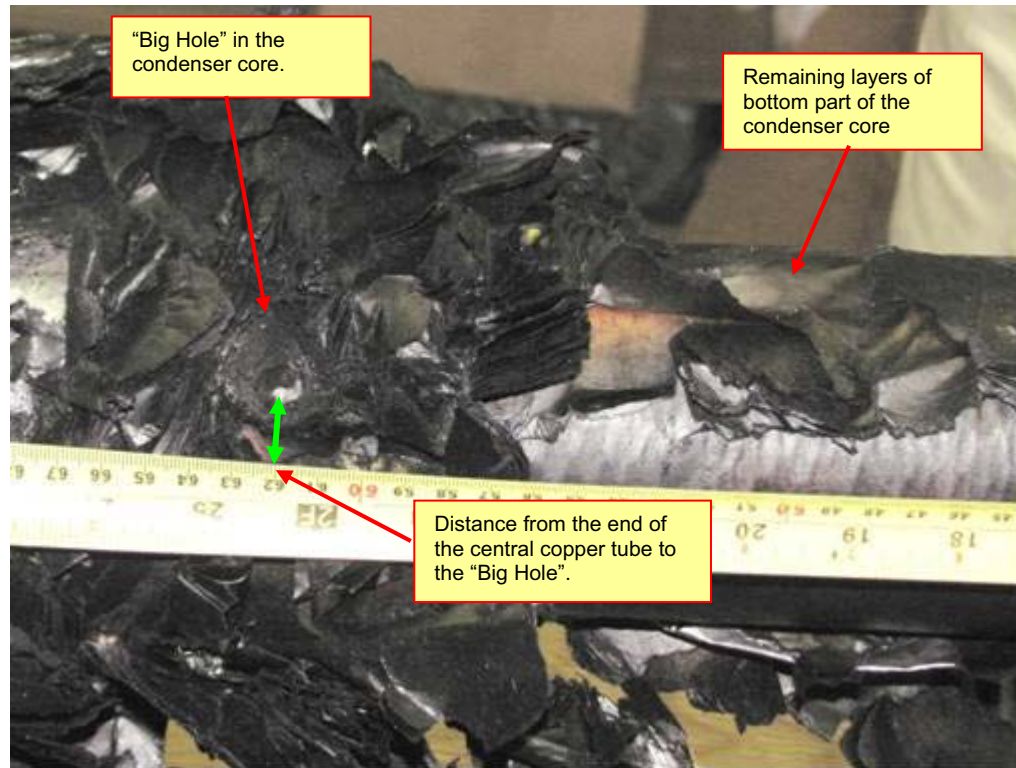
Picture 7: H2 bushing: identification of the major flashover path at the destroyed layers;

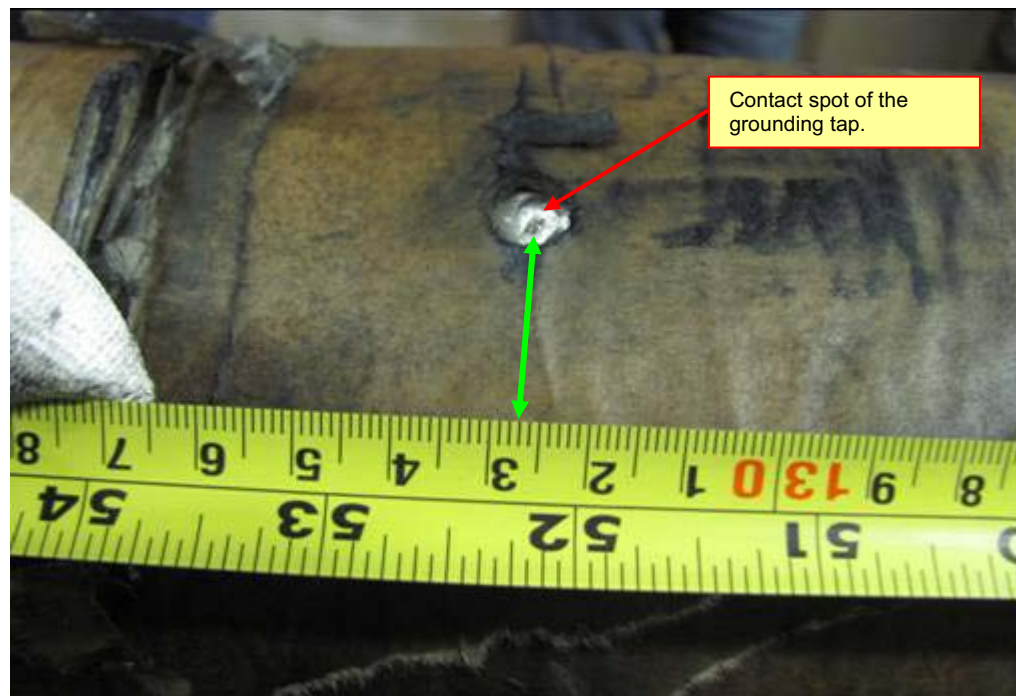
Picture 8: H2 bushing: distance from the end of the central conductor to the voltage tap.

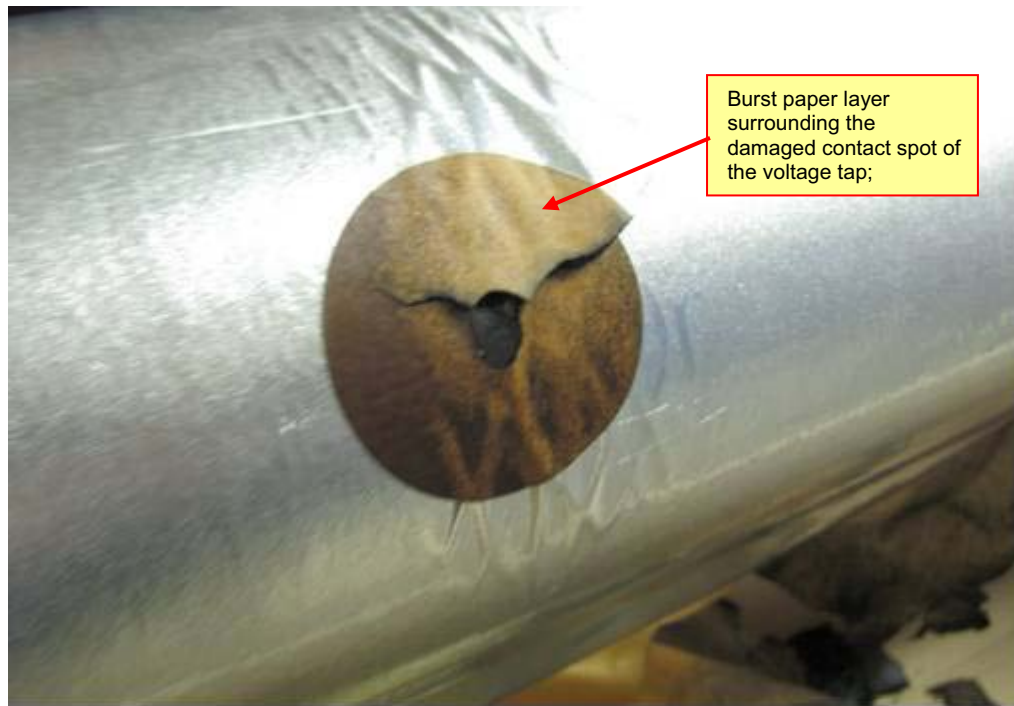
Picture 9: H2 bushing: Aluminum layer between the ground tap and the voltage tap.

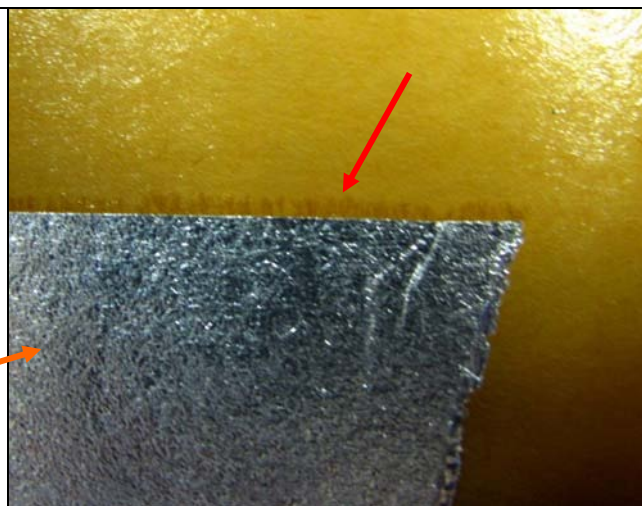
Picture 13: **Red arrow:** "Treeing" traces on the upper edge of the aluminum foil;

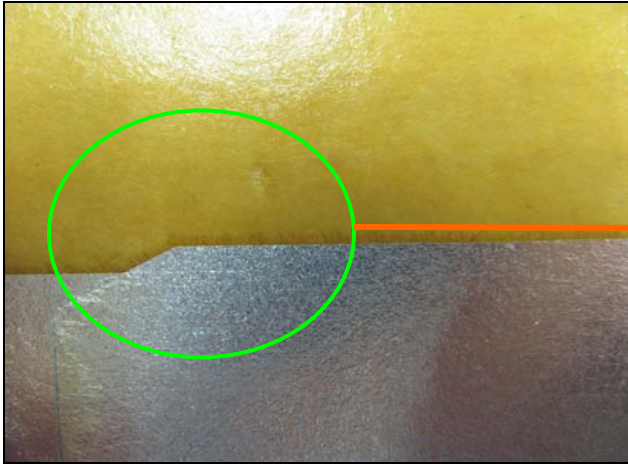
Picture 14: H2 bushing: Further detail of the 2nd layer beneath (inwards) the voltage tap layer with "treeing" traces on the edge.

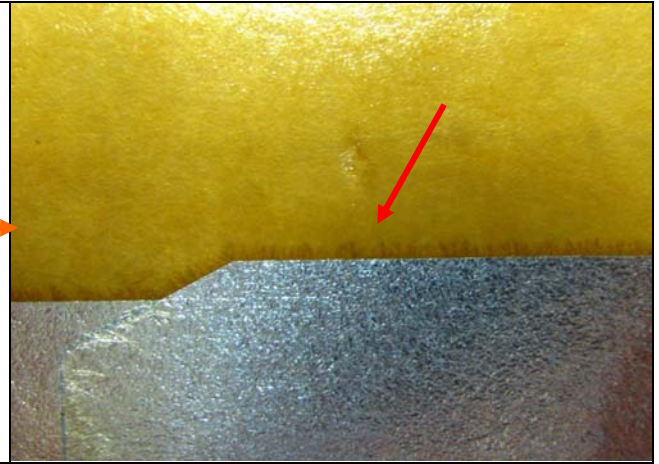
Picture 15: Red arrow: "Treeing" traces on the upper edge of the aluminum foil;

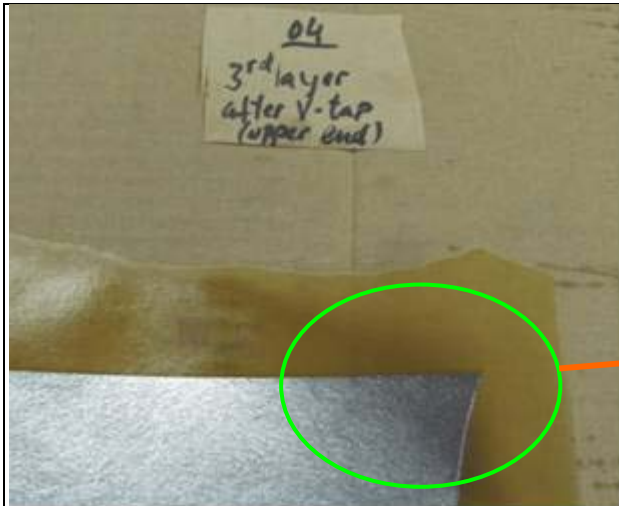
Picture 16: H2 bushing: Further detail of the 3rd layer after (inwards) the voltage tap layer with "treeing" traces on the edge.

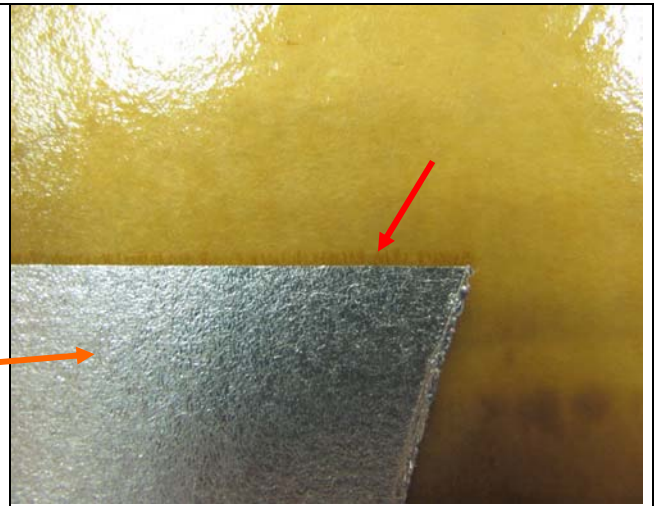
Picture 17: Red arrow: "Treeing" traces on the upper edge of the aluminum foil;

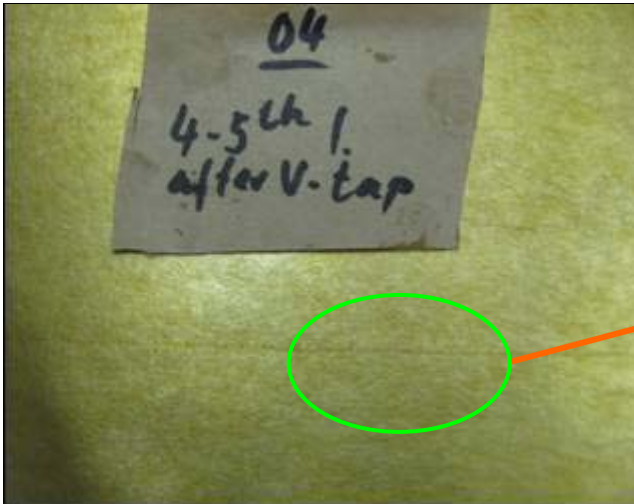
Picture 18: H2 bushing: "Treeing" traces on the paper layer underneath the aluminum foil. This is the 4th layer beneath (inwards) the voltage tap layer.
Green circle: enlarged area on the picture aside.

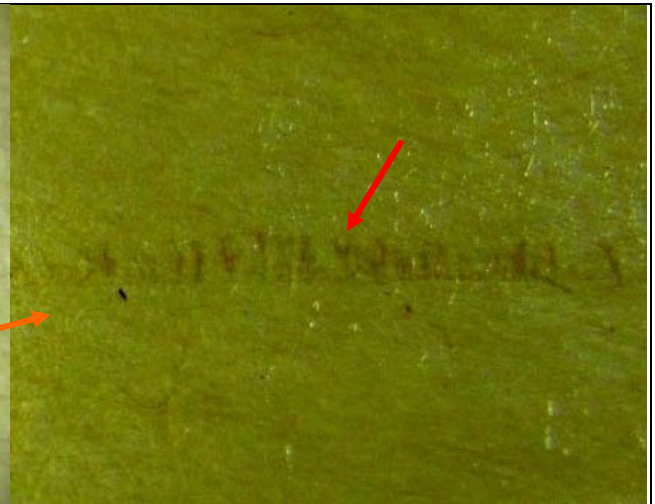
Picture 19: **Red arrow:** "Treeing" traces on the paper underneath the upper edge of the aluminum foil;

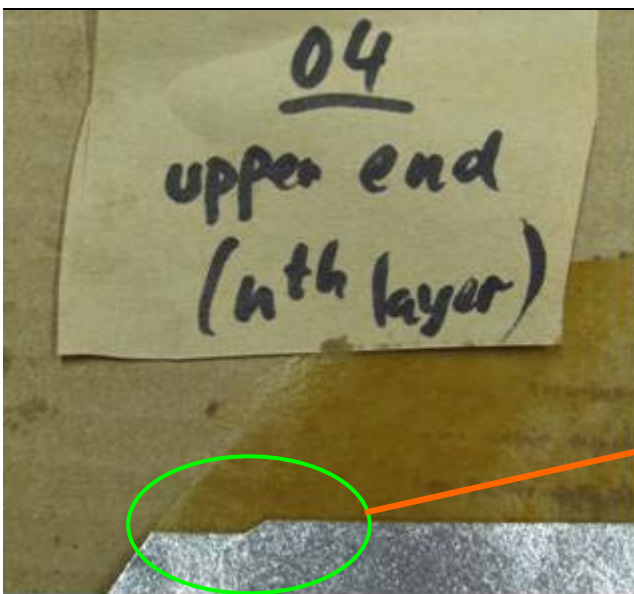
Picture 20: H2 bushing: "Treeing" traces on the edge of one further aluminum foil layer of the middle portion of the condenser core;
Green circle: enlarged area on the picture aside.

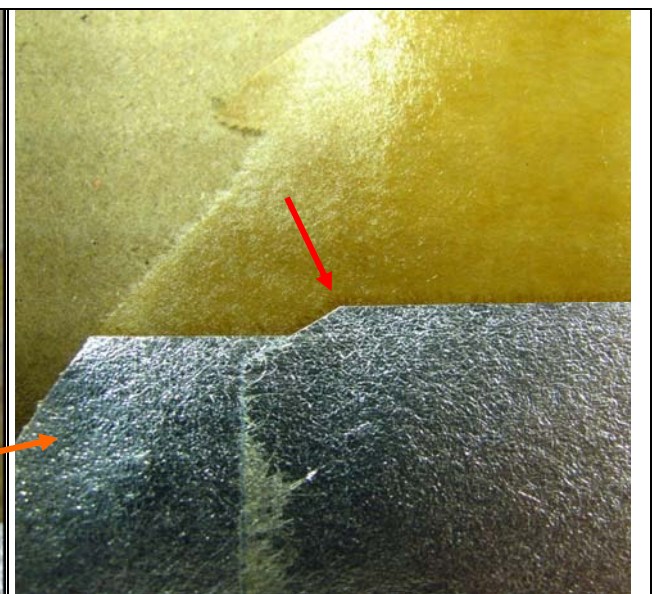
Picture 21: **Red arrow:** "Treeing" traces on the upper edge of the aluminum foil; the intensity of the traces became lighter on the layers closer to the central conductor.

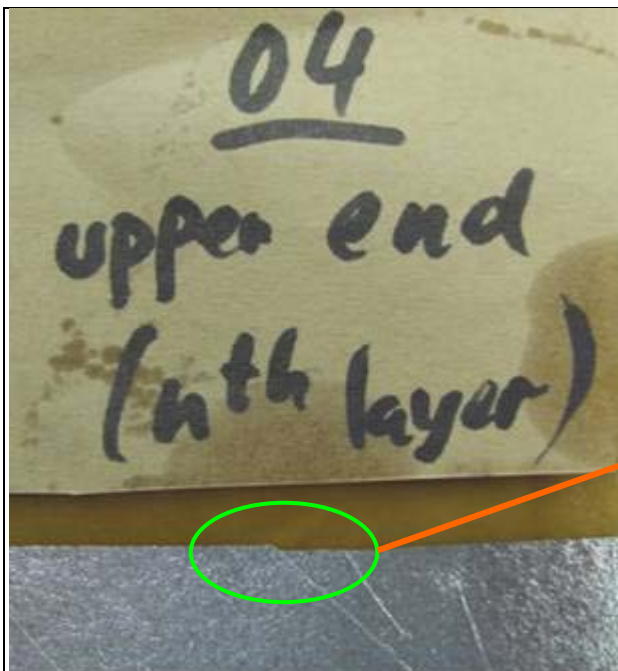
Picture 22: H2 bushing: "Treeing" traces on the edge of one further aluminum foil, one layer beneath the middle portion of the condenser core;

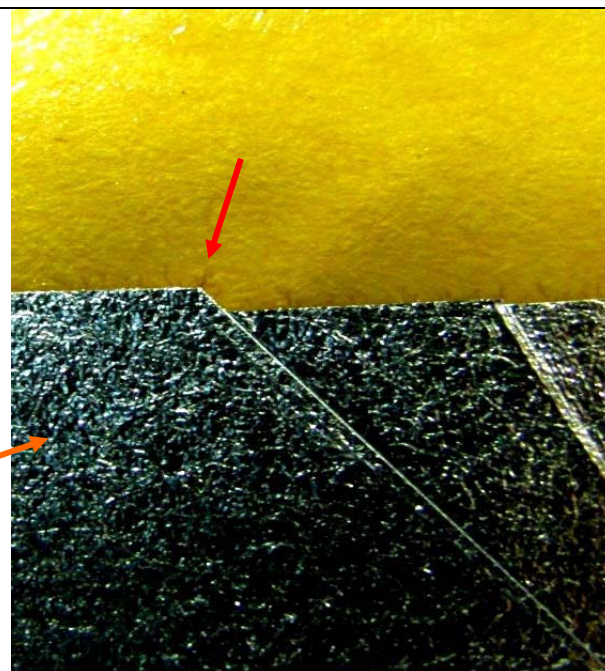
Picture 23: Red arrow: "Treeing" traces on the upper edge of the aluminum foil; the intensity of the traces became gradually lighter on the layers closer to the central conductor.

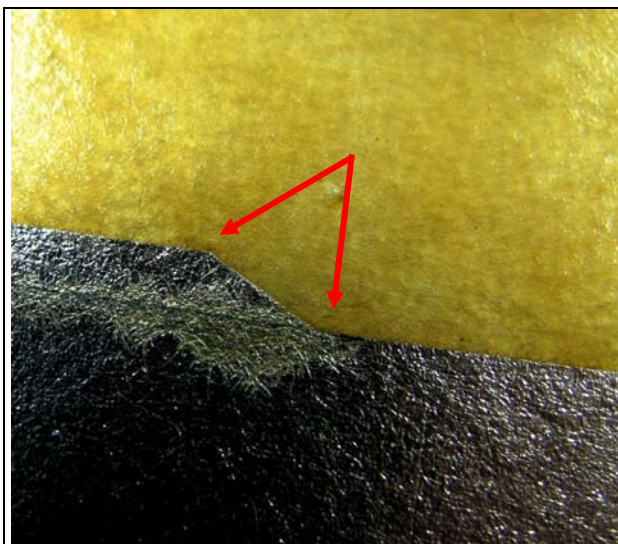
Picture 24: H2 bushing: Very light "treeing" traces (**red arrows**) on the edge of one aluminum foil layer situated near to the central conductor of the condenser core;

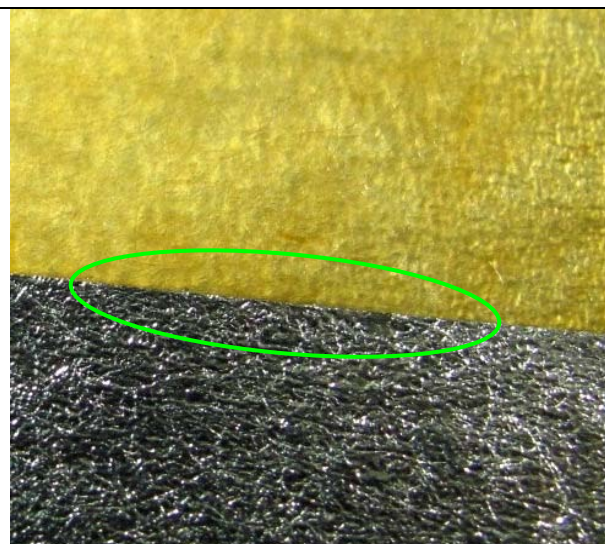
Picture 25: Green circle: Upper (internal) edge of a bottom aluminum layer; the region of edge of the aluminum foil is completely free from "treeing" traces. Similar situation was confirmed on the lower (internal) edge of the upper foil. All internal edges showed similar characteristic, being free of "treeing" traces.

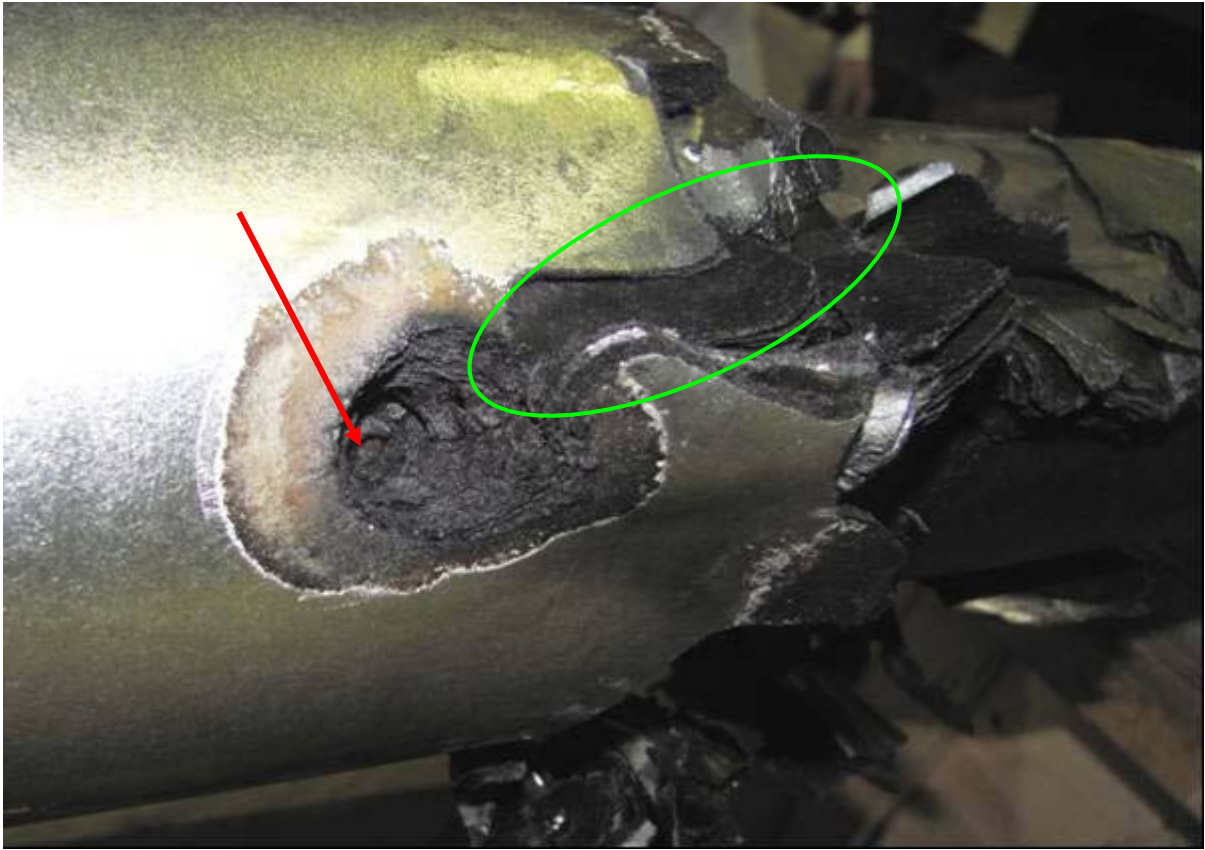
Picture 26: Detail view of the “big hole” extending down until the 19th layer (**red arrow**) (reckoning from the inner conductor outwards); **Green circle:** Discharge path, beginning on the hole.

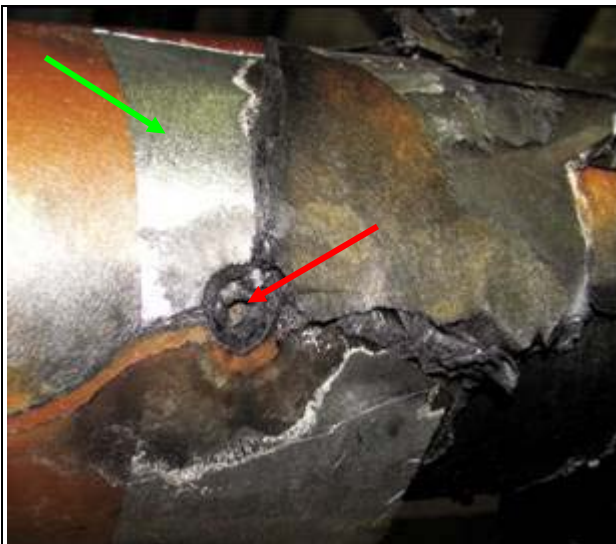
Picture 27: H2 bushing:
Red arrow: Bottom of the “big hole”
Green arrow: 21th layer (2 layers above the 19th)

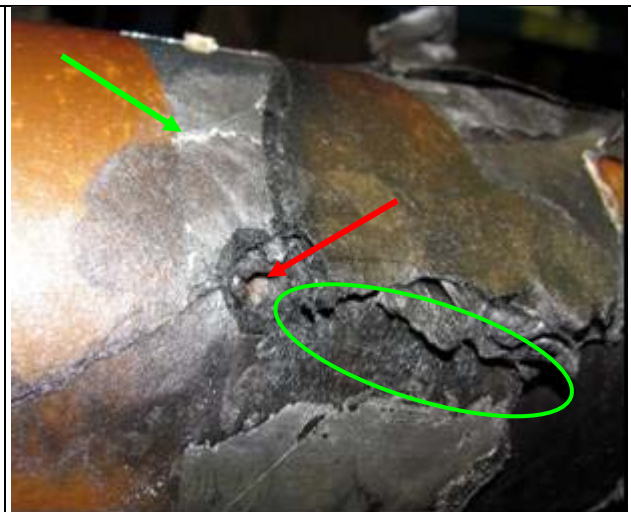
Picture 28: H2 bushing:
Green circle: discharge path;
Red arrow: Bottom of the “big hole”
Green arrow: 20th layer (1 layer above the 19th)

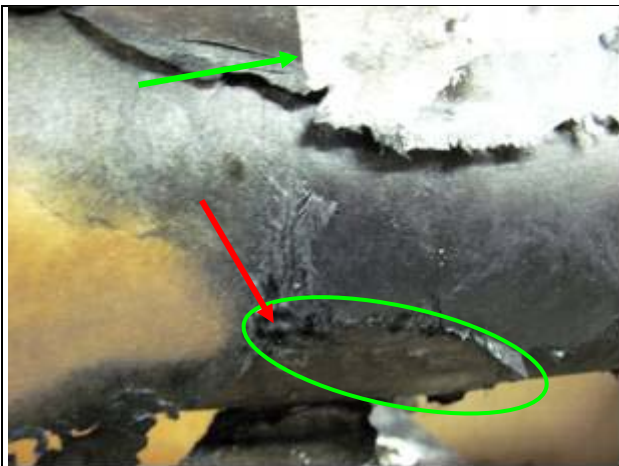
Picture 29: H2 bushing:

Green circle: discharge path;

Red arrow: Bottom of the "big hole"

Green arrow: remaining part of the 19th layer touched by the discharge.

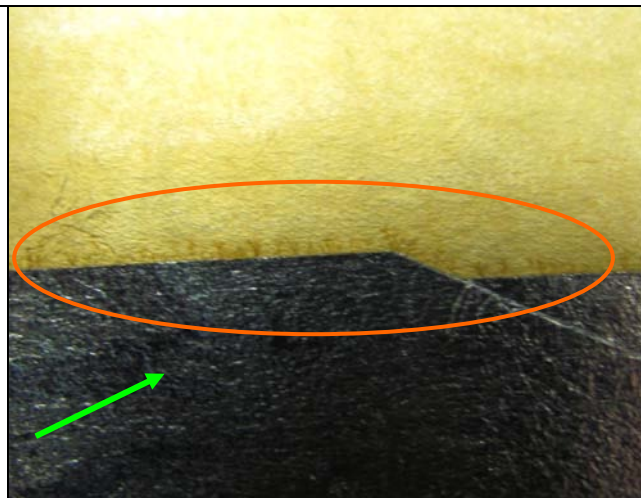
Picture 30: H2 bushing:

Orange circle: traces on the bottom edge of the 18th layer;

Green arrow: 18th layer (1 layer beneath the 19th)

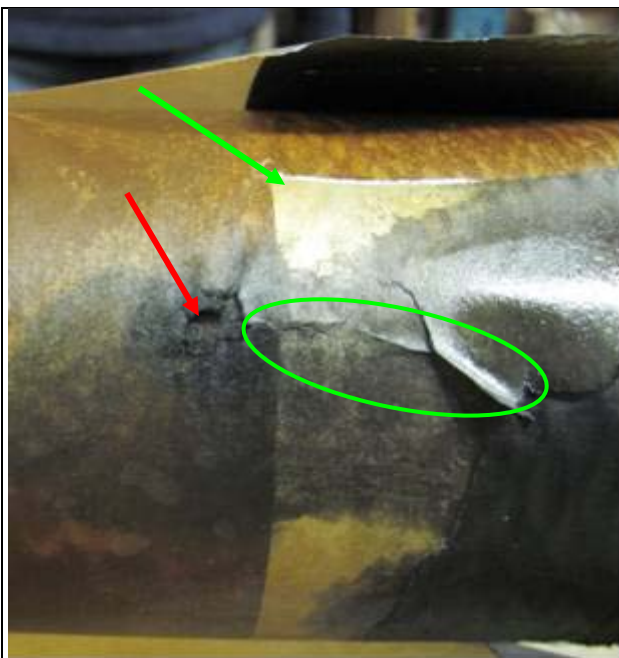
Picture 31: H2 bushing:

Green arrow: 18th layer;

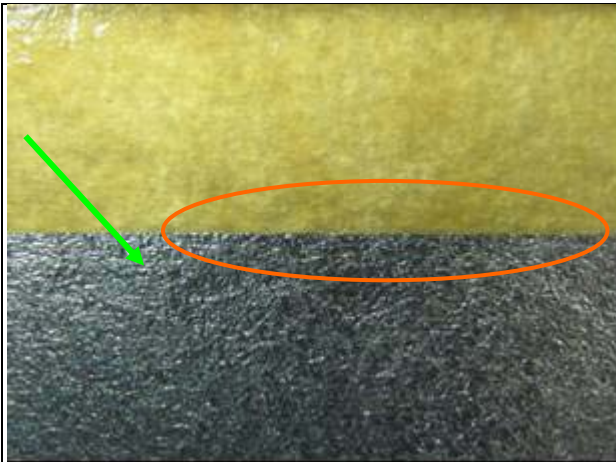
Picture 33: H2 bushing:
Green arrow: 18th layer;
Orange circle: upper edge of the 18th layer's bottom part completely free from "treeing" traces.

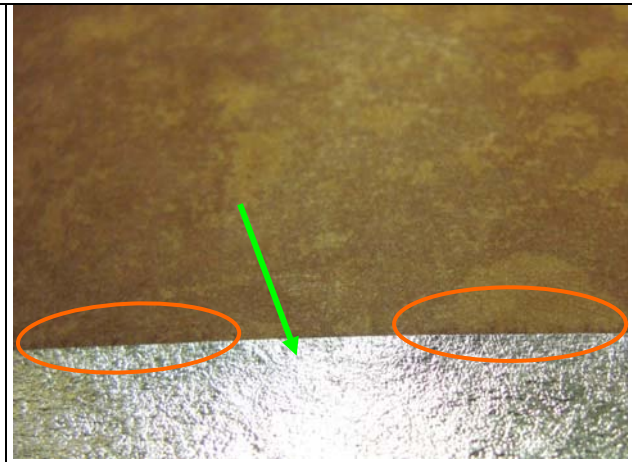
Picture 34: H2 bushing:
Orange circle: lower part of the 17th layer with slight "treeing" traces on the bottom edge
Green arrow: 17th layer;

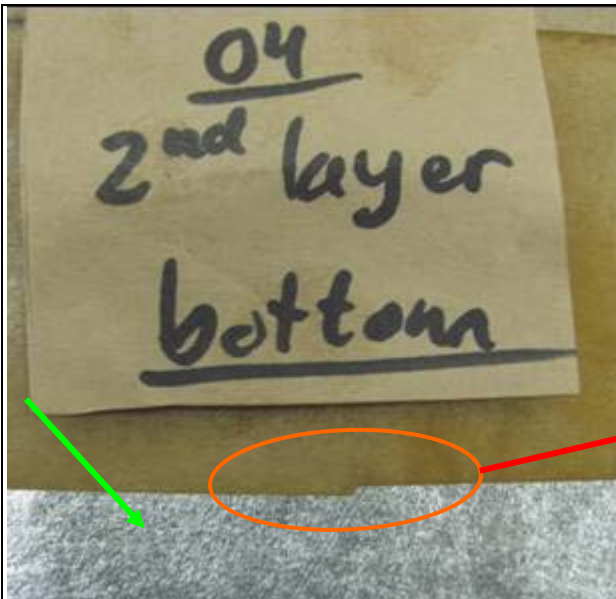
Picture 35: H2 bushing:
Green arrow: 2nd layer above the inner conductor;
Orange circle: enlarged region shown on picture 36, with slight "treeing" traces made visible.

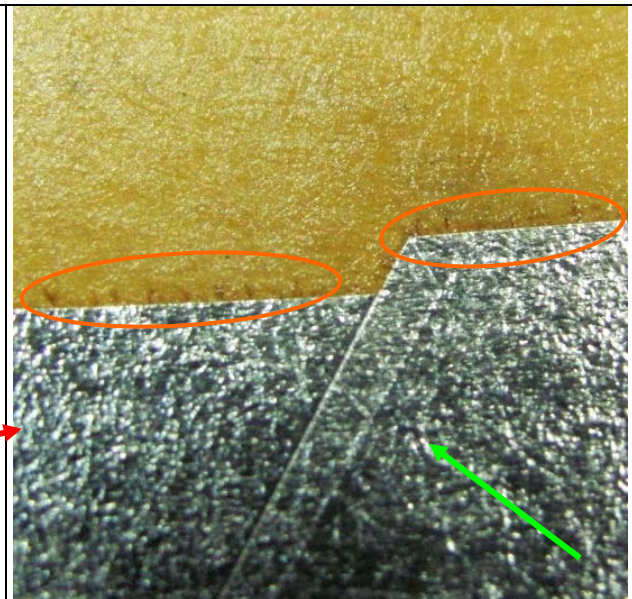
Picture 36: H2 bushing:
Green arrow: 2nd layer;
Orange circle: lower part of the 2nd layer with slight "treeing" traces on the bottom edge.

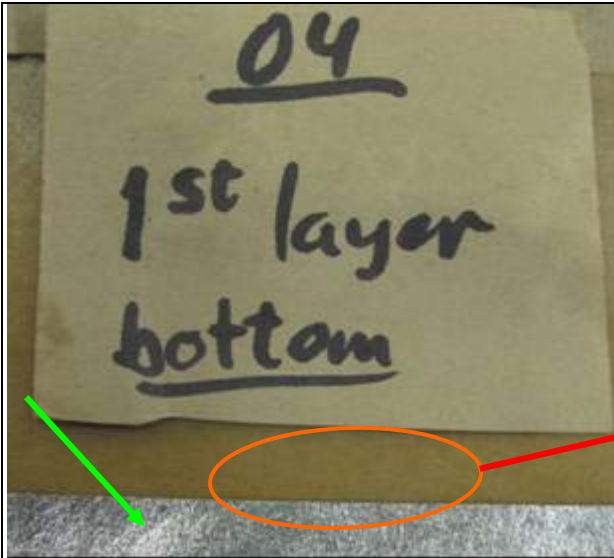
Picture 37: H2 bushing:
Green arrow: 1st layer wound on the central copper conductor after the required paper thickness is applied;
Orange circle: enlarged region shown on picture 38, with slight "treeing" traces made visible.

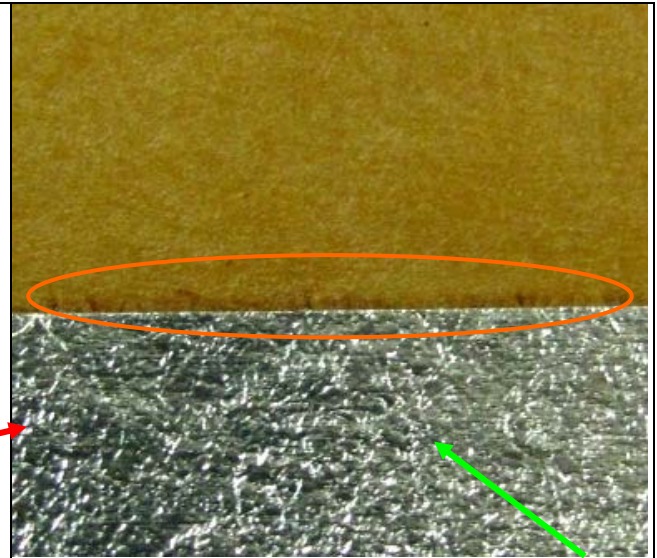
Picture 38: H2 bushing:
Green arrow: 1st layer;
Orange circle: lower part of the 1st layer with slight "treeing" traces on the bottom edge.

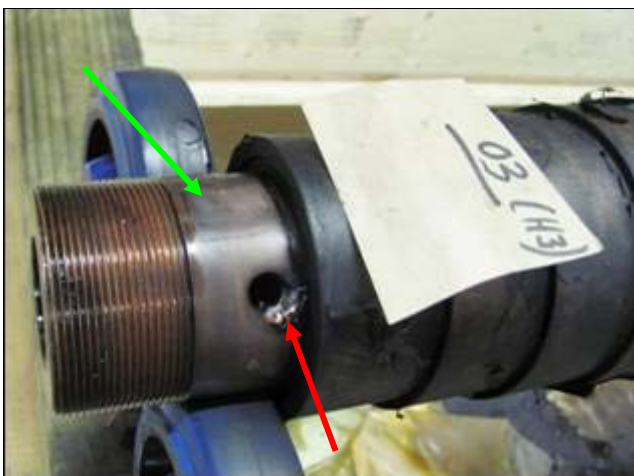
Picture 40: H3 bushing:

Green arrow: Central copper conductor;
Red arrow: Discharge mark on the central conductor, occurred after explosion of H2 bushing;

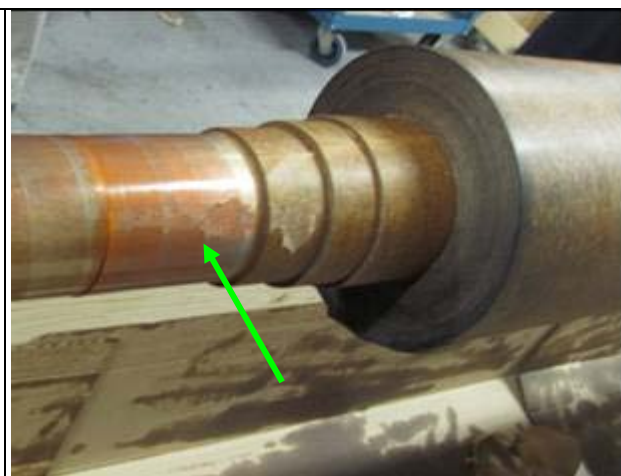
Picture 41: H3 bushing:

Green arrow: Central copper conductor of bushing H3, upper part.

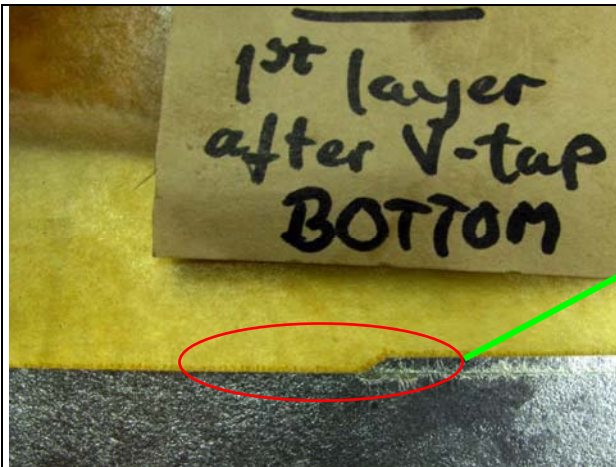
Picture 45: *H3 bushing*: further detail of the 1st layer beneath the voltage tap layer;;
Red circle: region enlarged on the photo #46 (**Green arrow**) with clear "treeing" traces at the bottom edge of the 1st layer beneath the voltage tap.

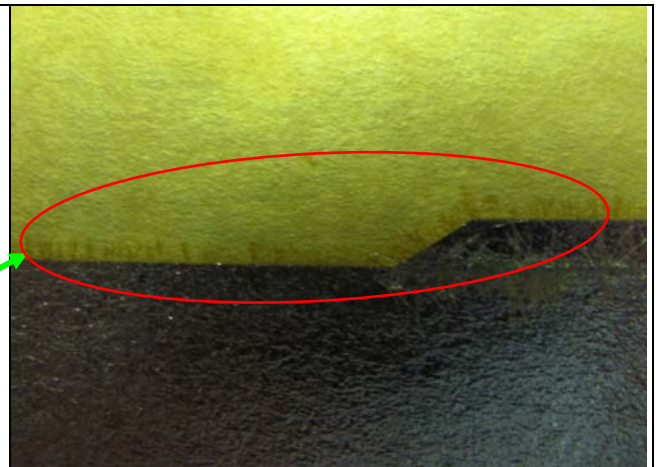
Picture 46: *H3 bushing*: detail view of the layer beneath the voltage tap:
Red circle: detail of "treeing" traces clearly shown at the lower edge of the layer.

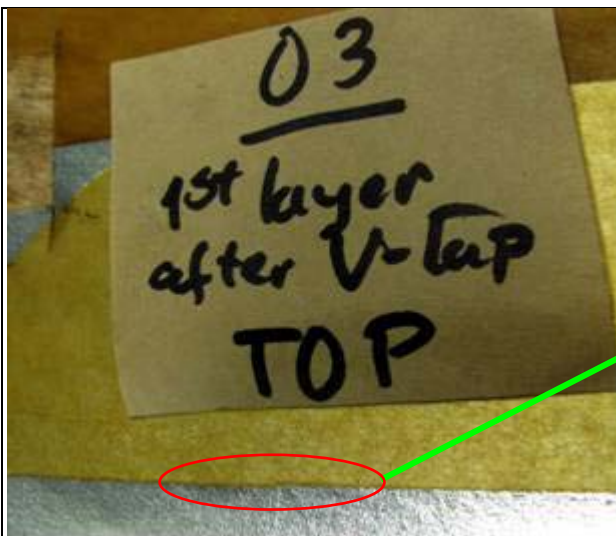
Picture 47: *H3 bushing*: detail of the 1st layer beneath the voltage tap layer, upper edge of the upper foil:
Red circle: region enlarged on photo #48 (**Green arrow**) These "treeing" traces are lighter than those at the bottom edge of the bottom layer beneath the voltage tap.

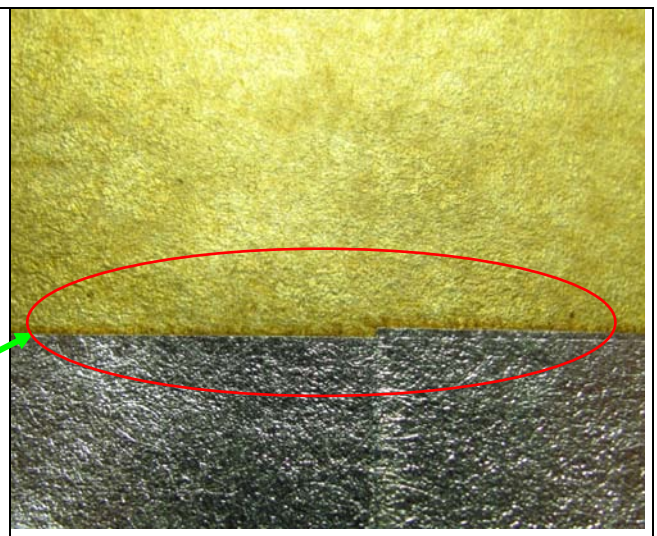
Picture 48: *H3 bushing*: detail view of the upper edge of the upper foil of the layer beneath the voltage tap:
Red circle: detail clearly shows "treeing" traces at the upper edge of the upper foil. These are lighter than discharge traces on bottom edge of bottom foil.

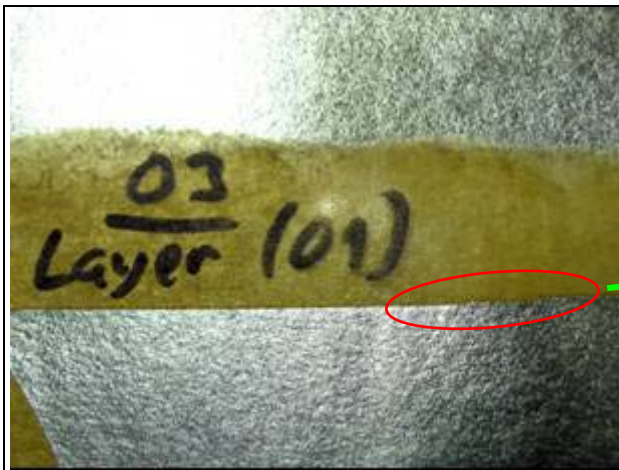
Picture 51: H3 bushing: detail of the innermost layer (1st layer over the central conductor), bottom edge of the lower foil:
Red circle: region enlarged on photo # 52 (**Green arrow**) with clearly visible "treeing" traces.

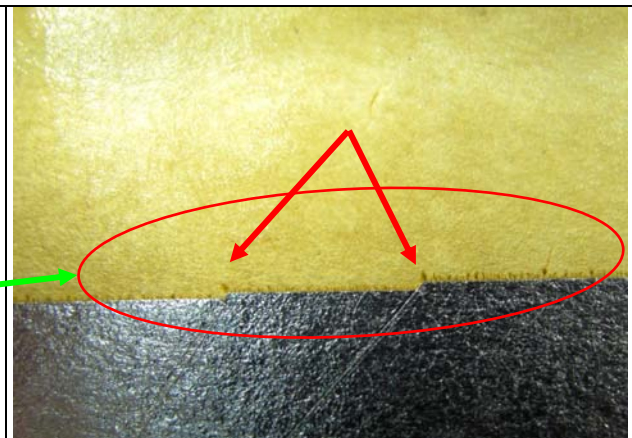
Picture 52: H3 bushing: detail view of the bottom edge of the lower foil of the innermost layer:
Red circle: detail of the clear but slighter traces, where it is visible that the "treeing" traces are more intense at the corners created by small folding of the aluminum foils (**red arrows**).

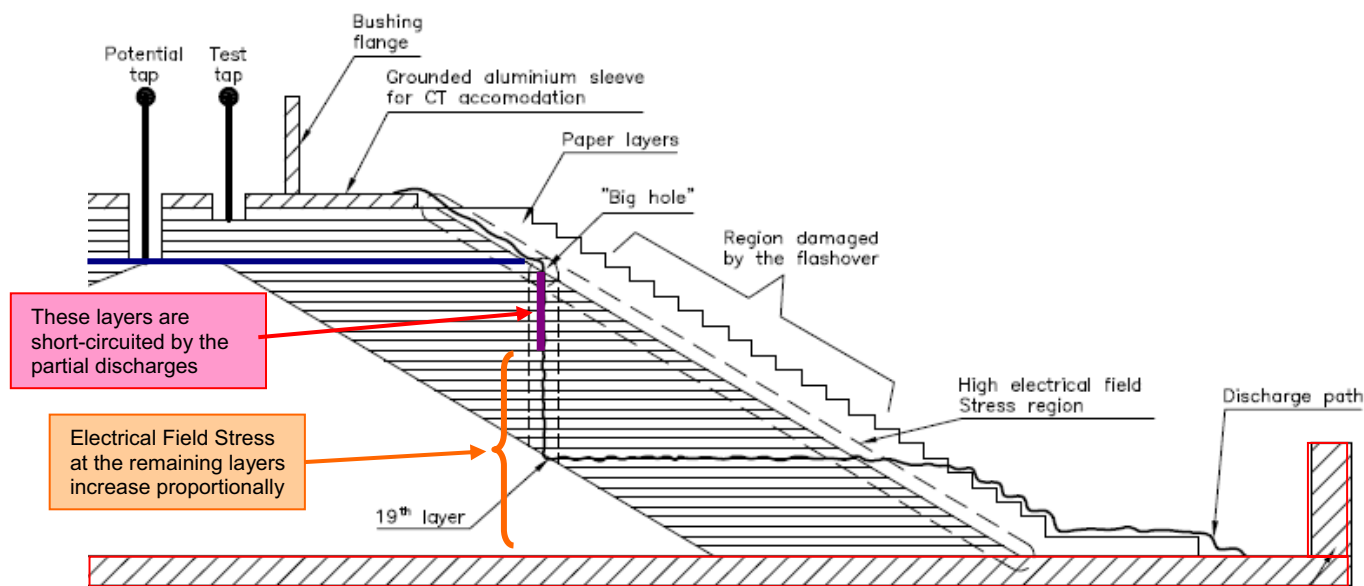
5.8 After a certain number of layers are short circuited by the mentioned carbonized path, PD's initiated by an overvoltage will no longer extinguish. This is because the voltage stress between layers is raised to the point where normal operating voltage maintains the PD activity.

Sketch 4. Once established, the partial discharges do not extinguish and continuously grow inwards.

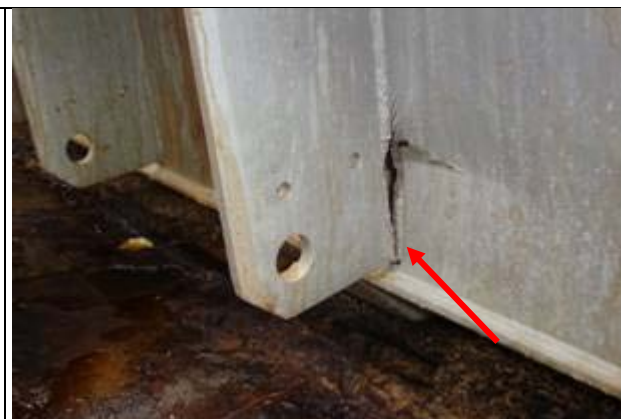
The flashover at the oil side of the H2 bushing caused an explosive pressure wave inside the tank which ruptured the weld between cover and tank in front of the middle phase (**Picture 2 & 8**). Other consequential damages (caused by the tank wall at the HV side bowing out) were found at several points of the tank reinforcements (**Picture 5 & 6**).

Picture 6: **Red arrow:** mechanical stress marks on the bottom end of the vertical tank reinforcements;

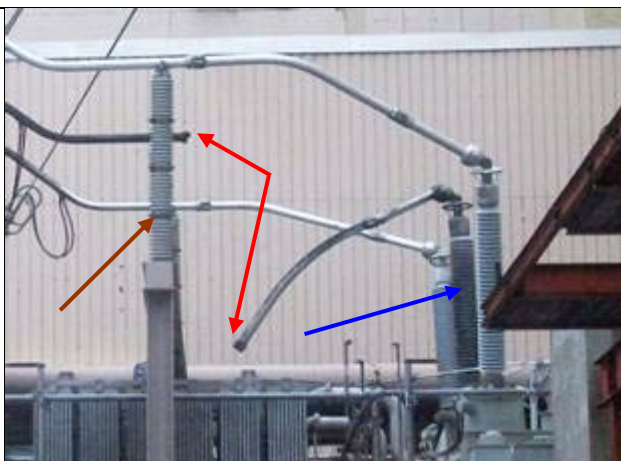
Picture 10: **Red arrows:** 345 kV bus disrupted due to the connector broke apart by the mechanical impact;
Blue arrow: H2 bushing (Phase "B");
Brown arrow: Insulating post for the 345 kV bus;

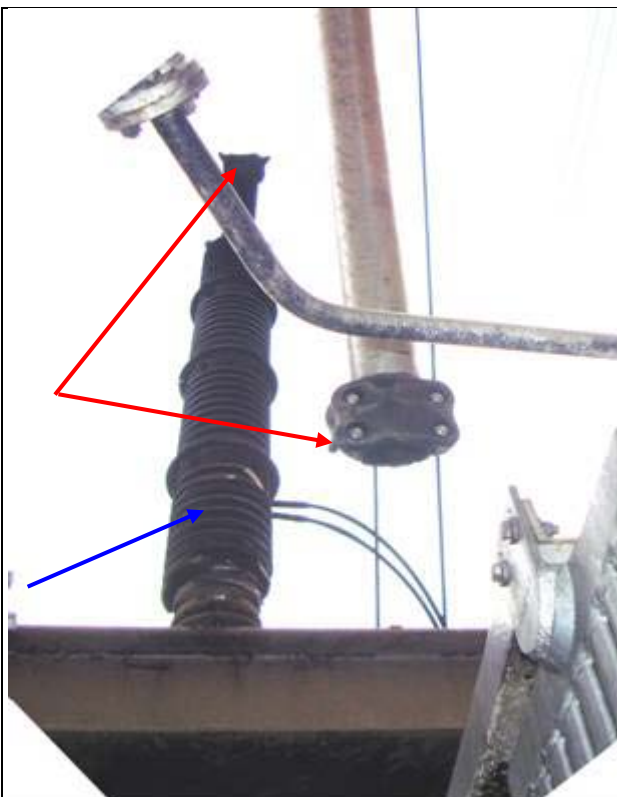
Picture 11:

Red arrows: Showing the parts of the connector which was broken due to the mechanical impact of the shock wave caused by the flashover on the H2 bushing;

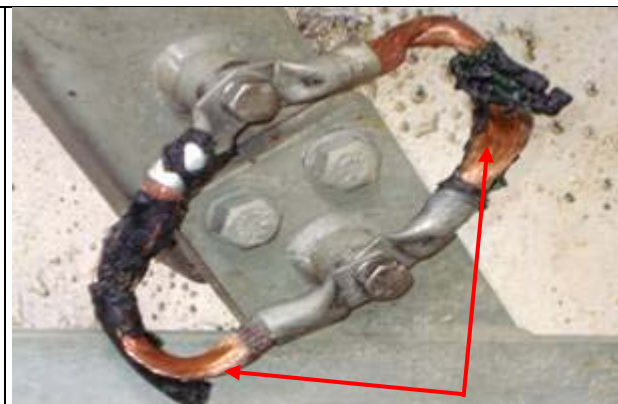
Picture 14: **Red arrows:** The plastic covering of the grounding leads melted away but the copper isn't discolored. Therefore no heavy fault current to ground circulated during the event through these components.
