Calc No.: F10503-R-001
Title: Transformer Internal Pressure
Evaluation

The photographic report ST02/11 summarizes Trench's and Siemens' investigation on the failed bushing serial number 05F9080-04 originally installed in phase B of TR#21 at Indian Point Nuclear station.

Problem Statement (object/deviation format): 21 Main Transformer Failed

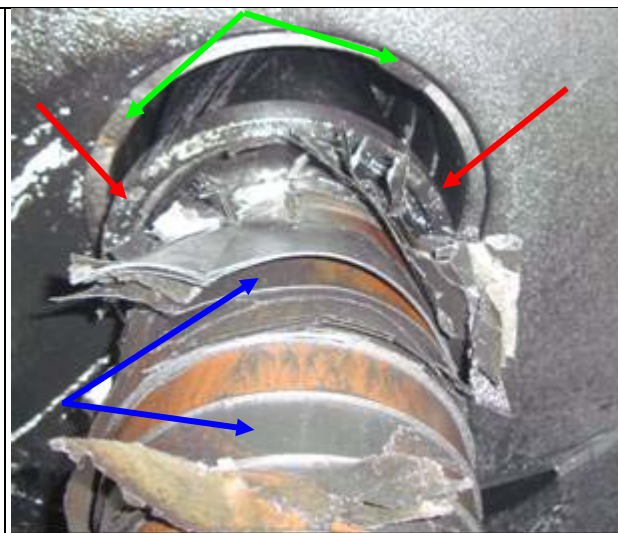
Picture 20: Red arrows: Flashover marks on the grounded parts of the H3 bushing;
Blue arrows: insulating layers of the condenser body;
Green arrows: Supporting spacers for the bushing CT's.

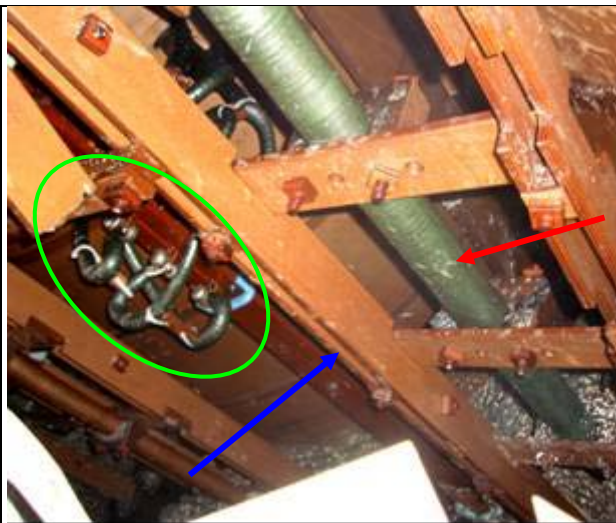
Picture 23: DETC on HV winding:

Red arrow: HV neutral point outlead connection without any damage, flashover or burning marks;
Blue arrow: Slider of the DETC didn't show any damage;
Green circle: The contact group of the DETC didn't show any damage or displacement;

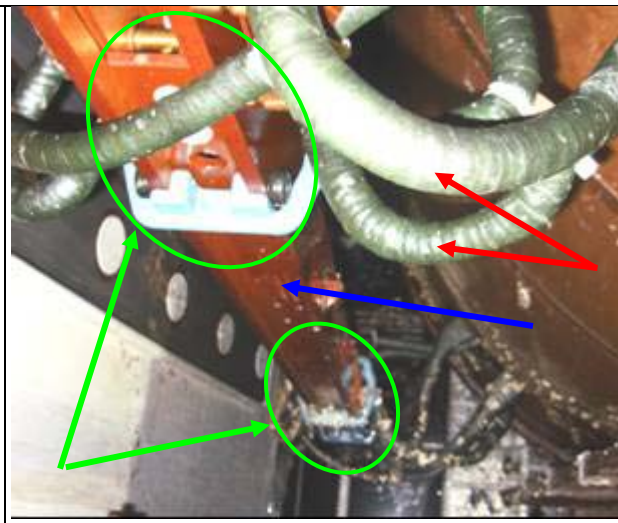
Picture 24: DETC on HV winding:

Green circles: Both contact groups of the DETC didn't show any damage or displacement;
Blue arrow: Slider of the DETC didn't show any damage;
Red arrows: HV tap outleads for the DETC;

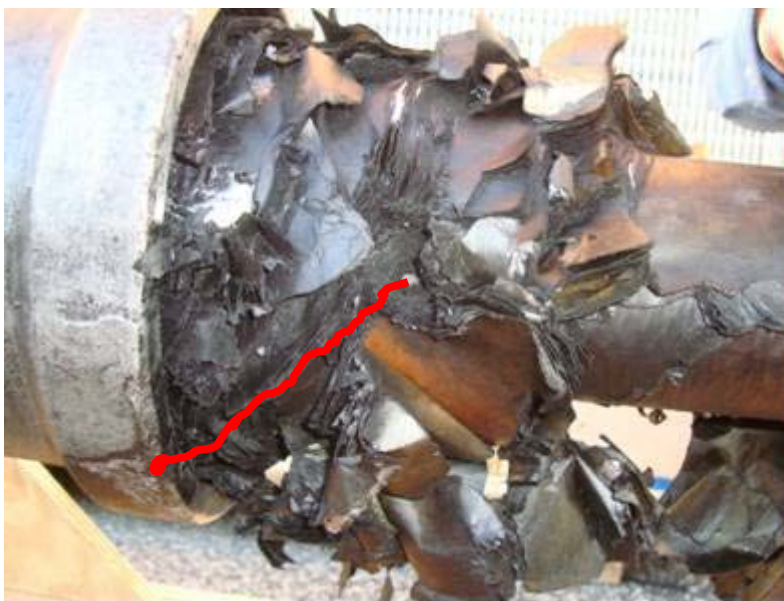
The flashover inside the bushing punctured its condenser body and hit the grounded metallic flange extension (see **Picture 05**).

Picture 05 – Detail view of failed bushing H2:

Red Line: indicates the arcing trace puncturing the condenser body and hitting the grounded flange extension.

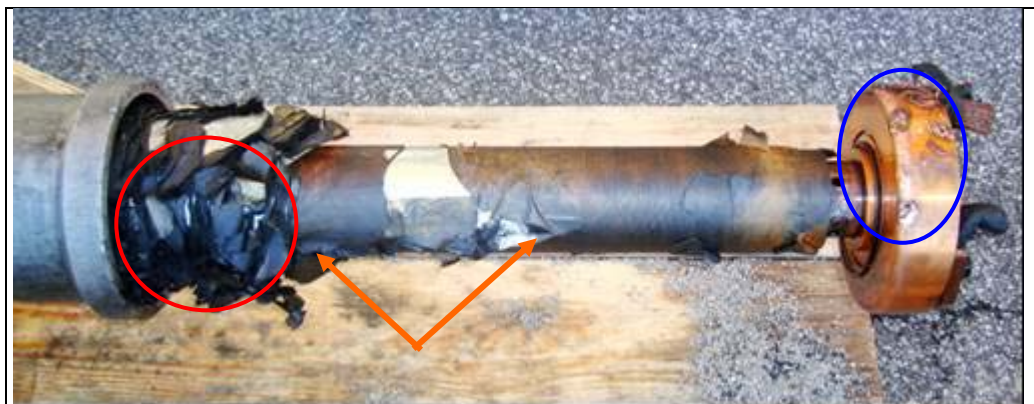
Picture 3: General view of the bushing H2:

Red circle: Area with the puncture to inner layers;

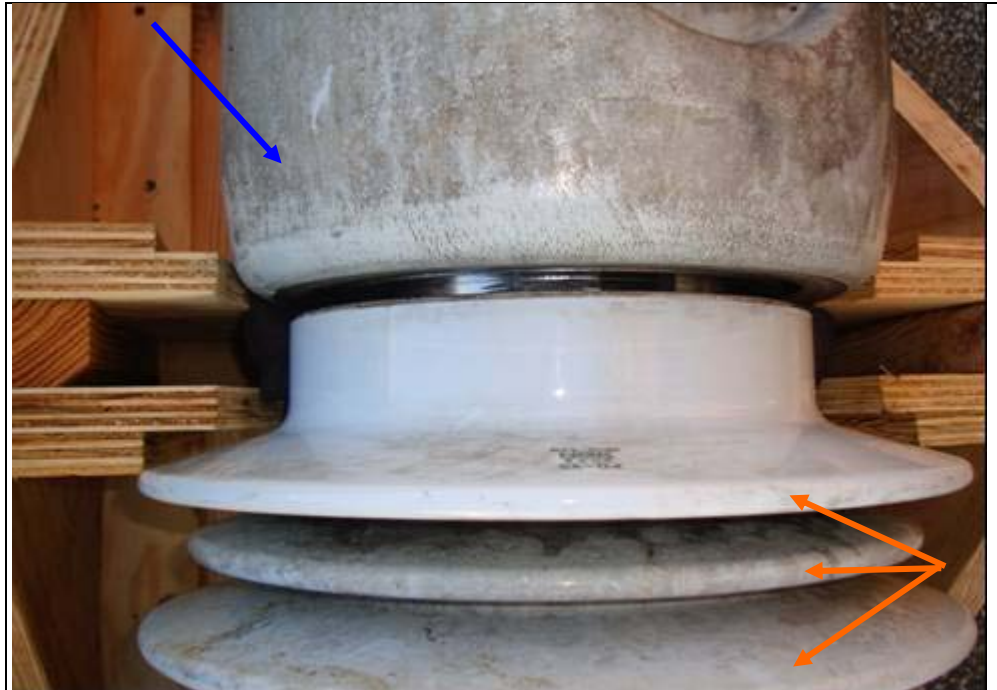
Picture 7: View of the H2 bushing head:
Red circle: The bushing head was detached from the porcelain as the lower epoxy shell was destroyed by the internal flashover;
Orange arrows: Porcelain sheds;
Blue arrow: Bushing head;

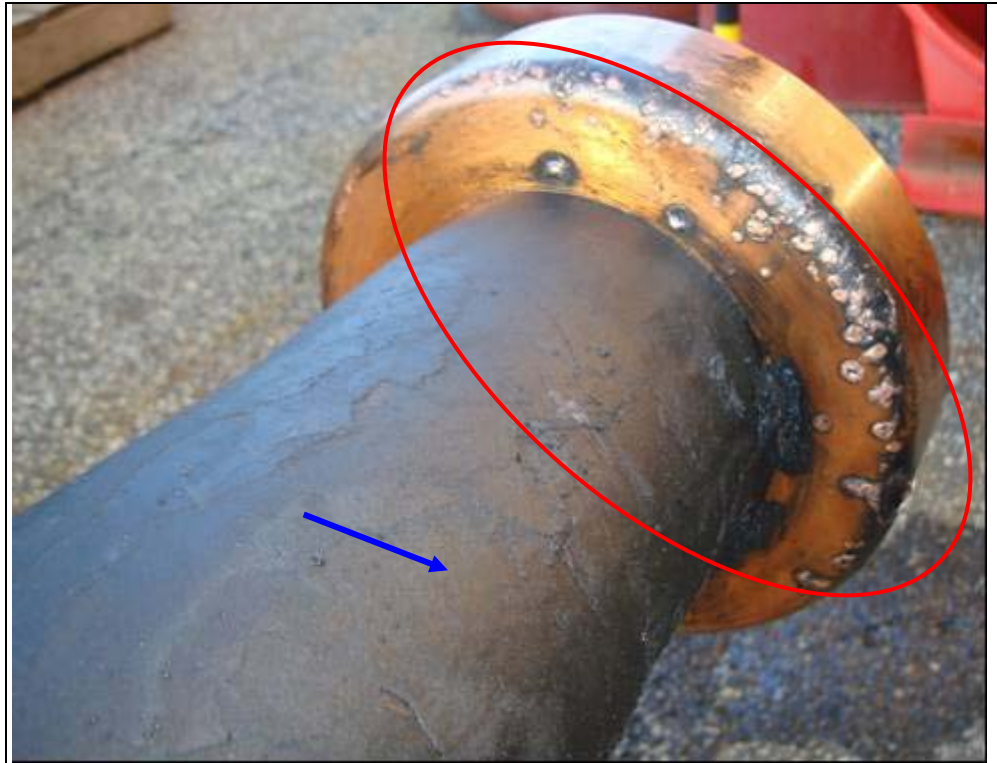
Picture 12: Detail view of the H1 bushing bottom plate:

Red circle: Foot points on the bottom plate caused by several flashover events occurred after the explosion of the H2 bushing;

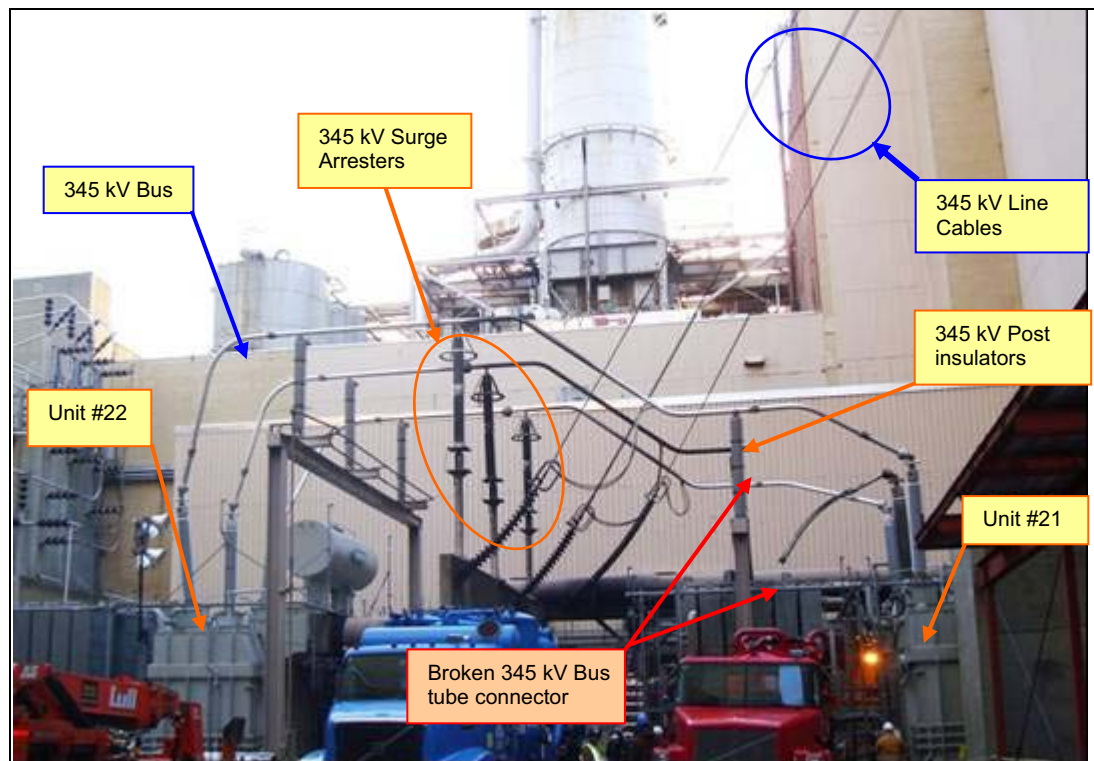
Consequently, the section connected to the H2 bushing fell apart as shown in **Picture1** below and the insulator post was broken at its base, as shown in the pictures of the following item.

Picture 1: General view of the transformer yard showing the main involved components.

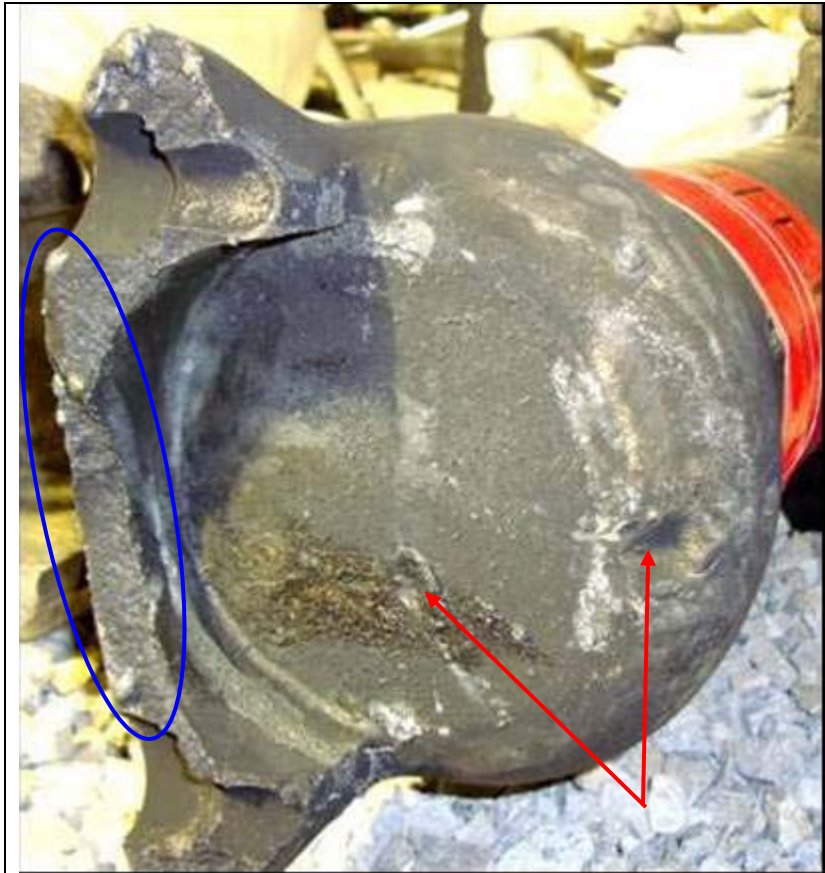
Picture 3: Detail view of the broken connector of phase “B”,
 (Surge arrester side);

Blue circle: Fractured surface with melting points caused by arcing;

Red arrows: Flashover marks;

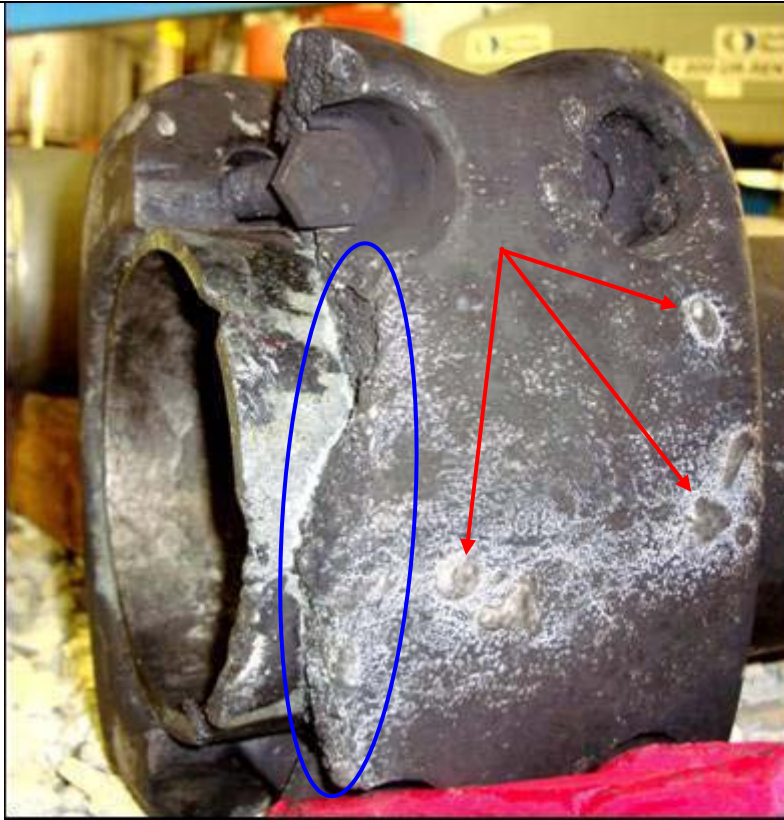
Picture 4: Detail view of other half of the broken connector of phase "B" (Transformer side);

Blue circle: Fractured surface with melting points caused by arcing;

Red arrows: Melted aluminum deposited on the connector surface, which fell down when the flashover occurred on the braking connector;

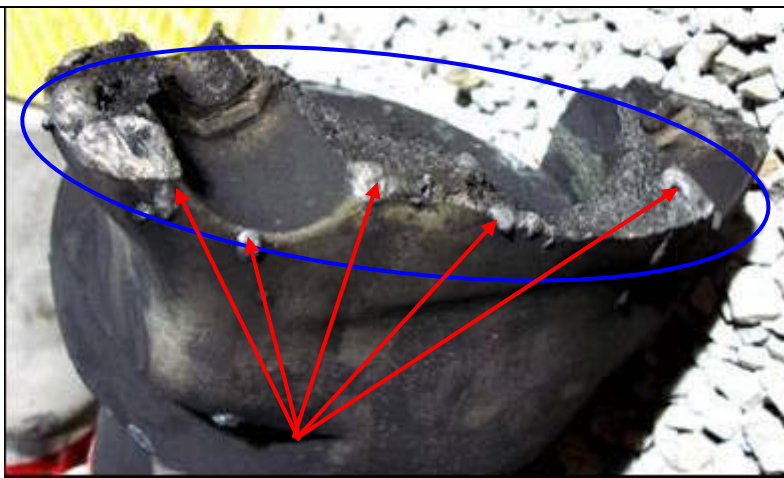
Picture 5: Detail view of one half of the broken connector of phase "B" (Surge arrester side);

Blue circle: Fractured surface with melting points caused by arcing;

Red arrows: Melted aluminum caused by the flashover occurred between the parts of the braking connector;

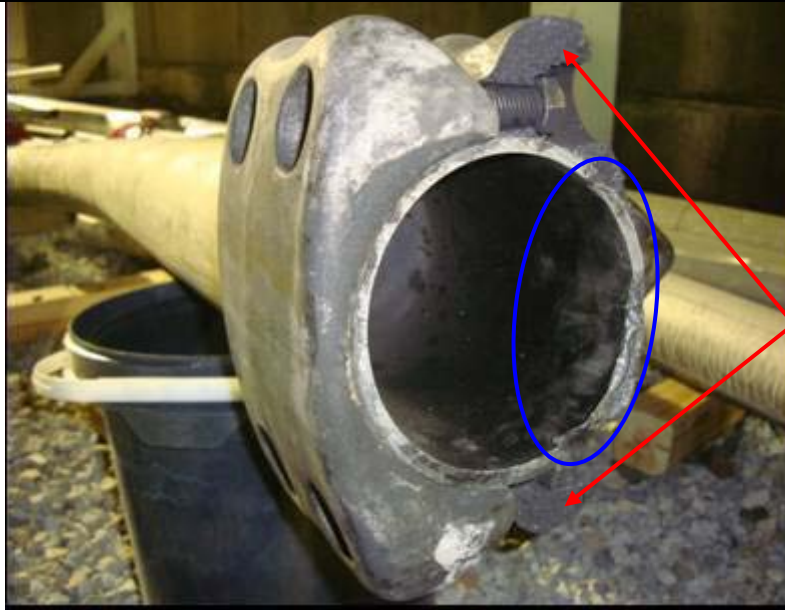
Picture 6: Detail view of one half of the broken connector of phase "B" (Transformer side);

Blue circle: Tube end with melting & arcing marks;

Red arrows: Fractured surface of the connector;

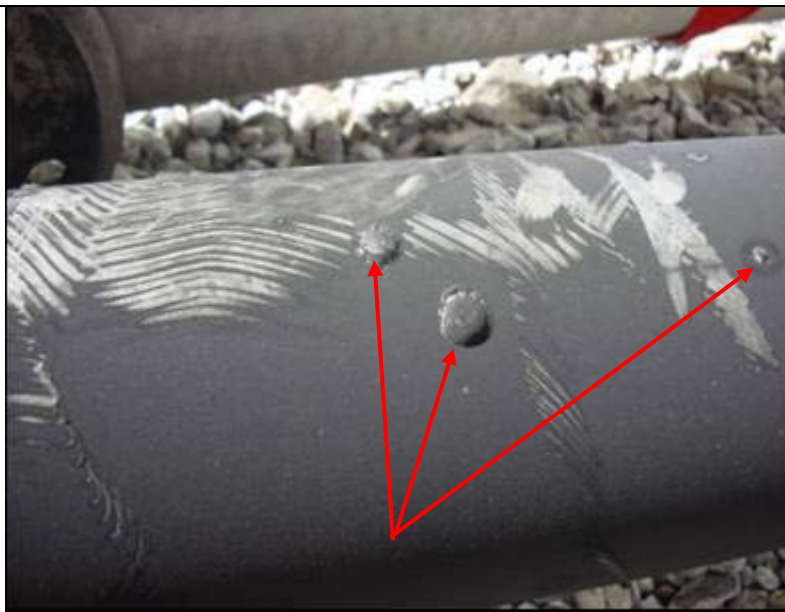
Picture 7: Detail view of bus tube of phase "B" (Transformer side);

Remark: the blackened surface of the tube was caused by the fireball which involved this part of the 345 kV bus after the explosion of the H2 bushing;

Red arrows: Melted aluminum deposited on the upper surface of the tube coming from the arcing occurred between the connector parts which broke in consequence of the mechanical shock wave;

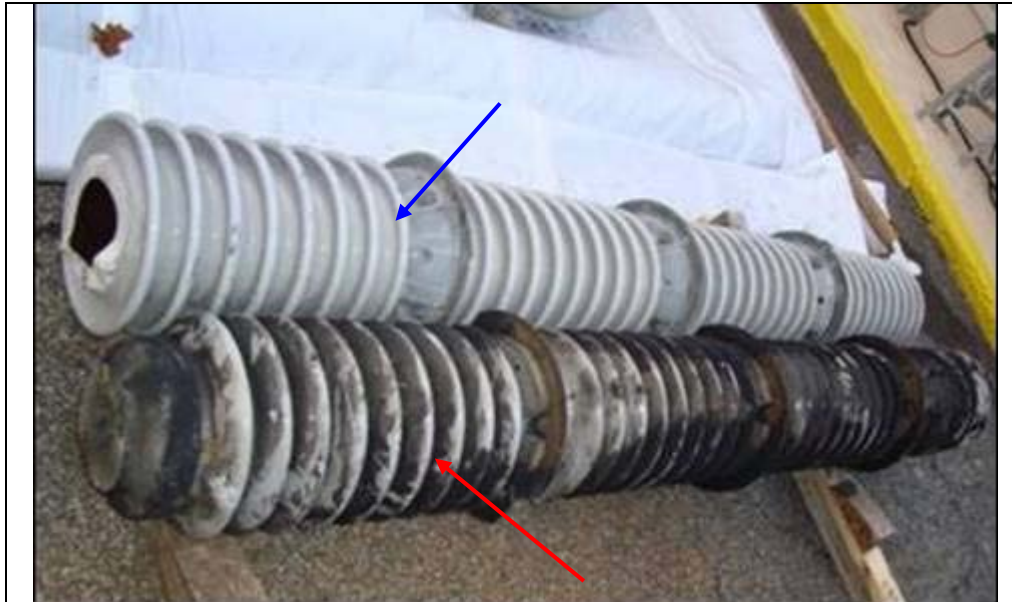
Picture 8: General view of the Post Insulators:

Red arrow: Phase “B” insulator, blackened by the dust of the fireball caused by the bushing explosion and which involved the components of phase “B”;
Blue arrow: Phase “C” insulator, with a clean porcelain surface.

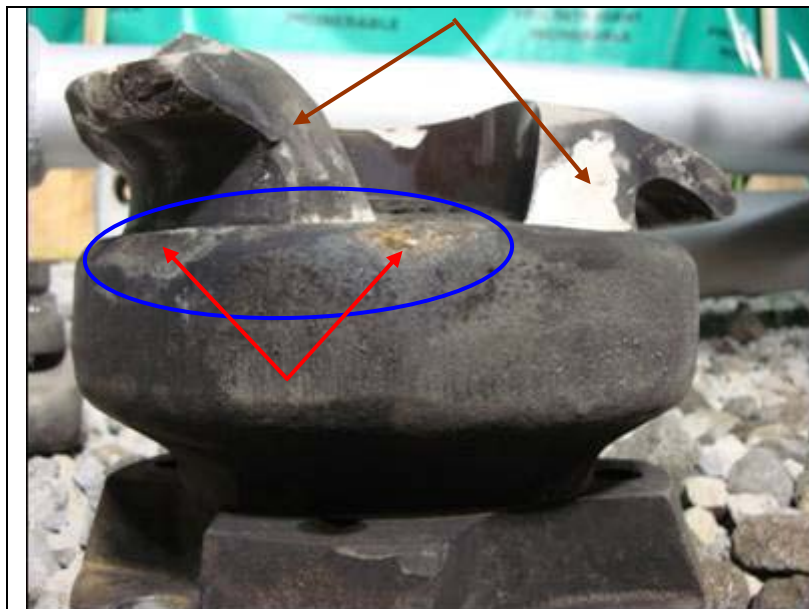
Picture 9: Detail view of the fixing base of the Post Insulator phase “B”:

Red arrow: Foot points of the flashover which occurred on the post Insulator, before the occurrence of rain;
Blue circle: Flashover marks on the fixing base of the Insulator;
Brown arrows: Fracture surface of the broken porcelain.

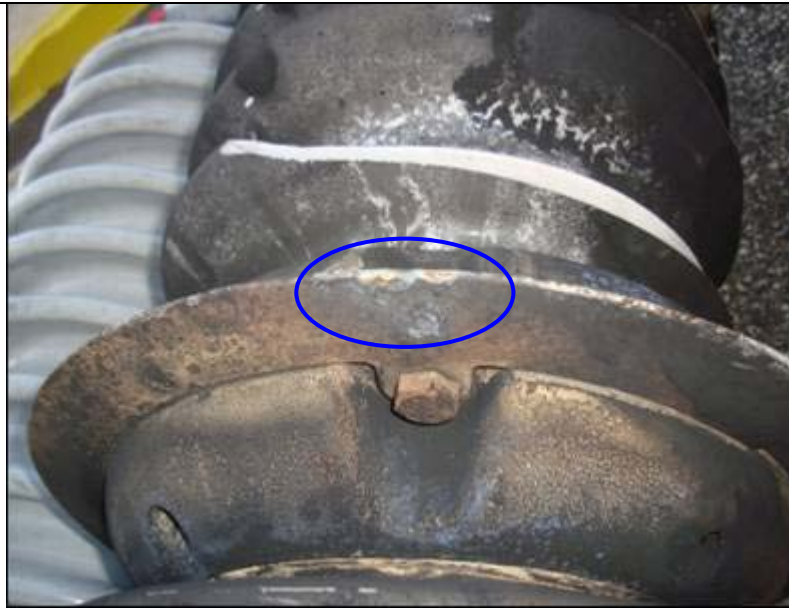
Picture 15: Detail view of the intermediate sections of the Post Insulator phase "B":
Blue circle: Flashover traces on the bottom metallic piece installed between porcelain sections;

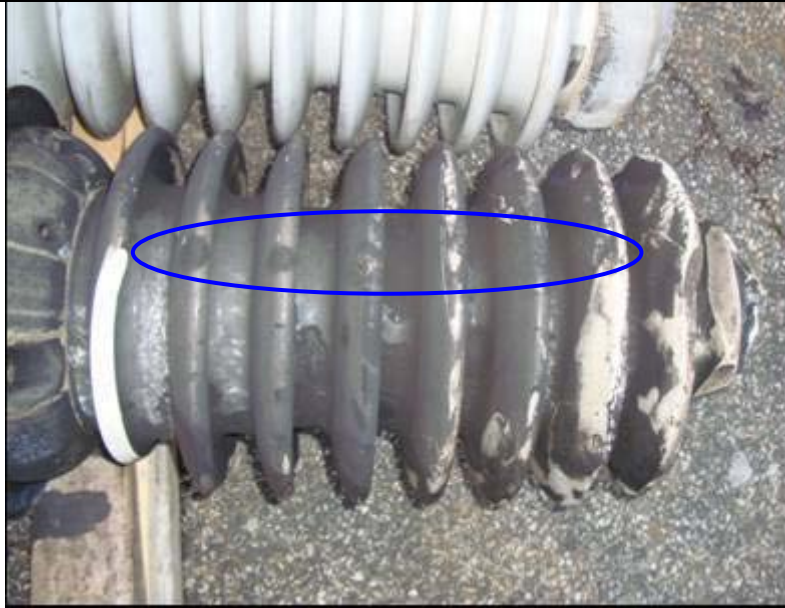
Picture 16: Bottom piece of the Post Insulator phase "B":
Blue circle: Flashover traces on the porcelain sheds;

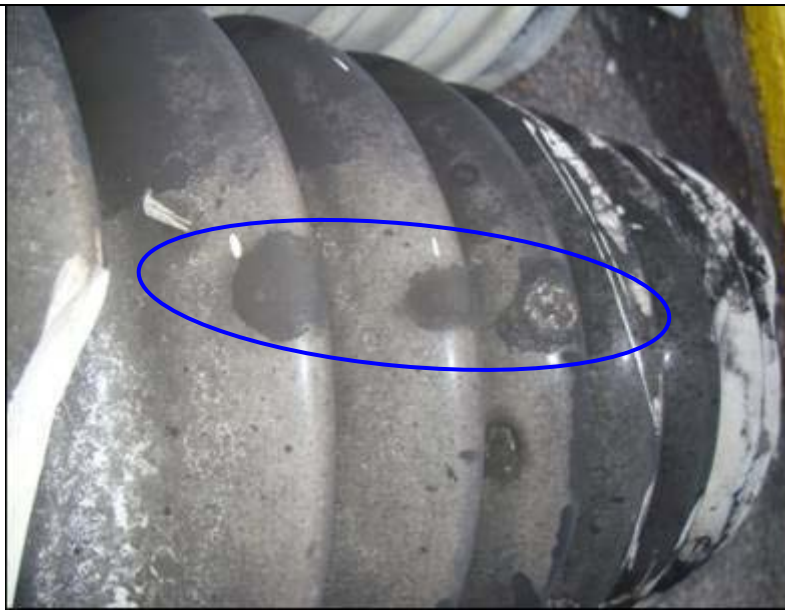
Picture 17: Detail view of the bottom piece of the Post Insulator phase "B":
Blue circle: Flashover traces on the porcelain sheds;
