FUKUSHIMA DAI-ICHI INITIATING EVENT SIGNIFICANCE

FUKUSHIMA DAI-ICHI FLOODING DAMAGE

FUKUSHIMA DAI-ICHI HYDROGEN GENERATION

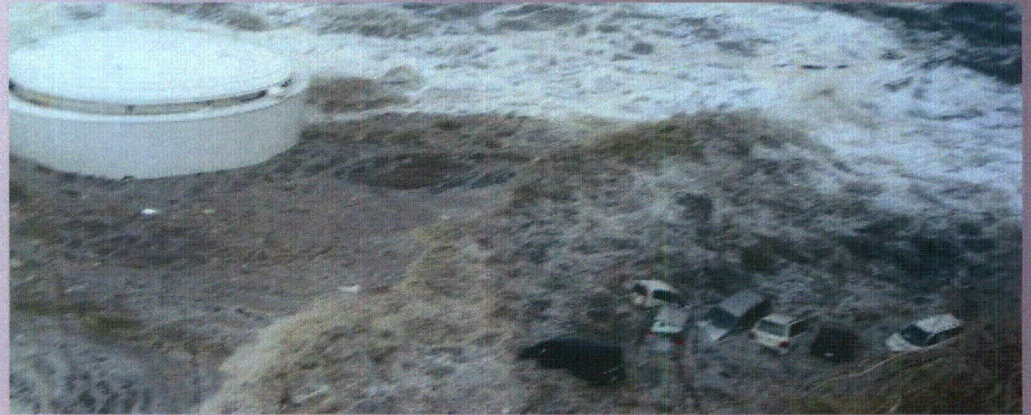
PLANT RESPONSE

- Station blackout
- Unit 1: Isolation condenser accommodating decay heat without shell makeup capability
- Units 2-3: RCIC accommodating vessel makeup and SRV's accommodating decay heat without suppression pool cooling
- Unit 4: Loss of spent fuel pool cooling
- Upon loss of RCIC/IC, the SRV's cycled on high pressure
- Suppression Pool reaches saturation temperature resulting in containment pressurization

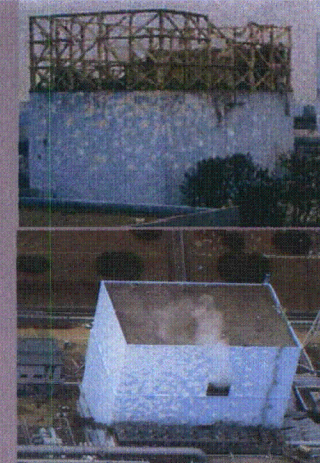
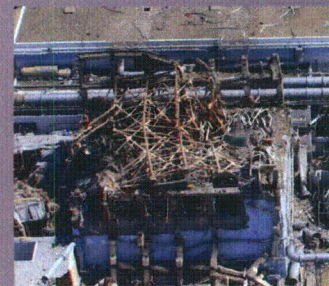
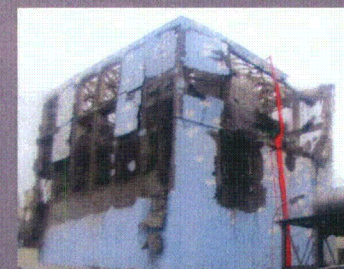
100 R/hr debris outside Unit 3 Reactor Building

UNIT	CORE DAMAGE ESTIMATE	CORE COOLING	PRIMARY CONTAINMENT	SECONDARY CONTAINMENT	DRYWELL RADIATION LEVELS	TORUS RADIATION LEVELS
UNIT 1	55% and uncovered	26 gpm fresh water via feedwater line	Damaged Leak rate est. at 3 cubic meters per hour	Severely damaged by hydrogen explosion	Unknown	114 R/hr 4 mR/hr at west gate
UNIT 2	35% and uncovered	30gpm fresh water	Damage suspected	Damaged	2070 R/hr	40 R/hr 4 mR/hr at west gate
UNIT 3	30% and uncovered	31 gpm fresh water	Damage suspected	Damaged	1260 R/hr	50 R/hr
UNIT 4	In spent fuel pool	N/A	Relaxed for outage	Severely damaged by hydrogen explosion	N/A	N/A
UNIT 5	None	N/A	N/A	N/A	N/A	N/A
UNIT 6	None	N/A	N/A	N/A	N/A	N/A

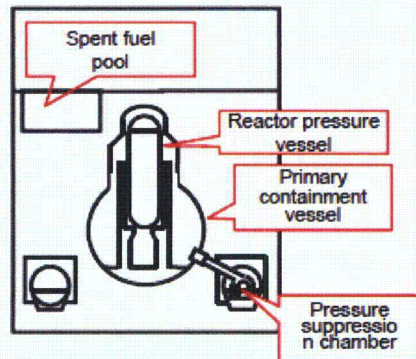
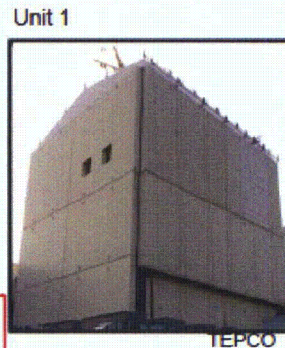
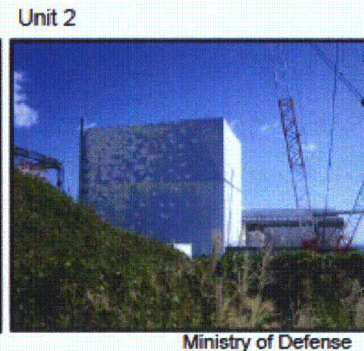
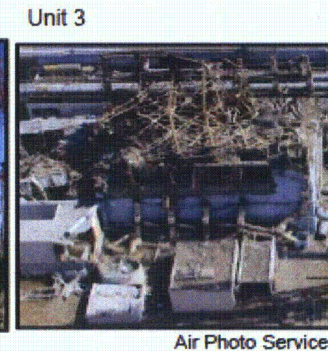
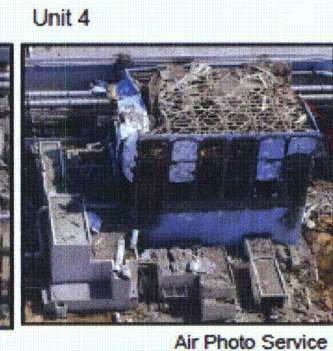
Current Status of Fukushima Dai-ichi NPP

Reactor Pressure vessel Temperature at reactor vessel bottom*	Circulating water injection cooling 24.3°C	Circulating water injection cooling 47.1°C	Circulating water injection cooling 51.4°C	No fuel
Primary Containment vessel Temperature of air in PCV*	Nitrogen injection 25.4°C	Nitrogen injection 54.3°C	Nitrogen injection 44.4°C	—
Fuel pool Temperature of pool water*	Circulation cooling 26.5°C	Circulation cooling 14.2°C	Circulation cooling 14.4°C	Circulation cooling 26°C
Highly-contaminated water in R/B and T/B**	14,100 m ³	22,000m ³	23,800 m ³	18,300 m ³

Effectively Cold Shutdown (100° C = 212° F)
