The Plutonium Spill at NIST- Boulder, June 2008

Richard E. Toohey, Ph.D., CHP
Sr. Scientific Advisor

Radiation Emergency Assistance Center / Training Site
Oak Ridge Institute for Science and Education (ORISE)

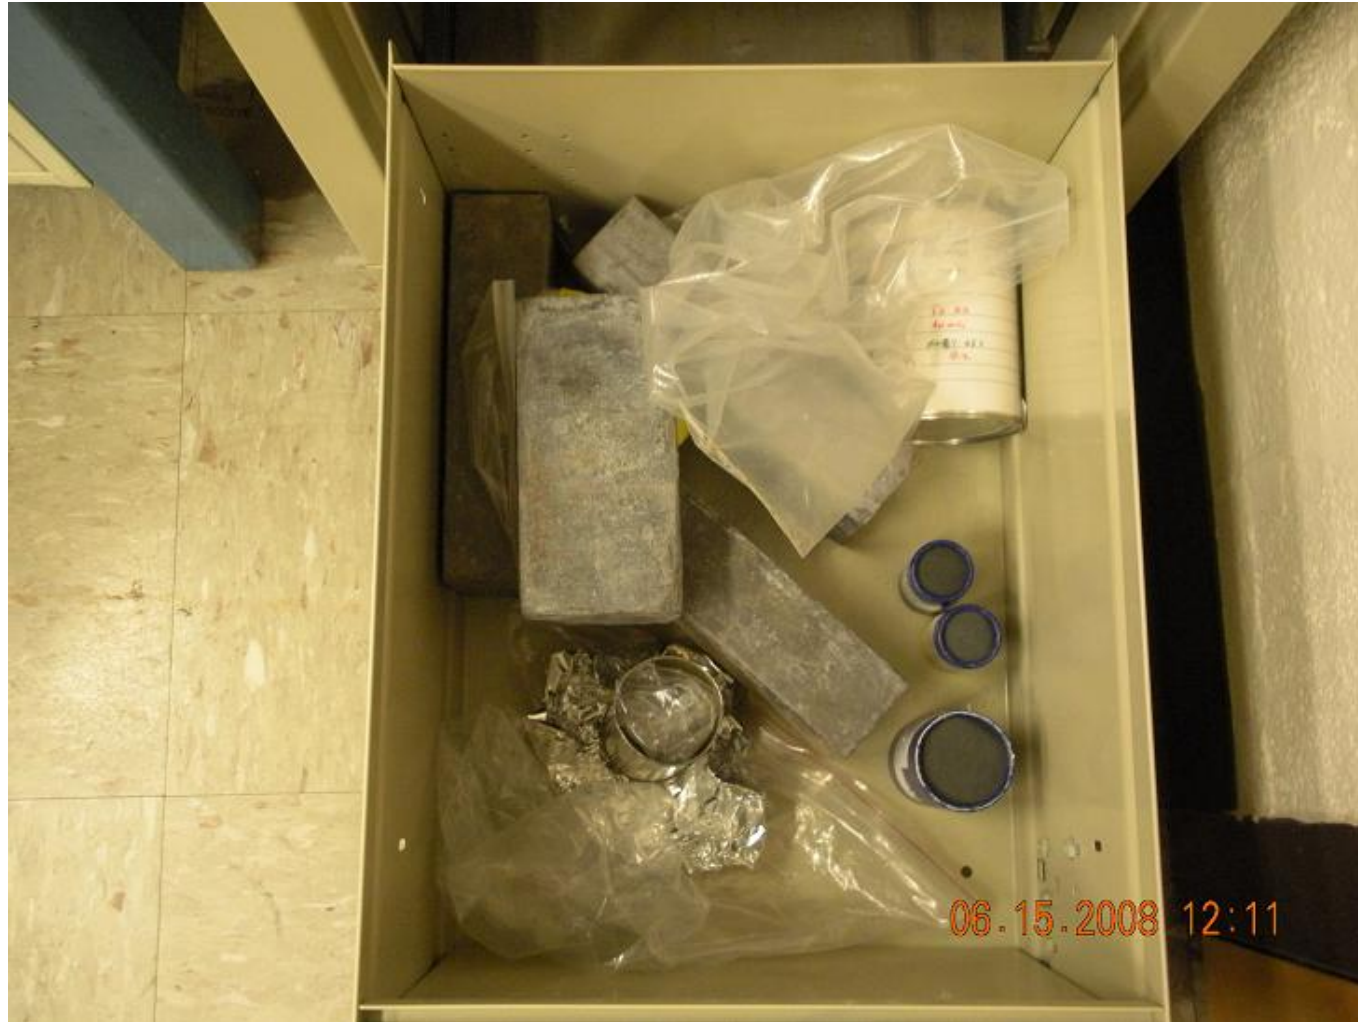
Source Drawer

- P.I. was not made aware of potential seriousness of incident, so went to lab ~30 minutes later
- P.I. looked in source storage drawer and saw a second source that was obviously intact
- Worker # 1 then showed him the “cracked” source bottle

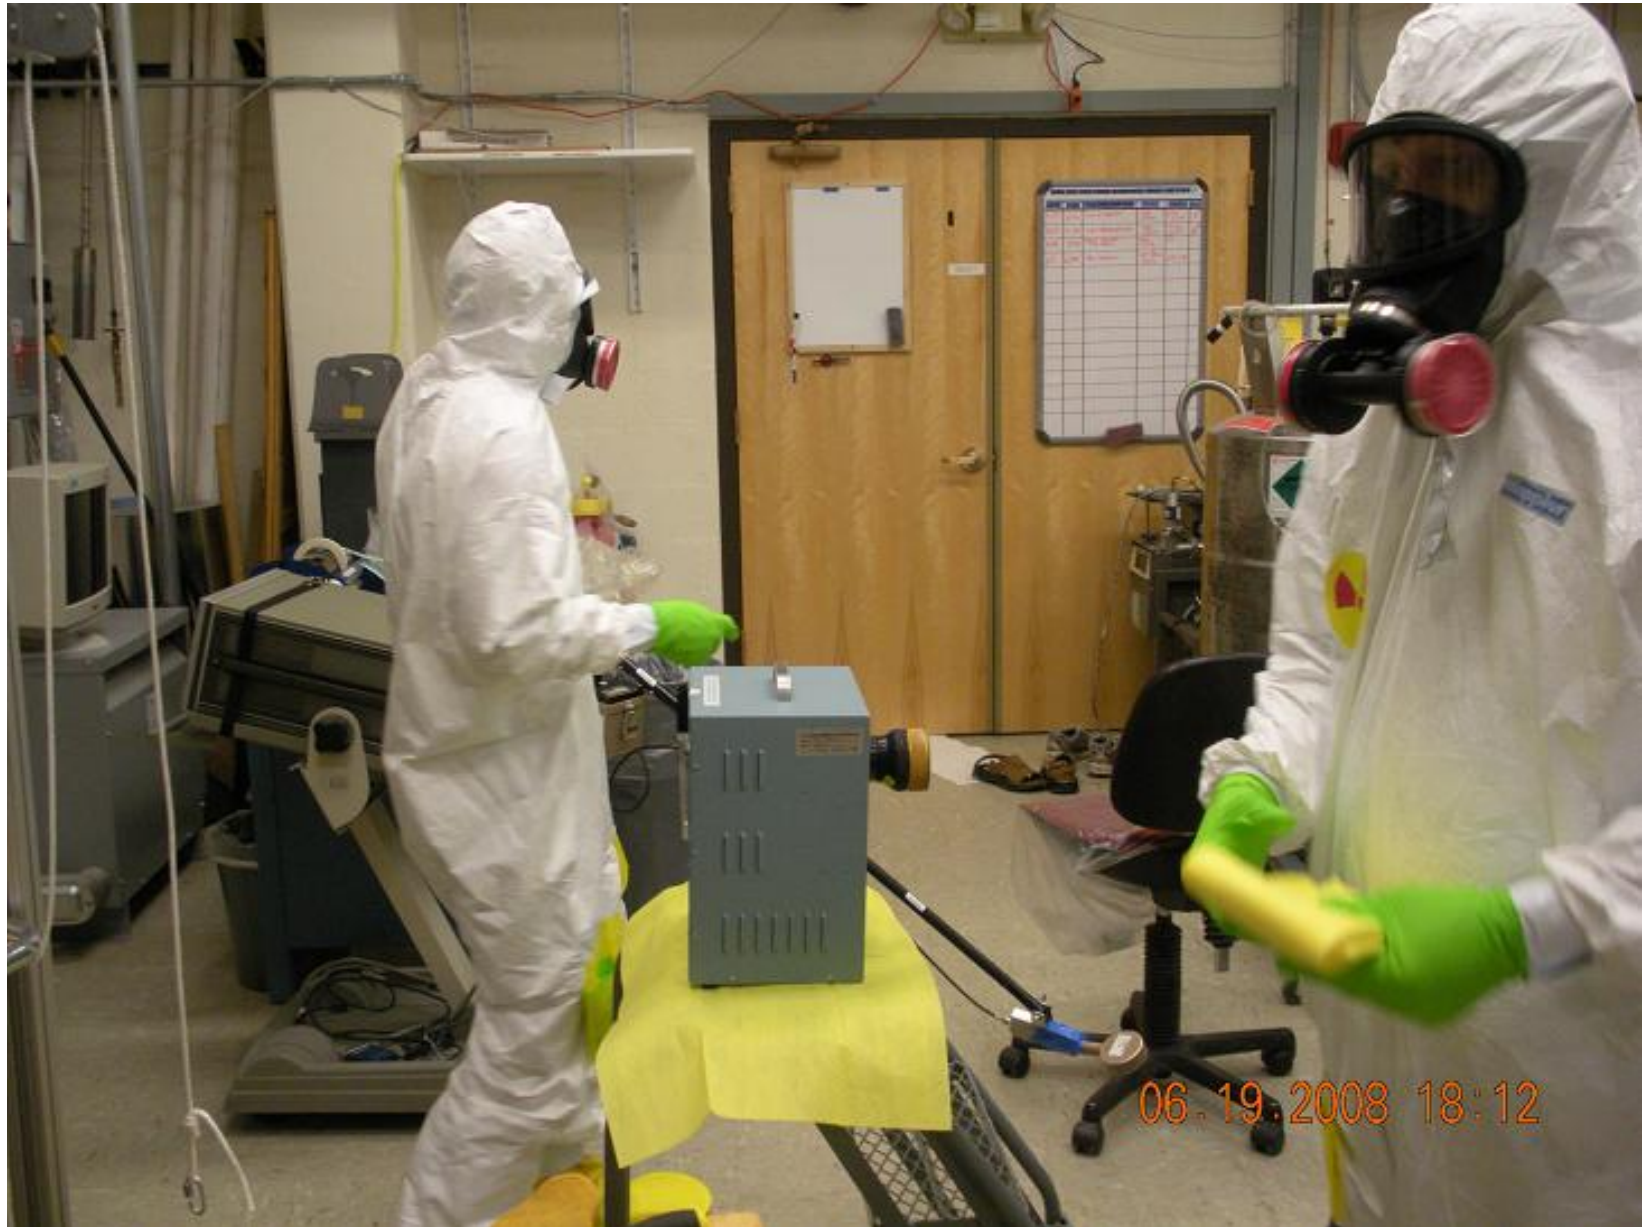
Rap Team

- On 12 June, NIST-B requested assistance from DOE for additional survey and decon work; Radiological Assistance Program (RAP) Teams from Los Alamos and Livermore arrived on site the next day
- High level of contamination found in lab sink, which discharged directly to municipal sewer line

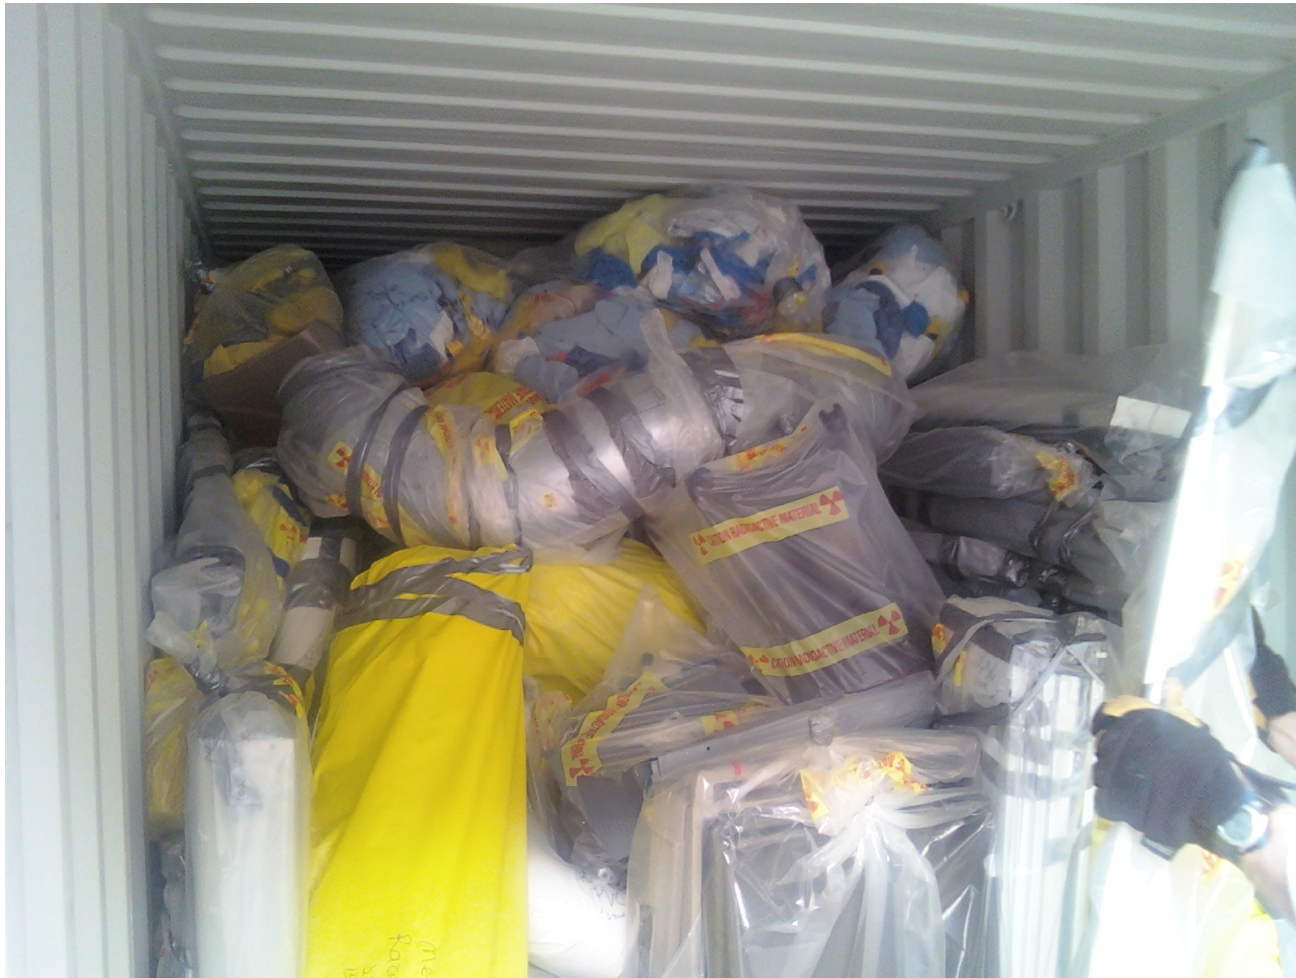
~50,000 lbs of waste

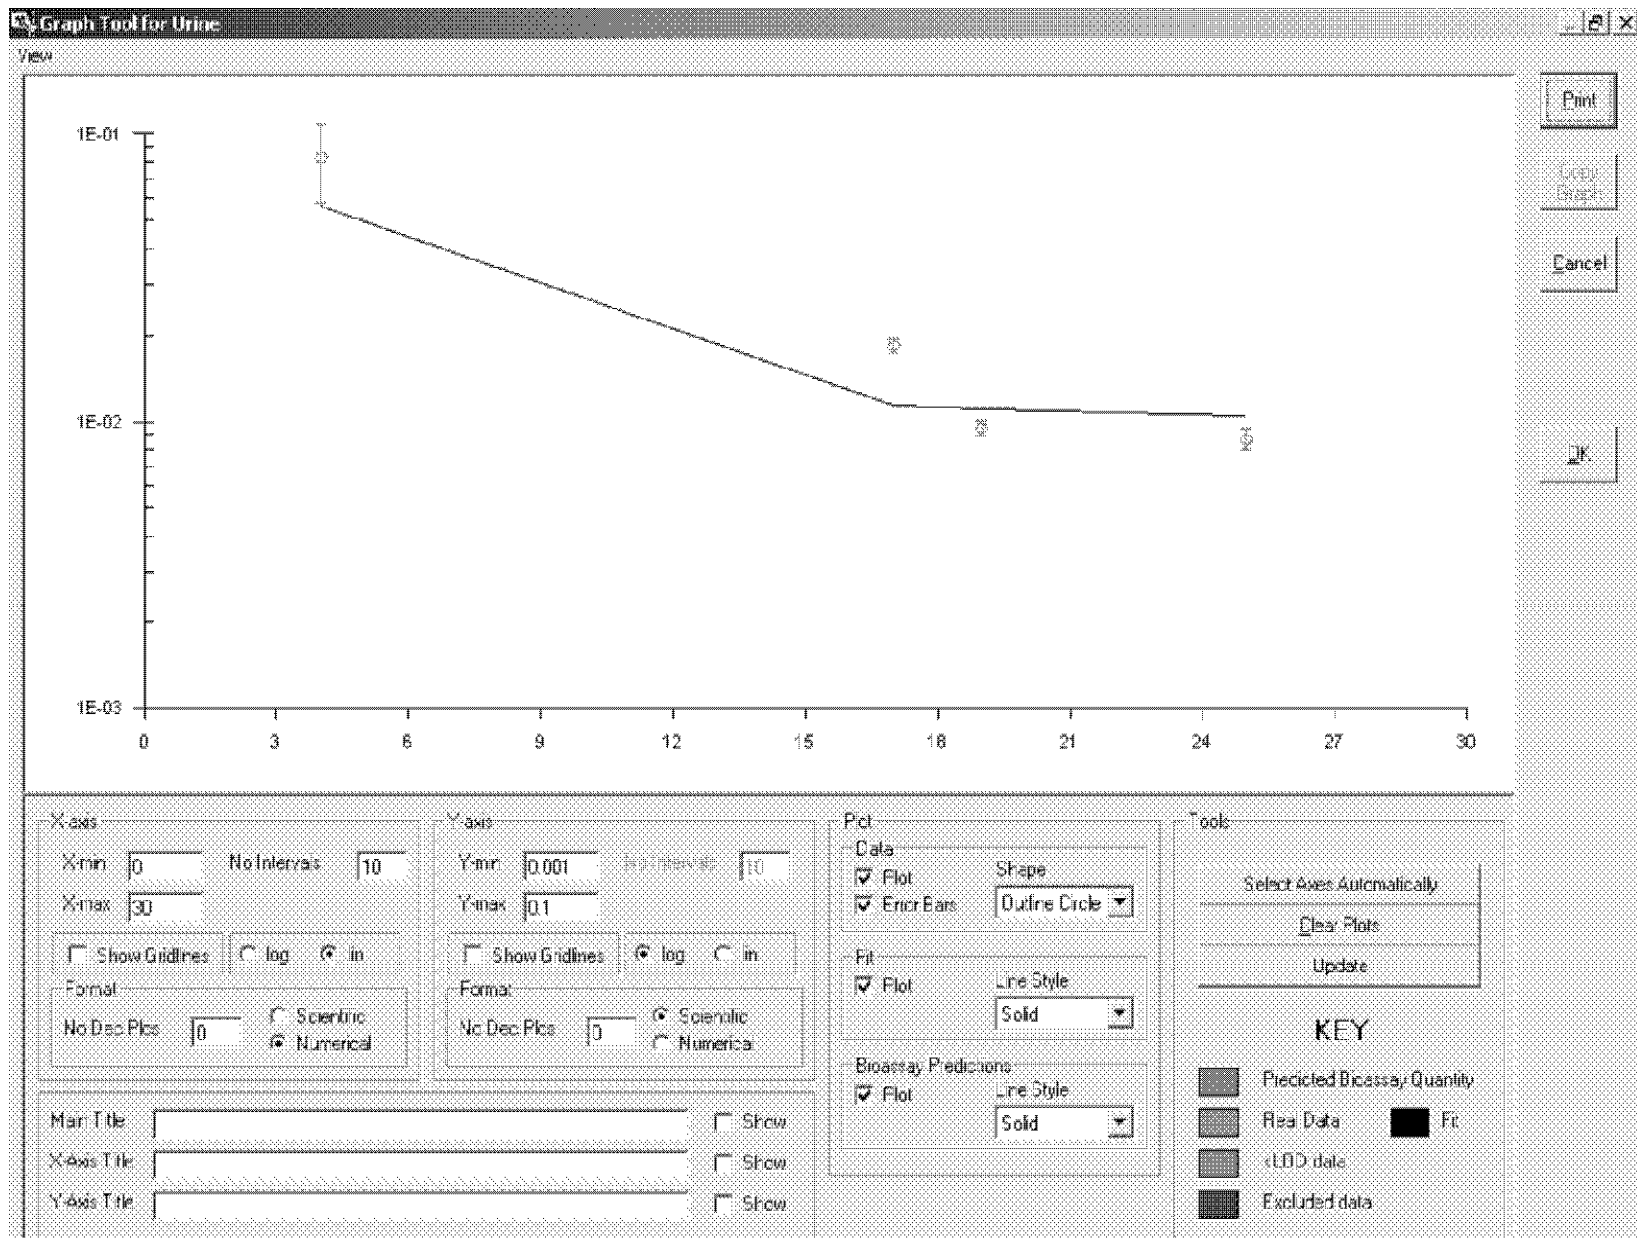
Worker #1 Bioassay

- Urine: 2 mBq/L; intake = 58 Bq;
CED (BS) = 60 mSv
eff. dose = 3 mSv
- Fecal: 9 Bq/d; intake = 56 Bq
- Initial report to REAC/TS was 20 (!) mBq/L,
resulting in recommendation for DTPA Tx

- Worker #1 intake = 40 Bq
Eff. Dose = 2 mSv
CED (BS) = 40 mSv
- DTPA TX averted 6 mSv CED (BS)
- Worker #1 had 2 Tx, wanted third
- 2 of 21 urine + via gross alpha/beta
- 2 of 10 urine + via alpha spec
- 16 of 29 urine + via TIMS
