POEF-2086  
ORNL/TM-11988

## Investigation of Breached Depleted UF<sub>6</sub> Cylinders

Date Published: September 1991

Prepared by the  
OAK RIDGE NATIONAL LABORATORY  
and  
URANIUM ENRICHMENT  
Oak Ridge, Tennessee 37831-6285  
managed by  
MARTIN MARIETTA ENERGY SYSTEMS, INC.  
for the  
U.S. DEPARTMENT OF ENERGY  
under contract DE-AC05-84OR21400 and  
DE-AC05-76OR00001

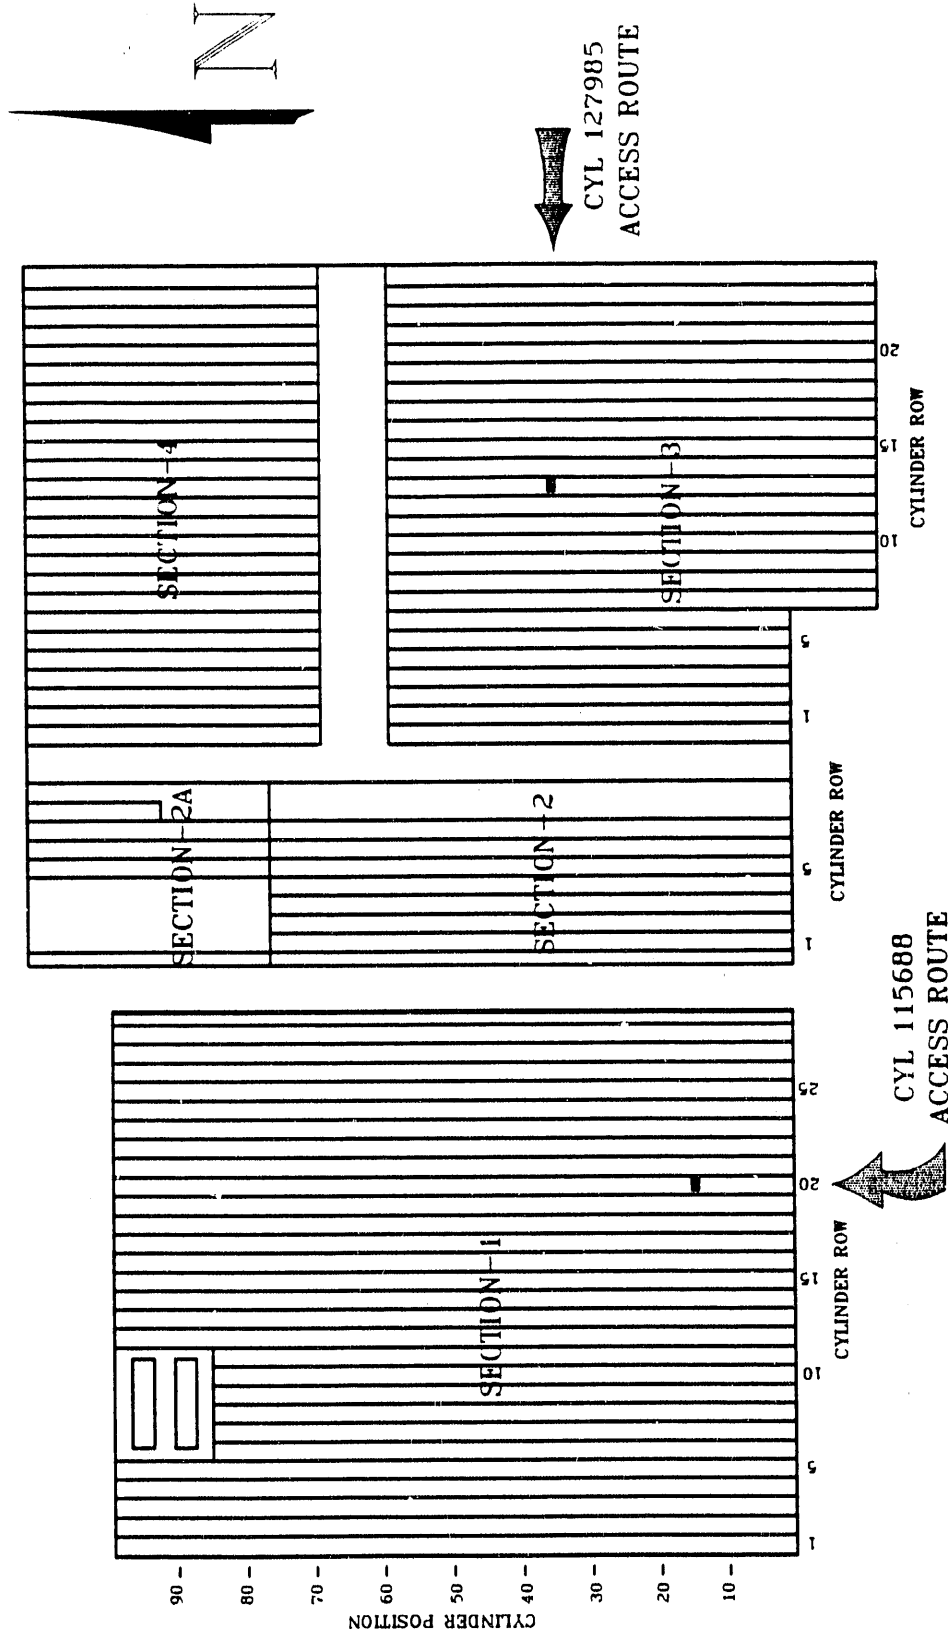
ORNL-DWG 91-9692

Note: Vertical lines represent aisleways between cylinder rows.

Positions of failed cylinders are represented by a rectangle, ■.

Fig. 1. Schematic of the Portsmouth depleted UF<sub>6</sub> storage area, C-lot, showing locations of failed cylinders and routes used to gain access.

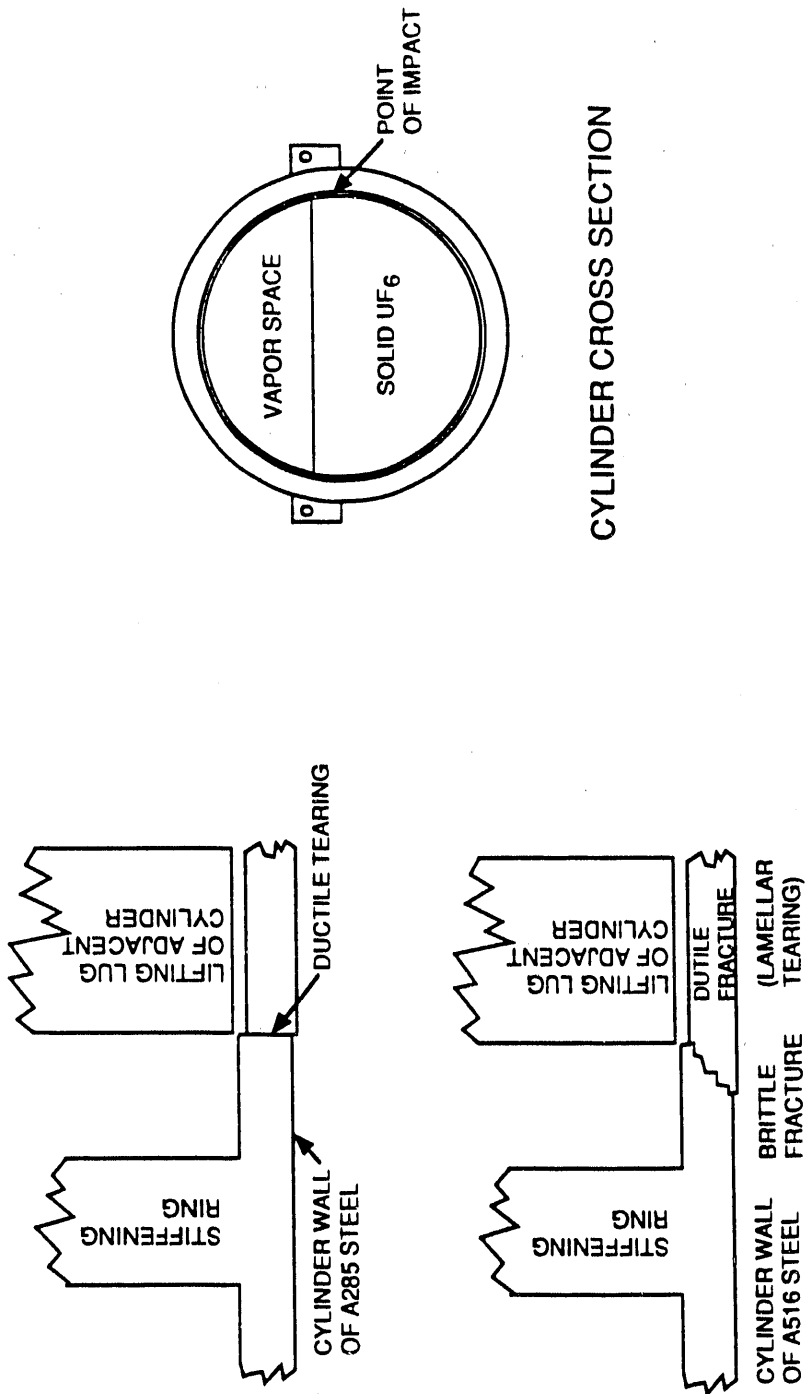
# IMPACT FRACTURE OF A285 AND A516 STEELS

Fig. B3.4. Types of impact fractures encountered with ASTM A285 and A516 steel and the impact location experienced.

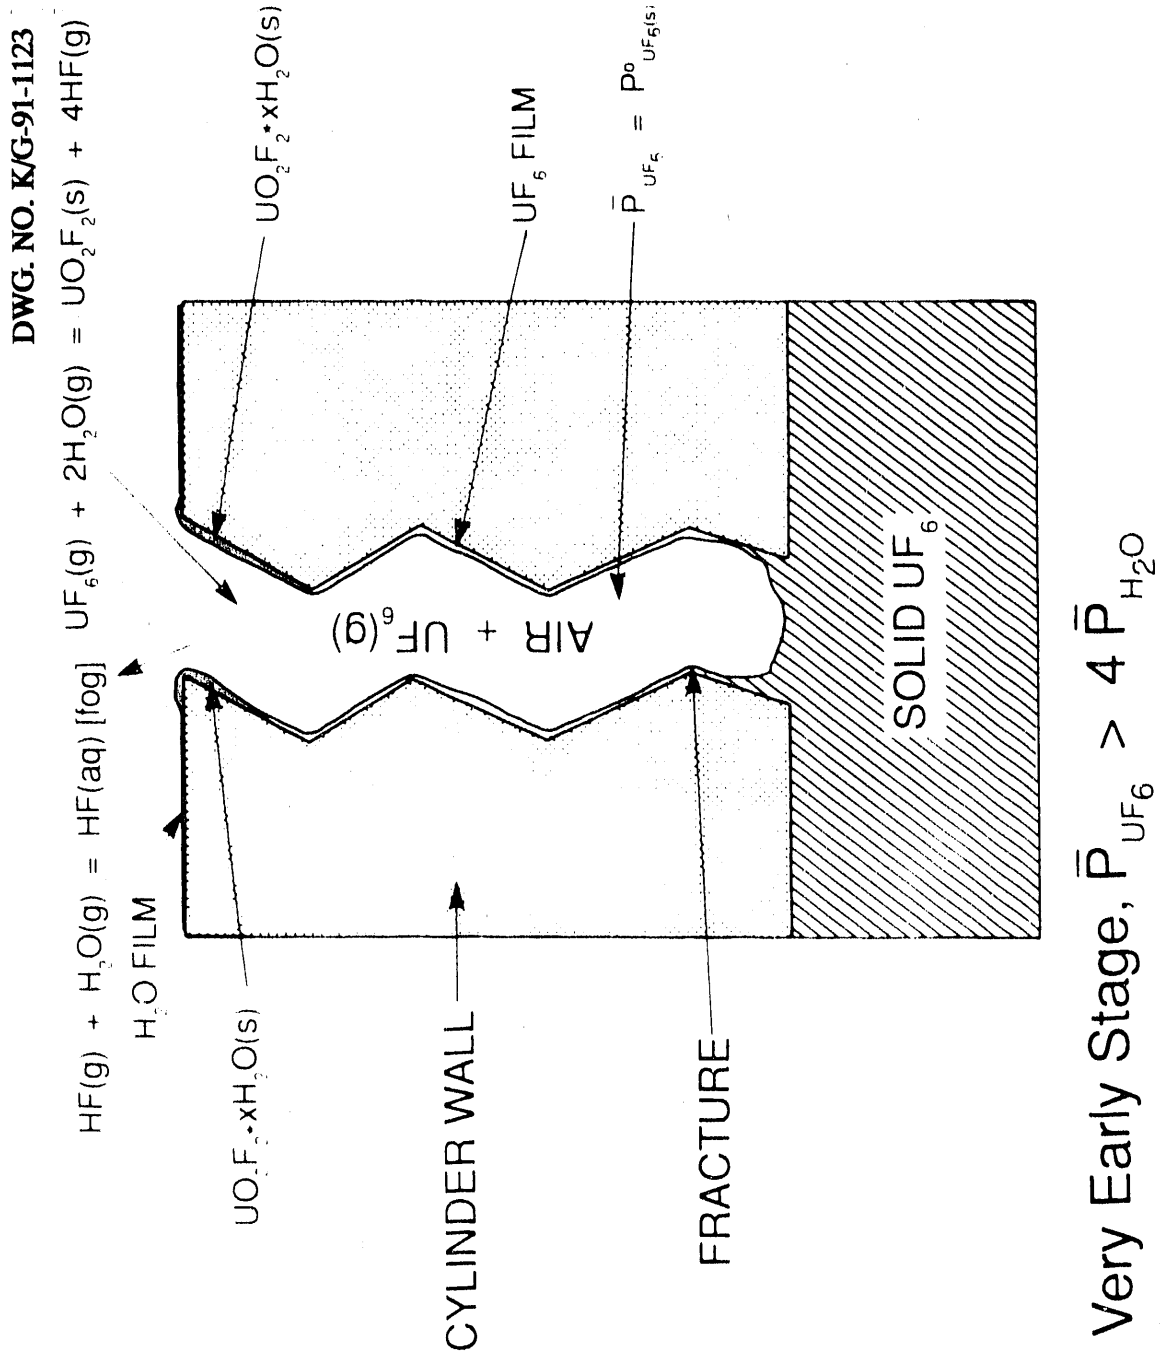
Fig. B3.5. Schematic cross section of fracture shortly after impact showing results of reaction initiation in phase 2.

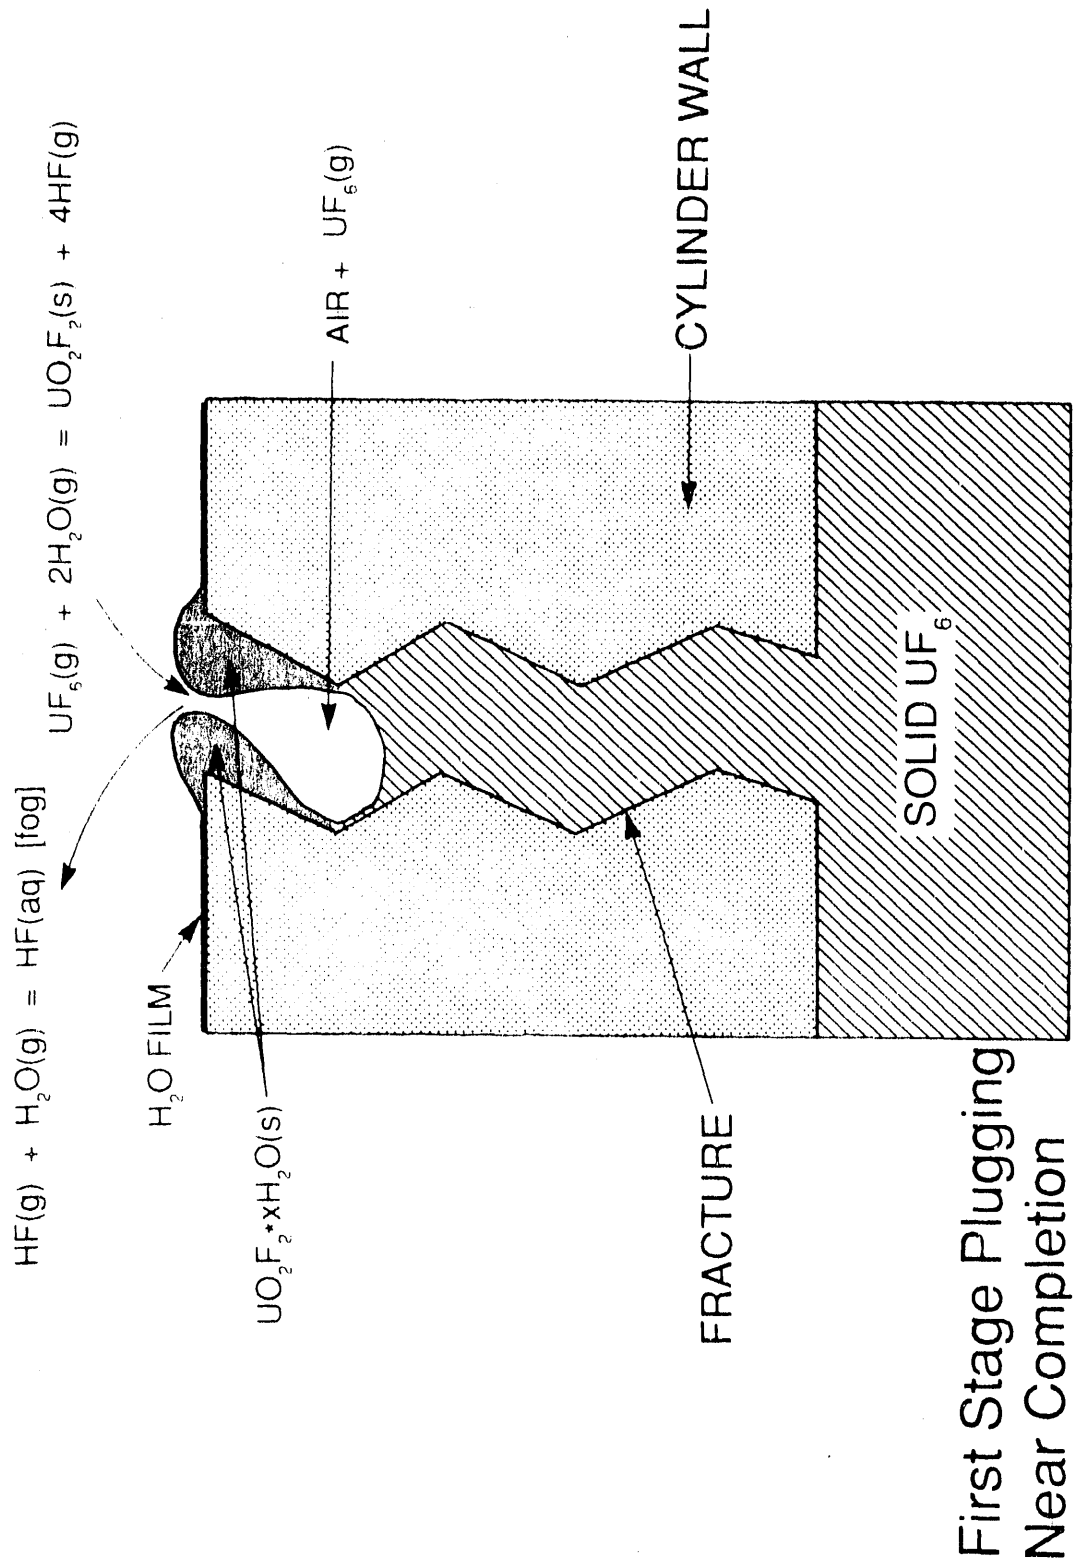
DWG. NO. K/G-91-1124

Fig. B3.6. Schematic cross section of fracture showing development of initial plug nearing completion.

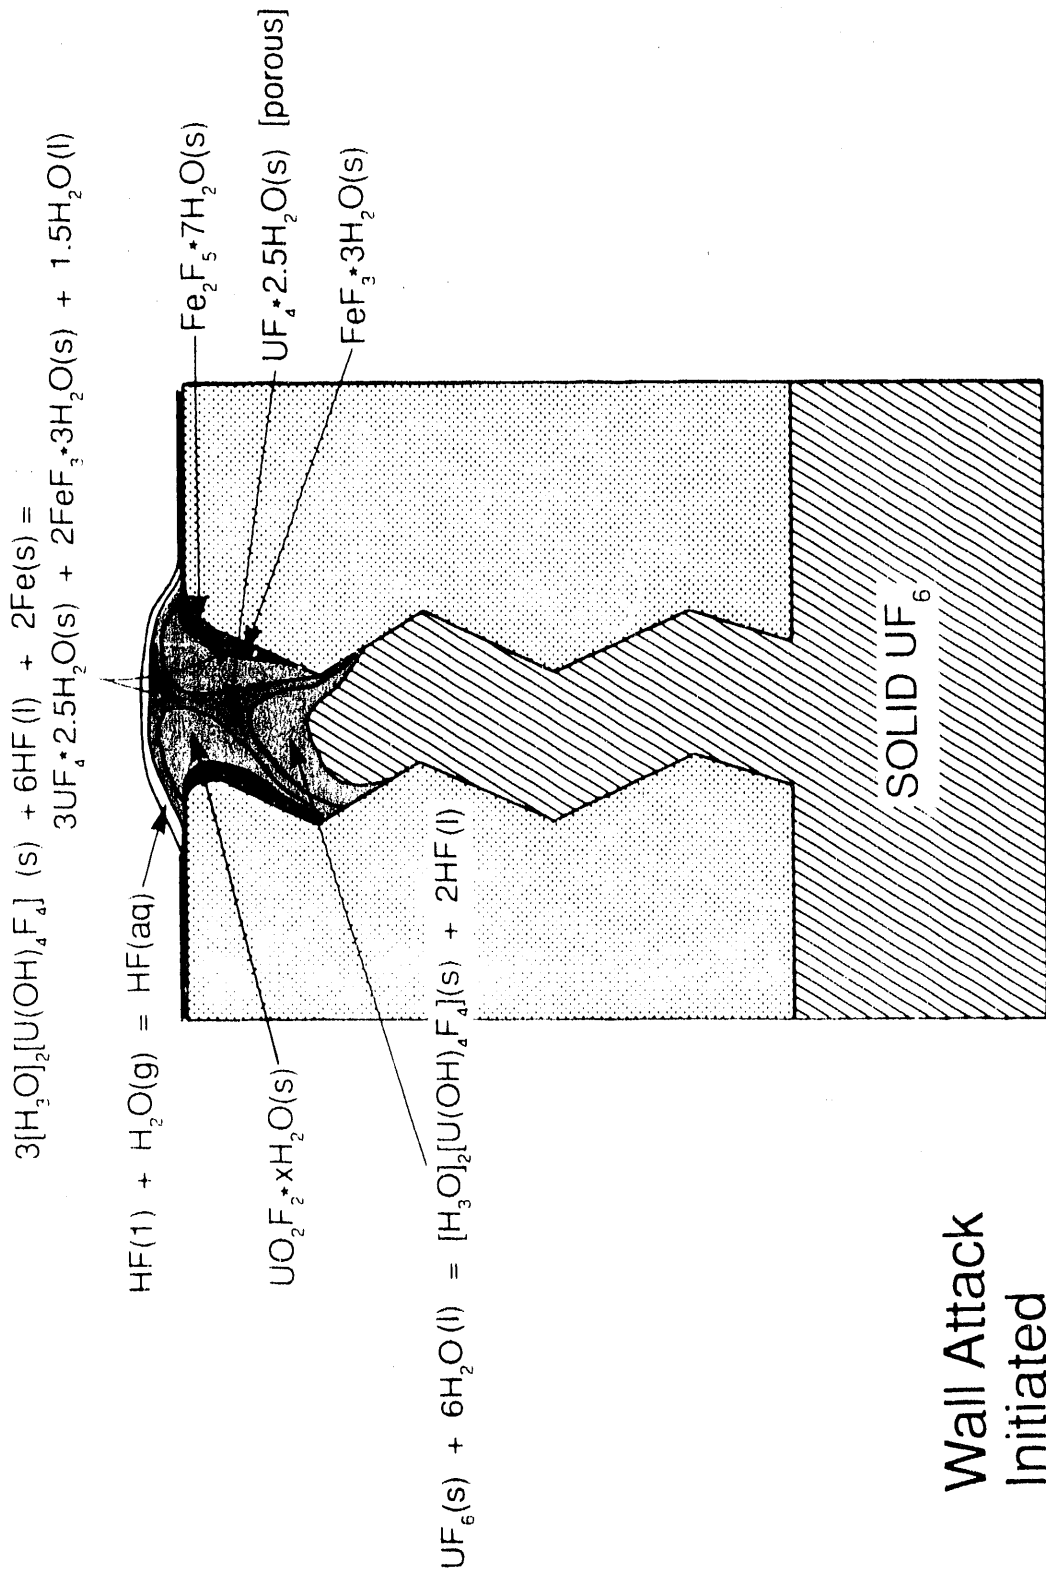
DWG. NO. K/G-91-1125

Fig. B3.7. Schematic cross section of fracture showing initiation of reduction and interior hydrolysis reactions in phase 3.

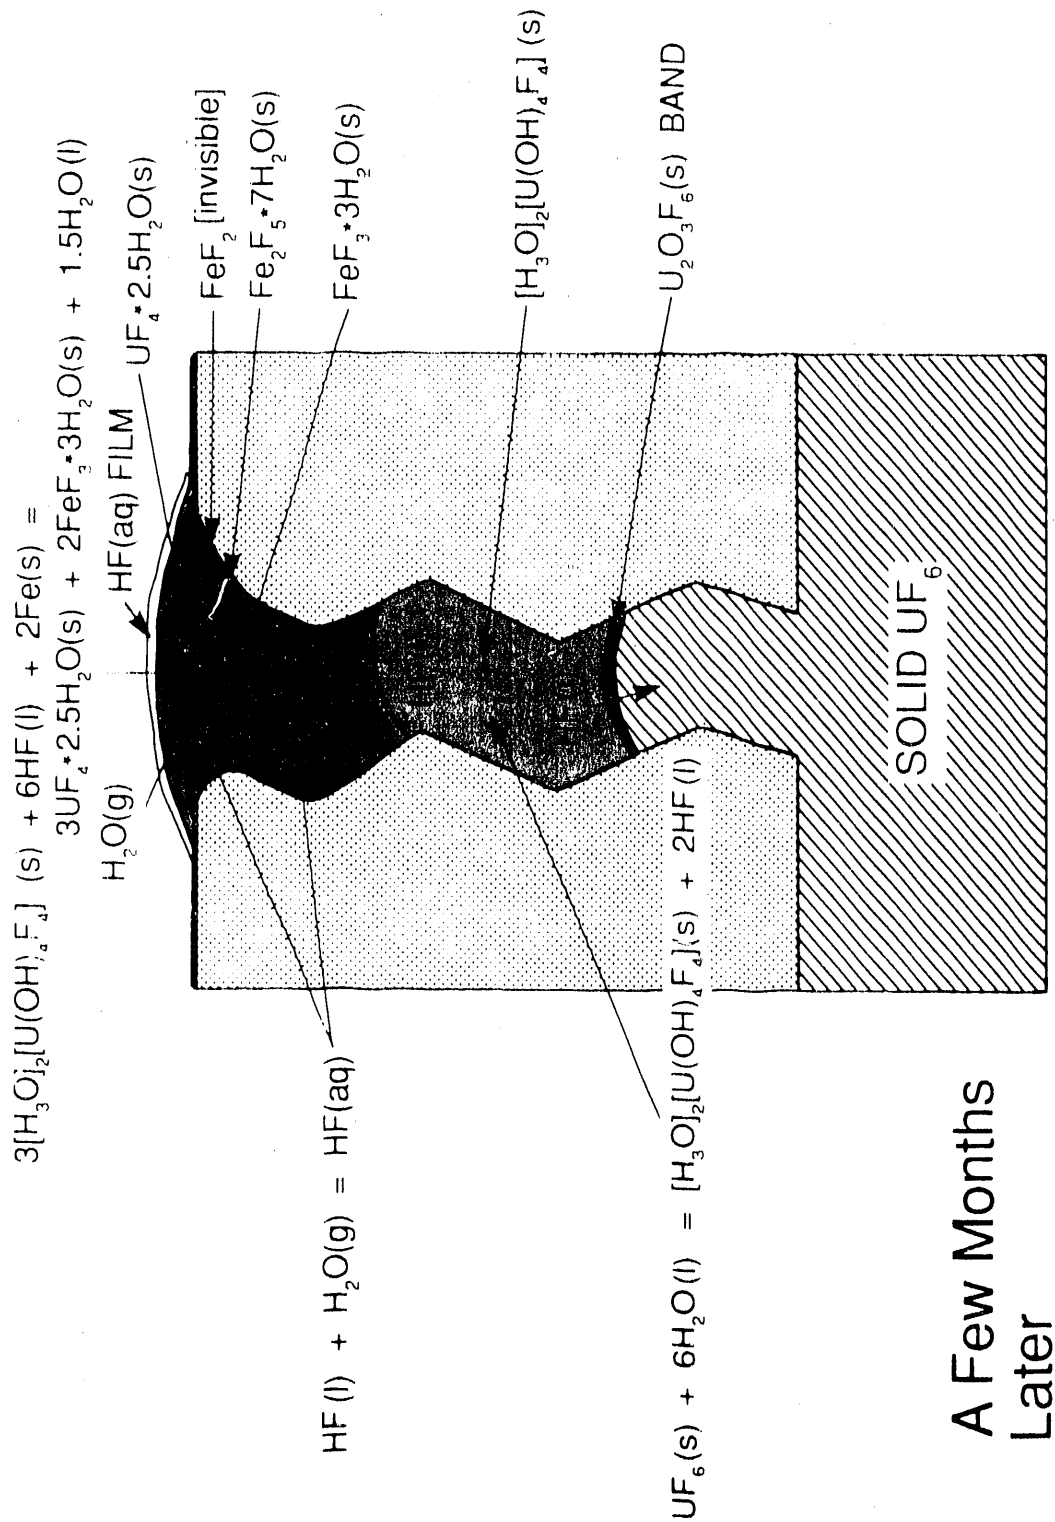
Fig. B3.8. Wall attack at fracture continues. Outer layer of  $\text{UO}_2\text{F}_2$  hydrate replaced by  $\text{UF}_6$  hydrate. Internal hydrolysis reaction continues down fracture.

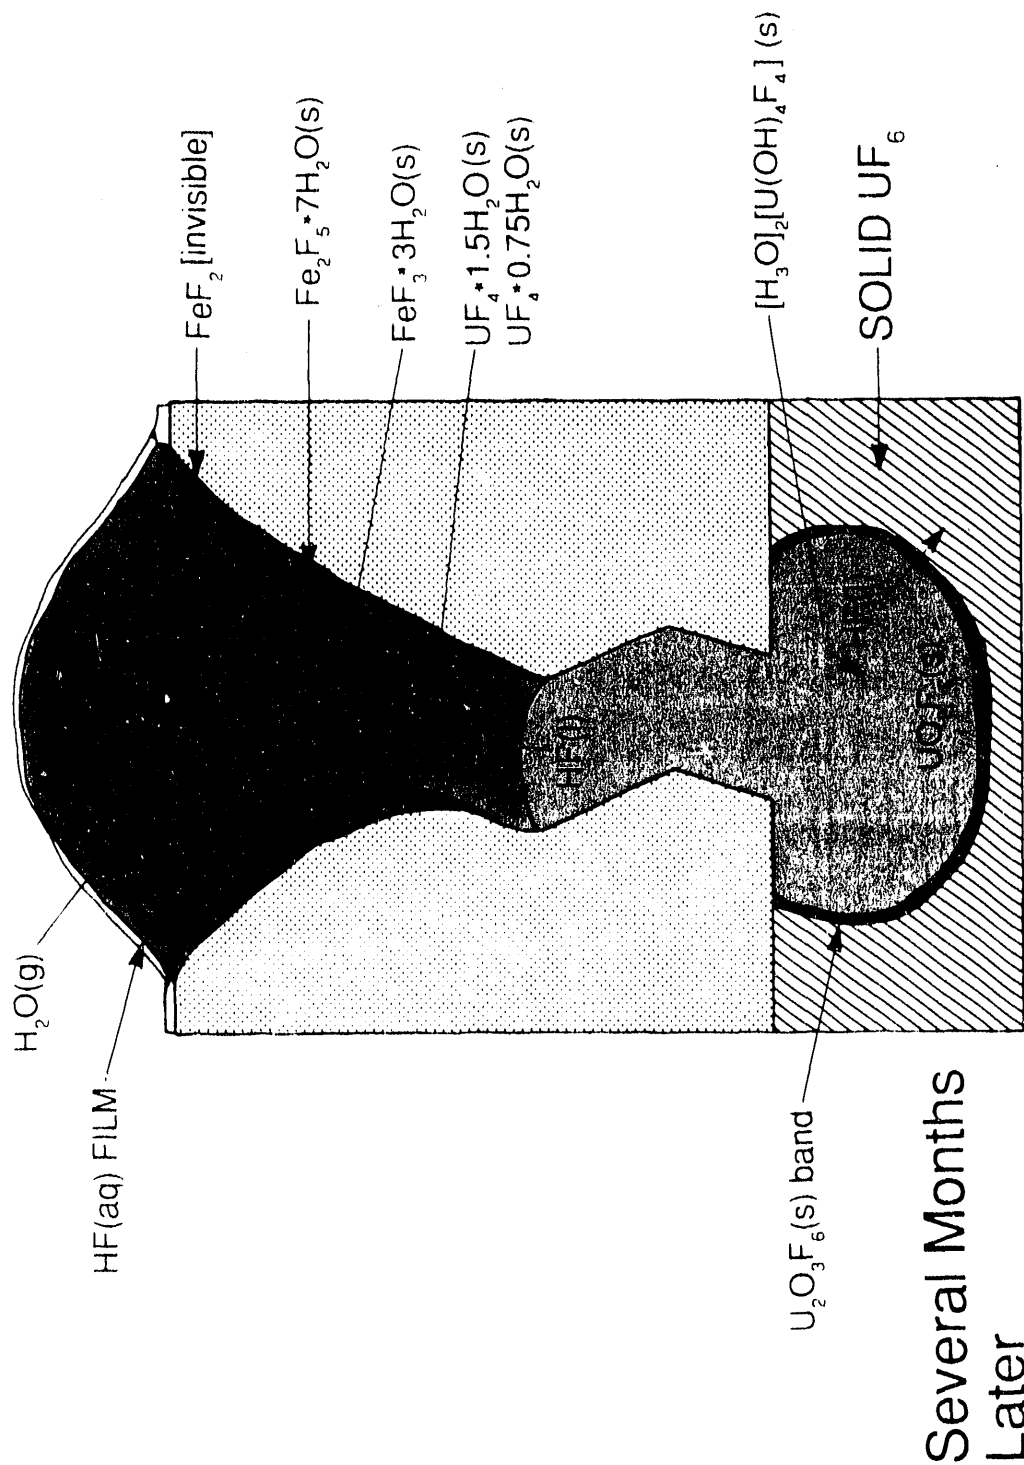
DWG. NO. K/G-91-1127

Fig. B3.9. Wall attack at fracture continues. Hydrolysis reaction enters into cylinder  $\text{UF}_6$ . Fracture is being enlarged from outside in.

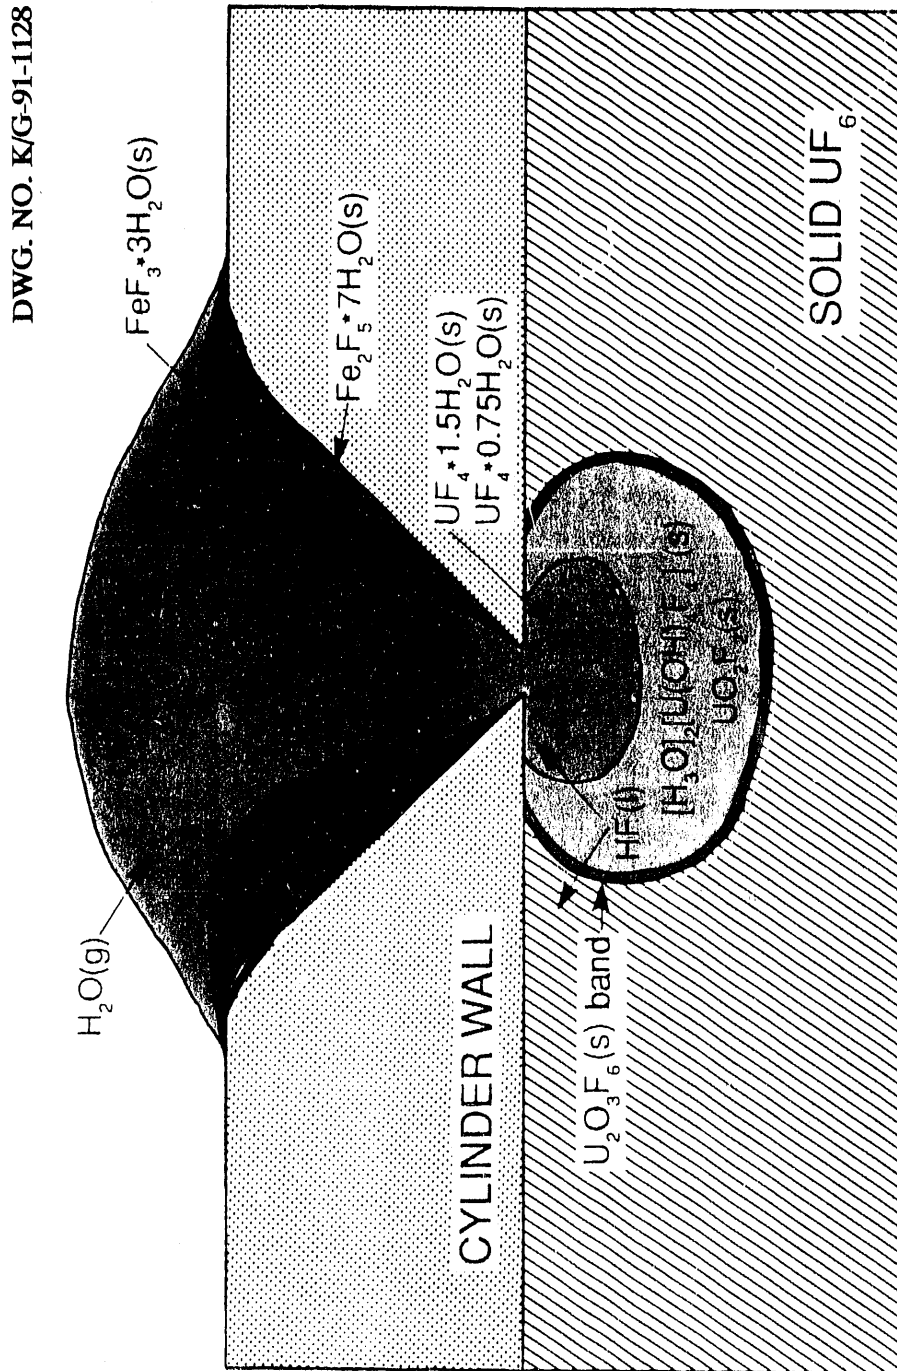
## Ten to Fourteen Months Later

Fig. B3.10. Phase 3 is completed as fracture is enlarged along full depth.  $\text{UF}_4$  hydrate is now forming inside cylinder. Hydrolysis of  $\text{UF}_6$  reactions surrounds the  $\text{UF}_4$  inside the cylinder.

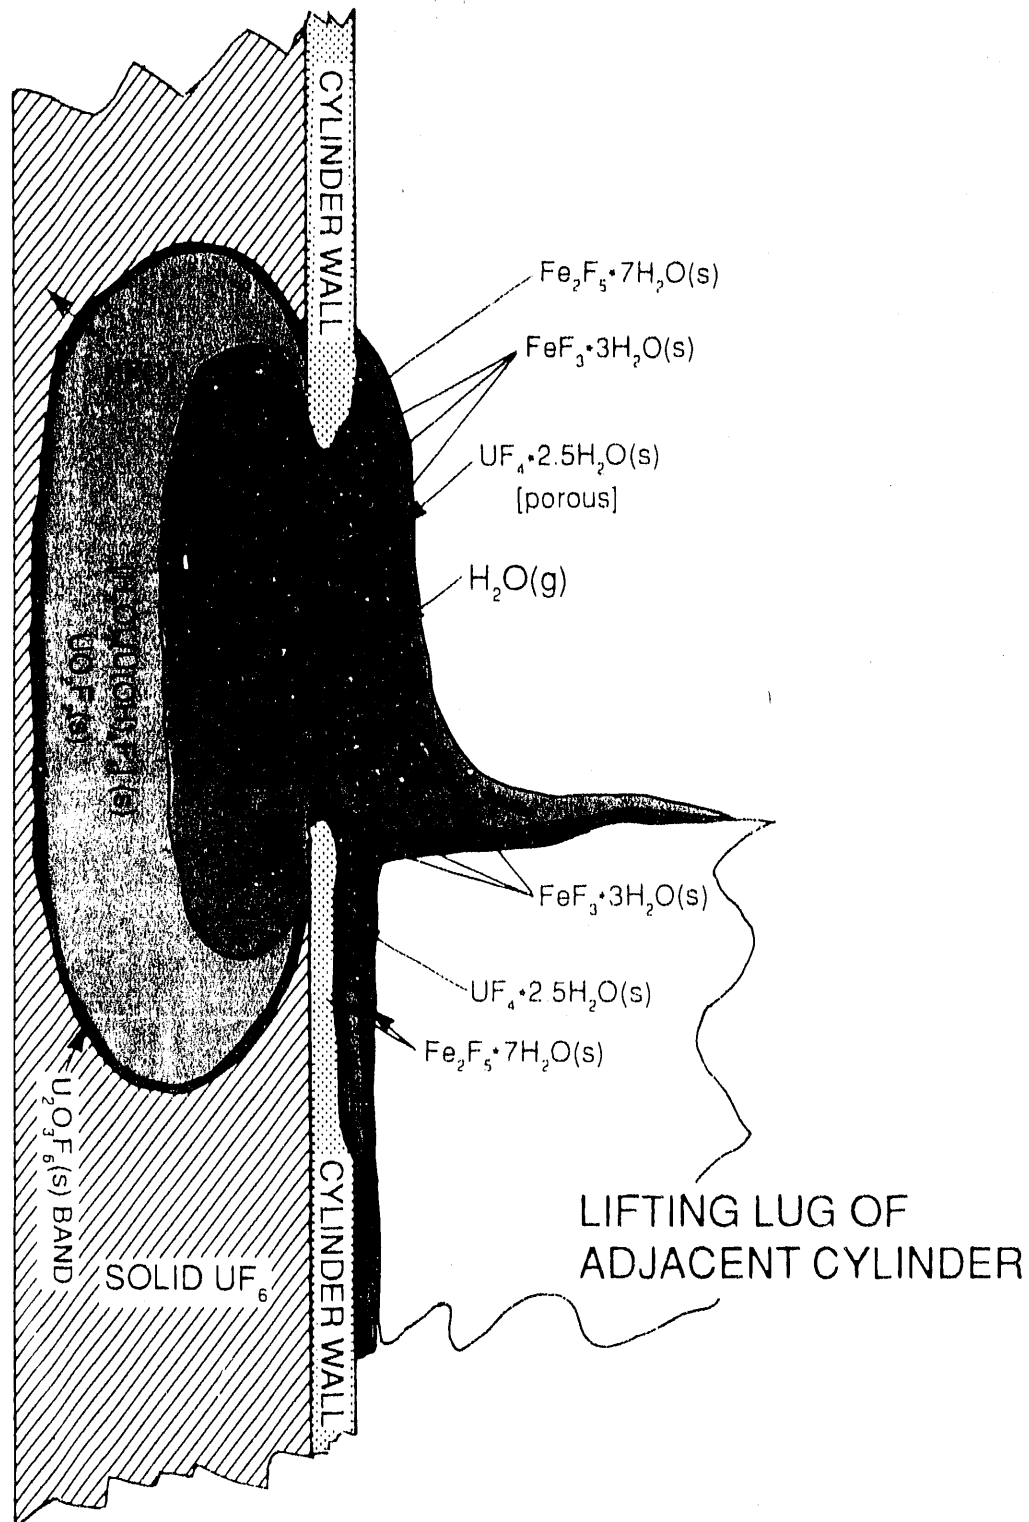
Four Years Later

Fig. B3.11. The main reactions continue to be hydrolysis of  $\text{UF}_6$  inside and reduction to  $\text{UF}_4$  inside and outside the cylinder. The fracture has become a small hole after 4 years.

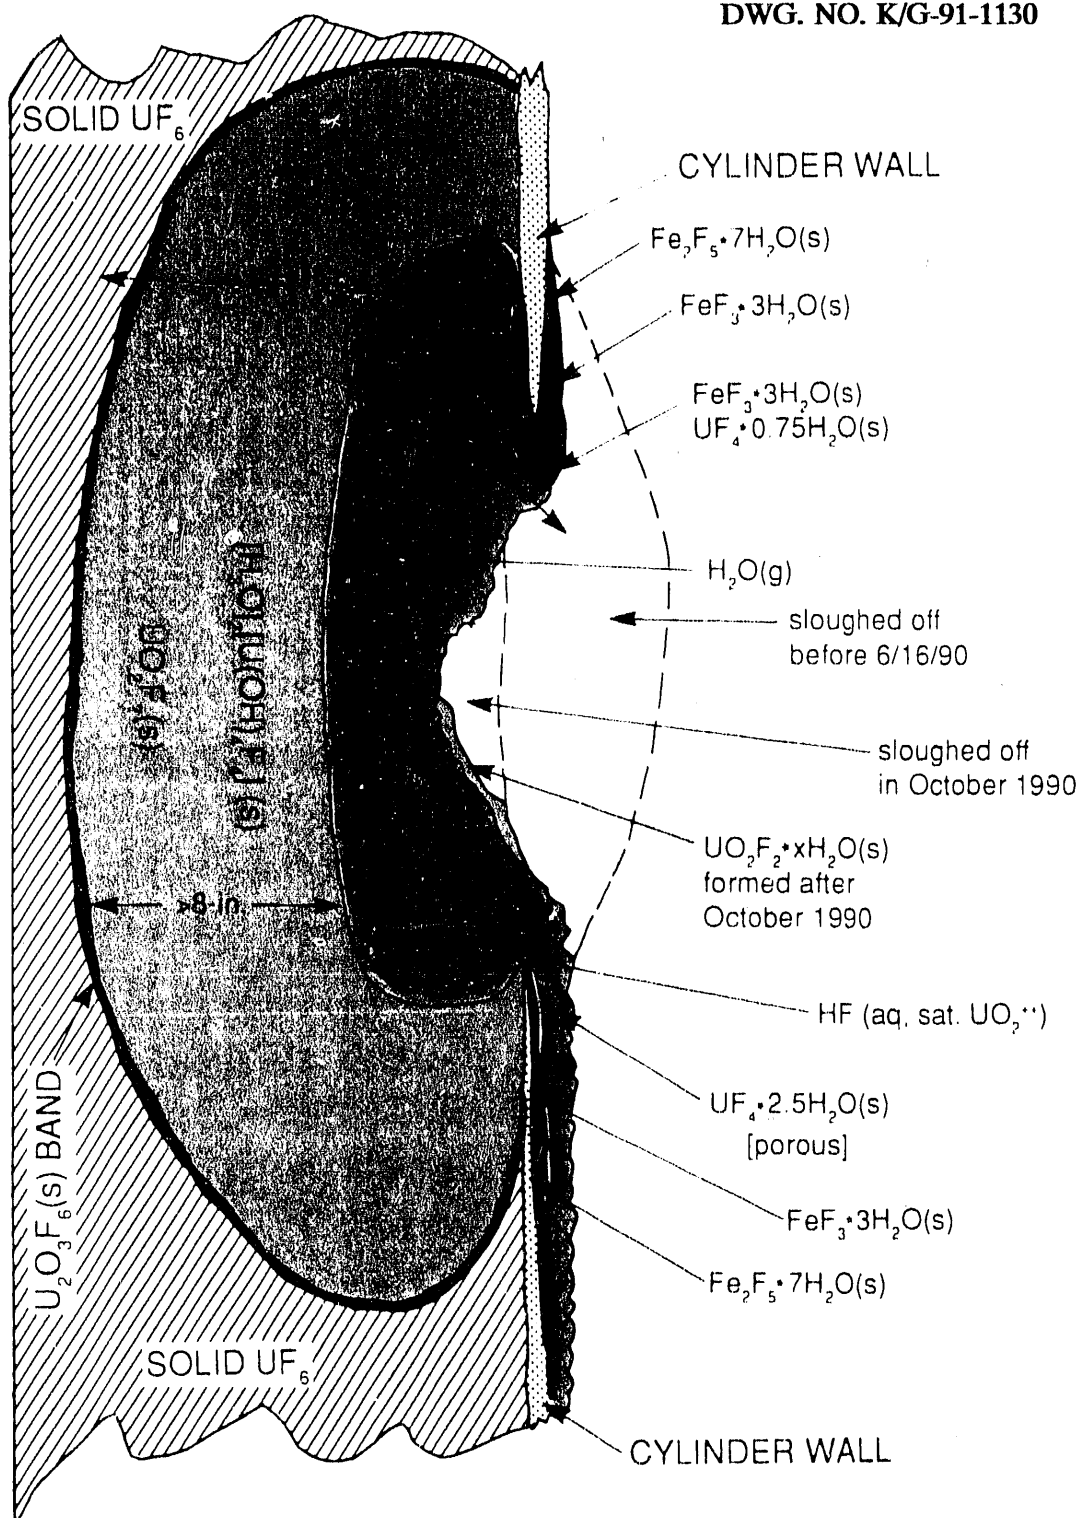
## Thirteen Years Later

Fig. B3.12. The hydrolysis and reduction reactions continue. Deposits outside the cylinder slough off. The HF escapes both as vapor and liquid solution. A small amount of hexavalent uranium in solution not reduced to  $\text{UF}_4$  hydrate escapes as  $\text{UO}_2^{++}$  from the vicinity of the cylinder. Condition shown is for 13 years after initial impact. The hole is now large, greater than 8 in.
