# A Review of Criticality Accidents

2000 Revision

**LA-13638**

**Issued: May 2000**

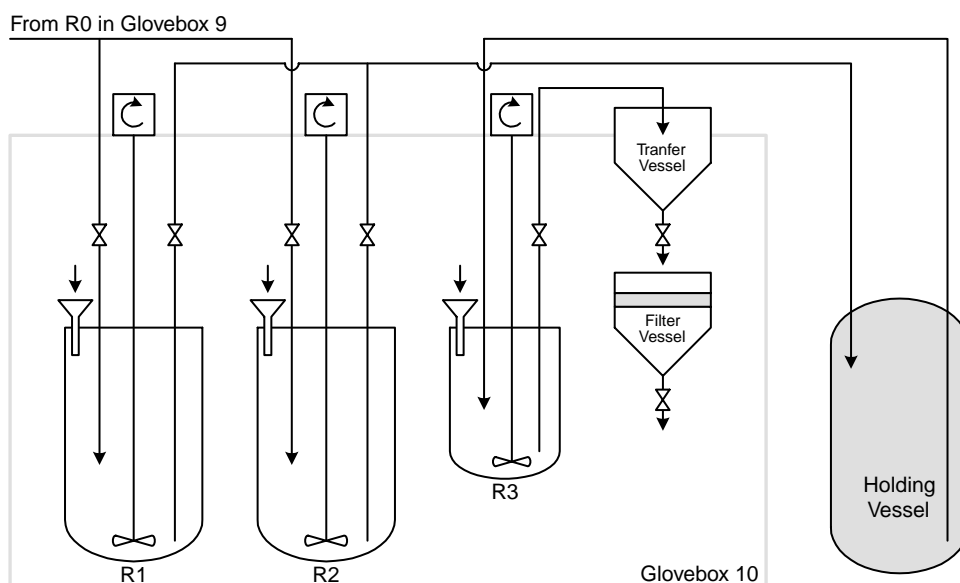
Figure 13. Layout of vessels in Glovebox 10 and the holding vessel external to the glovebox.

Figure 13 (not to scale) shows the five vessels located in glovebox 10 and the holding vessel located outside but connected directly to vessels inside the glovebox. Table 4 lists the seven vessels related to the reconstruction of the accident, along with their locations, dimensions, and function in the recovery operation. The operation began with a transfer of plutonium nitrate waste solution to vessel R0 in glovebox 9 where the first purification step was performed. This involved an oxalate precipitation of the plutonium, followed by a decanting of the supernatant liquid containing the impurities as well as some plutonium, and then re-dissolution of the plutonium into a carbonate solution. The end product from R0, the plutonium carbonate solution, was then transferred to either vessel R1 or R2 in glovebox 10 for the second purification (oxalate precipitation, supernatant decanting, re-dissolution) step. Vessels R1 and R2 were identical in dimensions and functions and were operated in parallel to increase productivity. The end

product from vessels R1 or R2 (again a plutonium carbonate solution) was then transferred to the holding vessel in preparation for batch transfer to vessel R3 where the last purification step was performed. The product from vessel R3, an oxalate precipitate slurry, was then vacuum transferred to the filter vessel via the transfer vessel. The oxalate precipitate collected by the filter vessel was then sent to another location for calcination.

Vessels R1 and R2 were equipped with transfer lines from R0 and to the holding vessel. The vessels also had stirrers and openings on top where a funnel could be used to add powdered reagents. The supernatant discharge lines (to vessels where the plutonium was concentrated by boiling and eventually returned to the recovery process) and the liquid chemical reagent supply lines are not shown. The supernatant typically had plutonium concentrations of about  $0.1 \text{ g/l}$ . Both vessels were shielded with 25 mm of lead. The holding vessel was unshielded and located about 400 mm above the concrete floor. The holding vessel was equipped with receiving lines from vessels R1 and R2, a transfer line to vessel R3, a vacuum line, and a compressed air line. Vessel R3 had lines and equipment identical to those of vessels R1 and R2. However, in the case of vessel R3, were solutions were received from the holding vessel and then sent out to the transfer vessel. Vessel R3 was also shielded by 25 mm of lead.

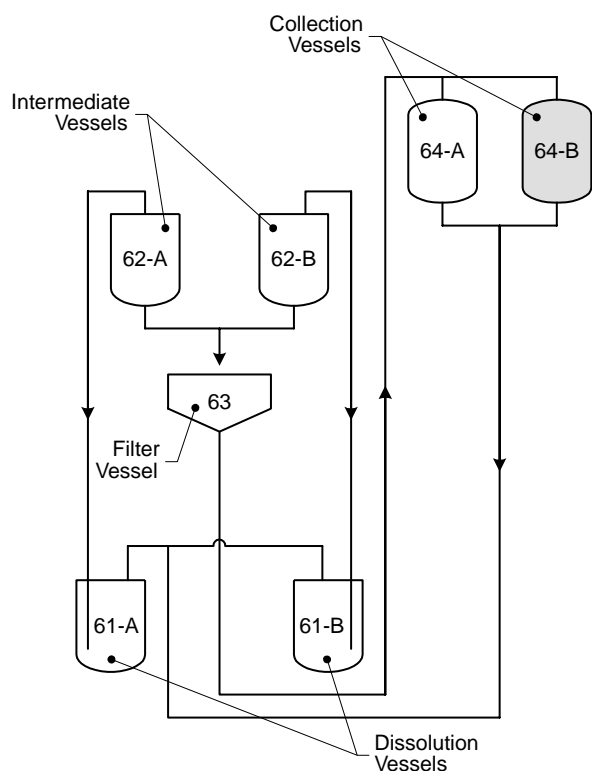
Figure 18. Process vessels and material flow diagram.

Using the erroneous work orders, an operator loaded 2 kg of precipitate from one container and 5 kg from another into dissolution vessel 61-A, believing the total uranium content to be 126 g when it was actually about 1,260 g. Because of a shift change, a different operator completed the dissolution process. The solution was then filtered and transferred to collection vessel 64-A, where a sample was taken to determine the concentration. Later during that same shift, the operator asked for the sample results by telephone. While this normally would have led to the discovery of the original recording error, the laboratory erroneously reported the results for a vessel other than 64-A. By an unfortunate coincidence, this other vessel contained solution with a uranium concentration 10 times lower than that in 64-A, thus reinforcing the operator's expectations.

The supervisor for the second shift, relying on this erroneous information, decided to recycle this supposedly low concentration solution to dissolve the next batch of dry precipitate. This next batch, still subject to the original recording error, contained ~1,255 g of uranium, about the same as that of the preceding batch. The dry precipitate was loaded into dissolution vessel 61-A and then the solution from collection

vessel 64-A was added. The dissolution vessel thus had over 2,500 g of uranium, an amount close to the unreflected critical mass for this diameter vessel. The solution was then filtered in 10 ℓ batches and transferred to the larger diameter collection vessel 64-B. In the course of this filtering/transfer operation, the solution exceeded the critical height in 64-B, and the first excursion occurred at 18:10 on 30 January 1963. The criticality alarm system sounded and all personnel evacuated. The γ-ray detectors were set to activate at 110 mR/h. Several of the personnel were directed to undergo medical assessment.

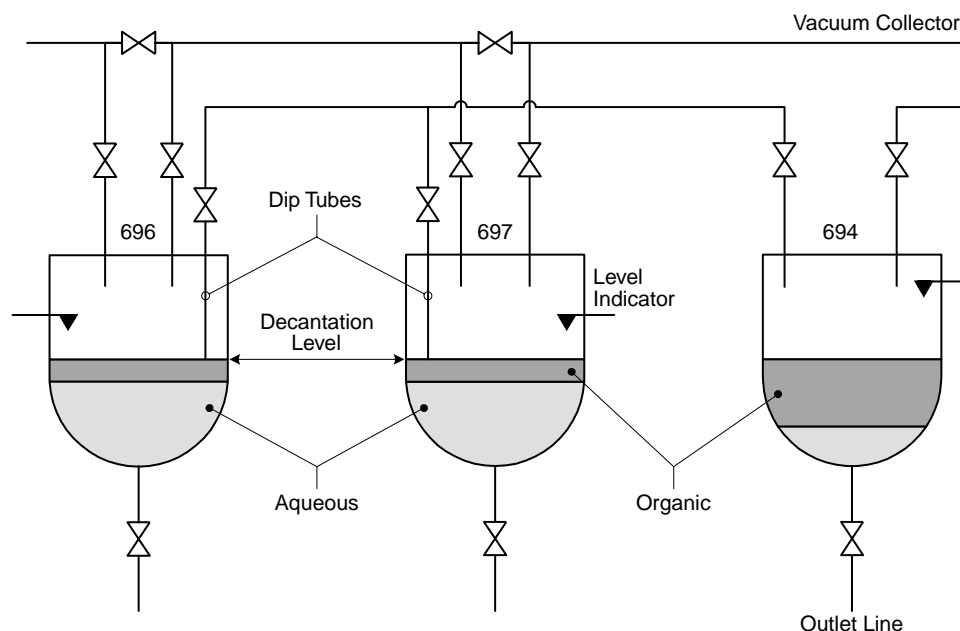
Figure 19. Schematic of vessels showing organic and aqueous solutions (not intended to imply the exact conditions at the time of the accident).

When these vessels were installed, it was believed that only high conductivity aqueous solutions would accumulate in them. However, because organics such as tributylphosphate were transferred in this facility using this same vacuum system, considerable amounts of organic solution were in fact also ending up in these vessels. The very low electrical conductivity of these organic solutions was insufficient to actuate the level indicators.

During typical operations, sufficient quantities of aqueous solutions would accumulate in vessels 696 and 697, causing the automatic decanting to occur up to four times per day. The elevation difference between the level indicator and the dip tube was slight, thus causing only 1 or 2 ℓ to be transferred at a time.

Because the organic solution was much less dense than the aqueous solution, the liquids separated into different layers within the vessels. Since the organic solution did not actuate the level indicators, it could continue to accumulate until the level of aqueous solution was sufficient to trigger a transfer. In addition, as aqueous solution entered the vessels it would temporarily mix with the organic solution. This caused a portion of the fissile material in the aqueous solution to be extracted into the organic layer, thus increasing its fissile material concentration.

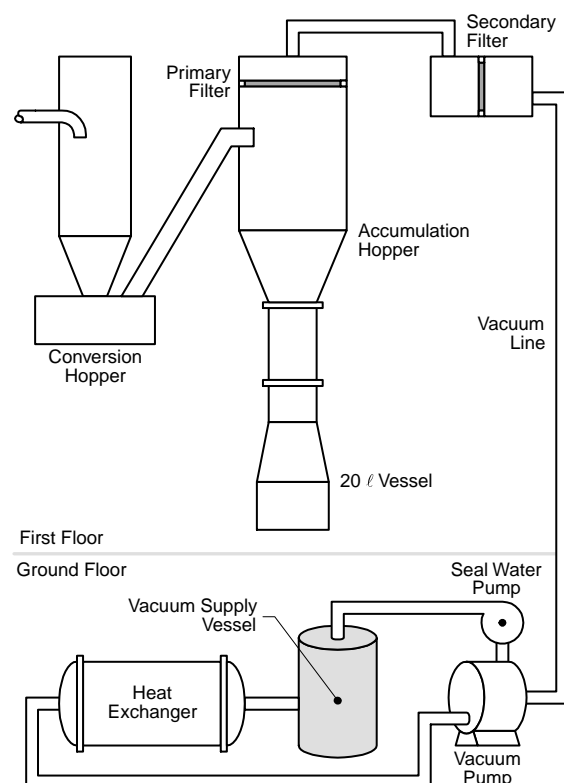
Figure 20. Layout of  $\text{UF}_6$  to uranium oxide conversion equipment and associated vacuum system.

Figure 20 is a layout of the Building 242 uranium hexafluoride to uranium oxide conversion system and associated vacuum system. The uranium hexafluoride was burned in a hydrogen-air atmosphere in the conversion hopper. The resulting uranium oxides were collected at the bottom of the conversion hopper and then transferred by vacuum to the accumulation hopper. The vacuum system was then switched off and the oxides were loaded into geometrically favorable 20 ℓ vessels by gravity. The vessels were then transferred from Building 242 to another location where the oxides underwent defluorination and complete reduction to  $\text{UO}_2$  in a rotating calcination furnace.

On 3 November 1965 at 11:10, the criticality accident alarm system sounded in Building 242. All personnel in Building 242 immediately evacuated. The alarm systems of the adjacent buildings did not activate. The facility's chief physicist made the first re-entry into Building 242 about 50 minutes after the building had been evacuated. Using a portable gamma-ray detector, he quickly determined that an accident had occurred in the vacuum supply vessel. At this time he recorded a gamma exposure rate of 3.6 R/h at a distance of 1.5 m from the surface of the vessel.

was used to break the glass site gauge on the side of the vessel. Geometrically favorable collection trays were positioned so as to collect the draining liquid. The draining operation resulted in the collection of about 60 ℓ of liquid. Analysis showed that the liquid contained 85 g of uranium per liter or a total of 5.1 kg of uranium. Eight days after the accident (11 November 1965), the vacuum supply vessel was opened and an additional 51 kg of uranium was recovered. The total material recovered from the vacuum supply vessel was 56.1 kg of uranium or, at 6.5% enrichment, about 3.65 kg of  $^{235}\text{U}$ . An additional 13.9 kg of uranium was recovered from the shell-and-tube heat exchanger and connecting lines. The total material recovered was 70 kg of uranium or about 4.6 kg of  $^{235}\text{U}$ .

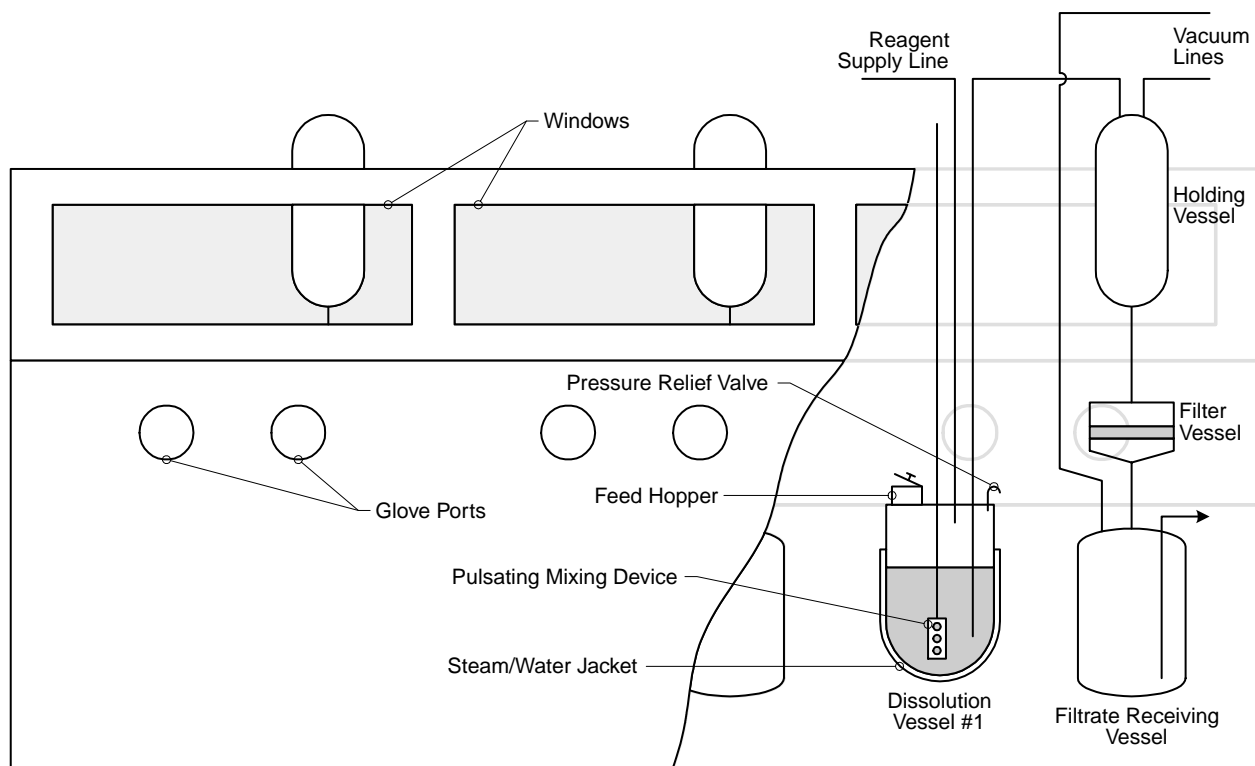
Figure 22. Layout of dissolution glovebox.

The residue dissolution glovebox where the accident occurred had three identical sets of process equipment as shown in Figure 22. Each set was equipped with a cylindrical dissolution vessel, a holding vessel, a filter vessel, and a filtrate receiving vessel. The dissolution vessels had elliptical bottoms, were 100  $\ell$  in volume, and 450 mm in diameter, and were equipped with a pulsating device for mixing, a flat cover plate with a feed hopper, and a pressure relief valve. Heating of the dissolution vessels was accomplished with a 25 mm thick, steam-water jacket. Solution was moved within the system through a transfer line by drawing vacuum.

The residues were loaded into the dissolution vessel via the feed hopper located on the cover plate. The feed hopper was equipped with a lid that was sealed and locked in place during dissolution. Dissolution was accomplished by adding acid and heating the solution while mixing with the pulsating mixing device. Once dissolution was complete, the resulting solution was vacuum transferred to the holding vessel. The solution was then passed through the filter vessel (to remove non-dissolved solids) to the filtrate receiving vessel.

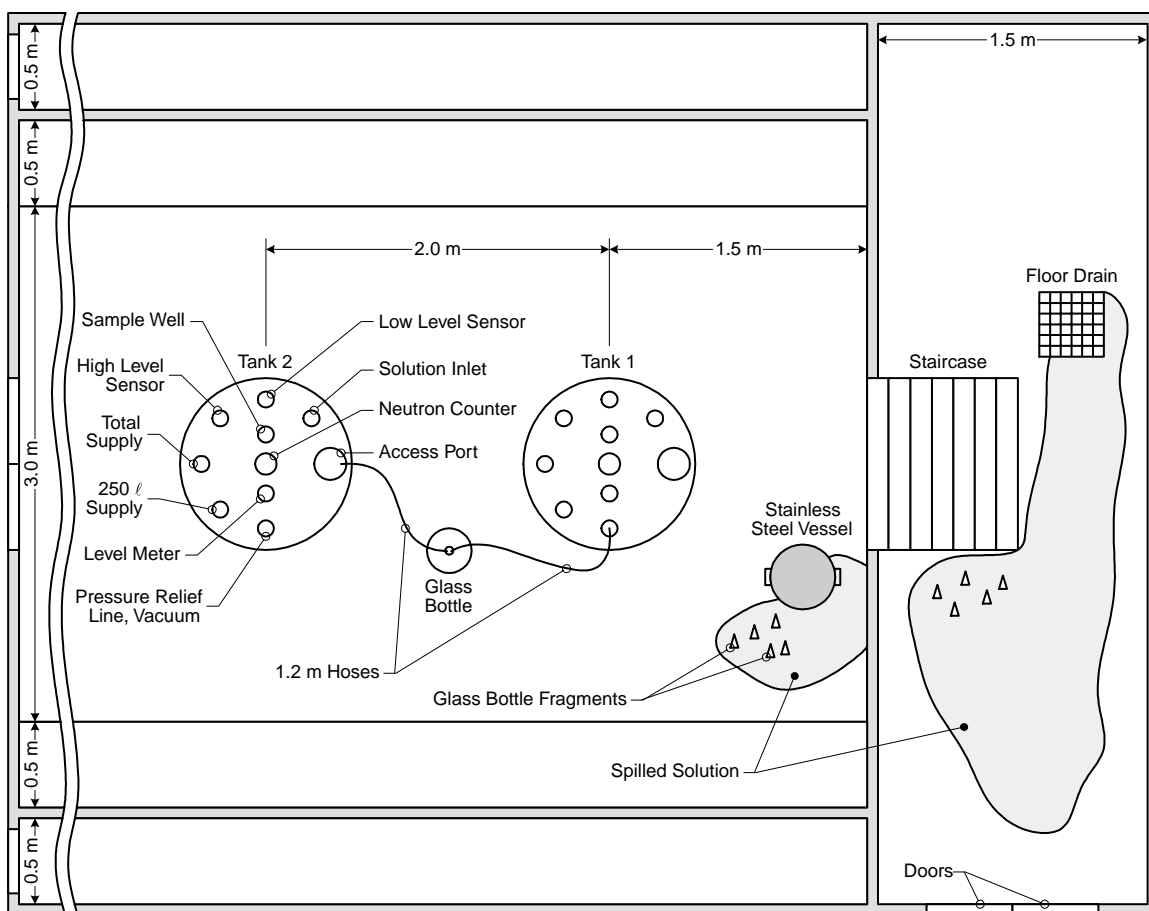
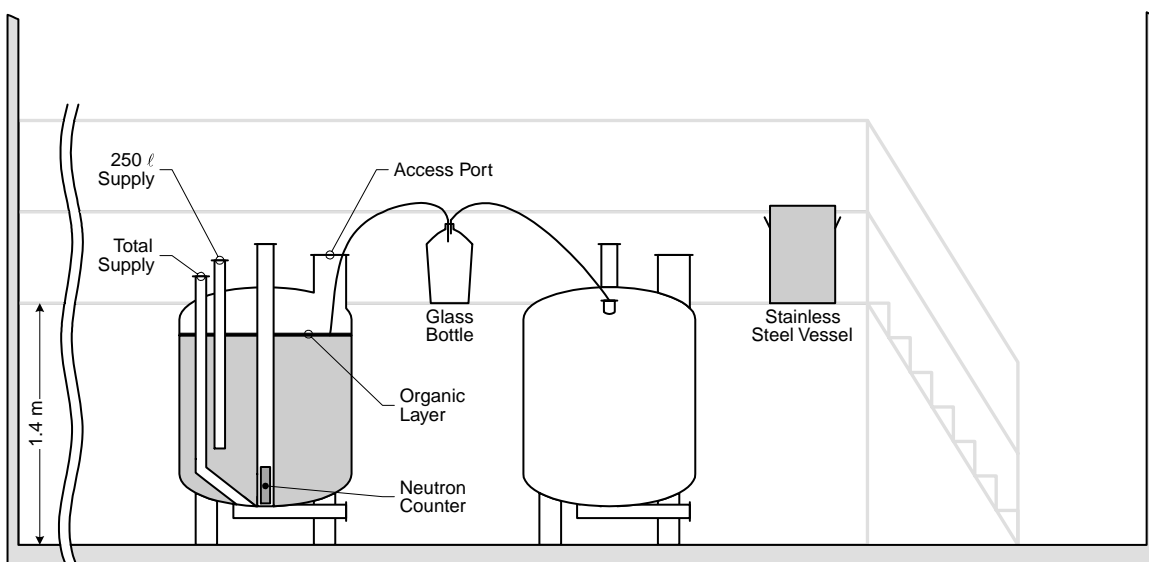
Figures 23 and 24 show plan and elevation views of these tanks, and the other vessels involved in the accident by their location in the basement room. Each tank had an operating volume of 800 ℓ. Each was equipped with neutron detectors located near the bottom to monitor the plutonium concentration and to detect any sediment accumulation.

On 10 December, the 19:00 shift supervisor instructed an operator to sample the contents of tank 2 before transferring it to recovery operations. Since the sampling device was out of order, the sample was taken by lowering a glass vial on a thin line through one of the upper level sensor ports [Figure 24]. The results of the analysis indicated that the plutonium concentration was  $\sim 0.6$  g/ℓ. Since the total volume of solution in the tank was  $\sim 800$  liters, the total plutonium mass was  $\sim 480$  g, which exceeded the criticality safety mass limit of 400 g. According to regulations, the shift supervisor then ordered that two additional confirmatory samples be taken.

The temporary arrangement of equipment used to remove the organic solution from tank 2 is shown in Figures 23 and 24. Two reinforced rubber hoses, 1.2 m in length and 13 mm in internal diameter, were fixed into the neck of a 20 ℓ glass bottle (usually used for chemical reagents) with a cloth plug. One hose was connected to the vacuum line on tank 1 and the other was lowered into tank 2 through its access port. If the 20 ℓ bottle became full, it was decided that the contents would be poured into a 60 ℓ vessel usually used for the collection of very low concentration wastes before reprocessing. The bottle and vessel were placed on the platform above tanks 1 and 2. The use of these types of temporary, improvised, setups as well as the use of unfavorable geometry vessels were strictly prohibited by existing regulations.

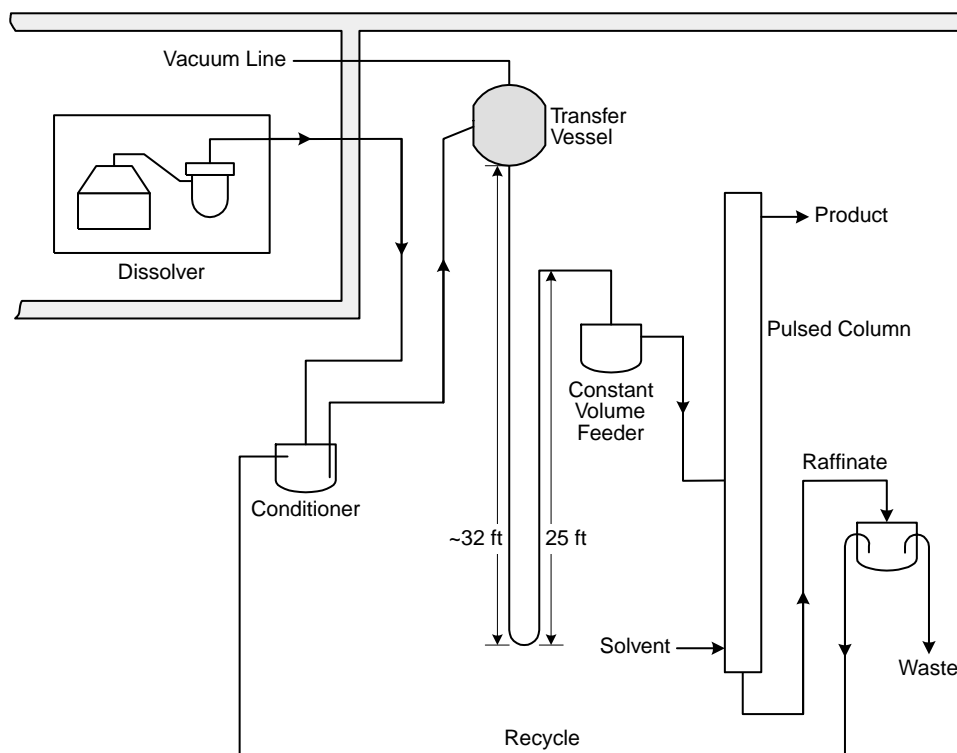
Figure 25. Process equipment related to the criticality accident.

The solution was vacuum lifted from the conditioner to a transfer vessel (Figure 25). When the transfer was

The excursion occurred on completion of the transfer of a 50 ℓ batch of solution from the conditioner to the transfer vessel. The small size ( $10^{15}$  fissions) and brief duration (less than 10 s) of the excursion precluded the termination of the excursion

due to any energy based shutdown mechanism. Radiation measurements indicated that the excursion occurred in the transfer vessel, but the solution from the conditioner was too lean to sustain criticality, and the total quantity of plutonium in the batch (300 g) was about 50% of the minimum critical mass. Thus, it was feared that the transfer vessel might contain large quantities of solids, perhaps tens of kilograms and that any disturbance of the system might cause another, possibly much larger, excursion.

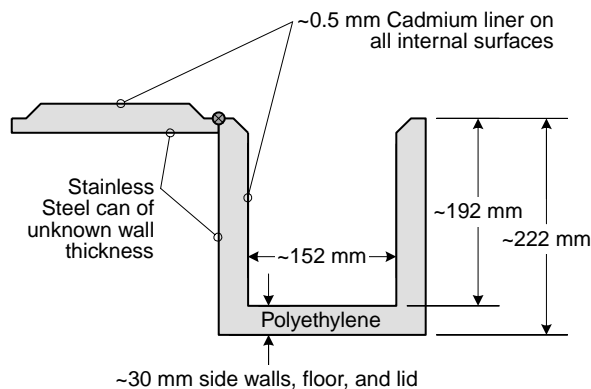
Figure 28. Storage container.

Transfer and temporary storage of the ingots within the gloveboxes was accomplished using cylindrical storage containers designed specifically for this purpose. The containers were lined with a 0.5 mm thick cadmium layer and had a 30 mm thick shell of polyethylene encased in a stainless steel sleeve (Figure 28). The design decreased the neutron interaction for a planar array to such a degree that it was not necessary to control the number or storage arrangement of the containers within any of the gloveboxes.

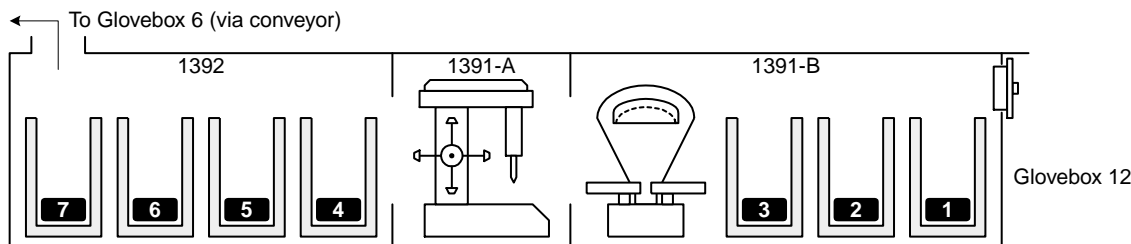
Figure 29. A simplified layout of Glovebox 13.

Glovebox 13, where the criticality accident took place, consisted of three workstations, (1391-A, 1391-B, and 1392, see Figure 29) and was connected to gloveboxes 12 and 6 by a pass-through port and conveyor, respectively. All of the ingots produced at the plant passed through this glovebox operation. For these particular workstations, the administrative limit for the containers was even stricter, allowing only one ingot regardless of its mass. Workstation 1391-A was used for extracting drill samples (up to 0.1 g) for chemical analysis of the impurities. The ingots were weighed in workstation 1391-B, where the samples were also temporarily stored. Workstation 1392 was used for measuring the dimensions of the ingots. Within the workstations the ingots were removed and returned to their original containers one at a time. The workstations were equipped with pass-through ports in the connecting walls, gloveports, and 50 mm thick leaded glass windows. The front of the workstation had a 30 mm thick lead shield to reduce the  $\gamma$ -radiation from the plutonium.

At the beginning of the shift on 13 December 1978, three containers were in workstation 1391-B, and four containers were in workstation 1392, each with one ingot. The ingots are numbered sequentially in Figure 29 for the purpose of the discussion that follows. Although the containers are depicted as being linearly arranged, in actuality the containers holding ingots 4 and 5 were behind those with ingots 6 and 7, making visual inspection of the contents more difficult

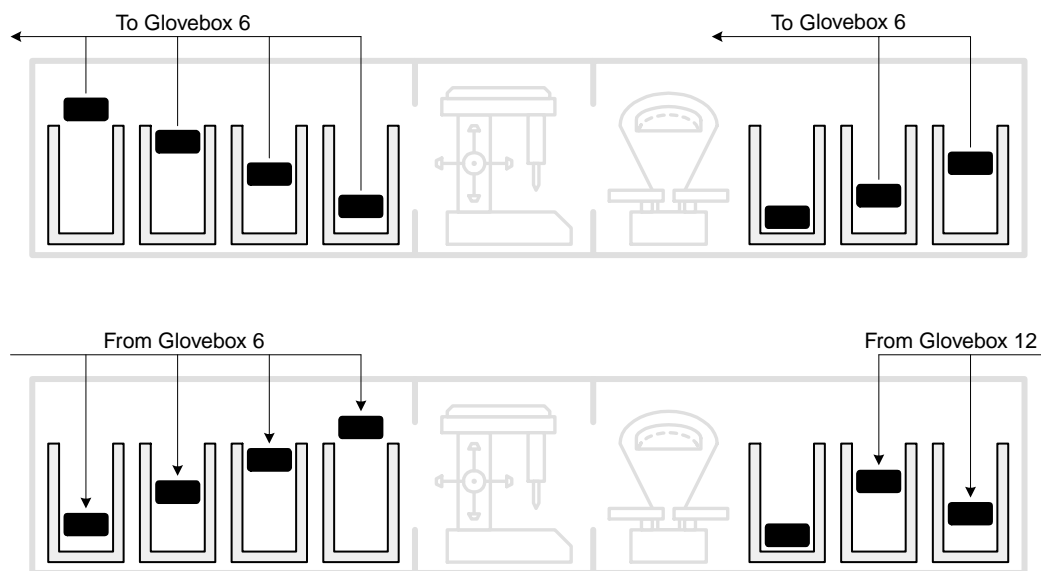
The intended order of ingot transfers, as specified in the shift instructions, is illustrated in Figure 30. The actual order of ingot transfer is shown in Figure 31, Frames 1 through 6. Operator A transferred two ingots, 6 and 7, from workstation 1392 to glovebox 6. These ingots were replaced in workstation 1392 by two ingots, 8 and 9, from glovebox 6. Both of these actions were in accordance with the shift instructions.

Figure 30. Intended sequence for the transfer of ingots from and to Glovebox 13.

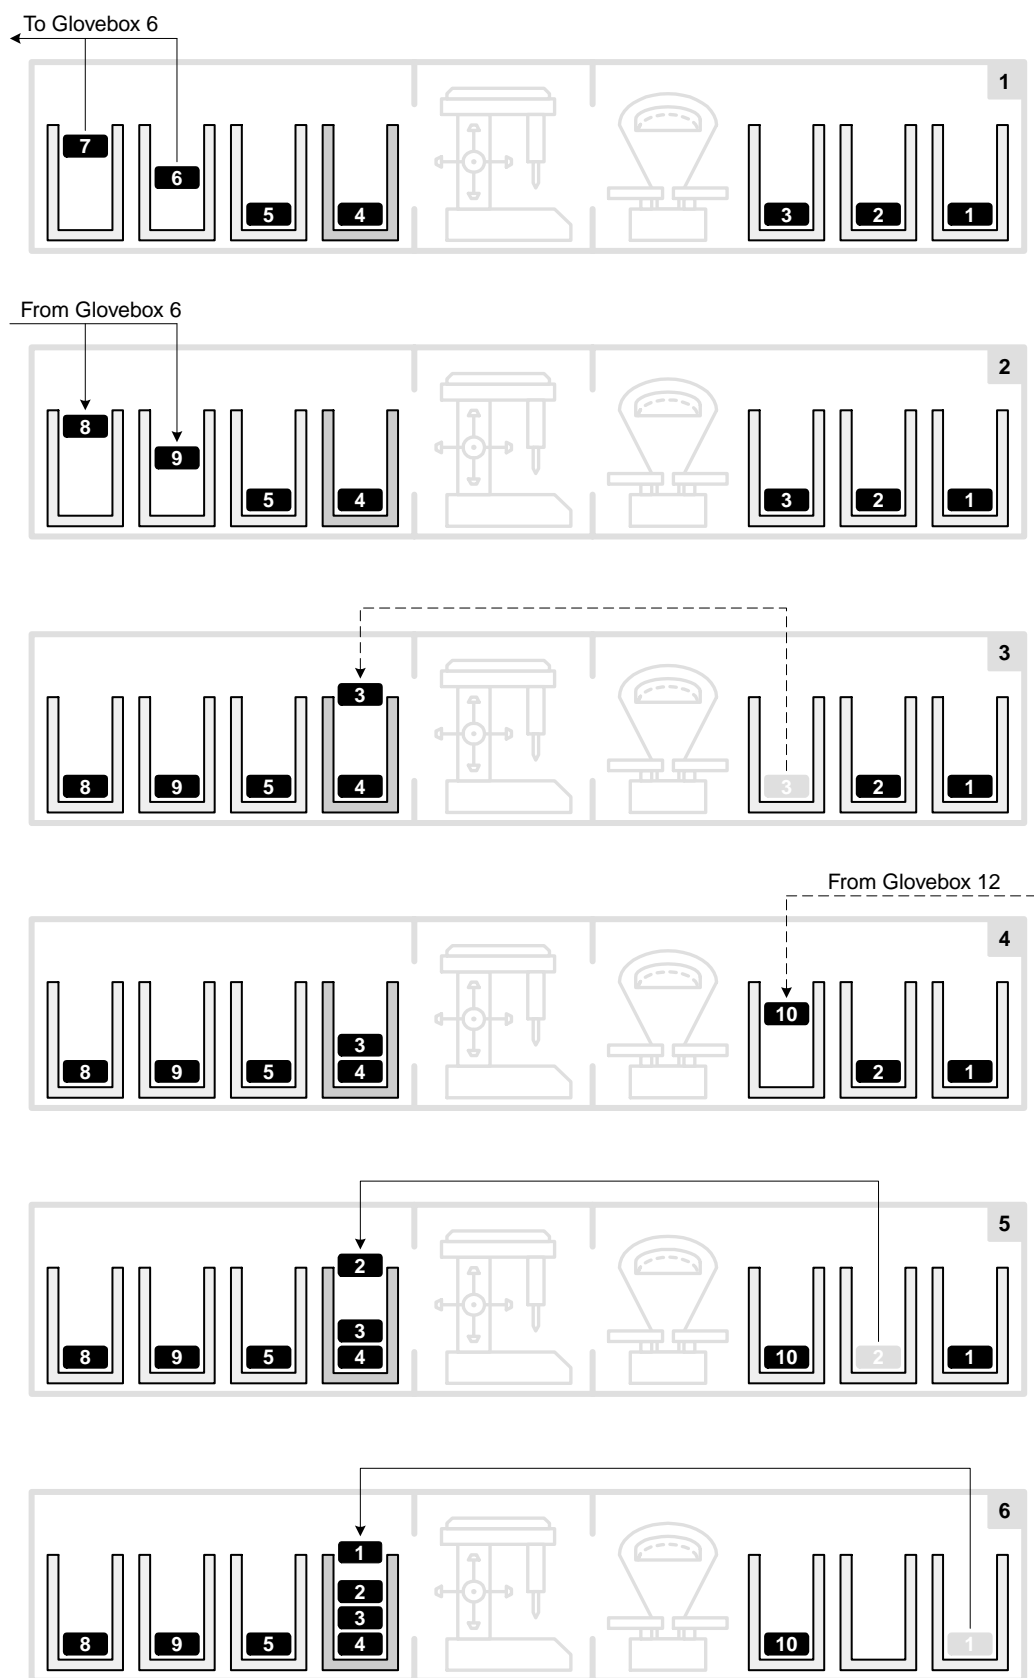
Figure 31. Actual order of ingot transfers from and to Glovebox 13. The solid lines represent the actions of operator A and the dotted lines the actions of operator B.

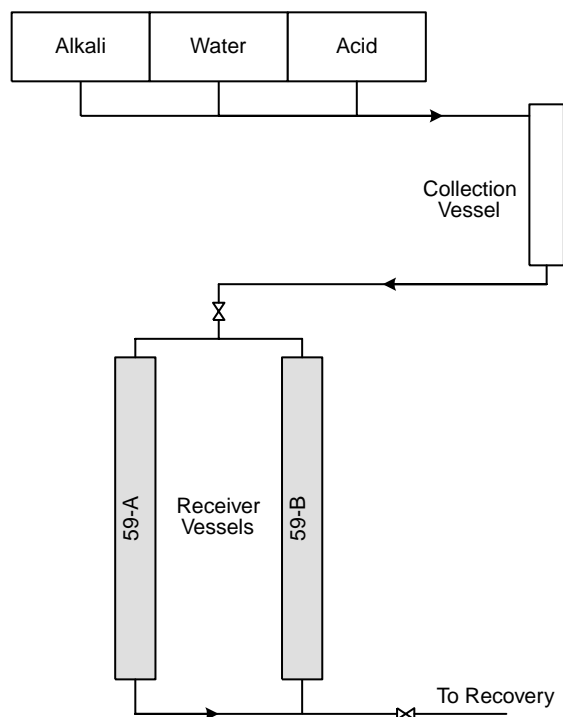
This accident occurred in Building 17 where highly enriched U(90) fuel rods were fabricated from  $\text{UO}_2$  and aluminum, using the powder metallurgy method. The final process prior to placing a rod into its aluminum cladding was chemical etching. The objective of this operation was to remove microscopic defects on the rod surfaces to ensure tight contact between the rod and its cladding. The major components of the process equipment are shown in Figure 32.

Figure 32. Major components of the chemical-etching process.

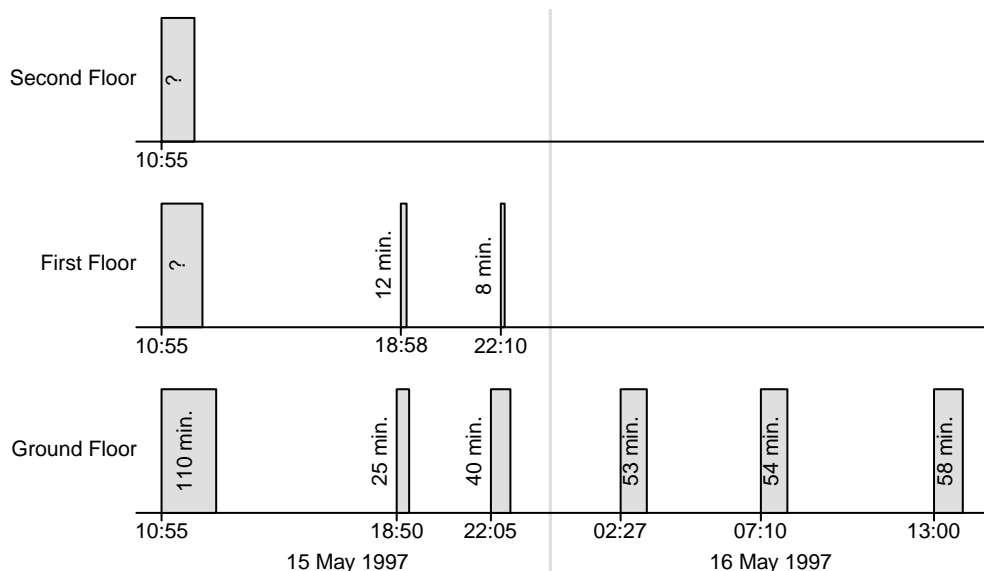
samples of the  $\text{UO}_2$  particles taken on 20 May. The detectors were located at 12 monitoring stations. However, during the excursions, at most only three of the monitoring stations alarmed, indicating very low peak power for each excursion. These three stations were located on the ground, first, and second floors directly above one another. From the central control room, health physicists documented the sequence of excursions, the response of the detectors, and the length of time that the detector alarm threshold ( $36 \text{ mR/h}$ ) was exceeded (Figure 33).

Figure 33. Sequence of alarms and duration that the radiation levels exceeded the alarm level ( $36 \text{ mR/h}$ ).

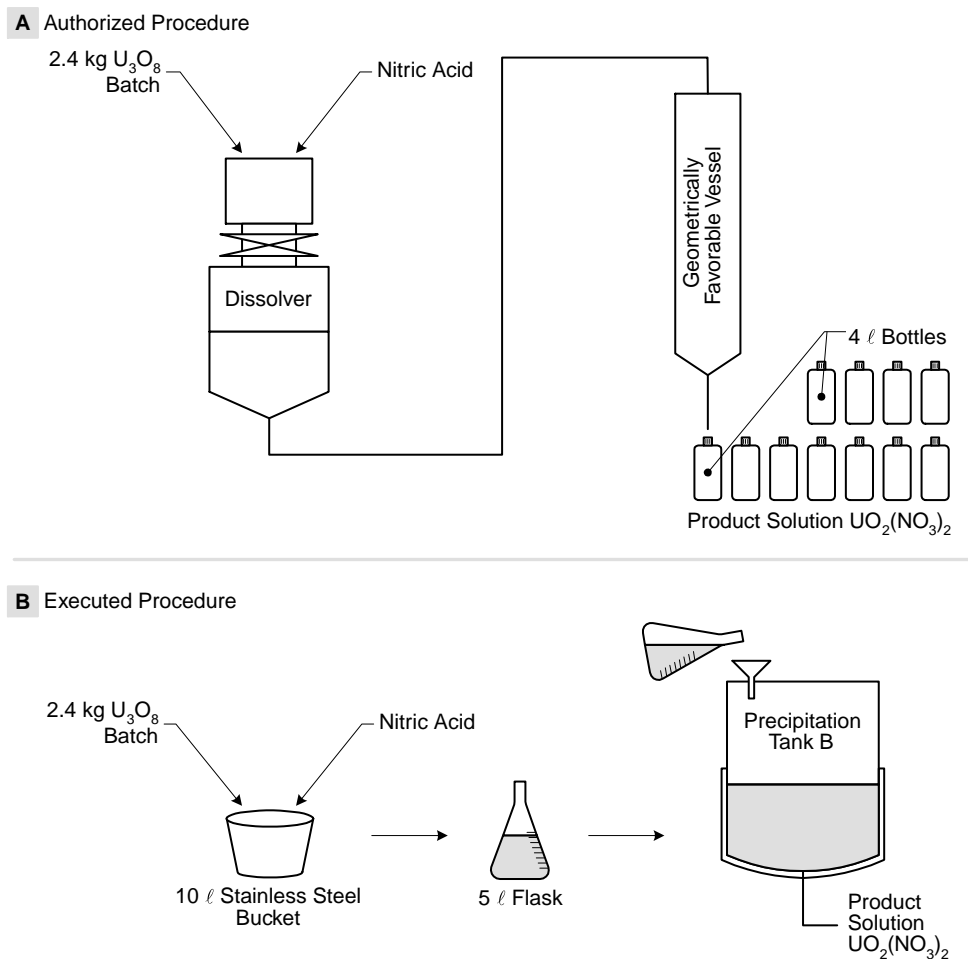
Three operators had begun the task on 29 September, the day prior to the accident, but were operating according to the procedure indicated in Figure 34-B. There were basically two deviations from the license-authorized procedure that were associated with the actual operations. First, the company procedure that the operators were to have followed, specified that the dissolution step was to be conducted in open, 10-liter, stainless steel buckets instead of the dissolution vessel indicated. This change was known to have saved about one hour in dissolution time.

The much more serious procedural departure, however, was the transfer of the nitrate solution into the unfavorable geometry precipitation vessel instead of the prescribed, favorable geometry columns. This deviation was apparently motivated by the difficulty of filling the product containers from the storage columns. The drain cock below the columns was only about 10 cm above the floor. The precipitation vessel had not only a stirrer to assure a uniform product but greatly facilitated the filling of the product containers.

Figure 34. Authorized and executed procedures.

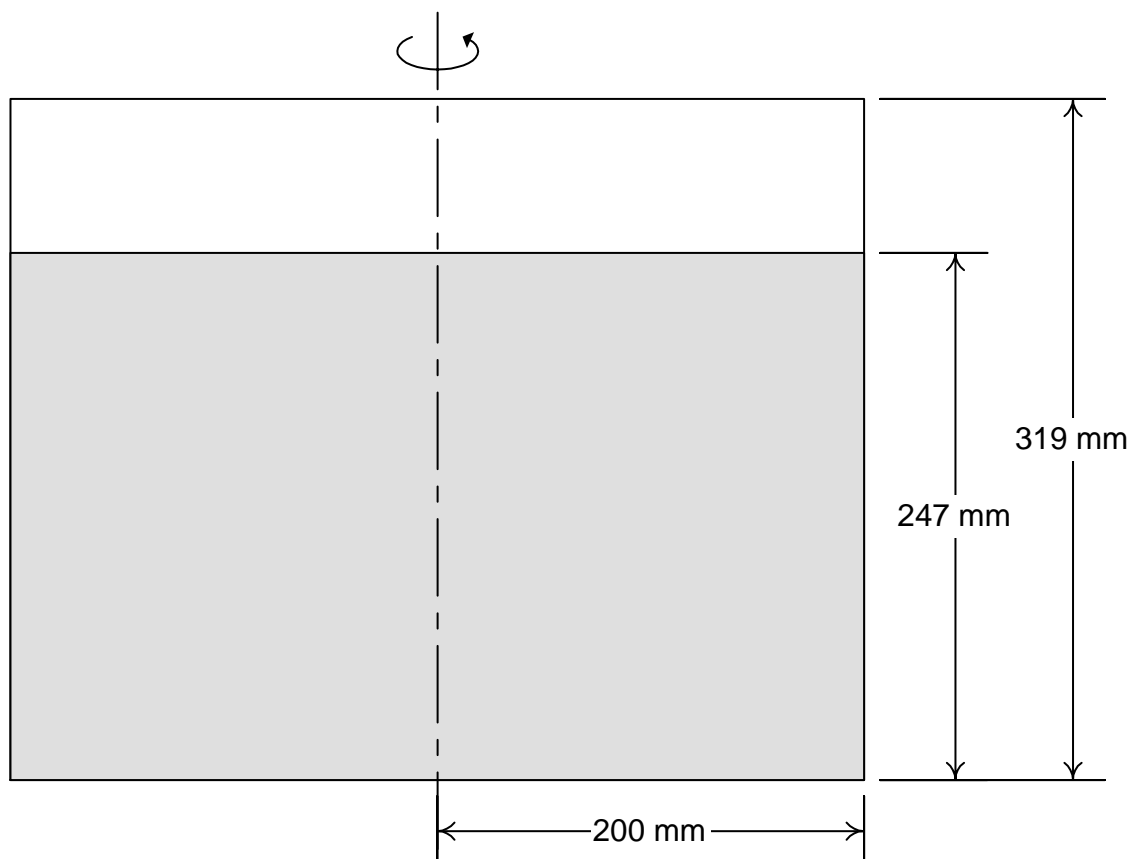
## 1. Mayak Production Association, 15 March 1953

*Plutonium nitrate solution in an interim storage vessel; single excursion; one serious exposure, one significant exposure.*

Vessel Volume	40.0 ℓ
Fissile Volume	31.0 ℓ
Fissile Mass	0.81 kg
Fissile Density	26.1 g/ℓ

Estimated Spherical Critical Mass	0.67 kg
First Spike Yield	unknown
Specific Spike Yield	unknown
Total Yield	$\sim 2.0 \times 10^{17}$

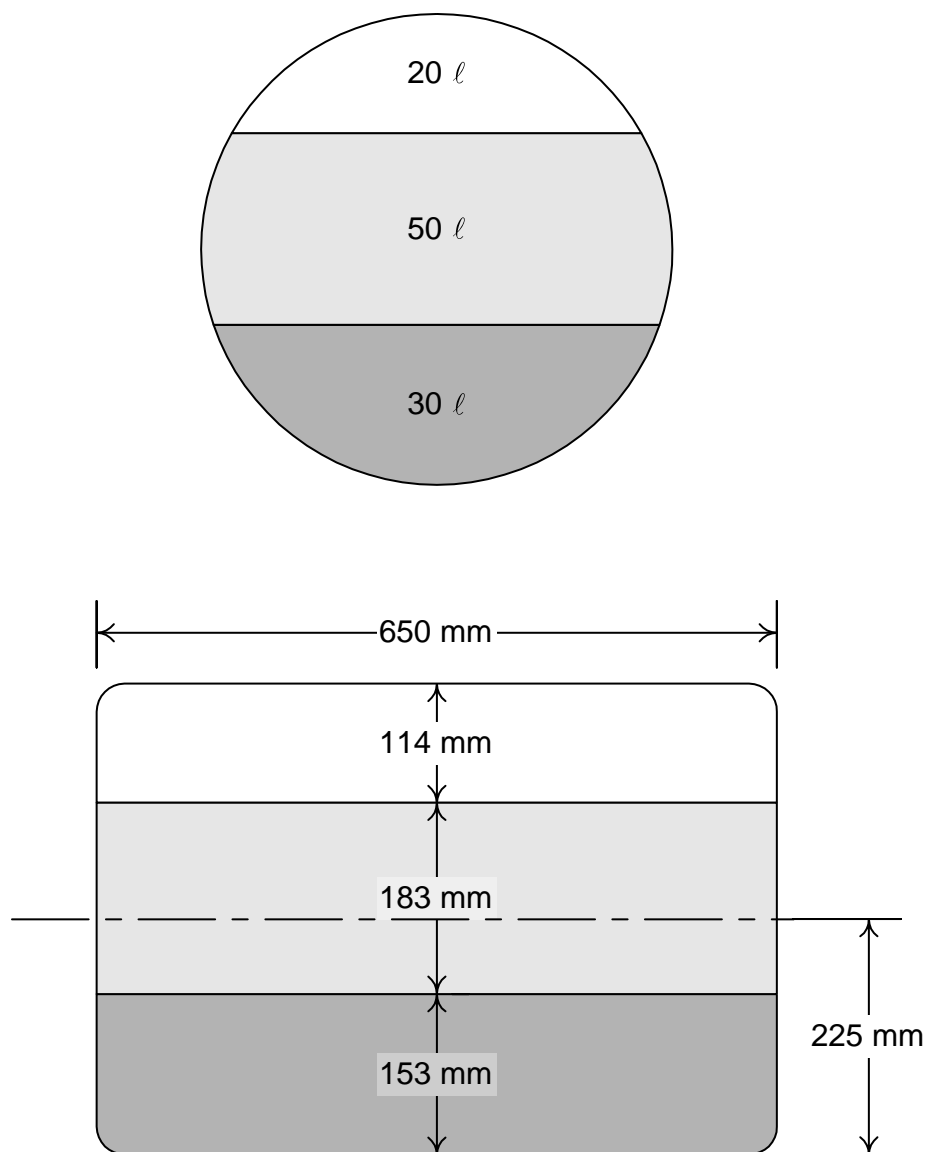
## 2. Mayak Production Association, 21 April 1957

*Uranium precipitate, U(90), buildup in a filtrate receiving vessel; excursion history unknown; one fatality; five other significant exposures.*

Vessel Volume	100.0 ℓ	Estimated Spherical Critical Mass	1.09 kg
Fissile Volume	30.0 ℓ	First Spike Yield	unknown
Fissile Mass	3.06 kg	Specific Spike Yield	unknown
Fissile Density	102.0 g/ℓ	Total Yield	$\sim 1.0 \times 10^{17}$

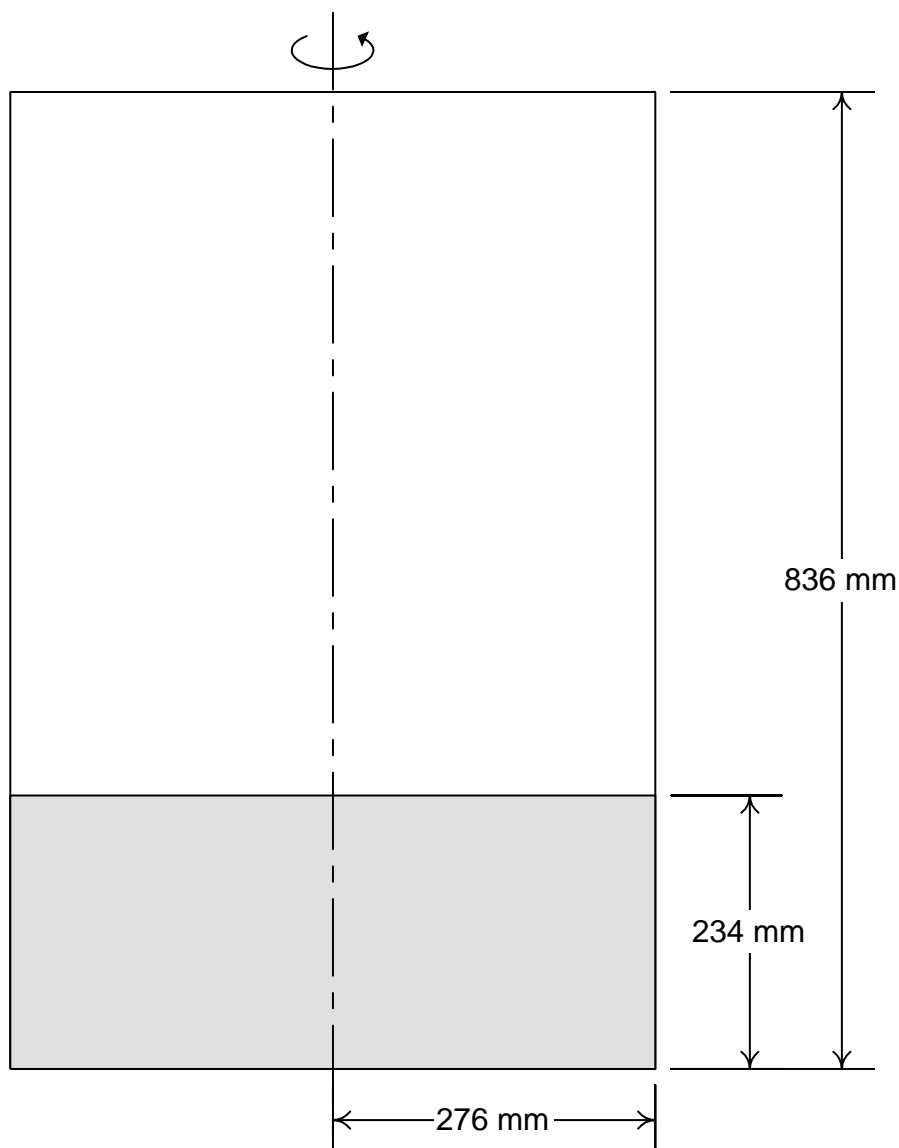
#### 4. Oak Ridge Y-12 Plant, 16 June 1958

*Uranyl nitrate solution, U(93), in a water collection drum; multiple excursions;  
seven significant exposures.*

Vessel Volume	208.0 ℓ	Estimated Spherical Critical Mass	1.50 kg
Fissile Volume	56.0 ℓ	First Spike Yield	$\sim 0.1 \times 10^{17}$
Fissile Mass	2.10 kg	Specific Spike Yield	$0.2 \times 10^{15}$
Fissile Density	37.5 g/ℓ	Total Yield	$13.0 \times 10^{17}$

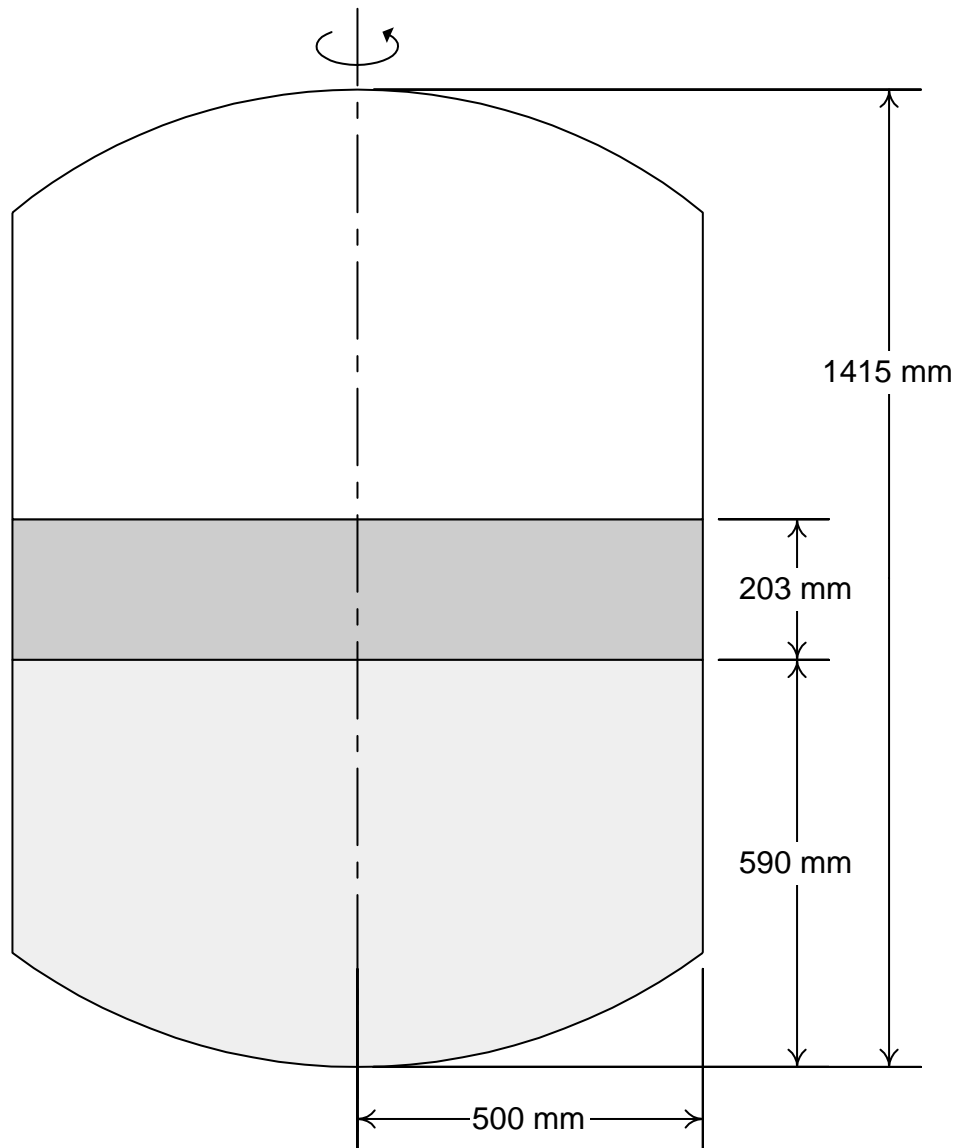
## 5. Los Alamos Scientific Laboratory, 30 December 1958

*Plutonium organic solution in an organic treatment tank; single excursion; one fatality, two significant exposures.*

Vessel Volume	982.0 ℓ
Fissile Volume	160.0 ℓ
Fissile Mass	2.94 kg
Fissile Density	18.4 g/ℓ

Estimated Spherical Critical Mass	0.84 kg
First Spike Yield	$1.5 \times 10^{17}$
Specific Spike Yield	$0.94 \times 10^{15}$
Total Yield	$1.5 \times 10^{17}$

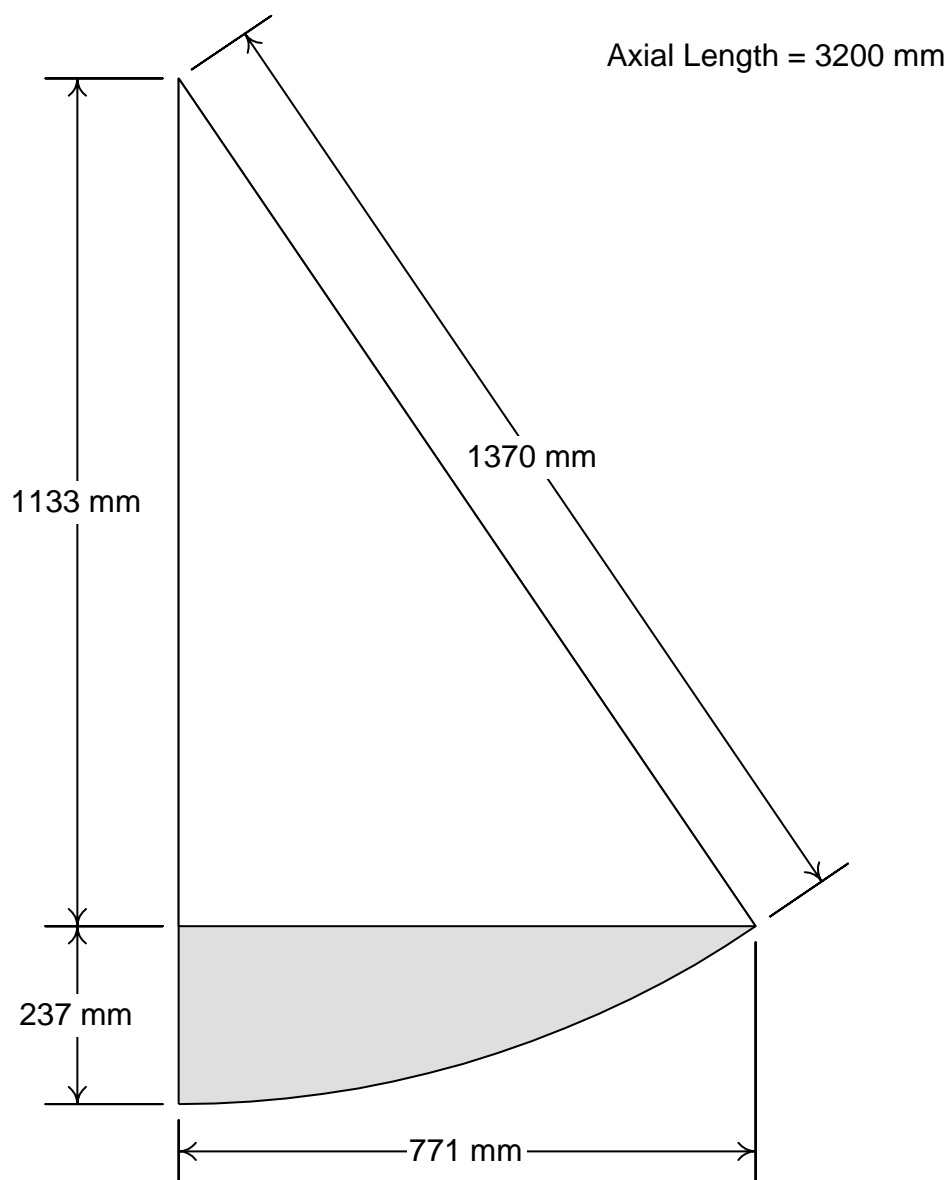
## 6. Idaho Chemical Processing Plant, 16 October 1959

*Uranyl nitrate solution, U(91), in a waste receiving tank; multiple excursions;  
two significant exposures.*

Vessel Volume	18,900 ℓ
Fissile Volume	800.0 ℓ
Fissile Mass	30.9 kg
Fissile Density	38.6 g/ℓ

Estimated Spherical Critical Mass	1.24 kg
First Spike Yield	$\sim 1.0 \times 10^{17}$
Specific Spike Yield	$\sim 0.1 \times 10^{15}$
Total Yield	$400 \times 10^{17}$

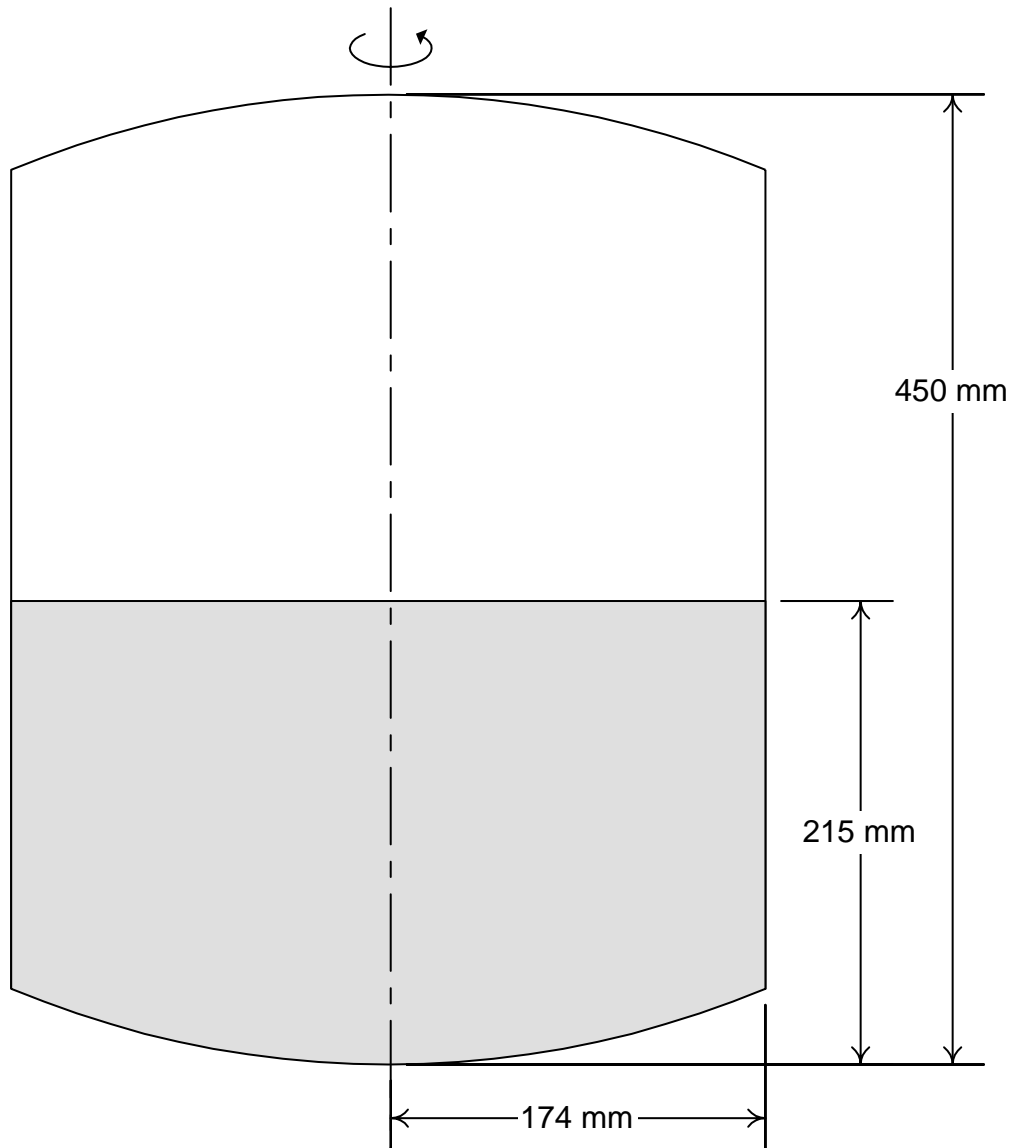
## 7. Mayak Production Association, 5 December 1960

*Plutonium carbonate solution in a holding vessel; multiple excursions;  
insignificant exposures.*

Vessel Volume	40.0 ℓ
Fissile Volume	19.0 ℓ
Fissile Mass	0.85 kg
Fissile Density	44.7 g/ℓ

Estimated Spherical Critical Mass	0.71 kg
First Spike Yield	unknown
Specific Spike Yield	unknown
Total Yield	$\sim 2.5 \times 10^{17}$
