# A Review of Criticality Accidents

2000 Revision

**LA-13638**

**Issued: May 2000**

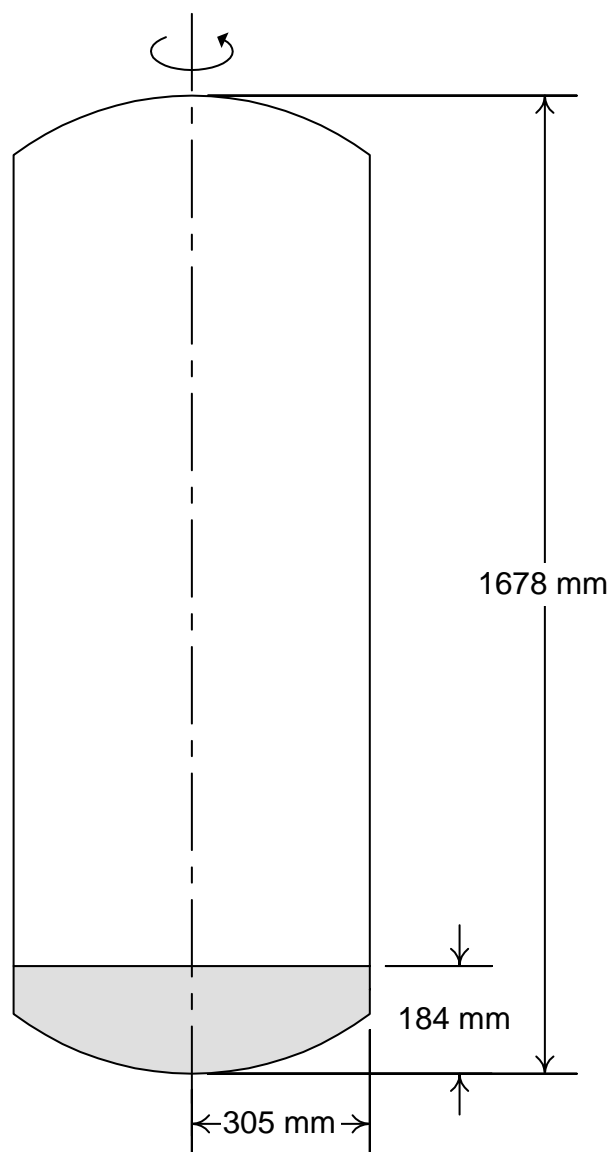
## 8. Idaho Chemical Processing Plant, 25 January 1961

*Uranyl nitrate solution, U(90), in a vapor disengagement vessel; multiple excursions; insignificant exposures.*

Vessel Volume	461.0 ℓ	Estimated Spherical Critical Mass	2.48 kg
Fissile Volume	40.0 ℓ	First Spike Yield	$\sim 0.6 \times 10^{17}$
Fissile Mass	7.20 kg	Specific Spike Yield	$1.5 \times 10^{15}$
Fissile Density	180.0 g/ℓ	Total Yield	$6.0 \times 10^{17}$

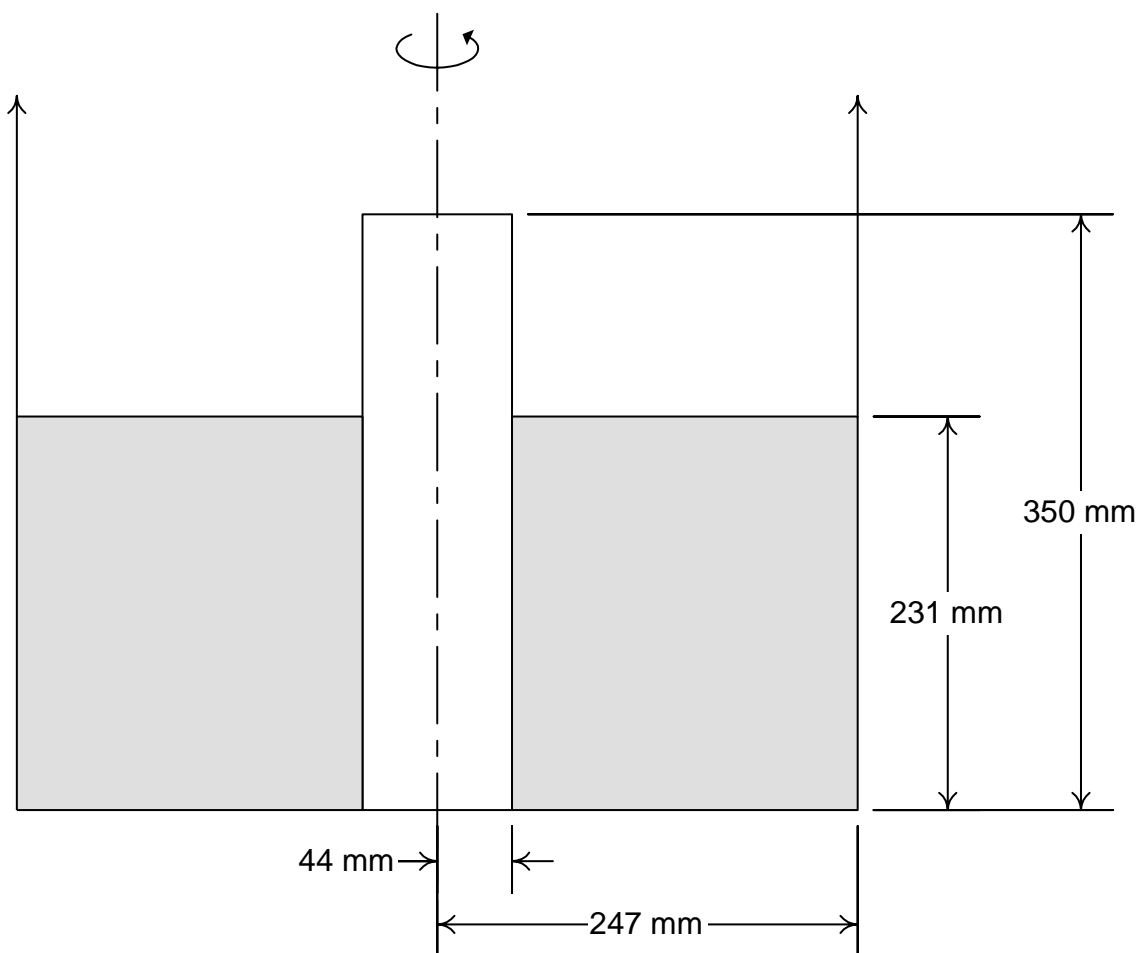
## 9. Siberian Chemical Combine (Tomsk), 14 July 1961

*Uranium hexafluoride, U(22.6), accumulation in a vacuum pump oil reservoir;  
two excursions; one significant exposure.*

Vessel Volume	65.0 ℓ
Fissile Volume	42.9 ℓ
Fissile Mass	1.68 kg
Fissile Density	39.2 g/ℓ

Estimated Spherical Critical Mass	0.9 kg
First Spike Yield	none
Specific Spike Yield	none
Total Yield	$0.12 \times 10^{17}$

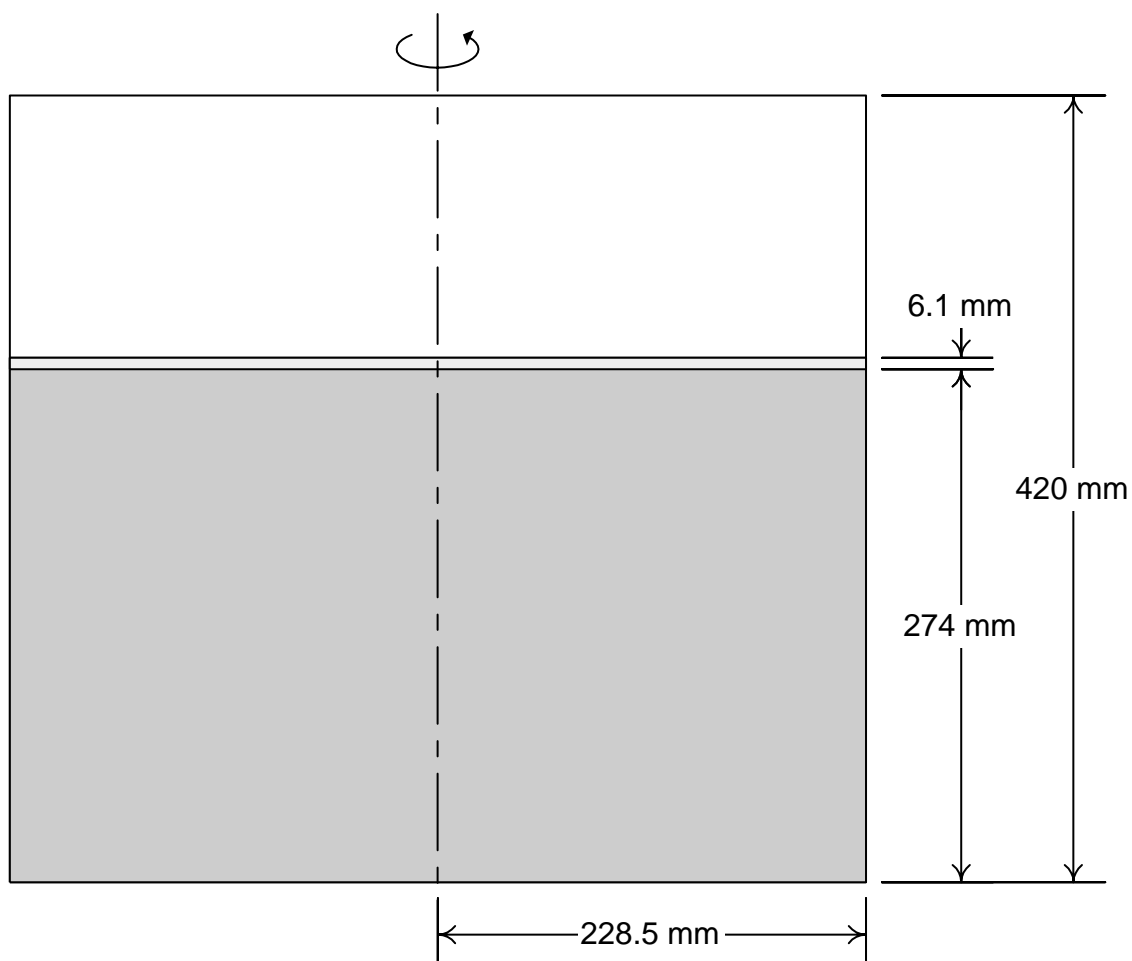
## 10. Hanford Works, 7 April 1962

*Plutonium solution in a transfer vessel; multiple excursions; three significant exposures.*

Vessel Volume	69.0 ℓ
Fissile Volume	45.0 ℓ
Fissile Mass	1.29 kg
Fissile Density	28.7 g/ℓ

Estimated Spherical Critical Mass	1.07 kg
First Spike Yield	$\sim 0.1 \times 10^{17}$
Specific Spike Yield	$0.2 \times 10^{15}$
Total Yield	$8.0 \times 10^{17}$

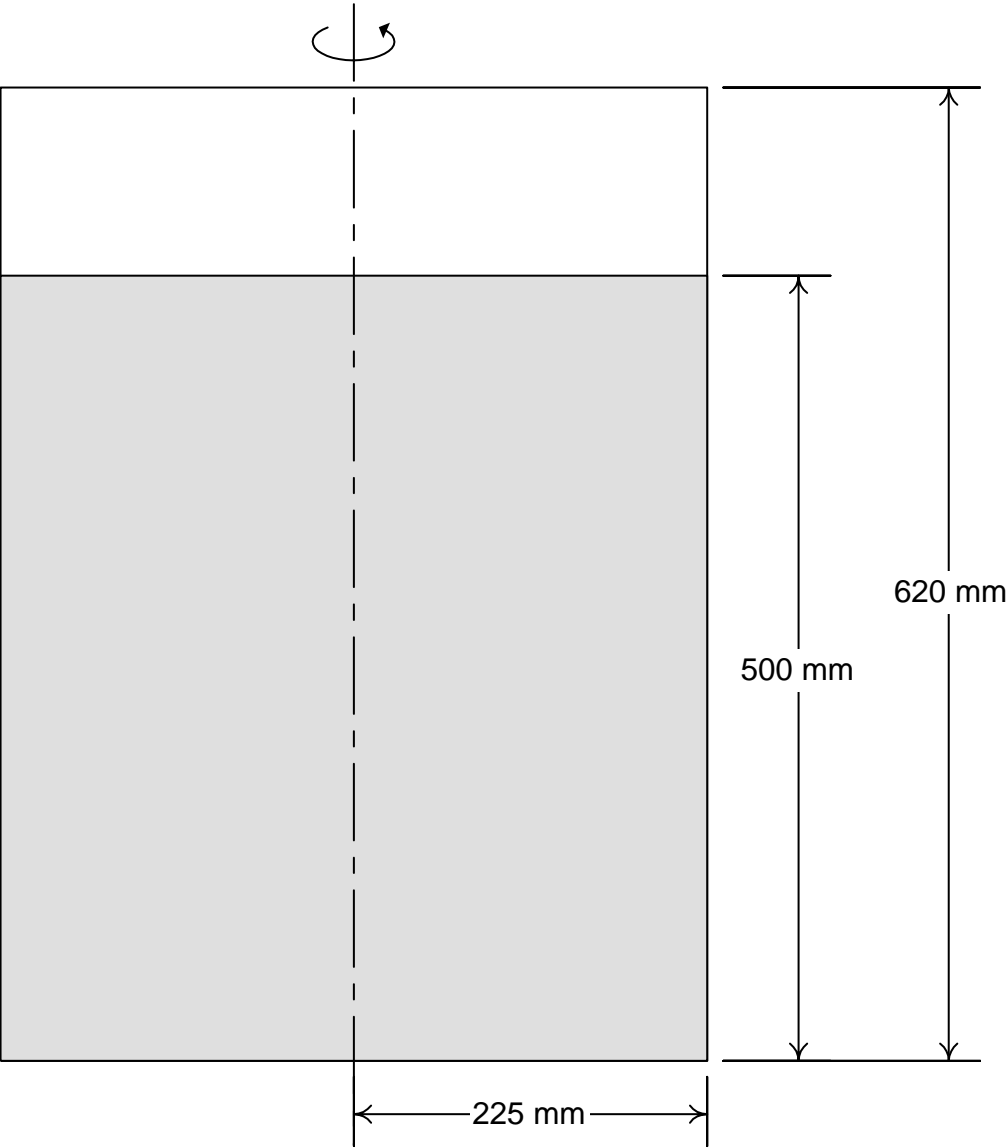
11. Mayak Production Association, 7 September 1962

*Plutonium nitrate in a dissolution vessel; three excursions; insignificant exposures.*

Vessel Volume	100.0 ℓ	Estimated Spherical Critical Mass	1.05 kg
Fissile Volume	80.0 ℓ	First Spike Yield	none
Fissile Mass	1.26 kg	Specific Spike Yield	none
Fissile Density	15.8 g/ℓ	Total Yield	~2.0×10 <sup>17</sup>

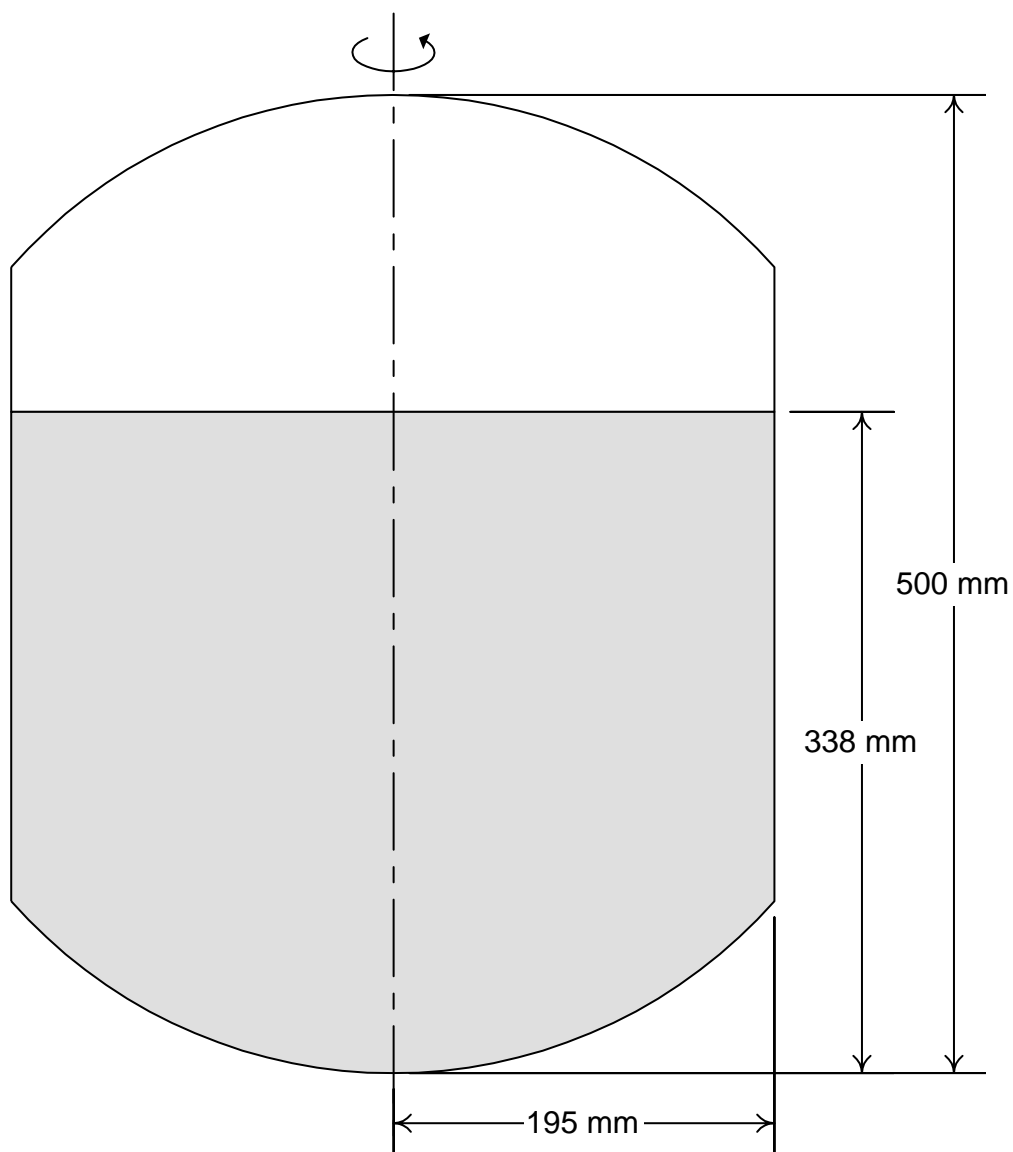
## 12. Siberian Chemical Combine (Tomsk), 30 January 1963

*Uranyl nitrate solution, U(90), in a collection vessel; multiple excursions;  
insignificant exposures.*

Vessel Volume	49.9 ℓ
Fissile Volume	35.5 ℓ
Fissile Mass	2.27 kg
Fissile Density	63.9 g/ℓ

Estimated Spherical Critical Mass	2.06 kg
First Spike Yield	unknown
Specific Spike Yield	unknown
Total Yield	$7.9 \times 10^{17}$

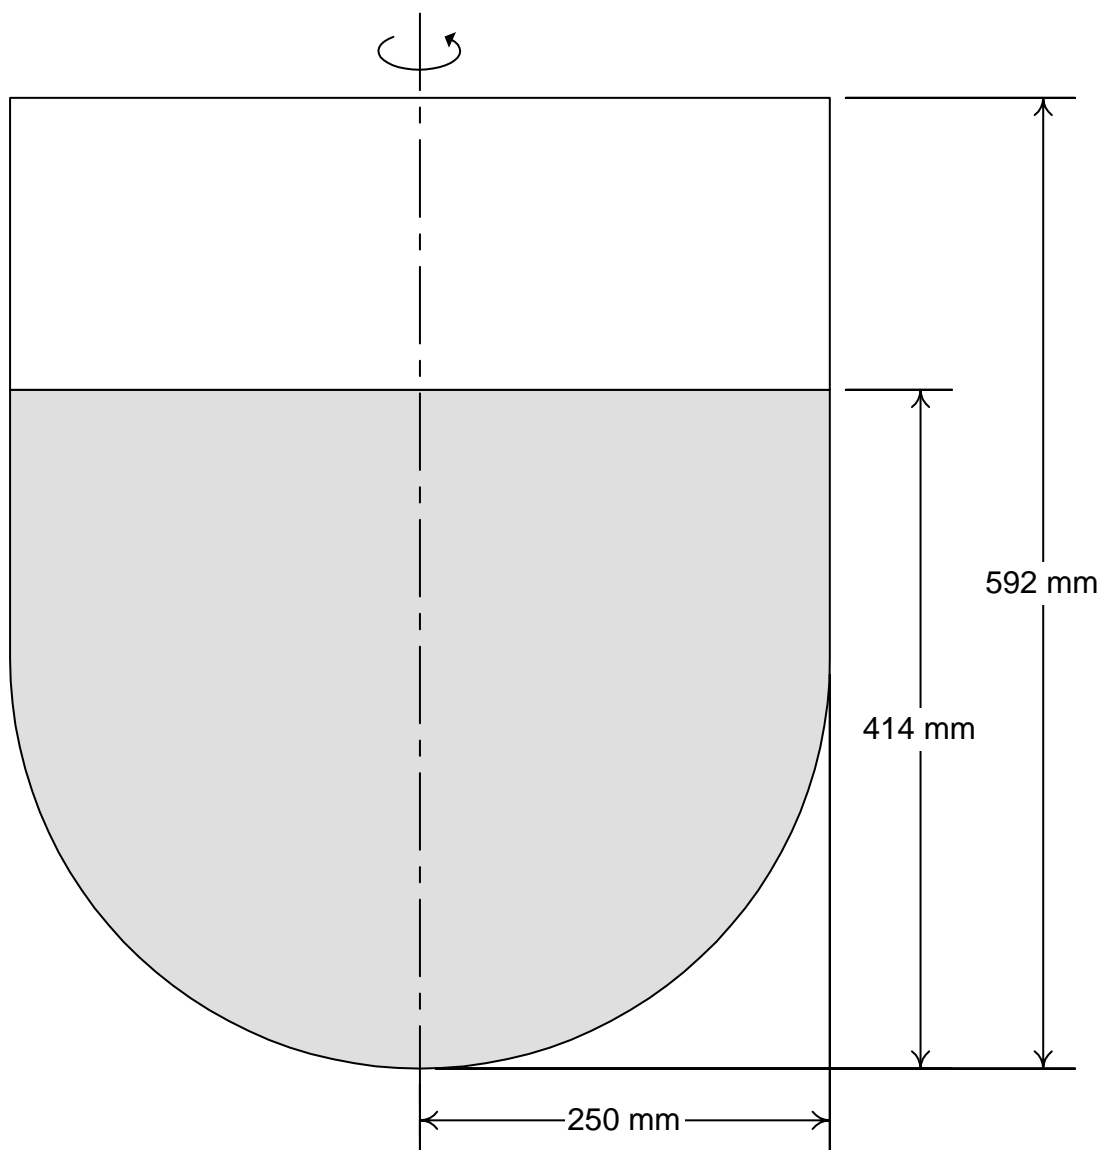
### 13. Siberian Chemical Combine, 2 December 1963

*Uranium organic solution, U(90), in a vacuum system holding vessel; multiple excursions; insignificant exposures.*

Vessel Volume	100.0 ℓ
Fissile Volume	64.8 ℓ
Fissile Mass	1.93 kg
Fissile Density	29.8 g/ℓ

Estimated Spherical Critical Mass	1.38 kg
First Spike Yield	none
Specific Spike Yield	none
Total Yield	$0.16 \times 10^{17}$

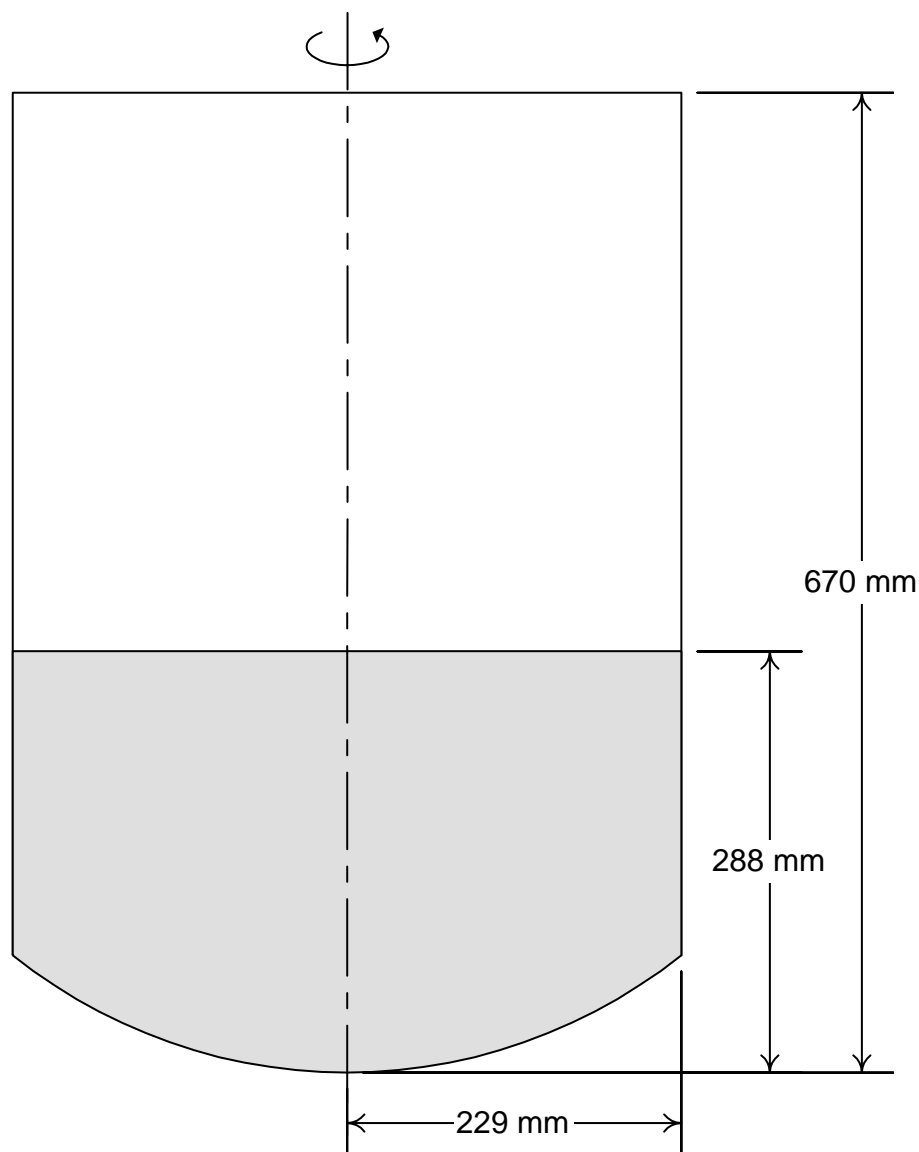
## 14. United Nuclear Fuels Recovery Plant, 24 July 1964

*Uranyl nitrate solution, U(93), in a carbonate reagent makeup vessel; two excursions; one fatality, two significant exposures.*

Vessel Volume	103.7 ℓ
Fissile Volume	41.0 ℓ
Fissile Mass	2.07 kg
Fissile Density	50.5 g/ℓ

Estimated Spherical Critical Mass	1.72 kg
First Spike Yield	$\sim 1.0 \times 10^{17}$
Specific Spike Yield	$2.4 \times 10^{15}$
Total Yield	$\sim 1.3 \times 10^{17}$

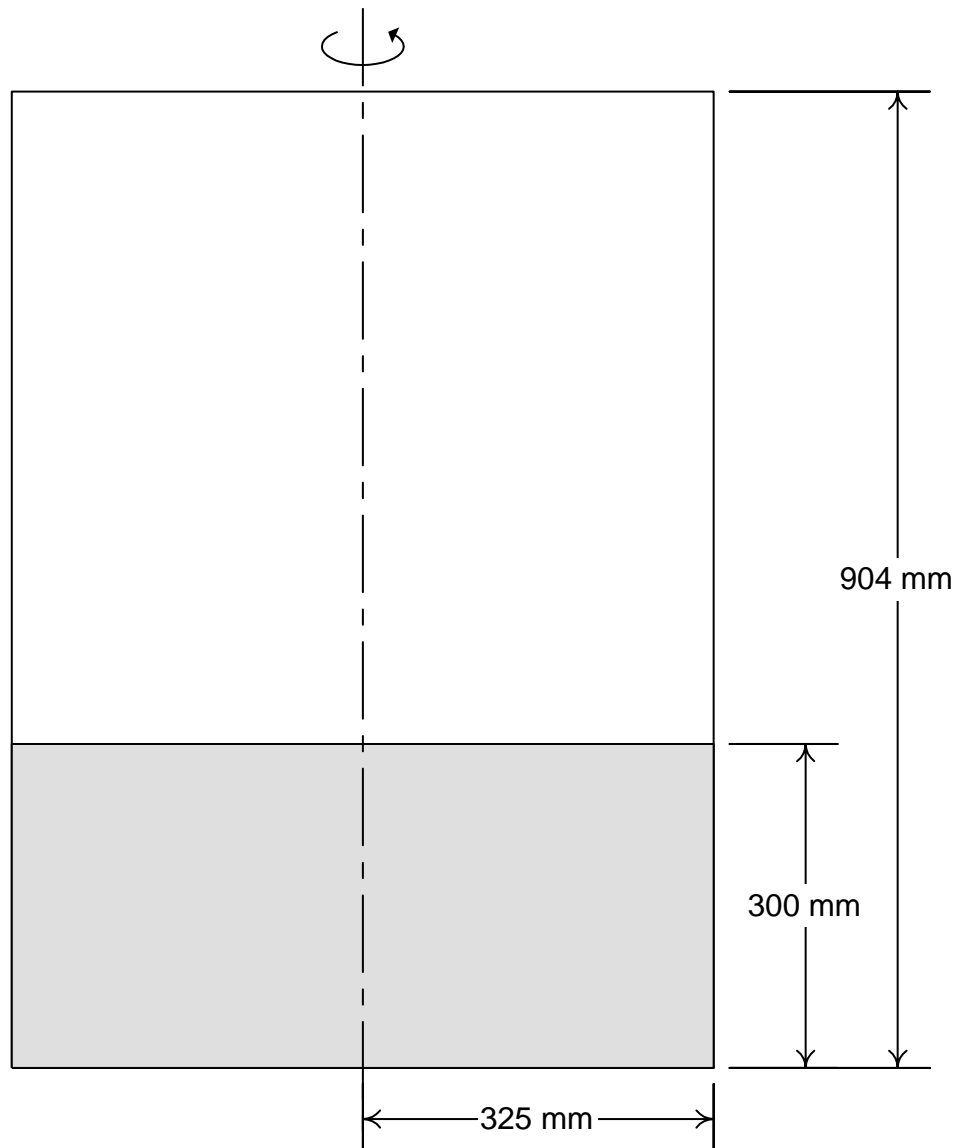
## 15. Electrosta Machine Building Plant, 3 November 1965

*Uranium oxide slurry, U(6.5), in a vacuum system vessel; single excursion;  
insignificant exposures.*

Vessel Volume	300.0 ℓ
Fissile Volume	100.0 ℓ
Fissile Mass	3.65 kg
Fissile Density	36.5 g/ℓ

Estimated Spherical Critical Mass	1.6 kg
First Spike Yield	none
Specific Spike Yield	none
Total Yield	$\sim 0.08 \times 10^{17}$

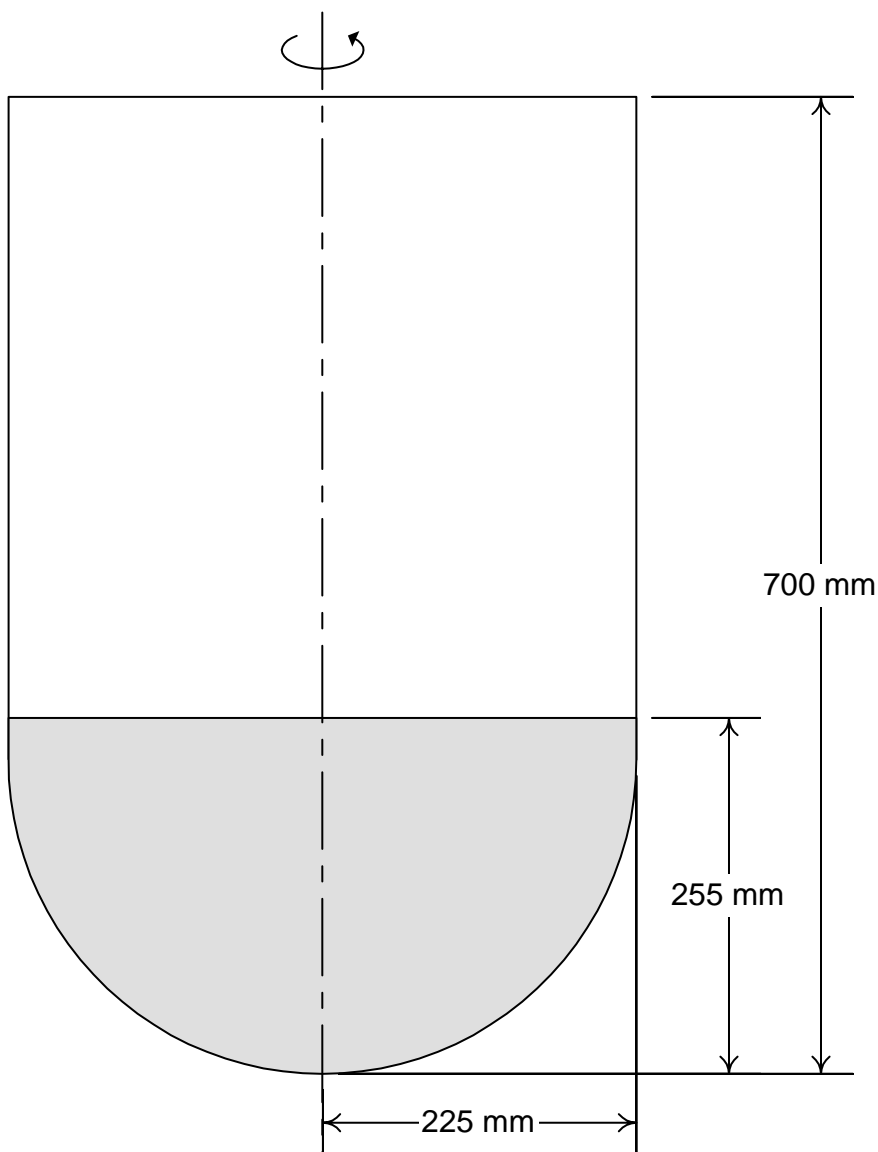
## 16. Mayak Production Association, 16 December 1965

*Uranyl nitrate solution, U(90), in a dissolution vessel; multiple excursions;  
insignificant exposures.*

Vessel Volume	100.0 ℓ
Fissile Volume	28.6 ℓ
Fissile Mass	1.98 kg
Fissile Density	69.2 g/ℓ

Estimated Spherical Critical Mass	1.65 kg
First Spike Yield	none
Specific Spike Yield	none
Total Yield	$\sim 5.5 \times 10^{17}$

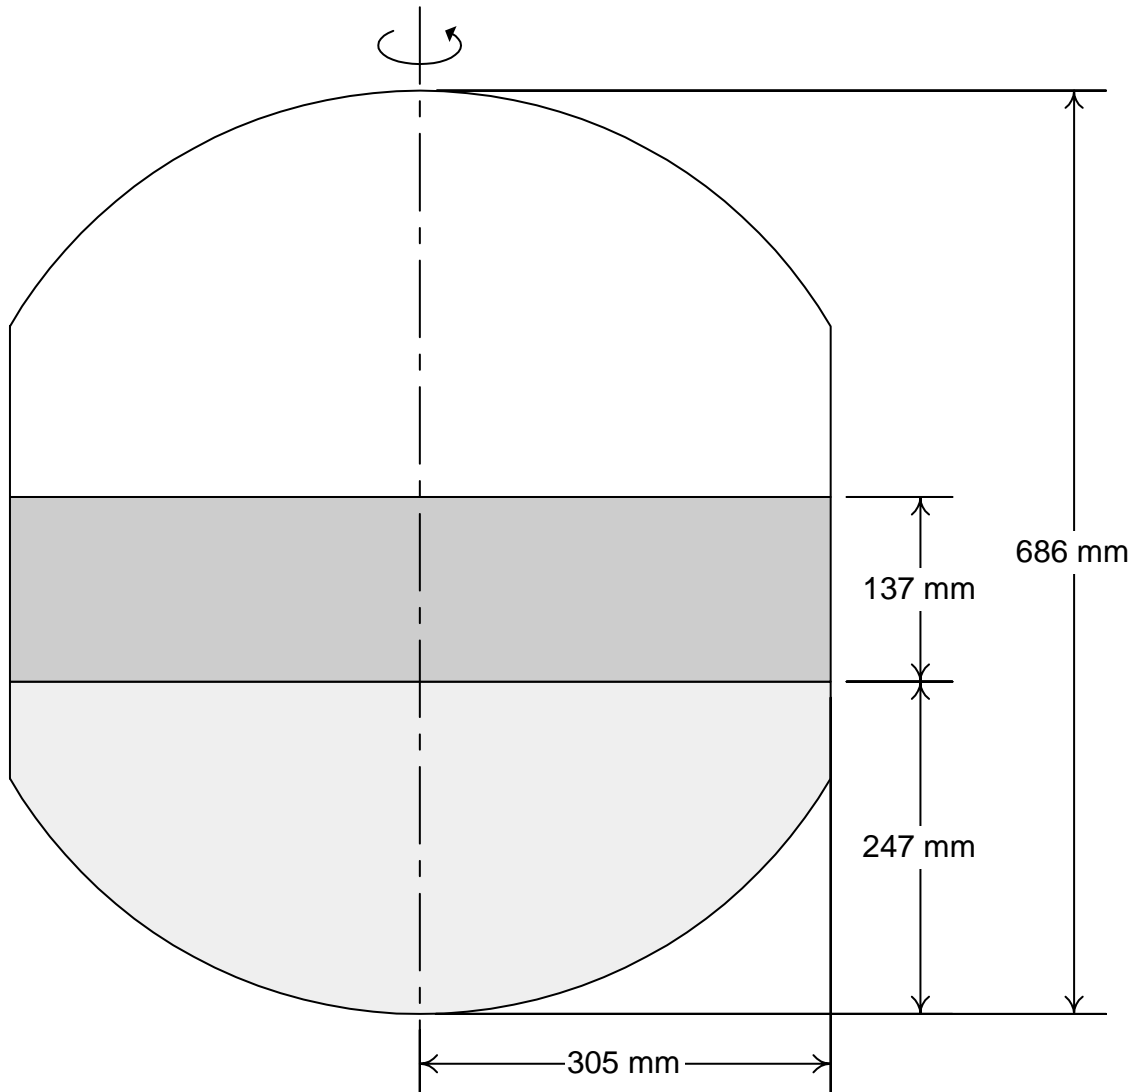
## 18. Windscale Works, 24 August 1970

*Plutonium organic solution in a transfer vessel; one excursion; insignificant exposures.*

Vessel Volume	156.0 ℓ
Fissile Volume	40.0 ℓ
Fissile Mass	2.07 kg
Fissile Density	51.8 g/ℓ

Estimated Spherical Critical Mass	0.69 kg
First Spike Yield	none
Specific Spike Yield	none
Total Yield	$0.01 \times 10^{17}$

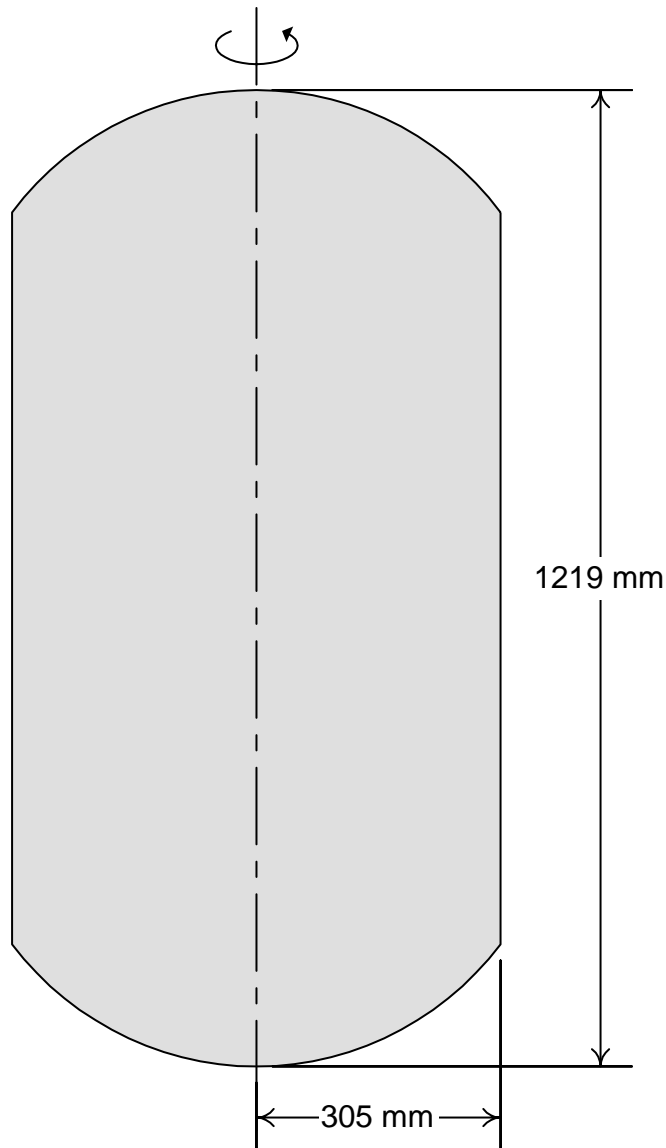
## 19. Idaho Chemical Processing Plant, 17 October 1978

*Uranyl nitrate solution, U(82), in a lower disengagement section of a scrubbing column; excursion history unknown; insignificant exposures.*

Vessel Volume	315.5 ℓ
Fissile Volume	315.5 ℓ
Fissile Mass	6.08 kg
Fissile Density	19.3 g/ℓ

Estimated Spherical Critical Mass	4.34 kg
First Spike Yield	unknown
Specific Spike Yield	unknown
Total Yield	$27.0 \times 10^{17}$

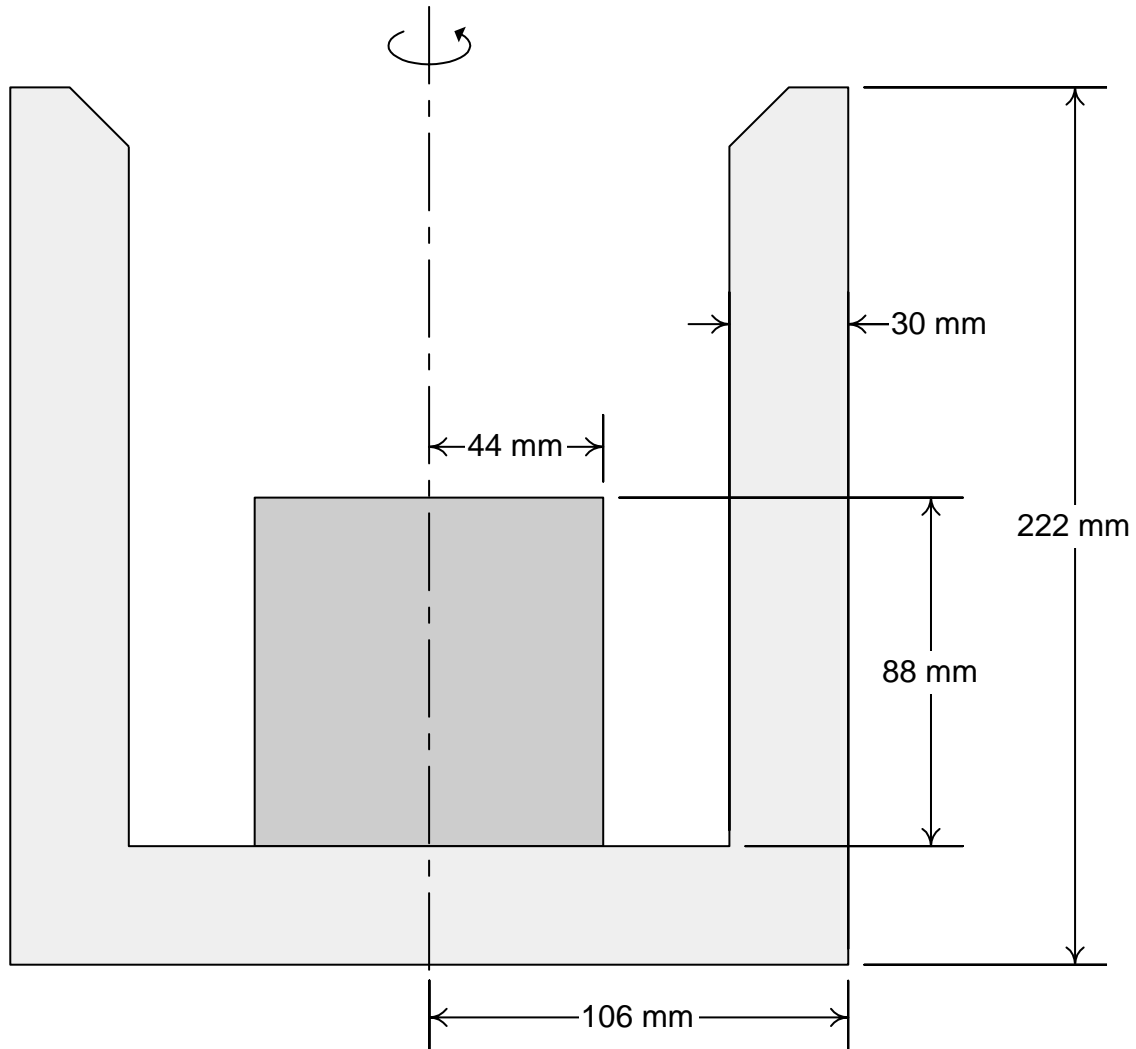
## 20. Siberian Chemical Combine (Tomsk), 13 December 1978

*Plutonium metal ingots in a storage container; single excursion; one serious exposure, seven significant exposures.*

Vessel Volume	3.2 ℓ
Fissile Volume	0.54 ℓ
Fissile Mass	10.1 kg
Fissile Density	18,700 g/ℓ

Estimated Spherical Critical Mass	9.18 kg
First Spike Yield	$0.03 \times 10^{17}$
Specific Spike Yield	$5.6 \times 10^{15}$
Total Yield	$0.03 \times 10^{17}$

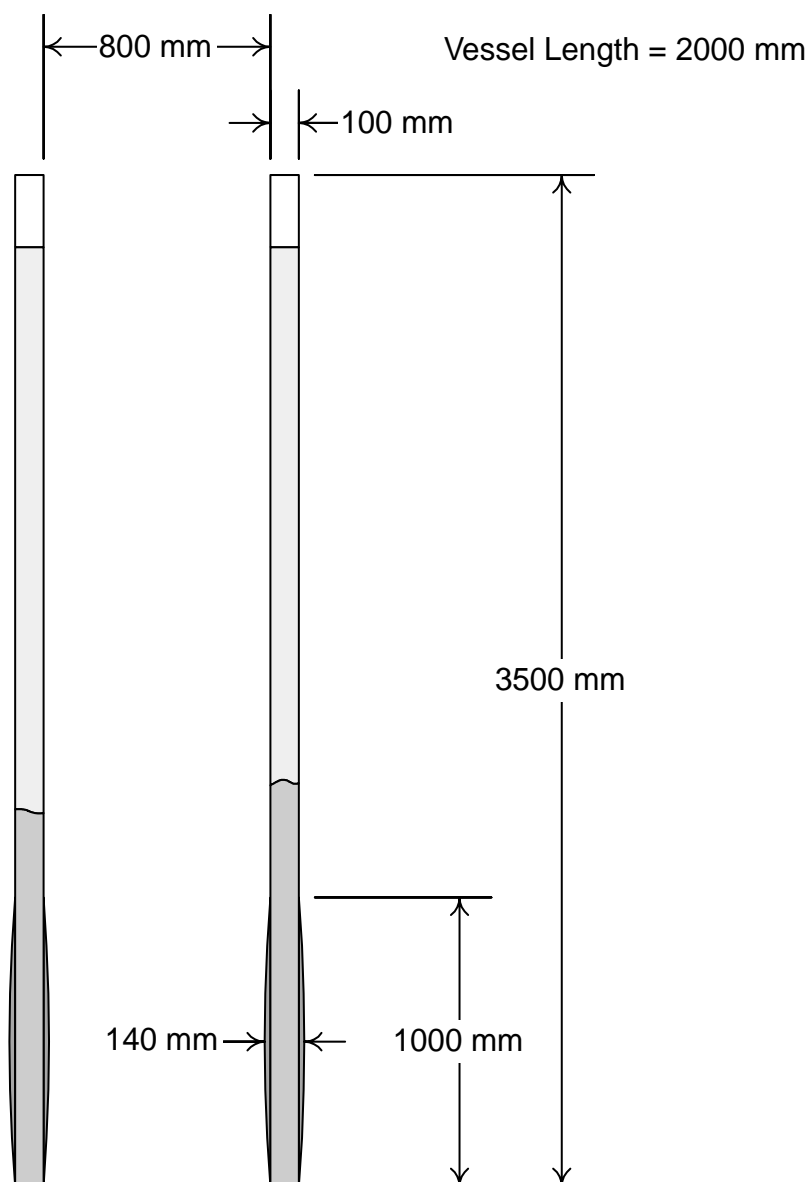
## 21. Novosibirsk Chemical Concentration Plant, 15 May 1997

*Uranium oxide slurry and crust, U(70), in the lower regions of two parallel vessels; multiple excursions; insignificant exposures.*

Vessel Volume	700.0 ℓ per vessel	Estimated Spherical Critical Mass	*
Fissile Volume	*	First Spike Yield	none
Fissile Mass	17.1 kg	Specific Spike Yield	none
Fissile Density	*	Total Yield	$0.055 \times 10^{17}$

\* System description was not adequate to estimate parameter.

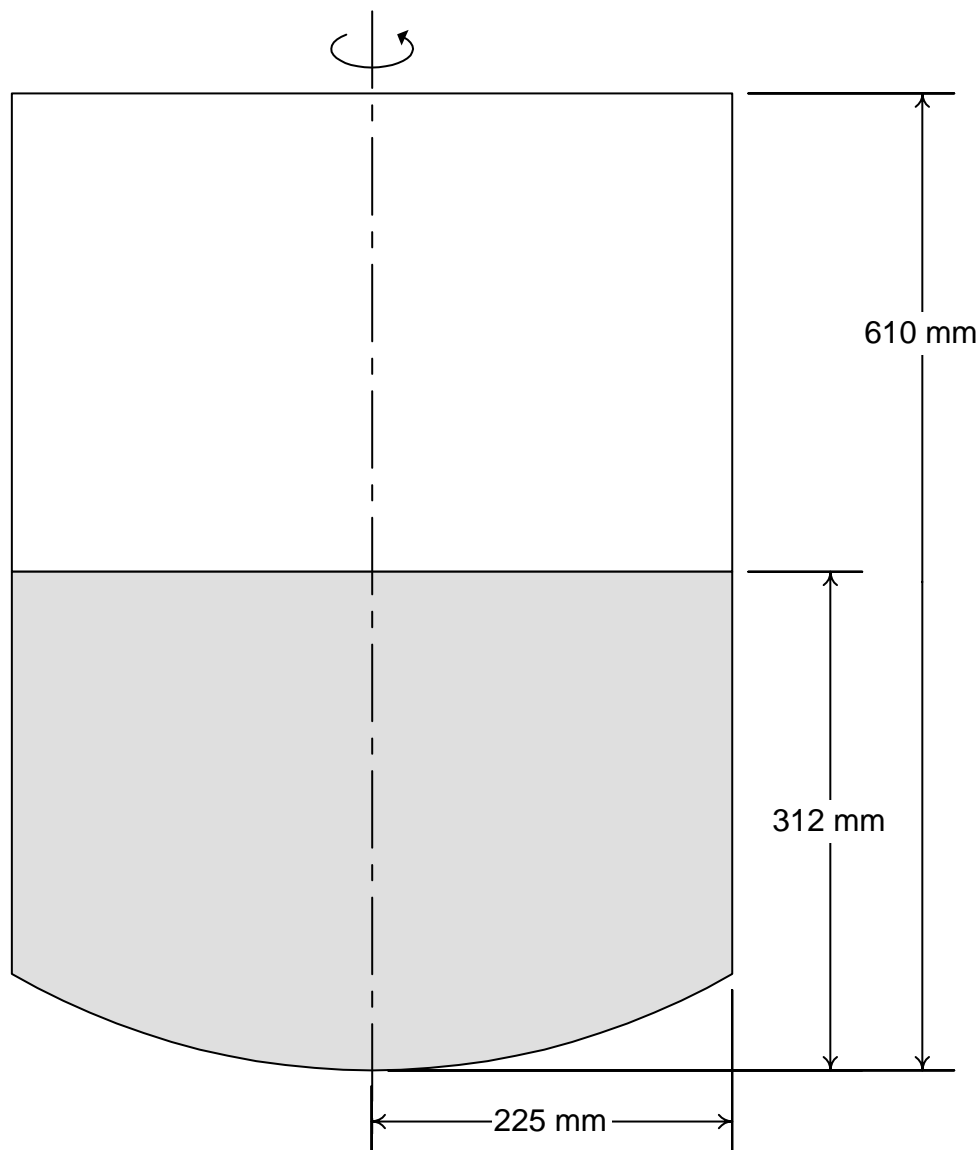
## 22. JCO Fuel Fabrication Plant, 30 September 1999

*Uranyl nitrate solution, U(18.8), in a precipitation vessel; multiple excursions;  
two fatalities, one significant exposure.*

Vessel Volume	100.0 ℓ
Fissile Volume	45.0 ℓ
Fissile Mass	3.12 kg
Fissile Density	69.3 g/ℓ

Estimated Spherical Critical Mass	1.9 kg
First Spike Yield	$\sim 0.5 \times 10^{17}$
Specific Spike Yield	$1.1 \times 10^{15}$
Total Yield	$25 \times 10^{17}$
