Exelon Generation Company, LLC
Byron Station
4450 North German Church Road
Byron, IL 61010-9794

Subject: Licensee Event Report 2012-001-00, "Unit 2 Loss of Normal Offsite Power and Reactor Trip and Unit 1 Loss of Normal Offsite Power Due to Failure of System Auxiliary Transformer Inverted Insulators"

1. FACILITY NAME Byron Station, Unit 1				2. DOCKET NUMBER 05000454		3. PAGE 1 OF 12			
4. TITLE Unit 2 Loss of Normal Offsite Power and Reactor Trip and Unit 1 Loss of Normal Offsite Power Due to Failure of System Auxiliary Transformer Inverted Insulators

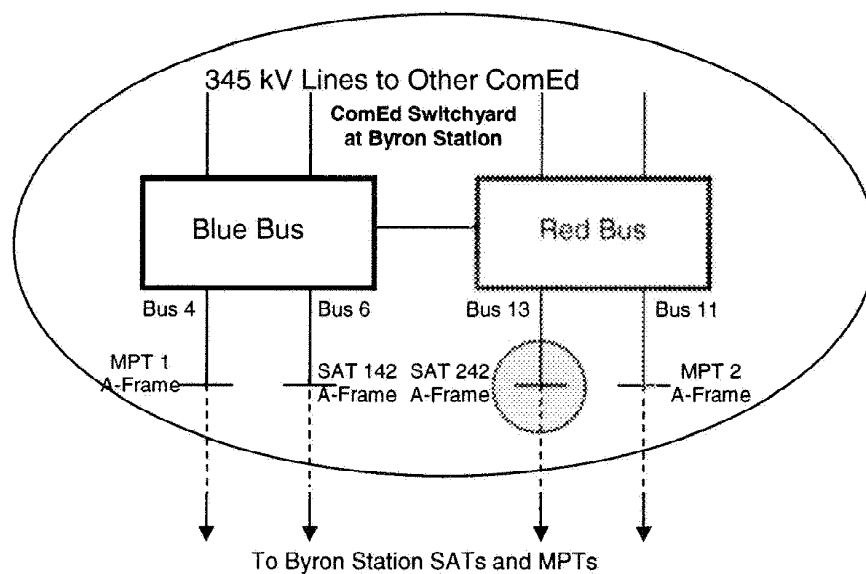
Figure 2

On January 30, 2012, at 1001:54 hours, a mechanical failure of a 345 kV under hung porcelain insulator on the SAT 242-1/2 A-Frame structure in the switchyard resulted in an open phase non-faulted condition on the SAT 242-1/2 C phase S-Bus lead between the A-Frame structure support insulator and the 345 kV Bus 13 disconnect switch (See figure 2). When the insulator failed, the S-bus fell causing both a mechanical and electrical failure at the terminal pad of the Bus 13 disconnect switch. The nature of the failure resulted in a sustained open phase event to the SAT 242-1/2 and a low level ground fault occurred on the SAT 242-1/2 side of the open phase.
