POEF-2086  
ORNL/TM-11988

## Investigation of Breached Depleted UF<sub>6</sub> Cylinders

Date Published: September 1991

Prepared by the  
OAK RIDGE NATIONAL LABORATORY  
and  
URANIUM ENRICHMENT  
Oak Ridge, Tennessee 37831-6285  
managed by  
MARTIN MARIETTA ENERGY SYSTEMS, INC.  
for the  
U.S. DEPARTMENT OF ENERGY  
under contract DE-AC05-84OR21400 and  
DE-AC05-76OR00001

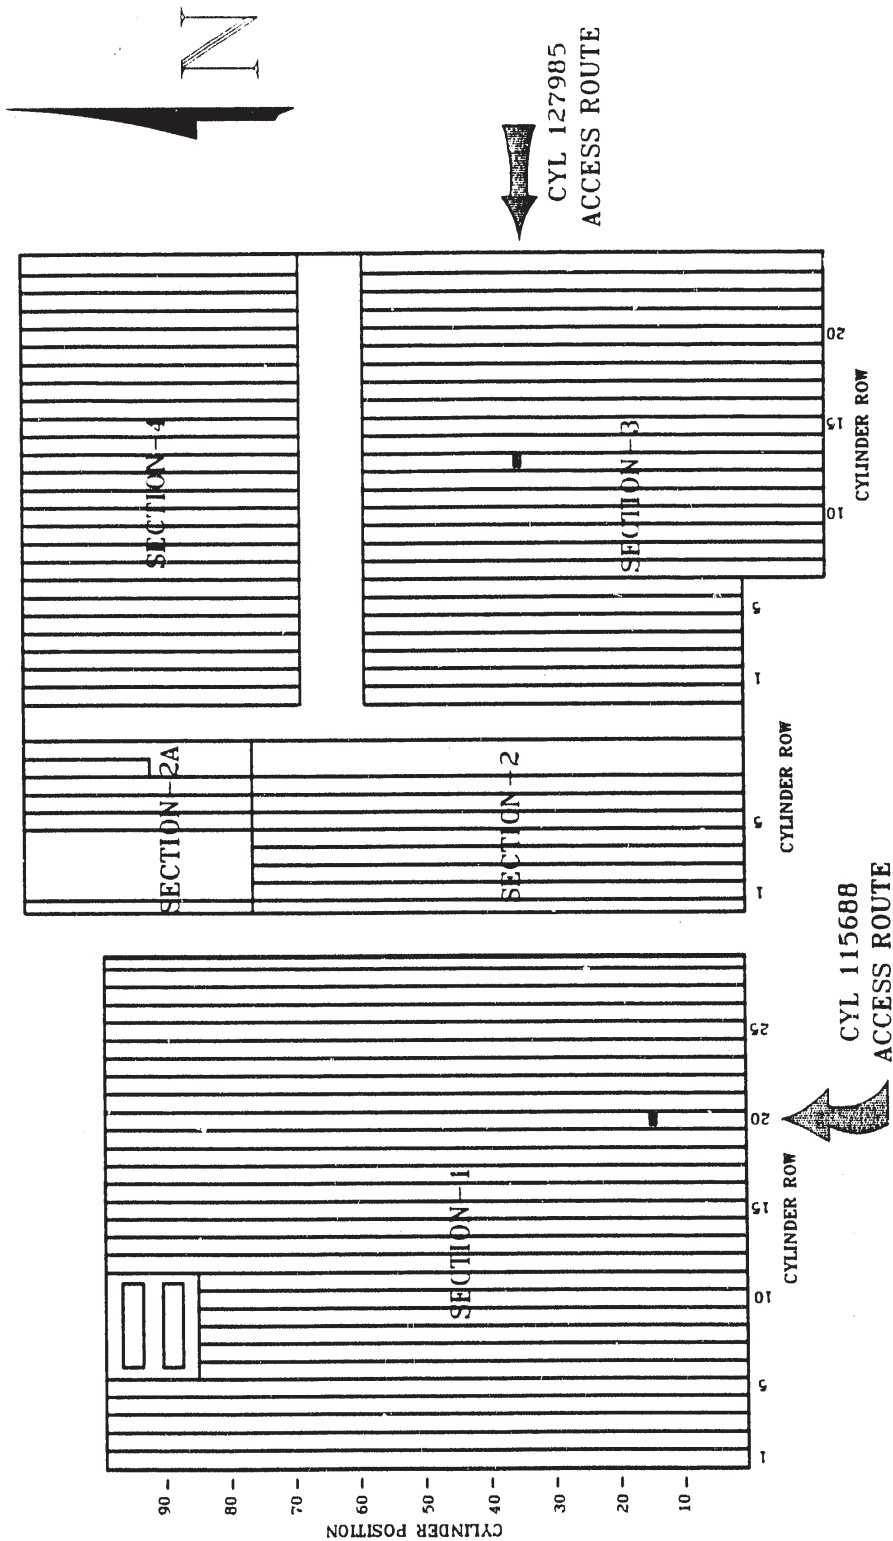
ORNL-DWG 91-9692

Fig. 1. Schematic of the Portsmouth depleted UF<sub>6</sub> storage area, C-lot, showing locations of failed cylinders and routes used to gain access.

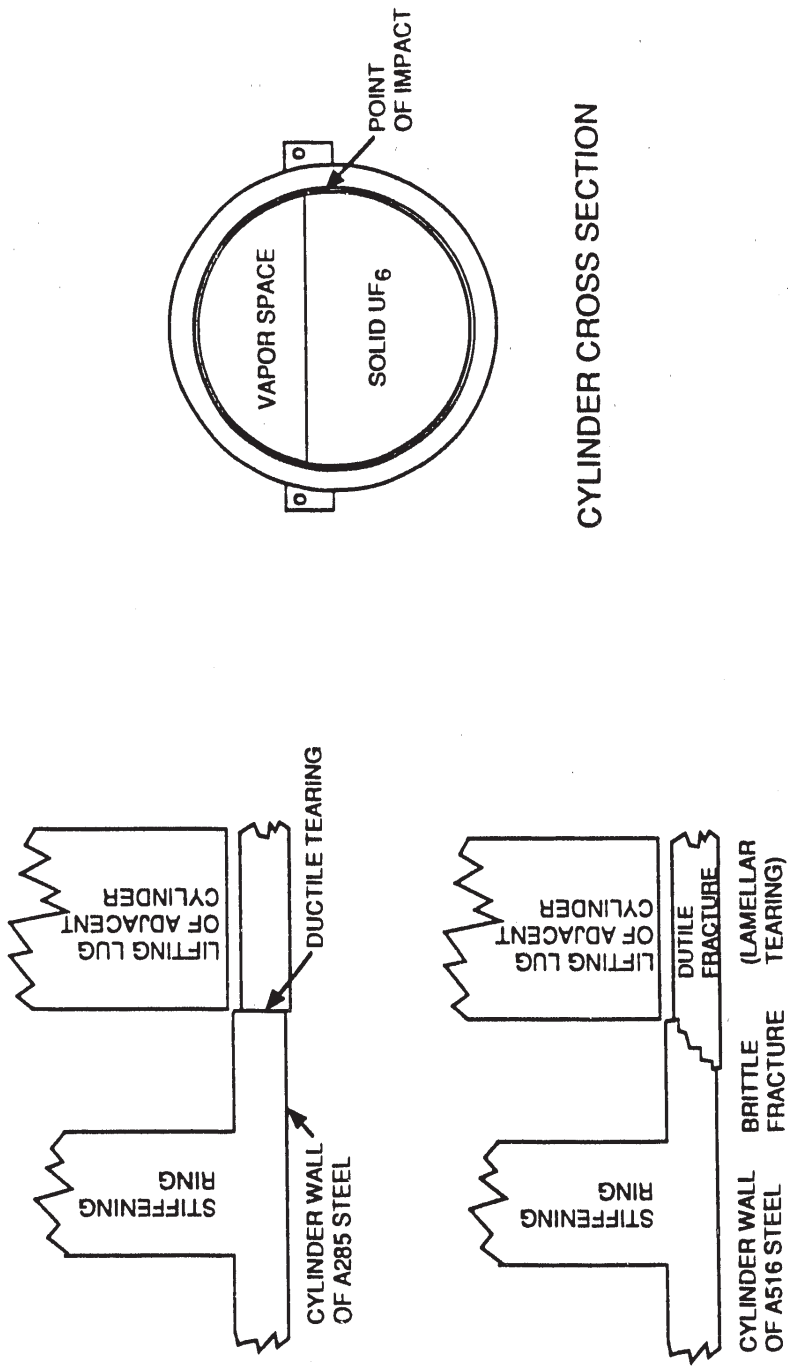
# IMPACT FRACTURE OF A285 AND A516 STEELS

Fig. B3.4. Types of impact fractures encountered with ASTM A285 and A516 steel and the impact location experienced.

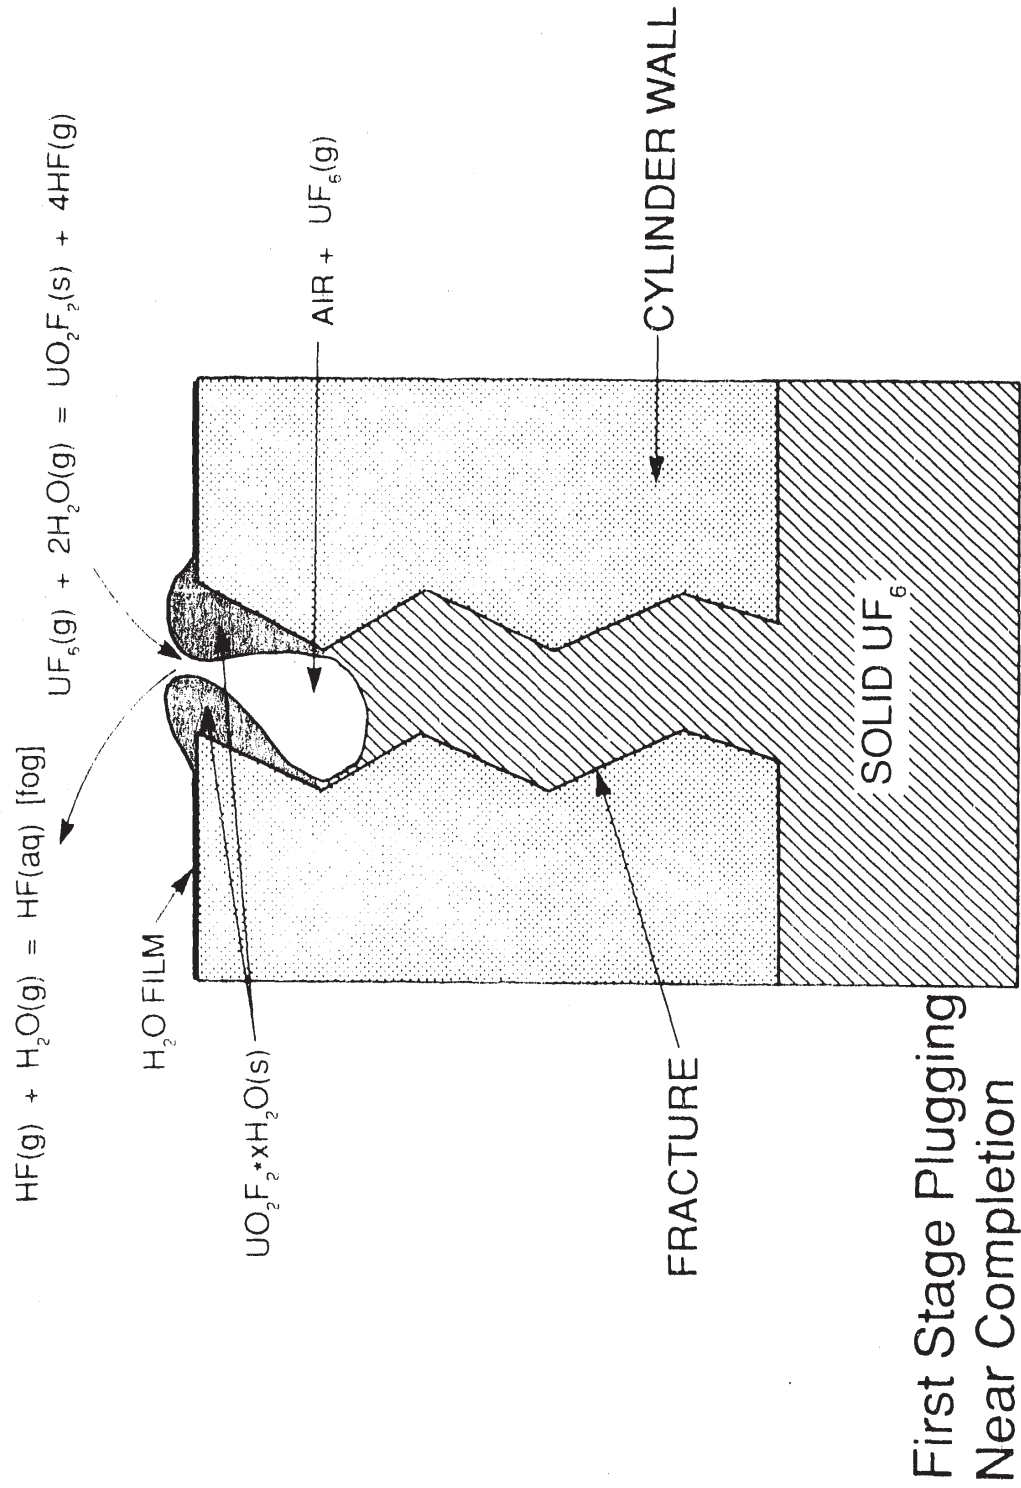
DWG. NO. K/G-91-1124

Fig. B3.6. Schematic cross section of fracture showing development of initial plug nearing completion.

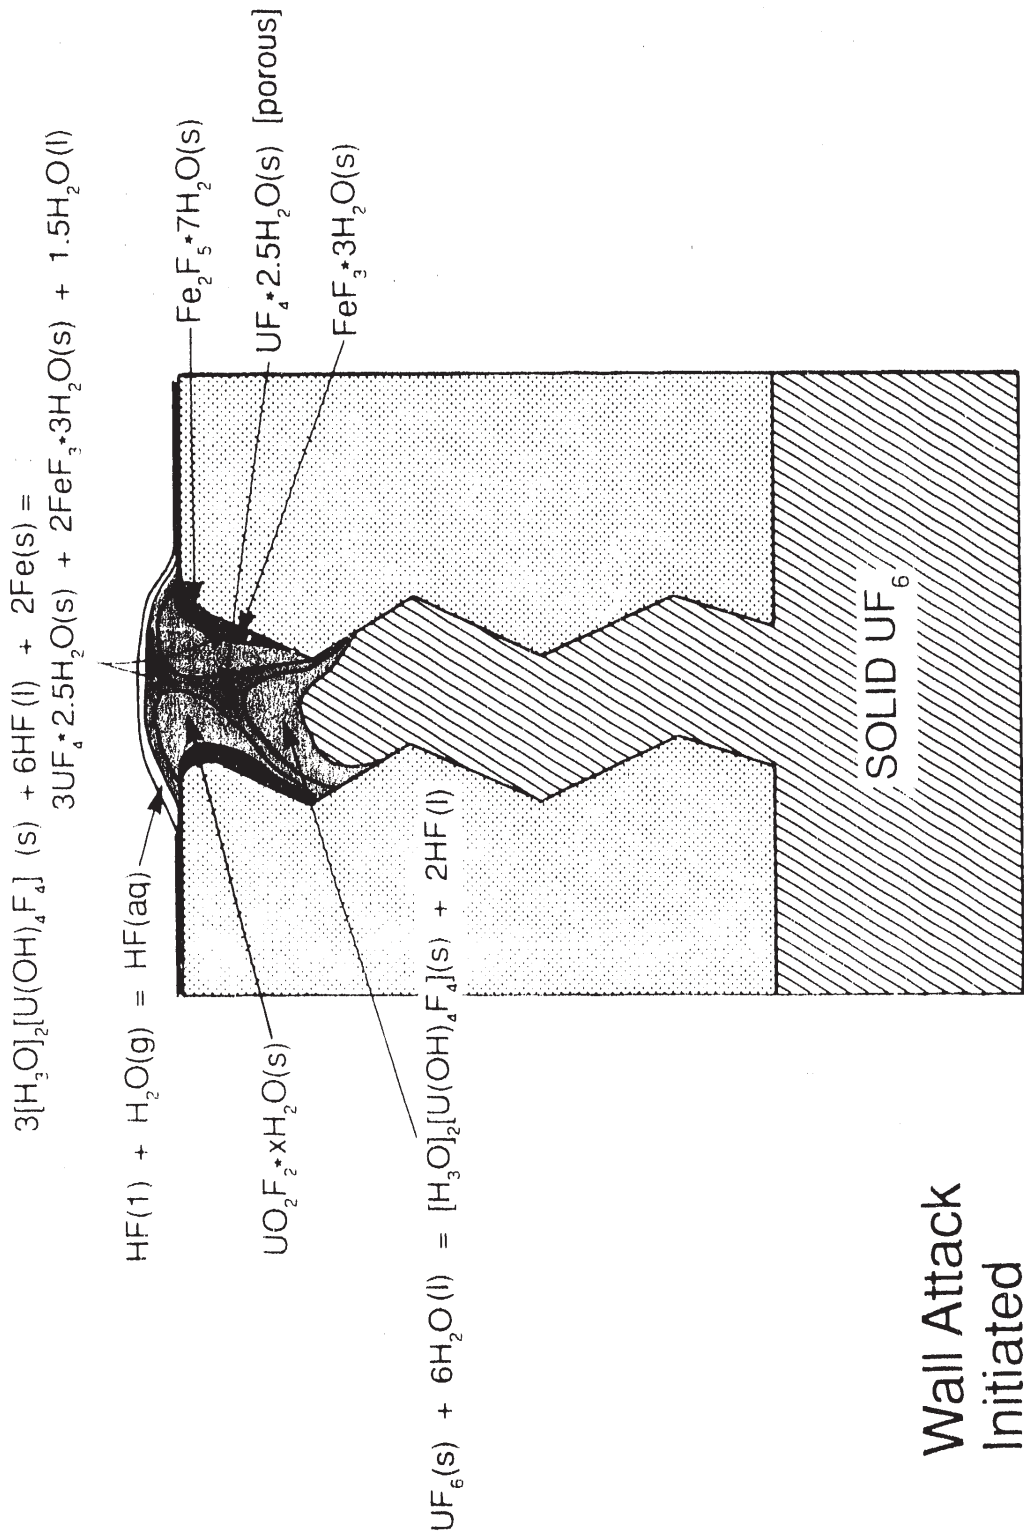
DWG. NO. K/G-91-1125

Fig. B3.7. Schematic cross section of fracture showing initiation of reduction and interior hydrolysis reactions in phase 3.

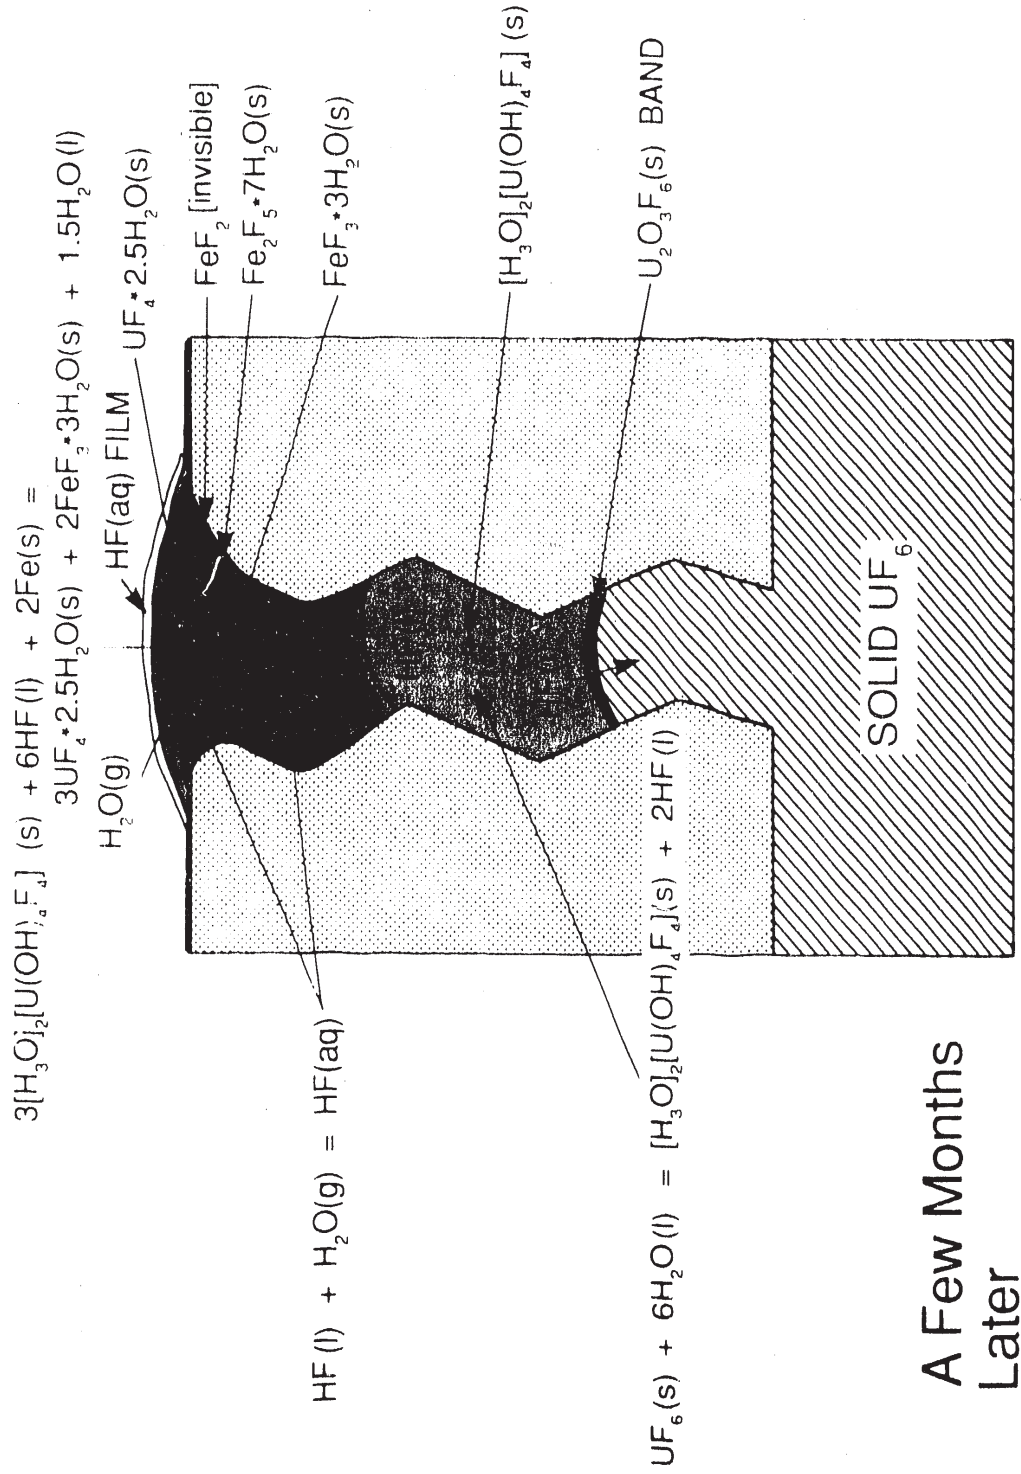
Fig. B3.8 Wall attack at fracture continues. Outer layer of  $\text{UO}_2\text{F}_2$  hydrate replaced by  $\text{UF}_6$  hydrate. Internal hydrolysis reaction continues down fracture.

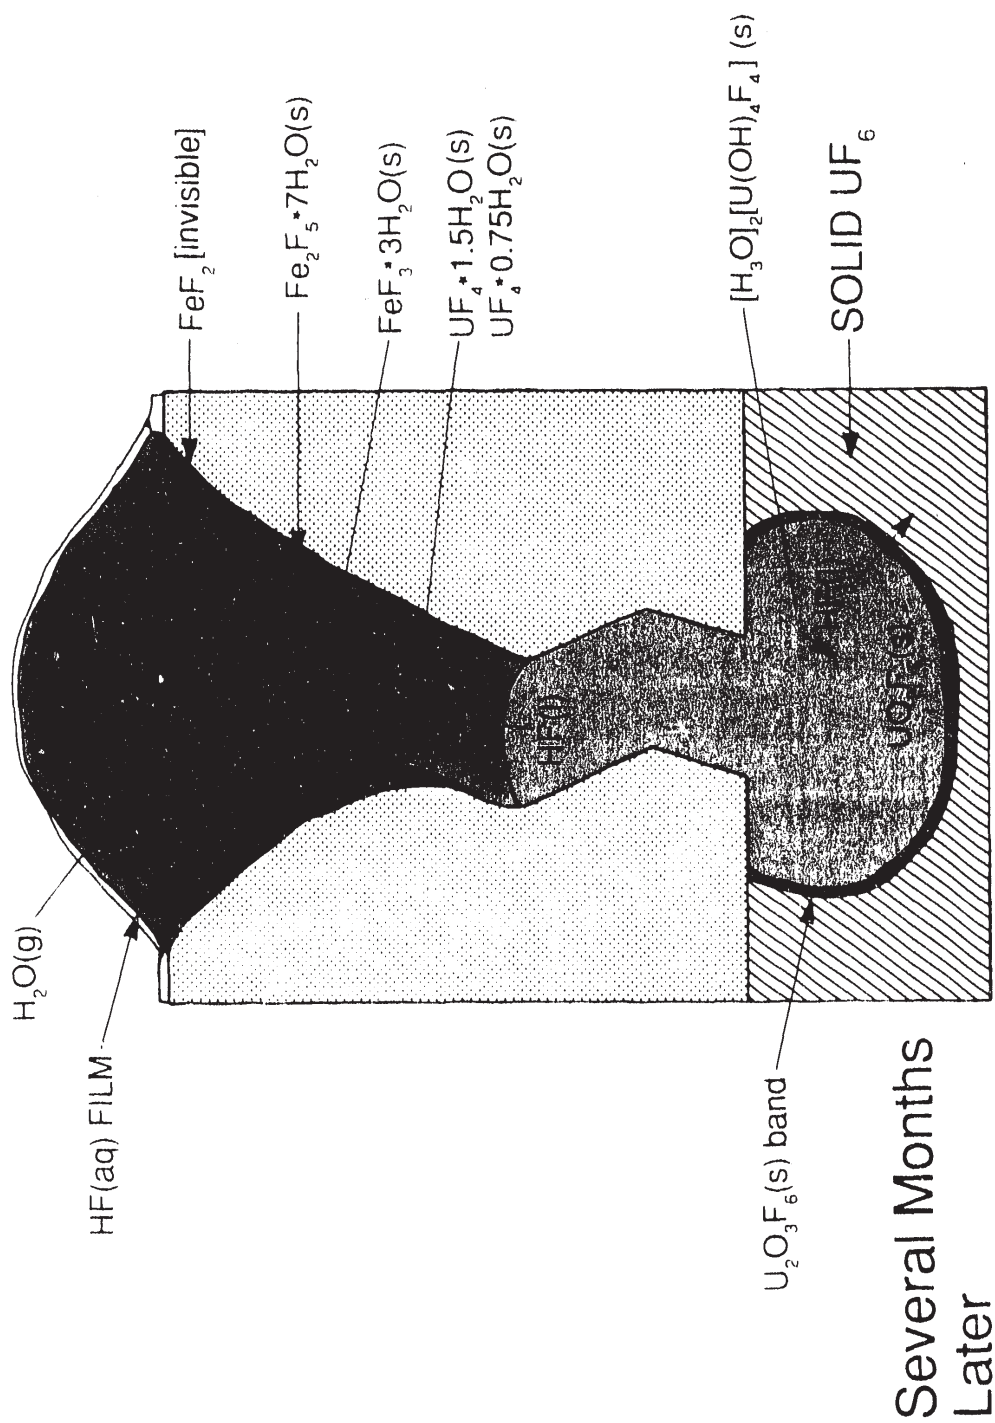
DWG. NO. K/G-91-1127

Fig. B3.9. Wall attack at fracture continues. Hydrolysis reaction enters into cylinder  $\text{UF}_6$ . Fracture is being enlarged from outside in.

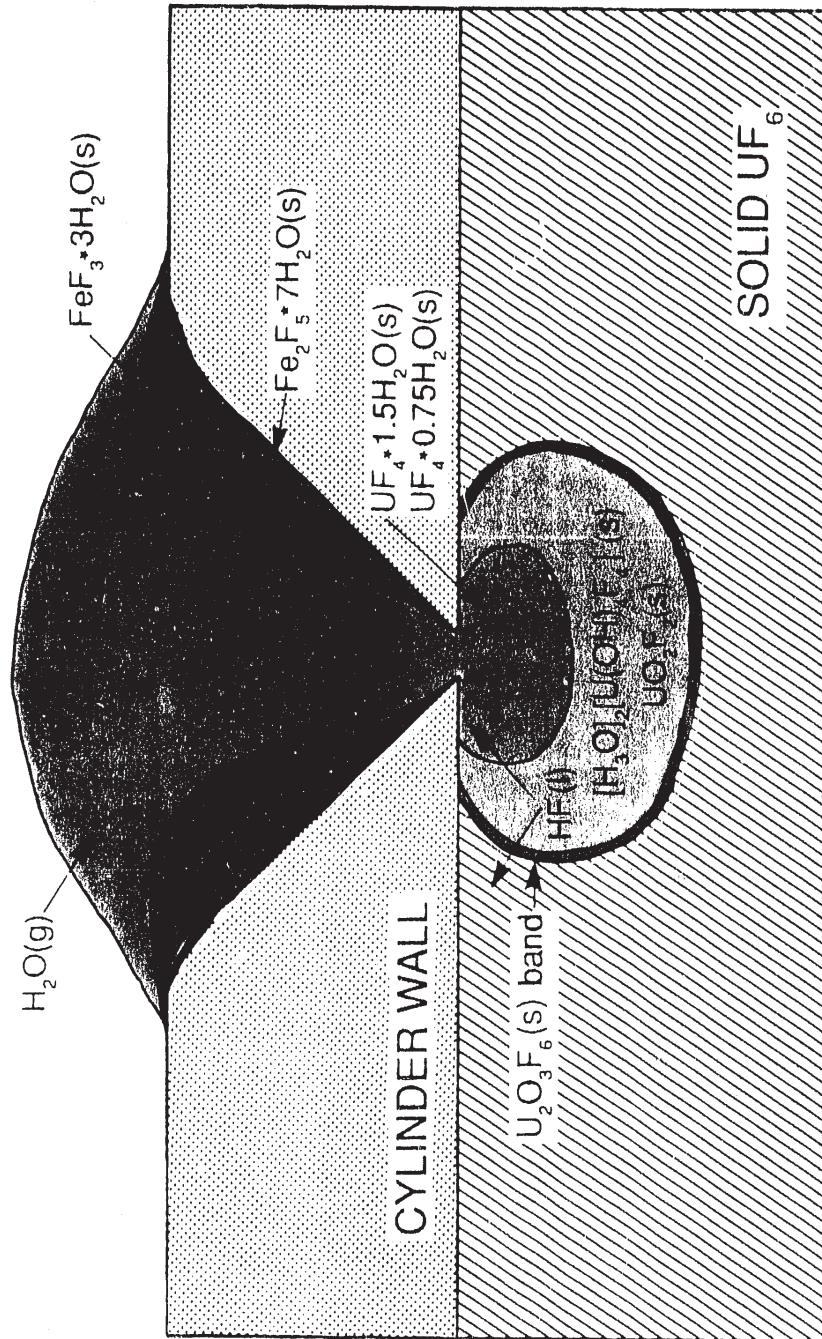
DWG. NO. K/G-91-1128

Fig. B3.10. Phase 3 is completed as fracture is enlarged along full depth.  $\text{UF}_4$  hydrate is now forming inside cylinder. Hydrolysis of  $\text{UF}_6$  reactions surrounds the  $\text{UF}_4$  inside the cylinder.

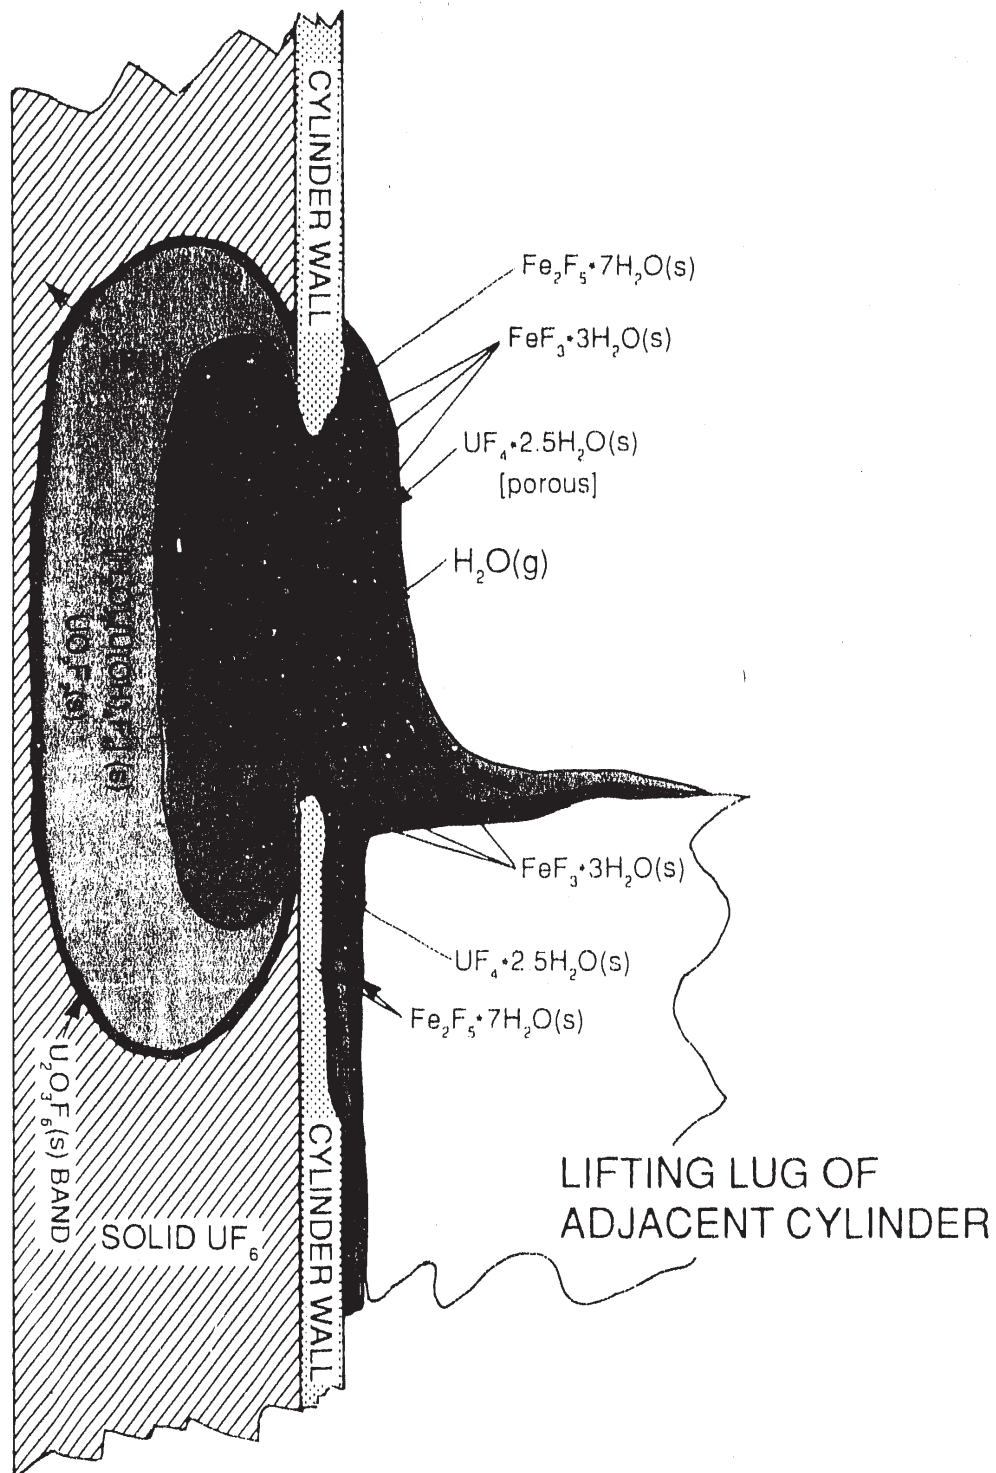
Four Years Later

Fig. B3.11. The main reactions continue to be hydrolysis of  $\text{UF}_6$  inside and reduction to  $\text{UF}_4$  inside and outside the cylinder. The fracture has become a small hole after 4 years.

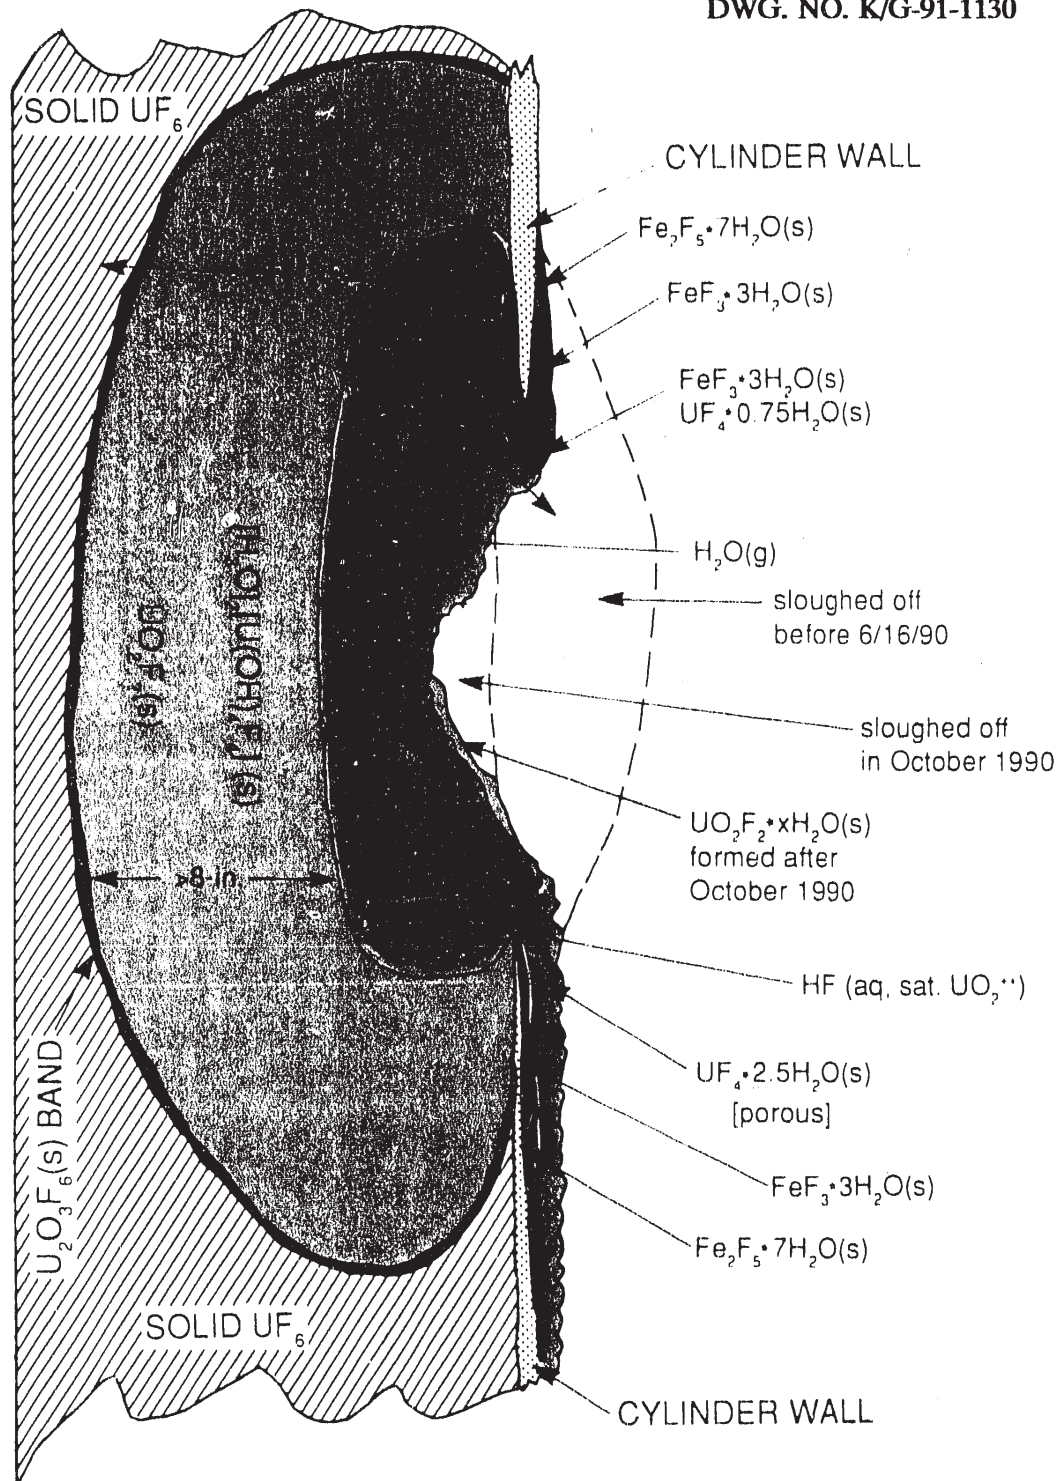
## Thirteen Years Later

Fig. B3.12. The hydrolysis and reduction reactions continue. Deposits outside the cylinder slough off. The HF escapes both as vapor and liquid solution. A small amount of hexavalent uranium in solution not reduced to  $\text{UF}_4$  hydrate escapes as  $\text{UO}_2^{++}$  from the vicinity of the cylinder. Condition shown is for 13 years after initial impact. The hole is now large, greater than 8 in.
