# A Review of Criticality Accidents

## 2000 Revision

**LA-13638**

**Issued: May 2000**

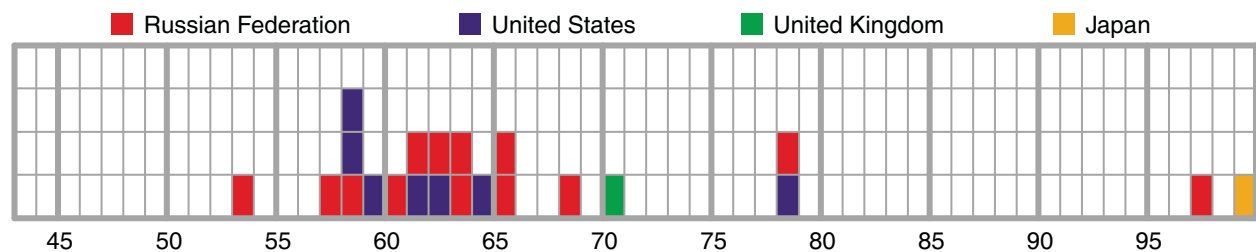
A chronology of the accidents that occurred in process facilities is provided in Figure 1. Below are listed highlights of these 22 process accidents.

Figure 1. Chronology of process criticality accidents.

That lessons have been learned from past criticality accidents is made clear from their time histogram, Figure 1. For about the first decade of operations with significant\* quantities of fissile materials, there was not a reported accident. This was likely associated with the relatively small scale of individual operations and the relatively small amounts of fissile material (almost exclusively plutonium and enriched uranium) that was available.

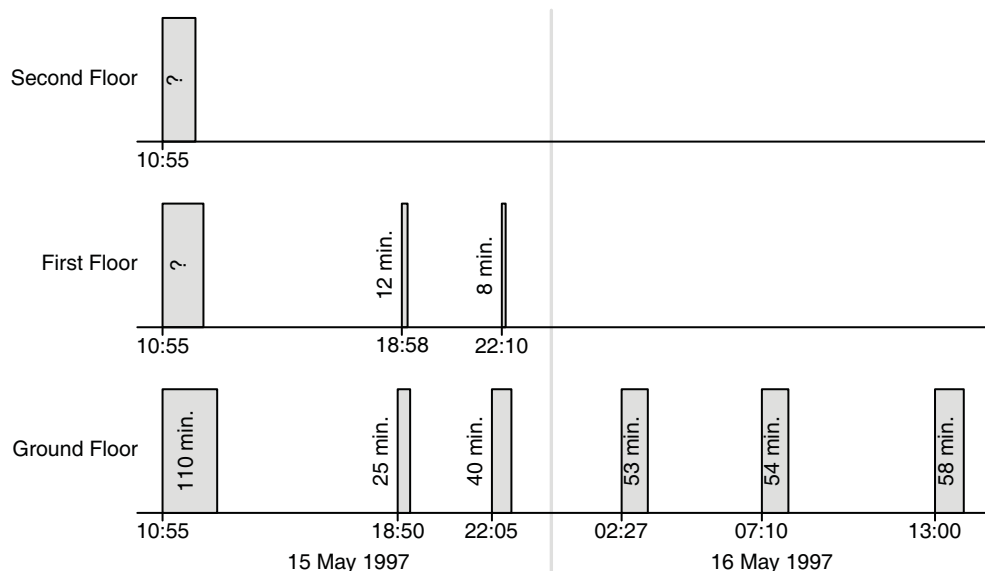
samples of the  $\text{UO}_2$  particles taken on 20 May. The detectors were located at 12 monitoring stations. However, during the excursions, at most only three of the monitoring stations alarmed, indicating very low peak power for each excursion. These three stations were located on the ground, first, and second floors directly above one another. From the central control room, health physicists documented the sequence of excursions, the response of the detectors, and the length of time that the detector alarm threshold ( $36 \text{ mR/h}$ ) was exceeded (Figure 33).

Figure 33. Sequence of alarms and duration that the radiation levels exceeded the alarm level ( $36 \text{ mR/h}$ ).

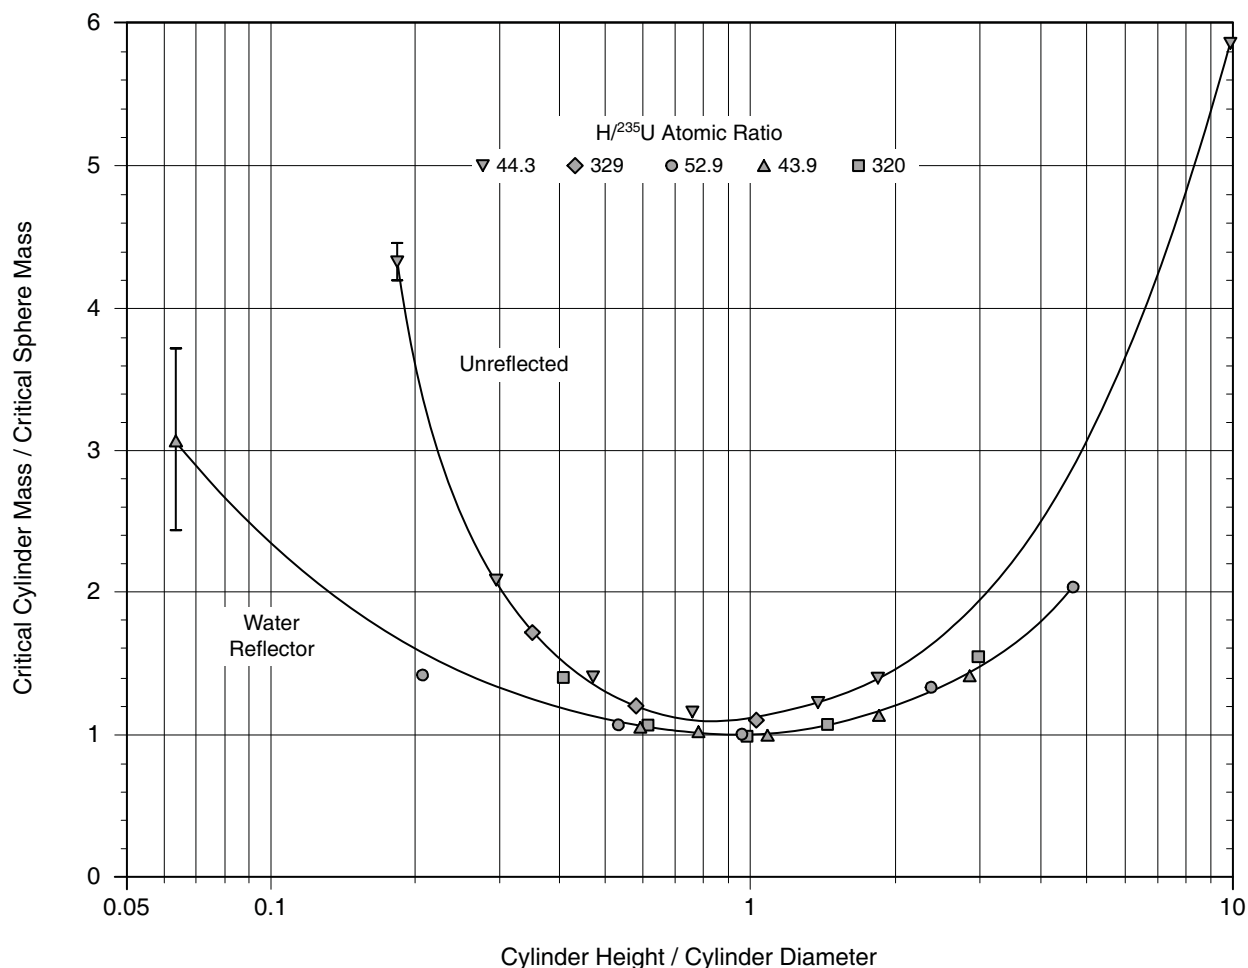
For the 18 accidents where **h/D** is specified, the unreflected curve in Figure 36<sup>34</sup> was used to determine the shape factor. The curve in Figure 36 is based directly on experimental results minimizing dependence on calculations. For the remaining 3 accidents (numbers 2, 6, and 20), buckling or other mathematically simple approximations were used to estimate the shape factor.

Figure 36. The ratio of cylindrical to spherical critical masses of  $\text{U}(93)\text{O}_2\text{F}_2$  solutions, unreflected and with water reflector, as a function of cylinder height to cylinder diameter ratio.

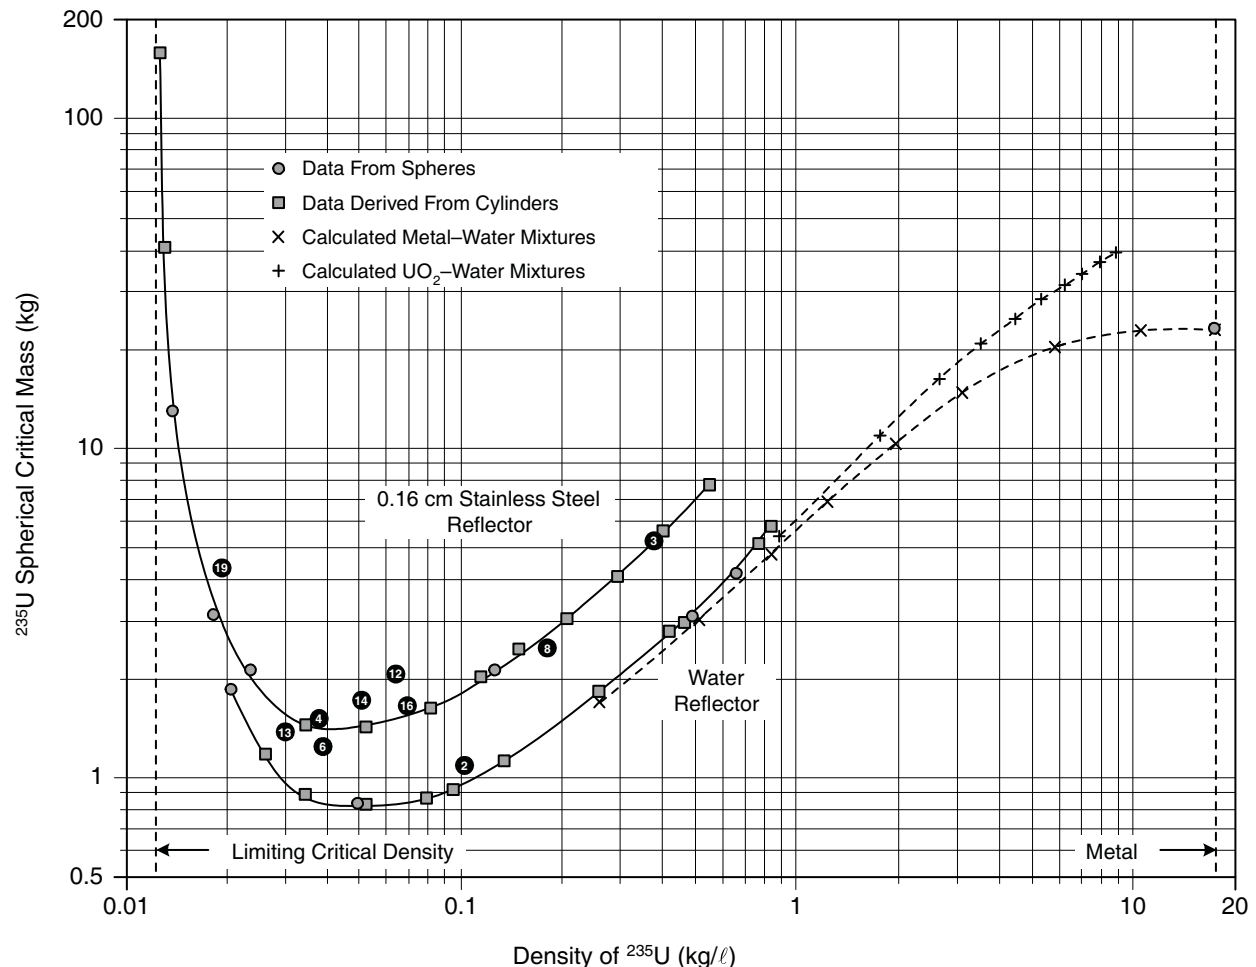
Figures 37, 38, and 39 are selected and adapted from Los Alamos report LA-10860.<sup>34</sup> These three figures include points corresponding to fissile density (or atom ratio) and the estimated spherical critical mass for the twenty-one accident re-constructions in Table 9. Figure 38 includes curves for systems with uranium enrichment corresponding

Considering the effects of partial reflection and inherent uncertainties in the estimates, it is judged that the position of 18 of the 21 points plotted in Figures 37, 38, and 39 are sufficient for establishing credible agreement between the reported accident conditions and known conditions for criticality. The estimates for accidents 1, 7, and 9 appear to be somewhat questionable in that more mass than reported in the accident would be required for criticality under the hypothesized unreflected accident conditions. However, accidents 1 and 7, would be in reasonable agreement if the partial reflection present during the accident were taken into account. It should be noted that for these two cases, the "missing" mass is no greater in magnitude than other accident reconstructions (notably, accidents 12, 14, and 17) in which the reported mass exceeds the known conditions for criticality. The discrepancy surrounding accident 9 is also consistent with the large reported uncertainty in the amount of mass present. No systematic features are distinguishable that differentiate the R.F., U.S., U.K., and Japanese accidents.

Figure 37. Critical masses of homogeneous water moderated U(93.2) spheres. Solution data appear unless indicated otherwise. The accidents are shown by numbered circles.

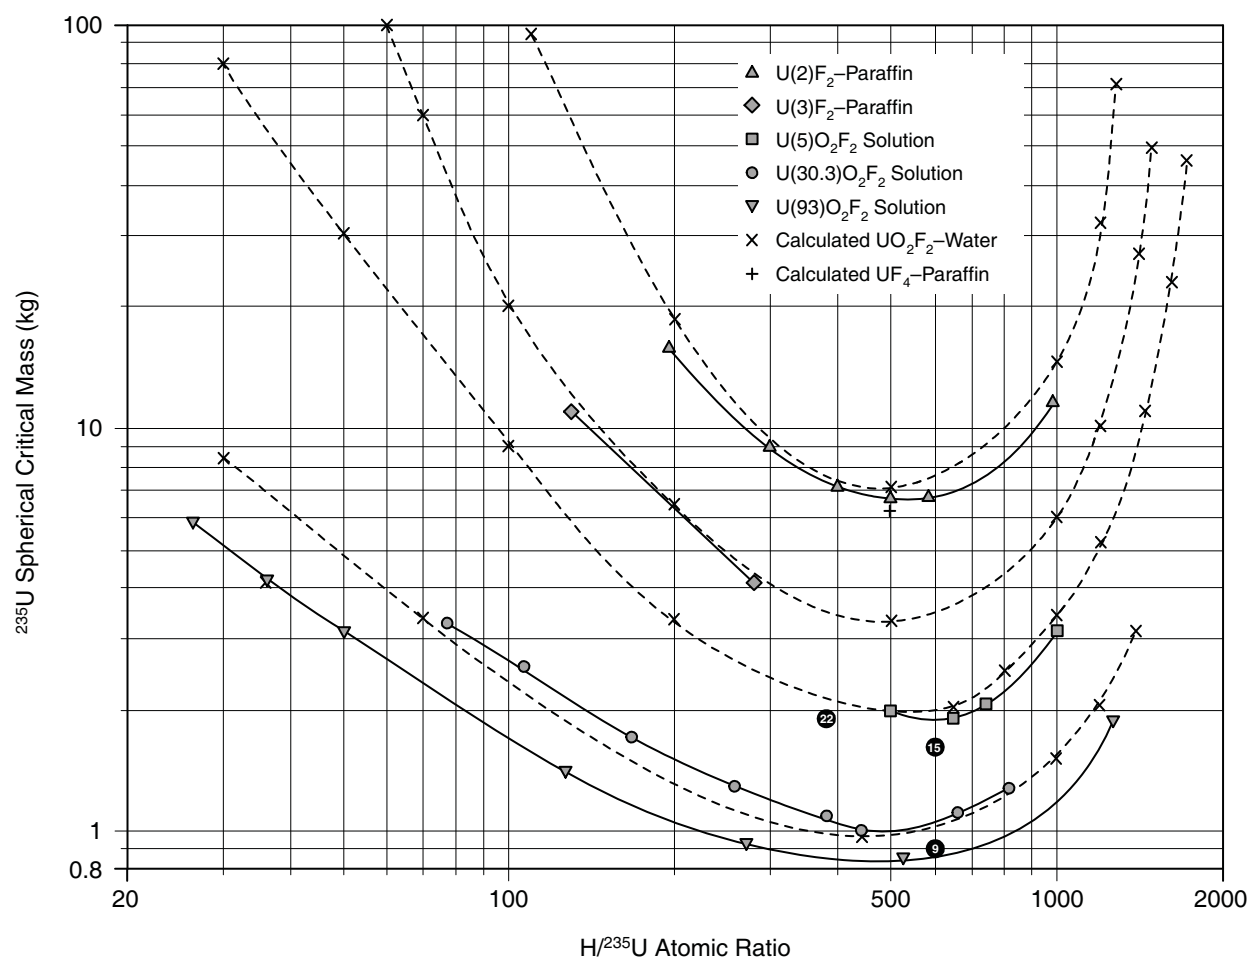
to 2.0, 3.0, 5.0, 30.3, and 93.0. Accidents 9, 15, and 22 are superimposed on this figure. Since the curves in Figure 38 are for water reflected systems, these points have been adjusted downward since the actual accidents were relatively unreflected.

Figure 38. Critical masses of water-reflected spheres of hydrogen-moderated U(93), U(30.3), U(5.00), U(3.00), and U(2.00). The accidents are shown by numbered circles.

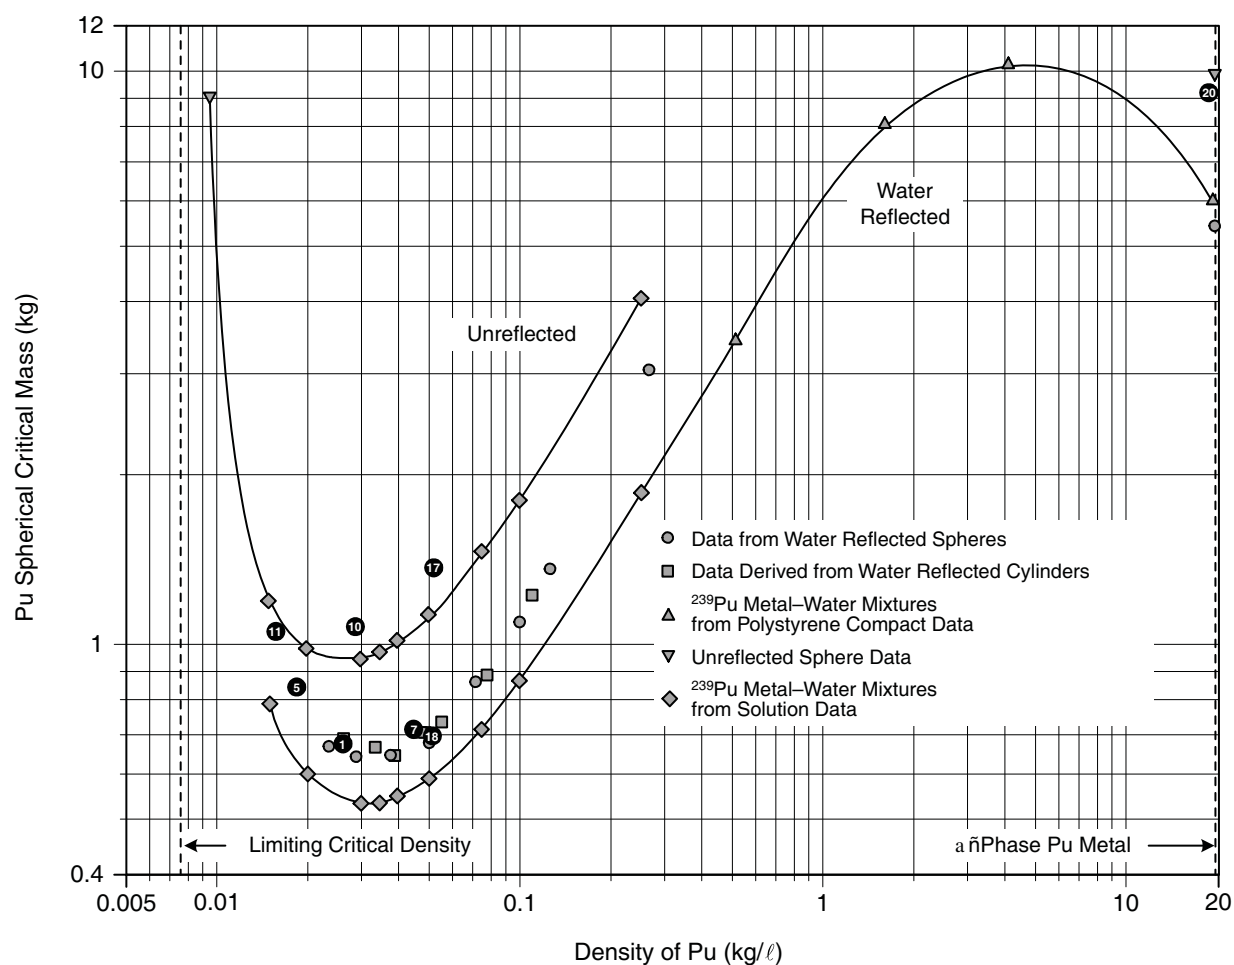
Figure 39. Critical masses of homogeneous water moderated plutonium spheres. The points suggesting an intermediate curve apply to water reflected  $\text{Pu}(\text{NO}_3)_4$  solution with 1 N  $\text{HNO}_3$  and 3.1%  $^{240}\text{Pu}$  content. The accidents are shown by numbered circles.

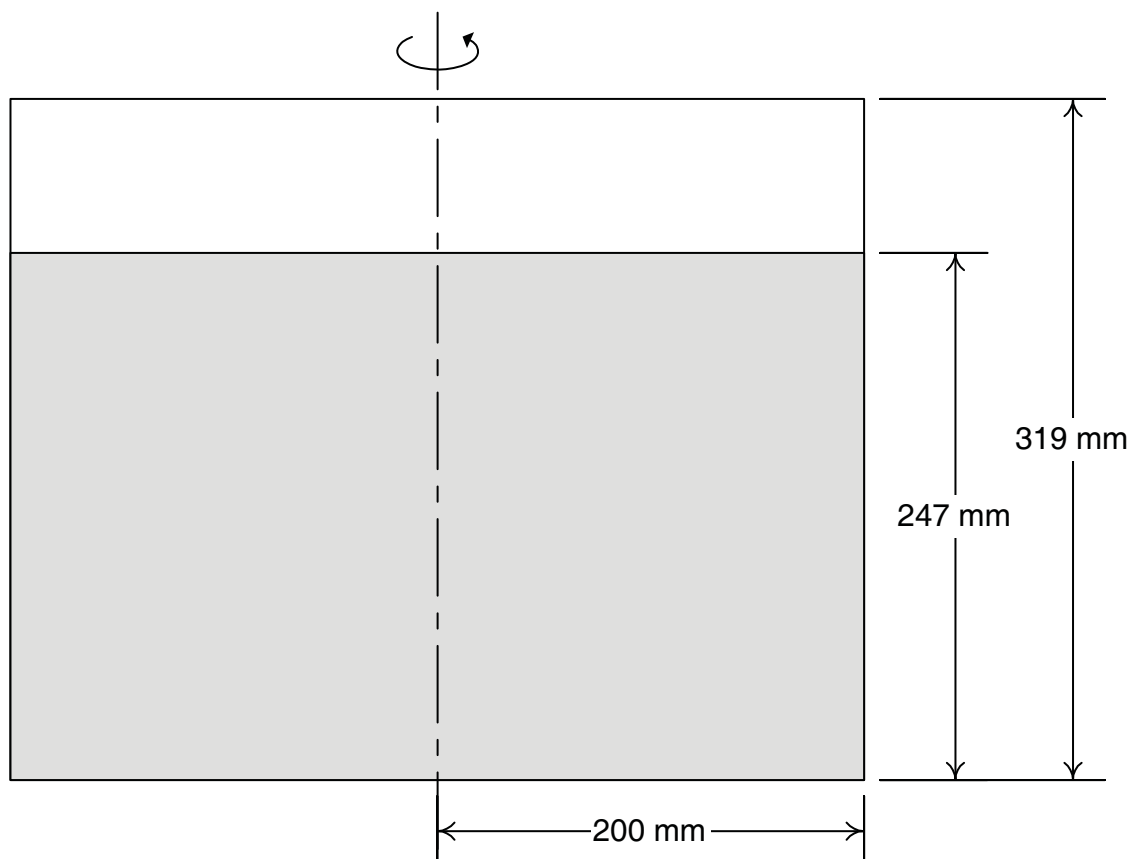
## 1. Mayak Production Association, 15 March 1953

*Plutonium nitrate solution in an interim storage vessel; single excursion; one serious exposure, one significant exposure.*

Vessel Volume	40.0 ℓ
Fissile Volume	31.0 ℓ
Fissile Mass	0.81 kg
Fissile Density	26.1 g/ℓ

Estimated Spherical Critical Mass	0.67 kg
First Spike Yield	unknown
Specific Spike Yield	unknown
Total Yield	$\sim 2.0 \times 10^{17}$

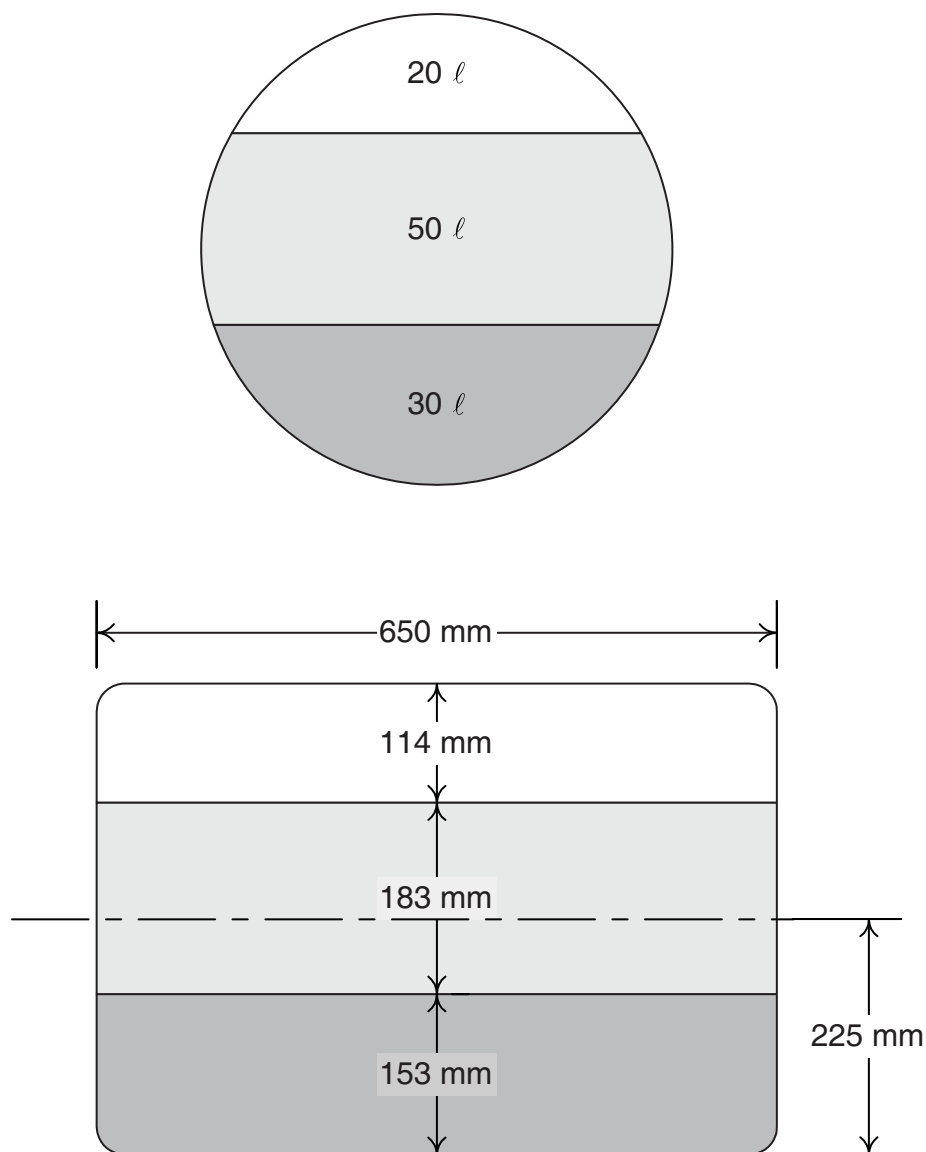
## 2. Mayak Production Association, 21 April 1957

*Uranium precipitate, U(90), buildup in a filtrate receiving vessel; excursion history unknown; one fatality; five other significant exposures.*

Vessel Volume	100.0 ℓ
Fissile Volume	30.0 ℓ
Fissile Mass	3.06 kg
Fissile Density	102.0 g/ℓ

Estimated Spherical Critical Mass	1.09 kg
First Spike Yield	unknown
Specific Spike Yield	unknown
Total Yield	$\sim 1.0 \times 10^{17}$

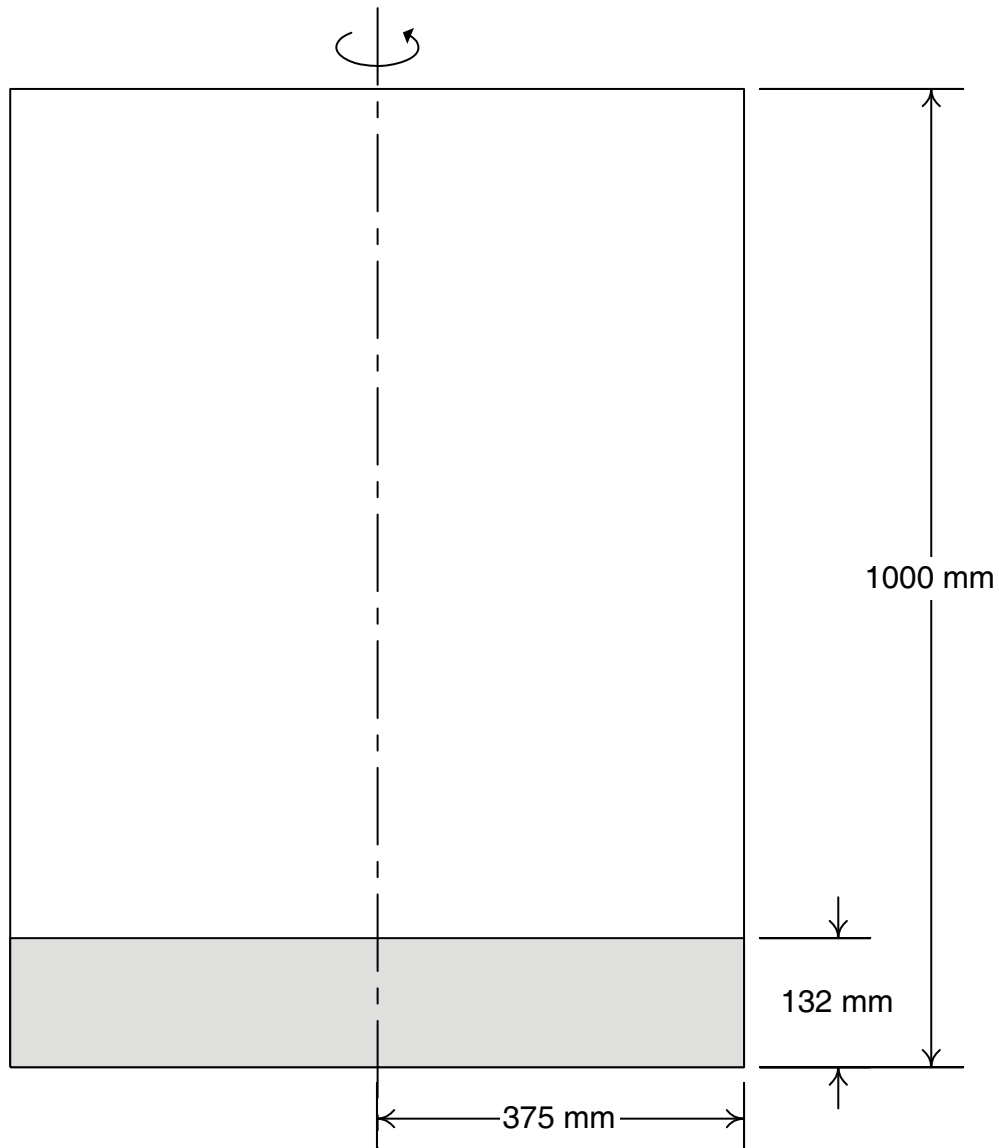
### 3. Mayak Production Association, 2 January 1958

*Uranyl nitrate solution, U(90), in an experiment vessel; one prompt critical burst; three fatalities; one serious exposure.*

Vessel Volume	442.0 ℓ
Fissile Volume	58.4 ℓ
Fissile Mass	22.0 kg
Fissile Density	376.7 g/ℓ

Estimated Spherical Critical Mass	5.24 kg
First Spike Yield	$\sim 2.0 \times 10^{17}$
Specific Spike Yield	$3.4 \times 10^{15}$
Total Yield	$\sim 2.0 \times 10^{17}$

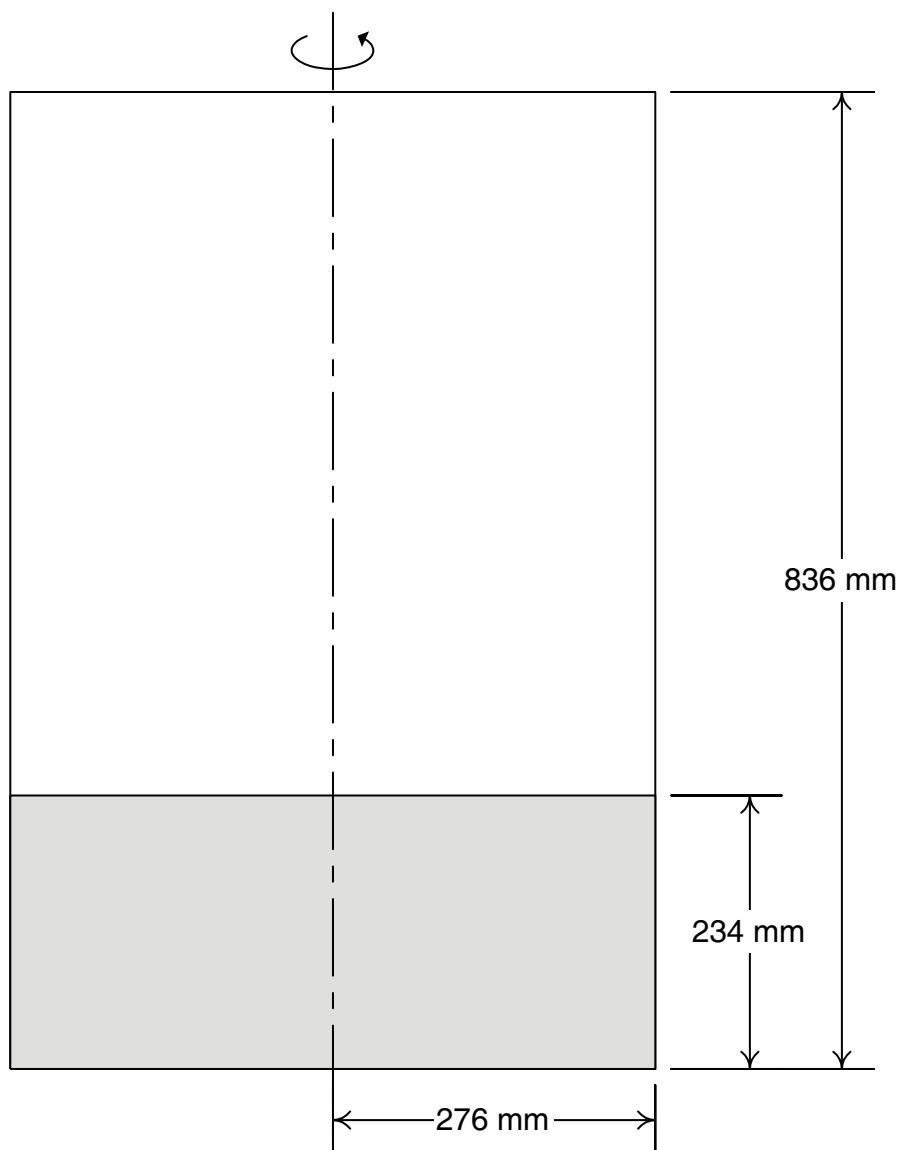
#### 4. Oak Ridge Y-12 Plant, 16 June 1958

*Uranyl nitrate solution, U(93), in a water collection drum; multiple excursions;  
seven significant exposures.*

Vessel Volume	208.0 ℓ
Fissile Volume	56.0 ℓ
Fissile Mass	2.10 kg
Fissile Density	37.5 g/ℓ

Estimated Spherical Critical Mass	1.50 kg
First Spike Yield	$\sim 0.1 \times 10^{17}$
Specific Spike Yield	$0.2 \times 10^{15}$
Total Yield	$13.0 \times 10^{17}$

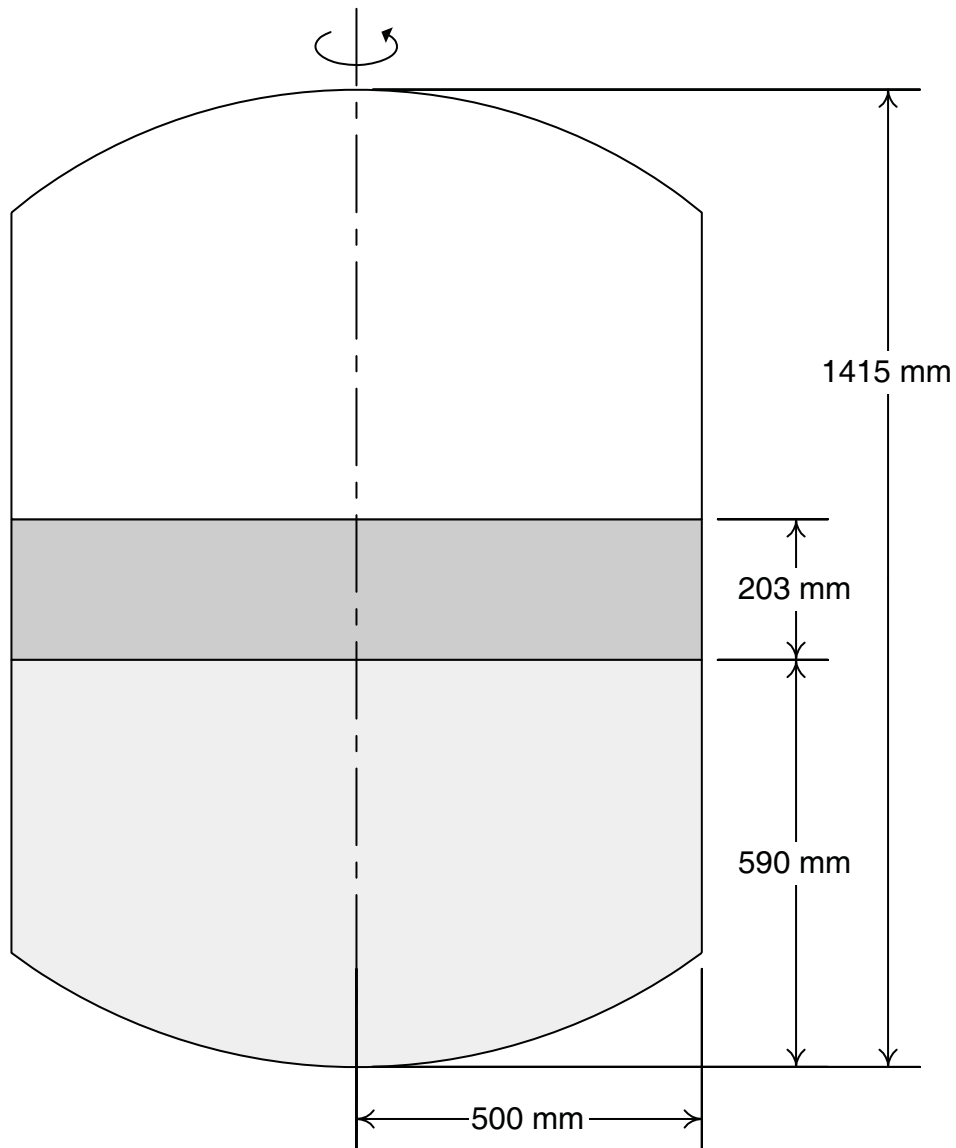
## 5. Los Alamos Scientific Laboratory, 30 December 1958

*Plutonium organic solution in an organic treatment tank; single excursion; one fatality, two significant exposures.*

Vessel Volume	982.0 ℓ
Fissile Volume	160.0 ℓ
Fissile Mass	2.94 kg
Fissile Density	18.4 g/ℓ

Estimated Spherical Critical Mass	0.84 kg
First Spike Yield	$1.5 \times 10^{17}$
Specific Spike Yield	$0.94 \times 10^{15}$
Total Yield	$1.5 \times 10^{17}$

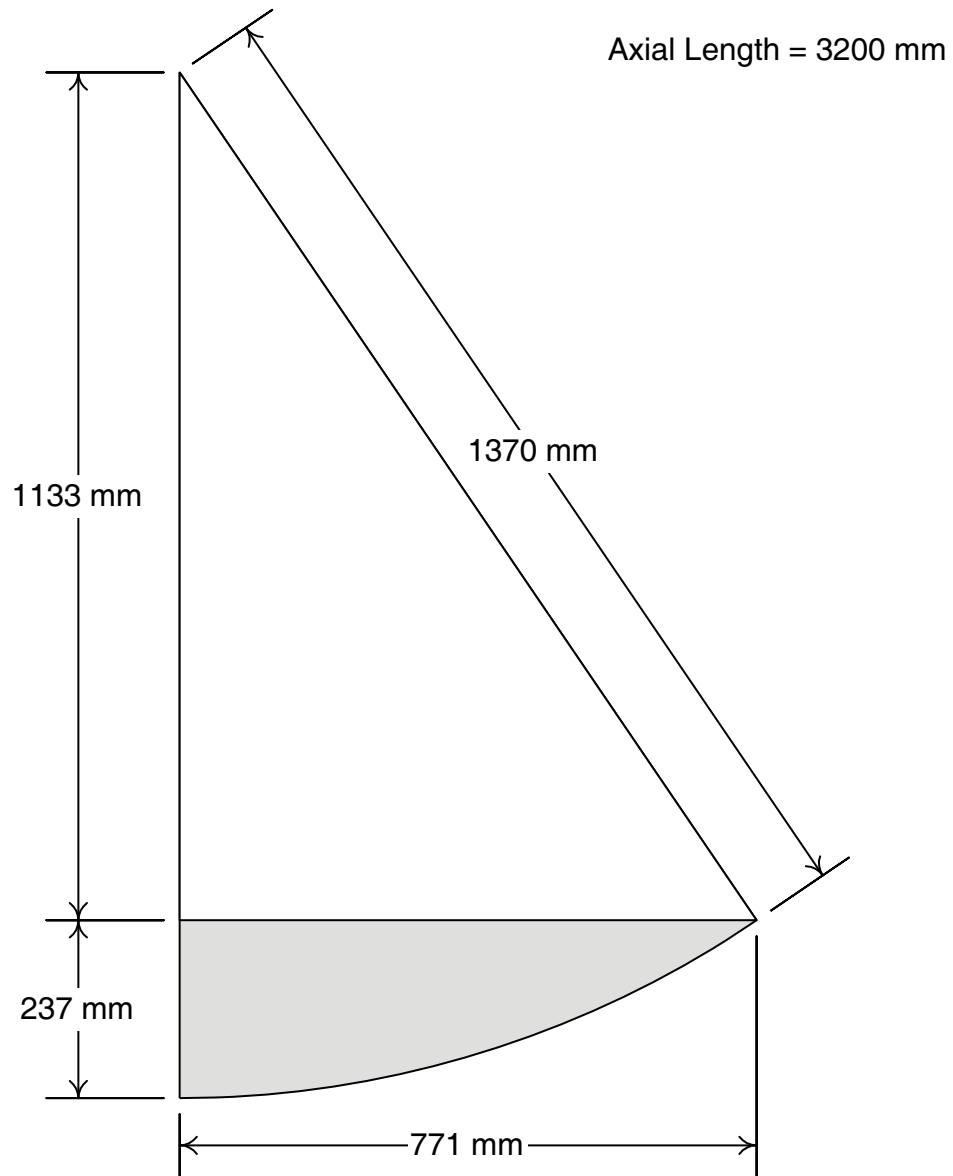
## 6. Idaho Chemical Processing Plant, 16 October 1959

*Uranyl nitrate solution, U(91), in a waste receiving tank; multiple excursions;  
two significant exposures.*

Vessel Volume	18,900 ℓ
Fissile Volume	800.0 ℓ
Fissile Mass	30.9 kg
Fissile Density	38.6 g/ℓ

Estimated Spherical Critical Mass	1.24 kg
First Spike Yield	$\sim 1.0 \times 10^{17}$
Specific Spike Yield	$\sim 0.1 \times 10^{15}$
Total Yield	$400 \times 10^{17}$

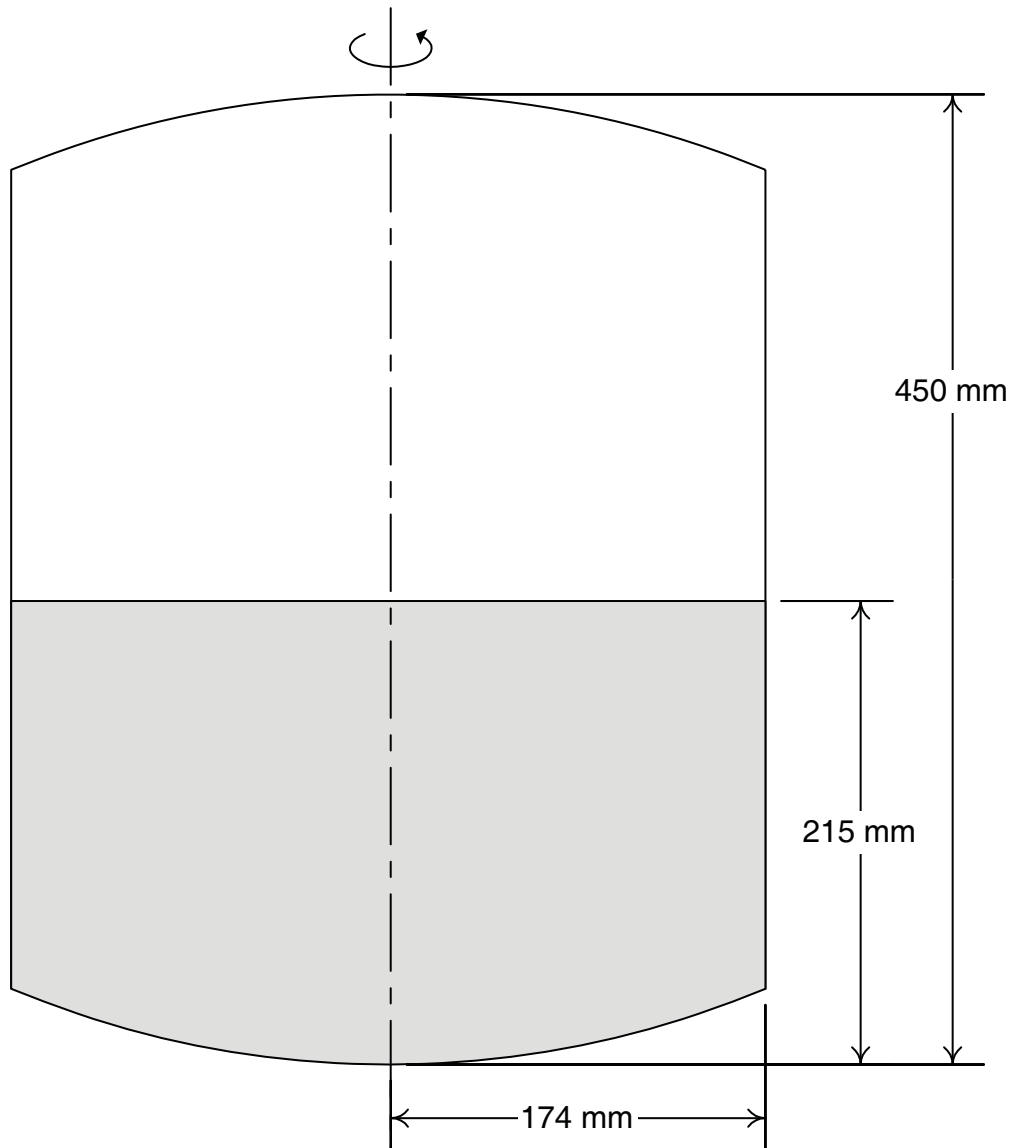
## 7. Mayak Production Association, 5 December 1960

*Plutonium carbonate solution in a holding vessel; multiple excursions;  
insignificant exposures.*

Vessel Volume	40.0 ℓ
Fissile Volume	19.0 ℓ
Fissile Mass	0.85 kg
Fissile Density	44.7 g/ℓ

Estimated Spherical Critical Mass	0.71 kg
First Spike Yield	unknown
Specific Spike Yield	unknown
Total Yield	$\sim 2.5 \times 10^{17}$

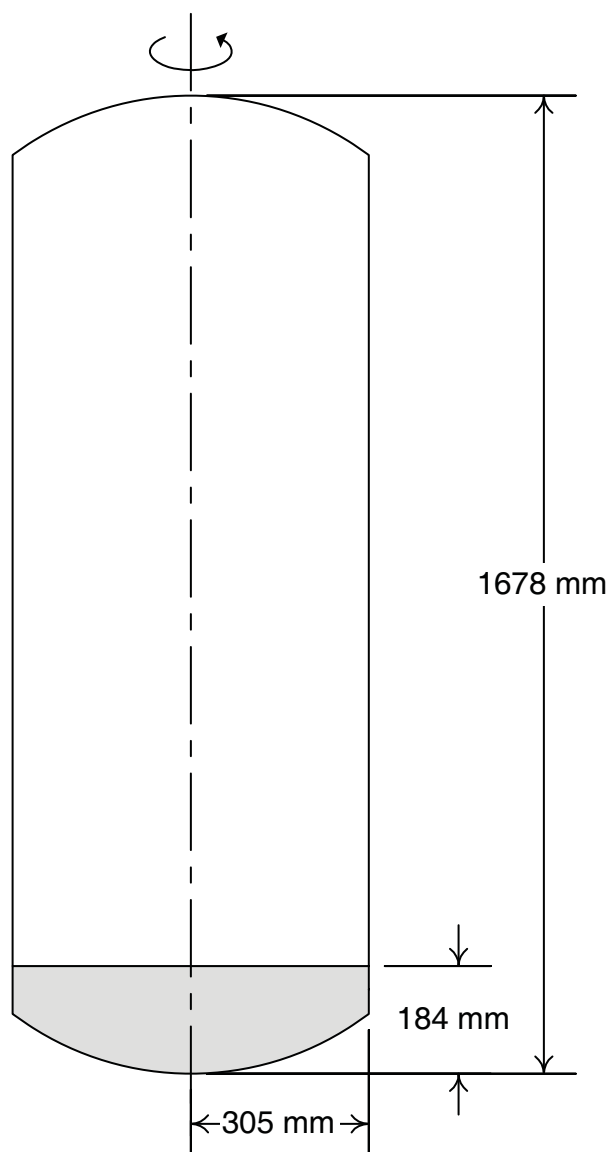
## 8. Idaho Chemical Processing Plant, 25 January 1961

*Uranyl nitrate solution, U(90), in a vapor disengagement vessel; multiple excursions; insignificant exposures.*

Vessel Volume	461.0 ℓ	Estimated Spherical Critical Mass	2.48 kg
Fissile Volume	40.0 ℓ	First Spike Yield	$\sim 0.6 \times 10^{17}$
Fissile Mass	7.20 kg	Specific Spike Yield	$1.5 \times 10^{15}$
Fissile Density	180.0 g/ℓ	Total Yield	$6.0 \times 10^{17}$

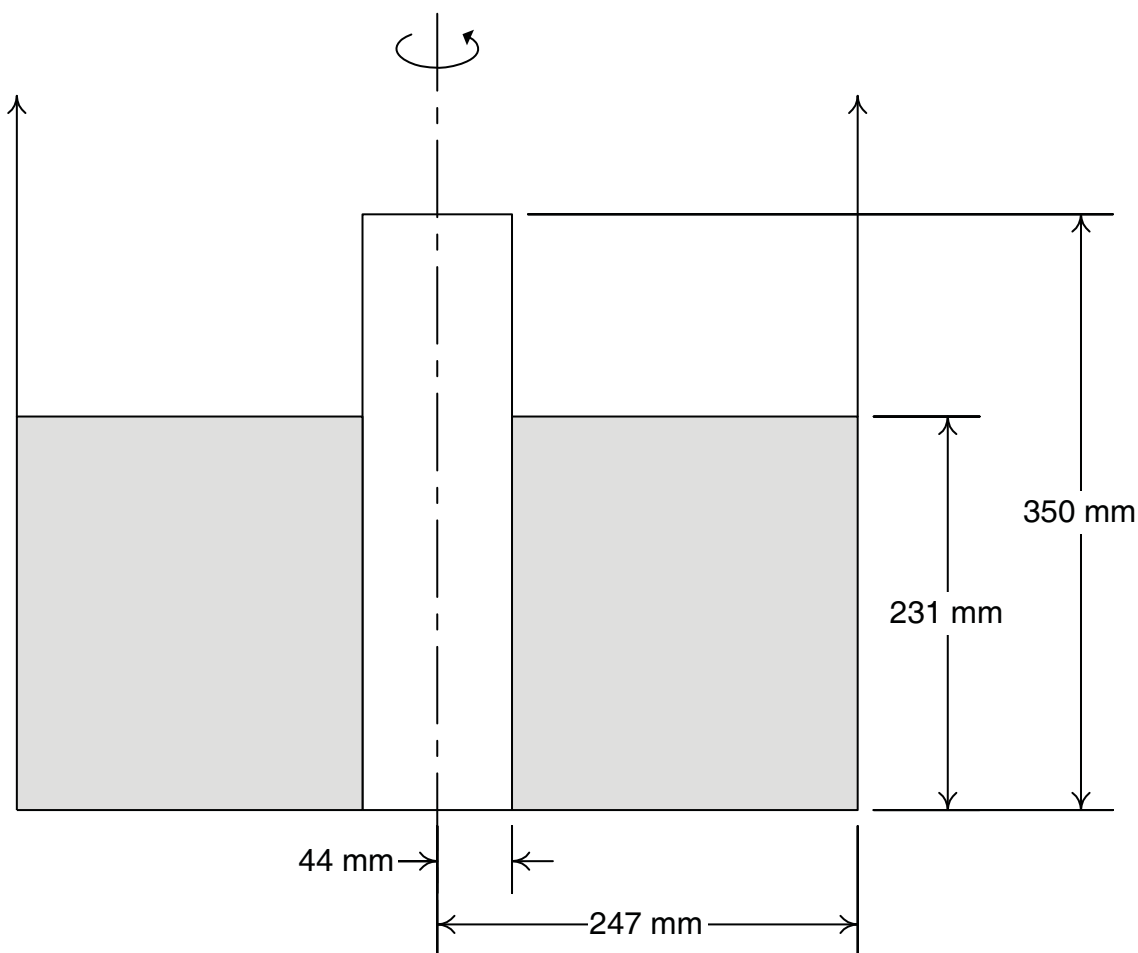
## 9. Siberian Chemical Combine (Tomsk), 14 July 1961

*Uranium hexafluoride, U(22.6), accumulation in a vacuum pump oil reservoir;  
two excursions; one significant exposure.*

Vessel Volume	65.0 ℓ
Fissile Volume	42.9 ℓ
Fissile Mass	1.68 kg
Fissile Density	39.2 g/ℓ

Estimated Spherical Critical Mass	0.9 kg
First Spike Yield	none
Specific Spike Yield	none
Total Yield	$0.12 \times 10^{17}$

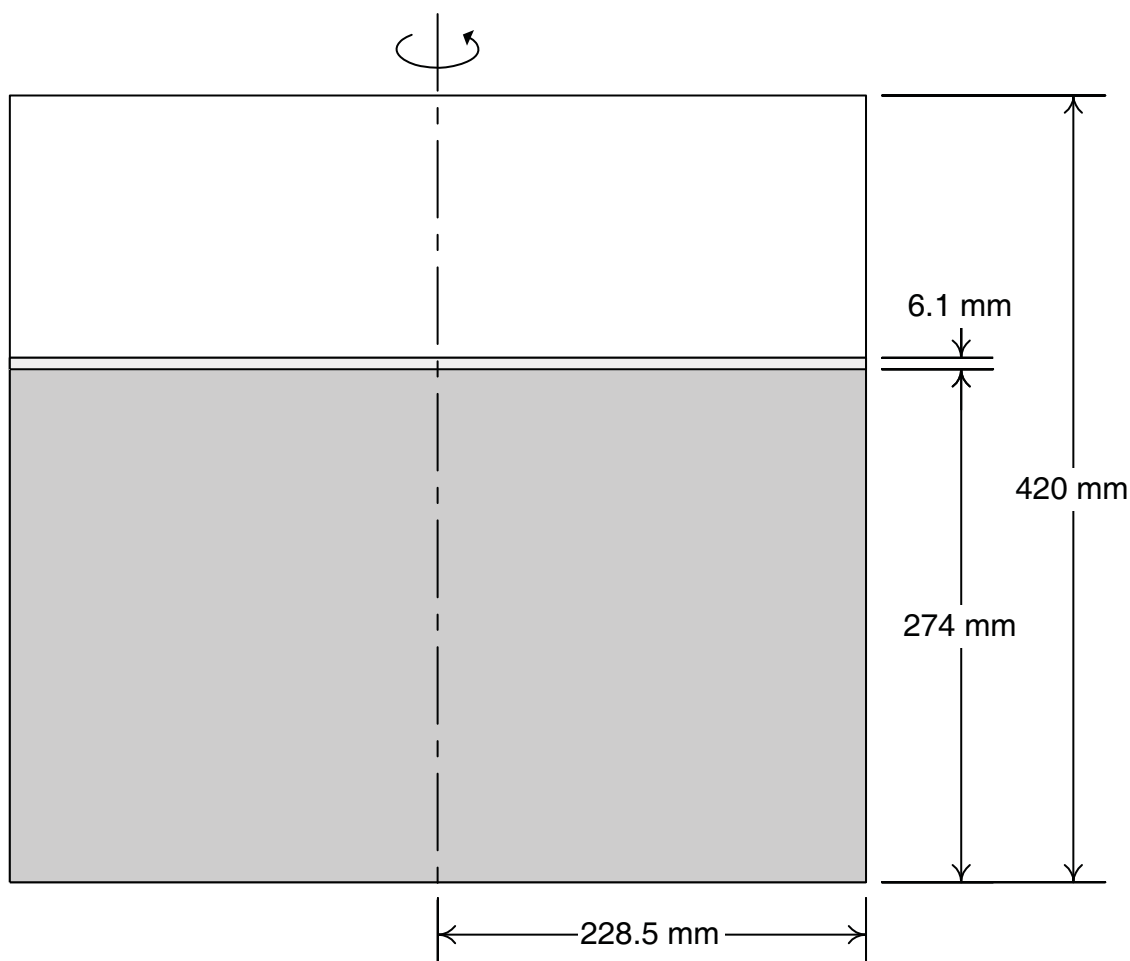
## 10. Hanford Works, 7 April 1962

*Plutonium solution in a transfer vessel; multiple excursions; three significant exposures.*

Vessel Volume	69.0 ℓ
Fissile Volume	45.0 ℓ
Fissile Mass	1.29 kg
Fissile Density	28.7 g/ℓ

Estimated Spherical Critical Mass	1.07 kg
First Spike Yield	$\sim 0.1 \times 10^{17}$
Specific Spike Yield	$0.2 \times 10^{15}$
Total Yield	$8.0 \times 10^{17}$

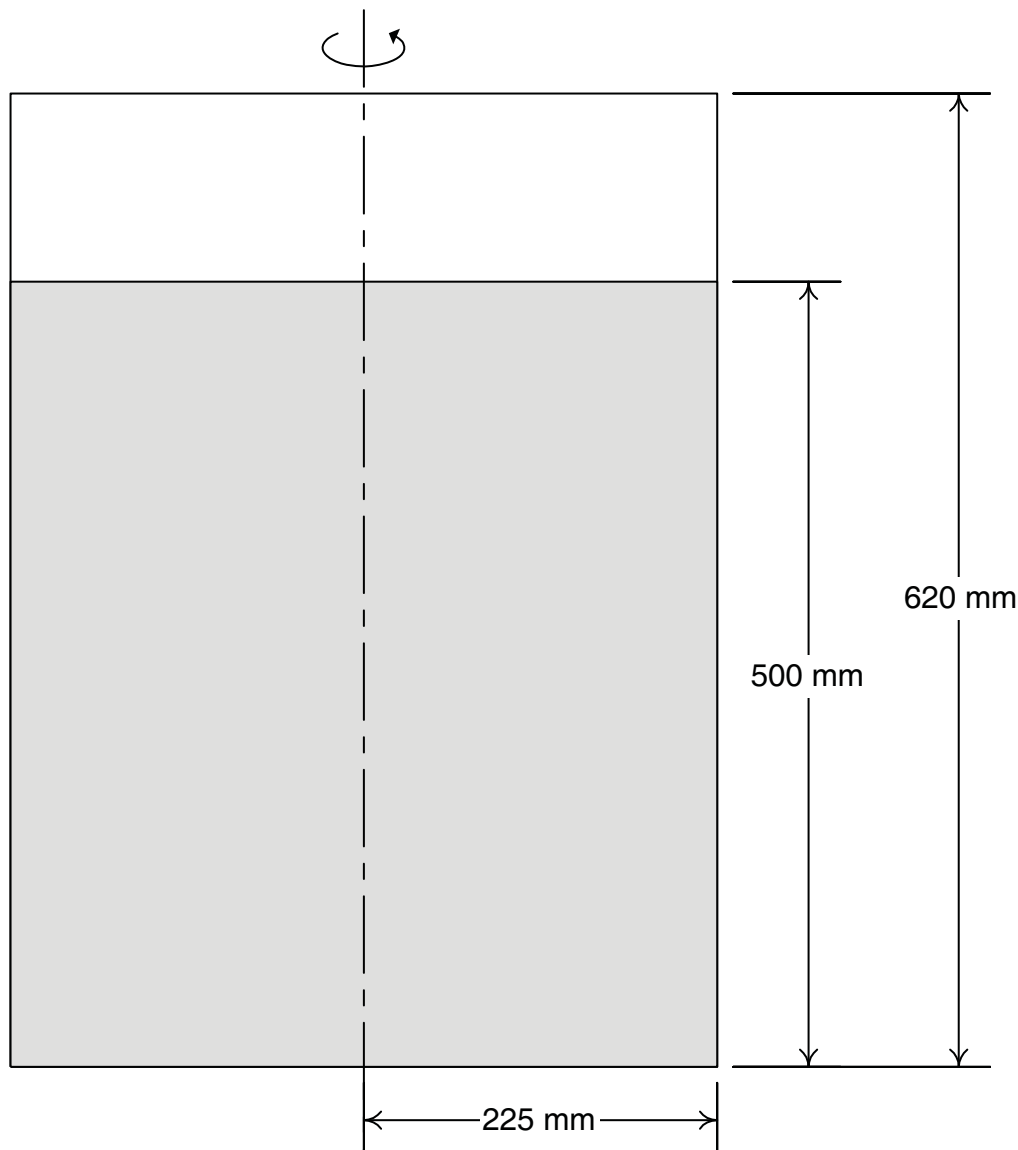
11. Mayak Production Association, 7 September 1962

*Plutonium nitrate in a dissolution vessel; three excursions; insignificant exposures.*

Vessel Volume	100.0 ℓ	Estimated Spherical Critical Mass	1.05 kg
Fissile Volume	80.0 ℓ	First Spike Yield	none
Fissile Mass	1.26 kg	Specific Spike Yield	none
Fissile Density	15.8 g/ℓ	Total Yield	~2.0×10 <sup>17</sup>

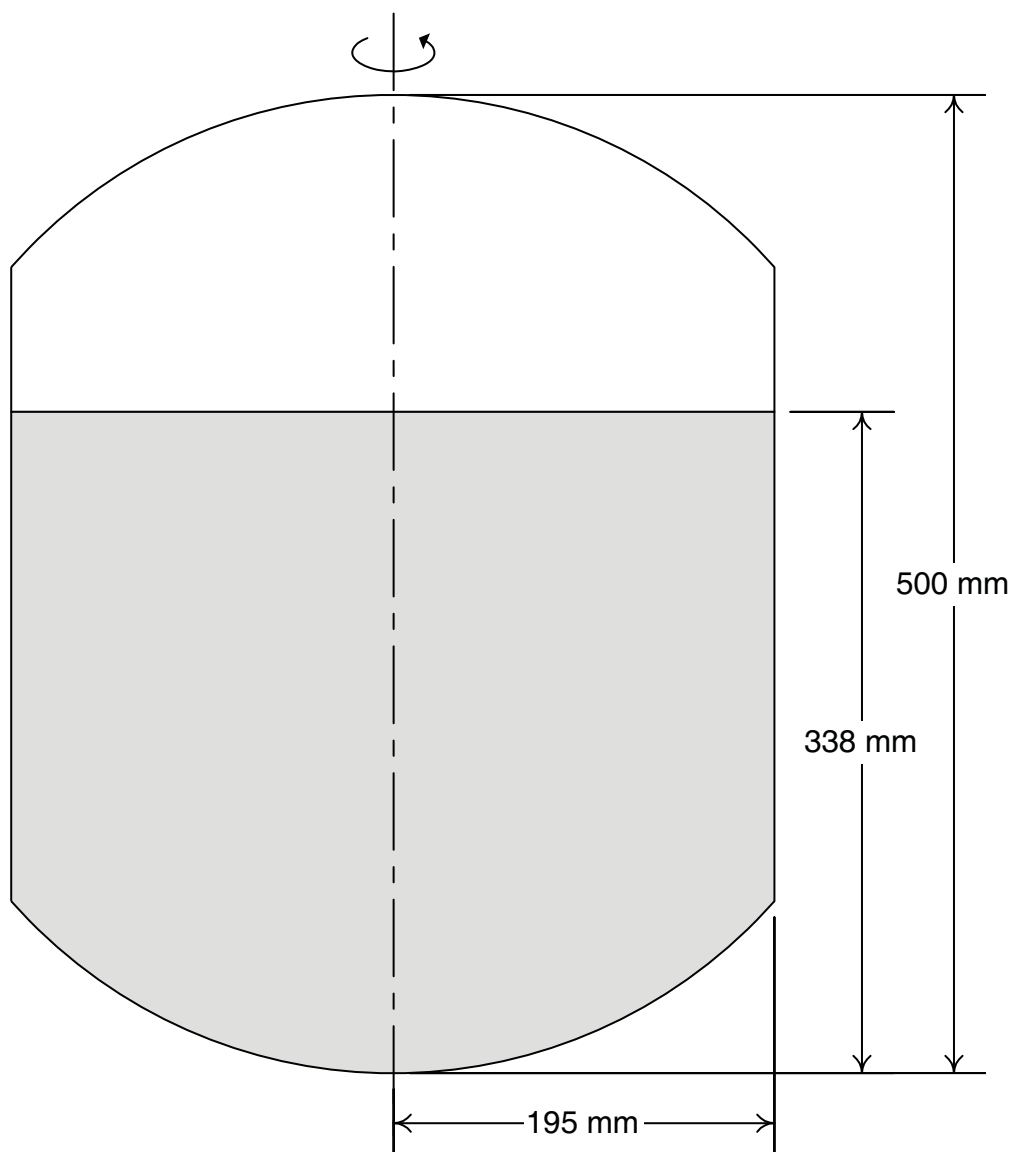
## 12. Siberian Chemical Combine (Tomsk), 30 January 1963

*Uranyl nitrate solution, U(90), in a collection vessel; multiple excursions;  
insignificant exposures.*

Vessel Volume	49.9 ℓ
Fissile Volume	35.5 ℓ
Fissile Mass	2.27 kg
Fissile Density	63.9 g/ℓ

Estimated Spherical Critical Mass	2.06 kg
First Spike Yield	unknown
Specific Spike Yield	unknown
Total Yield	$7.9 \times 10^{17}$

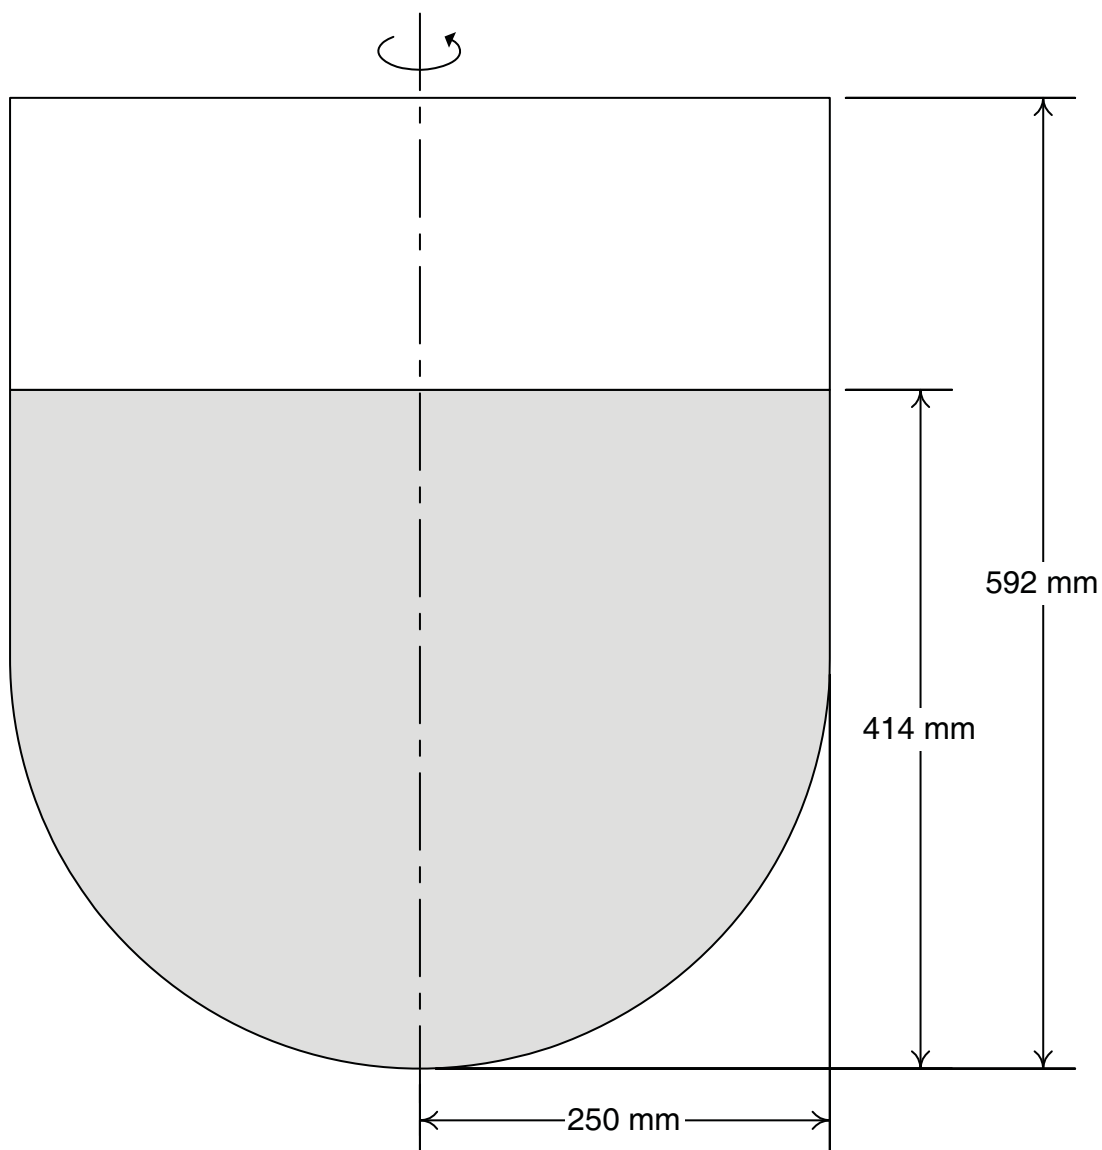
### 13. Siberian Chemical Combine, 2 December 1963

*Uranium organic solution, U(90), in a vacuum system holding vessel; multiple excursions; insignificant exposures.*

Vessel Volume	100.0 ℓ
Fissile Volume	64.8 ℓ
Fissile Mass	1.93 kg
Fissile Density	29.8 g/ℓ

Estimated Spherical Critical Mass	1.38 kg
First Spike Yield	none
Specific Spike Yield	none
Total Yield	$0.16 \times 10^{17}$
