# A Review of Criticality Accidents

## 2000 Revision

**LA-13638**

**Issued: May 2000**

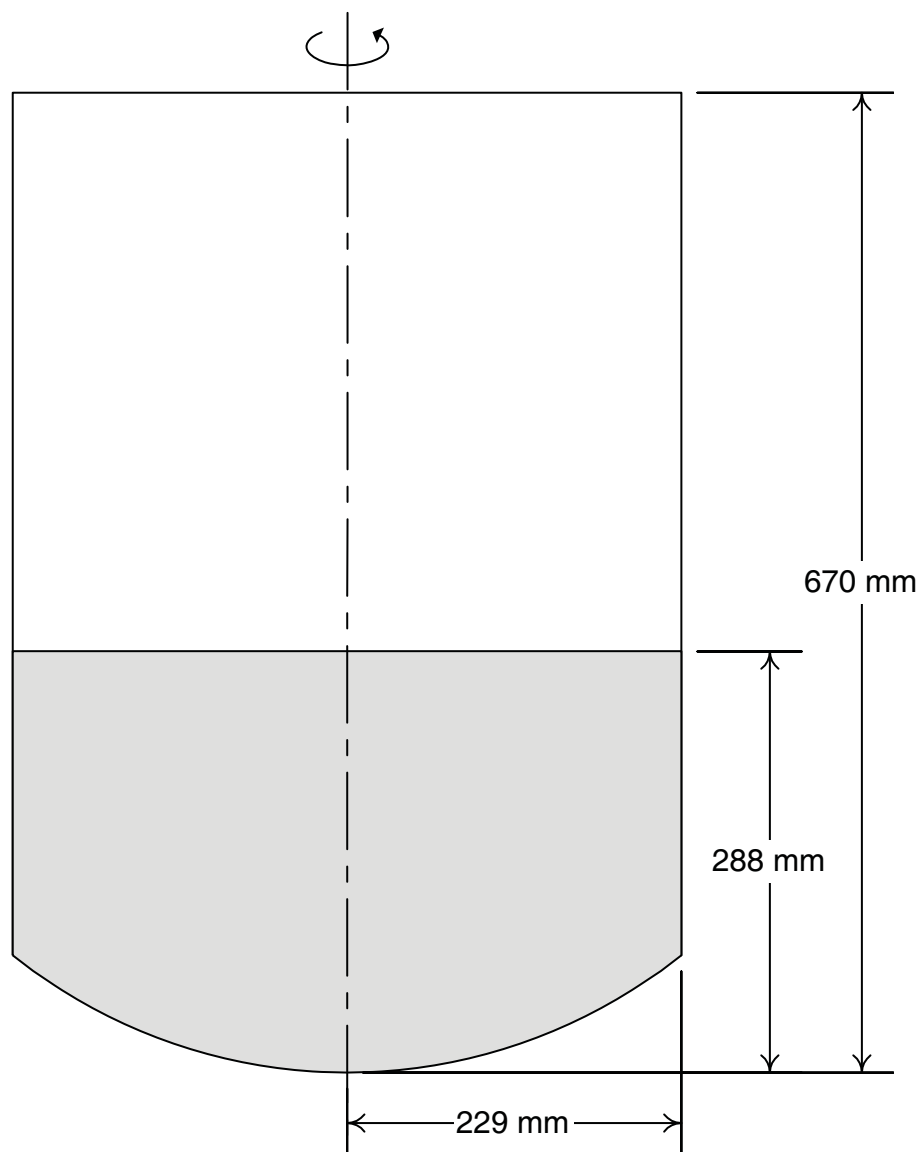
## 14. United Nuclear Fuels Recovery Plant, 24 July 1964

*Uranyl nitrate solution, U(93), in a carbonate reagent makeup vessel; two excursions; one fatality, two significant exposures.*

Vessel Volume	103.7 ℓ
Fissile Volume	41.0 ℓ
Fissile Mass	2.07 kg
Fissile Density	50.5 g/ℓ

Estimated Spherical Critical Mass	1.72 kg
First Spike Yield	$\sim 1.0 \times 10^{17}$
Specific Spike Yield	$2.4 \times 10^{15}$
Total Yield	$\sim 1.3 \times 10^{17}$

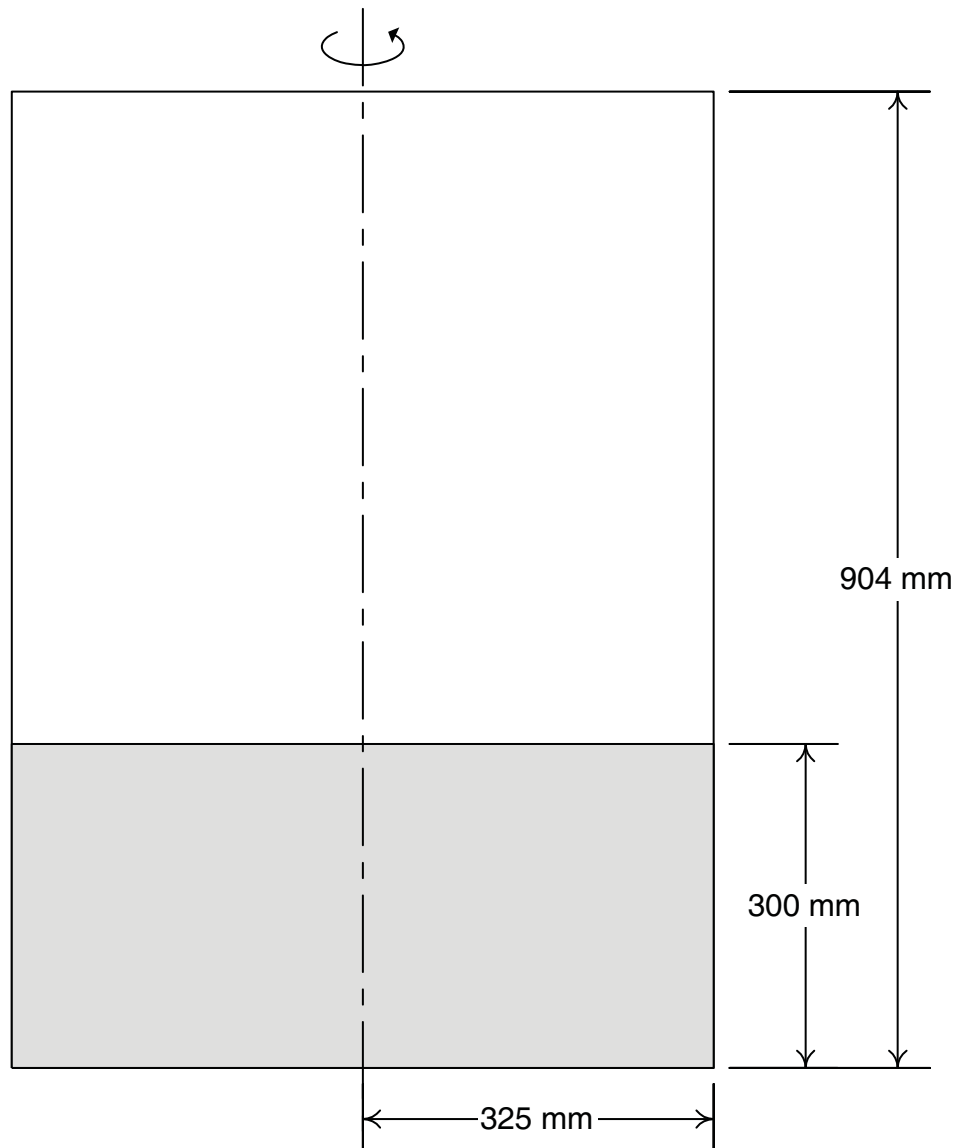
## 15. Electrosta Machine Building Plant, 3 November 1965

*Uranium oxide slurry, U(6.5), in a vacuum system vessel; single excursion;  
insignificant exposures.*

Vessel Volume	300.0 ℓ
Fissile Volume	100.0 ℓ
Fissile Mass	3.65 kg
Fissile Density	36.5 g/ℓ

Estimated Spherical Critical Mass	1.6 kg
First Spike Yield	none
Specific Spike Yield	none
Total Yield	$\sim 0.08 \times 10^{17}$

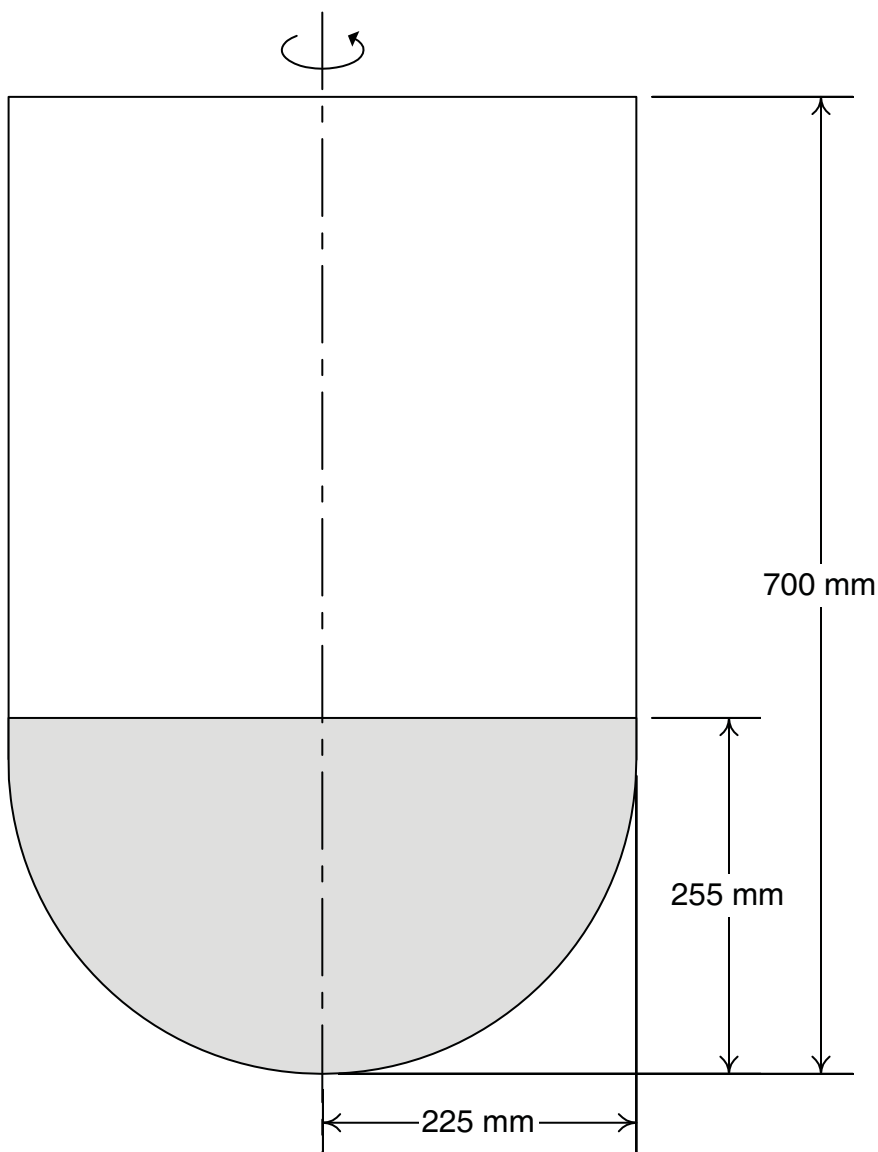
## 16. Mayak Production Association, 16 December 1965

*Uranyl nitrate solution, U(90), in a dissolution vessel; multiple excursions;  
insignificant exposures.*

Vessel Volume	100.0 ℓ
Fissile Volume	28.6 ℓ
Fissile Mass	1.98 kg
Fissile Density	69.2 g/ℓ

Estimated Spherical Critical Mass	1.65 kg
First Spike Yield	none
Specific Spike Yield	none
Total Yield	$\sim 5.5 \times 10^{17}$

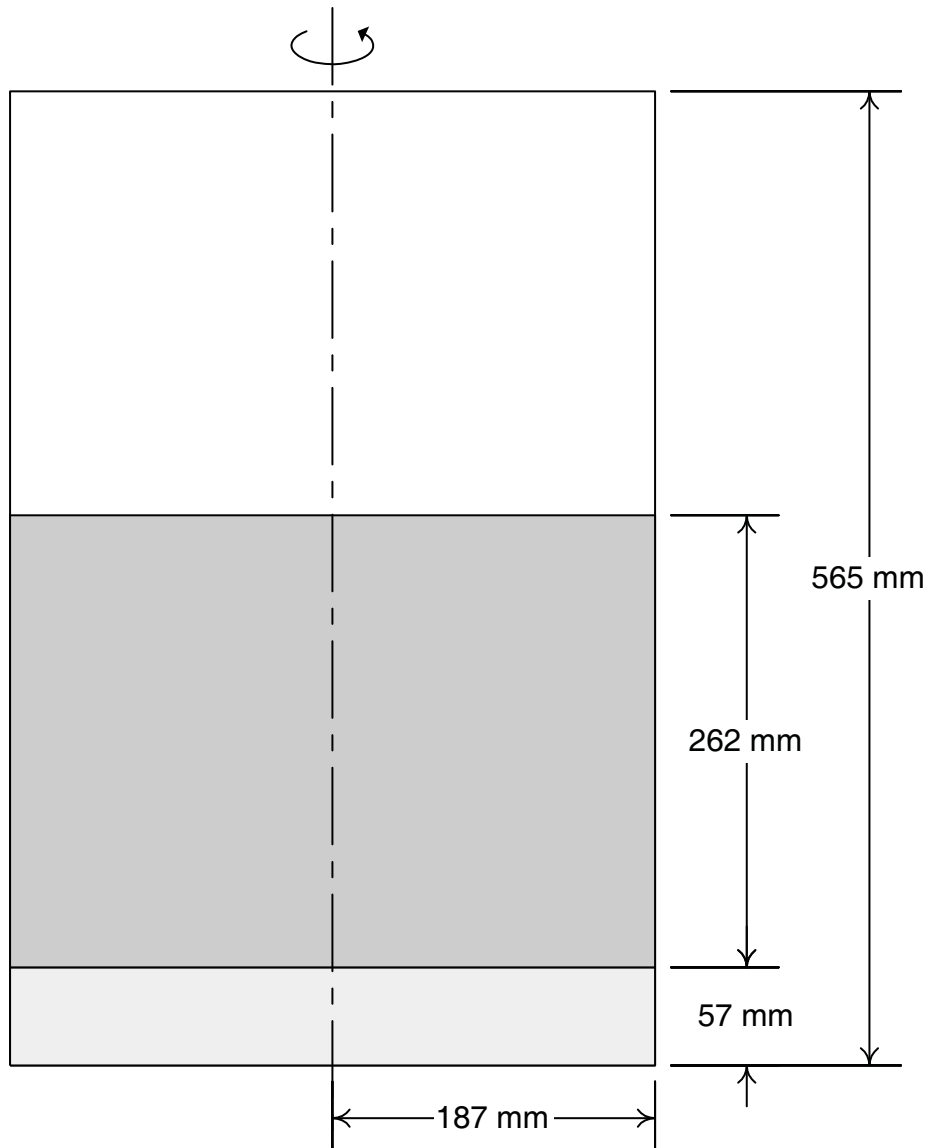
## 17. Mayak Production Association, 10 December 1968

*Plutonium solutions (aqueous and organic) in a 60 liter vessel; three excursions;  
one fatality, one serious exposure.*

Vessel Volume	62.1 ℓ
Fissile Volume	28.8 ℓ
Fissile Mass	1.50 kg
Fissile Density	52.1 g/ℓ

Estimated Spherical Critical Mass	1.36 kg
First Spike Yield	$0.3 \times 10^{17}$
Specific Spike Yield	$1.0 \times 10^{15}$
Total Yield	$\sim 1.3 \times 10^{17}$

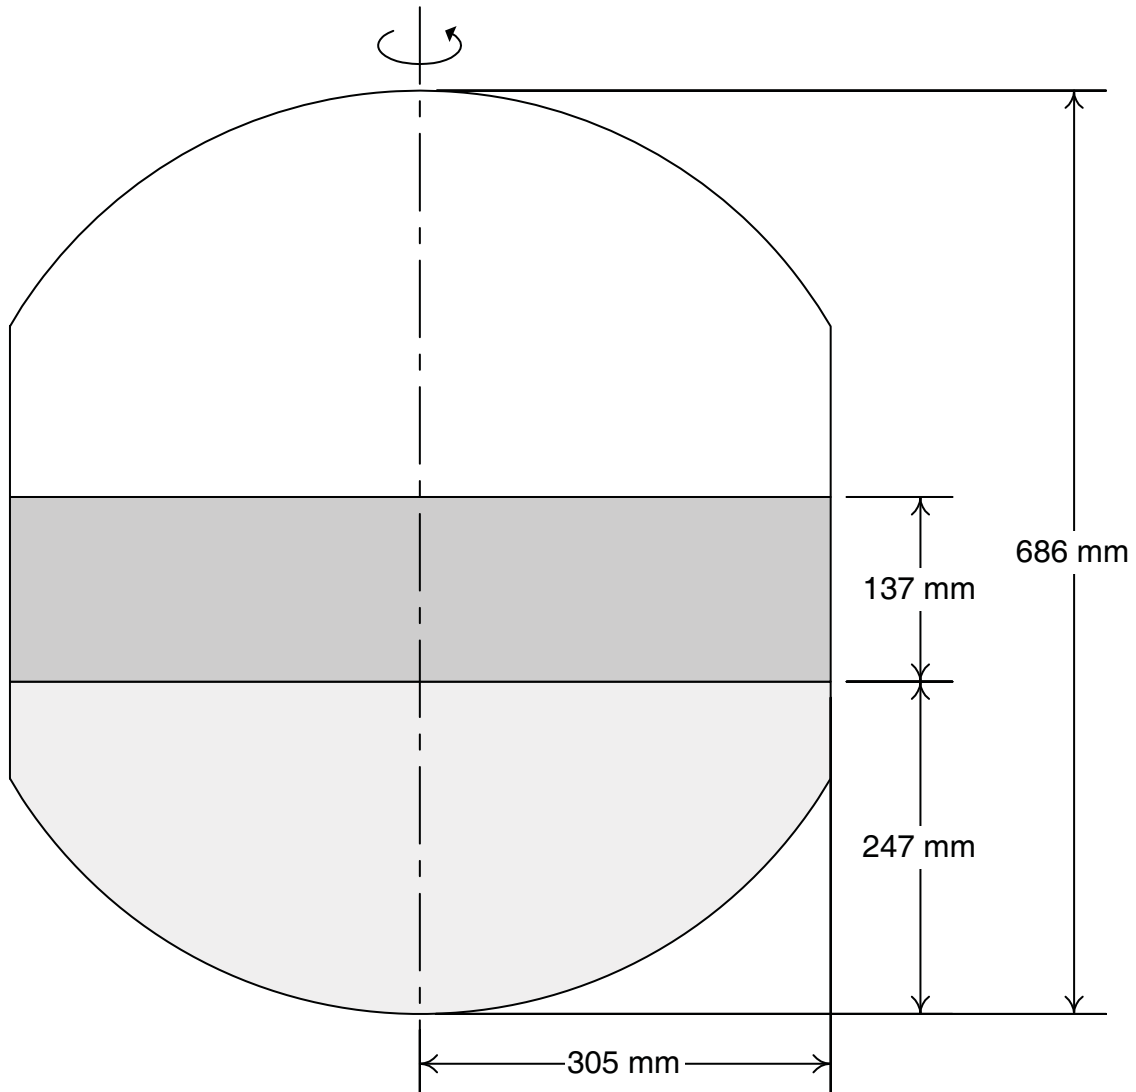
## 18. Windscale Works, 24 August 1970

*Plutonium organic solution in a transfer vessel; one excursion; insignificant exposures.*

Vessel Volume	156.0 ℓ
Fissile Volume	40.0 ℓ
Fissile Mass	2.07 kg
Fissile Density	51.8 g/ℓ

Estimated Spherical Critical Mass	0.69 kg
First Spike Yield	none
Specific Spike Yield	none
Total Yield	$0.01 \times 10^{17}$

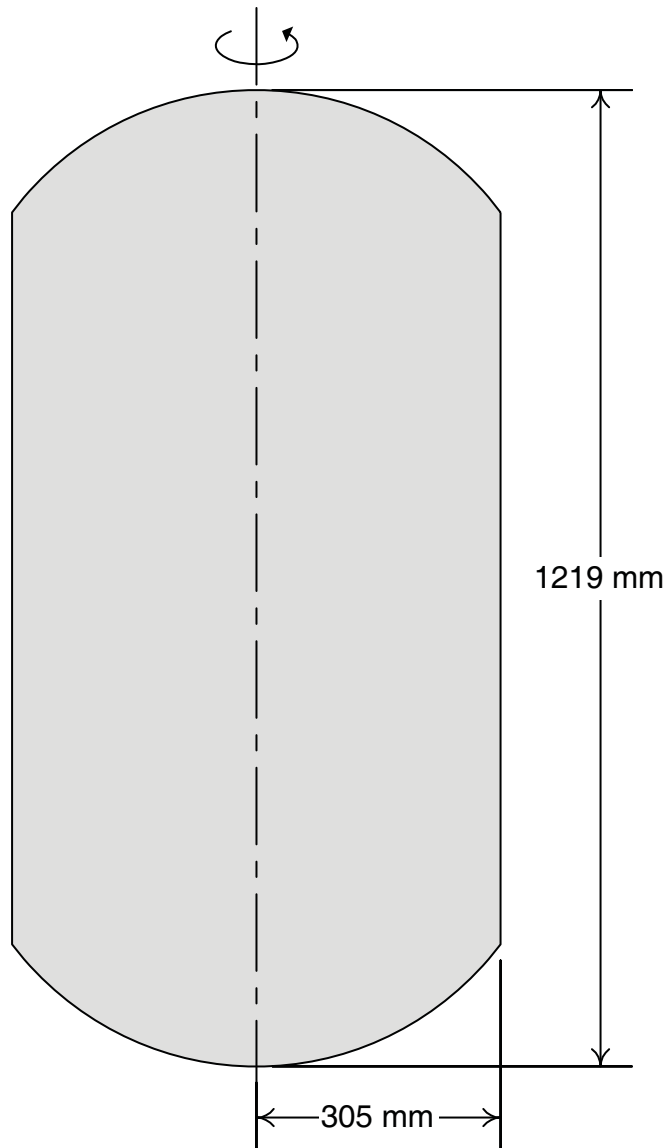
## 19. Idaho Chemical Processing Plant, 17 October 1978

*Uranyl nitrate solution, U(82), in a lower disengagement section of a scrubbing column; excursion history unknown; insignificant exposures.*

Vessel Volume	315.5 ℓ
Fissile Volume	315.5 ℓ
Fissile Mass	6.08 kg
Fissile Density	19.3 g/ℓ

Estimated Spherical Critical Mass	4.34 kg
First Spike Yield	unknown
Specific Spike Yield	unknown
Total Yield	$27.0 \times 10^{17}$

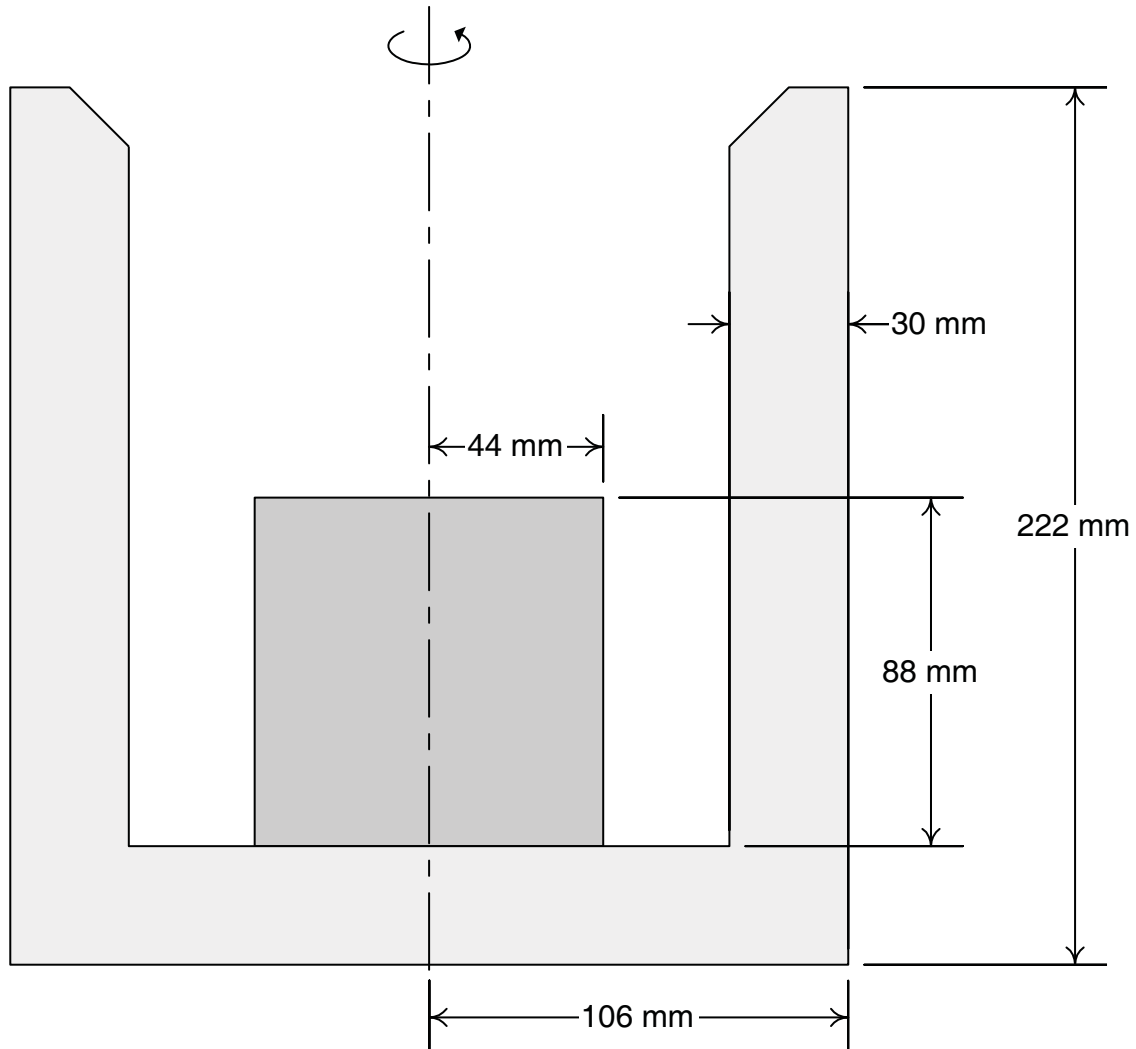
## 20. Siberian Chemical Combine (Tomsk), 13 December 1978

*Plutonium metal ingots in a storage container; single excursion; one serious exposure, seven significant exposures.*

Vessel Volume	3.2 ℓ
Fissile Volume	0.54 ℓ
Fissile Mass	10.1 kg
Fissile Density	18,700 g/ℓ

Estimated Spherical Critical Mass	9.18 kg
First Spike Yield	$0.03 \times 10^{17}$
Specific Spike Yield	$5.6 \times 10^{15}$
Total Yield	$0.03 \times 10^{17}$

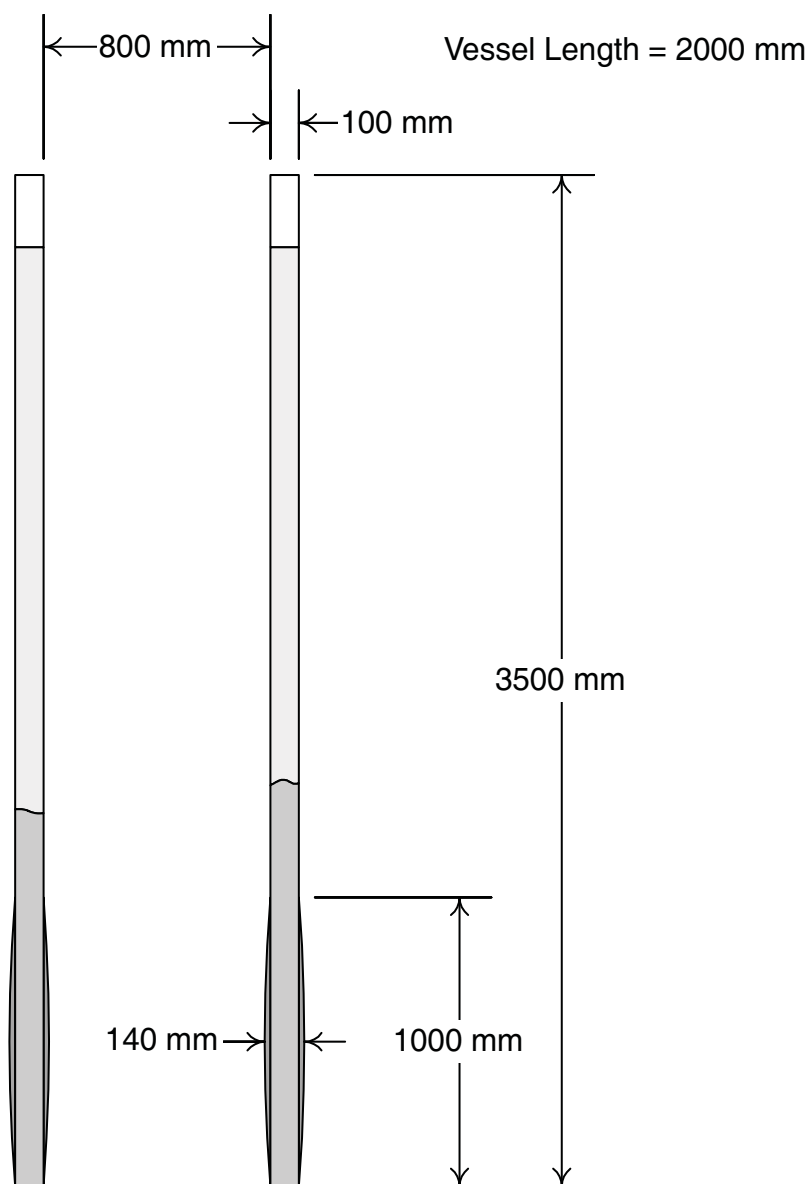
## 21. Novosibirsk Chemical Concentration Plant, 15 May 1997

*Uranium oxide slurry and crust, U(70), in the lower regions of two parallel vessels; multiple excursions; insignificant exposures.*

Vessel Volume	700.0 ℓ per vessel	Estimated Spherical Critical Mass	*
Fissile Volume	*	First Spike Yield	none
Fissile Mass	17.1 kg	Specific Spike Yield	none
Fissile Density	*	Total Yield	$0.055 \times 10^{17}$

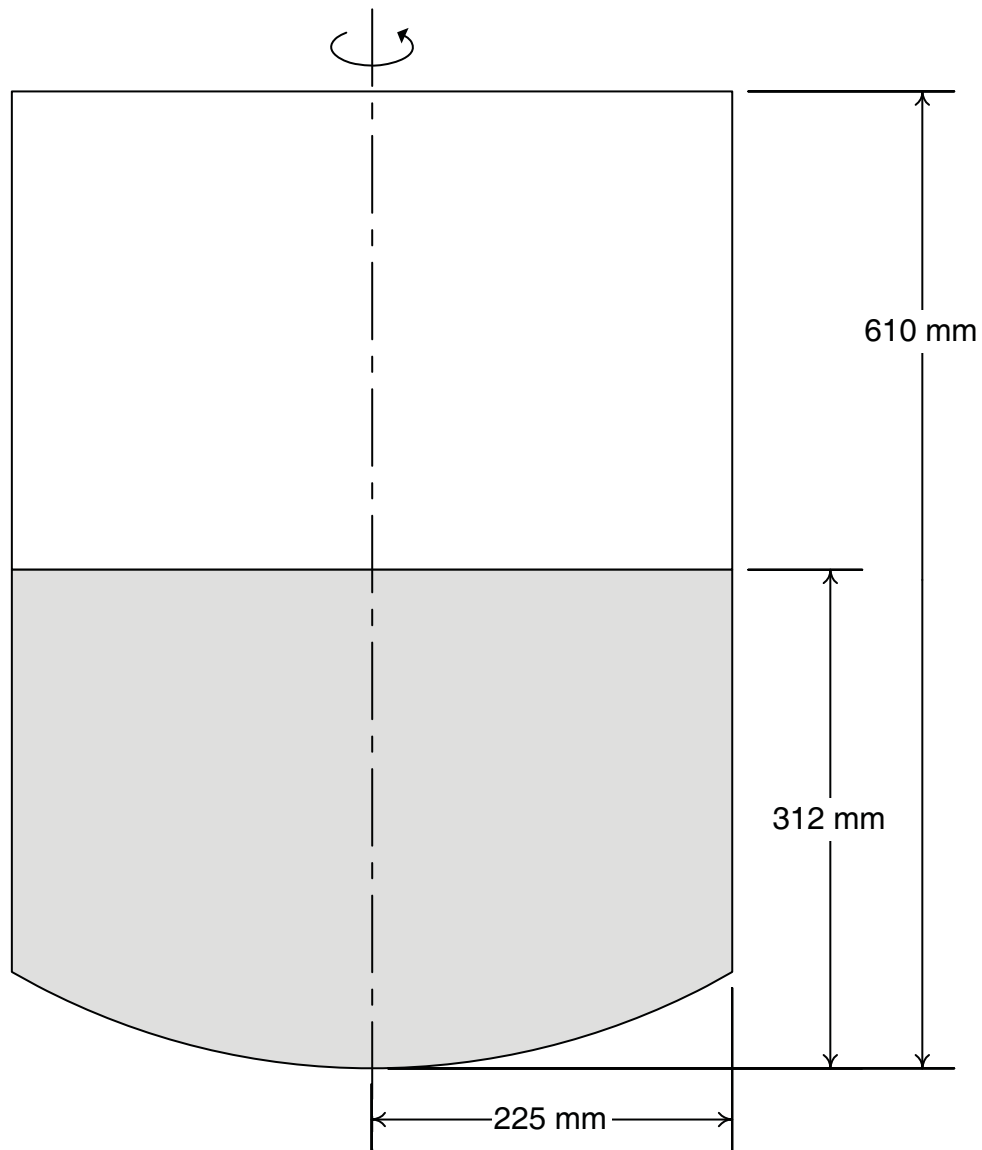
## 22. JCO Fuel Fabrication Plant, 30 September 1999

*Uranyl nitrate solution, U(18.8), in a precipitation vessel; multiple excursions;  
two fatalities, one significant exposure.*

Vessel Volume	100.0 ℓ
Fissile Volume	45.0 ℓ
Fissile Mass	3.12 kg
Fissile Density	69.3 g/ℓ

Estimated Spherical Critical Mass	1.9 kg
First Spike Yield	$\sim 0.5 \times 10^{17}$
Specific Spike Yield	$1.1 \times 10^{15}$
Total Yield	$25 \times 10^{17}$
