# Walker Run Geomorphic Assessment

**PPL Bell Bend Nuclear Power Plant**  
Salem Township, Luzerne County, PA

April 2009

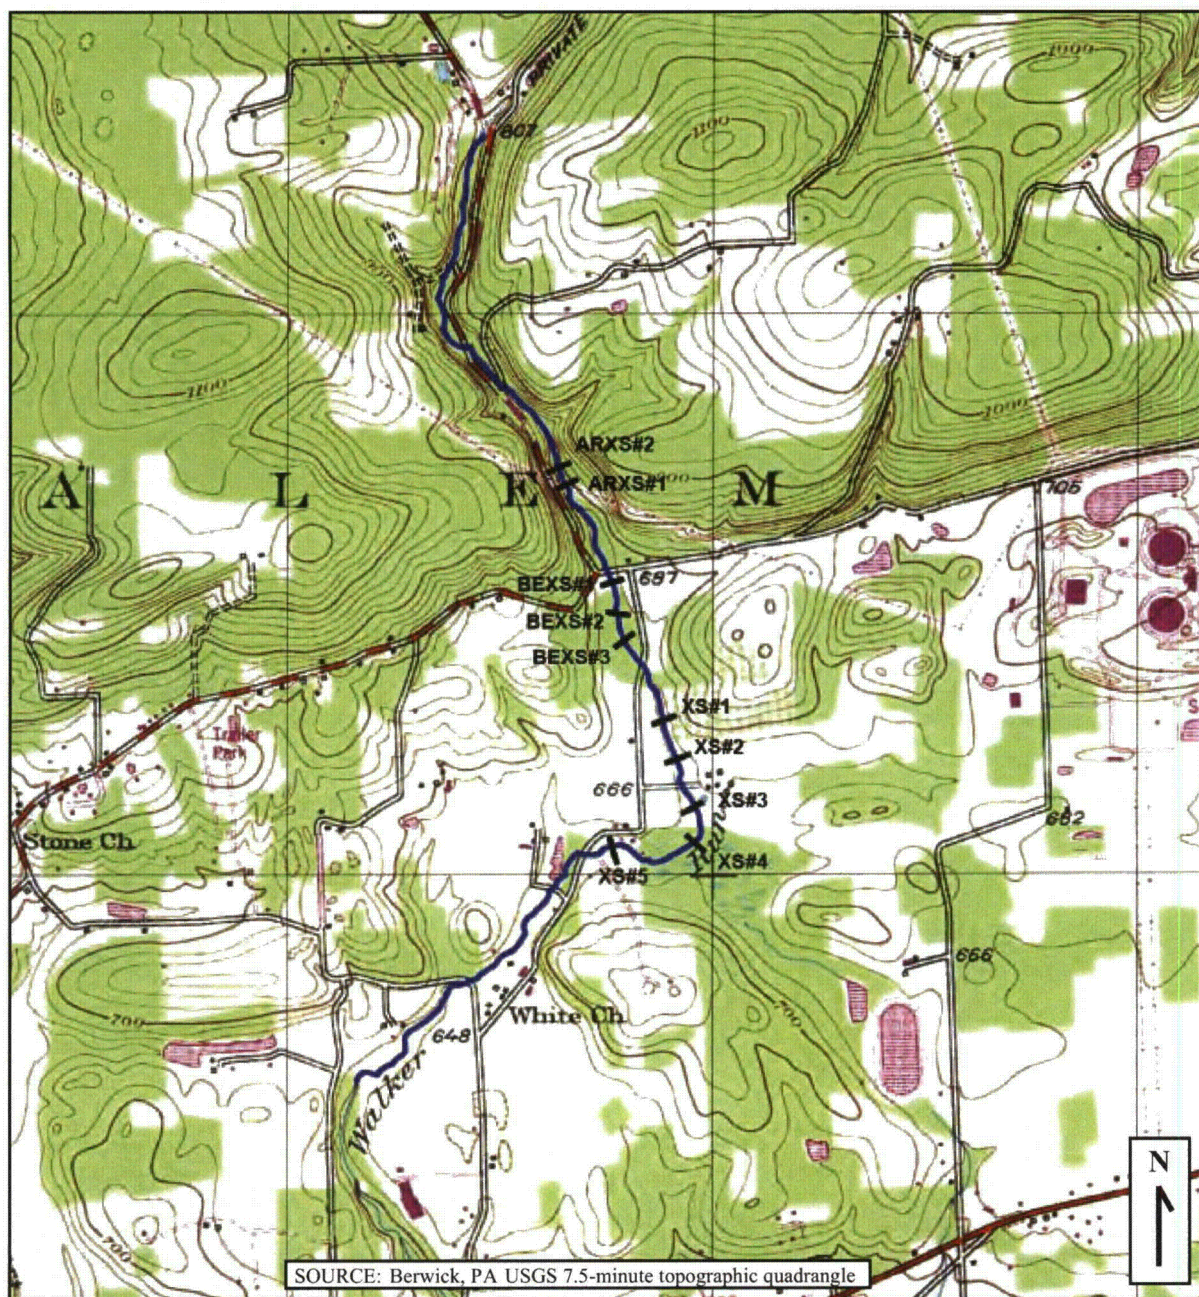
Farther upstream, a private farm road crossing over Walker Run consists of a 10-foot span concrete bridge with a vertical opening of approximately 24-36 inches. See *Figure 14* for private bridge crossing.

The stream in and around the private crossing is in a state of streambed aggradation on the upstream side and lateral adjustment and vertical degradation on the downstream side. The downstream degradation is a result of both lateral and vertical adjustments moving headward from the downstream direction. Above the private road crossing, channel aggradation is evident, as seen in *Figure 15*. The streambed aggradation is a result of the larger gravels and cobbles transported from the upstream-incised reach depositing there because they cannot be transported through the private crossing.

The aggradation process flattens out the stream slope and creates a backwater condition that further reduces the energy available to move the bedload and prevents additional material from being transported downstream. The process of bedload deposition in this area is also promoting lateral adjustments in order to accommodate the flows and sediment from upstream as material is being deposited and reducing conveyance in the channel. If the bridge is removed or fails, there will be significant adjustments in the longitudinal profile and the planform in both the upstream and downstream directions.

The backwater condition created by the local aggradation near the private bridge crossing extends approximately one thousand feet upstream. The backwater conditions of this reach create a long, flat pool with minimal vegetative cover that does not lend itself to a diverse macro-invertebrate community. In addition, the kind of streambed substrate required for a diverse benthic macro-invertebrate community is minimal in this reach. The majority of the streambed substrate consists of sands and silts. See *Figure 16* for typical backwater conditions. Throughout this reach, the channel is somewhat entrenched and, during higher flow events, the existing streambed material is being scoured because of the incision of the channel and is being mobilized and re-deposited at the downstream bridge crossing. This scour action also minimizes the potential for long-term stability and reduces the high-quality biological habitat.
