Rupture of Model 48Y UF₆ Cylinder and Release of Uranium Hexafluoride

Cylinder Overfill, March 12-13, 1986
Investigation of a Failed UF₆ Shipping Container

**U.S. Nuclear Regulatory
Commission**

This report, NUREG-1179, Volume 2, presents the findings made by the Augmented Investigation Team of the March 13 incident and the report of the detailed metallurgical examination conducted by Battelle Columbus Division of the cylinder damaged on January 4, 1986.

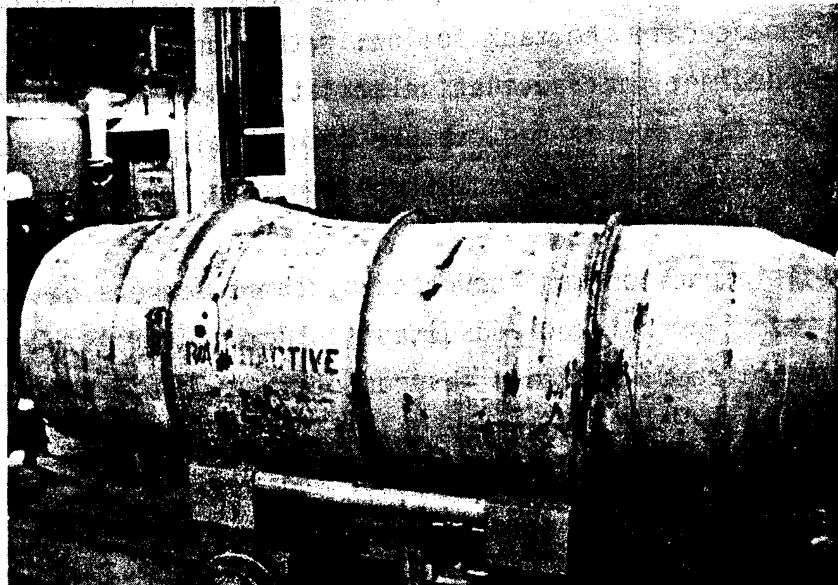
Valve
endDrain
end

located at the top of the vessel shown in Figure 4. The side of the vessel containing the rupture is shown in Figure 5, and the extent of the rupture is illustrated in Figure 6.

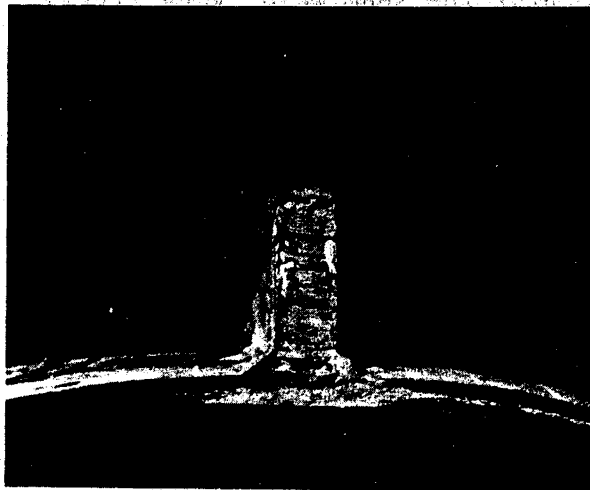
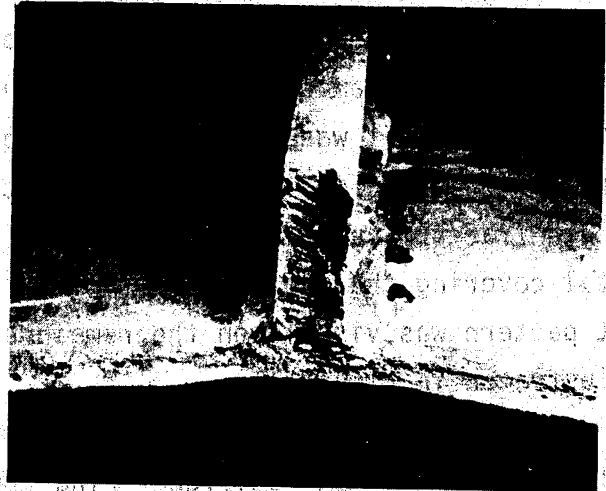
The fracture surfaces in the vessel wall directly below the butt weld in the valve-end stiffener ring contained a relatively flat region (essentially 90 degrees to the plate surfaces) except for the regions immediately adjacent to the fillet welds between the stiffener ring and the shell. The appearance of that flat region suggested that stable, slow-crack growth may have occurred in that region. Those features of the fracture appearance will be illustrated more clearly in a subsequent section of this report. The remainder of the surfaces of the fracture through the vessel shell exhibited features typical of crack propagation in a ductile (shear mode). In those regions, the fracture surfaces were at an angle of about 45 degrees to the plate surfaces.

The features observed on the surfaces of the rupture in the shipping container, suggest that the failure process began with failure of the valve-end stiffener ring through the butt weld. Cracks then extended through the fillet welds into the vessel shell below the fillet welds on either side of the stiffener ring. Those cracks joined forming a single crack front that extended both axially and through the vessel wall. When

a. Fracture Surface on the Side
Toward the Vessel Seam Weld

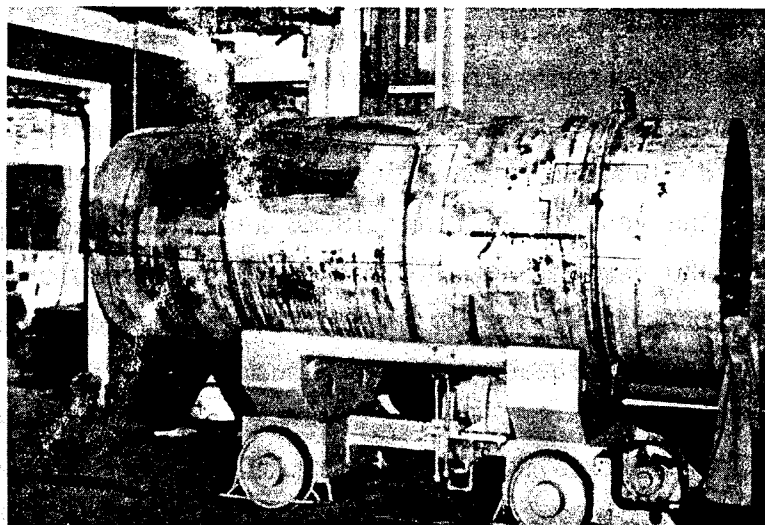
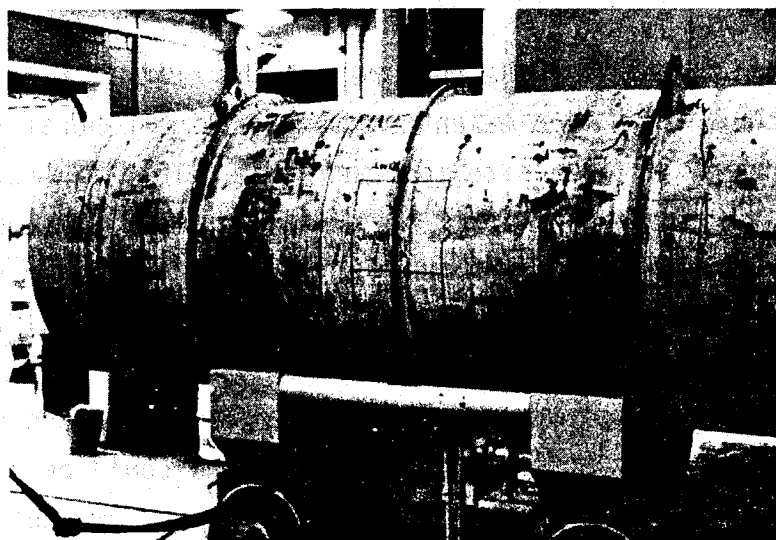
a. Locations of Sections OVFB and ODB

b. Locations of Sections 18OVFB, 180MB, 180MT, 180DB, and 180DT

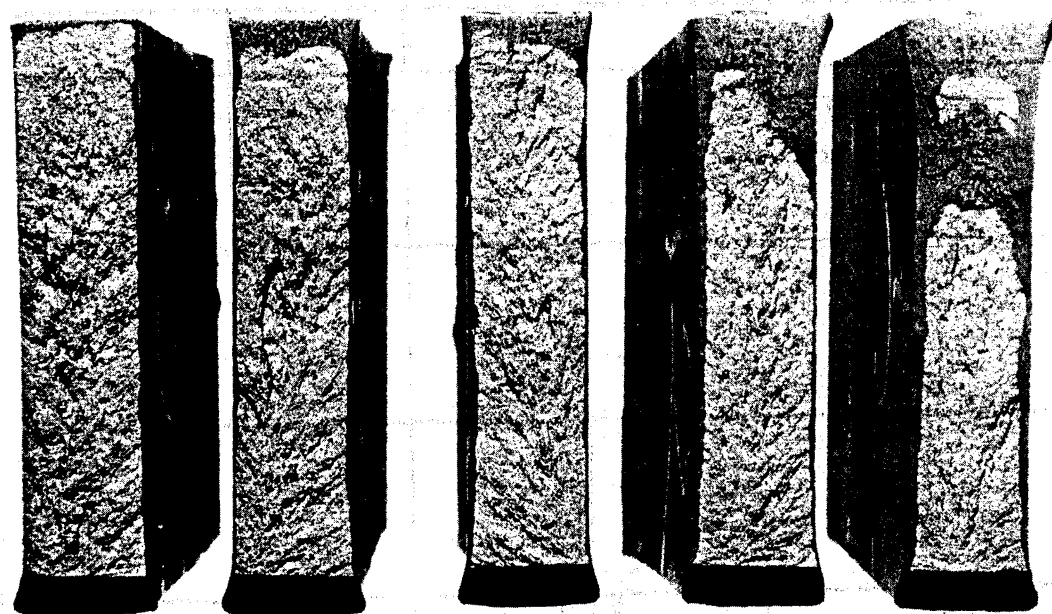
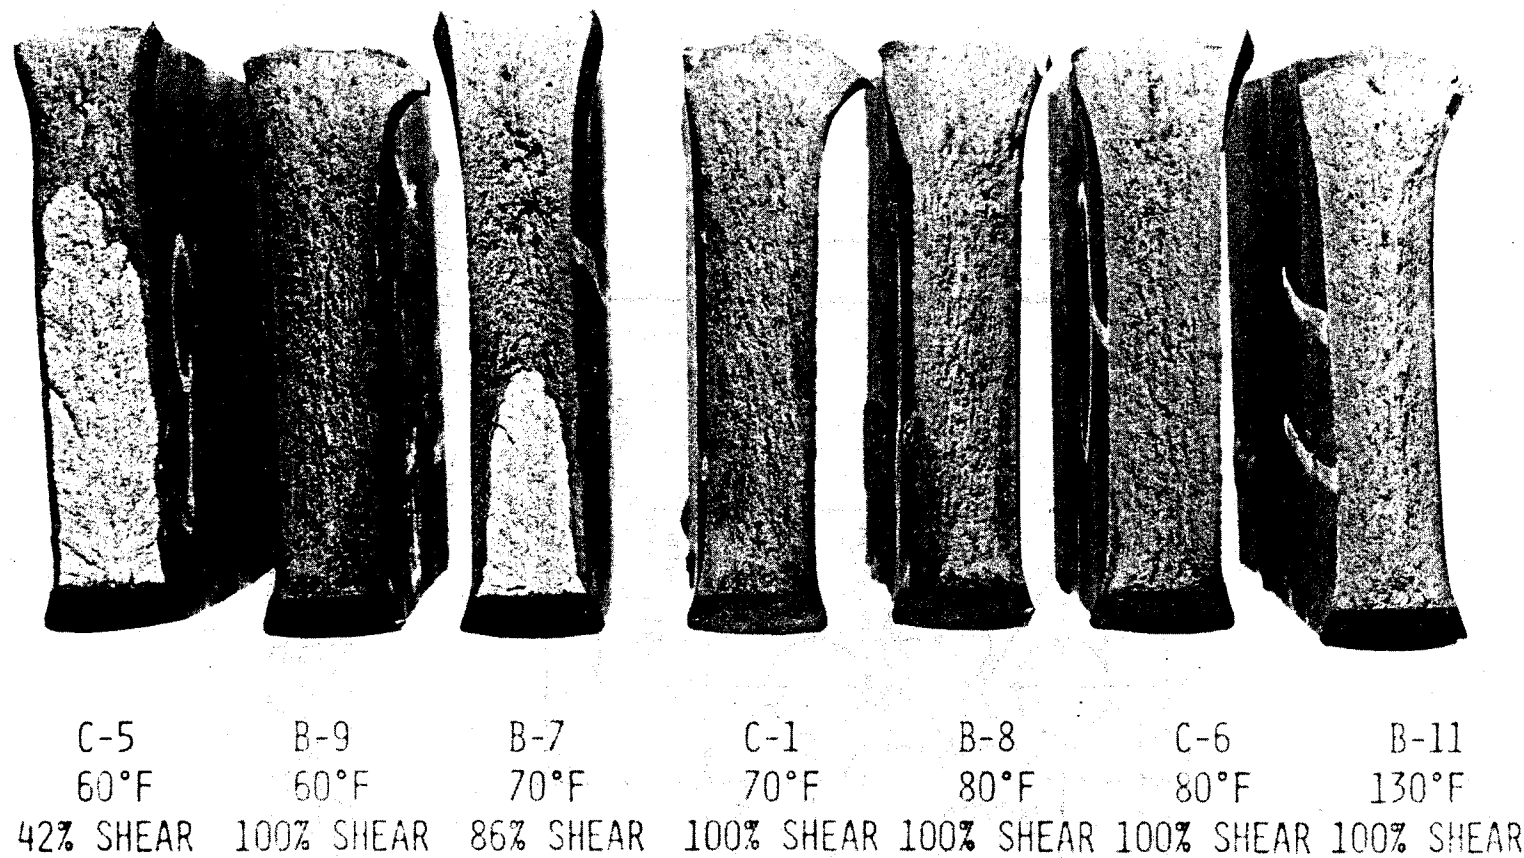
FIGURE 21. APPEARANCE OF THE FRACTURE SURFACES OF THE DWTT SPECIMENS FROM THE VESSEL PLATE

C-2	C-3	B-10	B-12	C-4
0°F	30°F	30°F	50°F	50°F
4% SHEAR	5% SHEAR	8% SHEAR	27% SHEAR	45% SHEAR

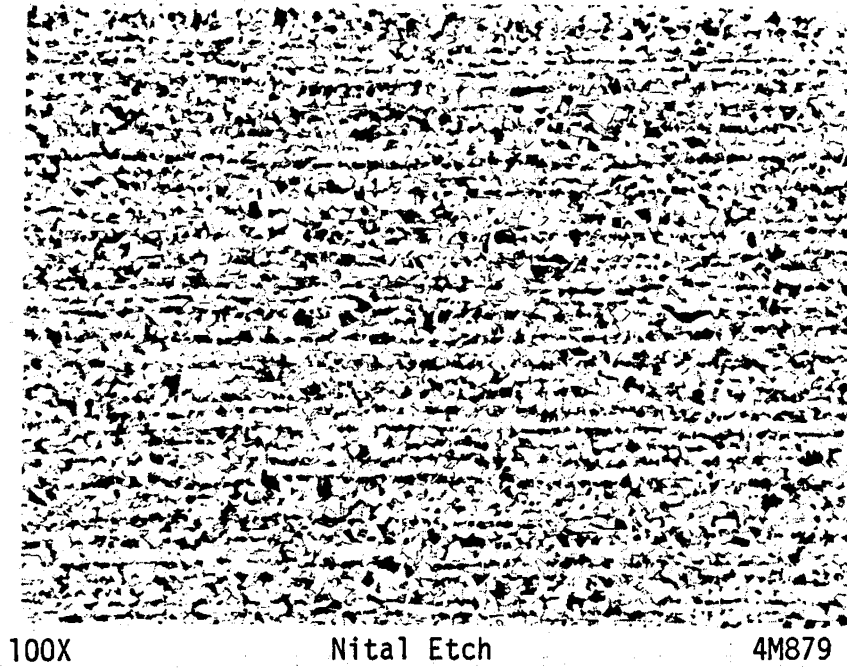
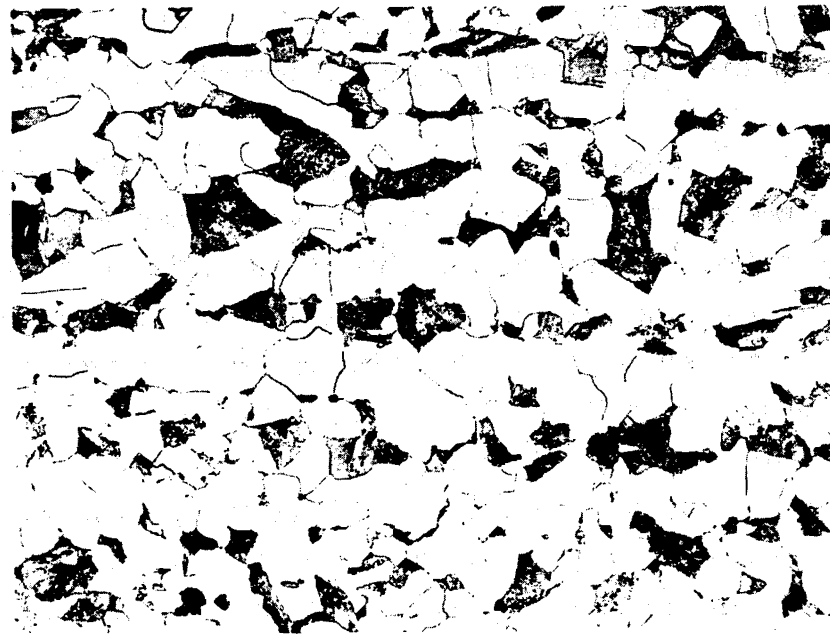
FIGURE 25. TYPICAL MICROSTRUCTURE OF THE STEEL FROM THE VESSEL SHELL AT TWO MAGNIFICATIONS

Figures 25a and b illustrate the typical microstructure of the SA516, Grade 70 steel from the vessel shell. The microstructure was banded and consisted of a mixture of ferrite and pearlite. Those features are typical of hot-rolled carbon steel plate material such as SA516 Grade 70. The average ferrite grain size of the steel was ASTM 9-1/2. That grain size is considered to be relatively fine for a normally produced hot-rolled plate and would be expected to have beneficial effects on the yield strength and toughness of the steel.

The microstructure is banded and consists of a mixture of ferrite and pearlite.

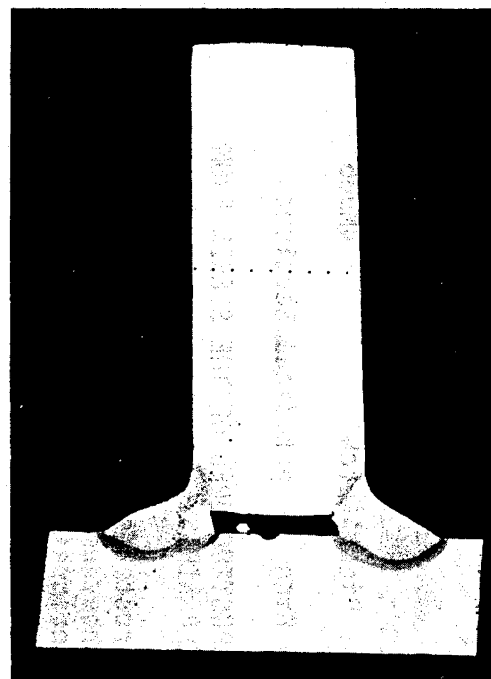
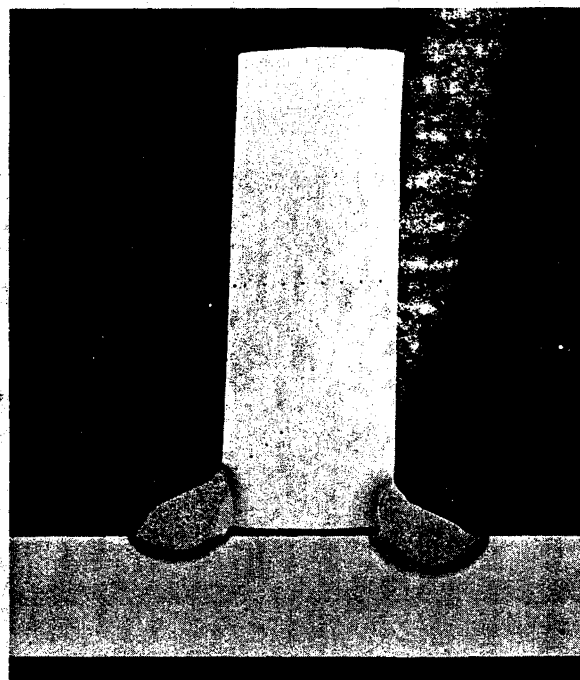
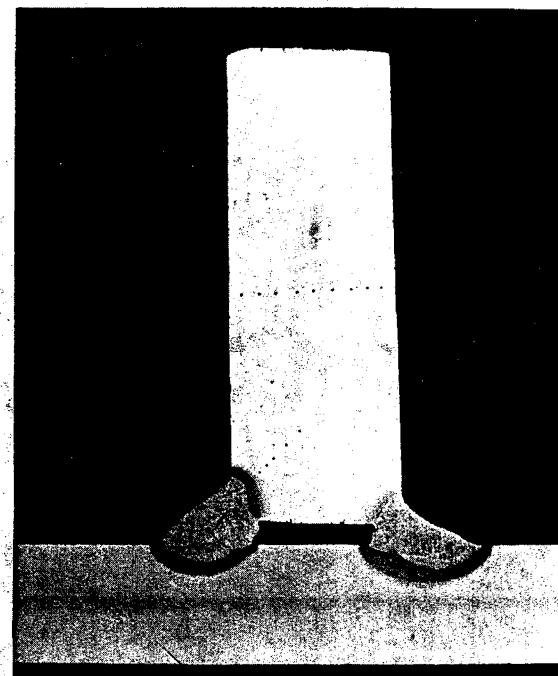
Examination of the sections from the stiffener rings revealed a segregation pattern present in the bar stock from which they were produced. That pattern in the transverse section from the three stiffener rings is illustrated in Figure 26. The pattern in the sections of the drain-end and valve-end stiffeners were similar, but that pattern was less pronounced in the section from the middle stiffener. Such segregation patterns frequently are observed in hot-rolled, carbon steel bar stock. The typical microstructures of the steel outside of that central segregation region is shown in Figure 27, and the typical microstructure within the region of segregation is shown in Figure 28. Those figures show that the microstructure consisted of a mixture of ferrite and pearlite with the microstructure in the segregation zone containing more pearlite. The presence of more pearlite in the segregation zone indicates somewhat higher carbon and manganese contents in that region. However, the ferrite grain sizes were virtually the same in both regions and the average grain sizes of the steel from each stiffener was ASTM 8 to 8-1/2.

FIGURE 26. PHOTOMACROGRAPHS OF SECTIONS THROUGH THE STIFFENER RINGS, FILLET WELDS AND VESSEL PLATE SHOWING SEGREGATION PATTERN IN THE CENTRAL REGIONS OF THE STIFFENER RINGS AND THE LOCATIONS OF HARDNESS TRAVERSES

These specimens were located between 1 and 2 inches from the fracture surfaces.

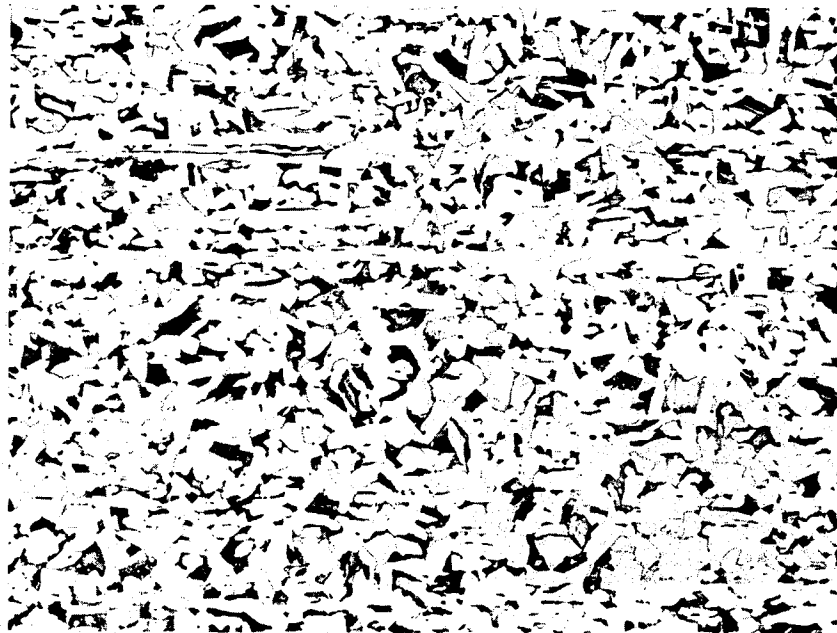
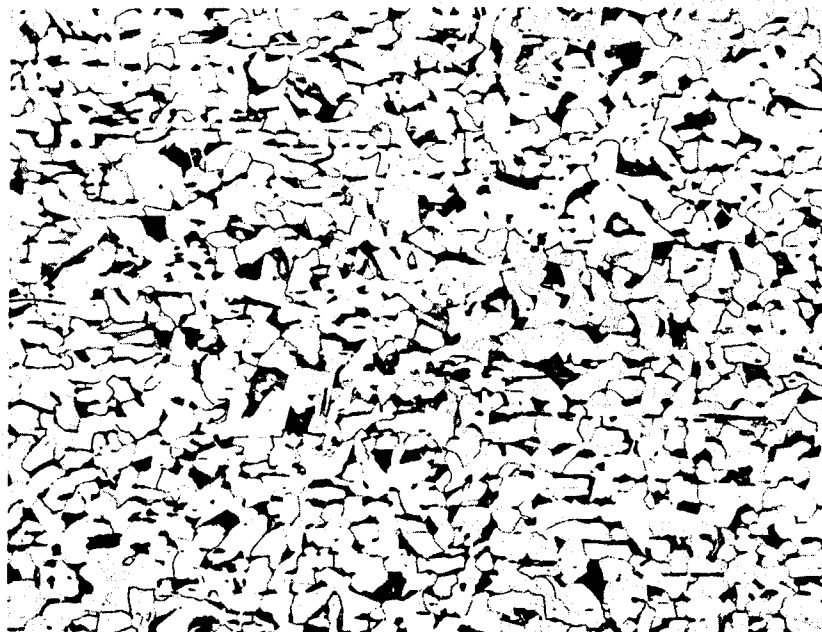
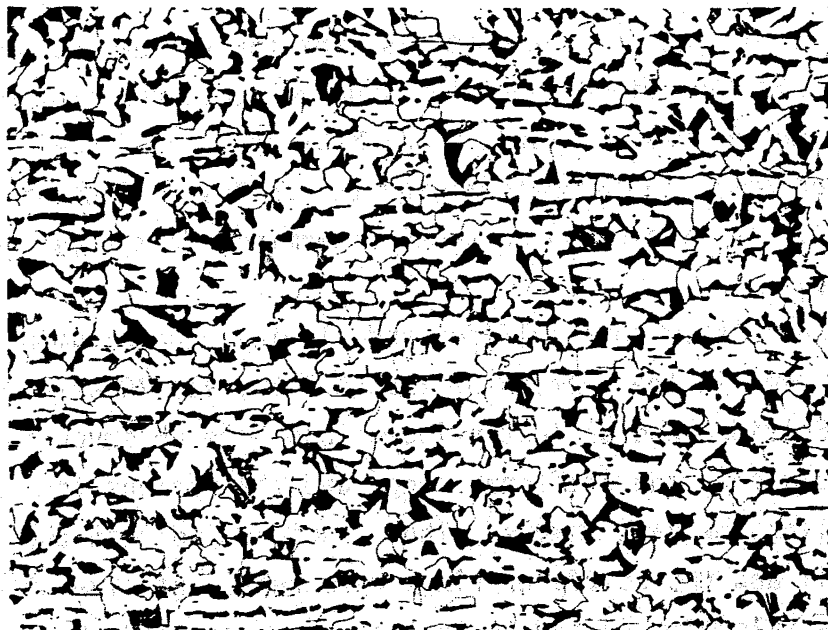
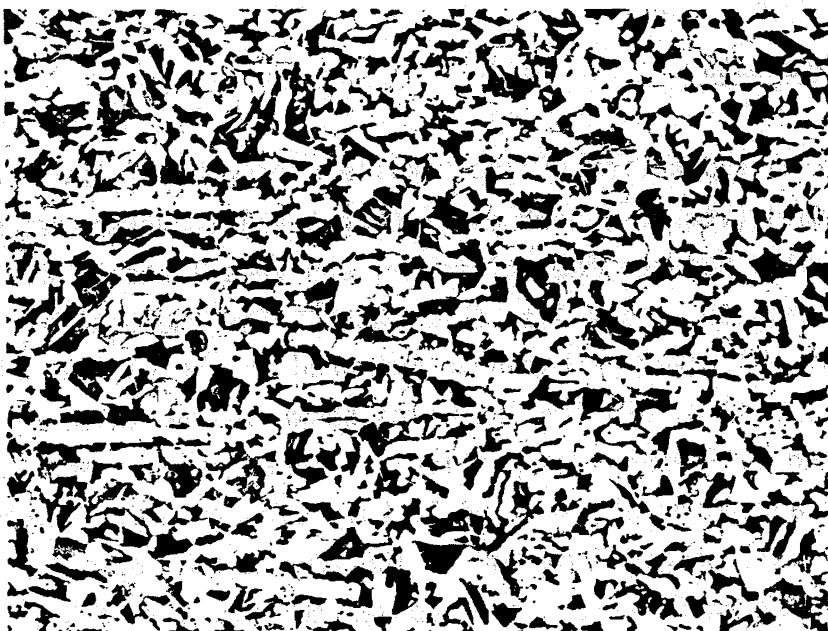
FIGURE 27. TYPICAL MICROSTRUCTURES OF THE STEELS FROM THE STIFFENER RINGS

The microstructures consist of ferrite and pearlite; they are less banded but exhibit a coarser grain size than the steel from the vessel shell.

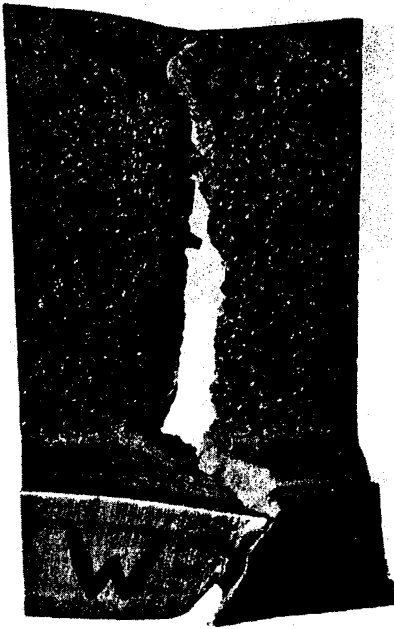
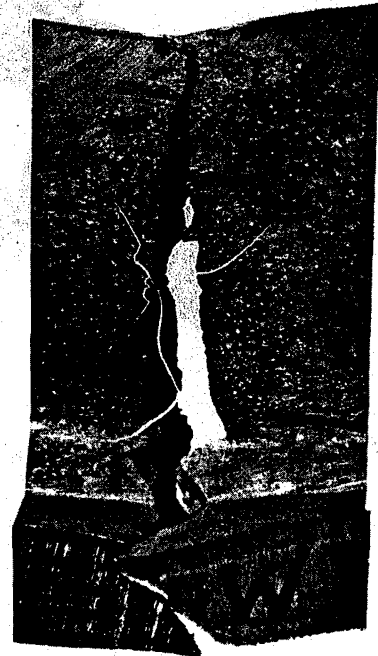
Figure 29 shows Specimens OVFB AND OVFB-W that contained the surfaces of the origin region of the primary rupture through the butt weld in the valve-end stiffener ring and the vessel shell after they had been removed from the large section identified as OVFB and cleaned in the laboratory. As is shown in Figure 29; the deformation in this region of the vessel prevented the matching fracture surfaces on these sections from fitting together closely. Figure 29 shows grinding marks on the top surface and the valve-end surface of the stiffener ring on either side of the crack through the butt weld. That grinding presumably was done to smooth the surfaces after the butt weld was deposited. In addition, numerous small pits were present on both sides of the valve-end stiffener ring. Those pits most likely occurred after the vessel rupture. Figures 29b and c also show short cracks extending circumferentially in the fillet welds adjacent to the stiffener surfaces in Specimen OVFB-W. Figure 30 shows short axial cracks in the vessel shell surface adjacent to the fracture surface beneath the stiffener ring and near the fillet welds, particularly on the right-hand side of the figure. Those cracks formed as a result of the plastic deformation in those areas during the failure process.

FIGURE 29. SURFACES OF SPECIMENS OVFB AND OVFB-W CONTAINING THE SURFACES OF THE FRACTURE THROUGH THE BUTT WELD IN THE VALVE-END STIFFENER RING AND THE VESSEL SHELL AFTER REMOVAL FROM SECTION OVFB AND CLEANING IN THE LABORATORY

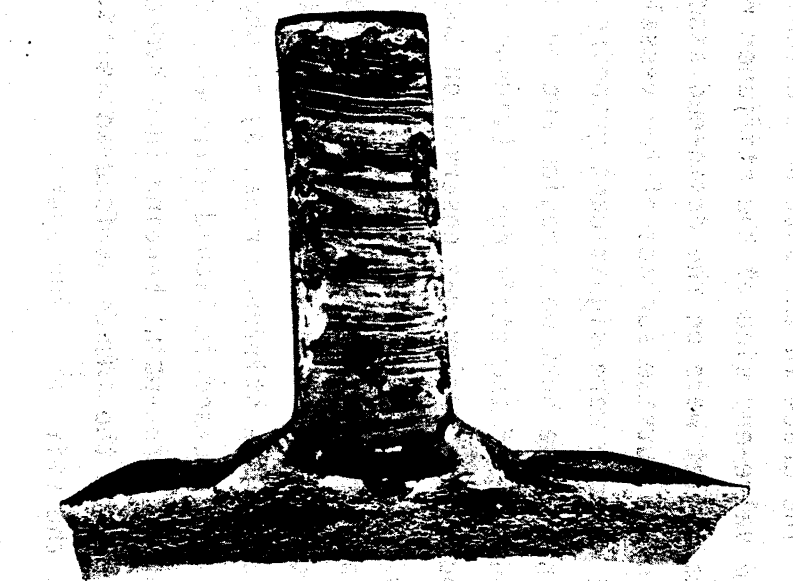
Figure 31 illustrates the matching fracture surfaces on Specimens OVFB and OVFB-W. The lack of full weld penetration and the pattern from the flame cutting of the stiffener surfaces during fabrication are clearly evident. There was a gap between the bottom of the stiffener ring and the outer surface of the vessel shell. That gap was about 1/8 inch on Specimen OVFB-W and 1/16 inch on Specimen OVFB. Also the region of flat fracture (essentially 90 degrees to the shell inner and outer surfaces) can be seen clearly on the fracture through the vessel wall. The appearance of that flat fracture region indicates stable slow-crack growth prior to the final rupture which occurred by rapid crack propagation by a shear fracture mode. The beginnings of the shear propagation are visible on the fracture surfaces on the vessel shell at each end of the sections where the fracture surface is not perpendicular to the inner and outer surfaces of the vessel shell.

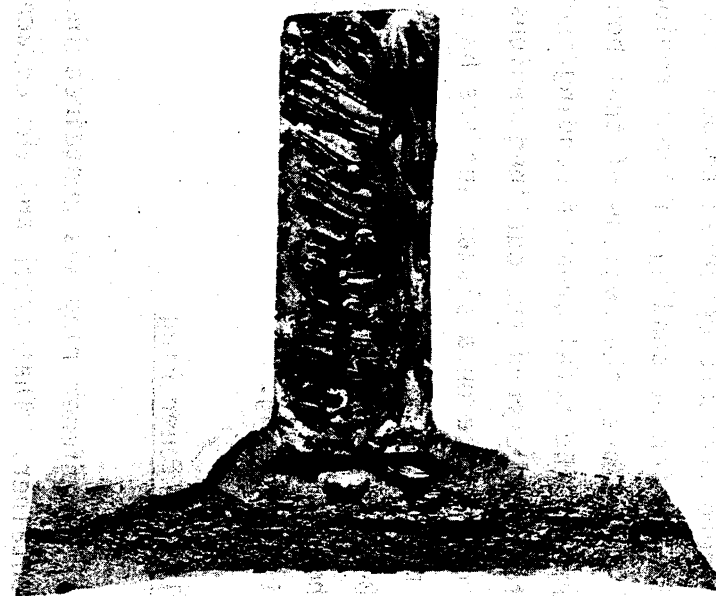
4M887

a. Specimen OVFB-W

FIGURE 31. MATCHING FRACTURE SURFACES ON SPECIMENS OVFB AND OVFB-W CONTAINING THE SURFACES OF THE CRACK THROUGH THE VALVE-END STIFFENER RING AND THE ORIGIN REGION OF RUPTURE THROUGH THE VESSEL SHELL

During the examination of surfaces of the fractures at magnifications up to 30X, the regions where fracture occurred through the weld metal of the butt weld indicating fusion or bonding in those regions, could be estimated quite well. Therefore, the regions of that bonding were outlined on a photomacrograph. The total area of bonding then was determined using a planimeter to trace around the outlined regions. A planimeter determines the area of a shape on a planar surface based upon its perimeter. The planimeter measurements made on the photomacrograph of the surface of Specimen OVFB-W indicated that area of fractured butt weld metal was 0.22 square inches, or only about 10.5 percent of the cross-sectional area of the stiffener ring.

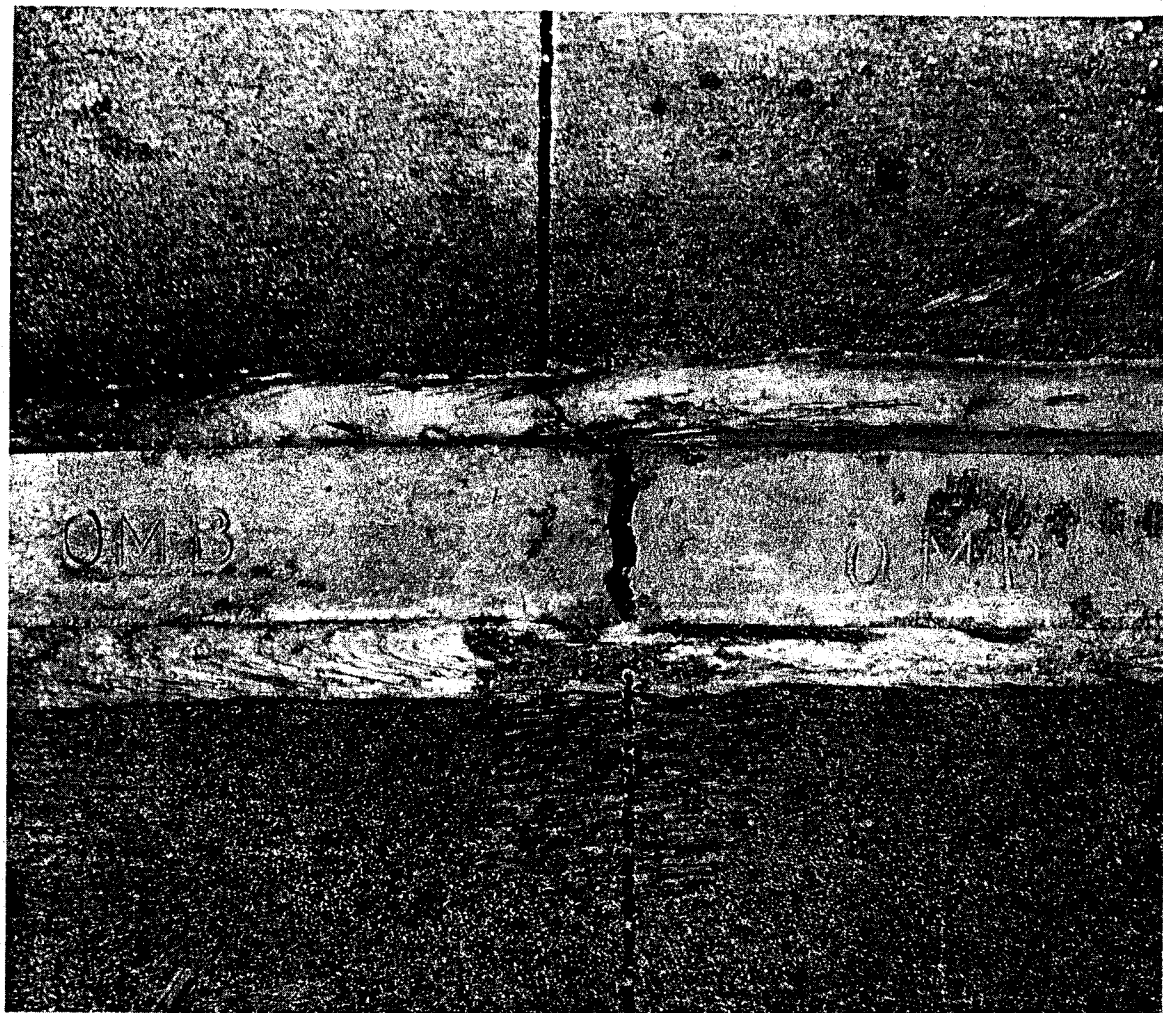
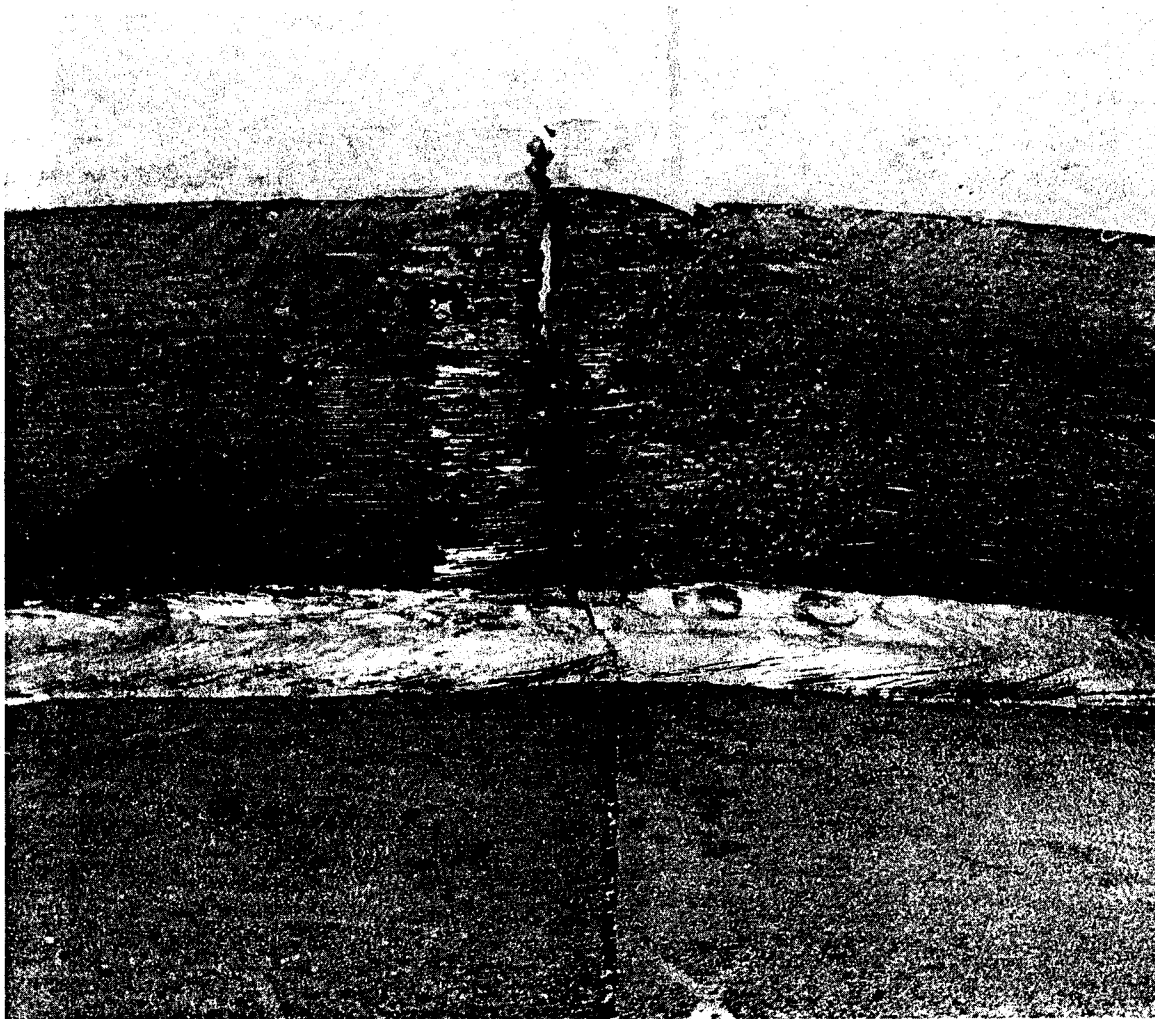
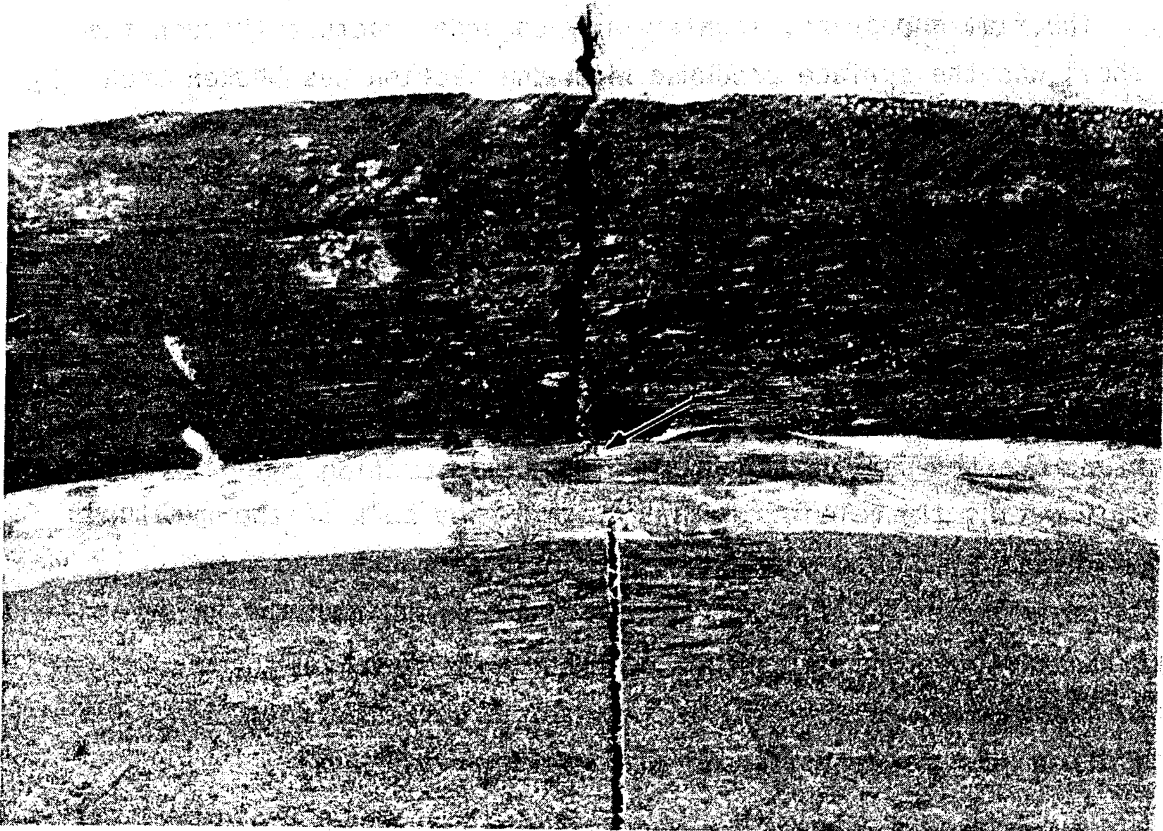
The crack in the middle stiffener ring was contained in Section OMB from the failed shipping container. That crack and the adjacent material from the stiffener ring and vessel shell are shown in Figures 32a, b, and c. The separation of the crack surfaces at the top of the middle stiffener ring was $3/32$ inch. The crack in the butt weld extended nearly through the fillet weld on the valve-end side of the stiffener ring, but only a short distance into the fillet weld on the drain-end side. There was no evidence of cracking in the outside surface of the vessel shell. As is shown in Figure 32b and c there were significant grinding marks on the sides of the stiffener ring in the butt weld region and on the vessel shell surface on the drain-end side of the stiffener. Evidence of extensive grinding to smooth the butt weld region was observed on the top surface of the stiffener ring, but it does not show clearly in Figure 32a.

- a. View of the Crack Across the Top Surface
of the Middle Stiffener Ring

FIGURE 32. PHOTOMACROGRAPHS OF THE CRACK THROUGH THE
BUTT WELD IN THE MIDDLE STIFFENER RING

- b. View of the Crack in the Valve-End Side
of the Middle Stiffener Ring

- c. View of the Crack in the Drain-End Side of the Middle Stiffener Ring.

Note the slight crack extension into the fillet weld shown by the arrow.

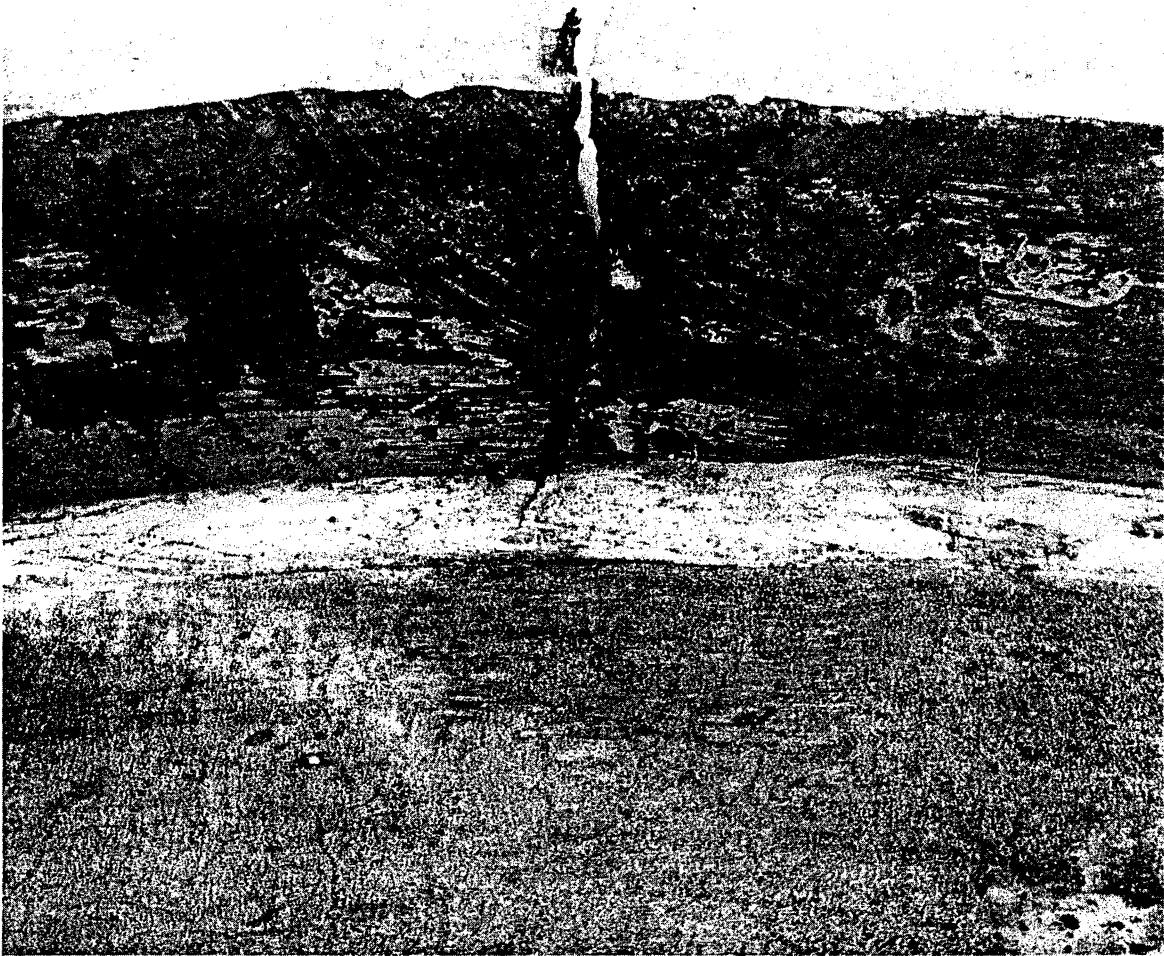
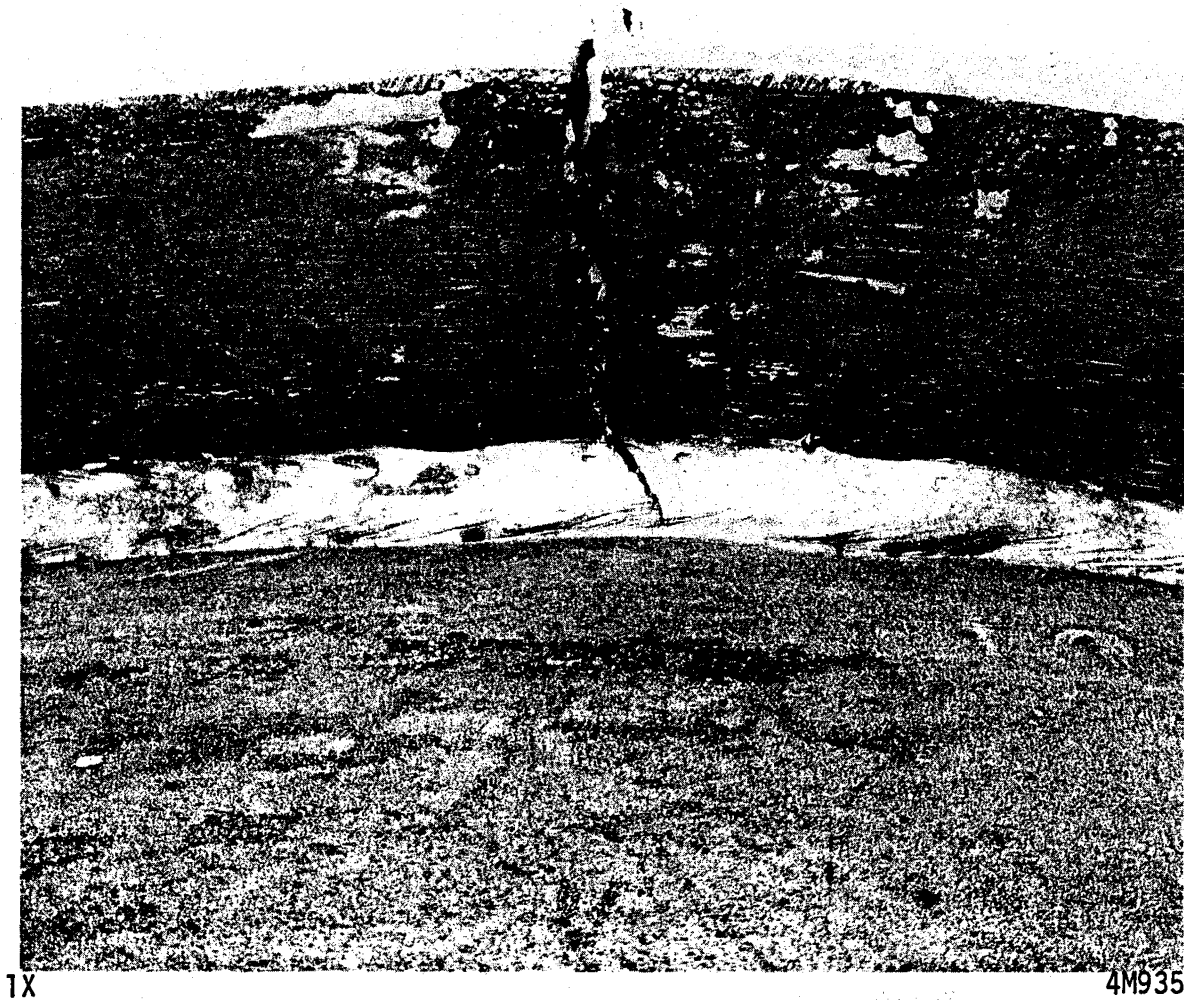
The crack through the butt weld in the drain-end stiffener ring was contained in Section ODB which was removed from the failed shipping container. The crack and the adjacent material from the stiffener ring and the vessel shell are shown in Figure 34a, b, and c. As is shown in the 1X photograph in Figure 34, the maximum separation between the crack surfaces at the top of the stiffener ring was 0.25 inch. It can be seen clearly in Figure 34 that the crack extended into the fillet welds on both sides of the stiffener ring. However, there was no evidence of crack

- b. View of the Crack in the Drain-End Side of the
Drain-End Stiffener Ring

- c. View of the Crack in the Valve-End Side
of the Drain-End Stiffener Ring

extension on the outer surfaces of the vessel shell. Again, grinding marks from smoothing of the butt-weld region were visible on the top and sides of the stiffener ring. Those marks were particularly severe on the drain-end side, as is shown in Figure 34b.

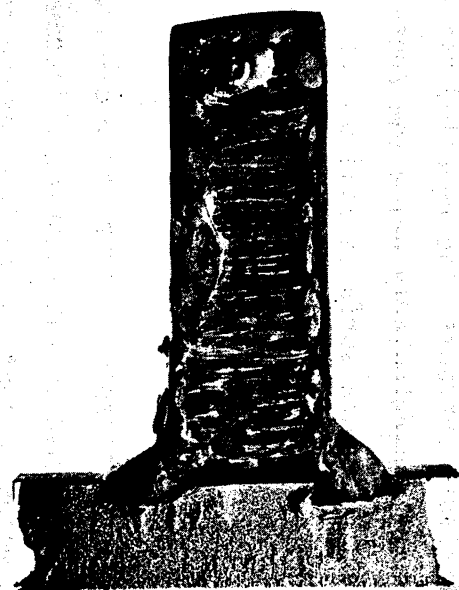
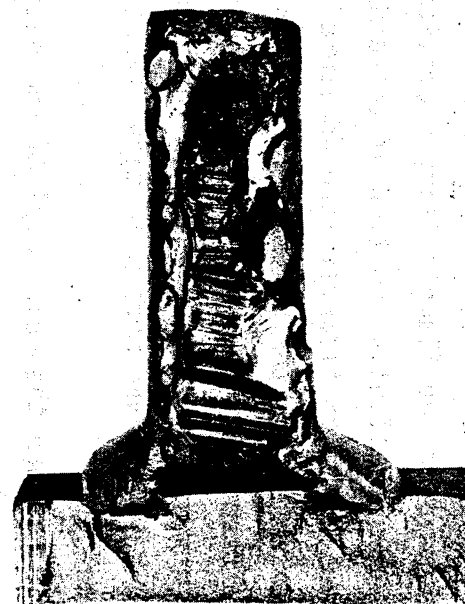
The surfaces of the fracture through the weld metal of the butt weld, shown in Figure 35, contained several oval-shaped, flat regions. Such regions were not as apparent on the fracture surfaces through the butt weld metal in the other two stiffener rings. For Specimen ODBW, the percentage of fused weld metal was 23.6 percent of the area of the stiffener cross section as measured by the planimeter tracings.

The examination of these fracture surfaces also revealed evidence of crack growth in the vessel shell steel, particularly below the roots of the fillet welds. The details of those fracture surfaces will be described in the section which presents the results of the fractographic examinations.

FIGURE 35. MATCHING SURFACES ON SPECIMENS ODB-W AND ODB
FROM THE CRACK IN THE DRAIN-END STIFFENER RING

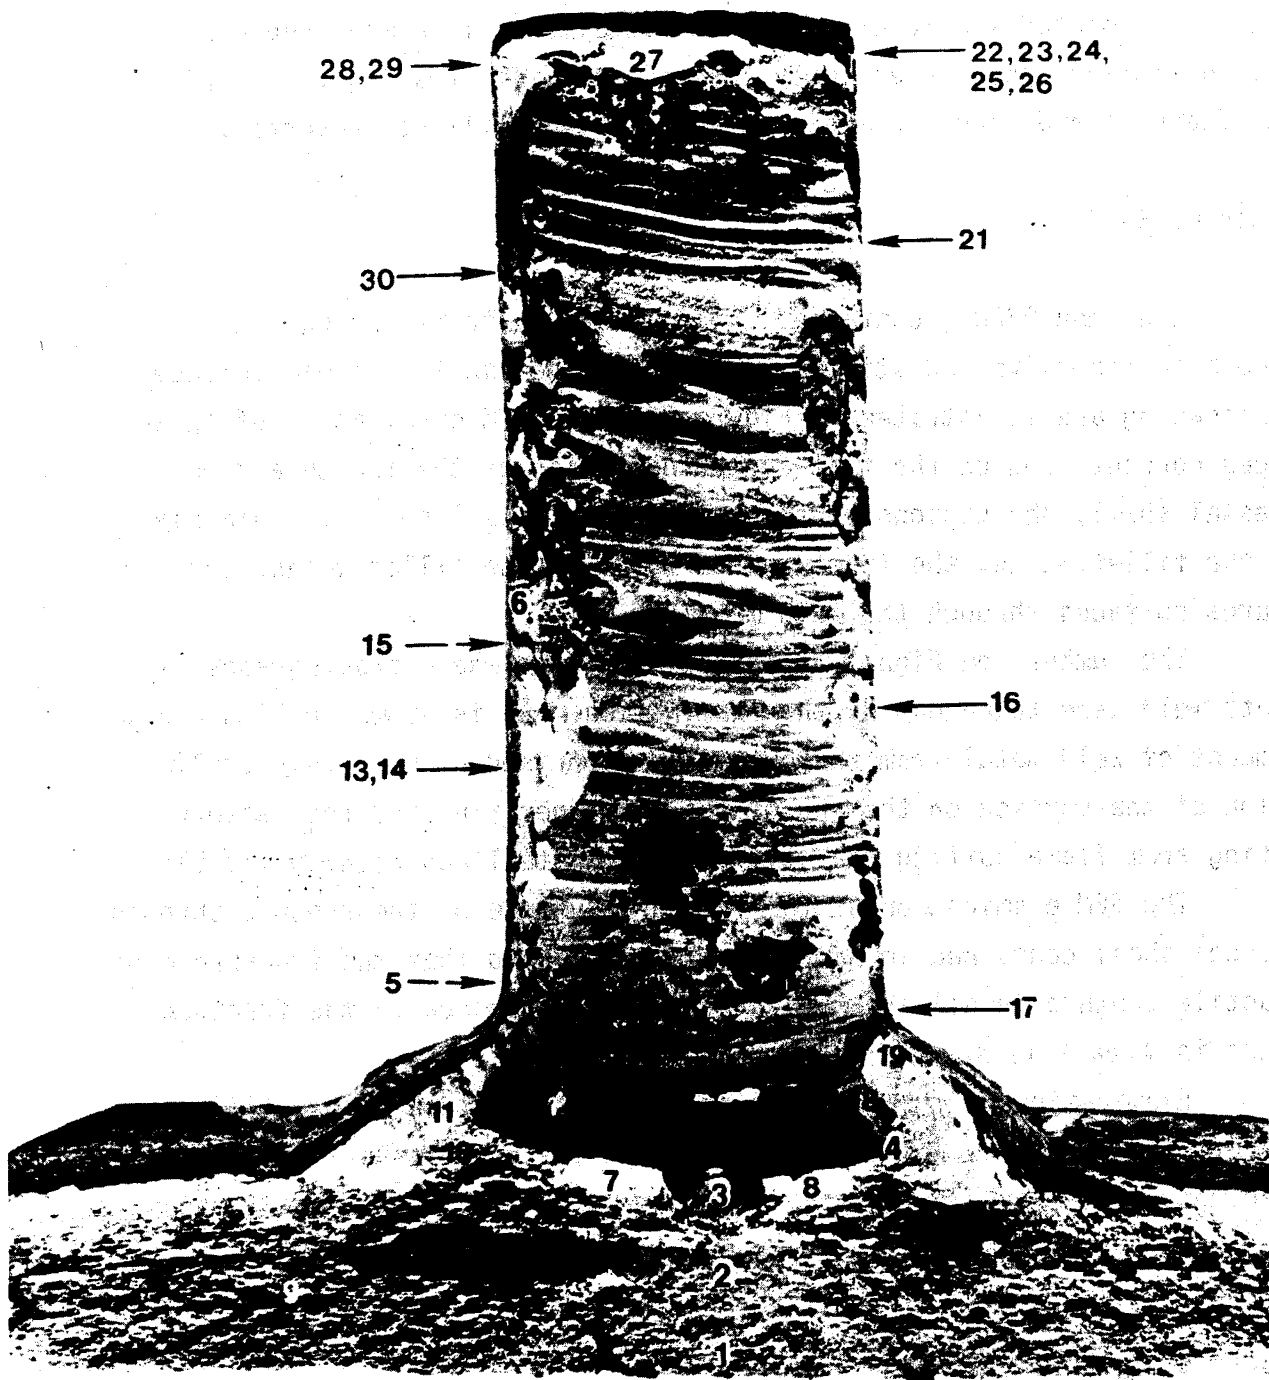
The numbers on Figure 36 indicate regions where fractographs of the butt weld were taken during the examination. As is shown in Figure 36, the amount of weld metal from the butt weld comprised a relatively small fraction of the surface on the end of the stiffener ring and the pattern resulting from flame cutting the stiffener ring steel was clearly visible.

FIGURE 36. FRACTURE SURFACE ON SPECIMEN OVFP-W (VALVE-END STIFFENER AND ADJACENT VESSEL SHELL) EXAMINED IN THE SEM

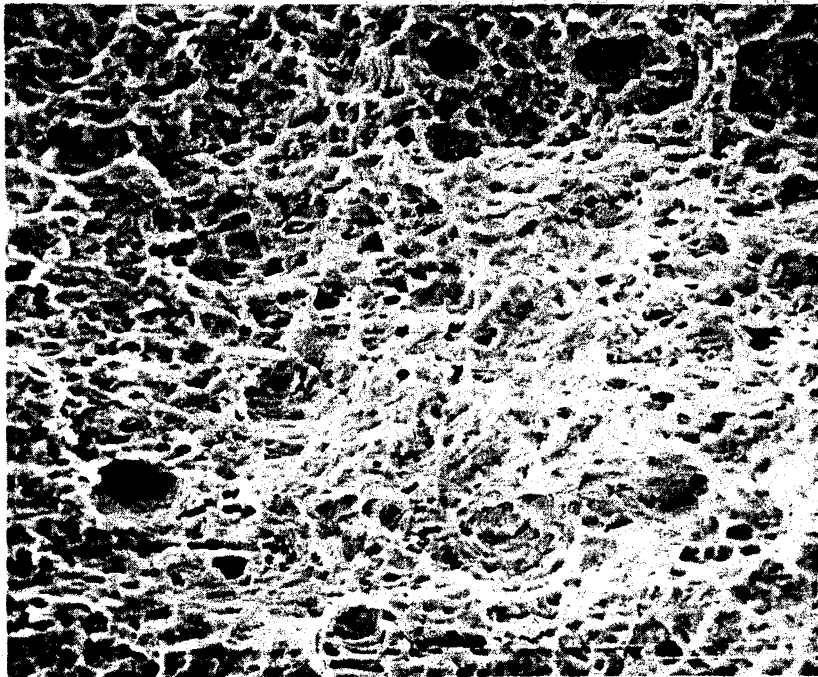
The SEM examination of the fracture surface of the rupture through the vessel shell contained in Sample OVFB-W, revealed that the fracture mode was ductile rupture in all areas. The typical appearance of the fracture surfaces in Area 2 is shown in Figure 37.

b. Higher Magnification Fractograph
Showing Ductile Dimples

FIGURE 37. TYPICAL DUCTILE FRACTURE APPEARANCE IN AREA 2
ON FIGURE 36 OF THE FRACTURE SURFACE OF THE
VESSEL SHELL

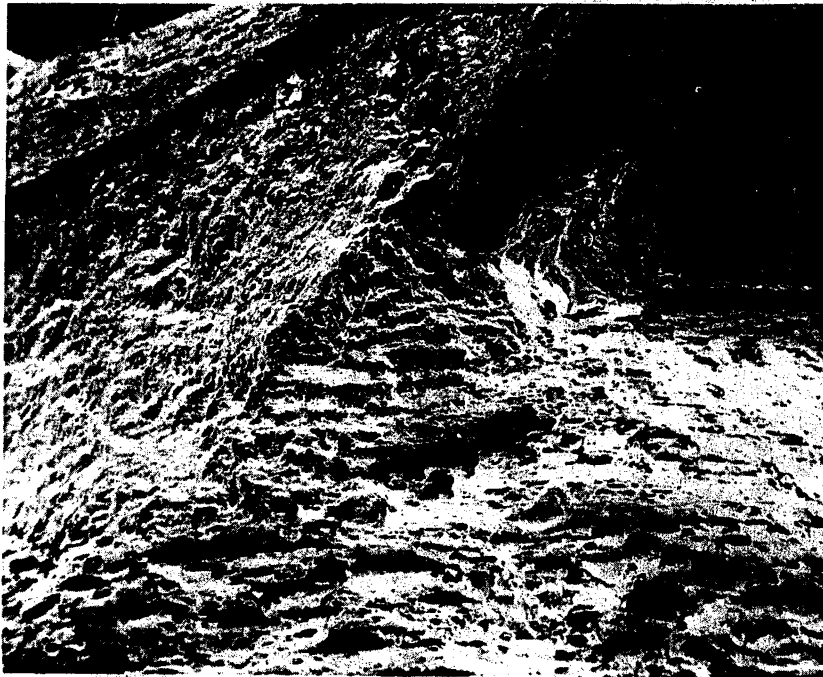
Examination of the surfaces of the fracture through the fillet welds between the valve-end stiffener ring and the vessel shell contained on Specimen OVFB-W revealed only evidence of ductile rupture. The typical appearance of these fracture surfaces are illustrated in Figure 38.

a. Fracture Surface Through Fillet Weld
and Vessel Shell in Area 11

b. Ductile Rupture in Fillet Welds from Area 11

FIGURE 38. TYPICAL APPEARANCE OF FRACTURE SURFACE
THROUGH FILLET WELDS BETWEEN THE VALVE-
END STIFFENER AND THE VESSEL SHELL ON
SPECIMEN OFVB-W
