Rupture of Model 48Y UF₆ Cylinder and Release of Uranium Hexafluoride

Cylinder Overfill, March 12-13, 1986
Investigation of a Failed UF₆ Shipping Container

**U.S. Nuclear Regulatory
Commission**

This report, NUREG-1179, Volume 2, presents the findings made by the Augmented Investigation Team of the March 13 incident and the report of the detailed metallurgical examination conducted by Battelle Columbus Division of the cylinder damaged on January 4, 1986.

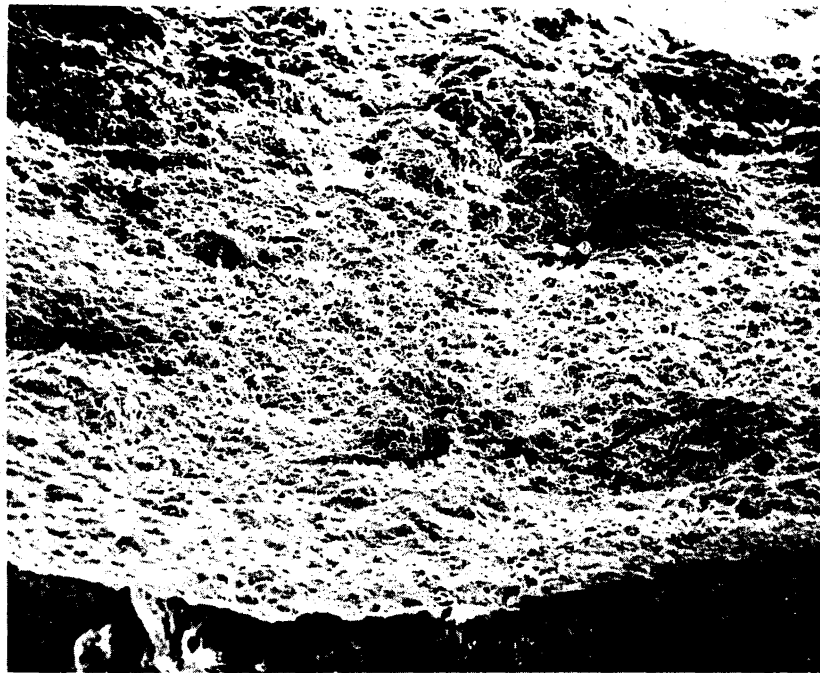
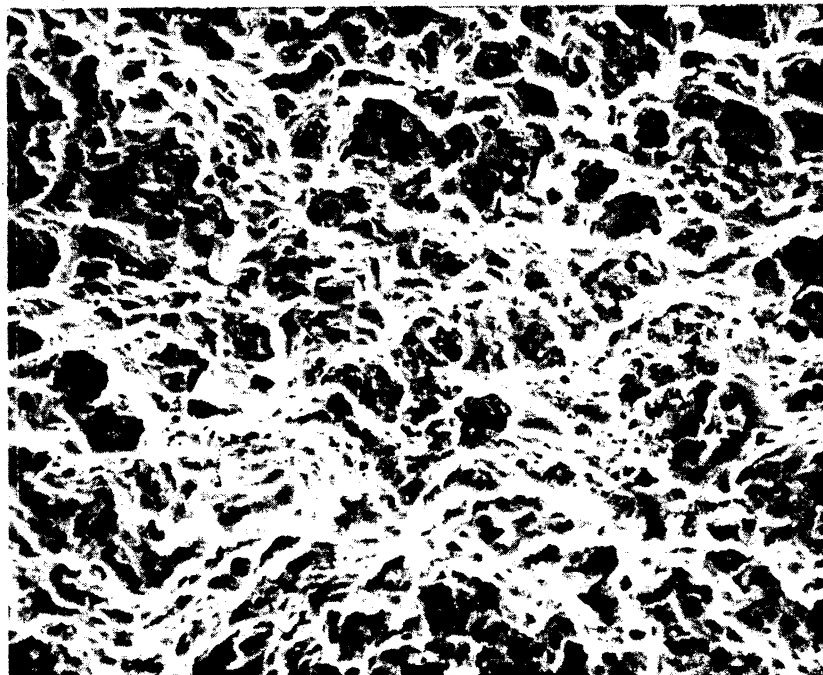
SEM examination of the fracture surfaces through the weld metal from butt weld between the ends of the valve-end stiffener ring again revealed that fracture mode in all regions was ductile rupture. That examination also revealed that in some regions where weld metal was present, there appeared to be no bond (fusion) between it and the base metal.

SEM fractographs illustrating ductile rupture on the butt-weld fracture surfaces are shown in Figure 39. Similar features were observed in Areas 5, 6, 13, 15, 16, 17, 22-30.

a. Appearance of Area 27

b. Ductile Rupture in Area 27

FIGURE 39. TYPICAL DUCTILE RUPTURE OBSERVED ON THE SURFACES OF FRACTURE THROUGH THE BUTT WELD METAL ON THE VALVE-END STIFFENER

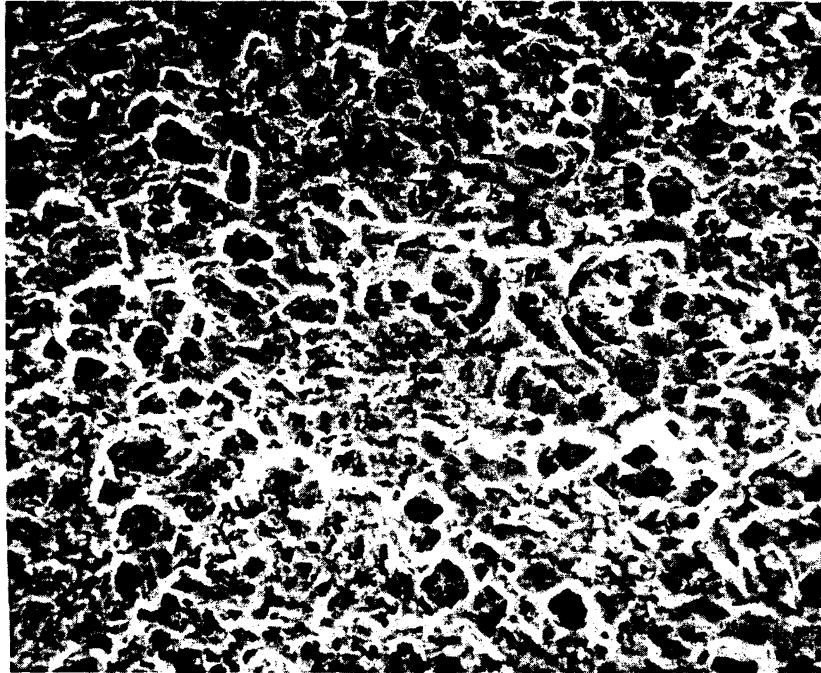
Figure 40a, b, and c illustrates the appearance of the fracture through the butt-weld metal (Area 13) and the appearances of the surface of a weld nugget (no bonding) through which fracture did not occur (Area 14). The fractograph shown in Figure 41c was on the side of the weld nugget adjacent to the ductile rupture observed in Area 13. The features shown in Figure 40 were typical of much of the butt-weld metal deposited on the ends of the stiffener rings in that a significant portion of the surface of weld metal visible was not bonded to the stiffener ring steel or an adjacent weld deposit. Thus, basing the amount of weld penetration on the total area of weld metal visible on those surfaces would result in a considerably greater amount than was obtained based upon the fracture area on the weld deposits as was done when the planimeter measurements were made.

FIGURE 40. FRACTURE APPEARANCE IN AREA 13 AND THE SURFACE OF A WELD NUGGET (AREA 14)

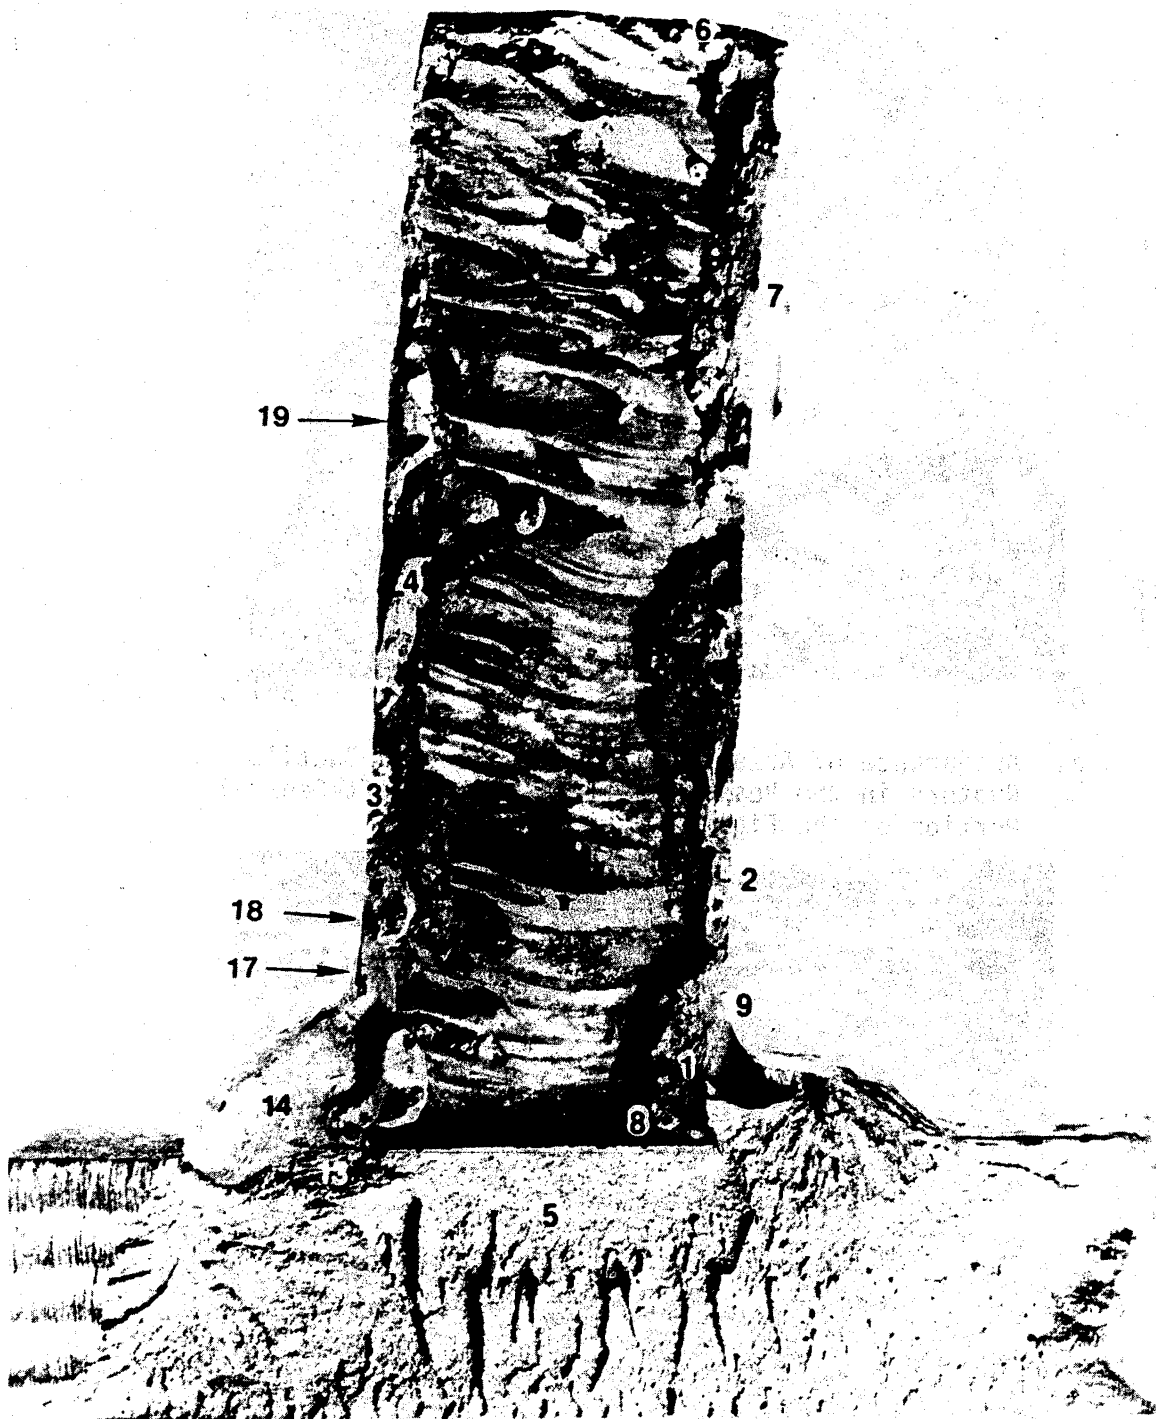
4M906E

Areas 3 and 4 on Figure 42 exhibited a flat region on the fracture through the butt-weld metal and somewhat different fracture appearances than the ductile rupture exhibited in nearly all other regions of fracture through the butt-weld metal. However, at higher magnifications those regions exhibited features indicative of ductile rupture as is shown in Figures 47 and 48. In Area 3, there appeared to be some small, featureless facets on the fracture surface. Those may have resulted from fracture through or along oxide films or merely may have been regions where corrosion products still remained on the surface after cleaning. In Area 4, the

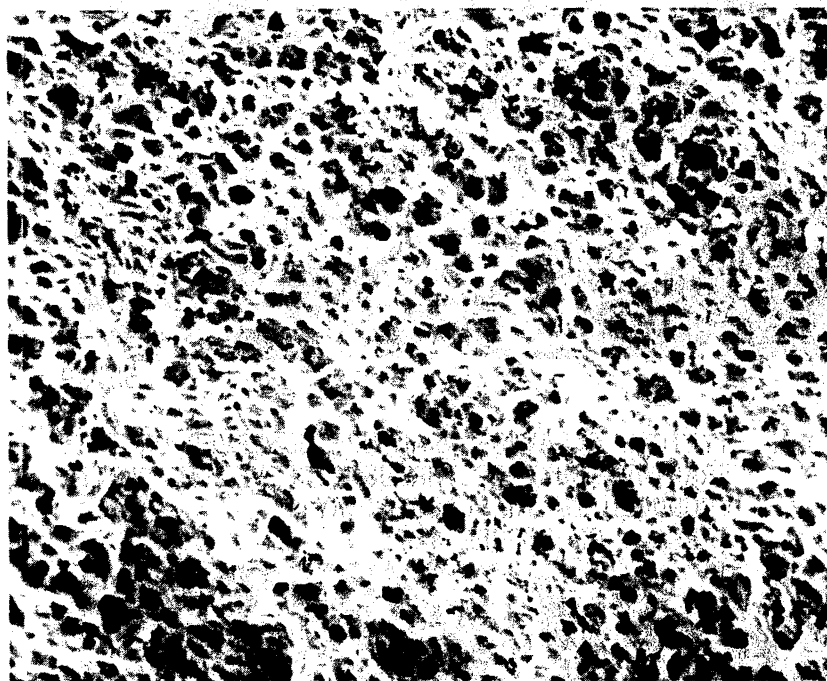
Most of the fracture surface through the butt-weld metal exhibited a ductile rupture mode, as is shown in Figure 46, which was taken in Area 19. Areas 2, 6, 7, 17, and 18 exhibited virtually the same fracture appearance.

FIGURE 46. DUCTILE RUPTURE TYPICAL OF THE FRACTURE SURFACES THROUGH THE WELD METAL ON THE BUTT WELD IN MIDDLE STIFFENER RING

This fractograph was taken in Area 19 on Figure 42. Areas 2, 3, 6, 7 and 18 exhibited virtually the same fracture appearance.

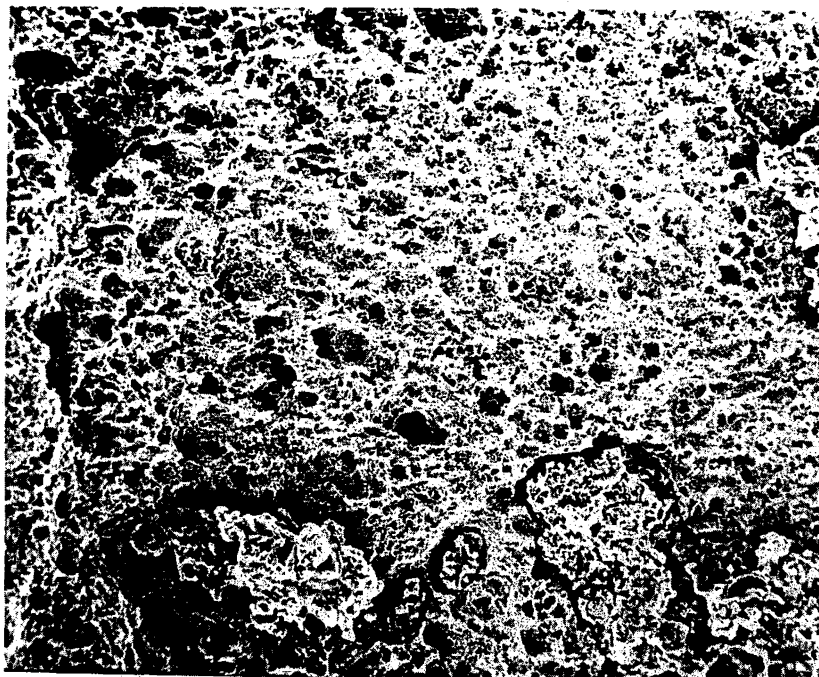
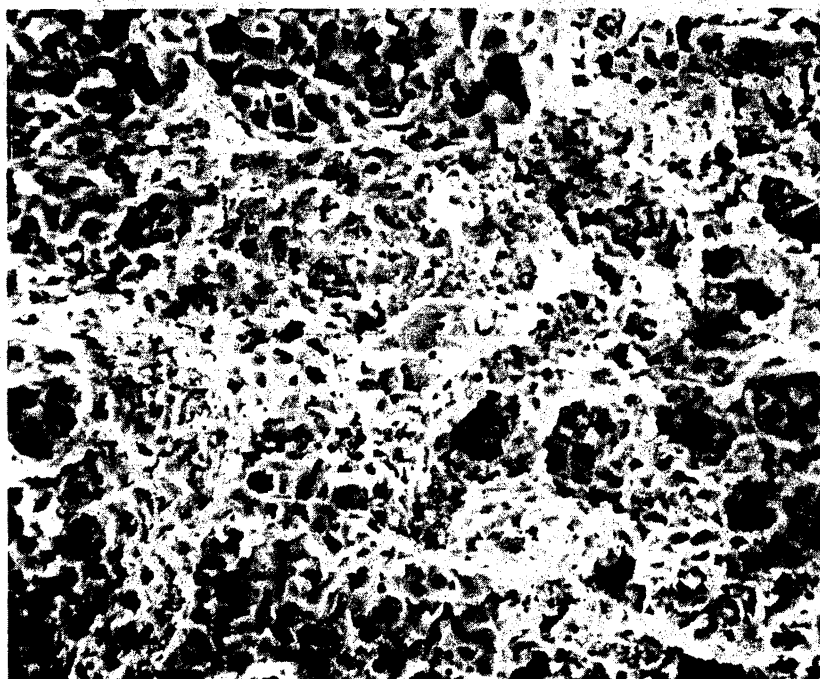
a. Typical Appearance of the Flat Fracture Region in Area 3 on Figure 42

b. Mixture of Ductile and Faceted Rupture in Area 3

FIGURE 47. APPEARANCE OF THE FRACTURE SURFACE IN AREA 3 ON THE FRACTURE THROUGH THE MIDDLE STIFFENER RING

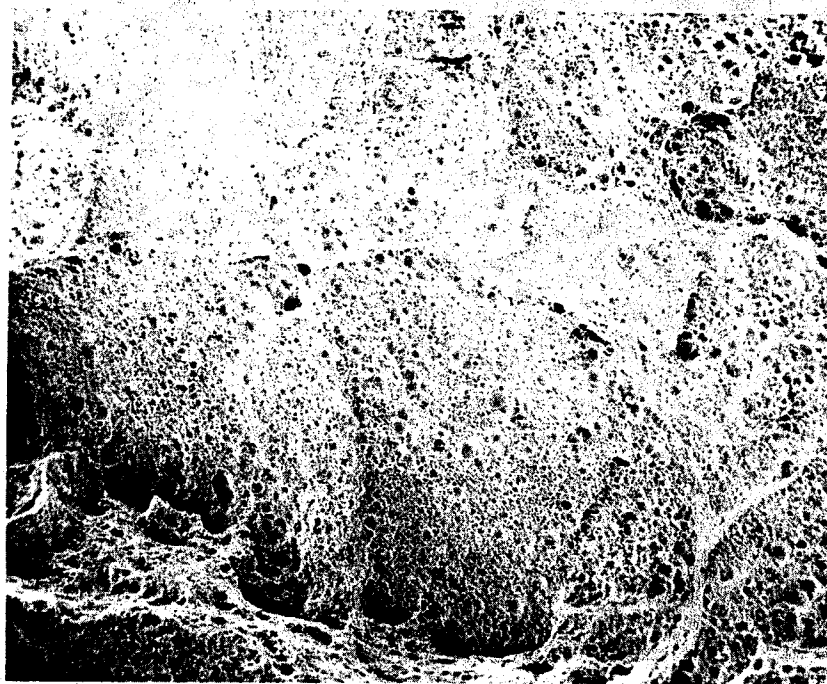
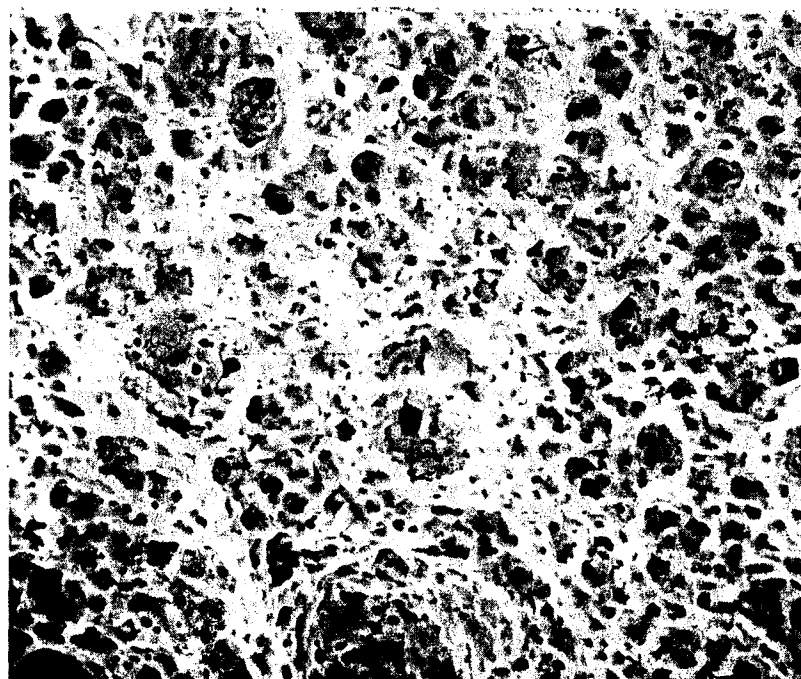
a. Flat Fracture Feature in Area 4 on Figure 42

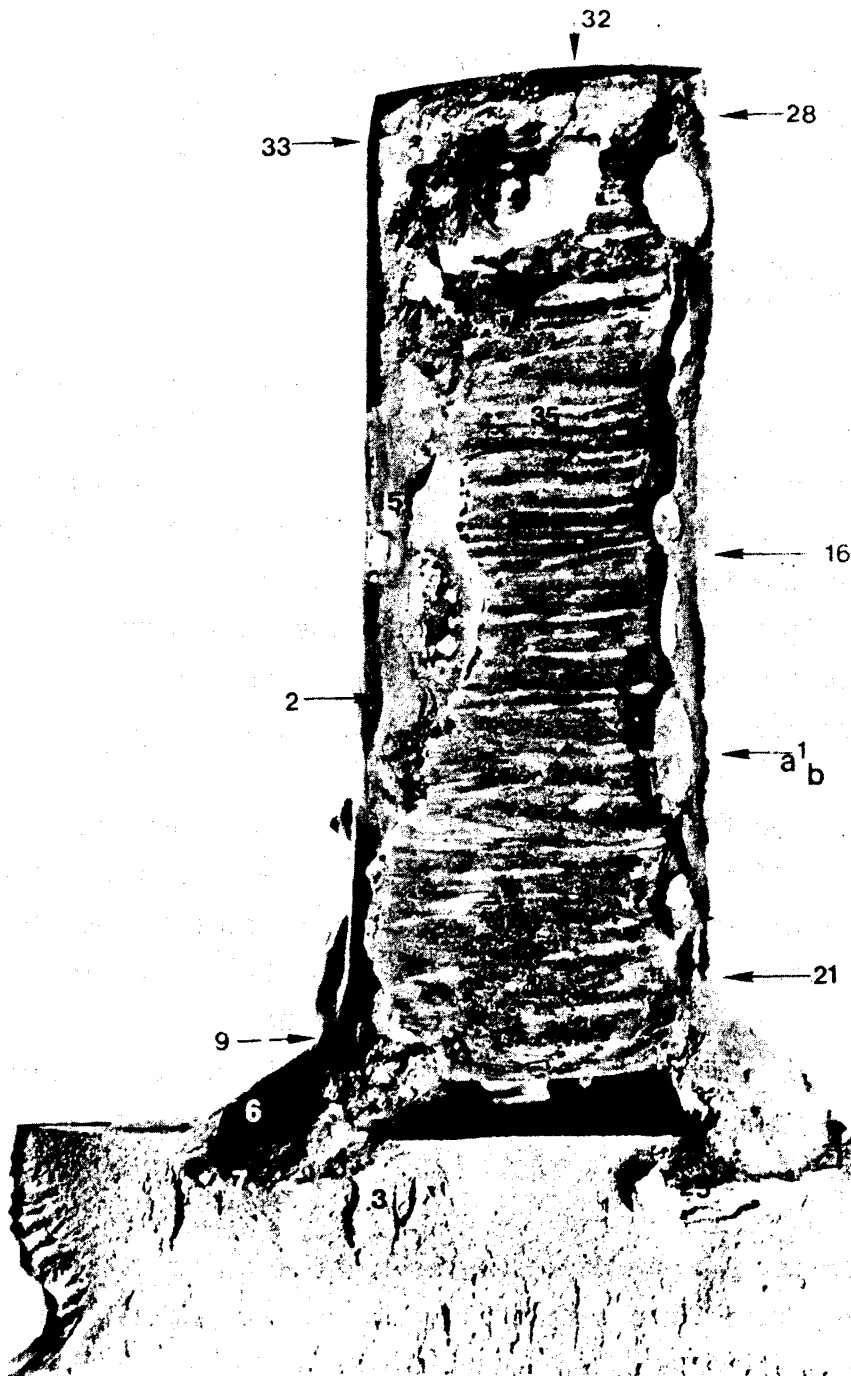
The fracture surfaces contained on Specimen ODB-W were examined in the SEM to determine the mode of fracture present in the various regions. That fracture surface is shown in Figure 49. The SEM examination revealed that the fracture surface produced in the laboratory when Section ODB was broken to expose the fracture crack surfaces was cleavage as would be expected since after immersion in liquid nitrogen the temperature of the steel was well below its ductile-to-brittle fracture transition temperature. The appearance of that fracture mode was shown previously in Figure 44.

Examination of the fracture surfaces on the vessel shell adjacent to the fillet welds, Areas 4 and 25 in Figure 49, revealed that some crack growth into the vessel shell had occurred prior to the rupture of the vessel. That crack extension occurred by ductile rupture, as is illustrated in Figure 50, and it occurred below the fillet welds on either side of the stiffener ring, even though the ultrasonic inspection indicated crack below the fillet weld only on the drain-end side. It appeared that the depth crack growth into the vessel shell below the fillet welds ranged from 1/16 to 1/8 inch.

FIGURE 49. SURFACE OF SPECIMEN ODB-W, FROM THE DRAIN-END STIFFENER RING THAT WAS EXAMINED IN THE SEM

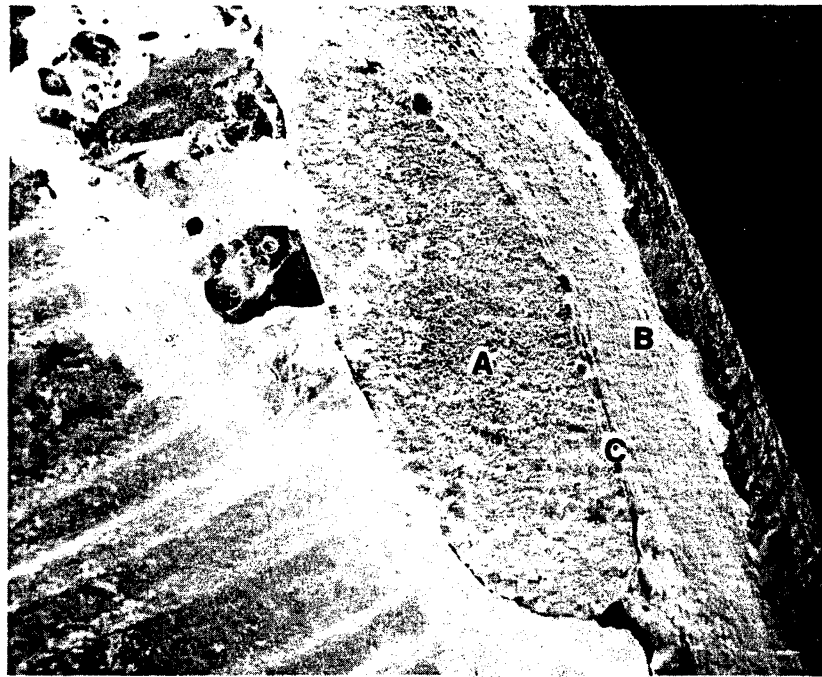
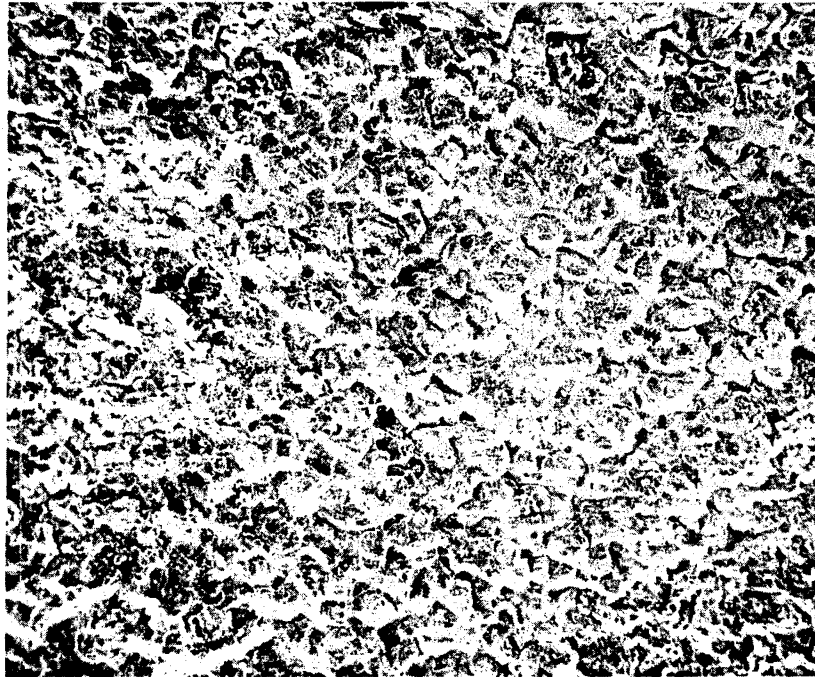
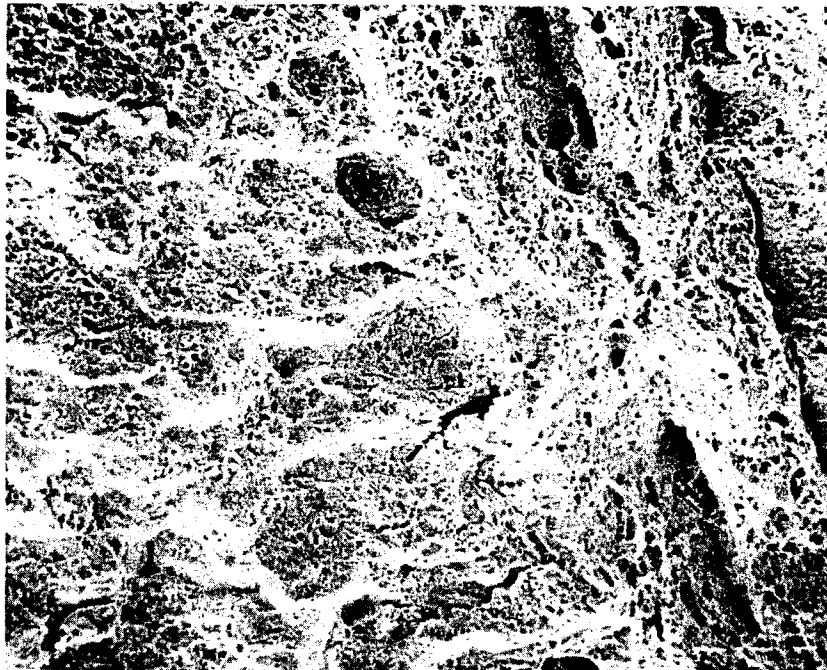
Examination of the surfaces of the fracture through the butt-weld metal in the drain-end stiffener revealed features that were not observed on the surfaces through the fracture in the valve-end stiffener ring. Those features were the flat oval shaped regions shown in Figure 49. Examination of those regions in the SEM revealed that they exhibited a significantly different appearance than the regions of ductile rupture. Figure illustrates the fracture appearance of the flat fracture region, shown in Area 1 on Figure 49. Figure 53a illustrates Area 1 at a magnification of 8X. It shows the oval shaped flat region (Area A), and a shear lip (Area B) extending from Area A to the surface of the stiffener ring. Figure 53b illustrates the unusual appearance of that flat region at 100X and Figure 53c illustrates the flat region and the start of the shear lip at 350X. Figures 53b and c suggest that the coarse features on the flat fracture area may have been related to some microstructural feature of the weld deposit. They did not show features typical of ductile rupture, cleavage, or truly intergranular fracture. As is shown in Figure 53c and at higher magnification in Figure 53d, that region appears to show more corrosion damage as indicated by the small circular pit-like features on the fracture surface. Figure 53e shows the ductile rupture typical of the shear lip (Area B).

a. Appearance of the Fracture Surface in Area 1 on Figure 49

b. Typical Appearance of the Flat Fracture Region in Area A of Figure 53a

FIGURE 53. TYPICAL FEATURES OBSERVED ON THE REGIONS OF FLAT FRACTURE THROUGH THE BUTT WELD IN THE DRAIN-END STIFFENER RINGS

c. Transition from Flat Fracture to the Shear Lip
in Area 1 shown in Figure 53a.

e. Typical Ductile Shear Fracture
in Area B of Figure 53a

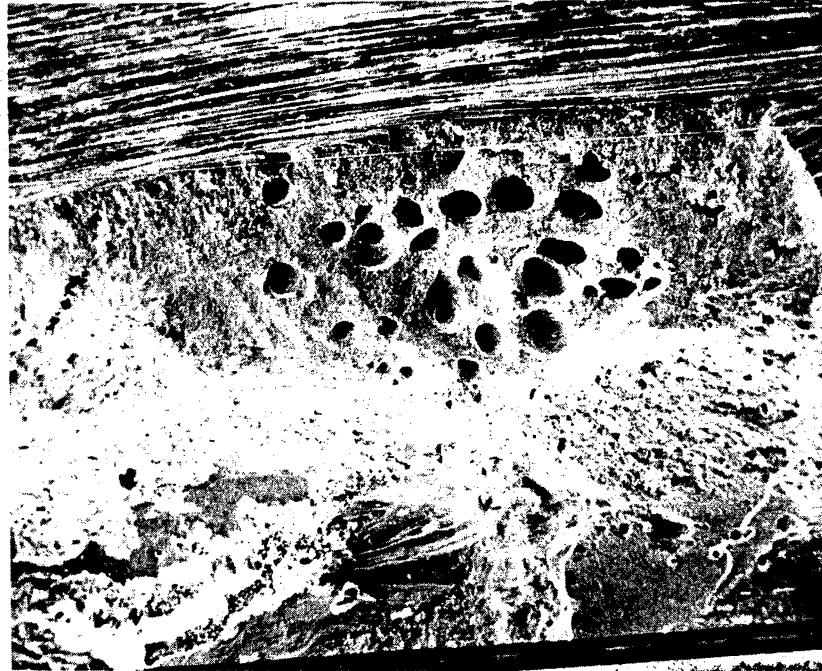
All other regions examined on the fracture surfaces through the butt weld in the drain-end stiffener showed ductile rupture. Figure 54 illustrates the ductile rupture features in Areas 2 and 33 on Figure 49. As is shown in Figure 55, some regions of the fracture through the butt-weld metal in the drain-end stiffener ring also contained significant porosity.

FIGURE 55. POROSITY IN THE BUTT WELD METAL
IN AREA 32 ON FIGURE 49

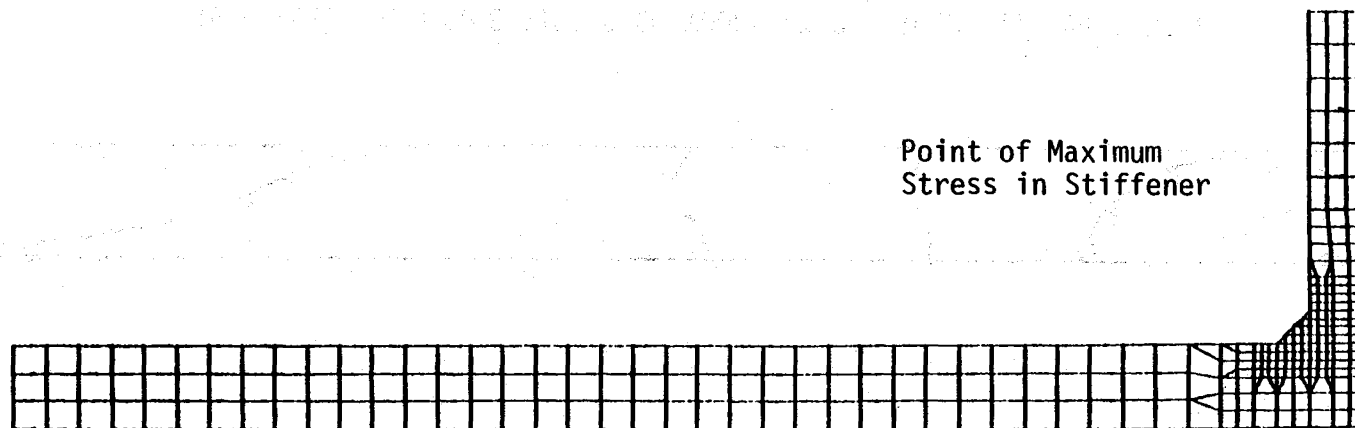
The results from this analysis show that the maximum stress in the vessel occurs on the inner surface of the vessel at the point midway between the stiffener and the head. The maximum stress in the stiffener occurs at the top of the fillet weld, as shown in Figure 61. Stress contours for the effective stress (von Mises) for each case at $P = 1000$ psi are shown in Figures 62 through 65. The stress levels corresponding to the contour numbers are presented in Table 14. The maximum effective stresses in the vessel and the stiffener at 1000 psi pressure are given in Table 15.

FIGURE 61. MAXIMUM STRESS LOCATIONS IN VESSEL
AND STIFFENER

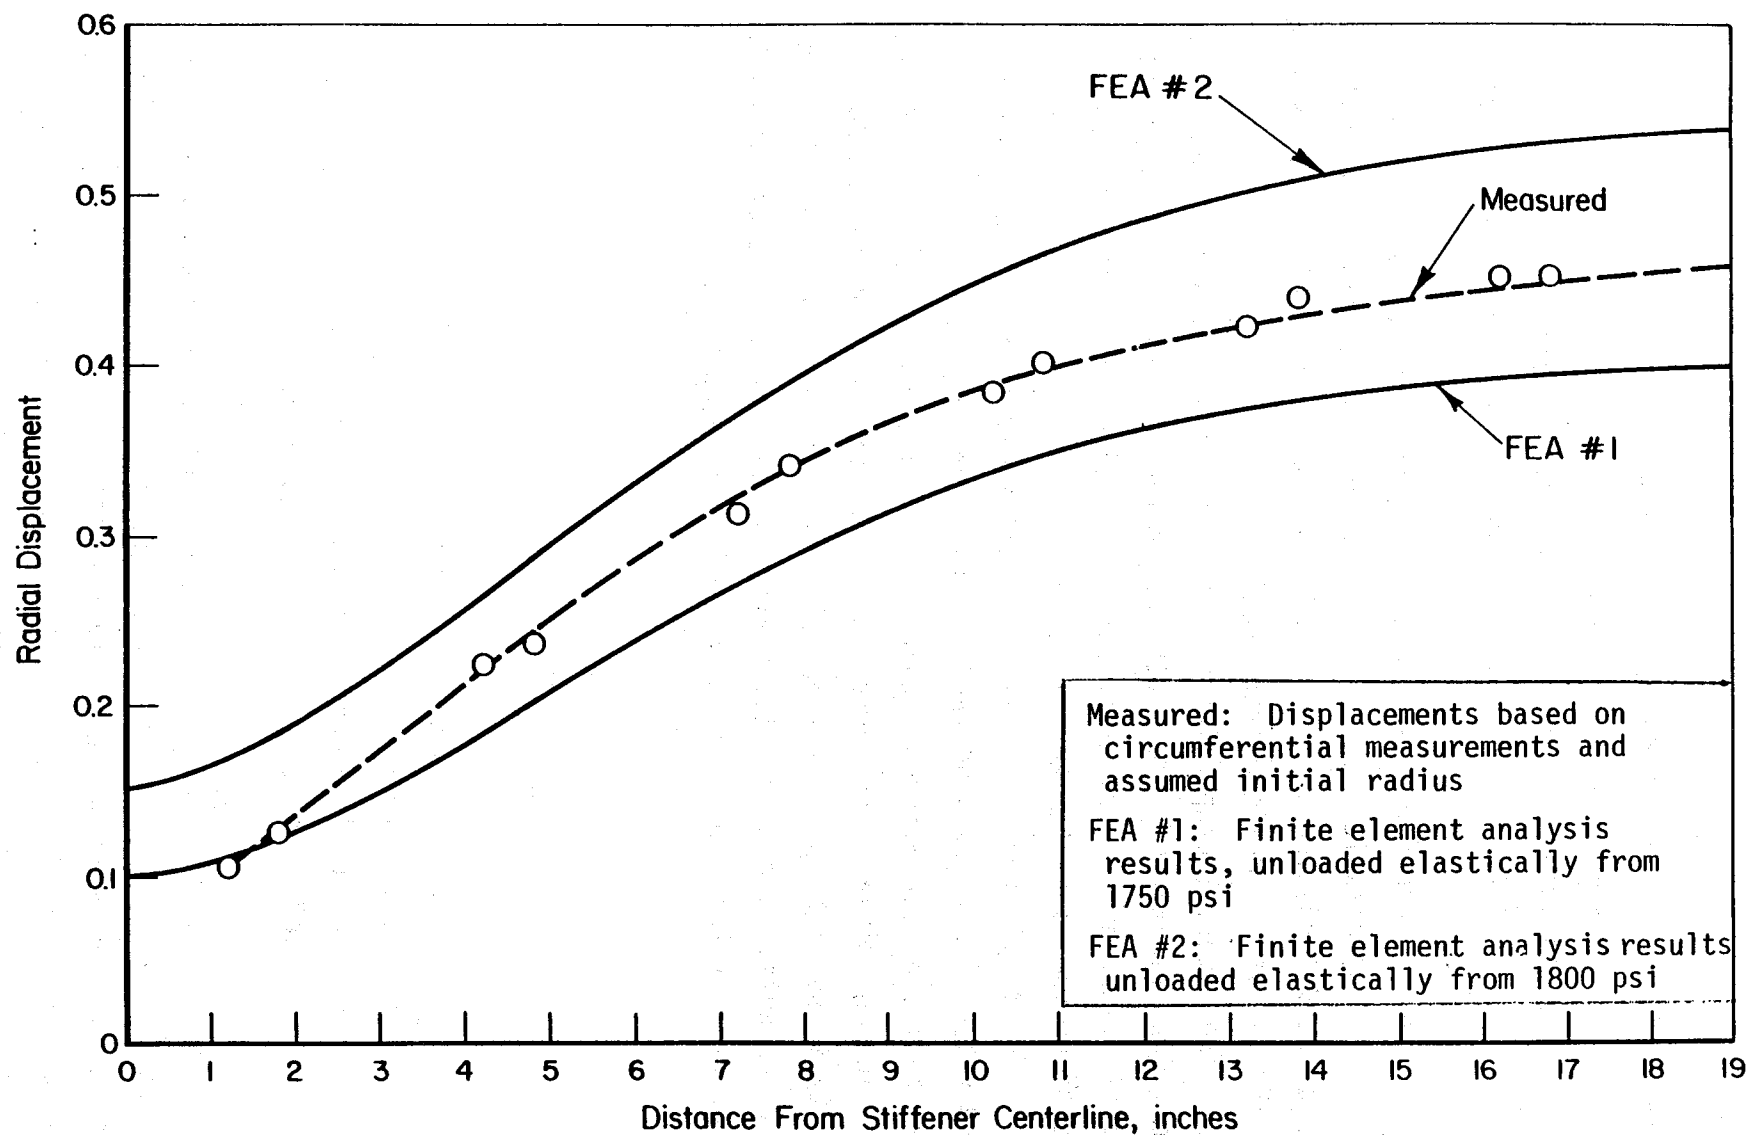
FIGURE 66. RADIAL DISPLACEMENT BETWEEN TWO STIFFENERS

The displacement results from this analysis are shown, with the measured values, in Figures 66 and 67. In Figure 66, the measured radial displacement was calculated from the measured circumferences, using an initial (undeformed) outer radius of the vessel as 24.625 inches (24 inches I.D. plus 5/8-inch plate thickness). In Figure 67, the apparent tangential strain was calculated by assuming a value of tangential strain of zero at the edge of the stiffener, as shown below.

The elastic-plastic analysis shows that the internal pressure at rupture was greater than 1750 psi. The results of this analysis indicate that the maximum pressure was approximately 1775 psi. However, the analysis was performed using the minimum material properties. Thus, the actual pressure at rupture may have been greater than 1775 psi.

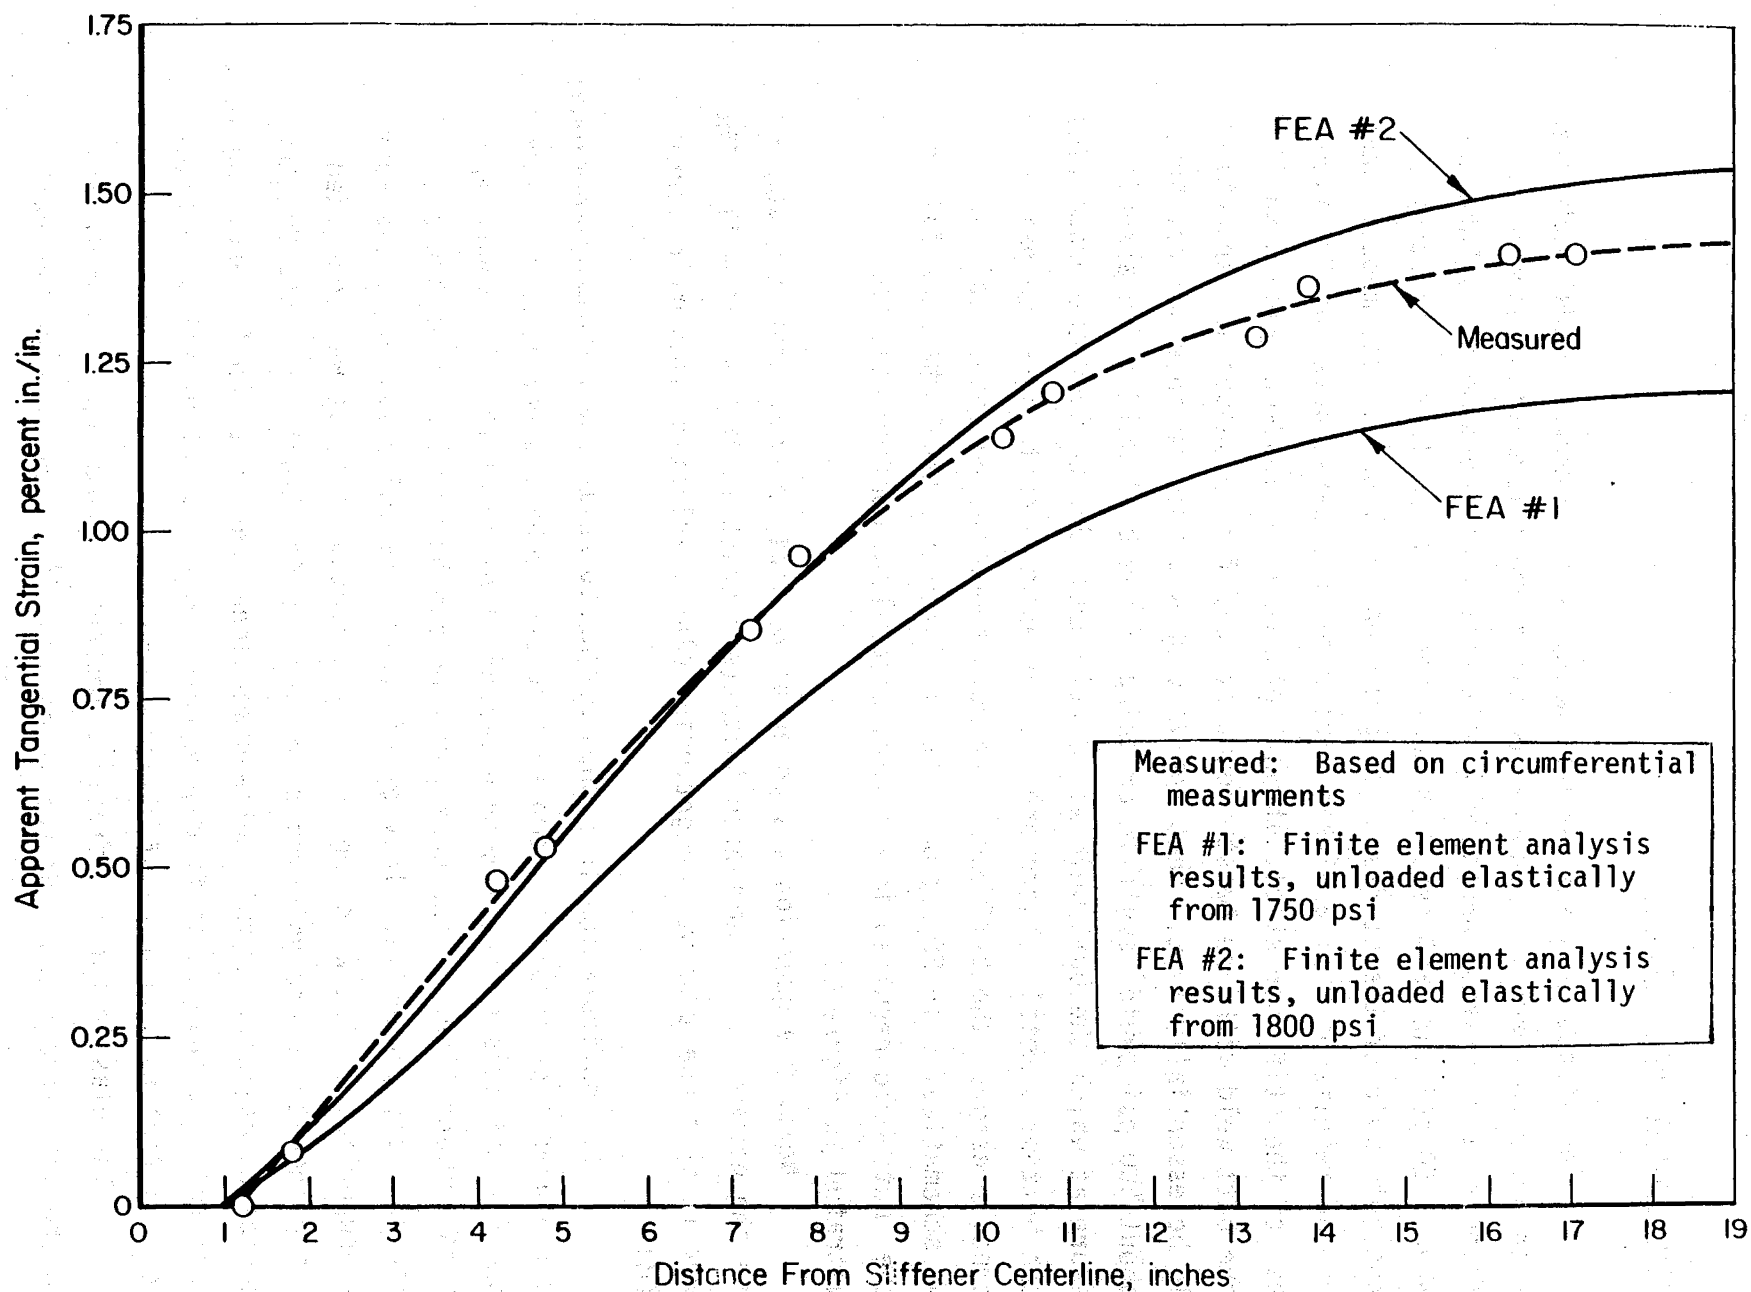
FIGURE 67. APPARENT TANGENTIAL STRAIN BETWEEN TWO STIFFENERS

where ϵ_{ta} = apparent tangential strain
 Δr = radial displacement
 Δr_s = radial displacement at edge of stiffener
 r_s = deformed radius at edge of stiffener.

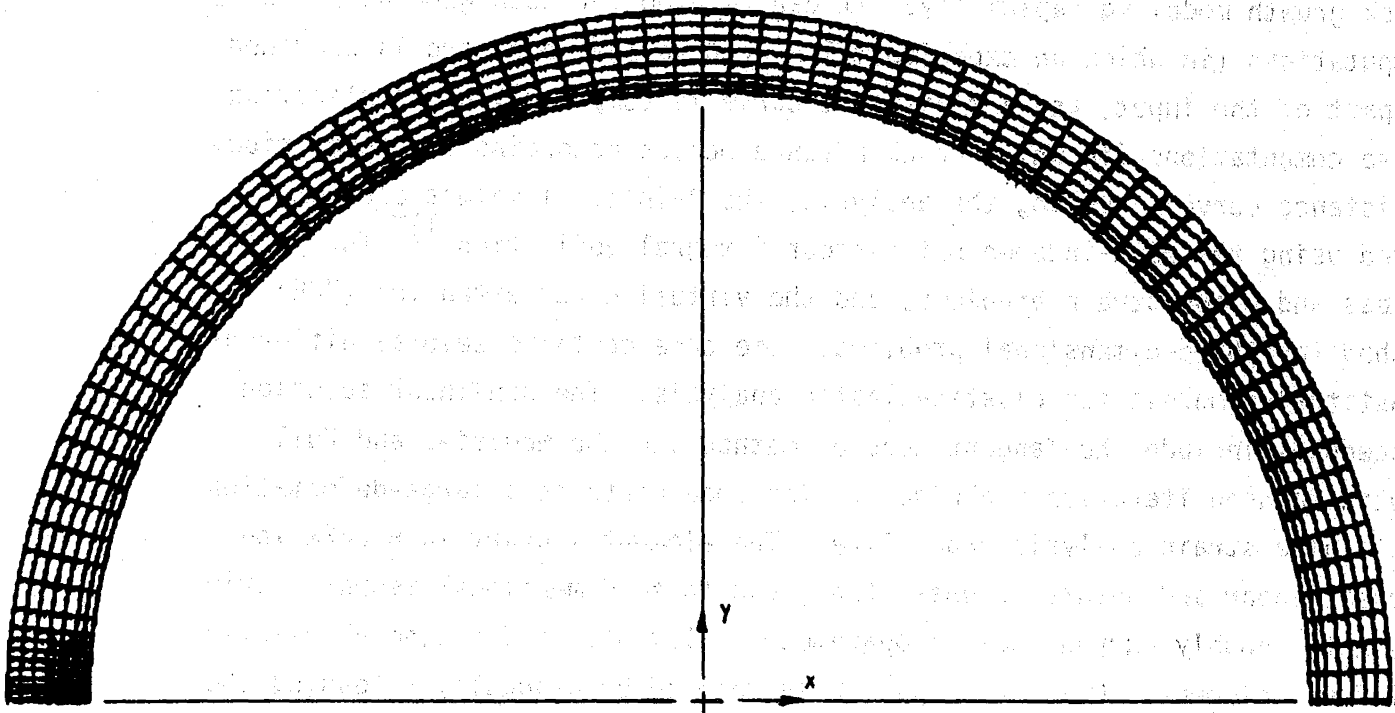
FIGURE 69. FINITE ELEMENT MODEL FOR FRACTURE MECHANICS ANALYSIS

For the present analysis, the finite element model (Figure 69) included 599 eight-noded isoparametric elements and 1962 nodal points. A 3 x 3 Gaussian quadrature was used for stiffness generation. The Newton Raphson iteration method was selected for equilibrium compensation. The hardening was assumed isotropic and the J_2 flow theory was used in the constitutive model. The material's behavior was modeled by a multilinear

representation of the stress-strain curve. The J-integral was computed using three different contours as indicated in Figure 69.

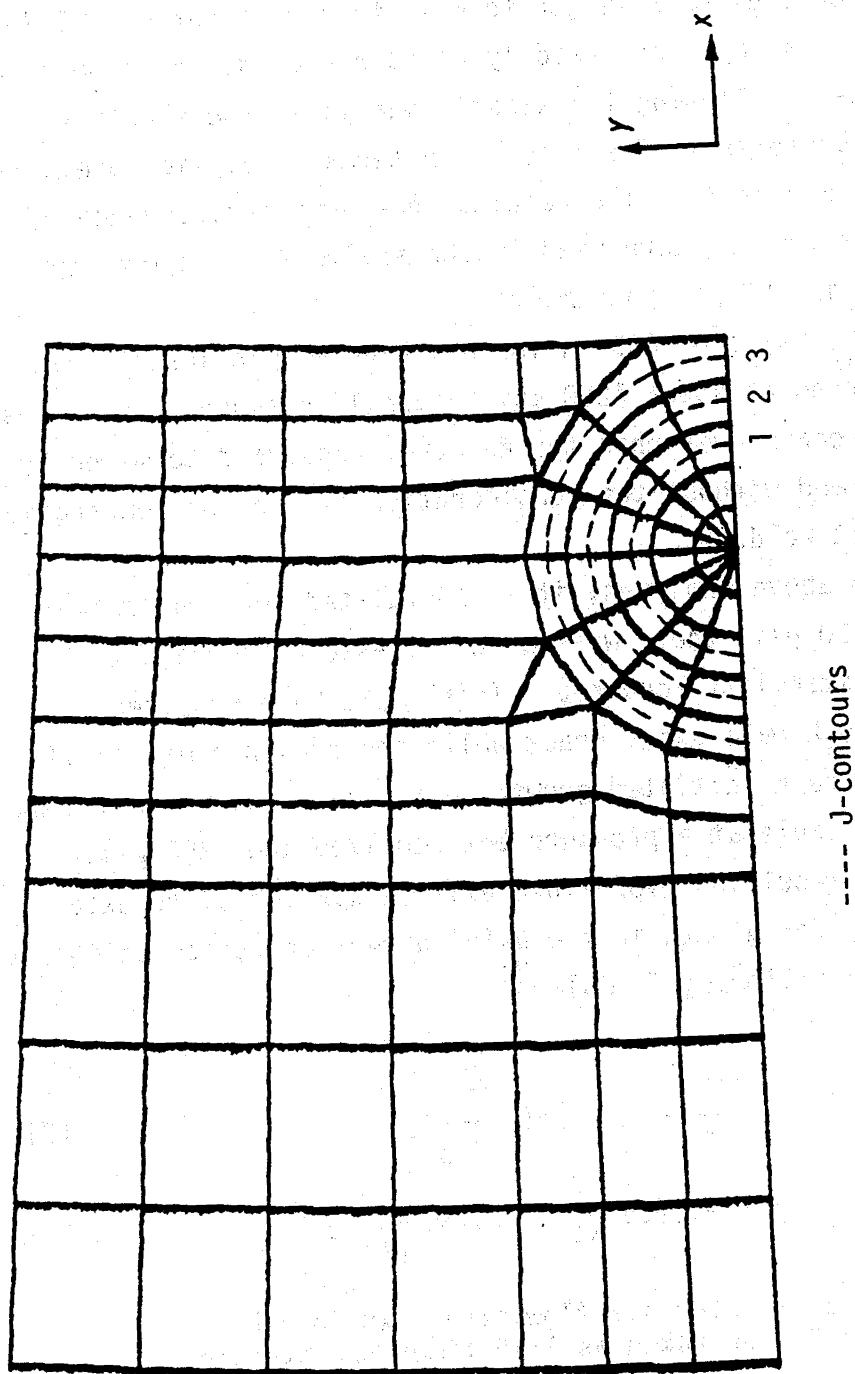
FIGURE 70. DETAILS OF NEAR-CRACK-TIP FINITE ELEMENT MESH SHOWING THE THREE J-CONTOURS

Analysis was first performed assuming the materials stress-strain curve to be linearly elastic. For 1000 psi internal pressure, the three contours in Figure 70 yielded values: 336, 339, and 336 in-lb/in² for J. This provided the indication of path-independence of J, and therefore, of the adequacy of finite element model refinement.

Using these values of J, the average stress intensity factor (K) is $100.55 \text{ ksi}\sqrt{\text{in}}$. For the crack length to wall thickness ratio of 0.794, a handbook solution for K could not readily be found for direct comparison of the present results. Following the elastic analysis, the elastic-plastic analysis was performed. The results in terms of applied pressure versus J are shown in Figure 71. The results show path independence of J all the way to the maximum pressure used in the analysis. The pressure was applied incrementally in 100 psi increments.
