# Shield Building Crack Investigation and Root Cause Presentation

**Davis-Besse Nuclear Power Station**

August 9, 2012

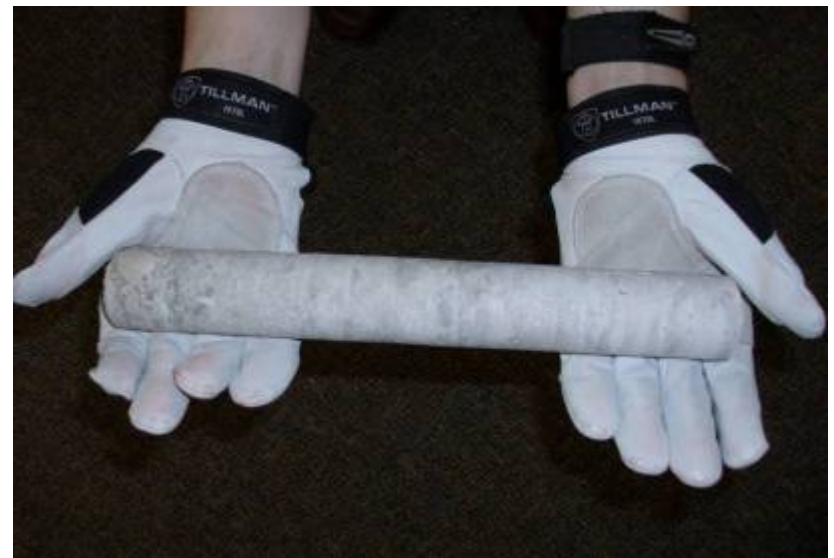
- Concrete was subjected to a series of tests
- 36 concrete cores from the Shield Building tested
- Concrete properties were determined
- Test results confirmed the concrete is sound and can be ruled out

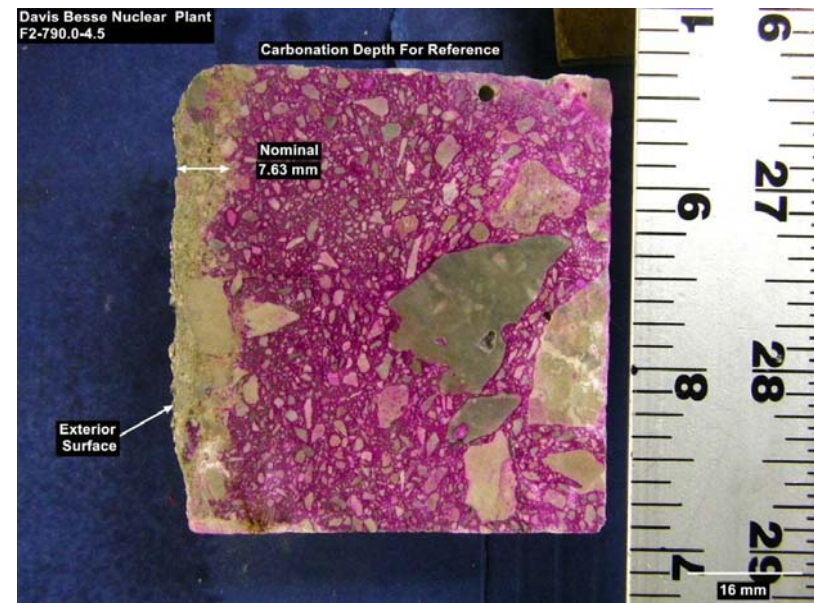
- **16 samples were tested for carbonation**
  - Average depth of carbonation is 8.57 mm (0.337 inches)
  - Maximum average 11.7 mm ( 0.46 inches)
  - Typical for concrete 40 years old

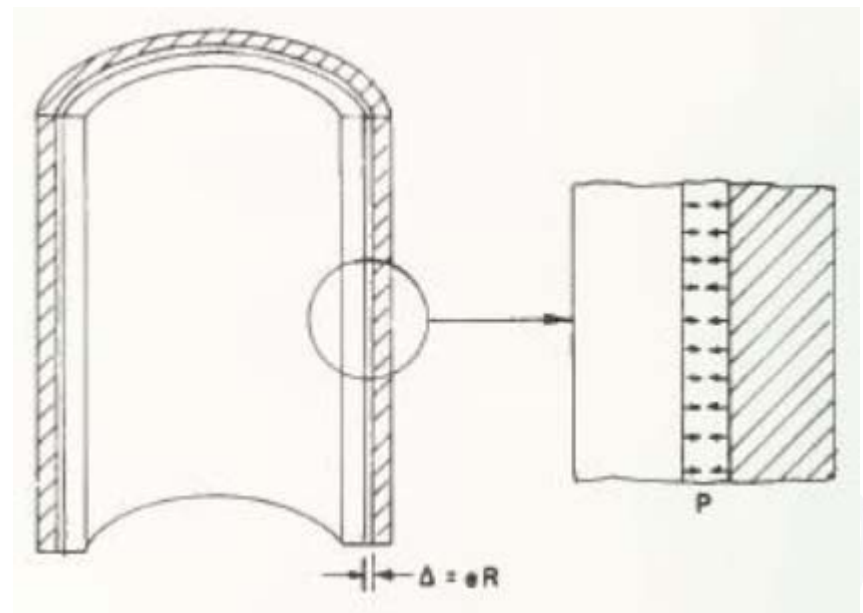
- Ontario Ministry of the Environment study on 50 above ground water tanks in Ontario
- Water migrated into the concrete from the inside
  - Inner layer of the wall freezes and expands
  - Outer layer of wall contracts
  - Creates high radial stress
  - Results in laminar cracking

- Conclusion: Laminar cracking as a result of water freezing is a real potential

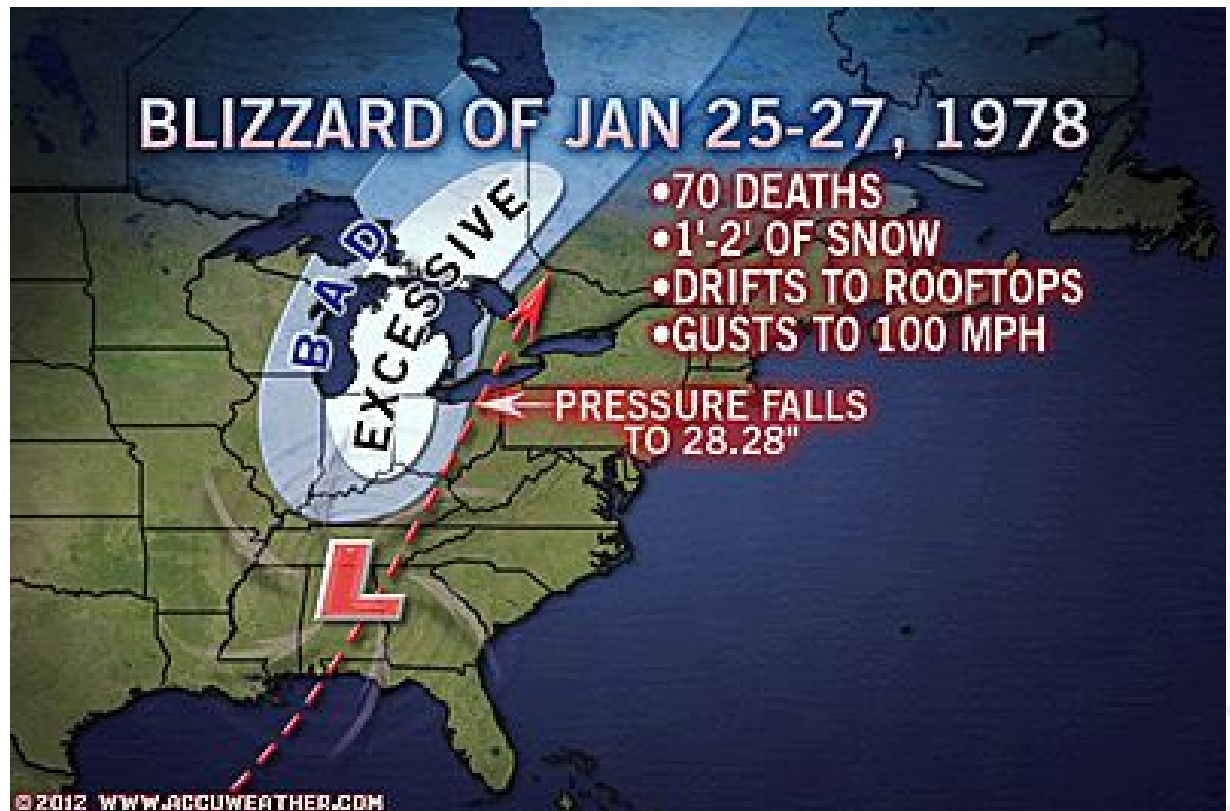
- January 25-27, 1978, was the worst in terms of:

- Moisture
- Winds
- Temperature
- Duration
- Pressure

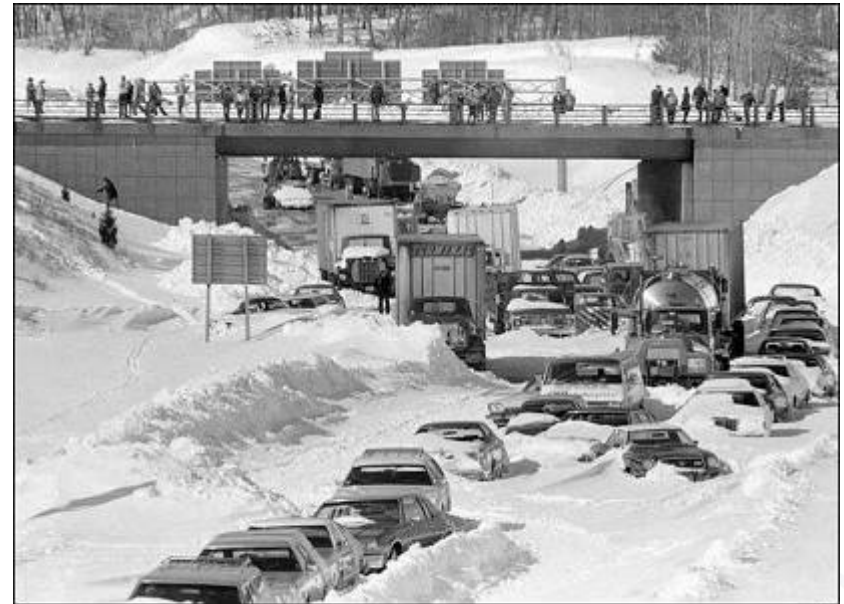
- Temperature near zero
- Sustained strong winds
- Moisture penetrated the Shield Building
- Moisture trapped in the outer layer of concrete crystallized
- Concrete expansion exceeded the tensile capacity of the concrete and propagated the crack

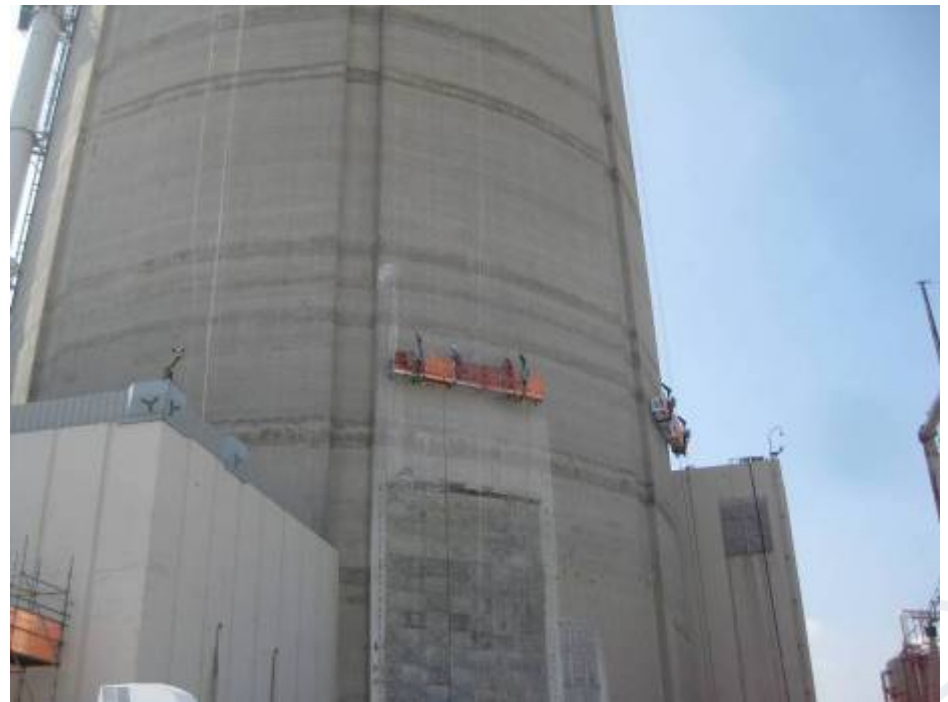
- **Complete IR examinations on the Shield Building wall and an independent structure**
  - All accessible areas of the Shield Building wall were mapped
  - Over 60,000 individual readings were obtained to fully characterize the condition of the building

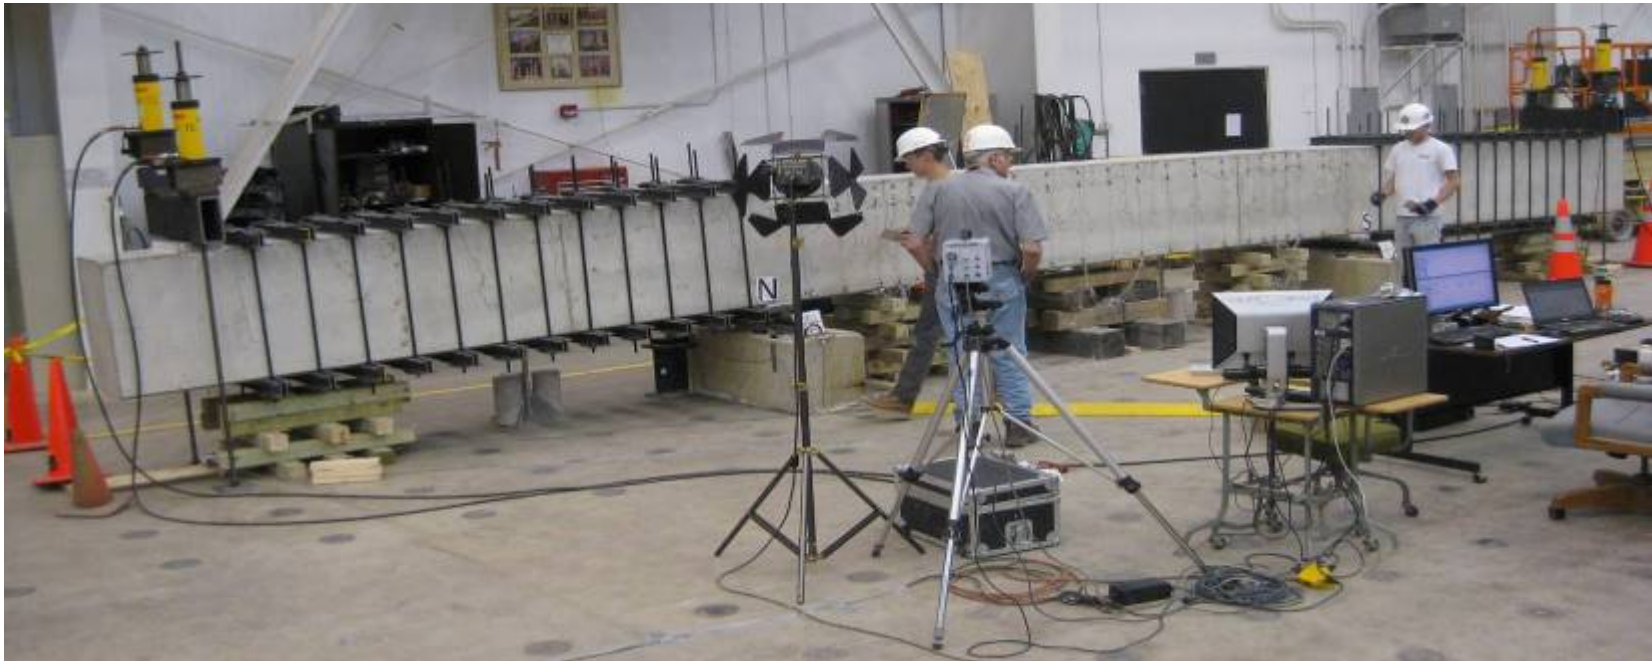
- Tests were developed and conducted at two nationally recognized universities
- Professors are industry experts and are American Concrete Institute (ACI) Committee members

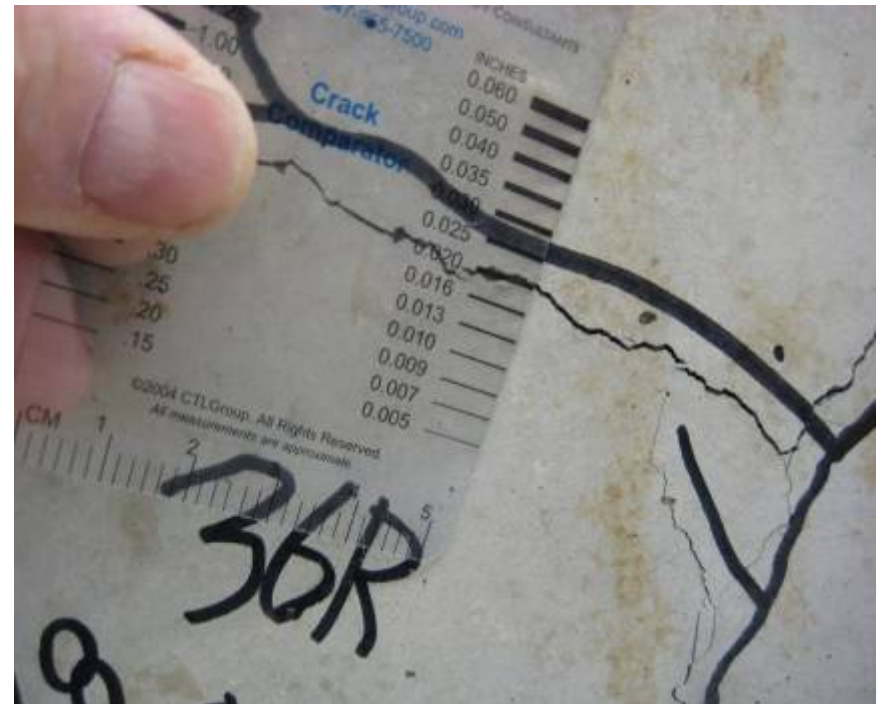
- Two different methods were used to create laminar cracks in the samples to be tested
- Results were independently verified
