Steam Generator Tube Degradation

Bill Borchardt
Executive Director For Operations
February 7, 2013

San Onofre Replacement Steam Generator Tube Wear

***SAN ONOFRE:
FAR OUTSIDE THE NORM***

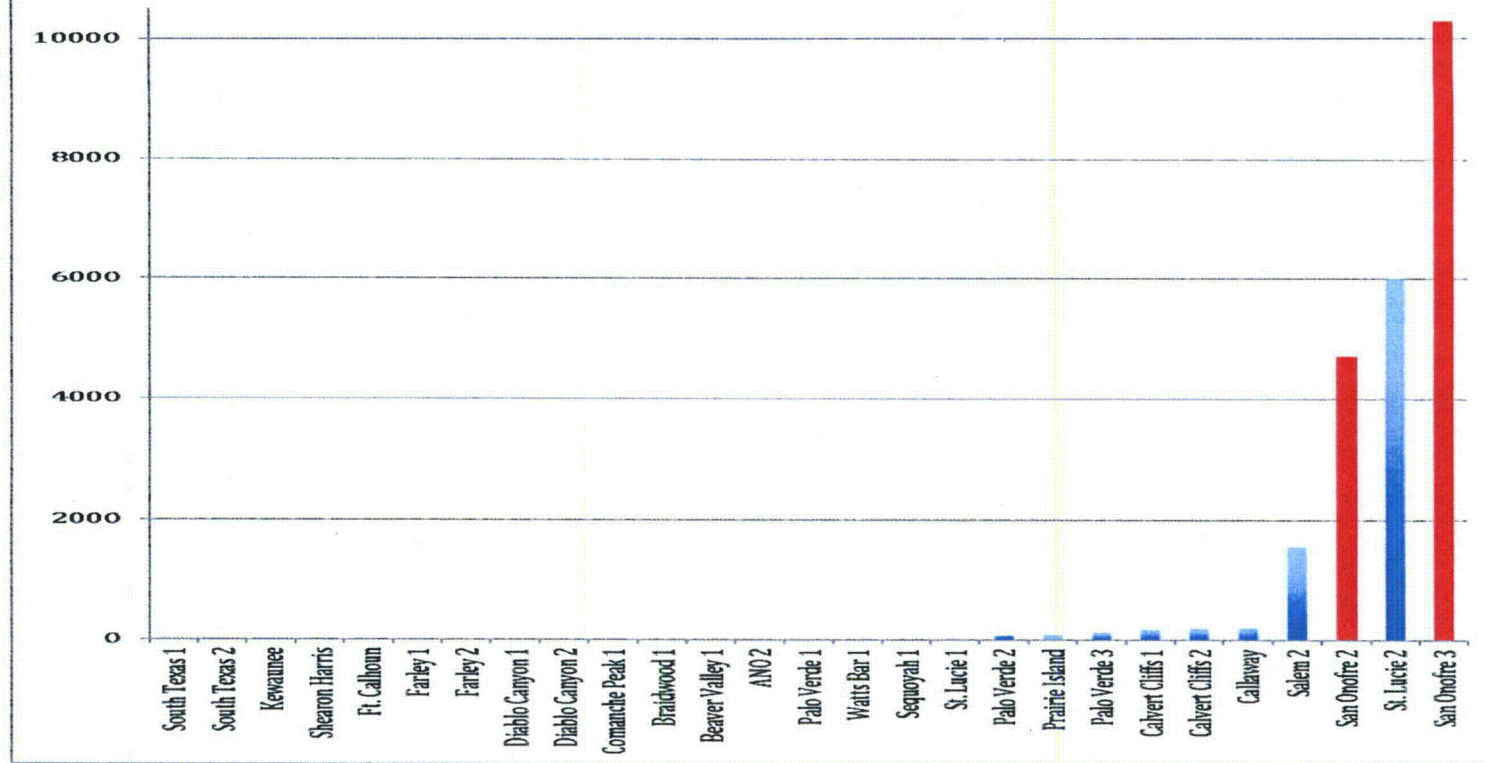
Number of Indications of Wear on Steam Generator Tubes

***THE MEDIAN NUMBER OF WEAR
INDICATIONS ON STEAM
GENERATOR TUBES AFTER ONE
CYCLE OF OPERATION IS—
FOUR.***

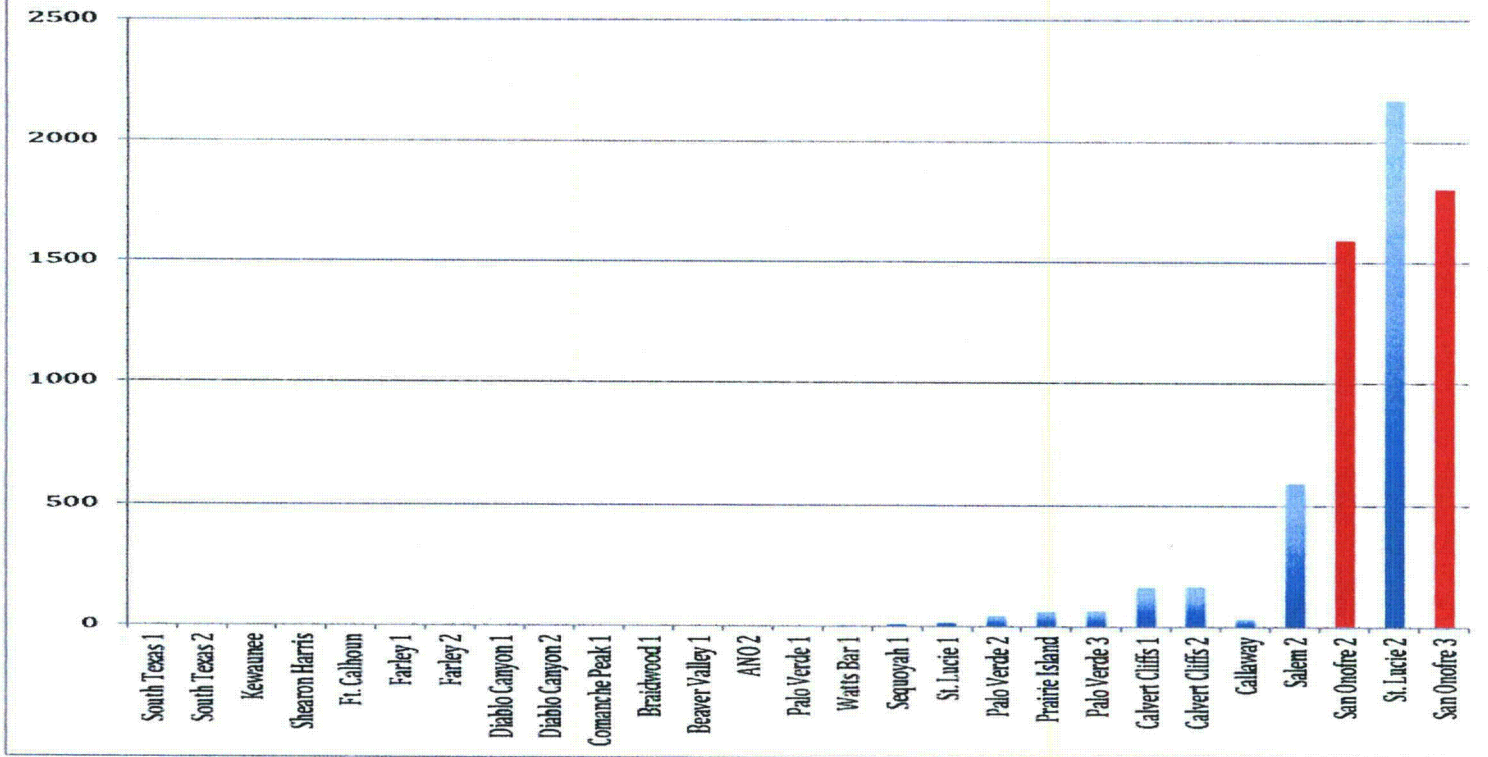
Number of Damaged Steam Generator Tubes

***THE MEDIAN NUMBER OF STEAM
GENERATOR TUBES SHOWING
WEAR AFTER ONE CYCLE OF
OPERATION NATIONALLY IS—
FOUR.***

**SAN ONOFRE UNIT 2
HAD 1595 DAMAGED
TUBES, APPROXIMATELY
400 TIMES THE MEDIAN.
SAN ONOFRE UNIT 3
HAD 1806.**

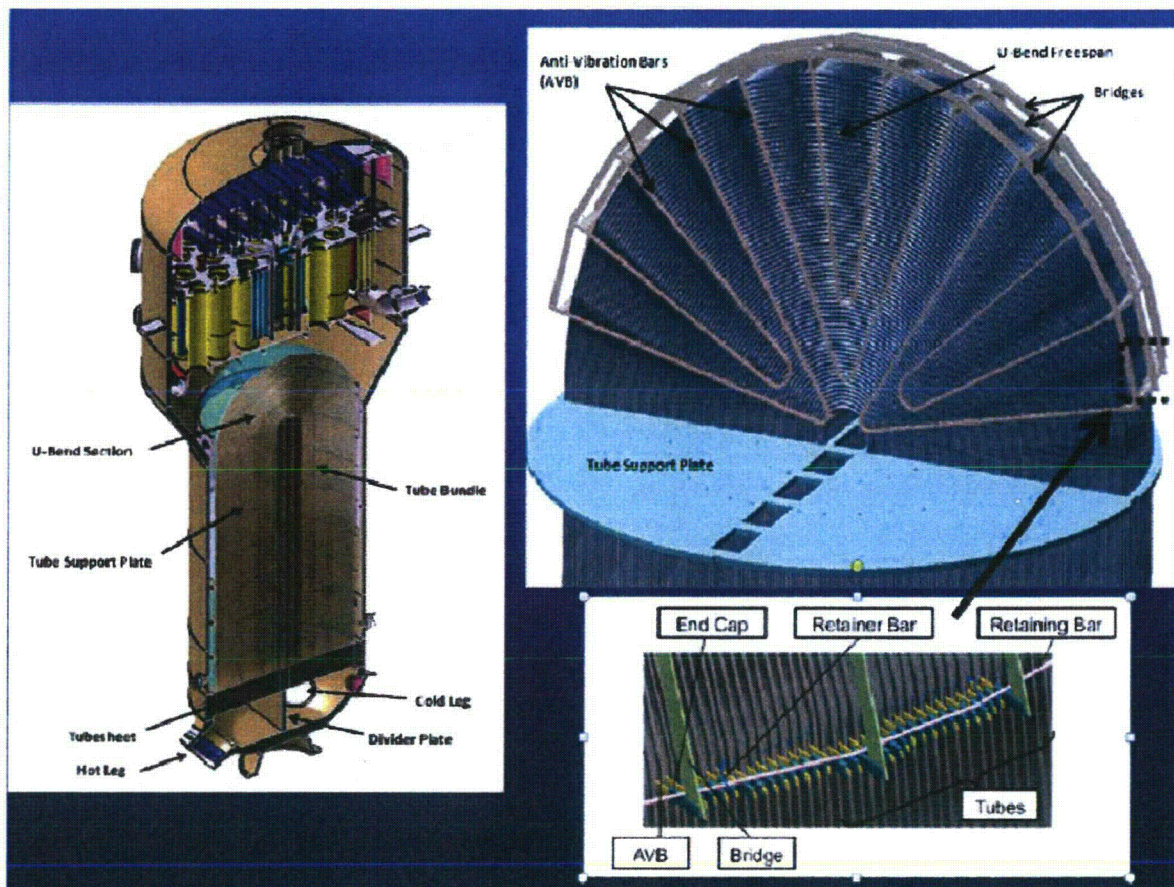
Figure 1 San Onofre Replacement Steam Generator Schematic

The tubes are in an inverted U shape: in the upper part of the steam generator, the tubes bend to return downward again. There are four key parts of the steam generators for the present discussion: the tube support plates, through which the tubes run; the anti-vibration bars (AVBs), designed to reduce vibration; the retainer bars, which help retain the AVBs; and the U-Bend Freespan, where the tubes bend near the top of the steam generator and have no immediate support.

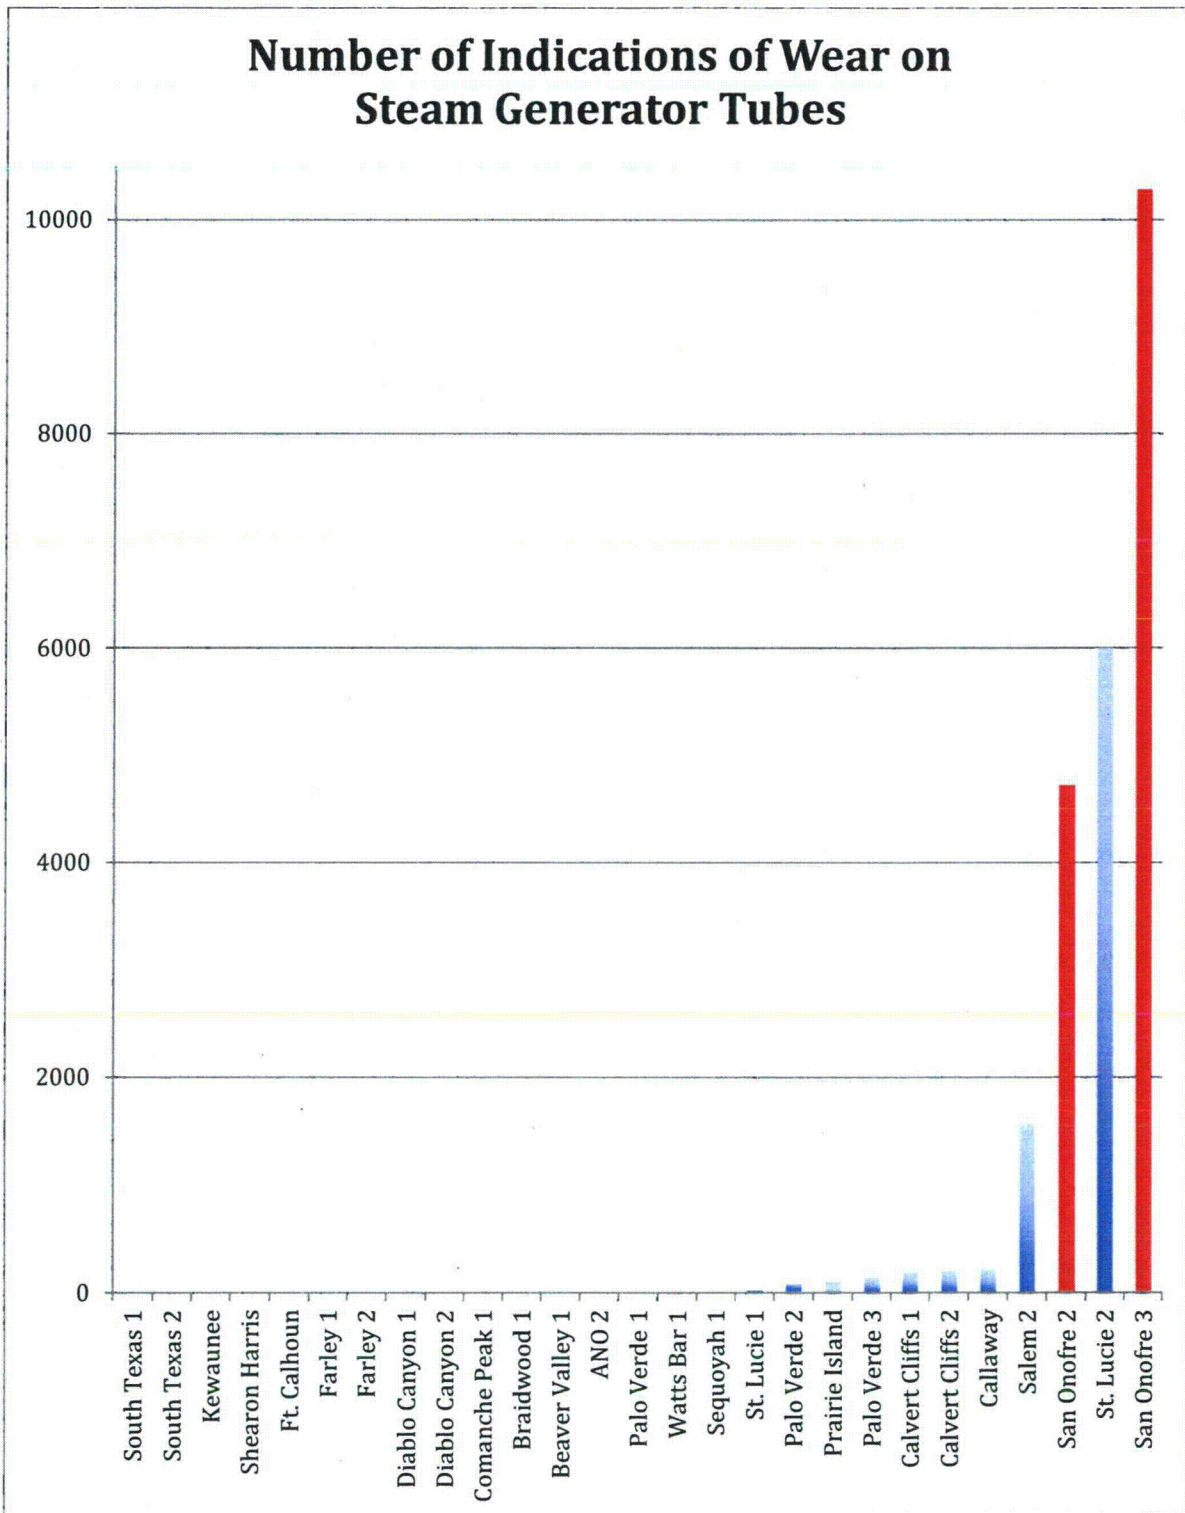
Figure 3

As dramatically shown in Figures 3, 4, and 5 of this report, the San Onofre experience after only two or less years of operation with replacement steam generators lies far outside the bounds of normality when compared to the experience of other nuclear units with such replaced components. Steam generators, and more specifically the tube boundaries, play a critical role in assuring plant safety and the containment of possible radioactive releases. In spite of Edison's attempt to assert a different level of risk between Units 2 and 3, it seems clear that similar design and failure challenges are present in both units and that future operation of either unit has not been technically justified. It is my opinion that measures necessary for the future safe operation of either of these unit have not been adequately put forth at this time, and that operation with or without reduced power of Unit 2 should not be authorized.

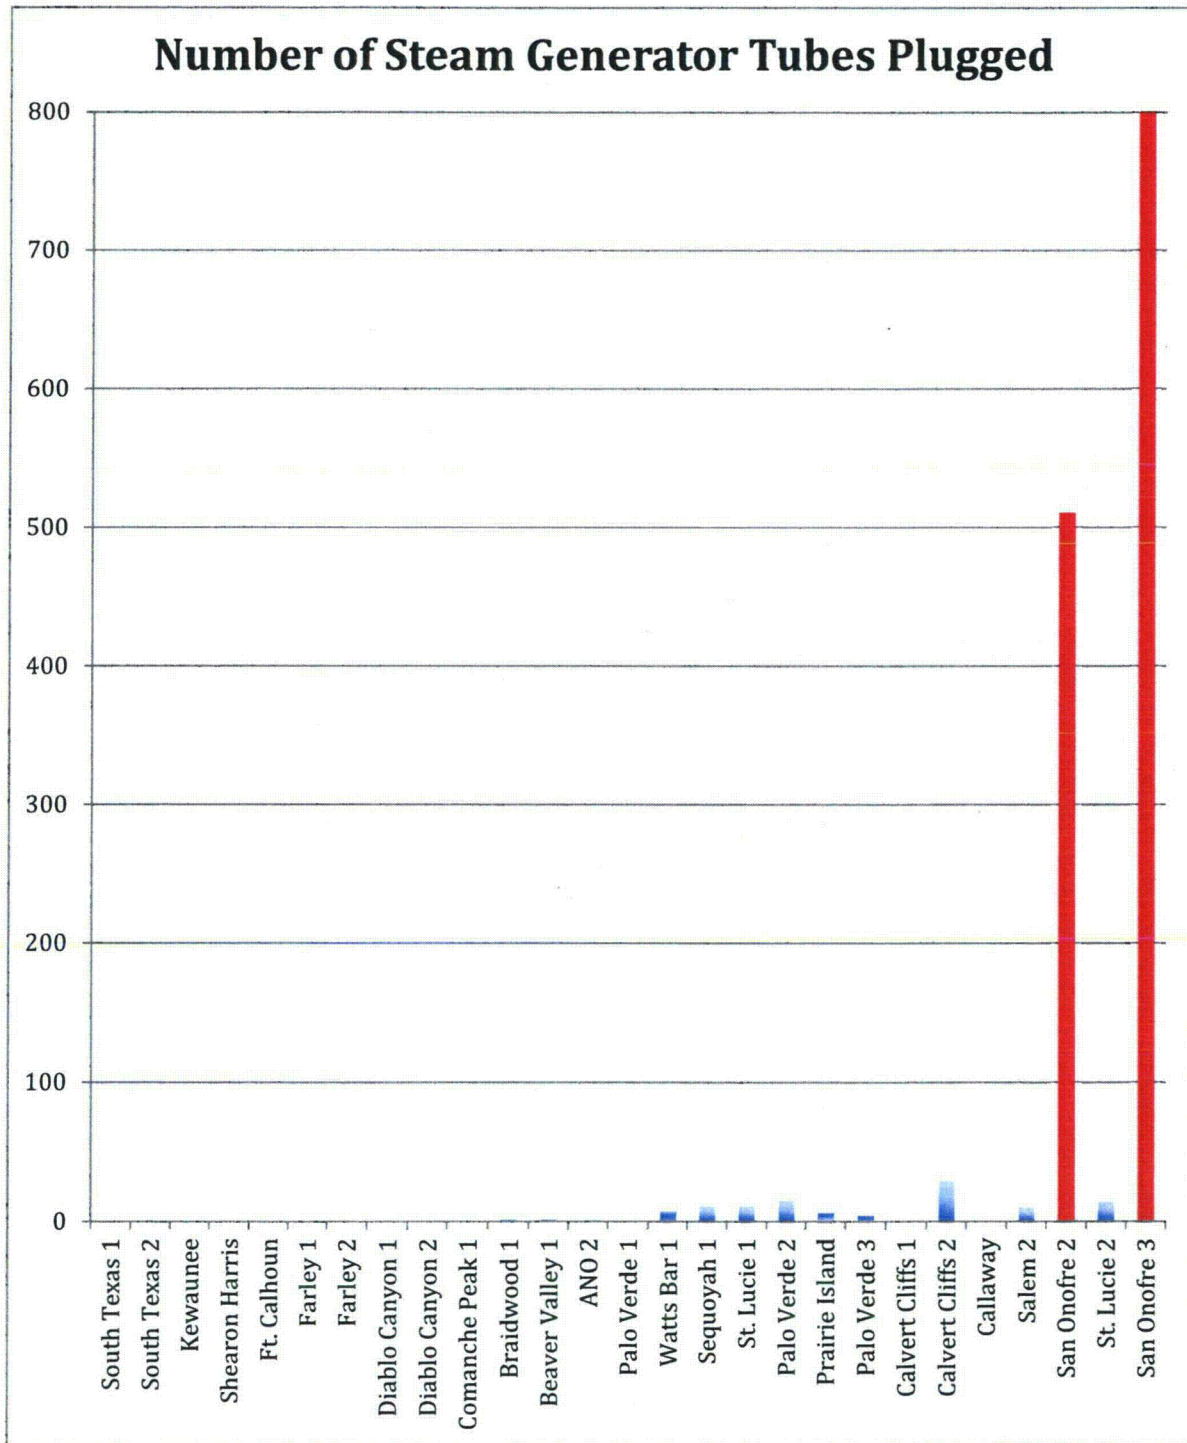
Figure 5

Additionally, as will be seen in Table 3 and Figure 5, the number of steam generator tubes that have had to be plugged in each reactor is in the same approximate range: 510 in Unit 2 and 807 in Unit 3. As this report shows, these numbers are dramatically higher than the national experience. Each San Onofre unit has had to plug many times more tubes than all reactors with new steam generators in the country, over a comparable operational period, combined.
