SUBJECT: MITSUBISHI HEAVY INDUSTRIES – REQUEST FOR WITHHOLDING ROOT
CAUSE ANALYSIS AND SUPPLEMENTAL TECHNICAL EVALUATION REPORT
INFORMATION FROM PUBLIC DISCLOSURE

REPLACEMENT STEAM GENERATORS

Root Cause Analysis Report for tube wear identified in the Unit 2 and Unit 3 Steam Generators of San Onofre Nuclear Generating Station

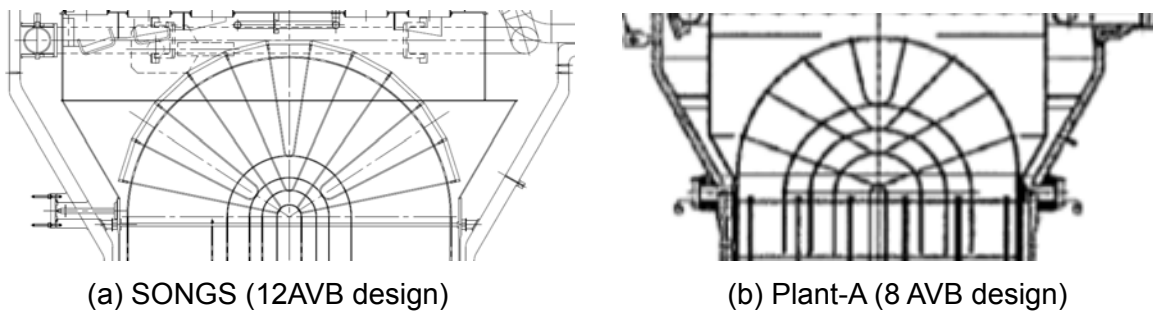
Fig.3.2.1-1 Comparison between 12 and 8 AVB Design

Tube wear patterns similar to those observed at SONGS were reported at the Plant-A large U-bend steam generators that were replacements for CE manufactured OSGs (See NRC ADAMS ML11270A015 and ML093230226). The Plant-A steam generators were designed by another vendor. They are slightly smaller than the SONGS steam generators but have U-bend tubes, flat bar AVBs, and BEC type TSPs, that are similar to the SONGS RSGs, except SONGS features a 12 AVB design and Plant-A has an 8 AVB design.

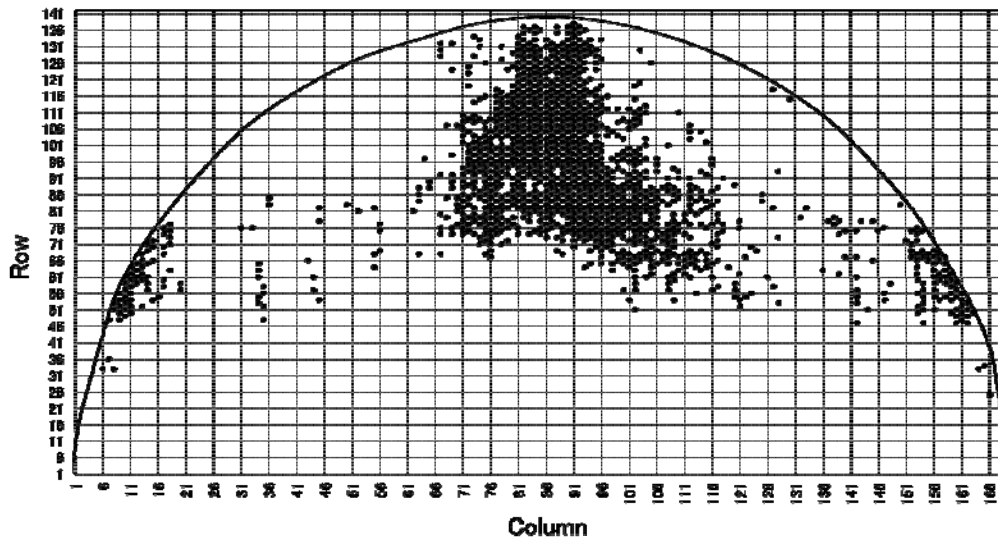
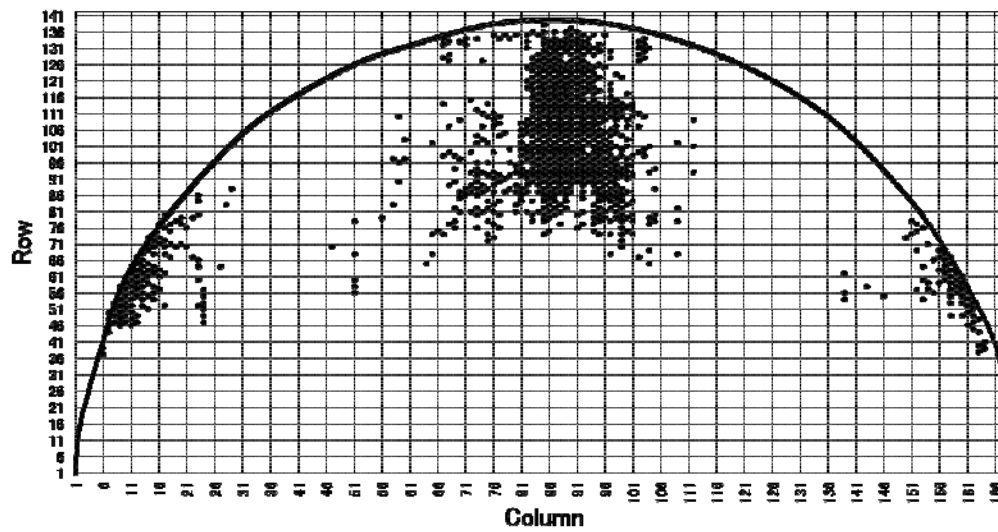
Fig.3.2.1-2 Plant-A Tubes with AVB Indications at first inspection
(based on information from NRC ADAMS ML11270A015 and ML093230226)

The Plant-A inspection results show a wear pattern with many tubes in the center of the U-bend that have tube-to-AVB wear similar to that found in the SONGS steam generators. Figure 3.2.1-2 shows the tubes with tube-to-AVB wear identified at Plant-A during the first inspection following installation of the RSGs and Figure 3.2.1-3 shows the tubes with tube-to-AVB wear identified at Plant-A during the second cycle inspection. Note that the locations of the Plant-A indications are very similar to those for SONGS shown in Figs. 3.1-1 and 3.1-2.

Figure 3.2.1-5 suggests that the tube-to-AVB wear depths at Plant-A have reached a plateau. The reason for such a plateau is unclear. It may be indicative of the type of tube vibration mechanism or an effect of the support condition. But it is clear that the number of tubes with tube-to-AVB wear at Plant-A is growing (refer to Fig. 3.2.1-2 and 3.2.1-3).

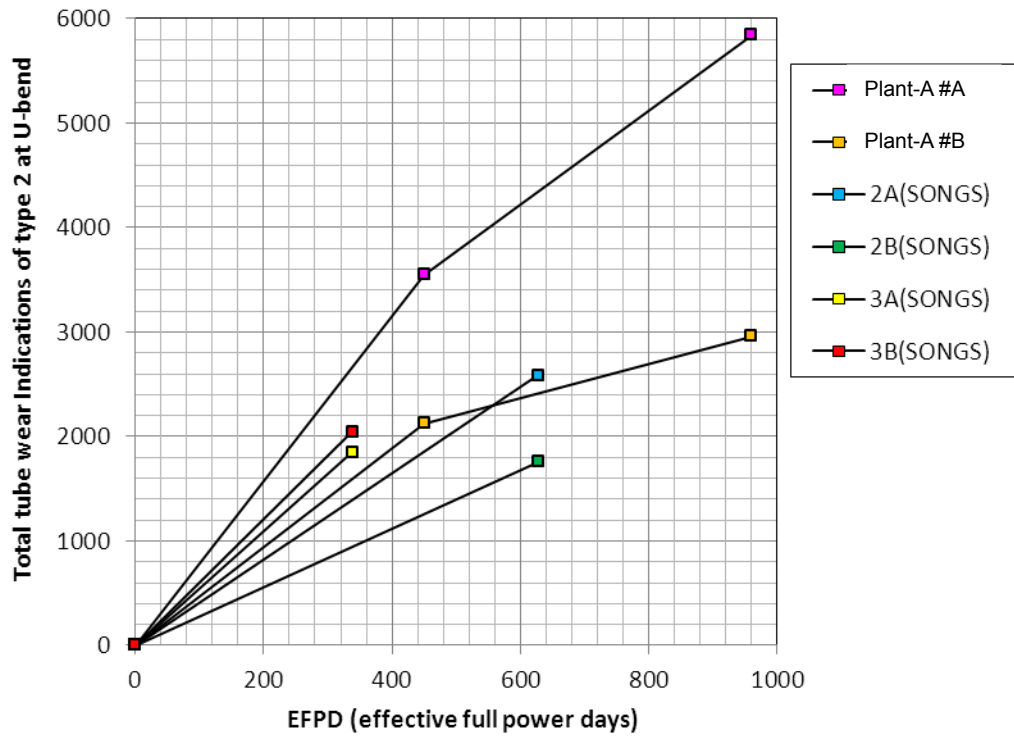
Fig.3.2.1-4 Total Tube-to-AVB Wear Indications

Figure 3.2.1-4 compares the total number of tube-to-AVB wear indications for Plant-A, SONGS Unit 2, and SONGS Unit 3 as a function of time and Figure 3.2.1-5 shows the average wear depths for the three plants (six RSGs) as a function of time. As can be seen from these figures, the total number of indications and average wear depth at Plant-A are comparable to that at SONGS.

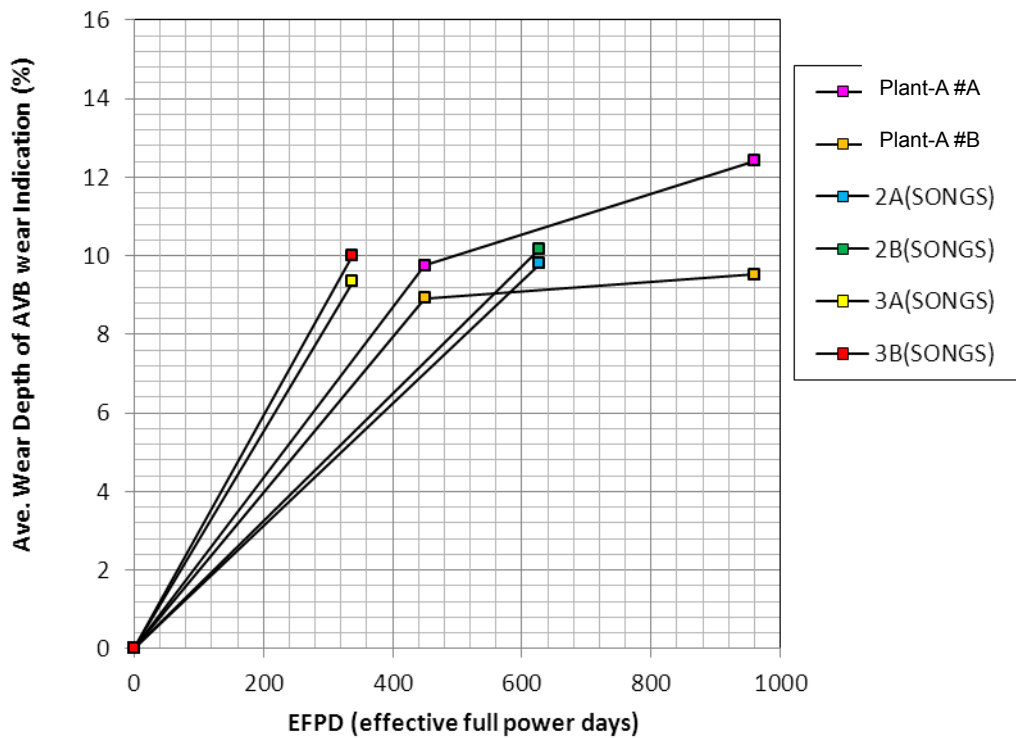
Fig.3.2.1-5 Average Tube-to-AVB Wear Rate

While the number of tubes with Type 2 wear is very similar for Unit 2 and Unit 3 (Compare Table 1-1 and Table 1-2), Unit 2 has operated approximately twice as long as Unit 3. As a result, as shown in Fig. 3.2.1-5, the wear rate in Unit 3 is faster than that for Unit 2. An explanation for this difference is found in the manufacturing assessment which concluded that the tube to AVB contact forces in Unit 3 were less than half than those in Unit 2. (See Section 2.3.3 above.)

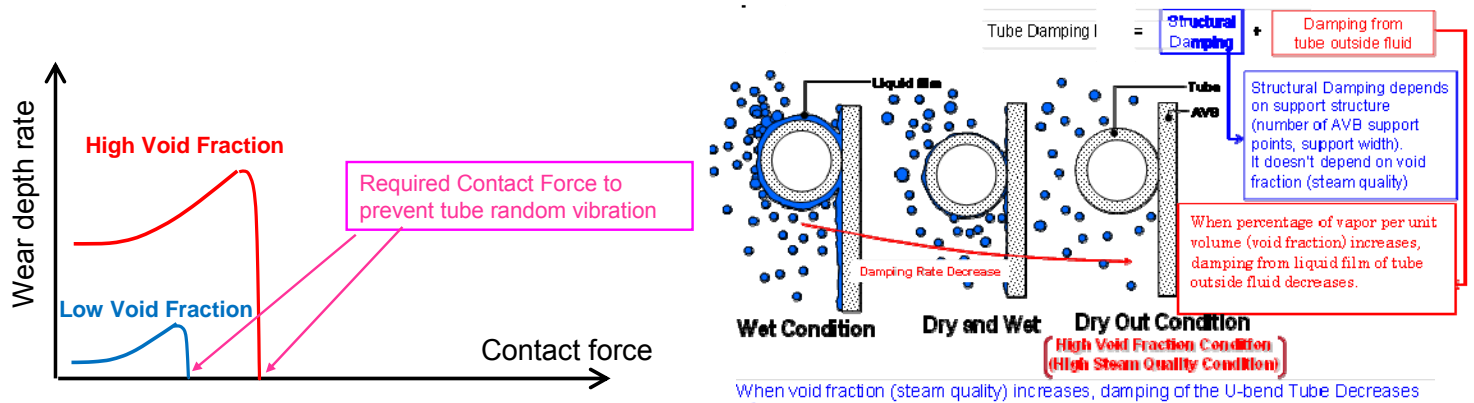
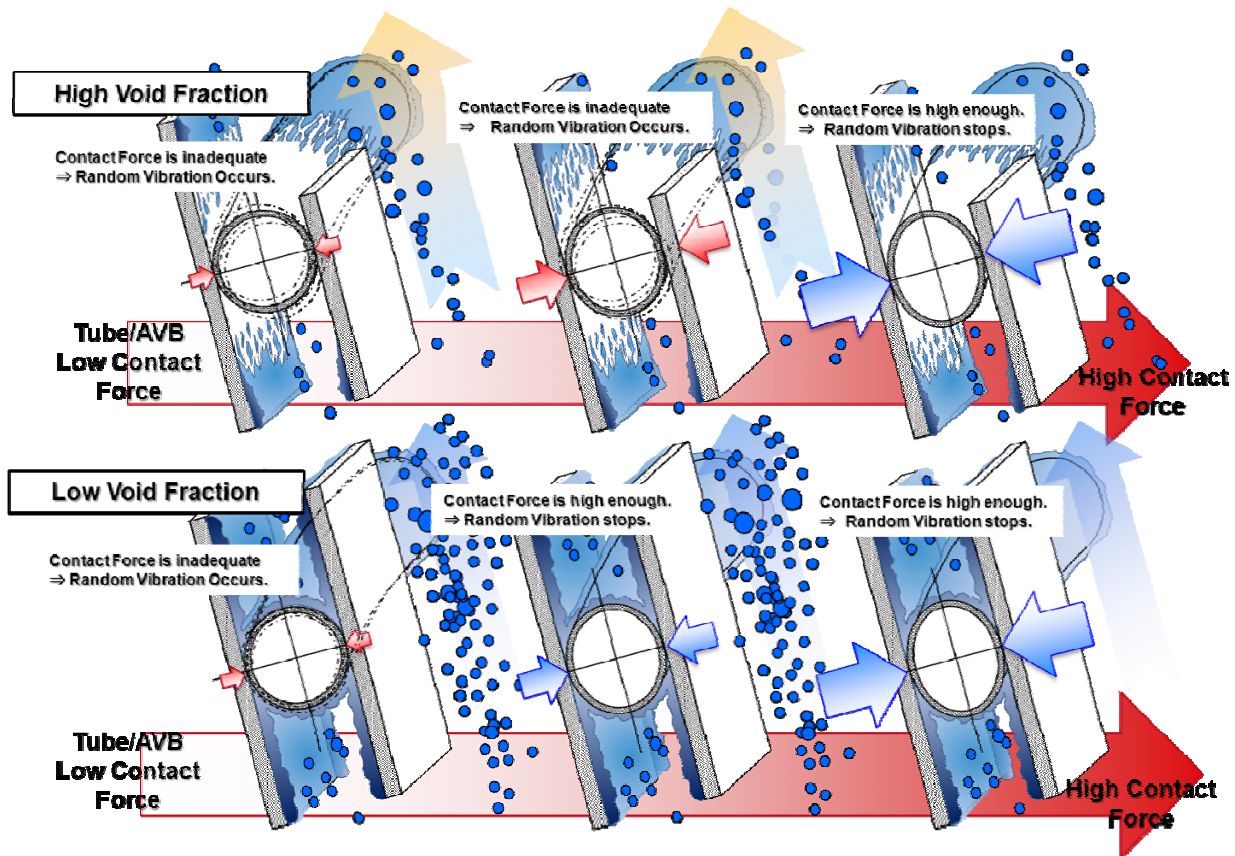
Fig.3.3-2 Contact force sufficient to prevent random tube vibration

As shown in the figure at the upper left corner of Fig.3.3-2, insufficient contact force has an adverse effect on tube wear caused by random tube vibration up to the point where the contact force is sufficient to prevent tube lift-off from (or sliding along) the AVB. The amount of contact force necessary to prevent random vibration is a function of the thermal-hydraulic condition. As the void fraction (steam quality) increases, the amount of contact force necessary to prevent random vibration increases. This is because the higher void fraction (steam quality) results in lower external fluid damping and a reduction in the liquid film damping (squeeze film damping).
